# Rugby Football League Our League Life Hub

## Phase 2 Ground Investigation

Curtins Ref: 077652-CUR-00-XX-RP-GE-003

Site Address: Land off Kirkstead Close, Beswick, Manchester, M11 3DS

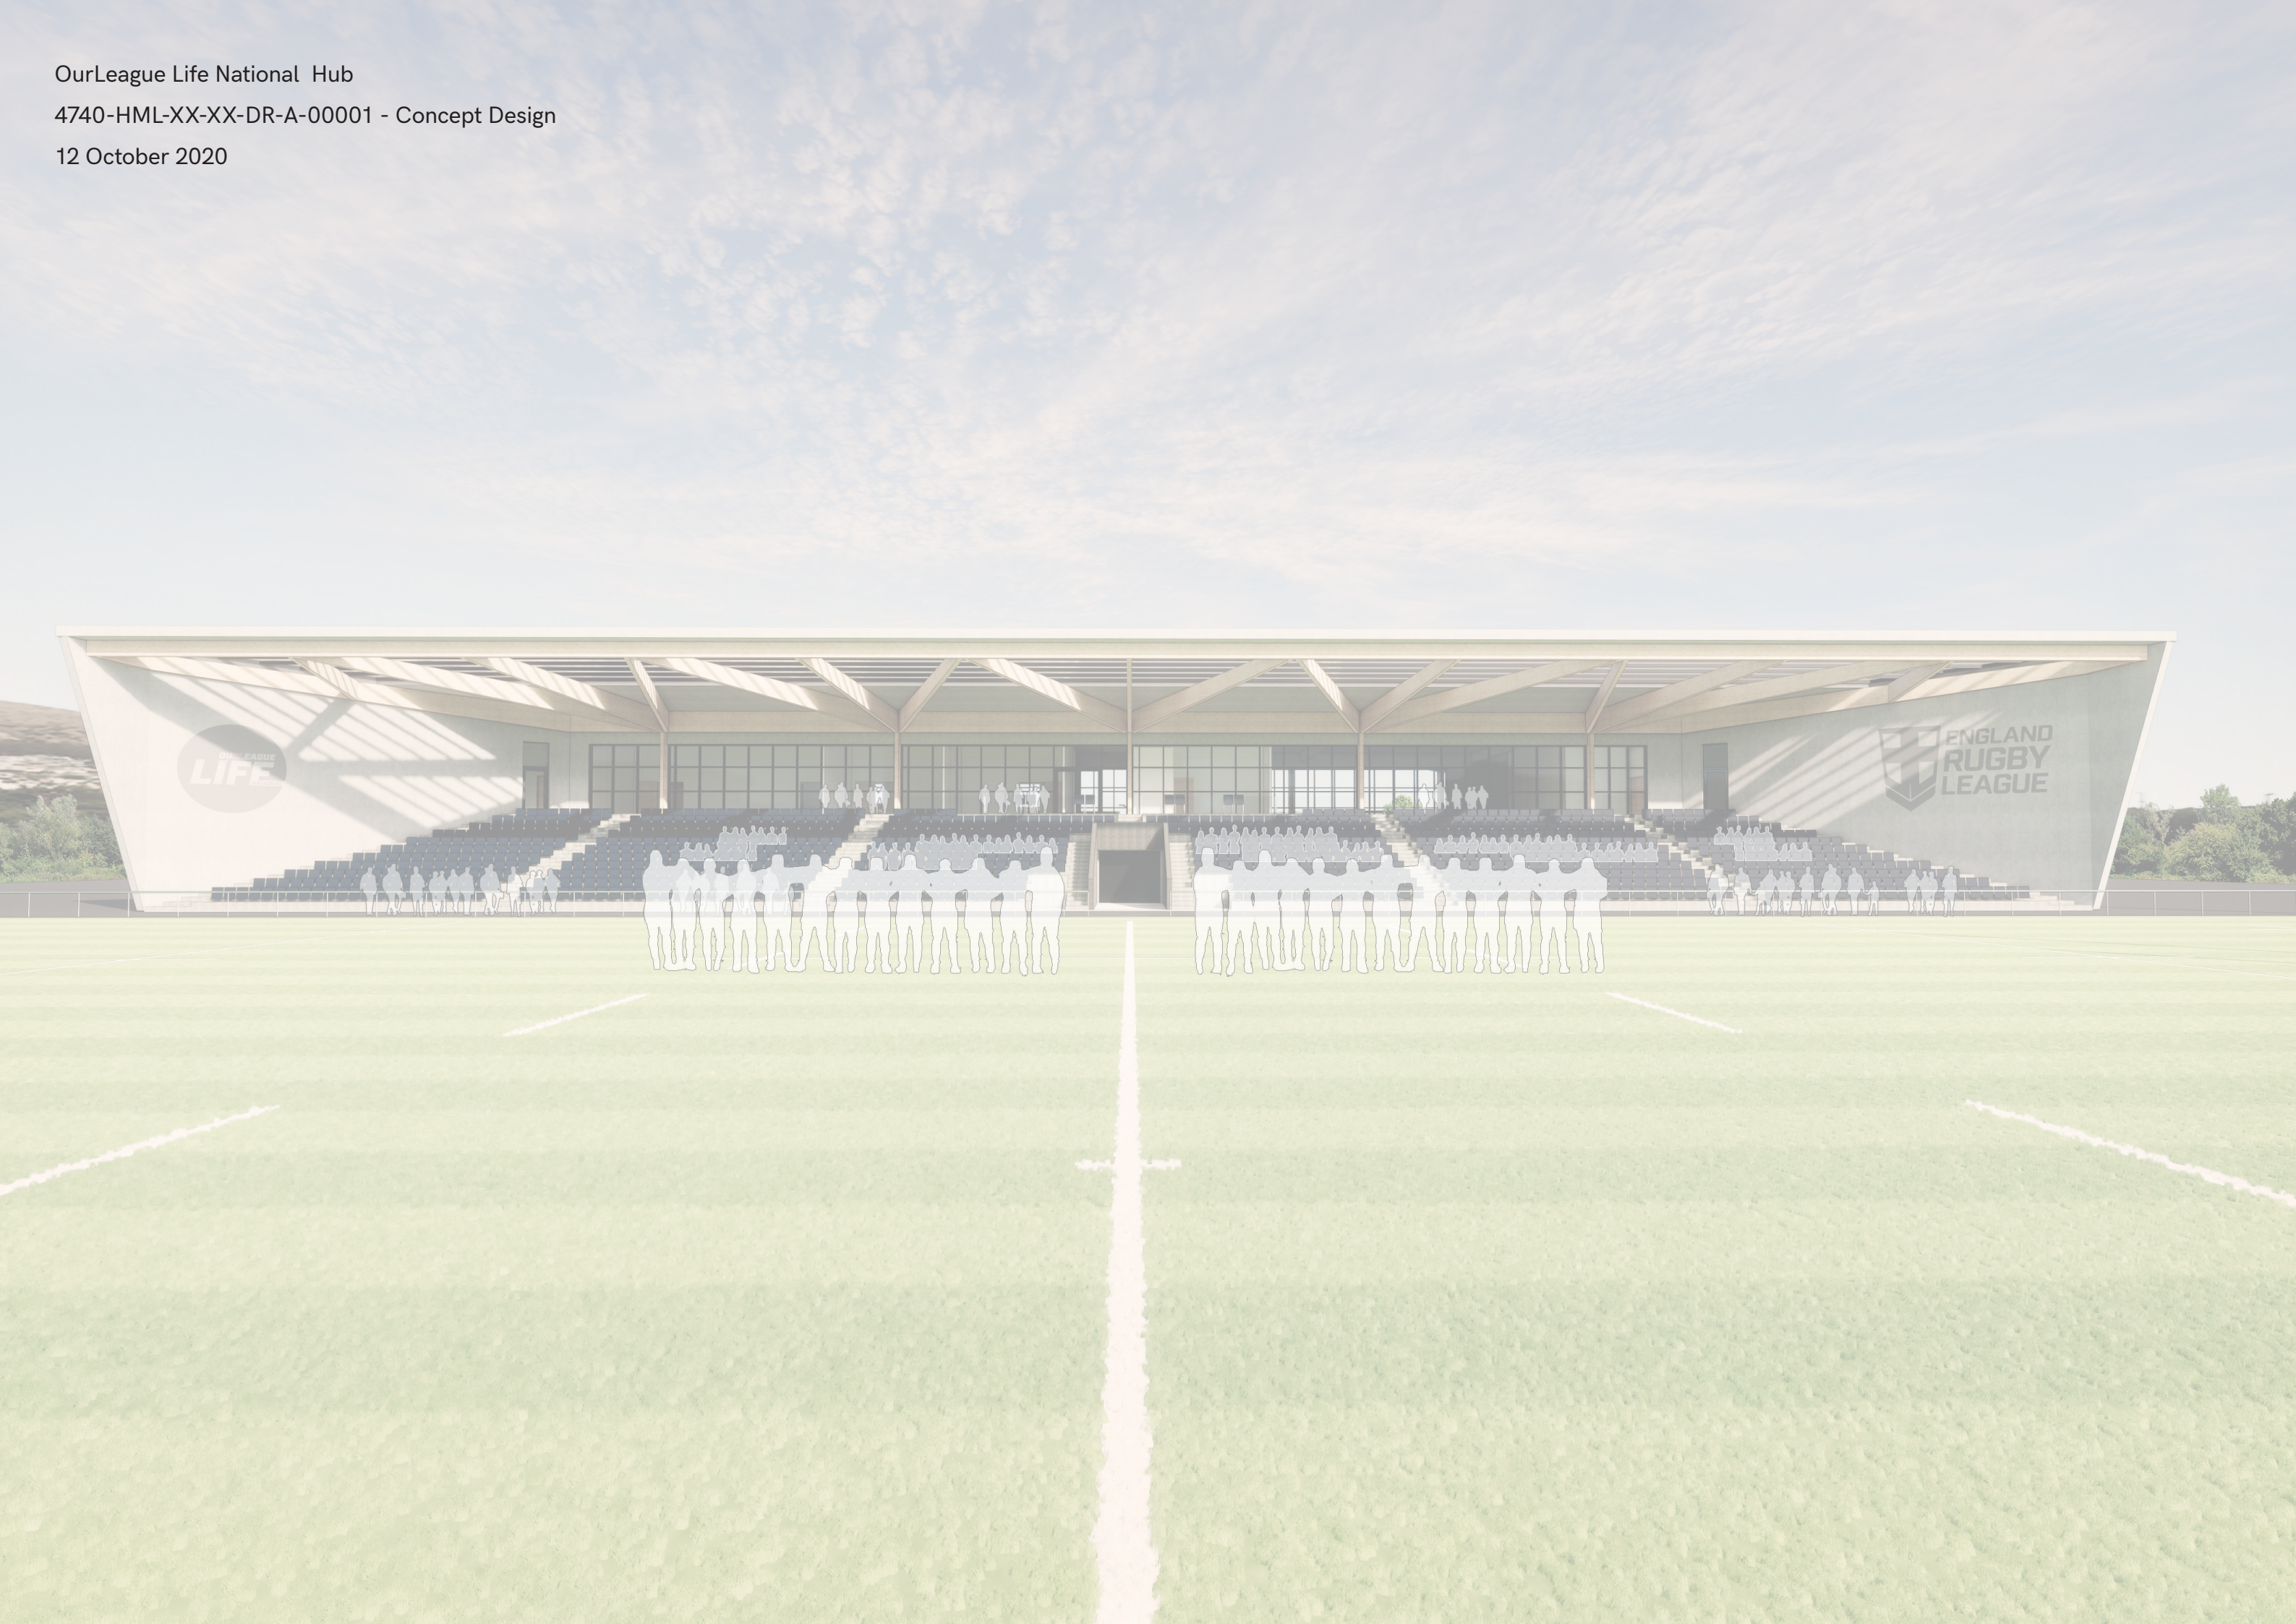
- Holmes Miller (2020), Concept Design (Presentation), ref. 4740-HML-XX-XX-PP-A-00001
- Curtins, Exploratory Hole Location Plan, ref. 077652.300-CUR-XX-DR-GE-80002-P01

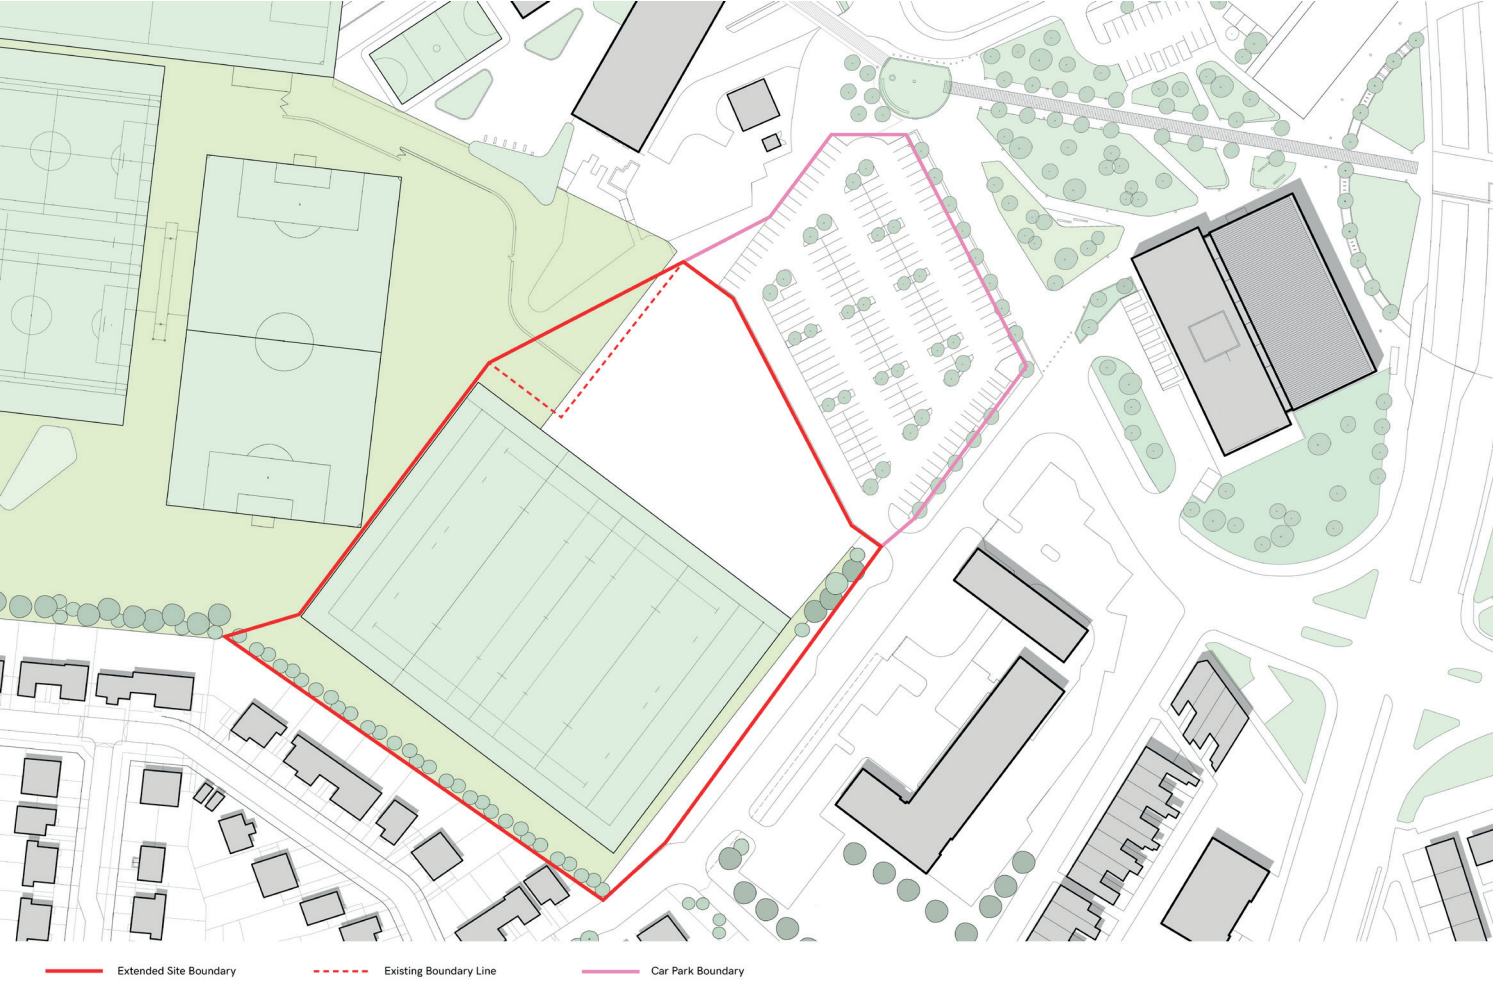
Site Boundary

In order to provide suitable sight-lines to the pitch, avoid steep embankments to the SE and maintain an appropriate distance from adjacent housing it is expected that extending the NW site boundary edge would be beneficial.

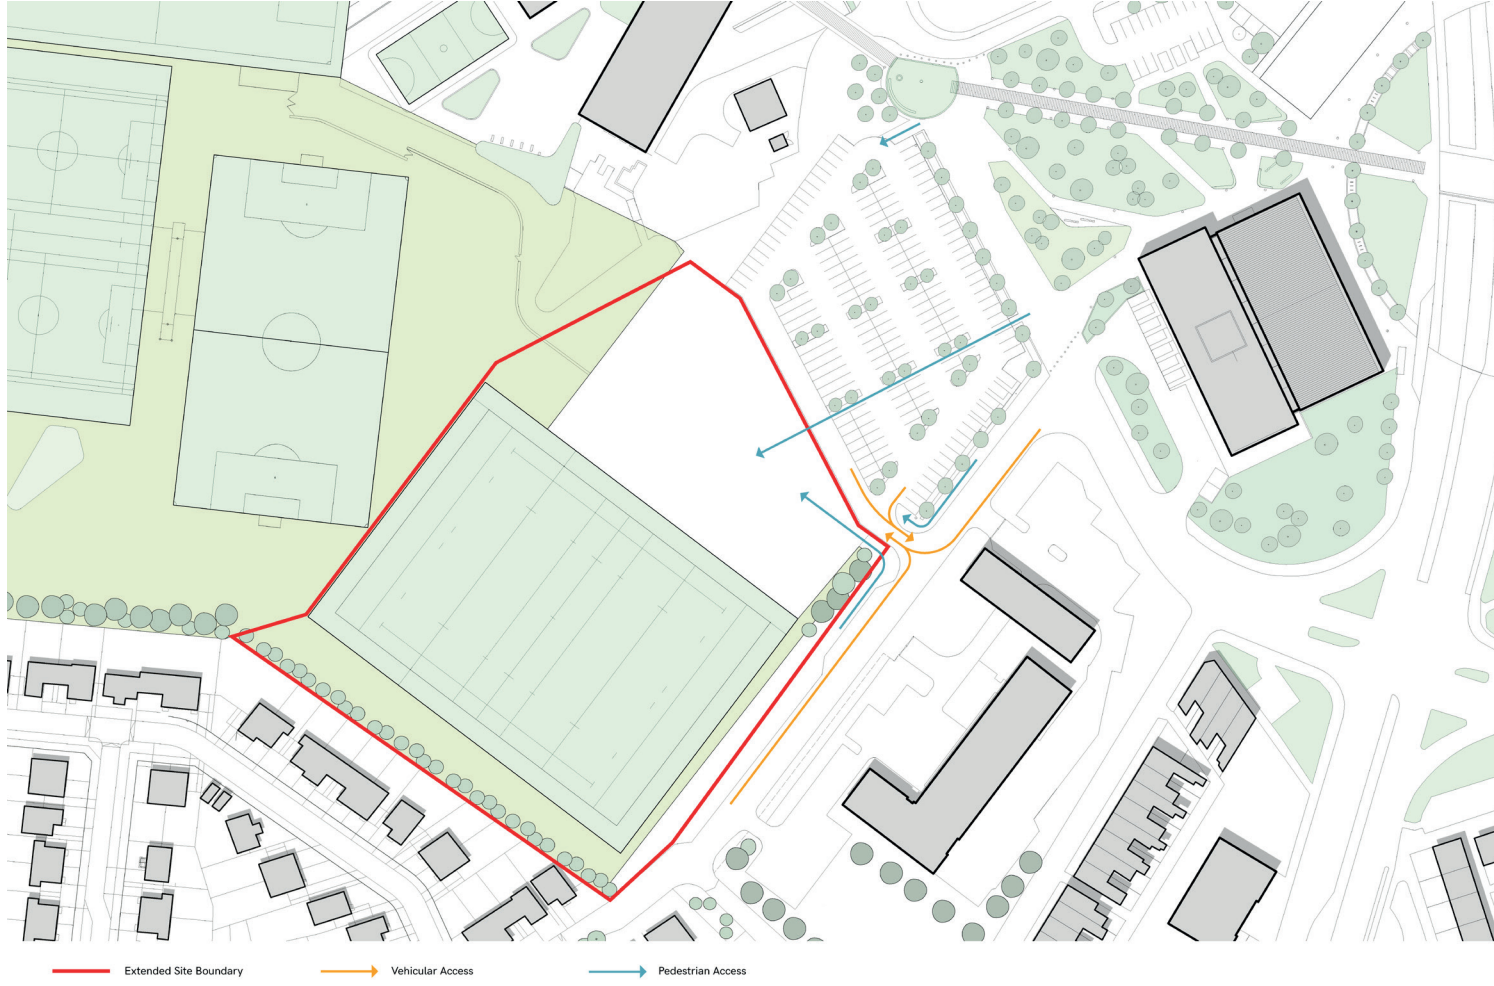
Access

Vehicular access to the existing carpark is via Kirkstead Close off of Bell Crescent. A new lay-by should be incorporated along the edge to provide accessible drop-off as well as access for deliveries, maintenance and emergency vehicles.

Primary pedestrian access is from the newly landscaped Grey Mare Lane, linking connections from the Ethad and Beswick campus to the North. Pedestrians can also access the site from Bell Crescent.

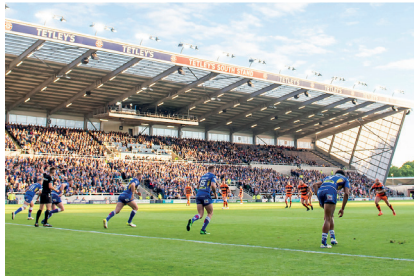
Emerald Headingley Stadium  
DLA Architecture

**ROOF:**  
**TRAPEZOIDAL METAL /  
POLYCARB**

- LIGHTWEIGHT
- DURABLE
- EFFICIENT
- COST EFFECTIVE

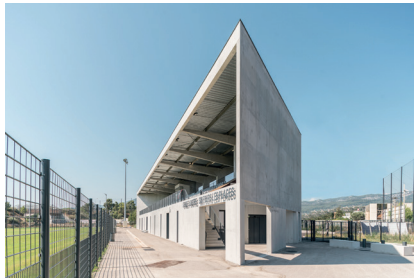
Stadium Saetre  
Baito Architects

**ENVELOPE:**  
**PRE-CAST CONCRETE**

- ROBUST
- DURABLE
- MONOLITHIC
- NON-COMBUSTIBLE
- PROTECTIVE

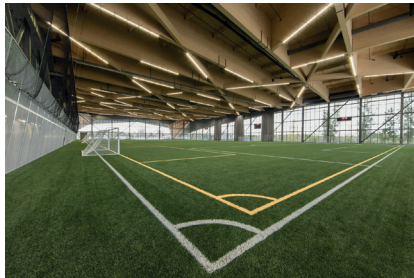
Stade De Soccer de Montréal  
Saucier + Perrotte architects + Hughes Condon Marler Architects

**STRUCTURE:**  
**GLULAM TIMBER**

- SOFT + WARM
- MORE TACTILE
- SUSTAINABLE
- AESTHETICS
- FIRE PERFORMANCE

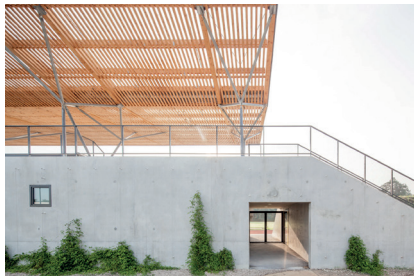
Philippe Mahut Stadium  
Barthélémy Griño Architects

**PLINTH:**  
**PRE-CAST CONCRETE**

- ROBUST
- DURABLE
- MONOLITHIC
- NON-COMBUSTIBLE
- HEAVILY TRAFFICKED
