OUR REF: A2212/21/LR/V1 16<sup>th</sup> June 2021

**Soil Contamination Delineation Letter Report**  
**Claremont Road, Manchester**

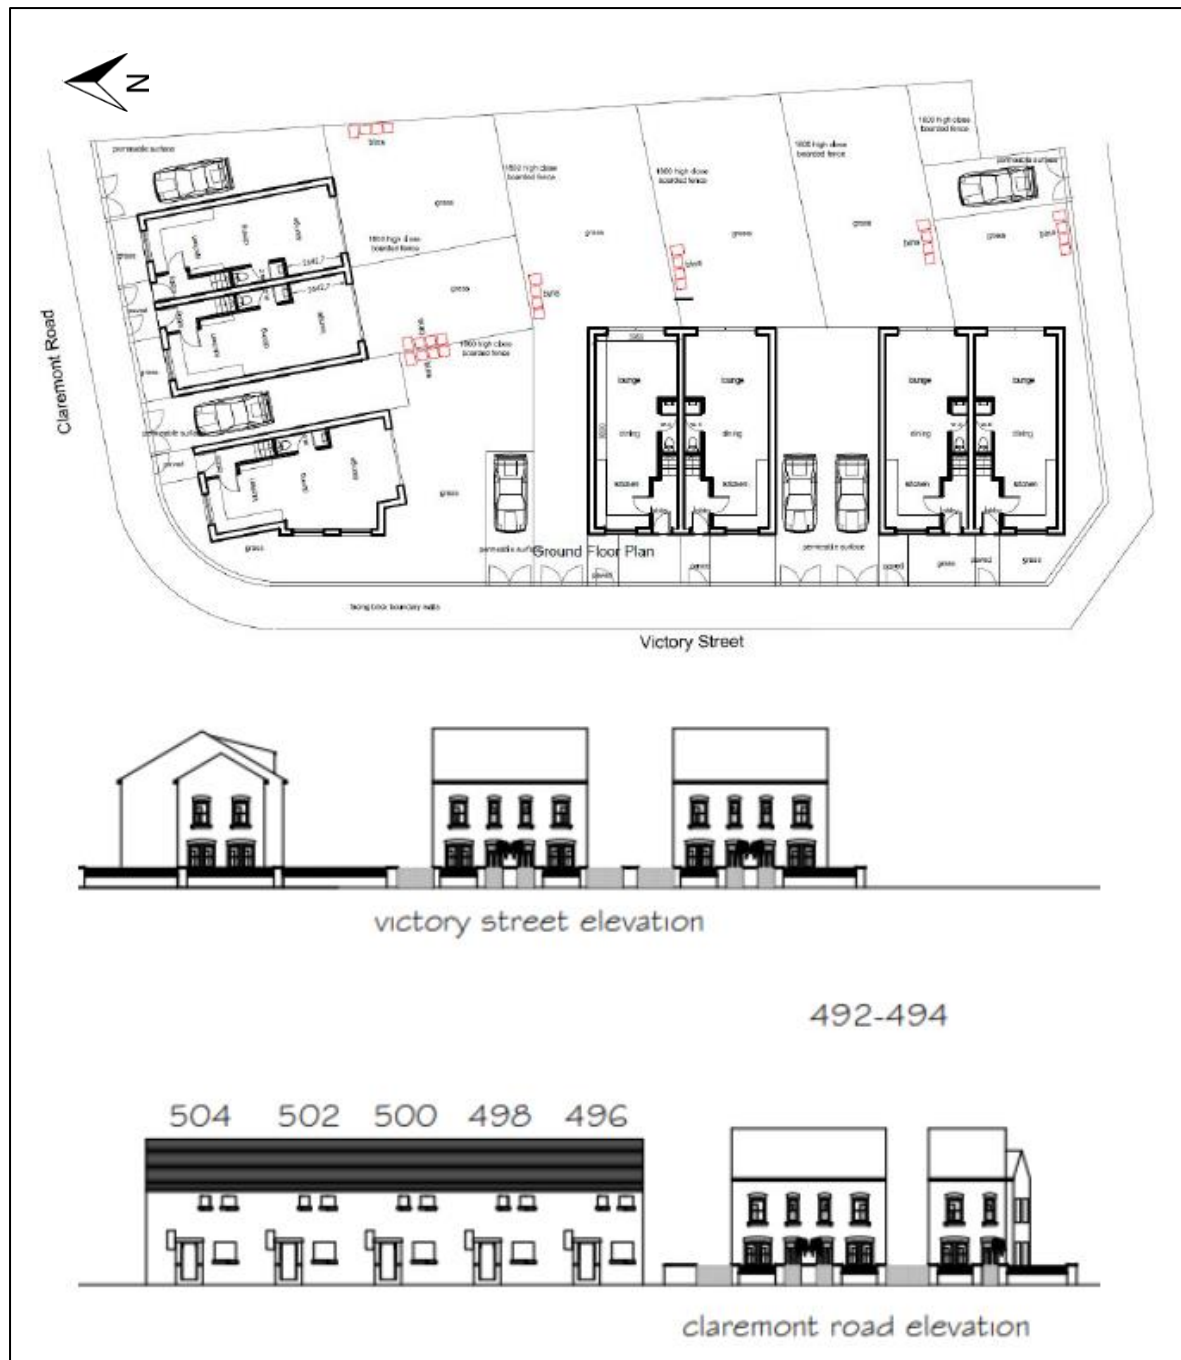
**Figure 1: Site Development Plan**

It is understood that the Client intends to construct 7no. two-storey residential dwellings with dormers and associated off street parking and garden areas.

A development plan has been provided as Figure 1 overleaf.

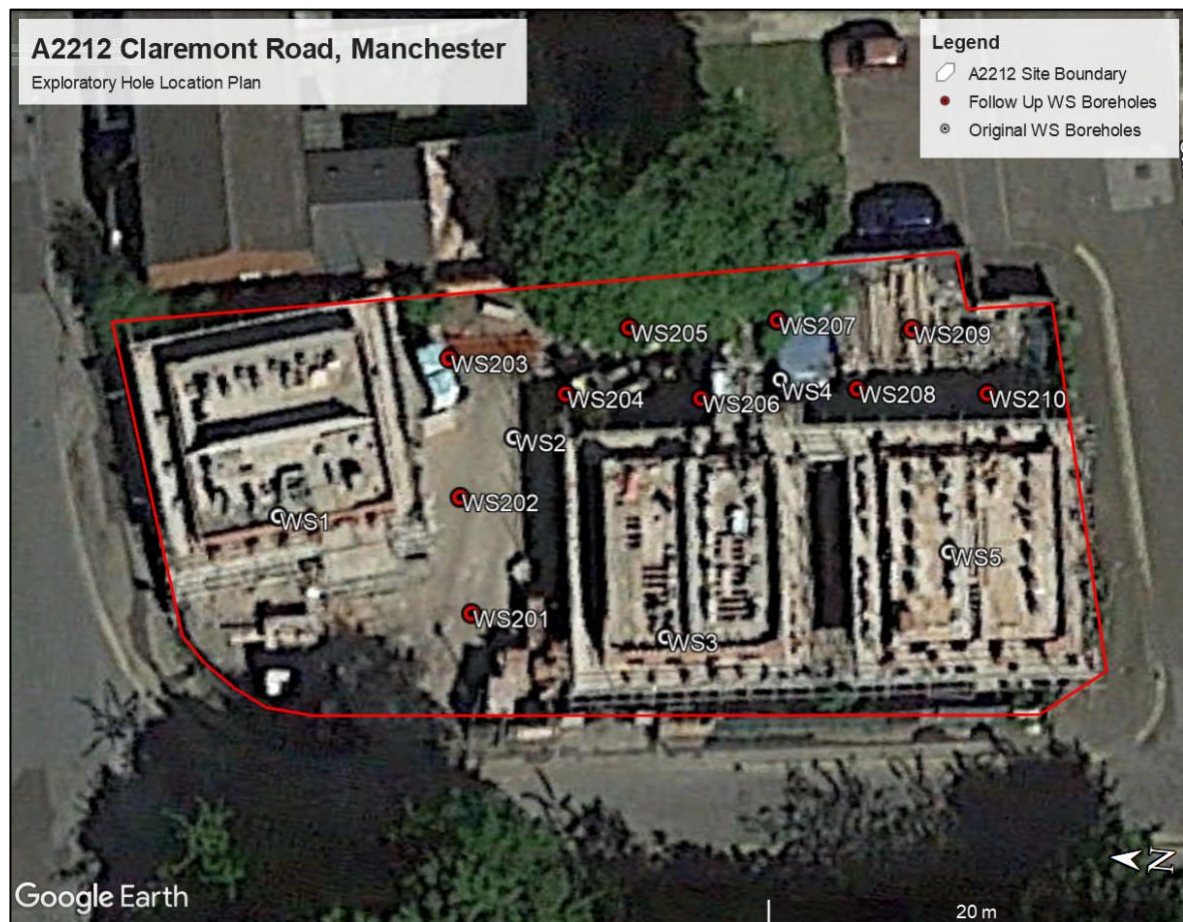
**Figure 2: Exploratory Hole Location Plan**

A site visit was conducted on the 26<sup>th</sup> May 2021, to retrieve samples from around identified contamination hotspots. Ten window sample boreholes (designated WS201 to WS210) were excavated to depths of 1.00m bgl. Each excavation was sampled and backfilled upon completion. Sampling locations are shown in Figure 2 overleaf.

In the area of the site investigated the ground conditions consisted primarily of variable made ground gravel with natural clay being encountered in WS209 and WS210.

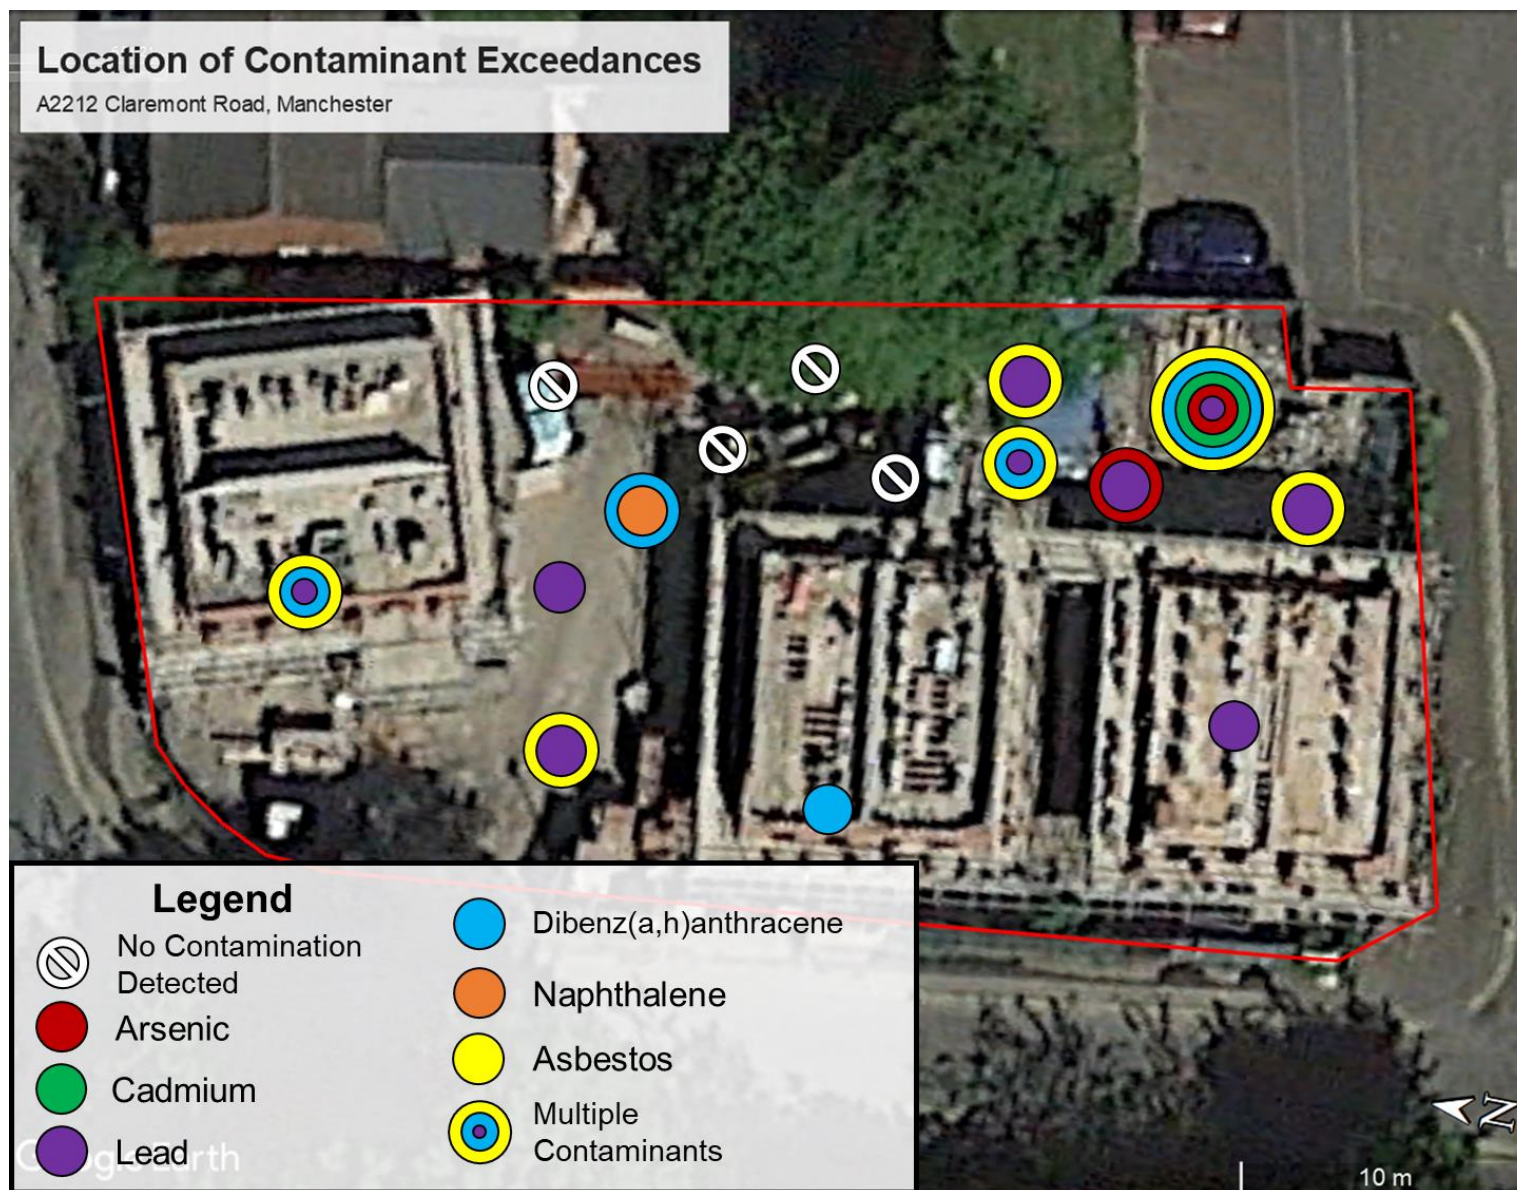
**Figure 3: Location of Contaminant Exceedances**

During the course of this investigation, chemical exceedances in arsenic, cadmium, lead and dibenz(a,h)anthracene (a species of PAH) were detected, with respect to the long-term protection of human health, have been identified across six of the samples tested during this investigation when compared to residential (with plant uptake) end use assessment criteria. The exceedances are summarised below in Table 2 and presented in Figure 3 alongside the previously identified contamination.

Asbestos was identified in four of the samples recovered from this investigation. The details of this can be found in Table 3 alongside the previously identified asbestos contamination with the locations presented in Figure 3.

In order to break potential pollutant linkages to future residential end users, it is recommended that landscaped areas in close proximity to the contaminated area should be capped with clean cover soils.
