# DAYTIME BAT SURVEY AT 246 PALATINE ROAD, DIDSBURY, GREATER MANCHESTER

NOVEMBER 2019

**RACHEL HACKING ECOLOGY**

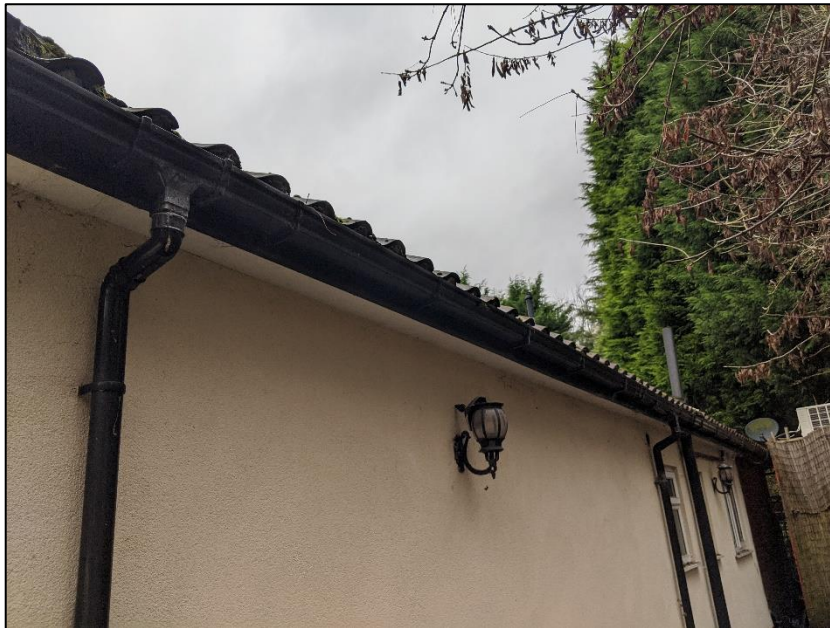
- 3.1 The development site at 246 Palatine Road is a detached residential dwelling, constructed from brick with a pitched, tiled roof.
- 3.2 The property exterior is fully rendered, with no cracks or gaps in the render for bats to exploit (see Photographs 1 and 2). The uPVC door and window frames are all intact and well-sealed to the surrounding masonry. The rear elevation has glass and uPVC conservatory, and this is well-sealed to the property exterior. The brick chimney stack is complete and intact. A small amount of lead-flashing occurs at the base of the chimney stack, and this is flat and flush to the brick and tiles.

Photograph 1 showing the side elevation

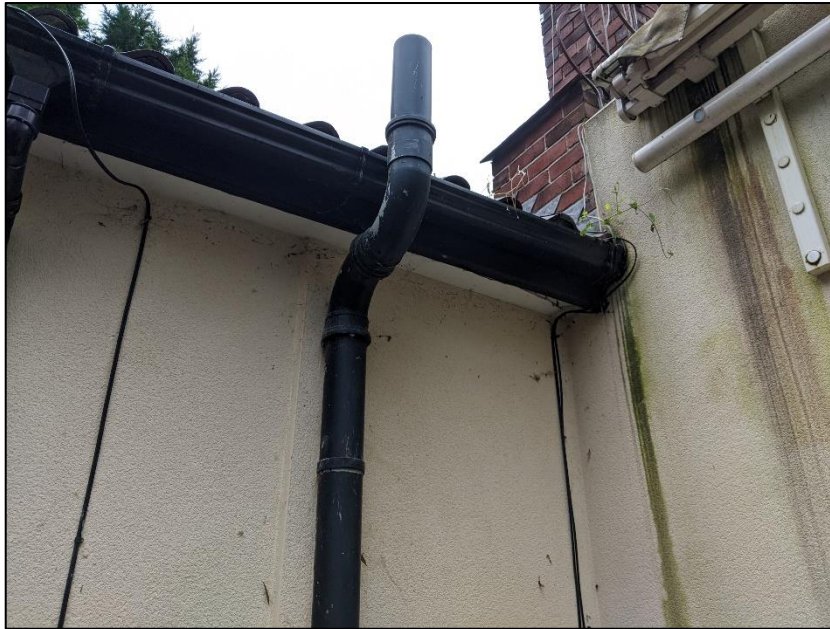
**Photograph 2 showing the rear elevation**

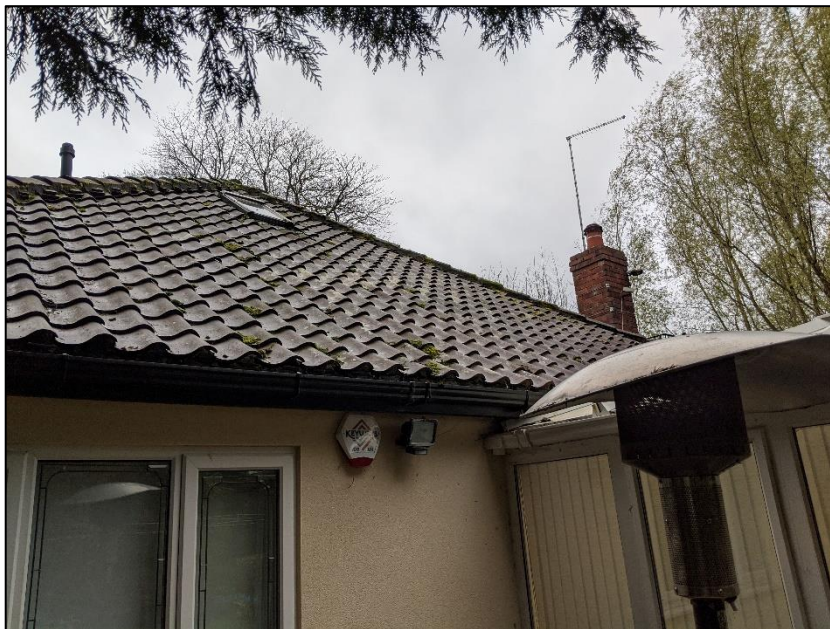
- 3.3 The roof of the property is pitched, with clay tiles (see Photographs 3 and 4). The tiles are all in position, with no slipped or visibly broken tiles. The ridge tiles are complete, and flush to one another, offering no suitable gaps for bats. The roof edge mortar is complete, providing a good seal to the roofing materials. The Velux windows are well-sealed to the surrounding tiles.

**Photograph 3 showing the roof of the property from the rear**

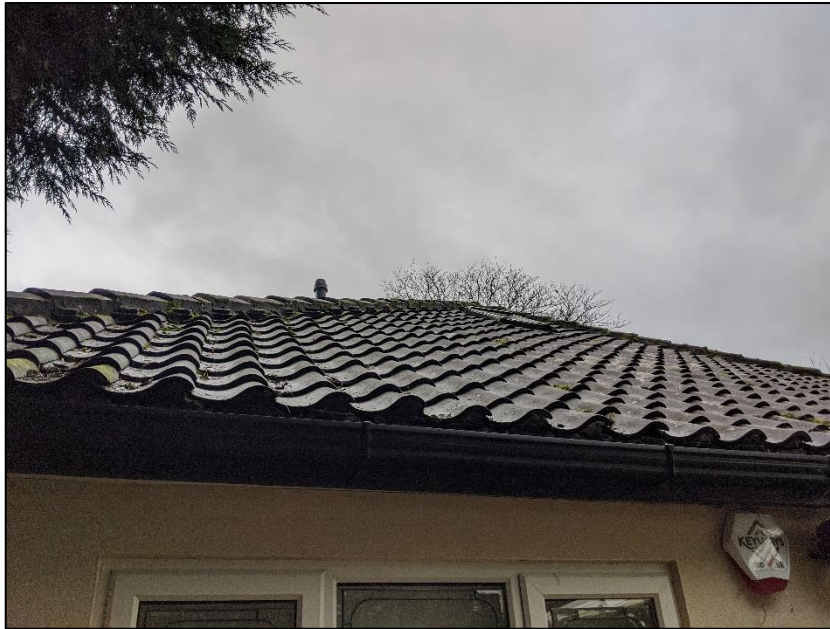
**Photograph 4 showing the roof of the property**

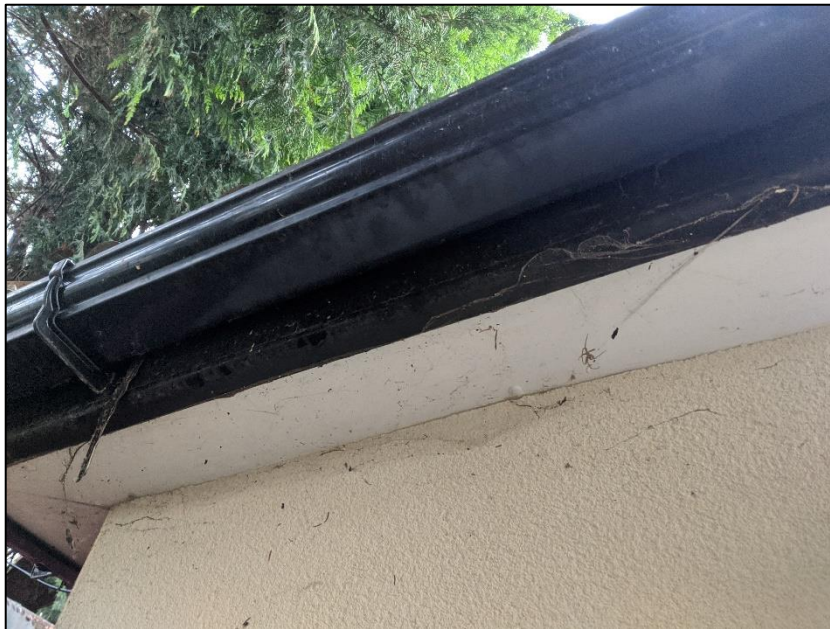
- 3.4 The property has soffits on each elevation (see Photograph 5). The soffits in good material condition and are well-sealed to the rendered bricks.

**Photograph 5 showing the soffits**

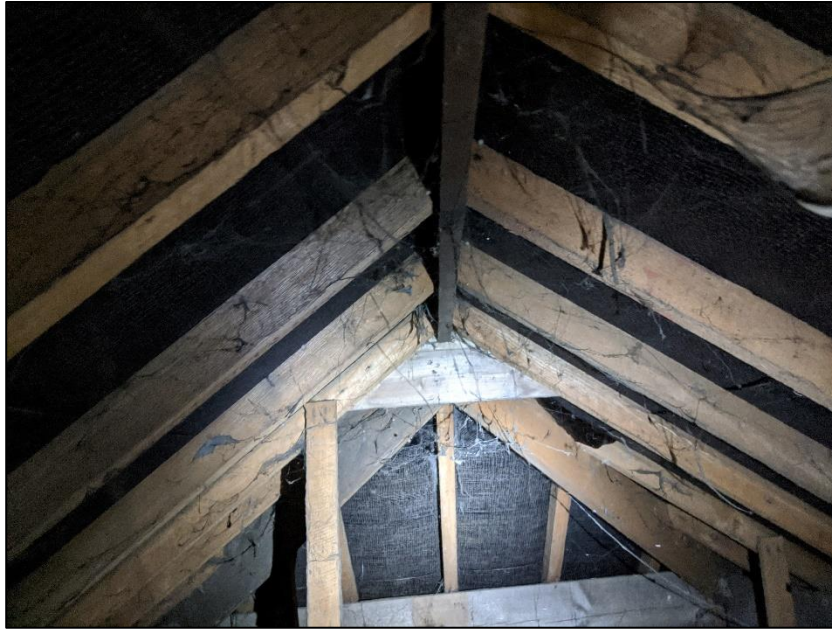
- 3.6 The roof void is small and enclosed. The wooden roof joists are complete and without gaps or cracks for bats to exploit (see Photograph 6). No daylight is visible at the roof edges, suggesting the roof void is well-sealed, and offers limited scope for bats to enter.

**Photograph 6 showing the roof timbers**

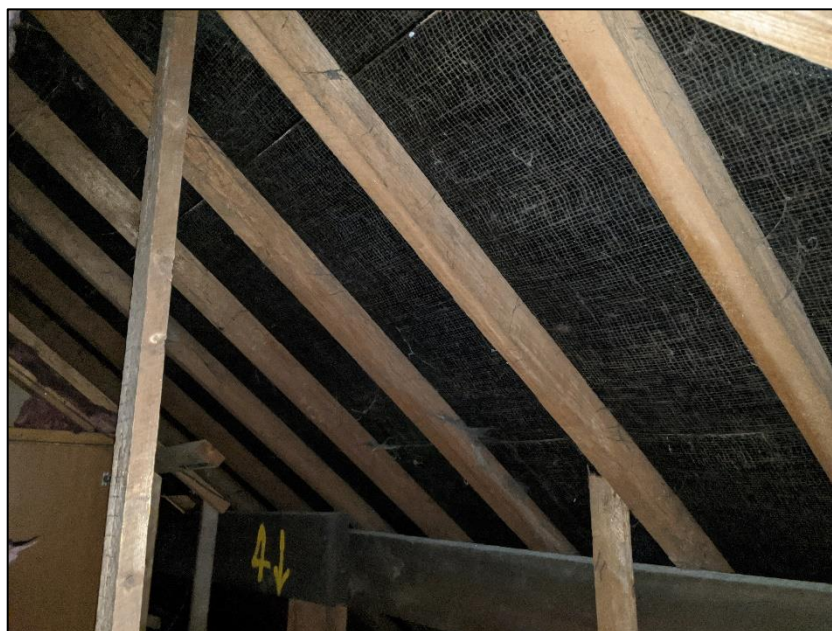
- 3.7 The ridge beam is cobwebbed, suggesting no recent bat access. The roof is lined with felt lining, which is complete with no major tears or rips (see Photograph 7). The roof void is fully insulated throughout. No evidence of bat activity, such as bat droppings, was found within the roof void.

**Photograph 7 showing the roof lining**

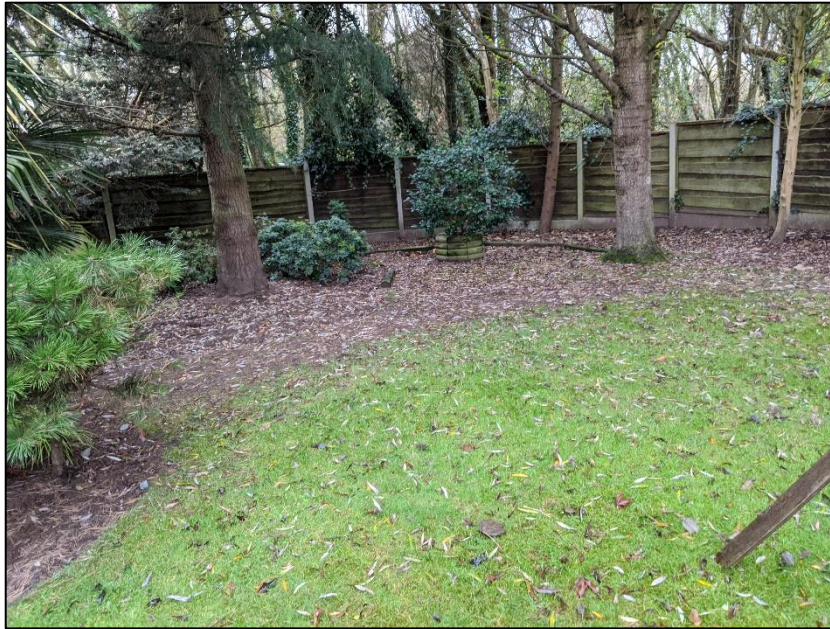
- 3.8 The property has a mature garden to the rear, consisting of amenity grass, two mature trees and introduced shrubs (see Photograph 8). The trees were inspected from the ground and were found to not support Potential Roosting Features (PRFs) for bats. No evidence of protected species could be found on the wider site.

**Photograph 8 showing the trees and mature garden on the site**
