**CCG-C-19-11344 REV.1**

**COMBINED PHASE I/II  
GEOENVIRONMENTAL REPORT**

**LAND AT 303 CHEETHAM HILL ROAD,  
MANCHESTER,  
M8 0SN**

**AUGUST 2020**

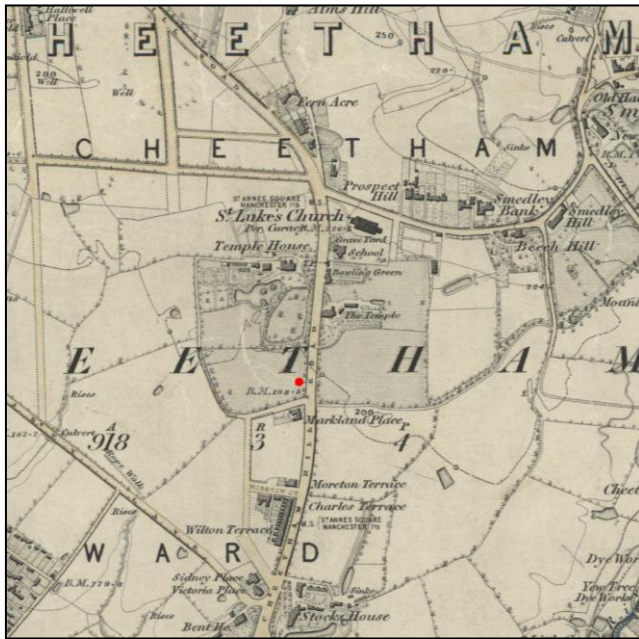
**Figure 1: Historical Mapping 1848**

| YEAR | ON SITE | <250M |
|---|---|---|
| 1848 | The site is occupied by fields and trees | The area is rural with a bowling green and St Luke's Church to the North East<br>There are buildings to the North West and North East of the site. |

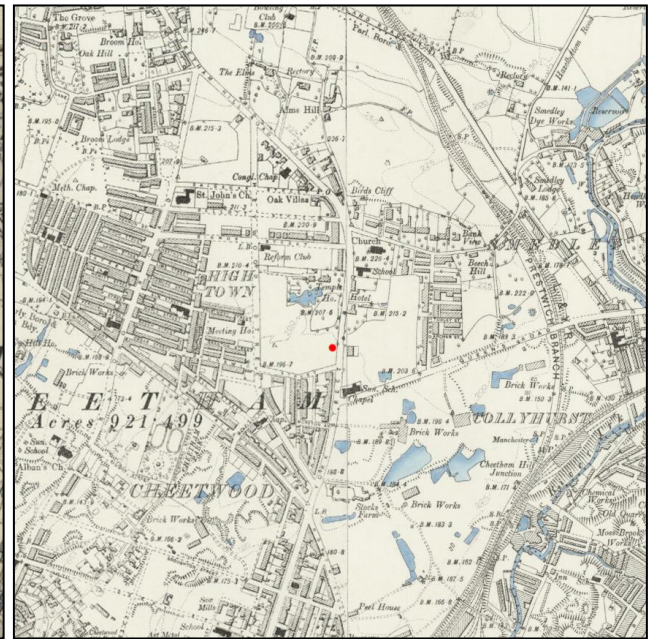
**Figure 2: Historical Mapping 1891-1894**

| YEAR | ON SITE | <250M |
|---|---|---|
| 1888-1913 | The site forms part of a larger parcel of land with building to the North West. | There are rows of terraced houses directly West of the site on Lytton avenue and South of Brunswick Street.<br>Directly East of the site is Cheetham Hill Road.<br>There is a school to the North East on Cheetham Hill Road and a Church to the South East.<br>The surrounding area is mainly residential, however there is a Tramsways Car Shed Company and trainline to the North East of the site.<br>There is a cricket and football ground located to the NW of the site. |

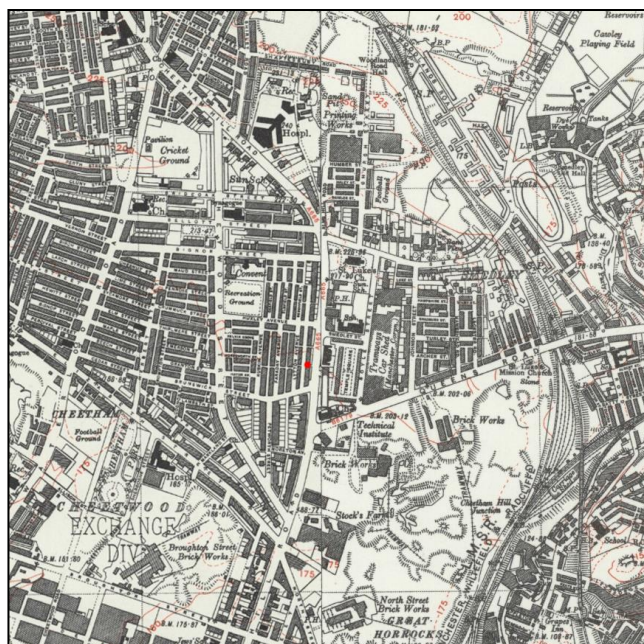
Figure 5: Historical Mapping 1946-1947

| 1949-1968 | No Significant Change | The Tramways Car Shed has been replaced by an Omnibus Depot to the East of the site.<br>There is a school and temple square now present to the East of Cheetham Hill Road adjacent to the depot.<br>The cricket ground to the North West is now part of Notre Dame Convent.<br>The tramlines on Cheetham Hill Road no longer exist.<br>The Brick Works to the South East is now disused and there is now a cinema on part of the land. |

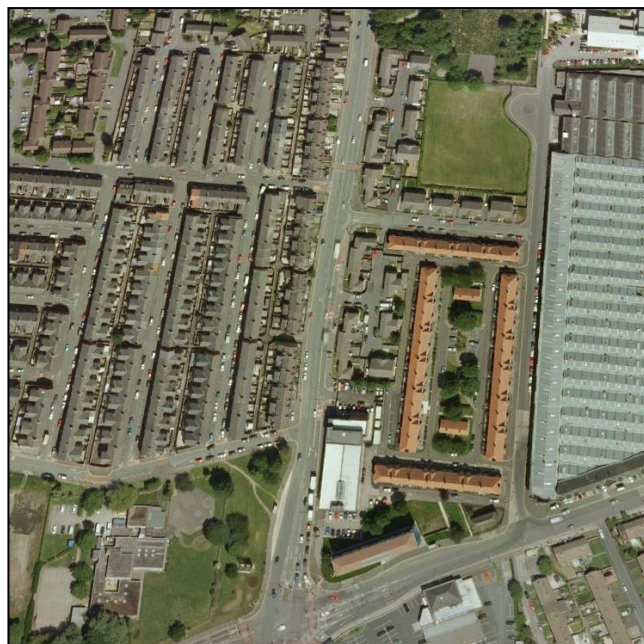
Figure 7: Google Earth 2009

| 2005-2009 | No Significant Change | Manchester Fort Shopping Centre has been built to the South West and Cheetham Hill Retail Park to the South. |

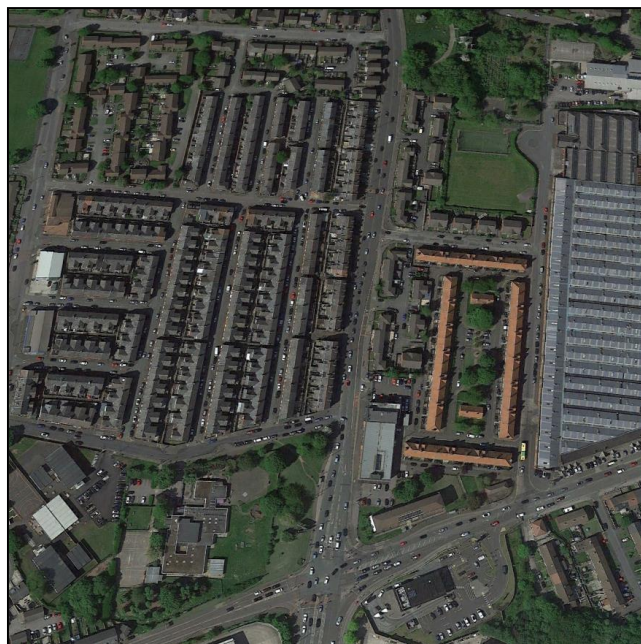
Figure 8: Google Earth 2019

| 2019 | No Significant Change | No Significant Change |
