# MMU Science & Engineering, Manchester

## Remediation Strategy

Curtins Ref: 069656-CUR-00-XX-RP-GE-003

Site Address: Manchester Metropolitan University, John Dalton Building, Chester Street, Manchester, M1 5GD

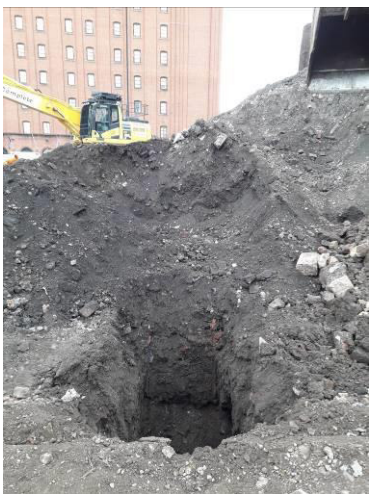
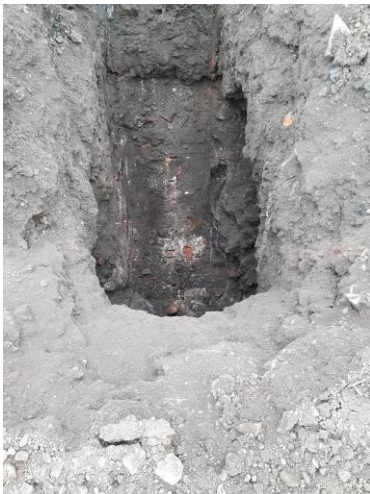
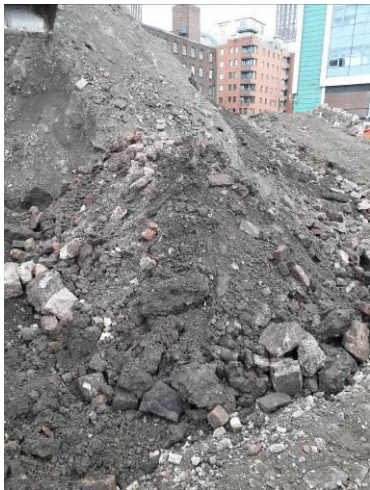
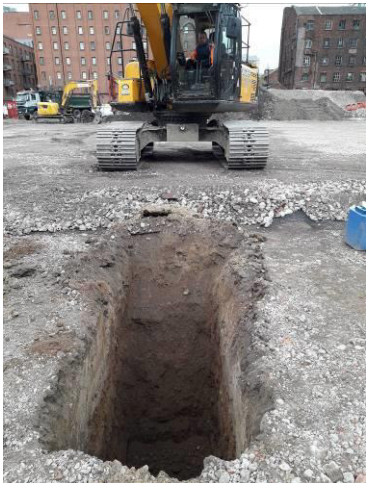
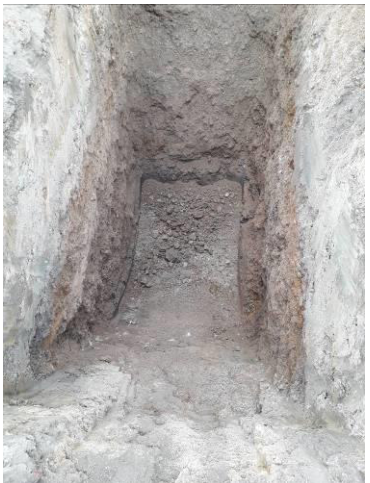
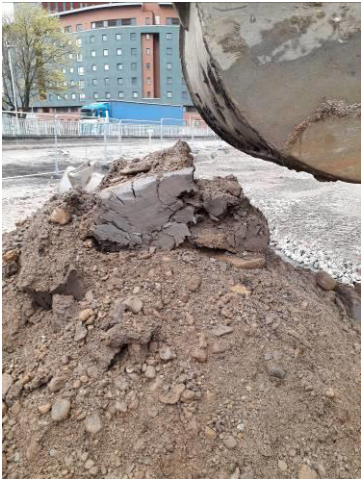
Curtins carried out TP1001 at the approximate location tank 2 was excavated along with visually contaminated soils to assess if any contamination remained. No visual or olfactory evidence of hydrocarbon contamination was identified and no exceedances above commercial GACs were identified, however asbestos fibres were found (see Section 3.5.1).

Remarks: Situated where tank 2 was previously found and removed along with extent of visually contaminated soils. No visual of olfactory evidence of hydrocarbon contamination identified in trial pit. No groundwater encountered.

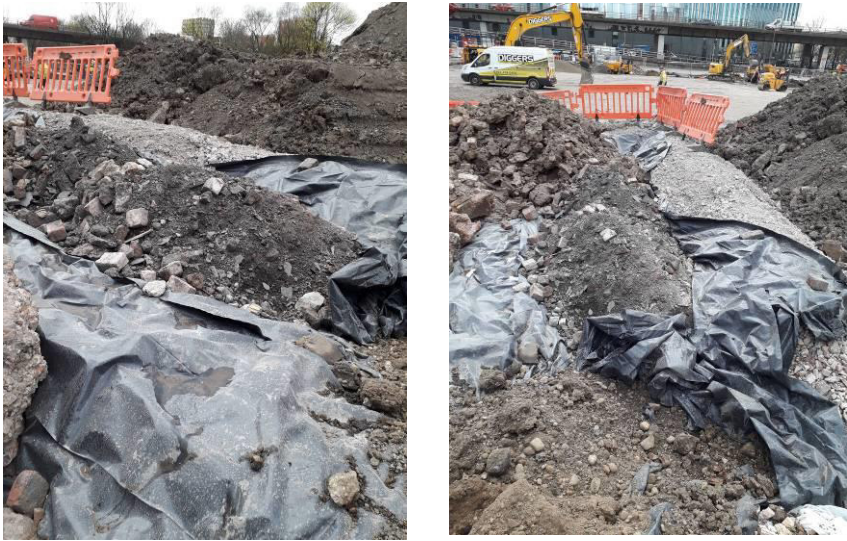
| <b>Photos Ref.</b> Stockpiled Arisings from around Tank 2 | | <b>Date:</b> 08/04/2021 |

Seven environmental soil samples were placed in laboratory provided containers and stored in cool boxes prior to being transported to the nominated laboratory under the laboratory's chain of custody documentation. The laboratory selected by Curtins for chemical analysis was Envirolab (UKAS and MCERTS accredited). Four samples were obtained from made ground soils, two samples from natural soils, one sample was obtained of possible Asbestos Containing Material (ACM) Debris identified in a stockpile of materials excavated from around where 'tank 2' had been found.

Except for the material excavated from around tank 2 exhibiting elevated concentrations of PCBs and presence of ACM and around Complete Regenerations trial pit 'TP08' where extensive ACMs were noted, the re-use of site-won soils may therefore be undertaken if the following principles are met:

It should be noted that asbestos containing soils may not be suitable for crushing for re-use due to the risk of fibre release and cross contamination.

Asbestos Containing Material (ACM) picking may enable for disposal of some soils as non-hazardous waste.

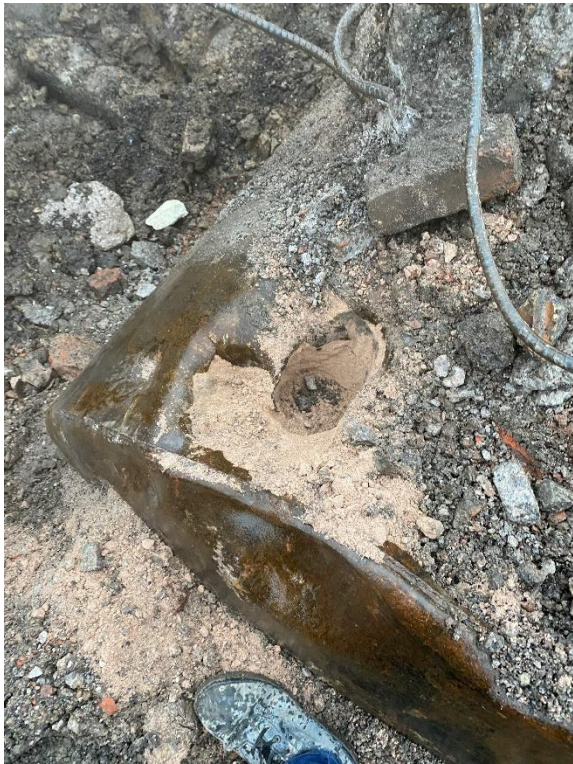
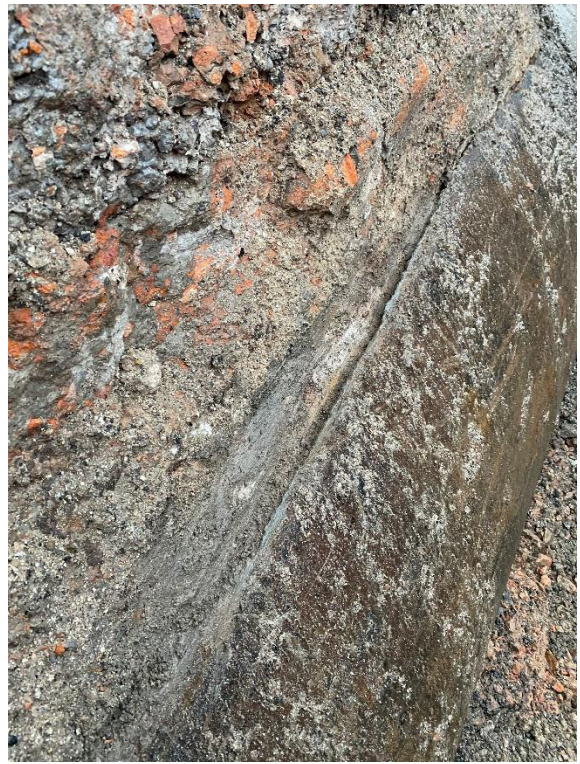
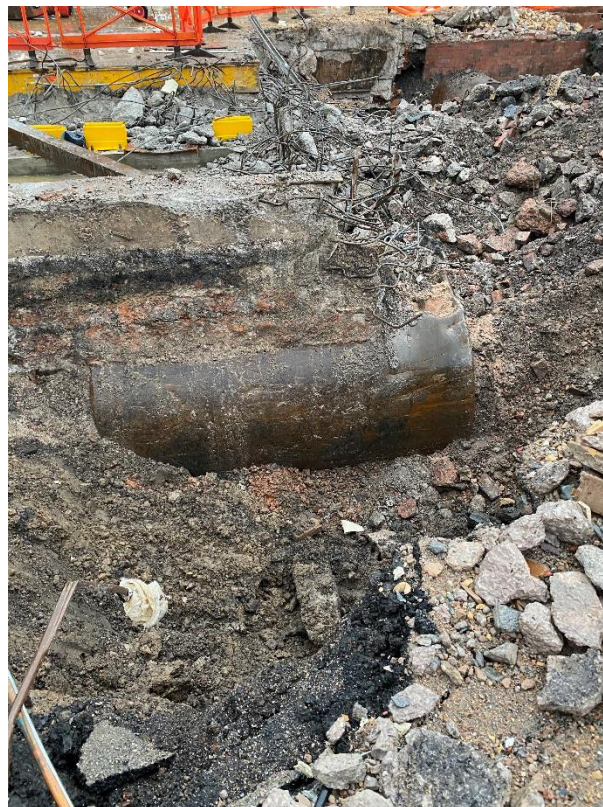
Tank 1

On Tuesday 09 March an unidentified tank was discovered under a weigh bridge at the north of site. Hereby known as 'tank 1'. Complete Regeneration report that this tank was found to be cut open and filled with concrete/sand. This tank was excavated and removed from site. No evidence of contamination was reported around the tank.

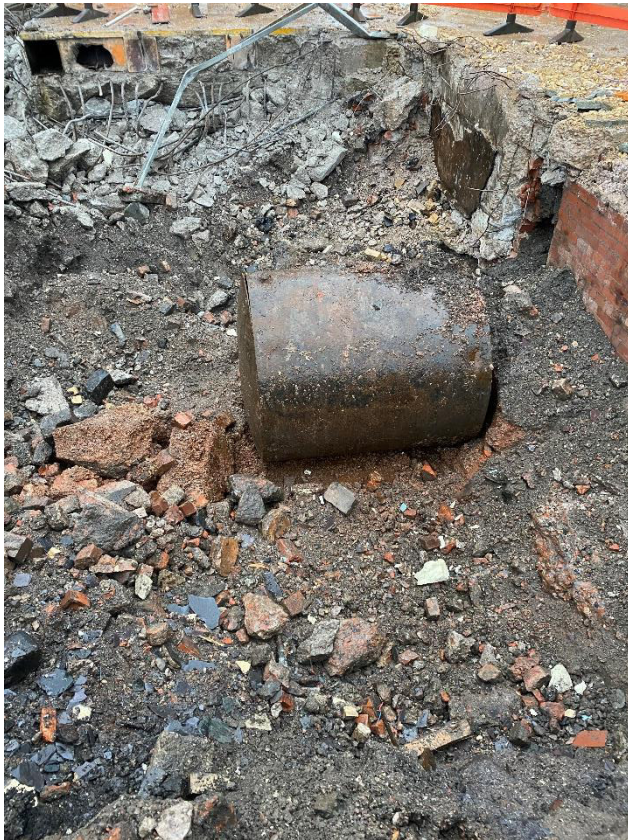
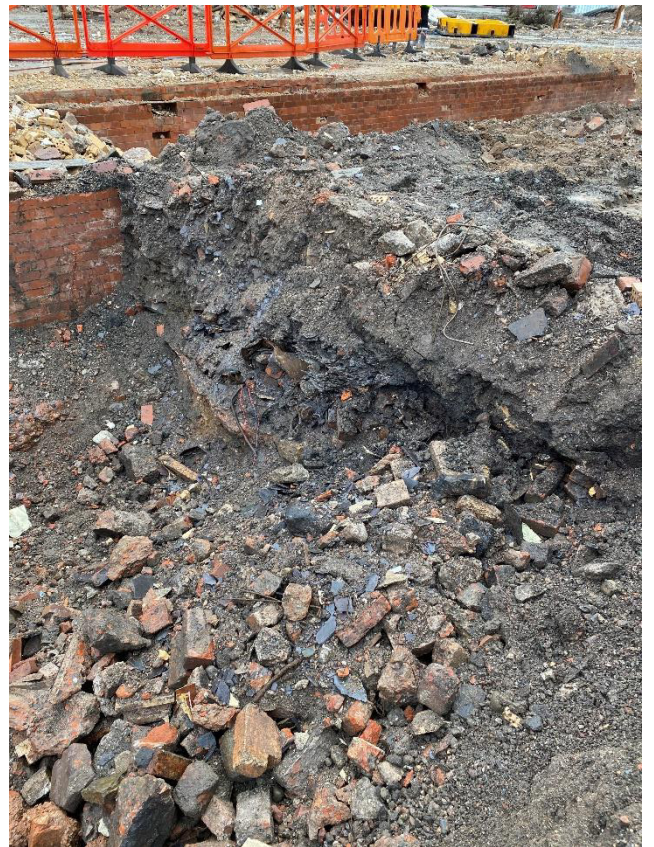
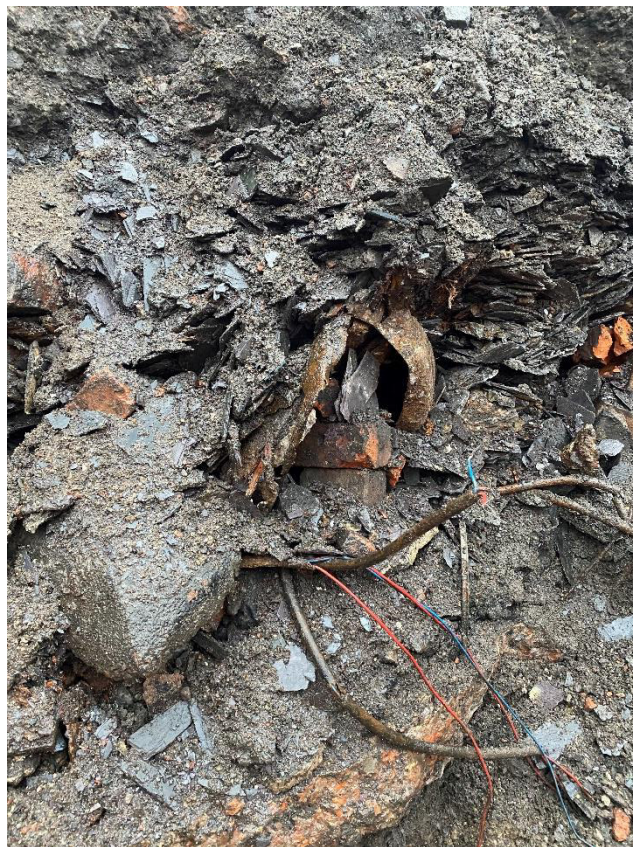
## Tank 2 & Surrounding Soils

On Wednesday 10 March an unidentified tank was discovered to the south east of tank 1, hereby known as 'tank 2'. Complete Regeneration report that this tank was filled with sludge, with 'black material surrounding with surrounding decaying metal drums fragments'. The tank and surrounding material was excavated and stored on polythene with samples taken for laboratory analysis. The tank was cleaned and disposed of off-site. During the post demolition investigation Curtins engineer inspected the stockpile of excavated materials, the material comprised a dark blackish brown and brown very gravelly sand with gravel of slate, brick, wiring and metal fragments, as well as large concrete pieces stored on a polythene membrane, no free product or gross contamination was identified. Curtins recommended that the stockpile is covered to prevent leaching of contamination while awaiting disposal. Curtins engineer also identified numerous pieces of potential ACM in the stockpile, one sample was taken and sent to the laboratory for screening which confirmed the material to be chrysotile cement (see Section 3.5.1).

Concentrations of chrysotile asbestos fibres encountered within the Made Ground soil in WS03 and TP1001 were relatively low at 0.02% w/w and <0.001% w/w respectively. In BH02, where chrysotile loose fibres and chrysotile loose insulation asbestos containing material was encountered, a concentration of 0.22% w/w of asbestos was recorded. Bulk quantification was undertaken on the ACM sample obtained from the on-site stockpile of excavated arisings from around Tank 2 which identified that chrysotile cement to contain 15% asbestos (w/w).
