Our Ref: BEK/19661/211027/CGL/P45

**Residential Development at Ilk Street and Alpine Street, Clayton- PLOT 45**

BEK Enviro (BEK) has been commissioned by The Casey Group (CG) to supervise and validate the remediation works required at the above site.

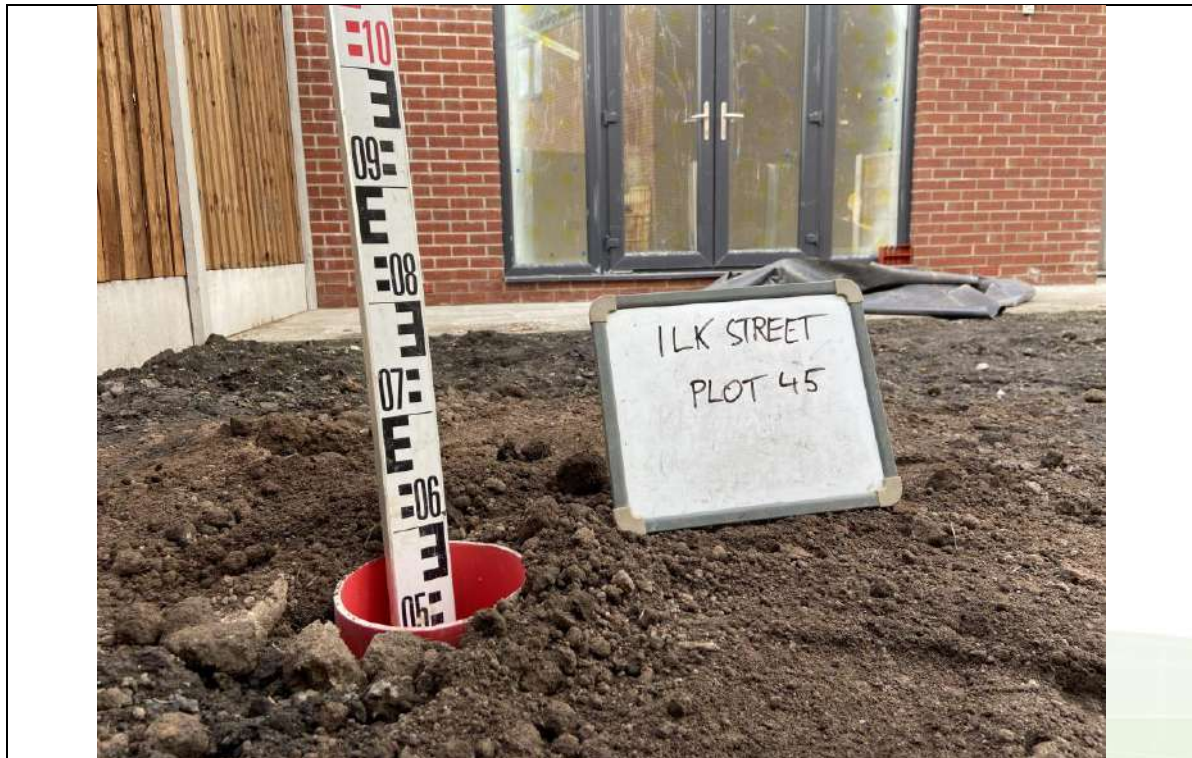
Photograph 1: Validation of Garden Capping Thickness

Following placement of the validated soils by CG, an engineer from BEK carried out spot checks and can confirm that the capping layer for Plot 45 comprises in excess of 600 mm of suitably clean validated soils. The capping soils overly a geotextile membrane at the base. Photographs showing capping thickness are provided within Annex E.

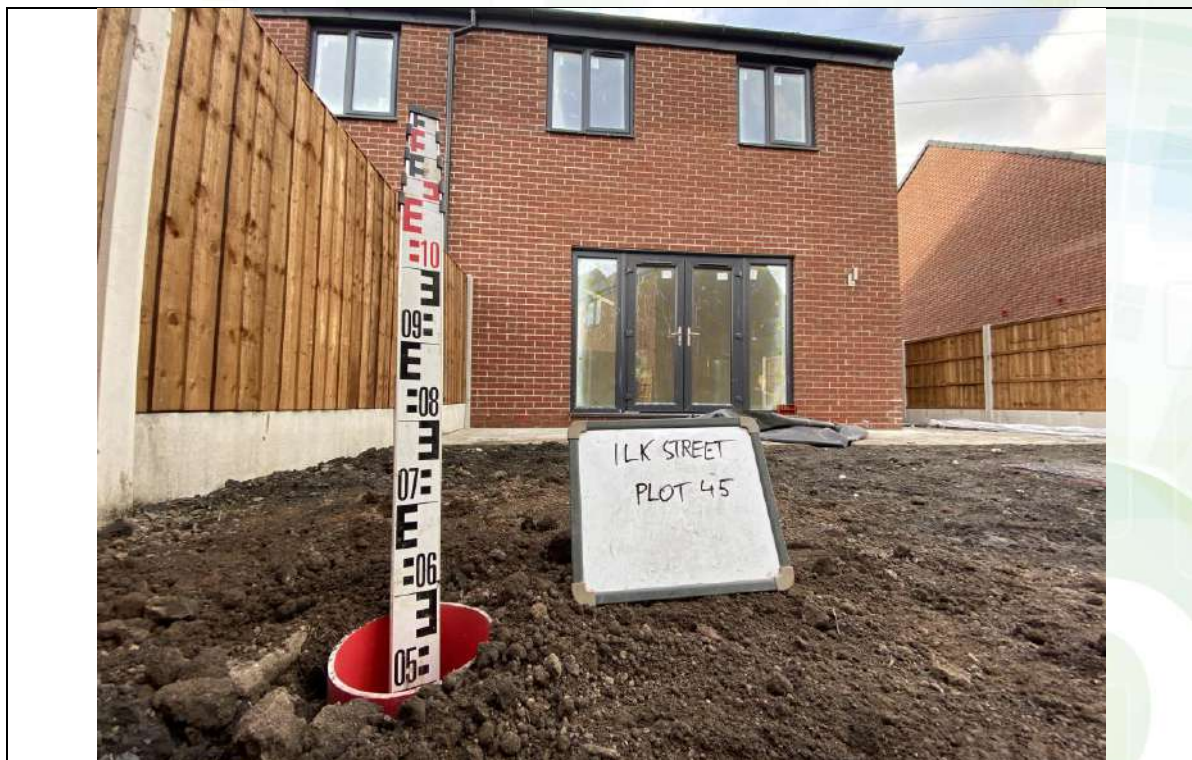
Photograph 2: Validation of Garden Capping Thickness

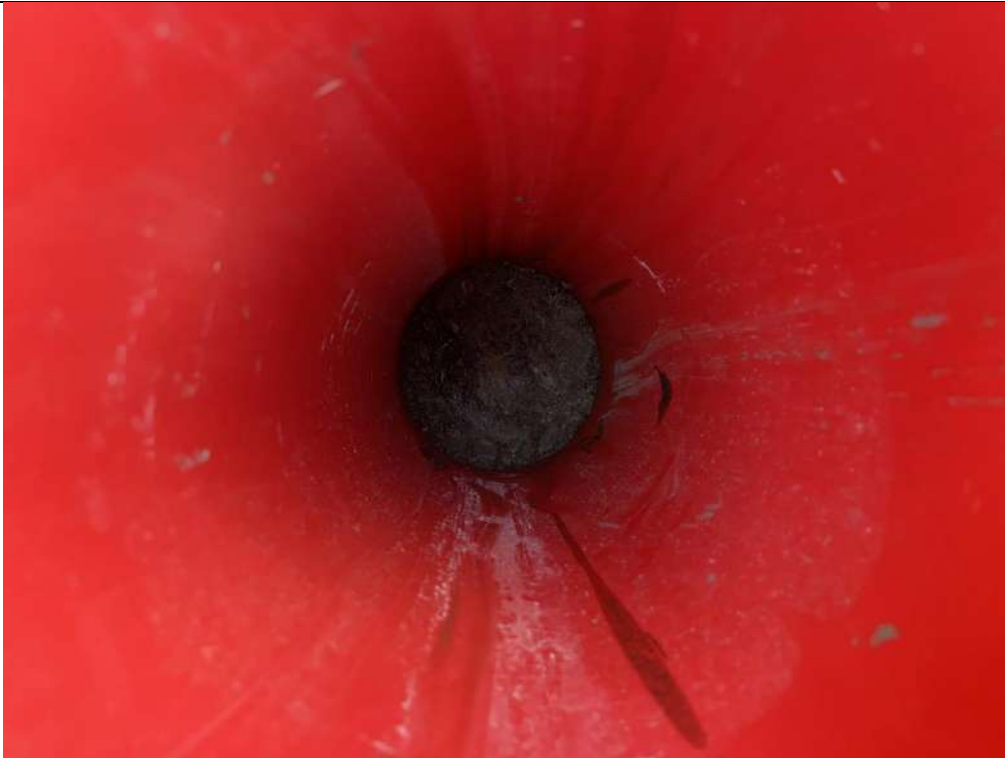
Photograph 3: Validation of Geotextile Membrane

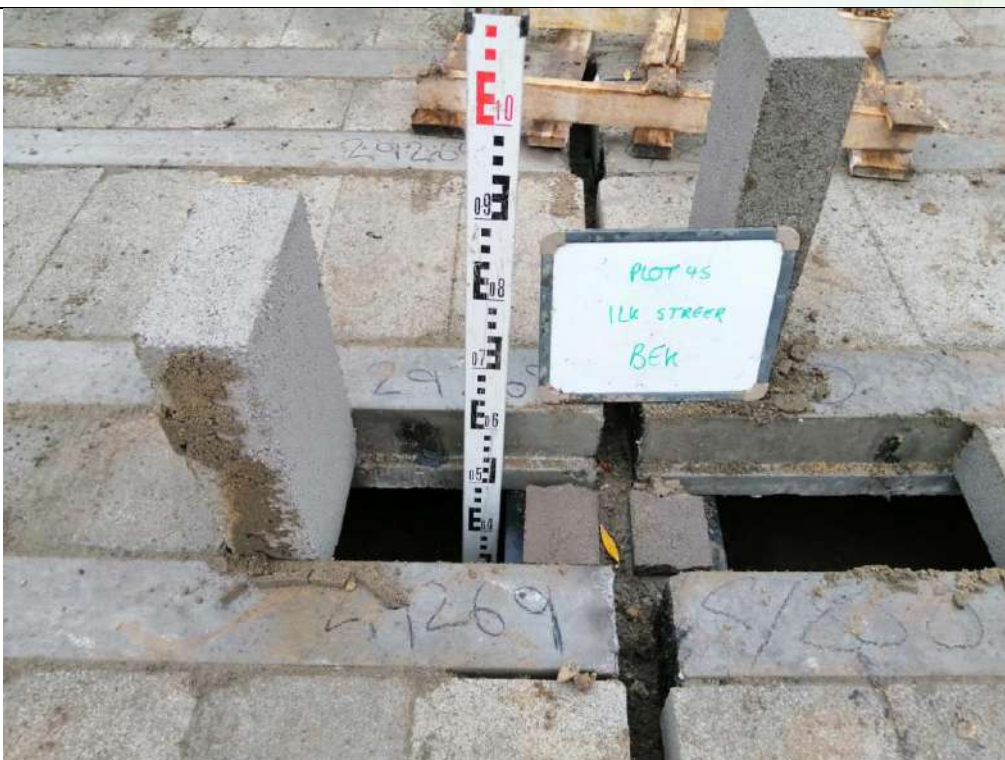
Photograph 4: Validation of Sub-Floor Void Space (min 150 mm)

The sub-floor void and the installation of the membrane has been validated and BEK can confirm the gas measures incorporated into the foundation design of Plot 45 conforms to the specified requirements. The membrane installation was verified by an Engineer from BEK who has attended the Verification of Gas Protection Systems Course delivered by CL:AIRE Training Course.

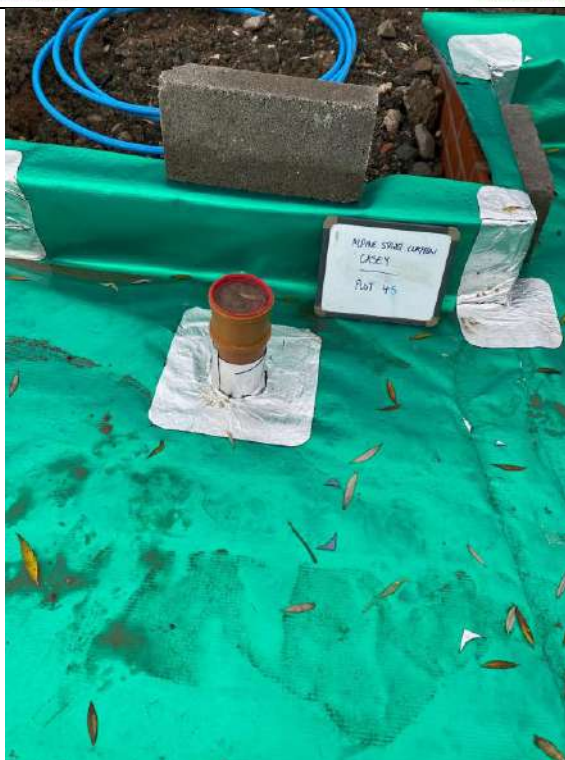
Photograph 5: Validation of Gas Membrane Installation

CG commissioned Reeve-Tec Membranes Limited to install the gas membranes at the site, who have used the Protech GM Super gas membrane which is considered suitable for use. A copy of the data sheet for this membrane is presented in Annex C. The completed gas validation proforma for this plot is presented in Annex D and validation photographs are presented in Annex E.

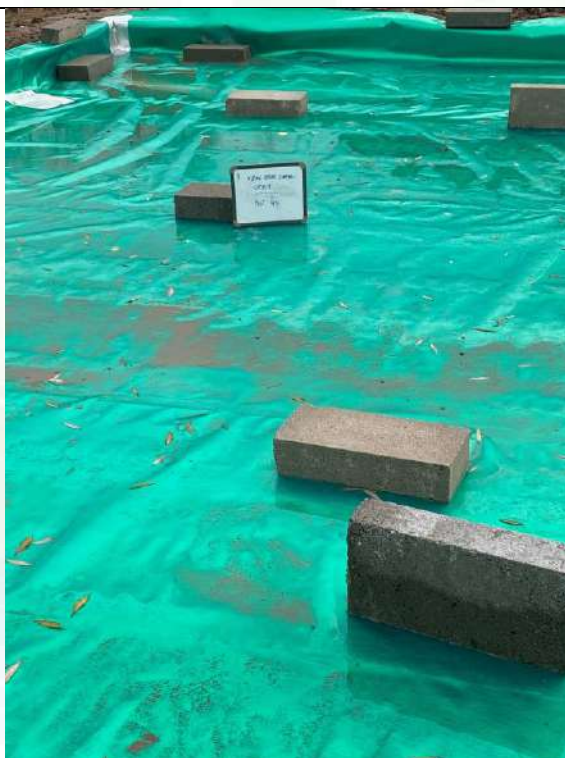
Photograph 6: Validation of Gas Membrane Installation

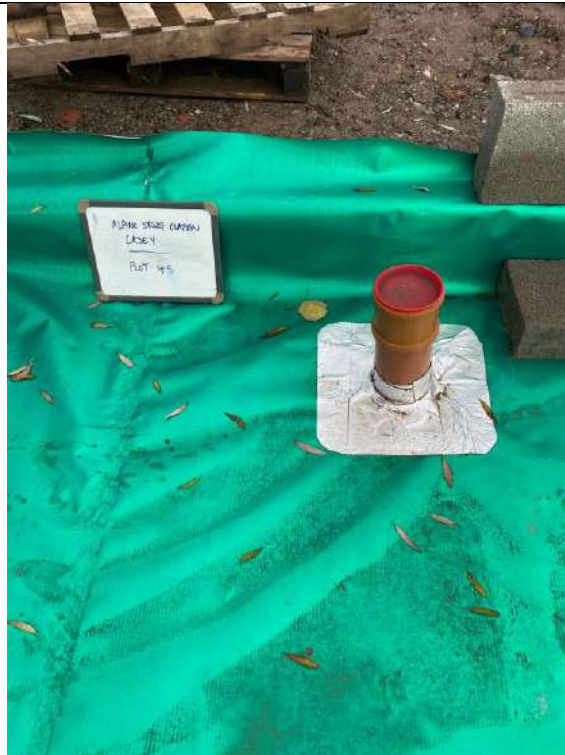
**Photograph 7: Validation of Gas Membrane Installation**
