Wythenshawe Park Cycle Facilities

Skills Area

Flood Risk Assessment Report

Manchester City Council

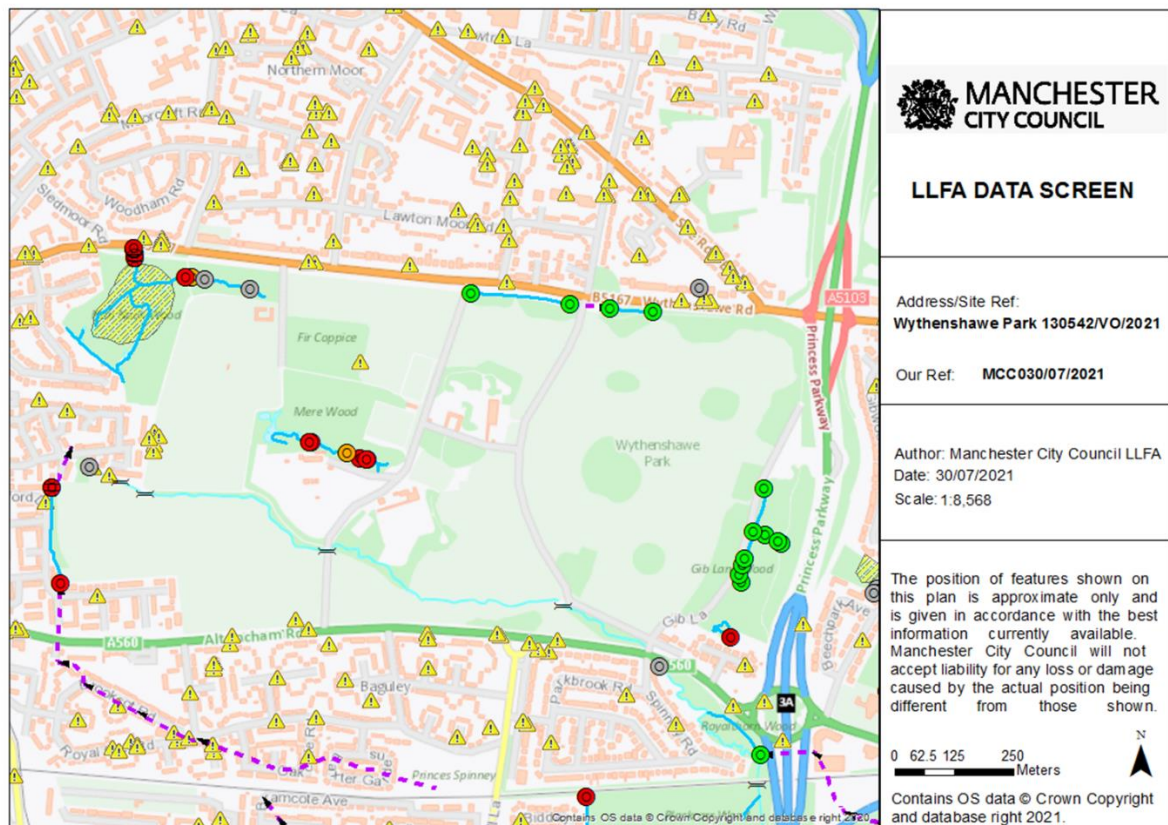
1.3 Also, in discussion with the Council's Flood Risk Management Team Officer there has been identified specific requirements relating to recent flood records in the park as recorded on the Lead Local Flood Authority (LLFA) Data Screen reproduced below (full details in Appendix B). This shows a cluster of incidents on the Western Park boundary together with one to Fir Coppice (denoted by the ! in a yellow triangle, full key in Appendix A). Also the yellow hashed area to Nan Nook Wood in the north west corner of the park is identified as a recorded flooding area.

1.4 The incident in Fir Coppice was a manhole cover not a flooding occurrence ( a copy of the incident report provided by LLFA is in Appendix B) and so can be ignored for this assessment.

3.3 The Skills Area is proposed on an open grassland area which at present is the western end of the mini golf course in the park marked green on the plan below. This appears to flow into Nan Nook Wood which is a wooded area with multiple ponds which correspond the yellow hatched area on the LLFA plan in 1.3 above. The proposed Skills Area will be a series of six to seven cycle track routes of varying skill levels as shown below that will reduce the grassed area by only some 10%. Details of the track construction is given in Appendix C. With the surface run off reporting to French drains connected to local soak aways. A soak away test has been performed in this area which demonstrated a capacity of local soak aways to take the nominal flow expected from the small areas of hard standing of this cycle feature. The details are included in Appendix E.

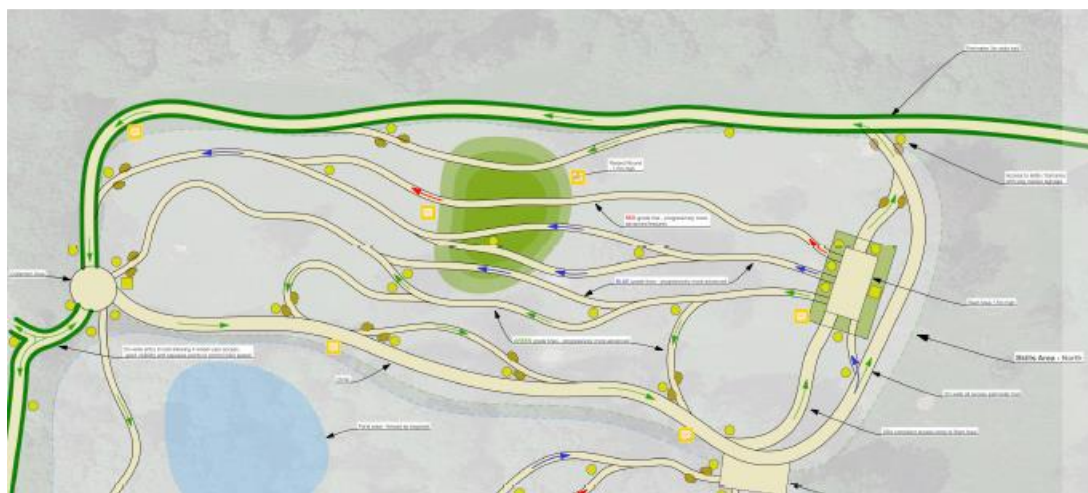
Extract of drawing 20-011(08)002 D3 in Appendix D

3.4 The plan below shows the latest design proposal. The final six Soak away locations (the yellow Squares) indicated on the plan below will be determined to suit any final grading and topography in this area.

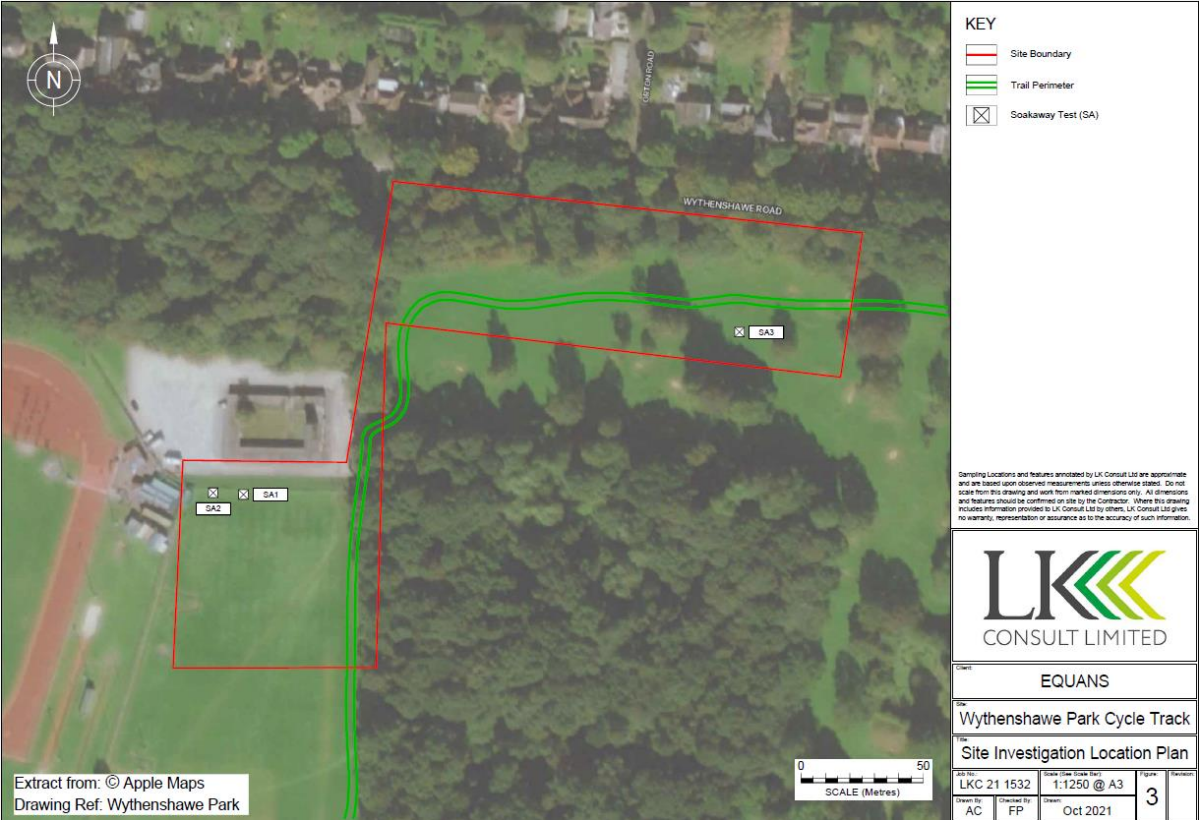
Sheet  
3 / 4

| Location | Date | Level | Location |
|---|---|---|---|
| SA3 | 01/10/2021 | 36.00 mOD | E: 381311 N: 390079 |

| Soil type at test level | SAND |

| | 1 | 2 |
|---|---|---|
| SOIL INFILTRATION RATE (m/s), f | 1.73E-5 | 2.29E-5 |

3.6 A soak away test was conducted in this area following the guidelines of the BRE digest 365 which found that there was a soil infiltration rate of between 1.73 E-5 and 2.29 E-5 (ms-1) into the sand lens found at 1.7m depth. The full details are provided in Appendix E. While this is not high it is sufficient for the proposed areas. With each of the six proposed soak aways taking some 13m2 of surface run off the soak aways are proposed to be 2m deep and 2m x 4m on plan.
