**Site Walk Over – 16<sup>th</sup> October 2016**

**GARDENS HOTEL, MANCHESTER**

**FACTUAL REPORT ON  
GROUND INVESTIGATION**

**Contract: 41977**

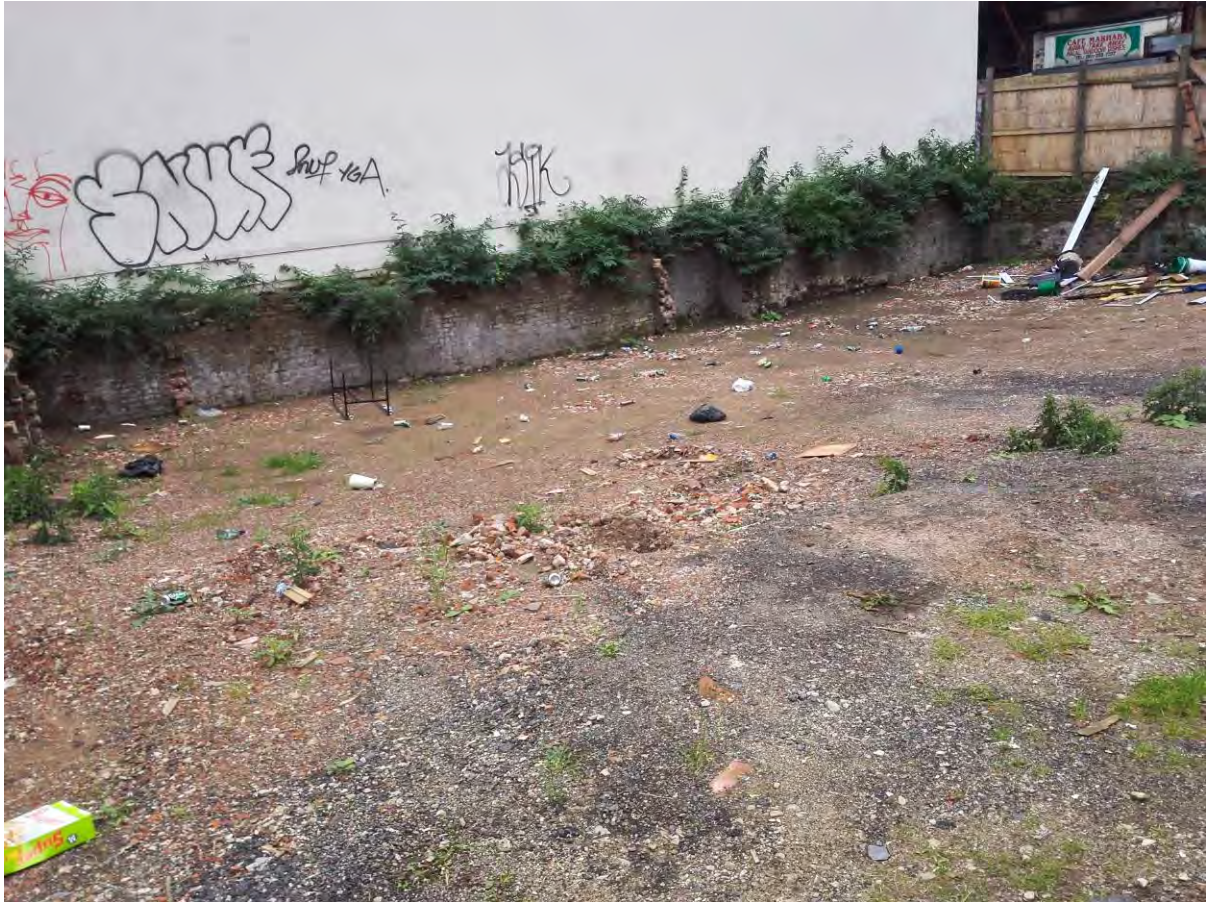
**Photograph 1** – Looking south from the northern corner of the site.

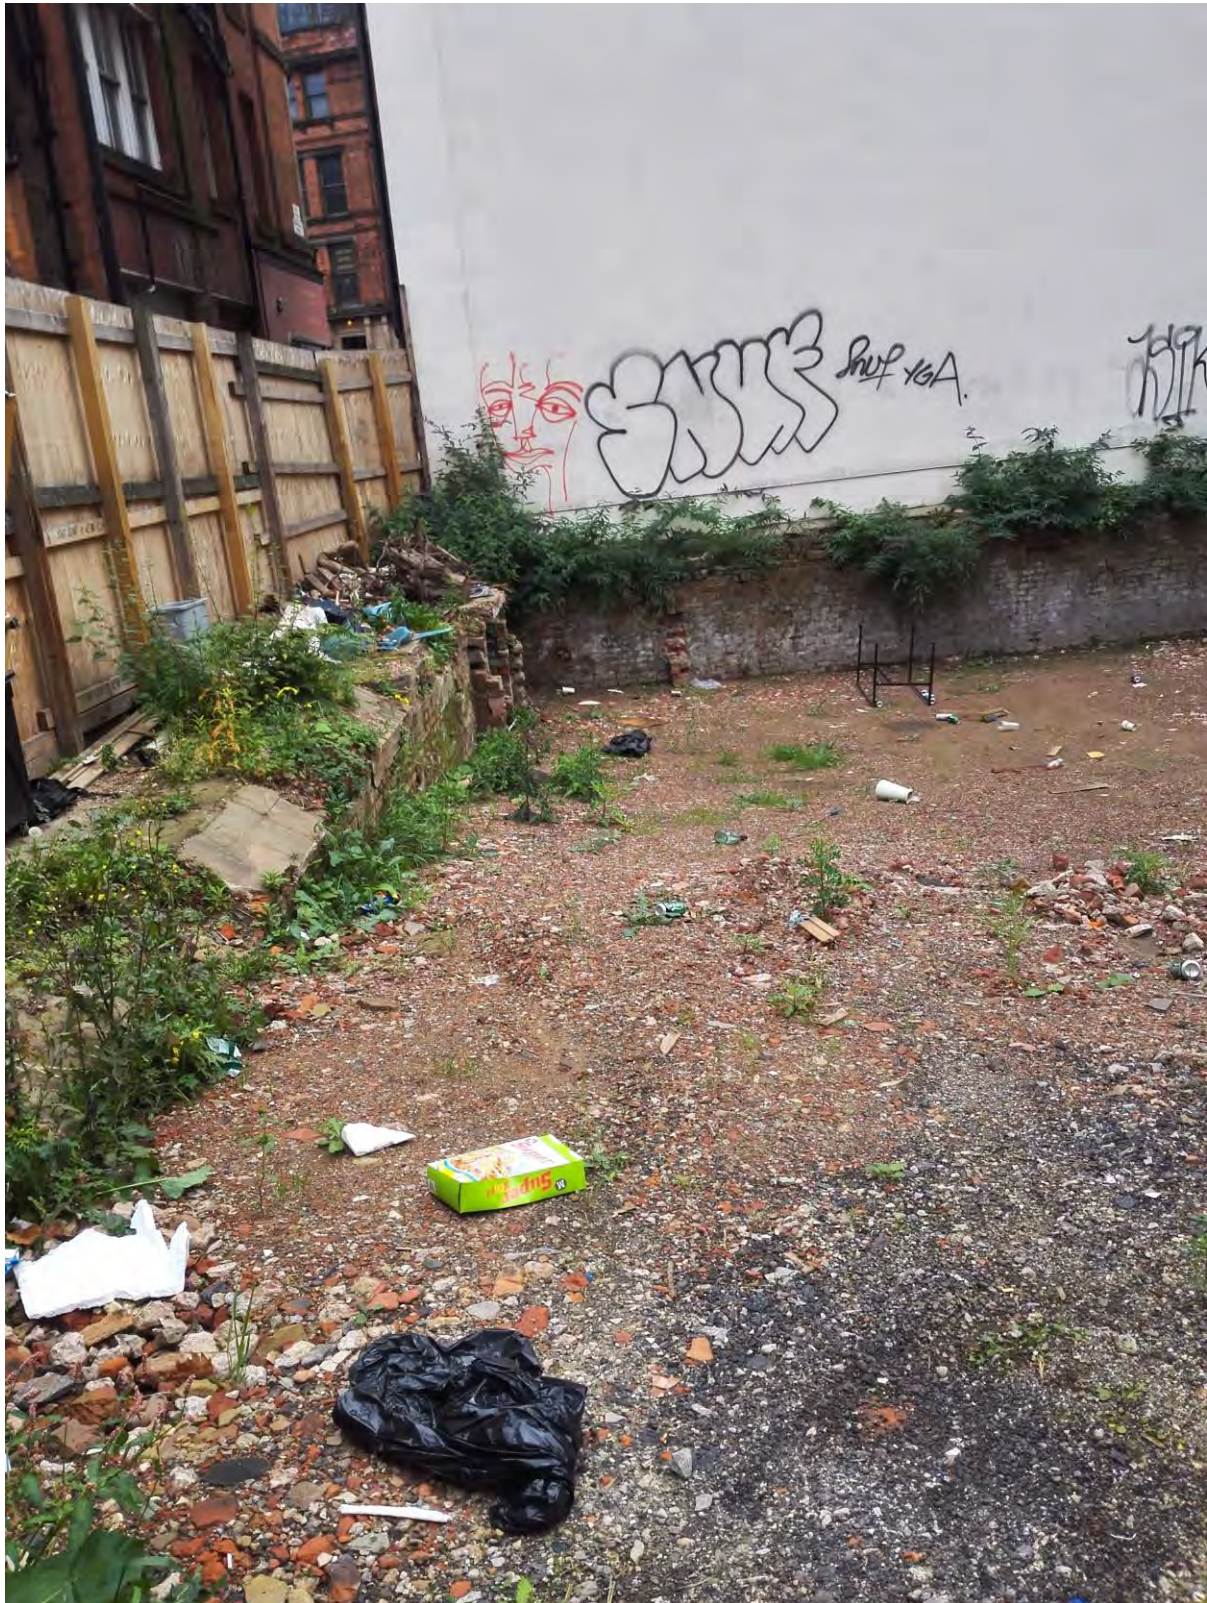
**Photograph 2** – Looking south-east from the north-west corner of the site along the south-west boundary.

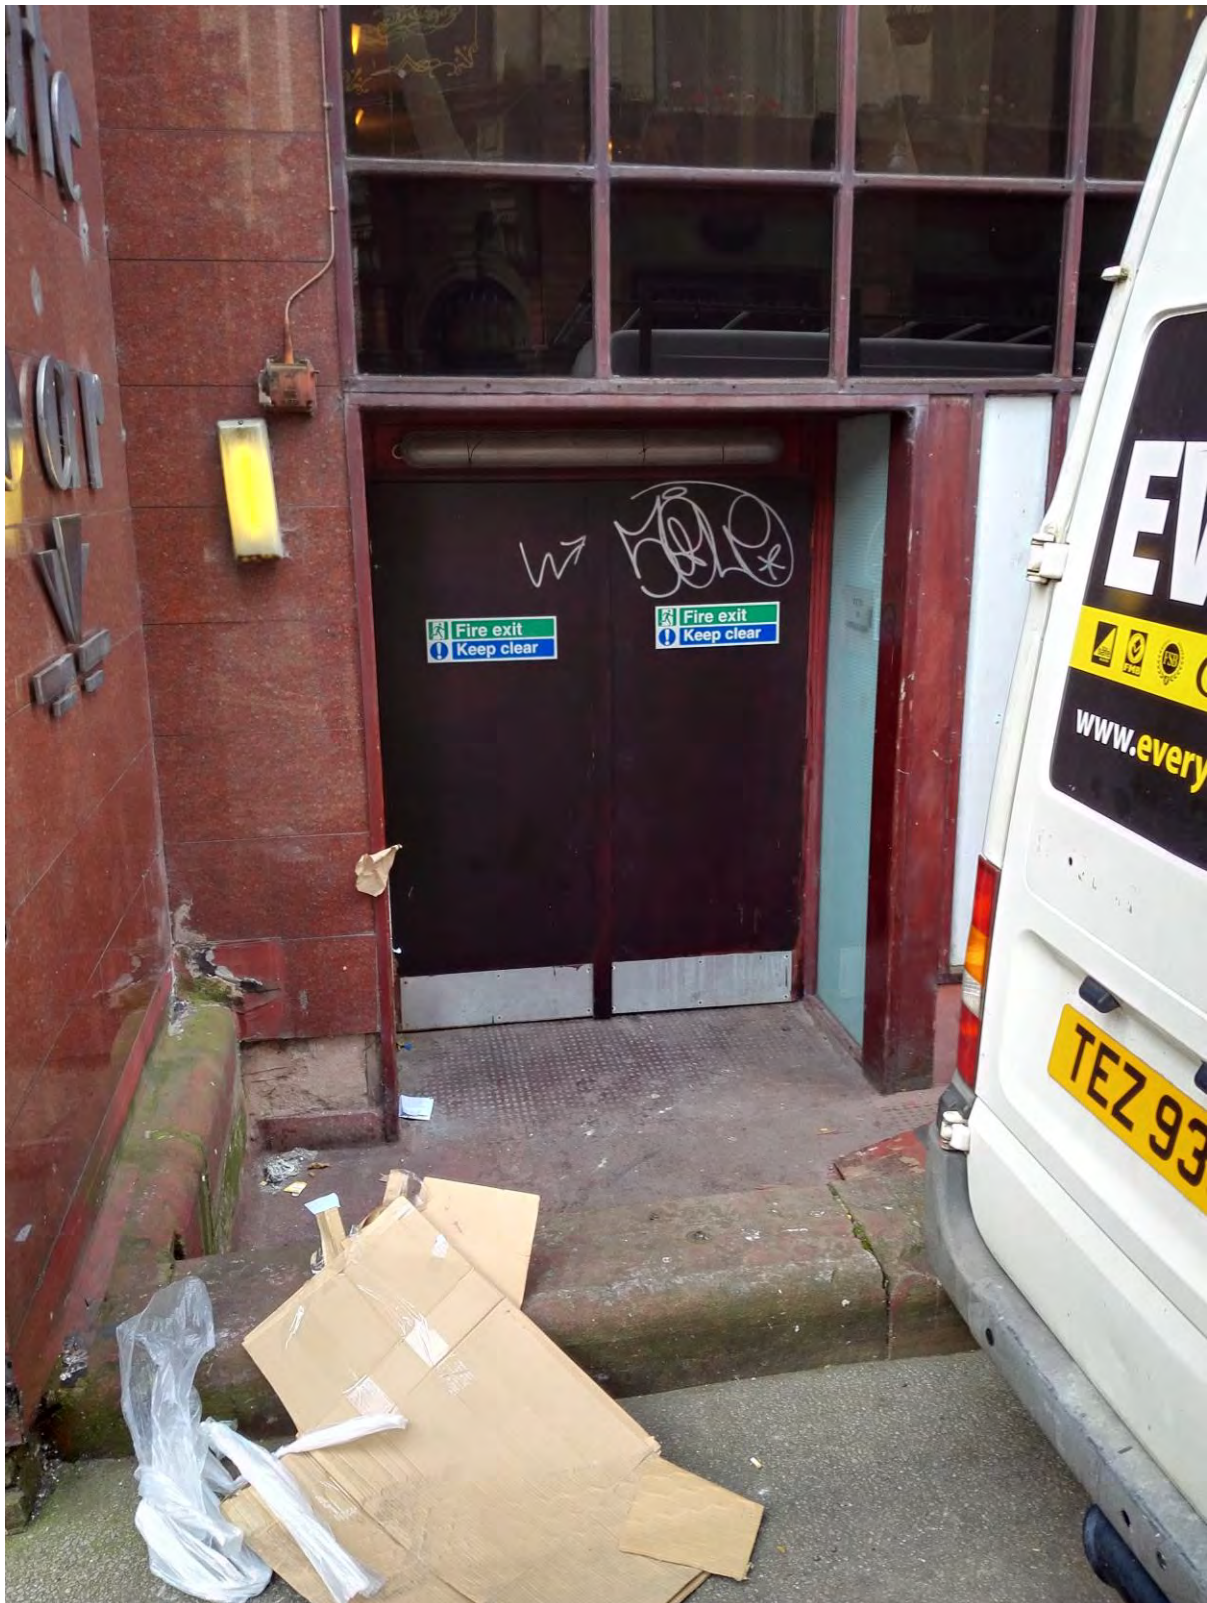
**Photograph 3** – Access to the basement through a fire exit off of Back Piccadilly.

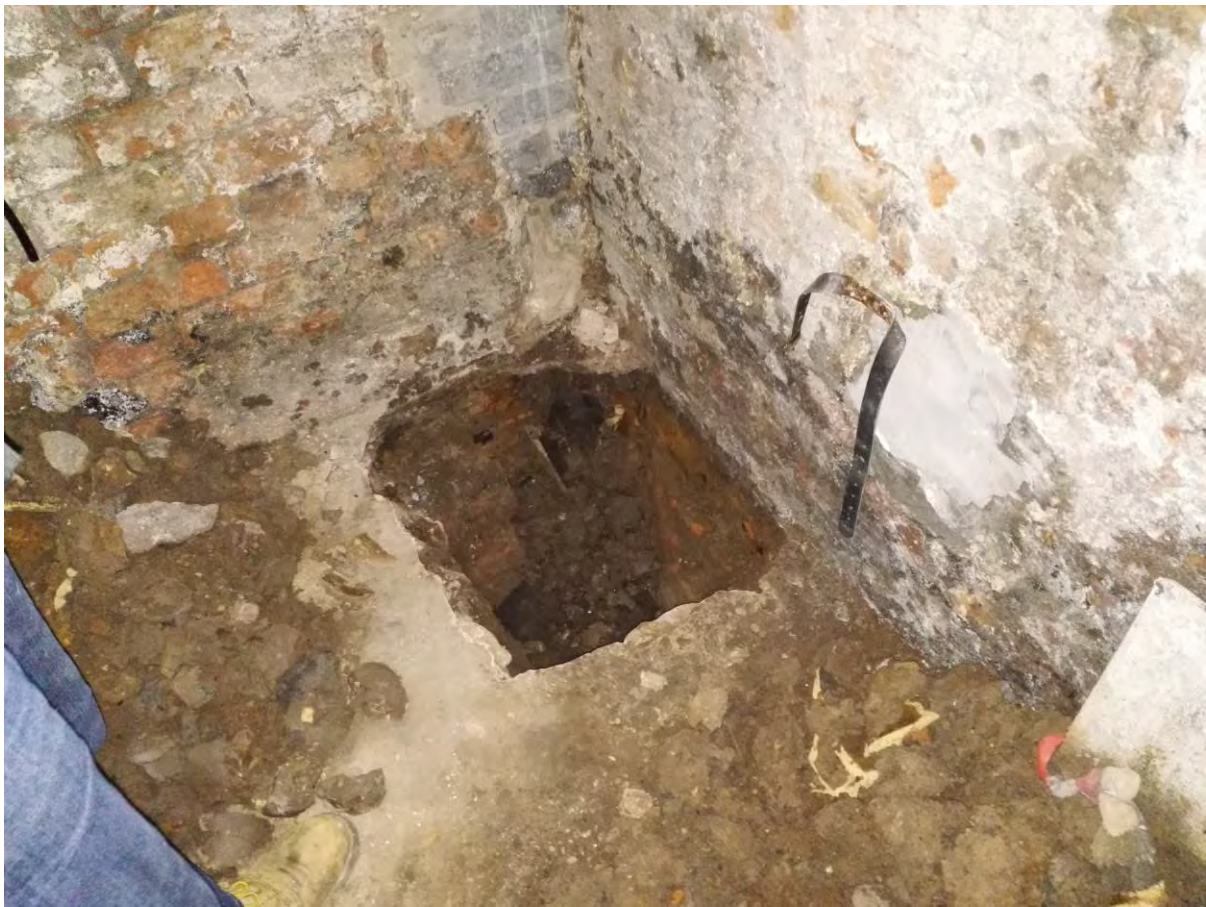
**Photograph 4** – Previous excavation in the basement.

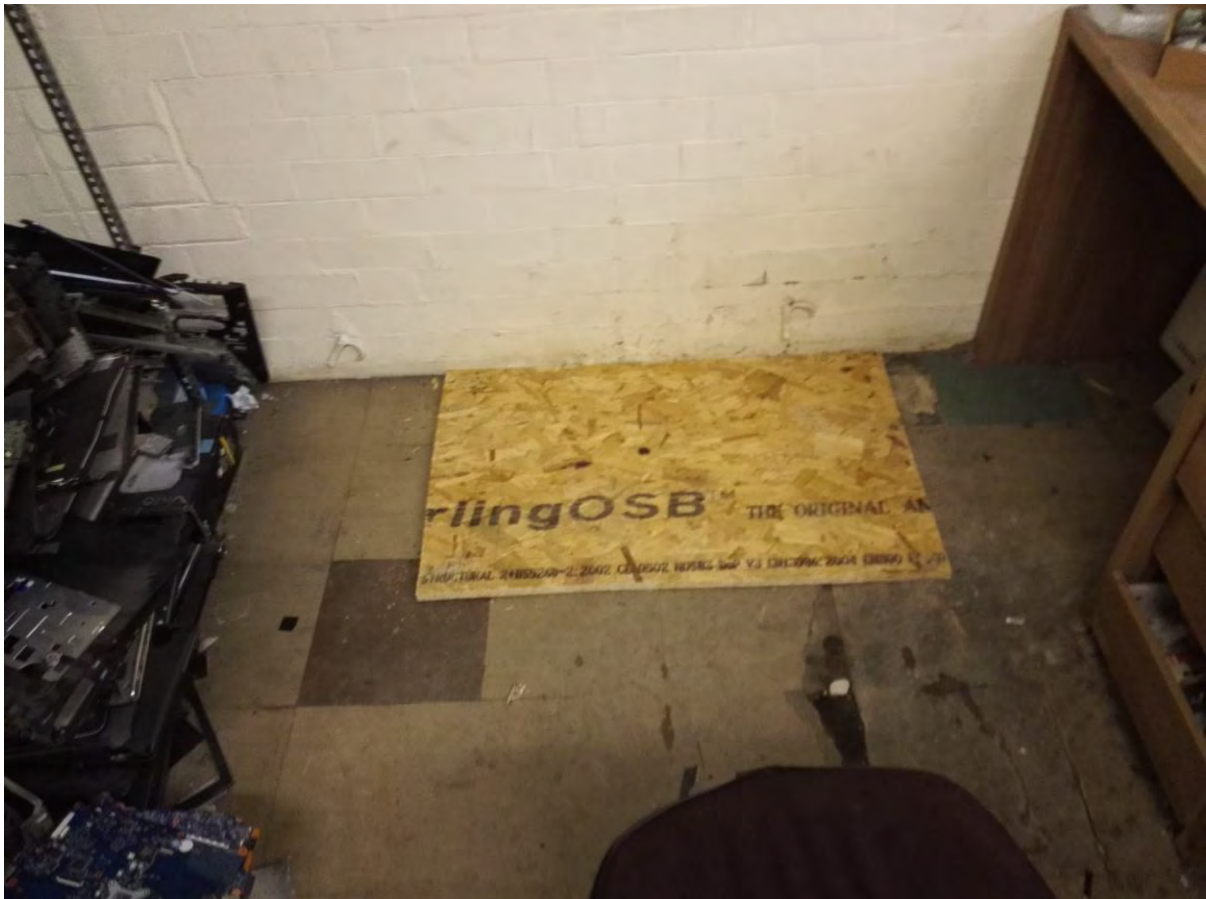
**Photograph 5** – Previous excavation identified, covered by a wooden board.

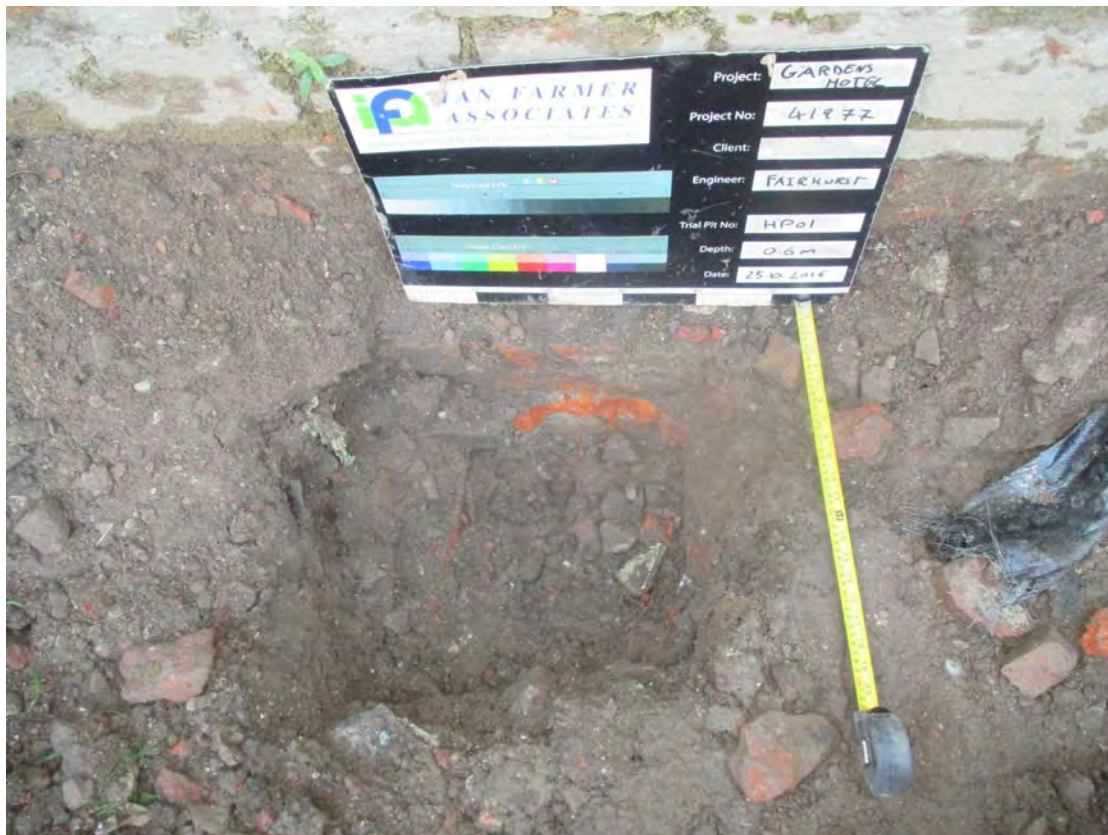
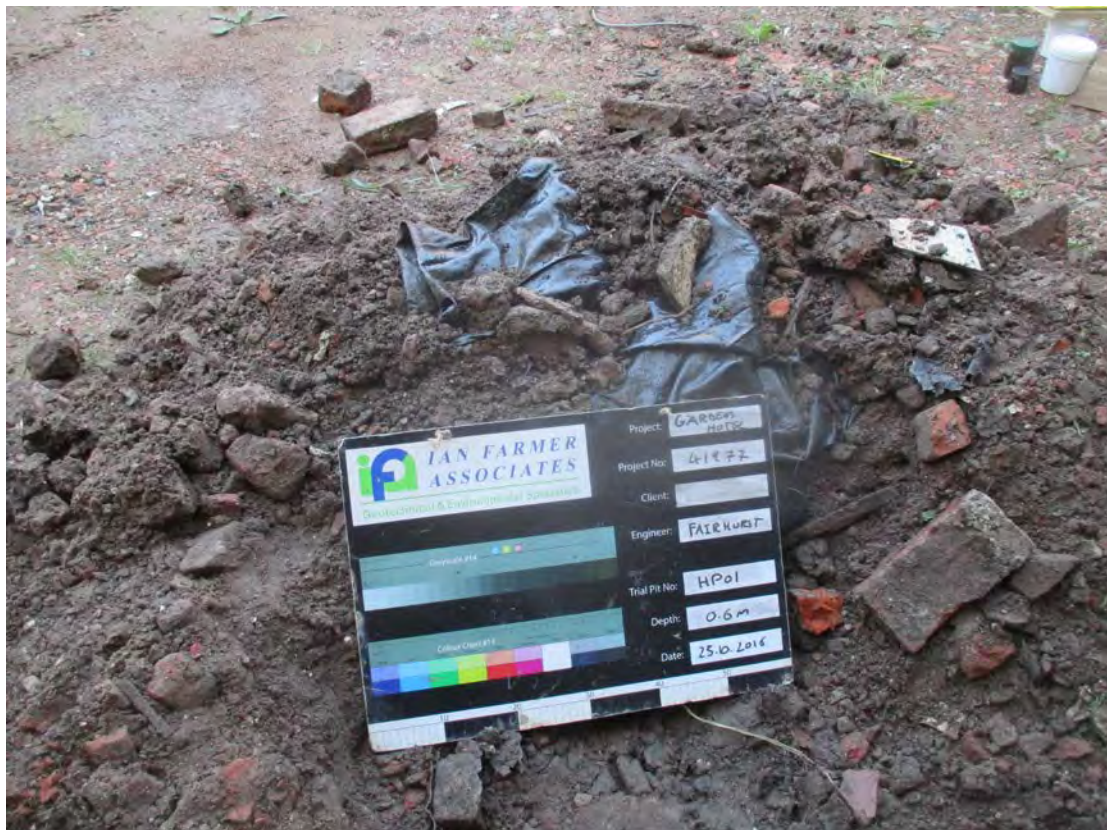
## Hand Pit Photographs HP01

- 3.7 A photographic record of the trial pits (TP01, TP02, TP04, HP01 and HP02) is presented in Appendix 6. Foundation sketches encountered within HP01 and HP02 are presented in Appendix 6.

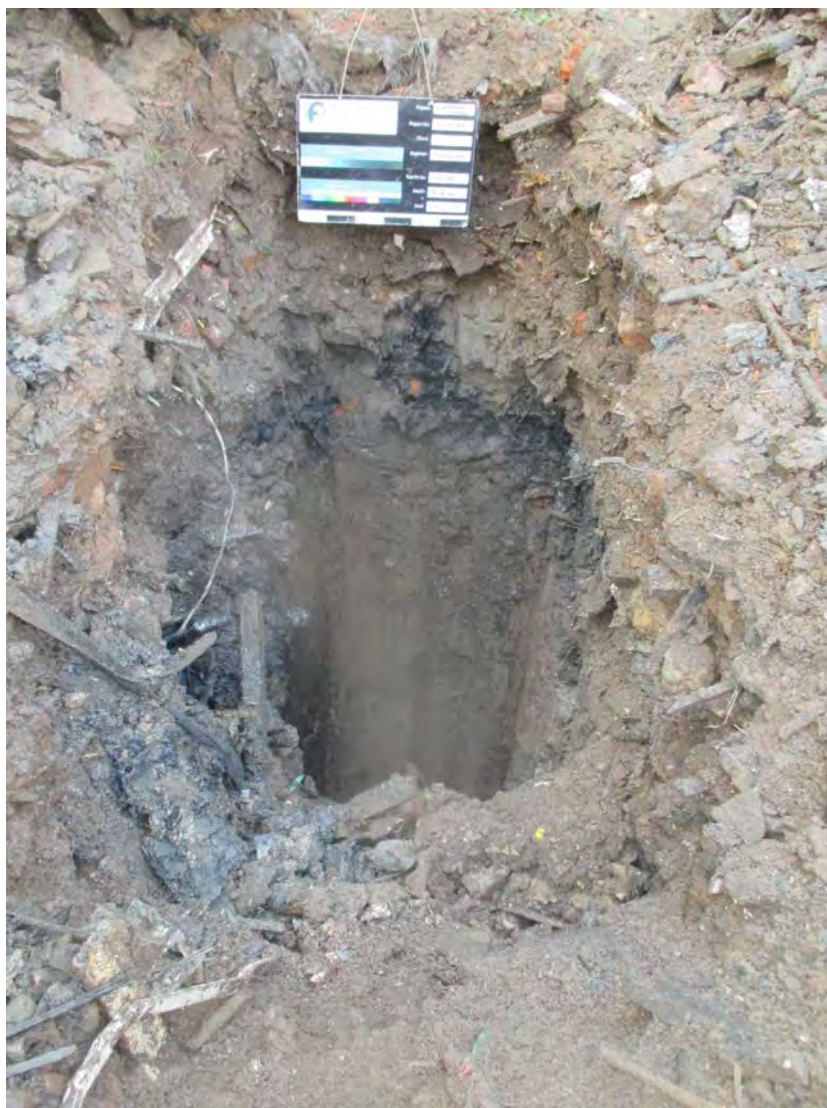
## **Trial Pit Photographs TP04**

| Target | Material Type | Sample Location | Concentrations above Assessment Criteria (AC) | Testing Undertaken |
|---|---|---|---|---|
| | Made Ground | TP04 | Lead = 910mg/kg (AC = 200 mg/kg)<br>Sulphate Aqueous Extract as SO <sub>4</sub> = 1400mg/l & pH = 8.9 = DS-2, ACEC Class AC-2 | GS, Asb, sPAH, sTPH, CS |
