## Phase 1 GeoEnvironmental Assessment

Claremont Road

Rusholme

**Report No. A2212/17**

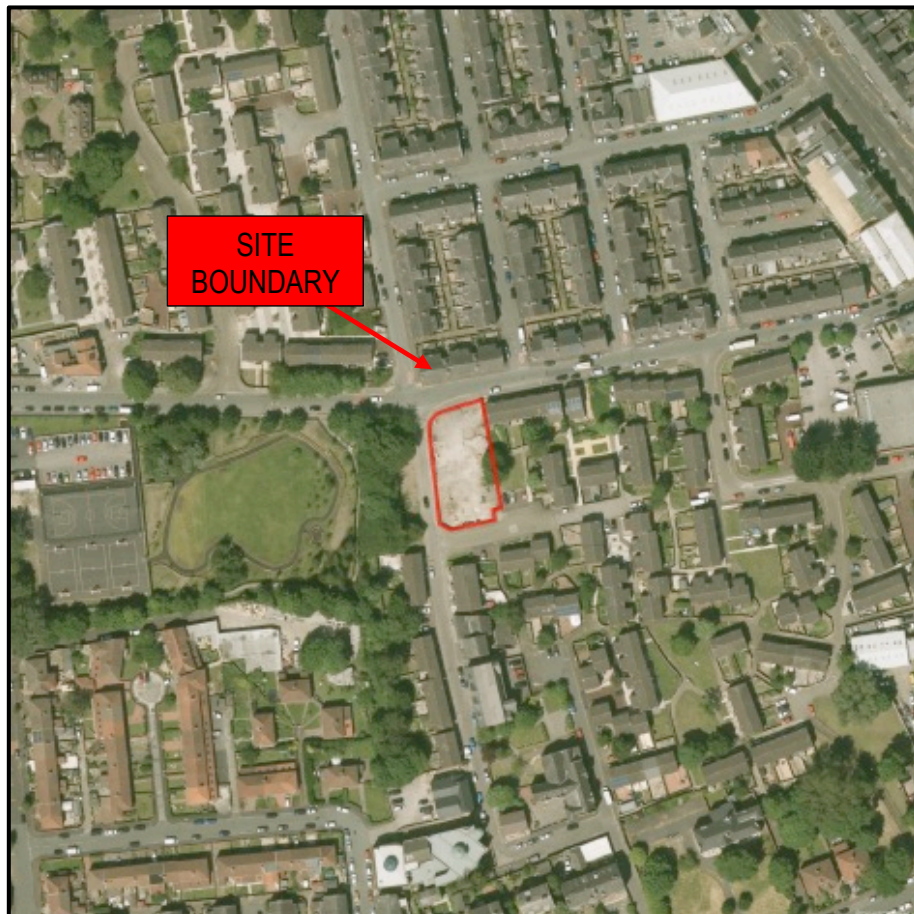
**Figure 2 Site Location Plan**

- 2.1 The site is situated between and bounded by Claremont Road to the north, Victory Street to the west with a park further west, Stenbury Close to the south and residential homes and gardens to the east.
- 2.2 The site is located approximately 3.1km south of the centre of Manchester and 1.25km north of Fallowfield. Access to the site is from the east via Victory Street. The approximate National Grid Reference for the centre of the site is SJ 85087 95107 (X: 385087 Y: 395107) with the closest postcode being M14 5AB.
- 2.3 The site occupies approximately 0.10ha across a rectangular shaped, generally level parcel of land, approximately 50m long and 20m wide.
- 2.4 A location plan is shown as Figure 2, below.

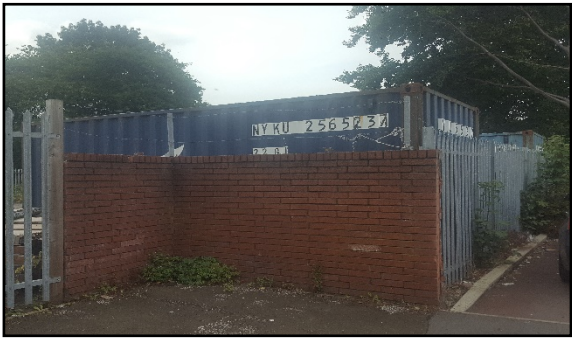
| <p><b>Plate 1 SE of the site boundary, looking N along the site boundary.</b></p> | <p><b>Plate 2 SE of the site boundary, looking W along the site boundary.</b></p> |

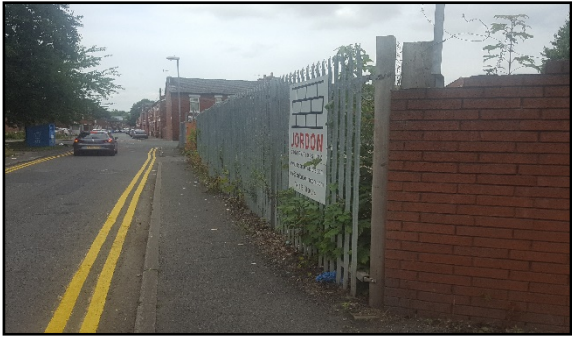
| <p><b>Plate 3 SW of the site boundary, looking N along the site boundary.</b></p> | <p><b>Plate 4 W of the site boundary, looking E at the site boundary.</b></p> |

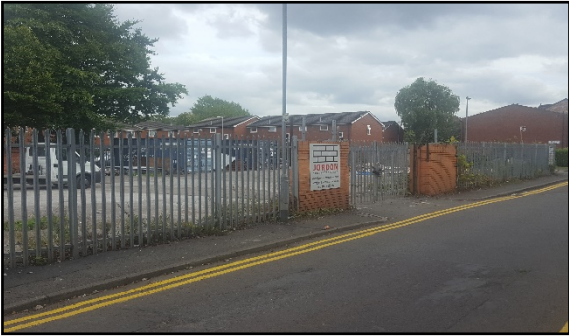
| <p><b>Plate 5 W of the site boundary, looking SE at the site boundary.</b></p> | <p><b>Plate 6 W of the site boundary, looking NE at the site boundary.</b></p> |

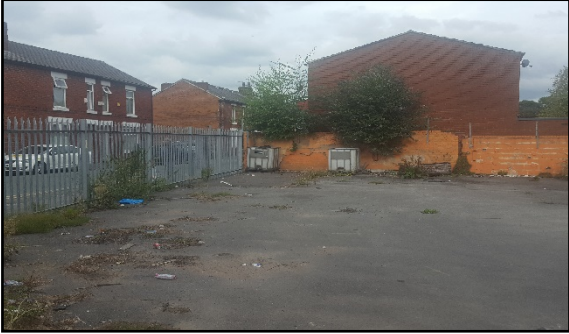
| <p><b>Plate 7 NW of the site looking NE of the site. (two IBCs)</b></p> | <p><b>Plate 8 NW of the site looking SE of the site (vehicles and storage containers).</b></p> |
