## Phase II GeoEnvironmental Investigation

Claremont Road

Manchester

**Report Ref: A2212/19/B.0/V2**

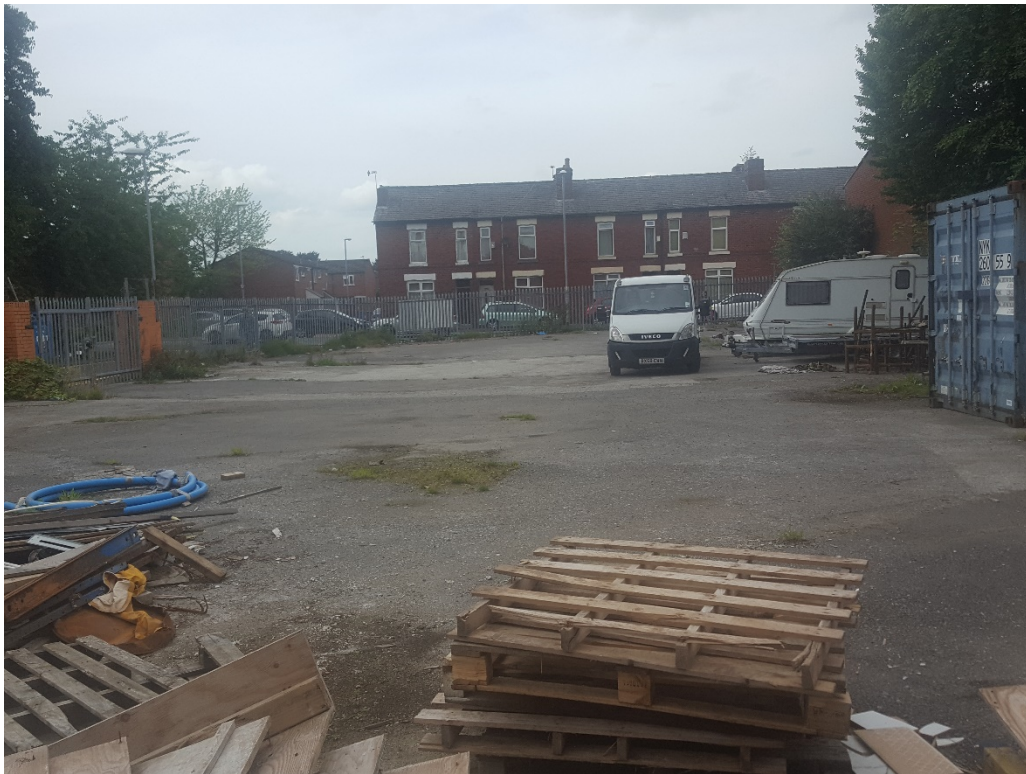
The site is located at the junction of Claremont Road (north) and Victory Street (west) and currently comprises a vacant, completely hard surfaced, storage yard, which is absent of any buildings or permanent structures. The surfacing appears to be in poor condition in places, with emerging vegetation.

**Figure 2 Overview of site, looking N**

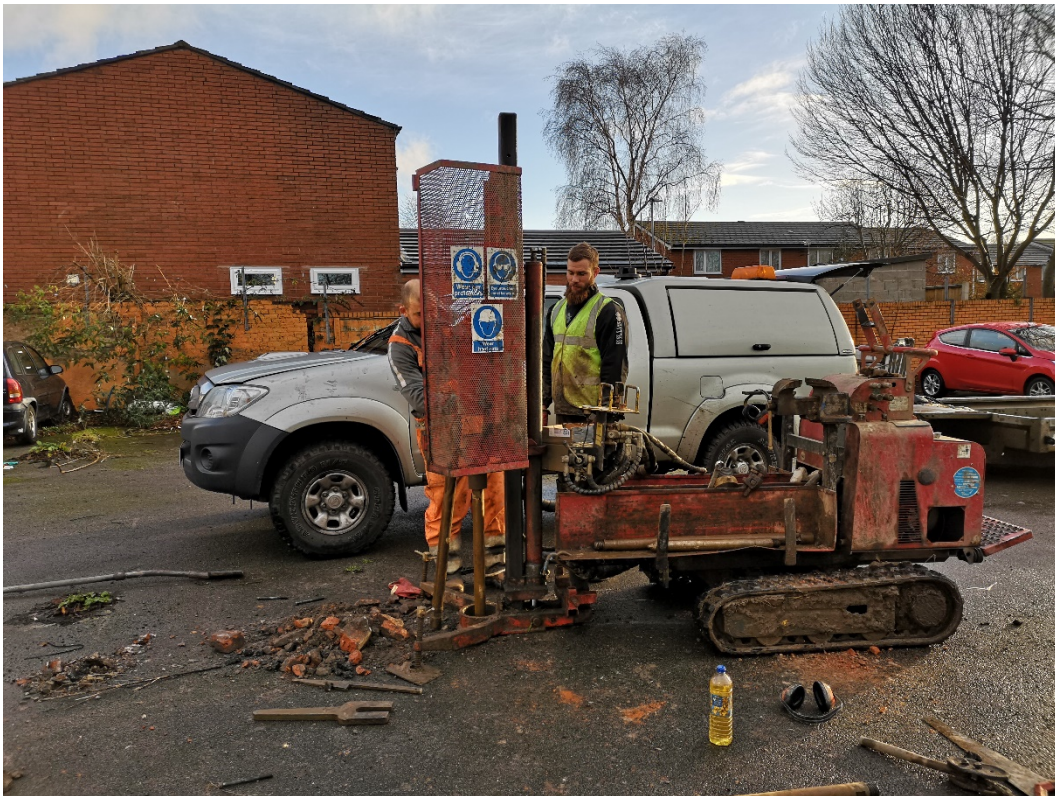
Figure 4 Drilling rig in position WS1

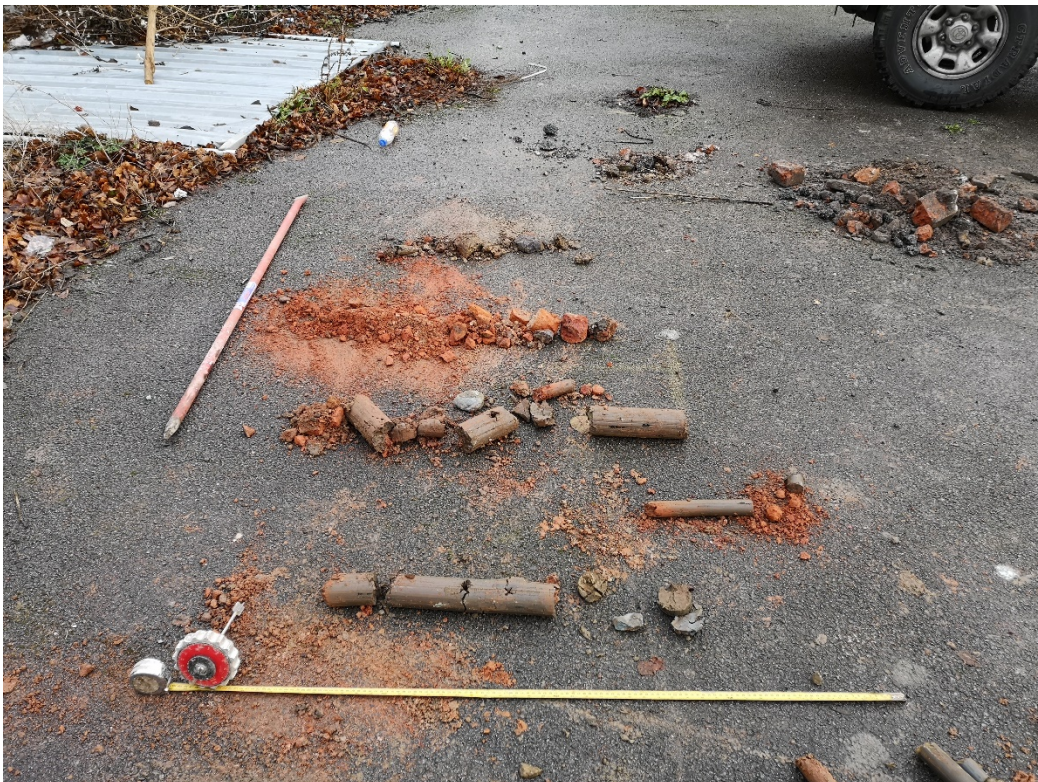
Figure 5 Soils encountered in WS1

It should, however, be noted that Made Ground may extend deeper than recorded in the area of the former Public House in the north of the site (2.20m bgl WS1), and an alternative foundation solution may be required in this part of the site.

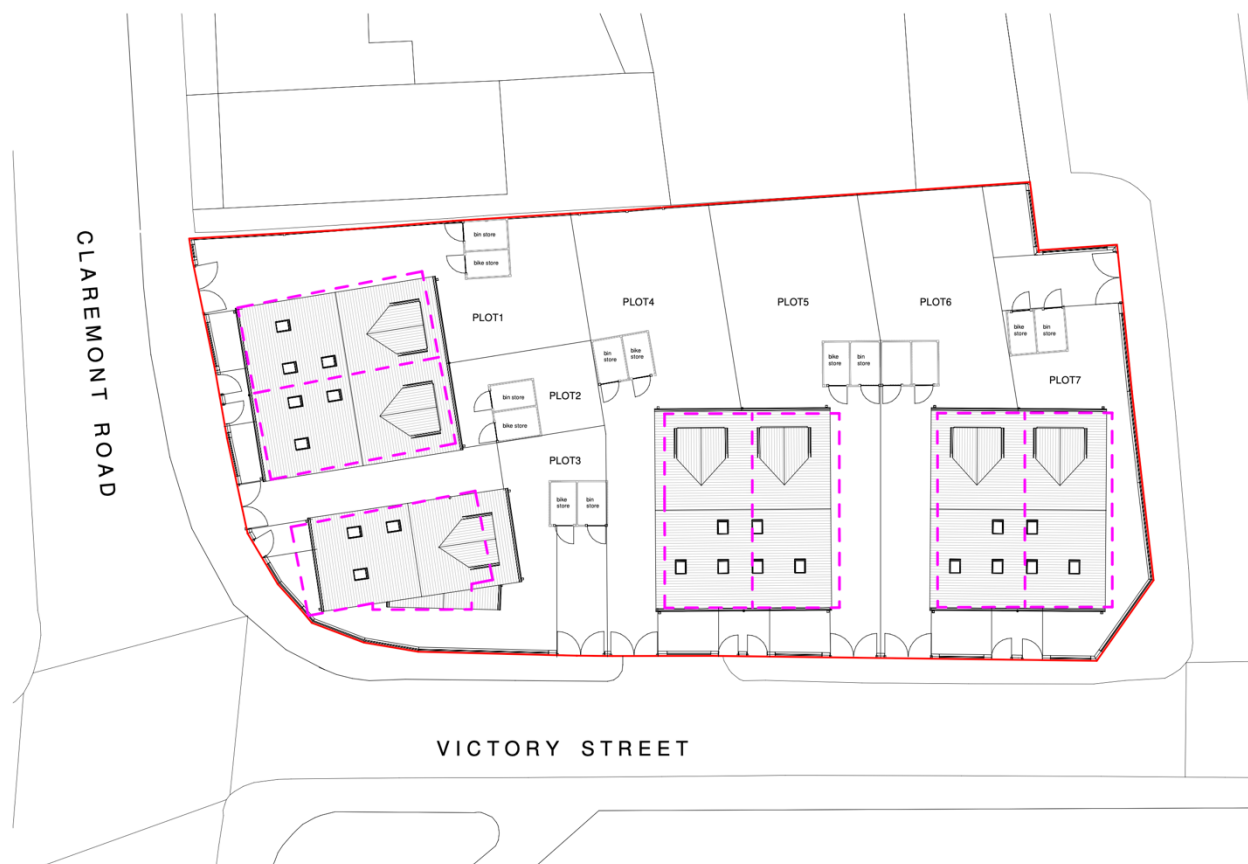
It is understood that the client intends to construct 7no. residential dwellings.

**Figure 7 Development Layout Plans**
