Our Ref: BEK/19661/211027/CGL/P49

**Residential Development at Ilk Street and Alpine Street, Clayton- PLOT 49**

BEK Enviro (BEK) has been commissioned by The Casey Group (CG) to supervise and validate the remediation works required at the above site.

# GAS PROTECTION VALIDATION RECORD:

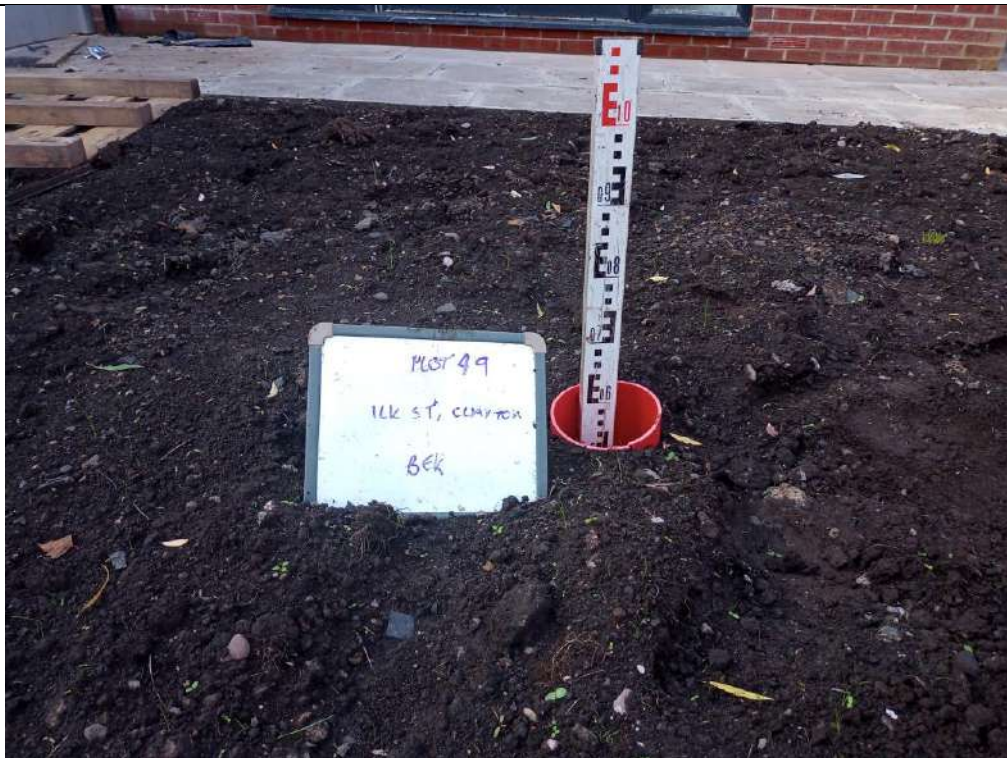
Photograph 1: Validation of Garden Capping Thickness

Following placement of the validated soils by CG, an engineer from BEK carried out spot checks and can confirm that the capping layer for Plot 49 comprises in excess of 600 mm of suitably clean validated soils. The capping soils overly a geotextile membrane at the base. Photographs showing capping thickness are provided within Annex E.

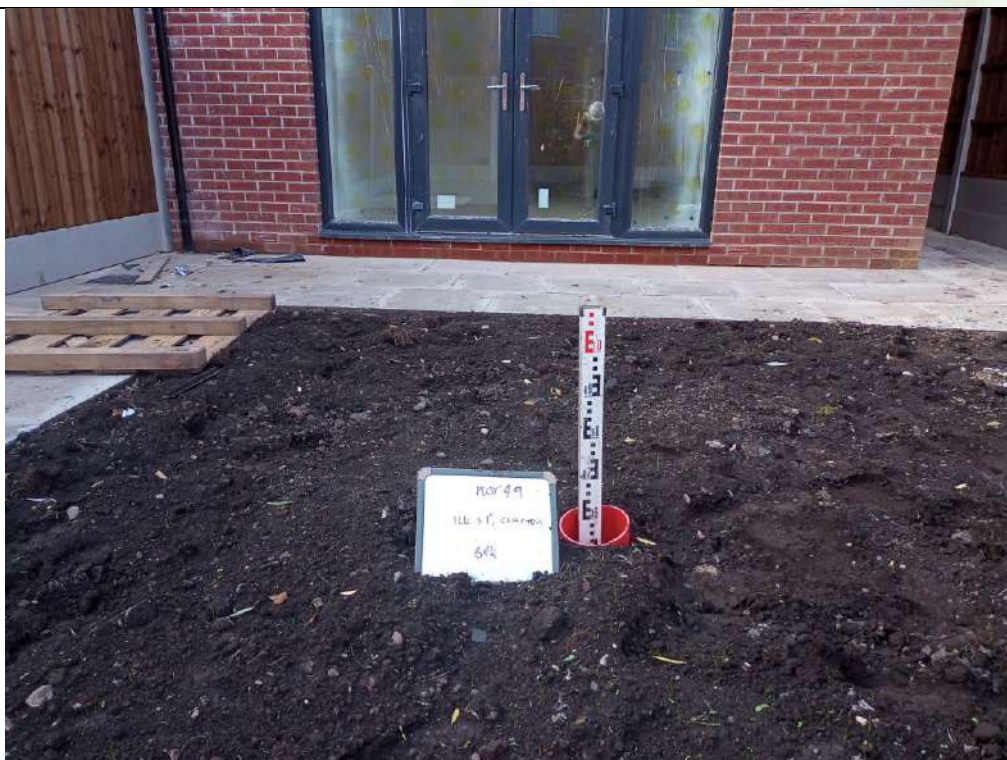
Photograph 2: Validation of Garden Capping Thickness

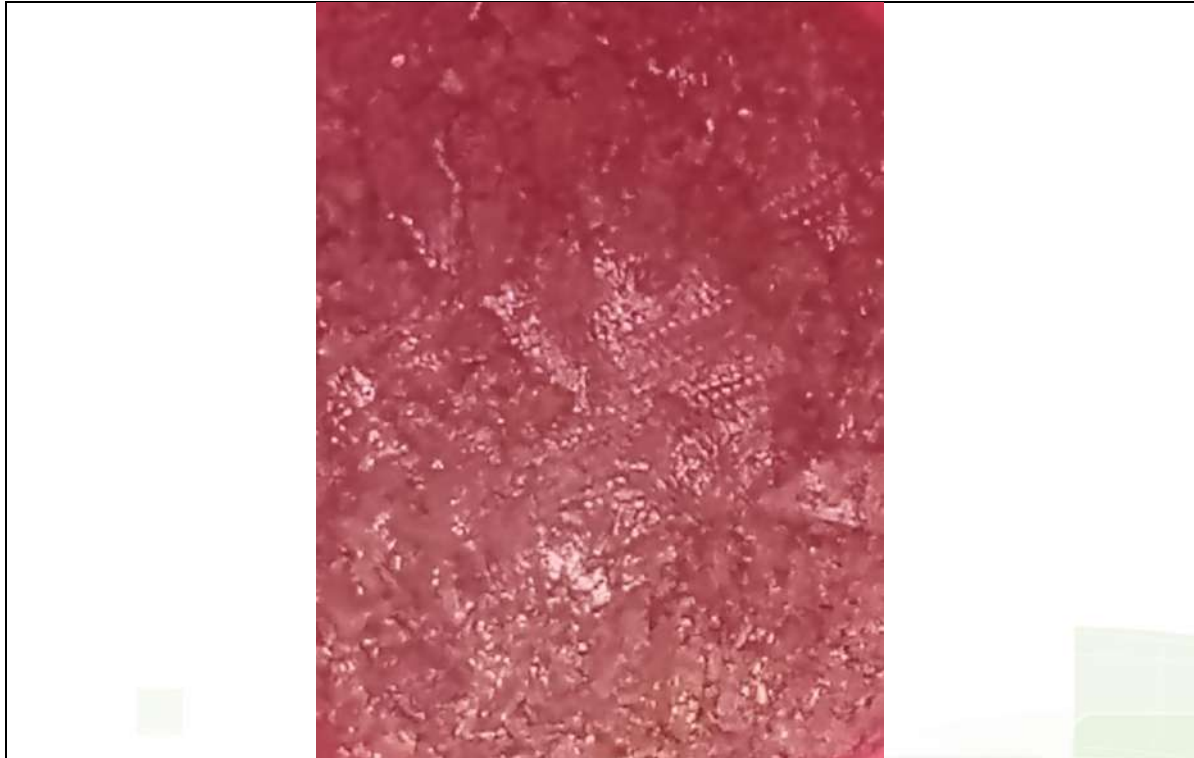
Photograph 3: Validation of Geotextile Membrane

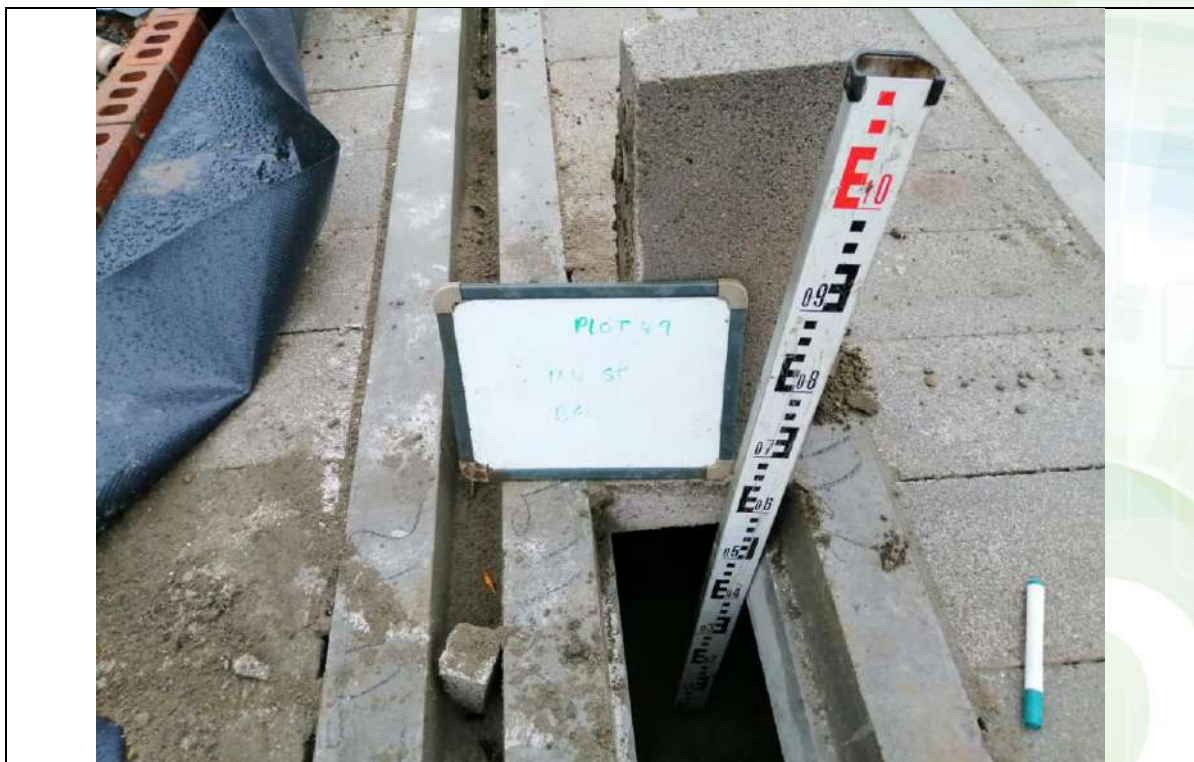
Photograph 4: Validation of Sub-Floor Void Space (min 150 mm)

The sub-floor void and the installation of the membrane has been validated and BEK can confirm the gas measures incorporated into the foundation design of Plot 49 conforms to the specified requirements. The membrane installation was verified by an Engineer from BEK who has attended the Verification of Gas Protection Systems Course delivered by CL:AIRE Training Course.

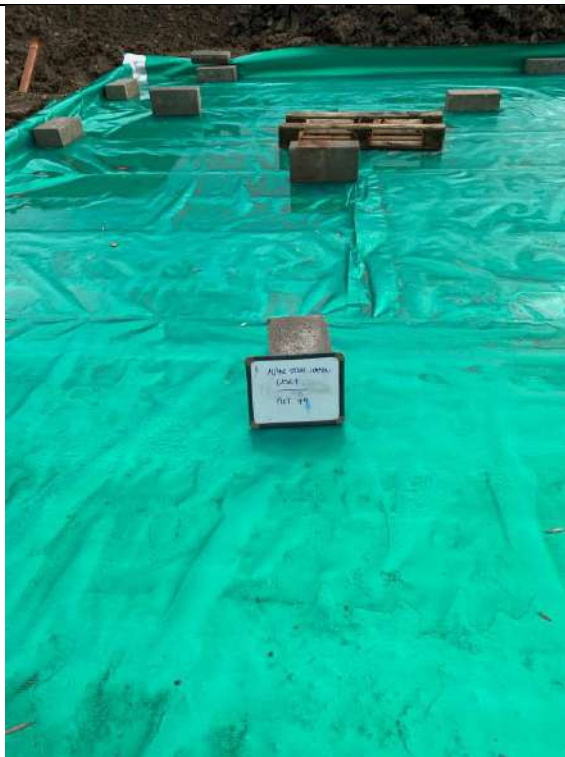
Photograph 5: Validation of Gas Membrane Installation

CG commissioned Reeve-Tec Membranes Limited to install the gas membranes at the site, who have used the Protech GM Super gas membrane which is considered suitable for use. A copy of the data sheet for this membrane is presented in Annex C. The completed gas validation proforma for this plot is presented in Annex D and validation photographs are presented in Annex E.

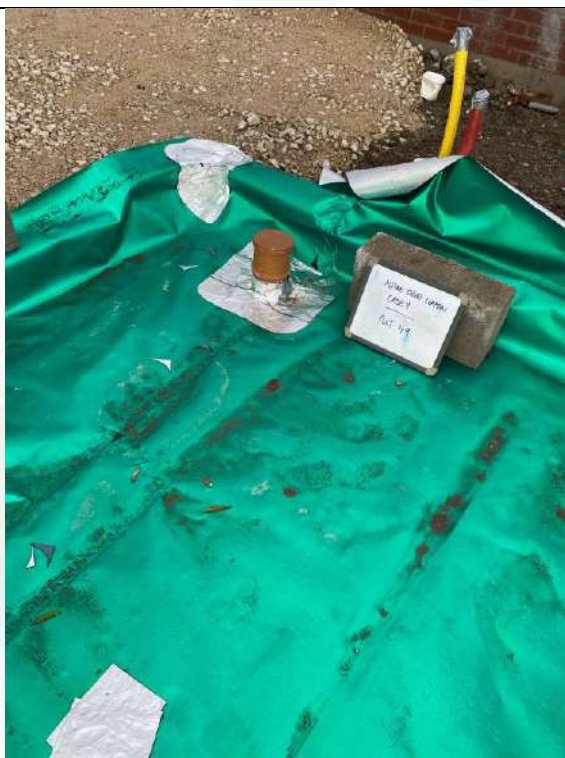
Photograph 6: Validation of Gas Membrane Installation
