| To: | Manchester City Council LLFA | Job number: | 949-02 |
| Subject: | Medieval Quarter CDN/21/0878<br>Response to LLFA Comments<br>14 December 2021 | Cc: | Adam Liu<br>Frank Fitzpatrick |

**Title: Response to LLFA Comments 14.12.21**

See below response to comments received for Phase 1A of the Medieval Quarter development

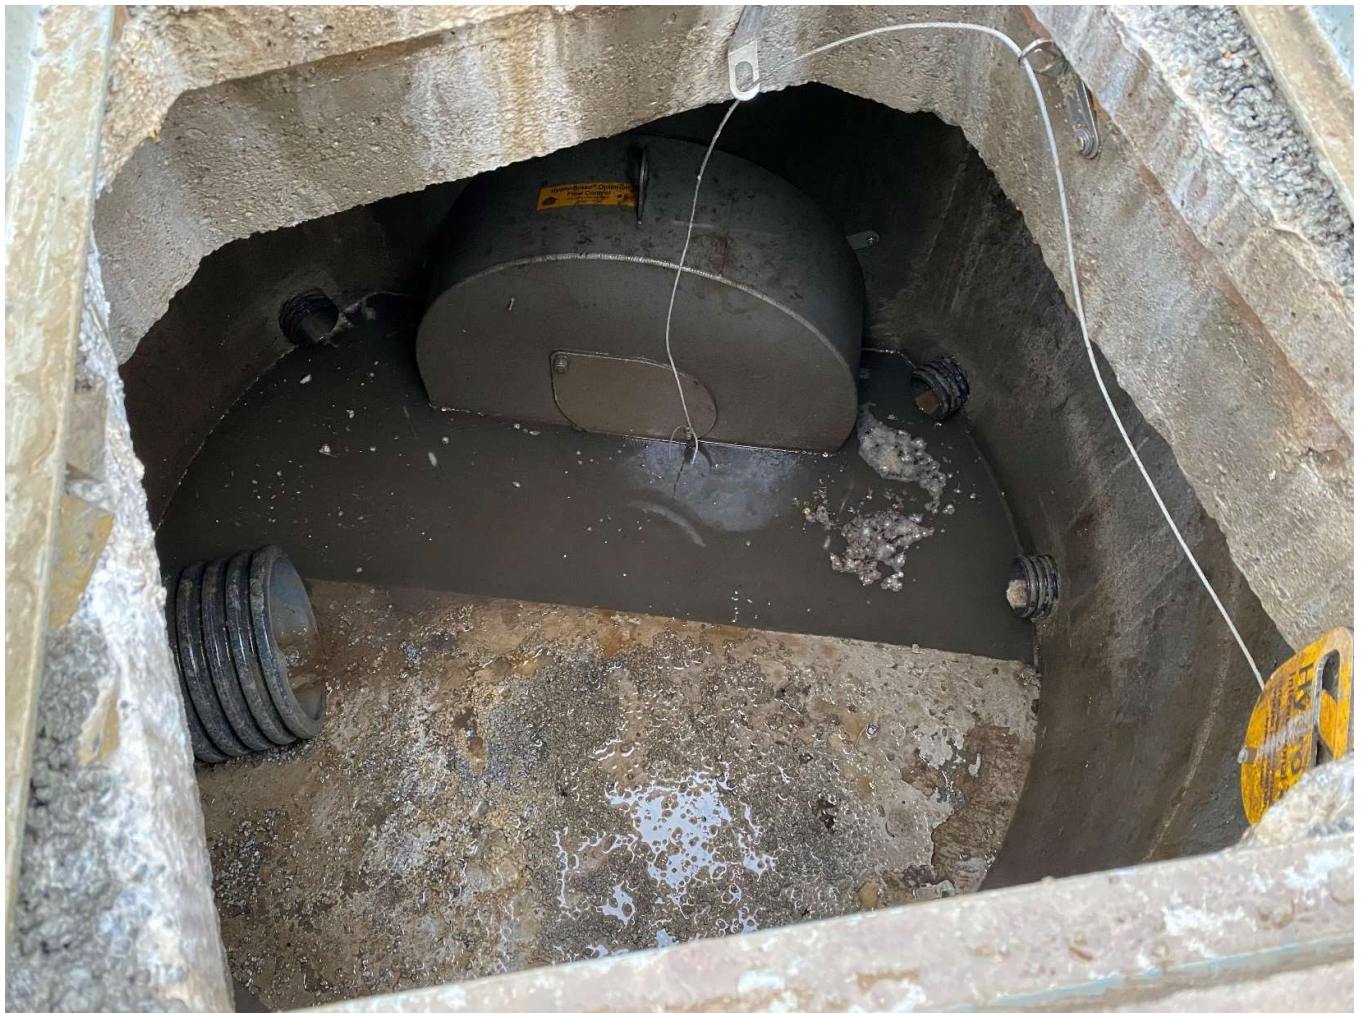
**Response:** See below photo of vortex flow control device installed at manhole SWMH4

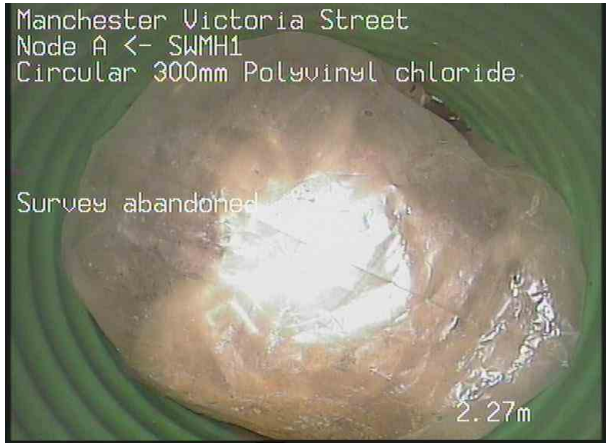
| <b>Comments:</b> | Upstream not connected as of yet. Capped off | | | | |

Node  
AX\_dfb9f765-3fdf-4c79-9749-2480b181680b\_20210824\_0952  
12\_936.jpg, 00:00:10, 2.27 m  
Survey abandoned, Capped of

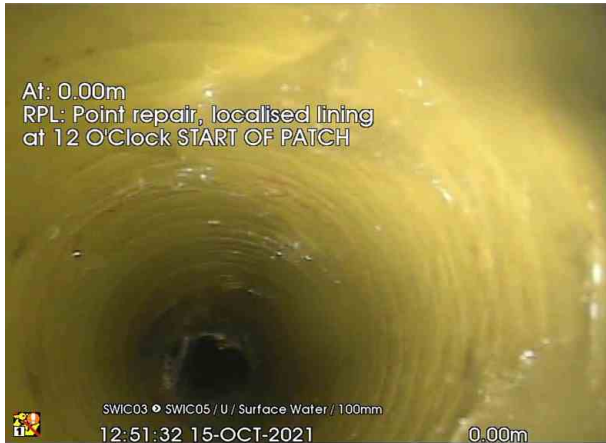
SWIC05X\_0fe94daa-ea73-4b8a-9439-d2f074dc3fba\_2021101  
9\_153859\_851.jpg, 00:00:03, 0.00 m  
Point repair, localised lining at 12 o'clock, START OF PATCH

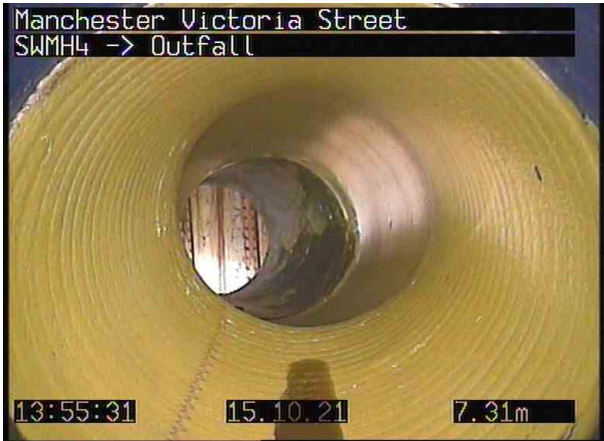
SWMH4X\_1efb133e-cbb1-49ba-8a6b-ce4472694a3b\_20211019\_153845\_315.jpg, 00:00:40, 7.36 m  
Point repair, localised lining from 12 o'clock to 12 o'clock, Start Of Patch

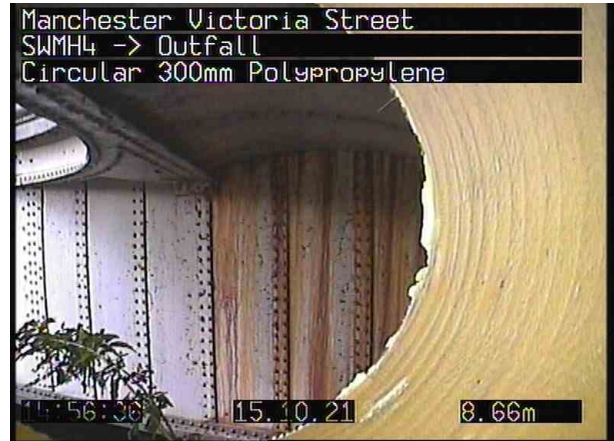
SWMH4X\_4fe15750-e136-467e-83f6-88fe7f023eca\_20211019\_153850\_128.jpg, 00:02:27, 8.66 m  
Point repair, localised lining from 12 o'clock to 12 o'clock, end of patch
