## Appendix D – Geotechnical Laboratory Testing Results

## FINAL ANALYTICAL TEST REPORT

**Project Manager:** Matthew Holroyd/Siobhán Hyde  
**Project Name:** Swan House Manchester  
**Project Ref:** B067266.201  
**Order No:** EBMA1394  
**Date Samples Received:** 12/09/18  
**Date Instructions Received:** 13/09/18  
**Date Analysis Completed:** 26/09/18

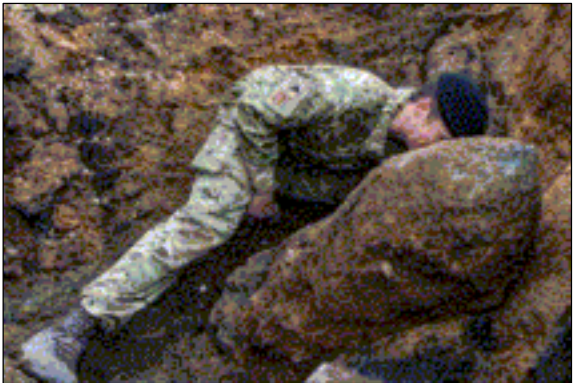
**Top:** J-curve Effect - Due to angle of entry, unexploded bombs would often end their trajectory at a lateral offset from point of entry, often ending up beneath adjacent extant structures/sites. The photograph above shows 250kg bomb found in Bermondsey pointing upwards, demonstrating 'J-curve'

One of the most common scenarios for UXO going unnoticed was when a UXB fell into a 'bomb site' (such as the area shown **Top Left**), the entry hole of the bomb obscured by any debris and rubble present. Note that the entry hole of a 50kg UXB could be as little as 20cm in diameter (**Left**).

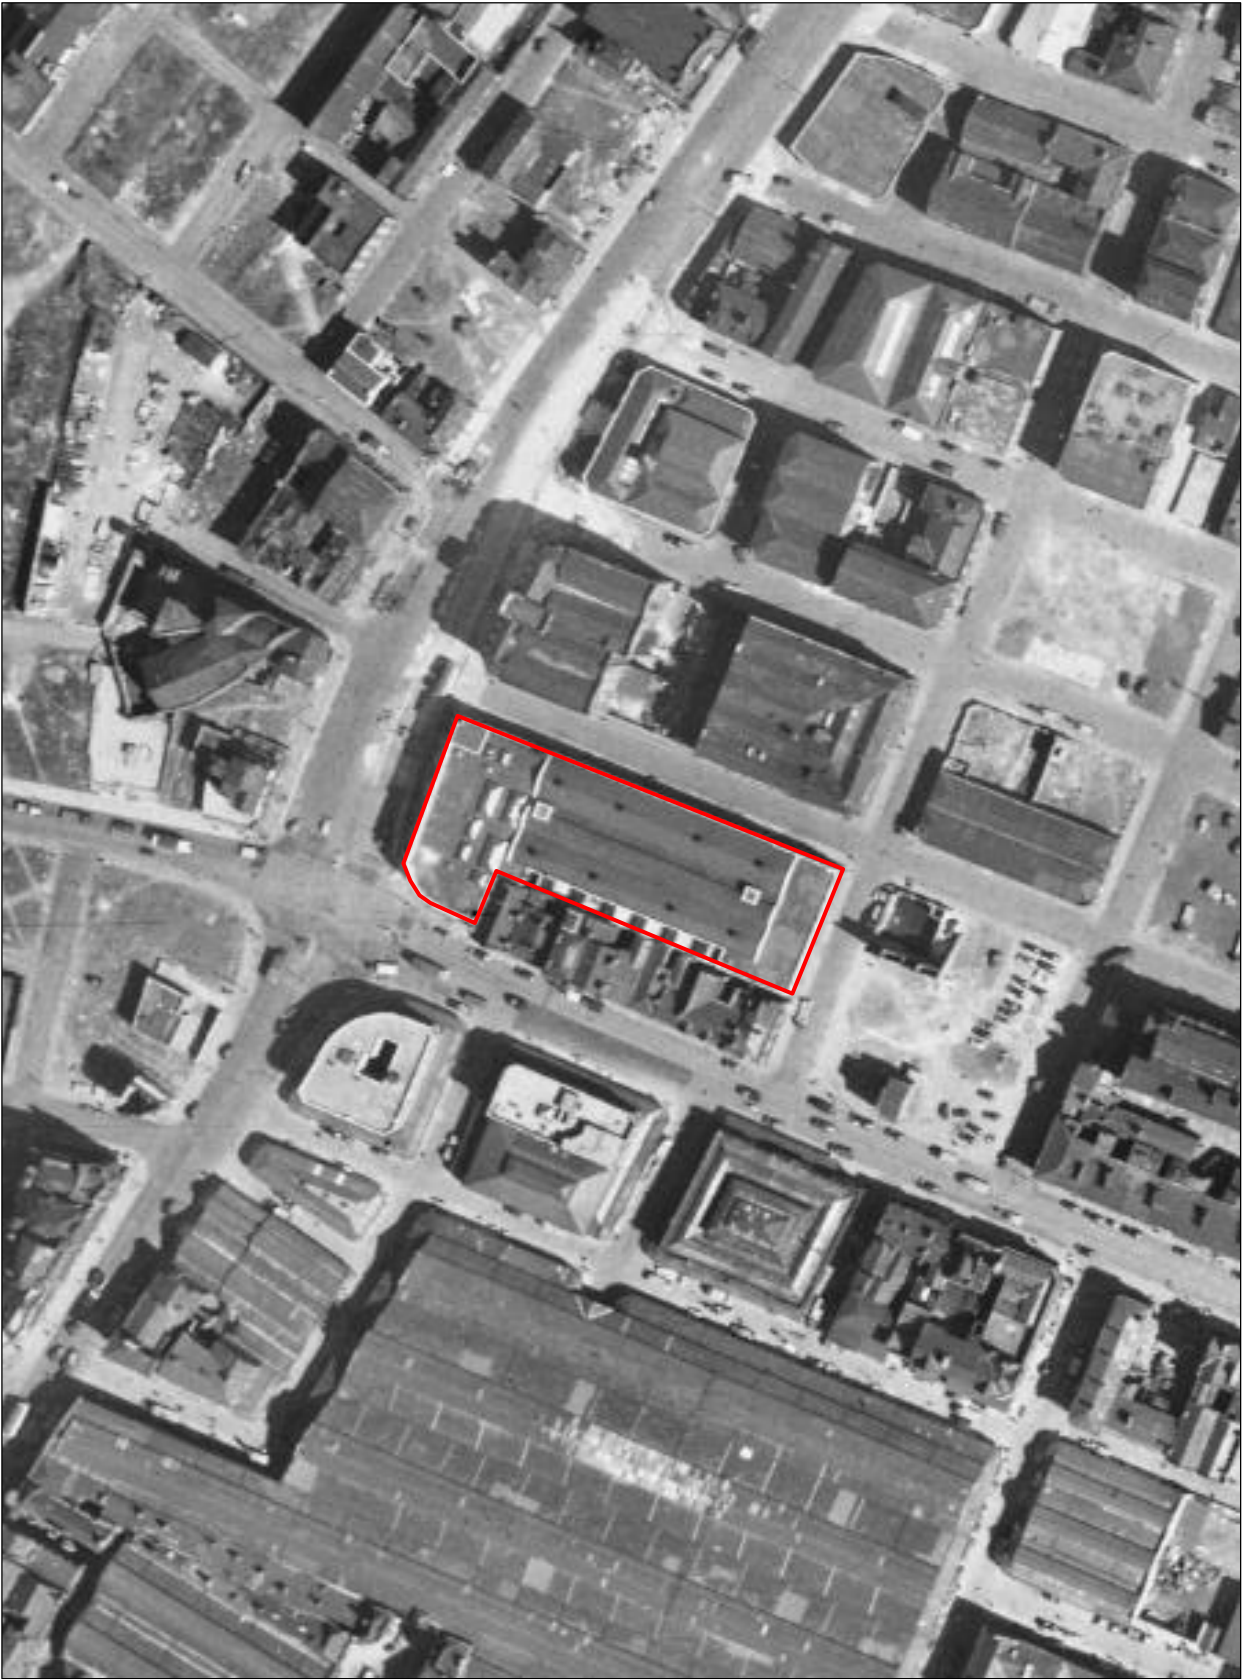
| Ref: <b>DA12456-00</b> | Source: Manchester Central Library |

- The Manchester bomb damage map records no bomb damage to this structure on site. The outline of one terraced structure adjacent to the southern extent of the site boundary is highlighted in red indicating that the structure sustained some bomb damage. However, as this is not represented in the damage key and the structure appears structurally intact in the post-WWII era, the recorded damage is anticipated to have been minor in nature.

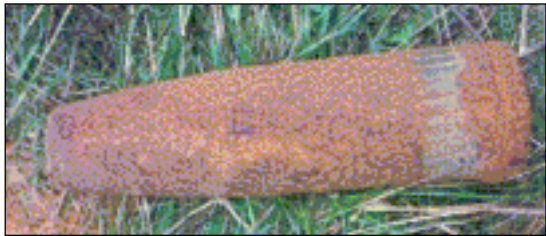
40mm Bofors Projectile

| Projectile Weight | 1.96lb (0.86kg) |
| Ceiling | 23,000ft (7000m ) |
| Remarks | Light quick fire high explosive anti-aircraft projectile. Each projectile fitted with small tracer element. If no target hit, shell would explode when tracer burnt out. Designed to engage aircraft flying below 2,000ft |
