**Land adjacent to  
929 Oldham Road  
Manchester**

**Quantitative Ground Contamination  
Risk Assessment Report**

**Project Reference: P15349**

**Report Reference: R15026**

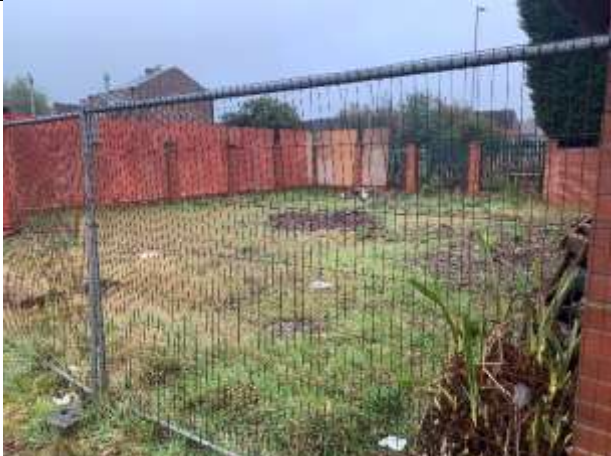
| Current vacant site | Shipping container in the north east of the site and Ceylon St to the north of the site |

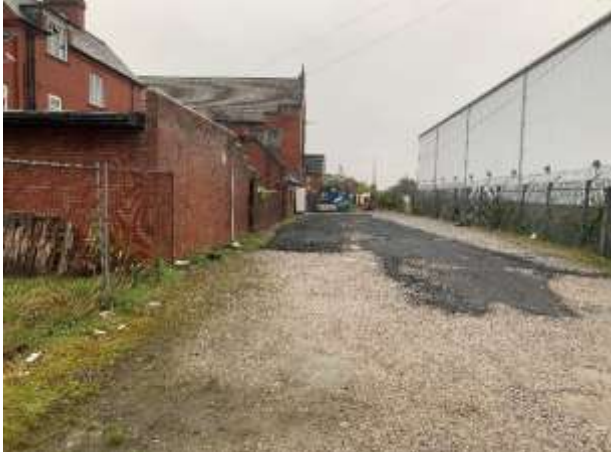
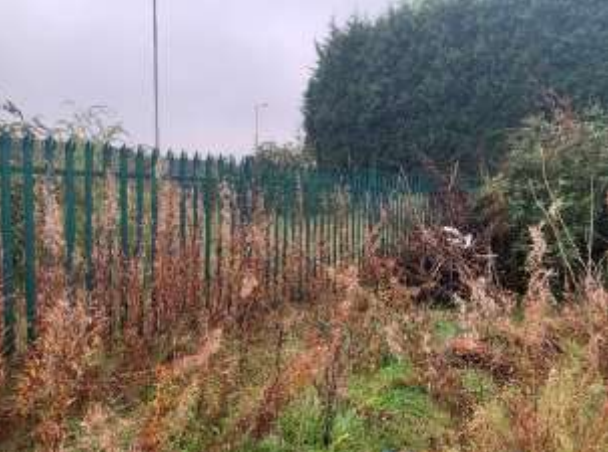
| Current vacant site | Shipping container in the north east of the site and Ceylon St to the north of the site |
|---|---|
| Industrial unit to the north of Ceylon St and School building to the west | Scrub land to the south of the site |

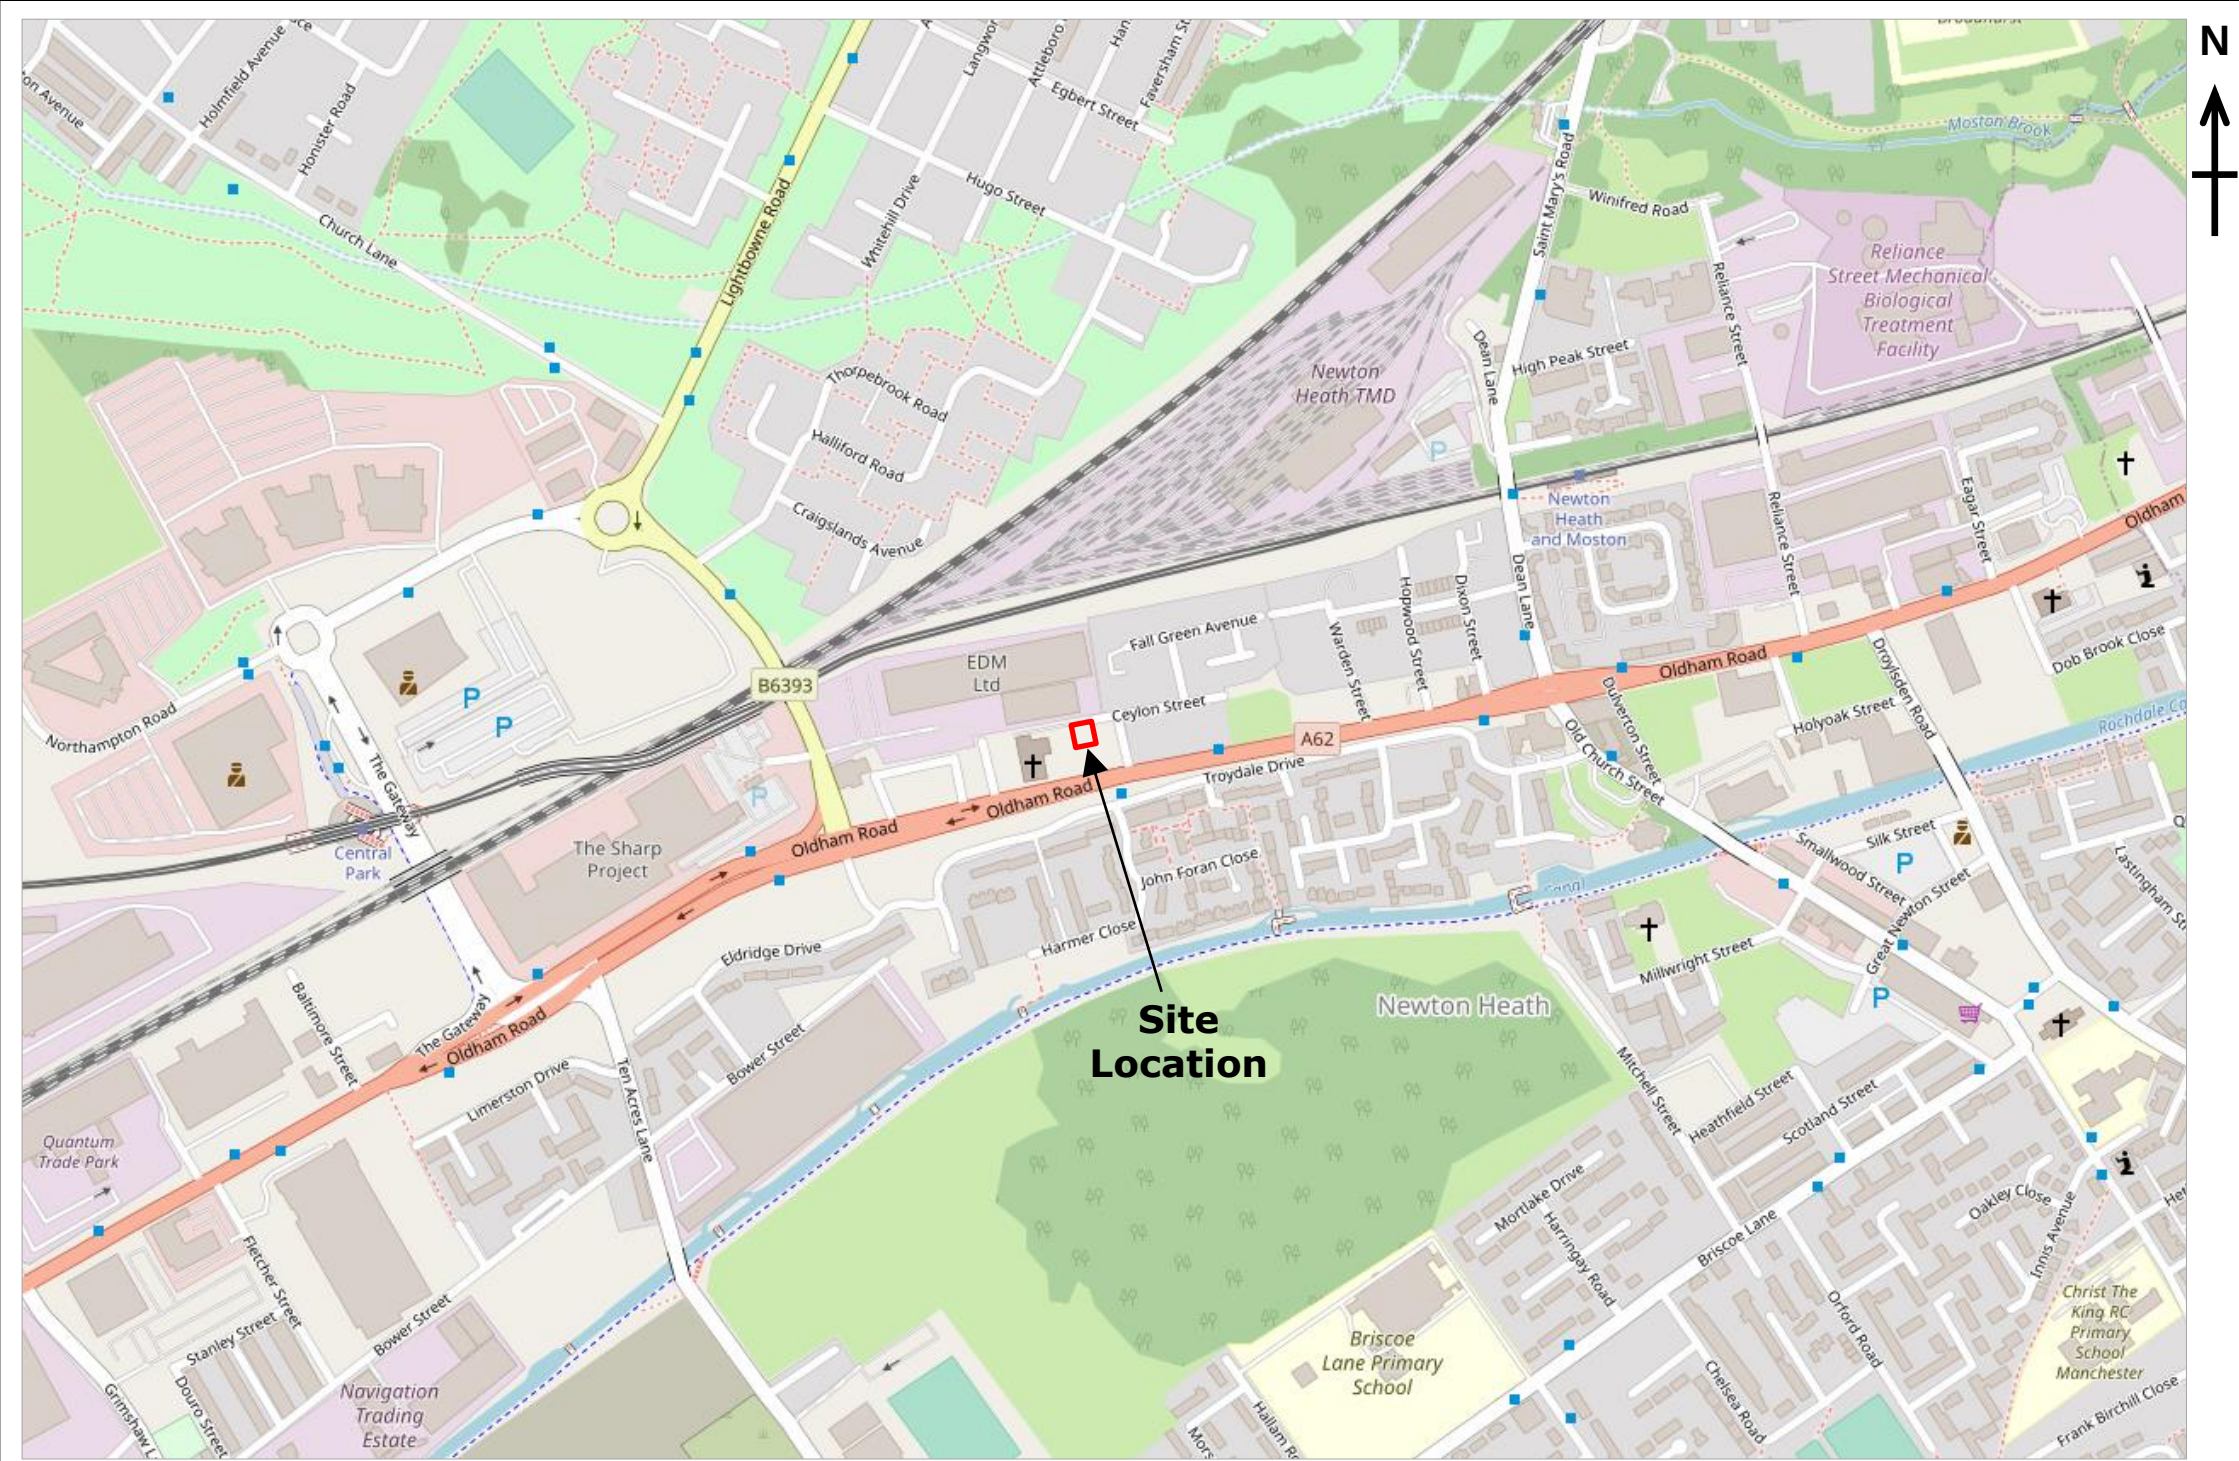
Figure 1 Site Location Plan

The site comprises a rectangular shaped plot of land located to the south of Ceylon Street, Manchester and is centred on the approximate Ordnance Survey national grid reference 387500, 400640. A site location plan is presented as Figure 1.

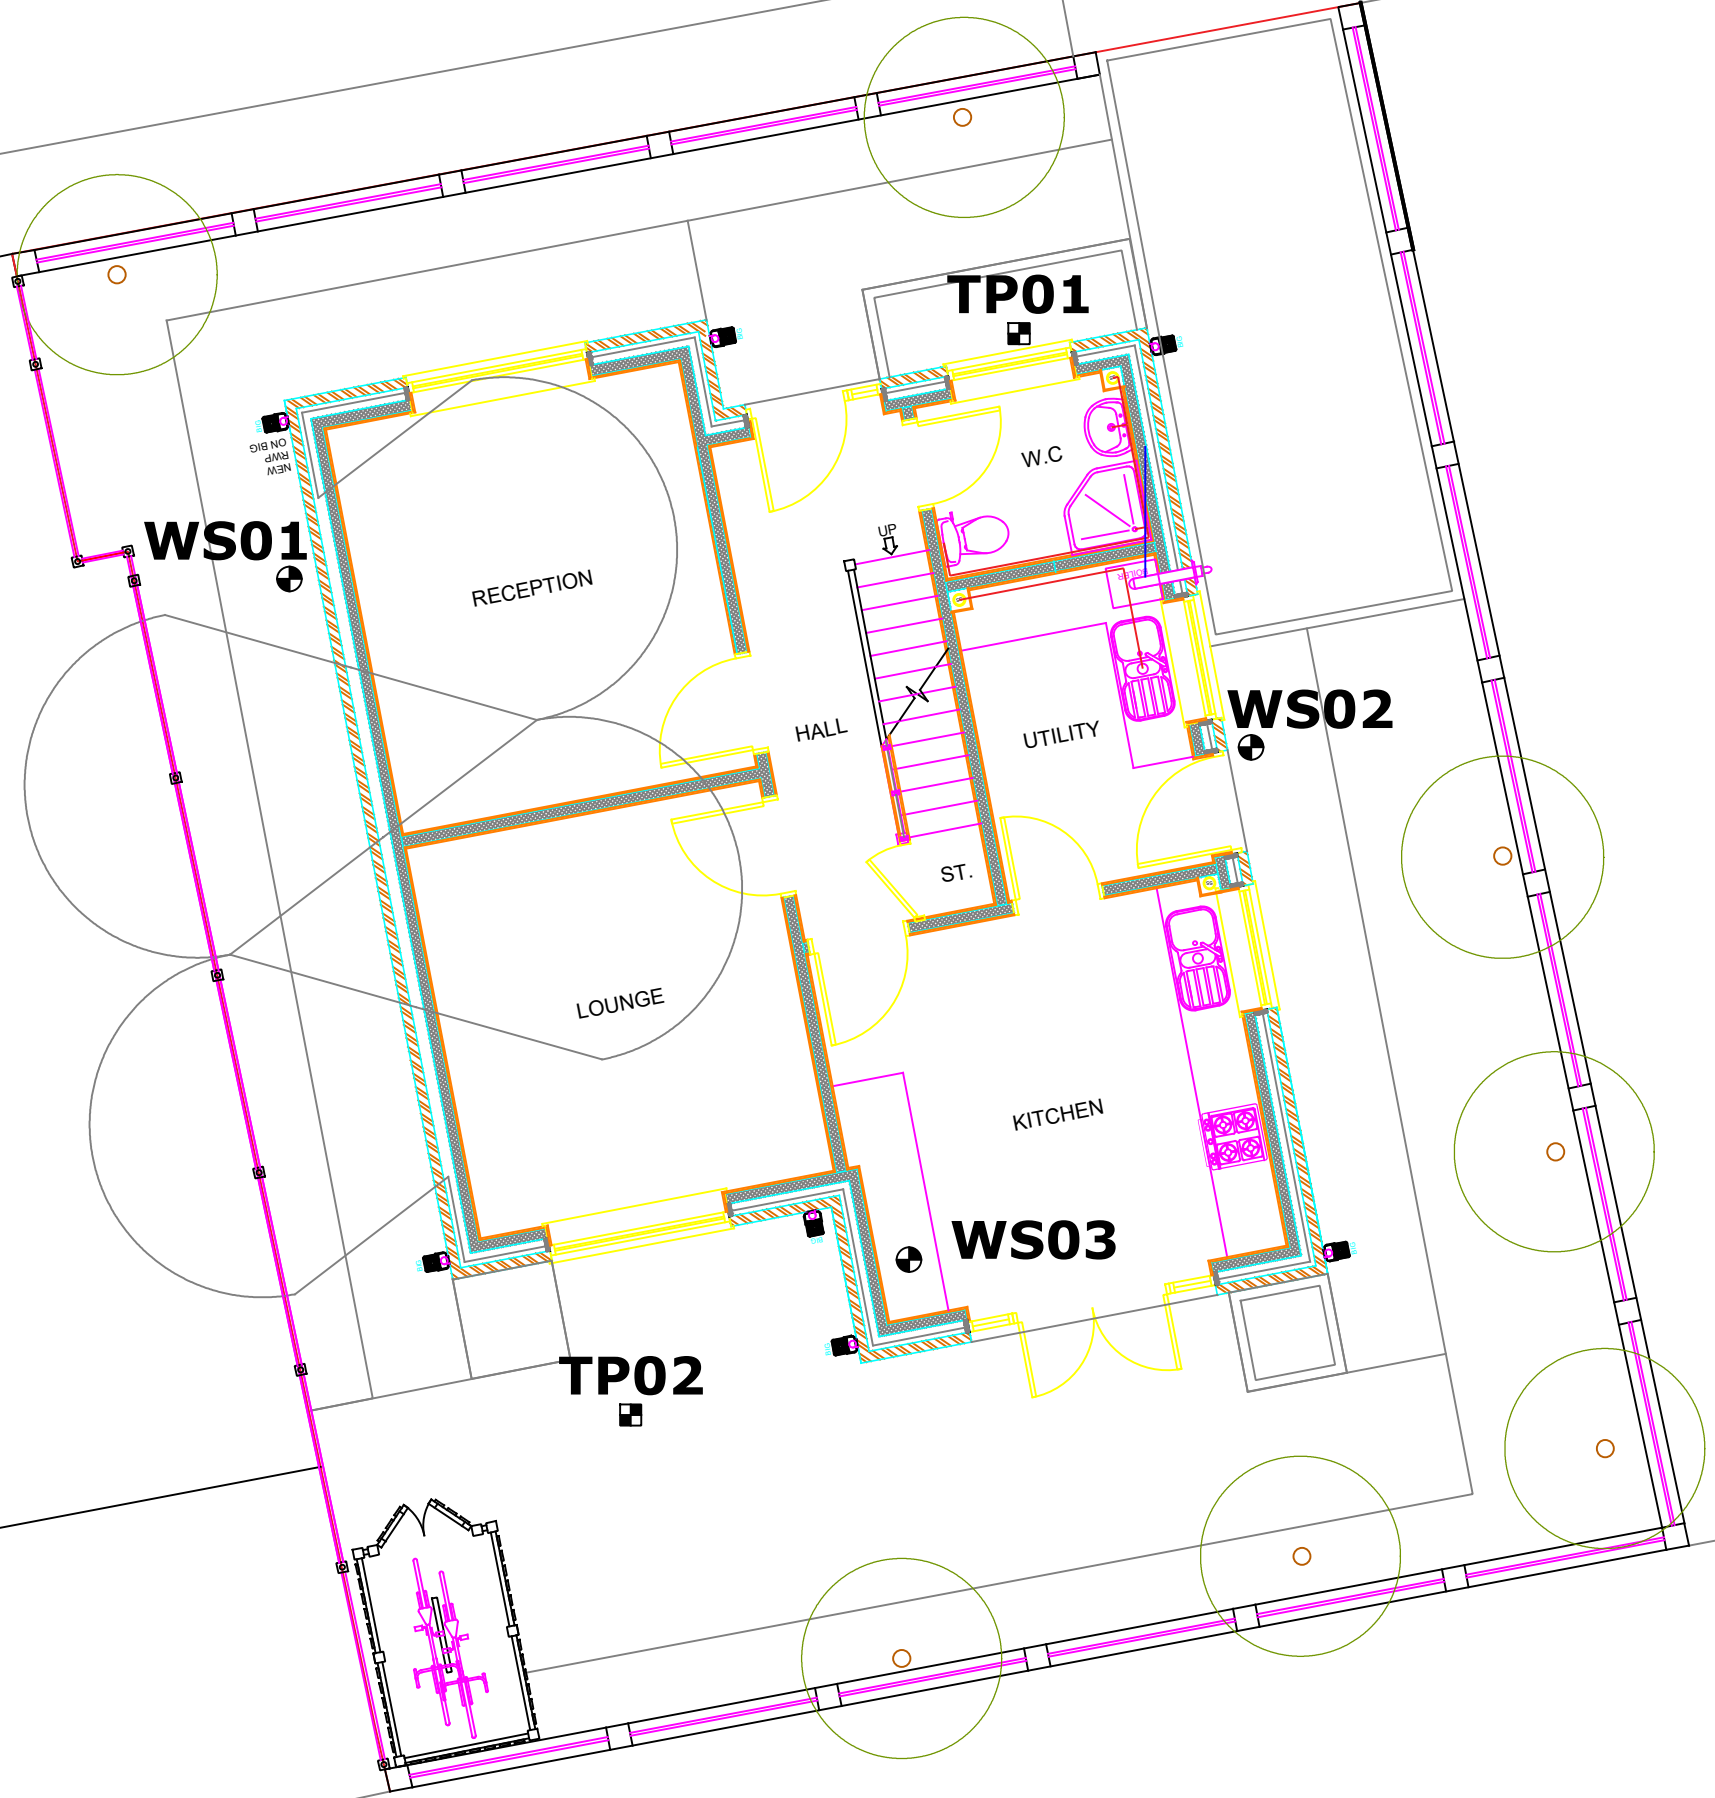
Figure 2 Site Plan

The ground investigation comprised the excavation of a series of dynamic sampler boreholes, and hand dug trial pits. The intrusive work was carried out on 13<sup>th</sup> October 2021. The exploratory hole locations are shown on Figure 2.

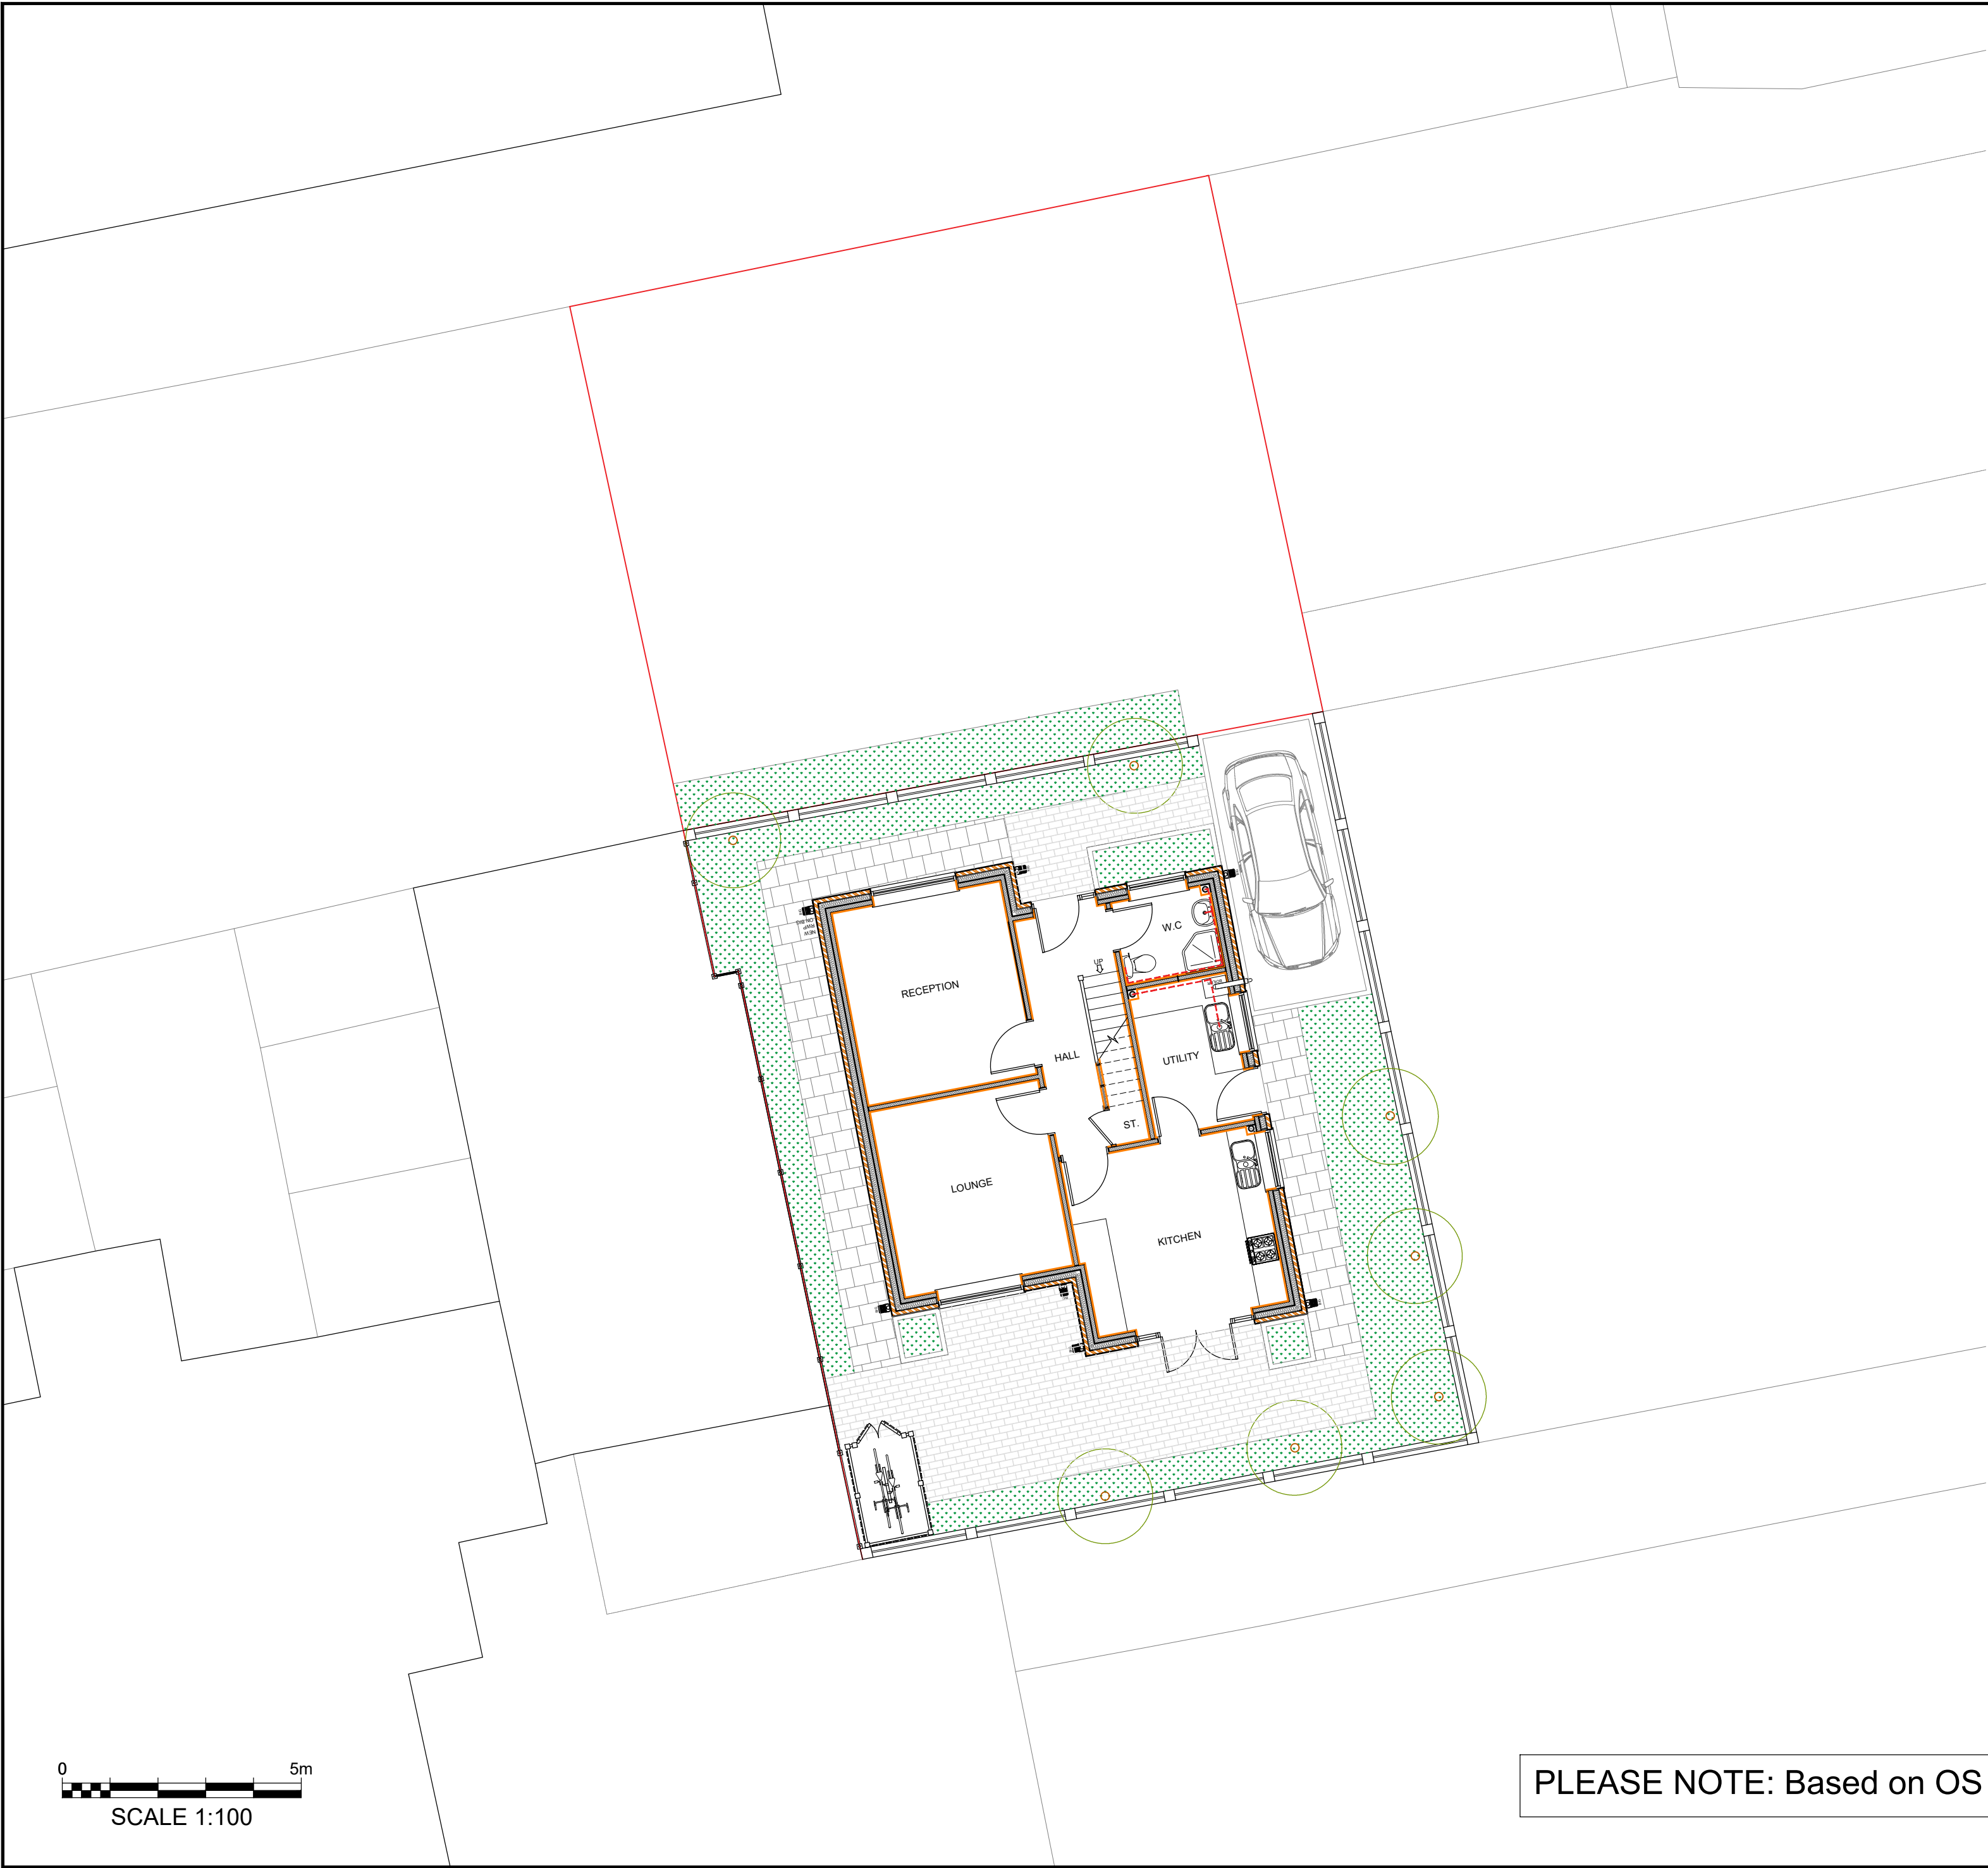
Proposed Development Layout

It is proposed to develop the land adjacent to 929 Oldham Road, Manchester. The development proposals are understood to comprise the construction of a two-storey house with areas of private garden and car parking. A copy of the proposed development layout is presented in Appendix A.
