# DAYTIME BAT SURVEY

## 567 WILMSLOW ROAD, DIDSBURY, GREATER MANCHESTER

JANUARY 2022

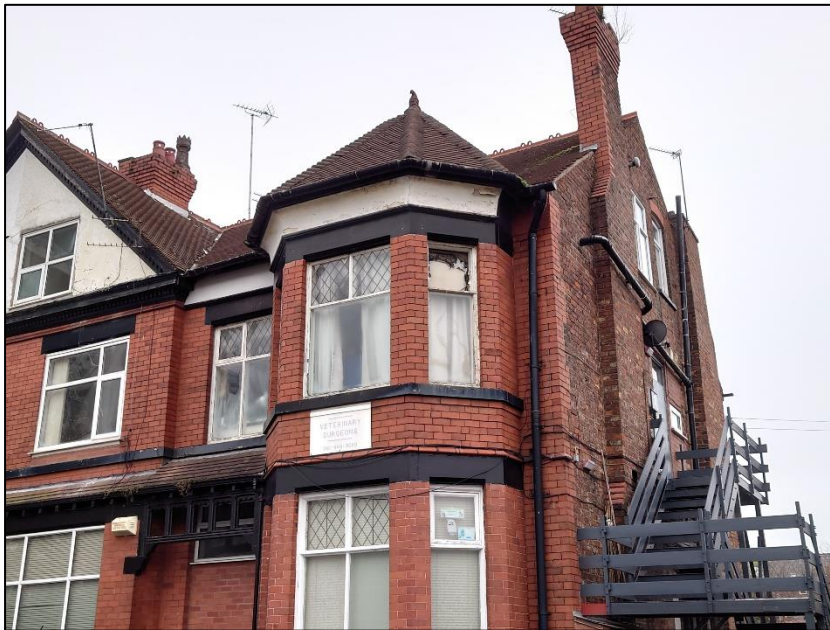
- 3.2 The external brick work is complete and intact (see Photographs 1 and 2), with no significantly damaged bricks or missing mortar. The door and window frames are flush to the surrounding masonry. The brick chimney stack is complete. The brick and stone window lintels are without cracks or gaps for bats to exploit.

*Photograph 1 showing the front elevation of the building*

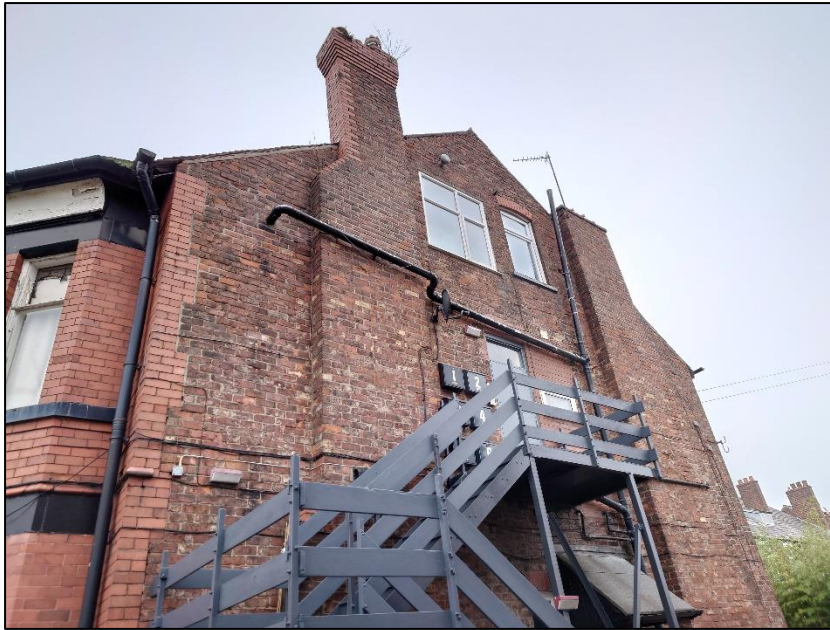
*Photograph 2 showing the side elevation*

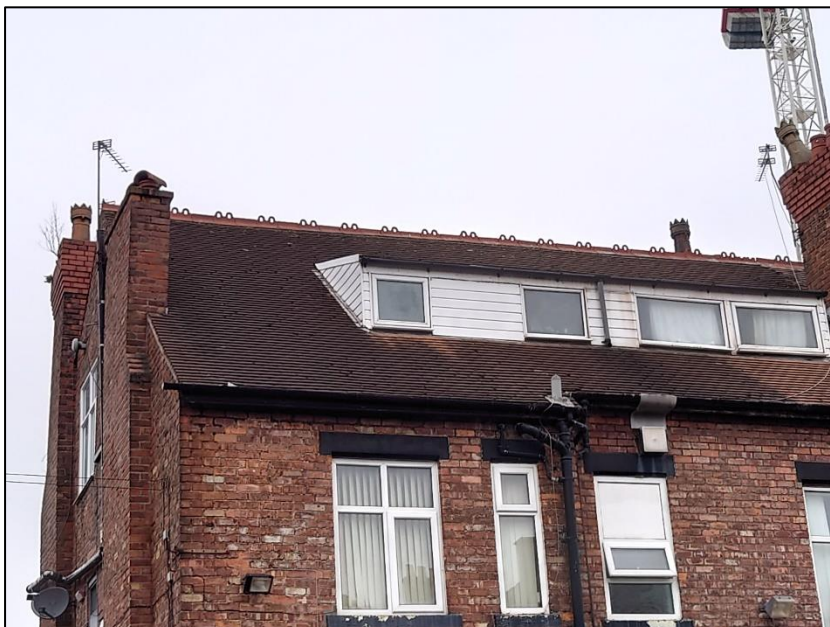
- 3.3 The roof of property is pitched and tiled with clay roof tiles throughout (see Photographs 3 and 4). The roof tiles are in position and flush to one another, offering no suitable gaps for bats to use. The ridge tiles are in situ and mortared. A small amount of lead flashing is present at the base of the chimney stack and this is flat and flush to the brick and tiles. The rear dormer window has wooden panelling, which is complete and the panels sit flush to one another. The mortar at the dormer edges is complete and provides a good seal to the surrounding tiles. The roof edges are mortared.

*Photograph 3 showing the roof at the rear of the property*

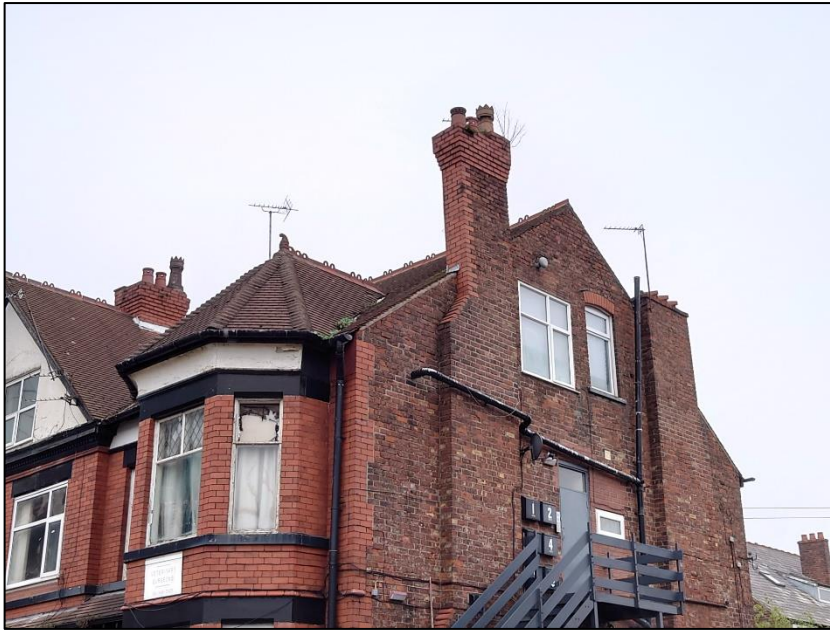
*Photograph 4 showing the roofing at the front of the property*

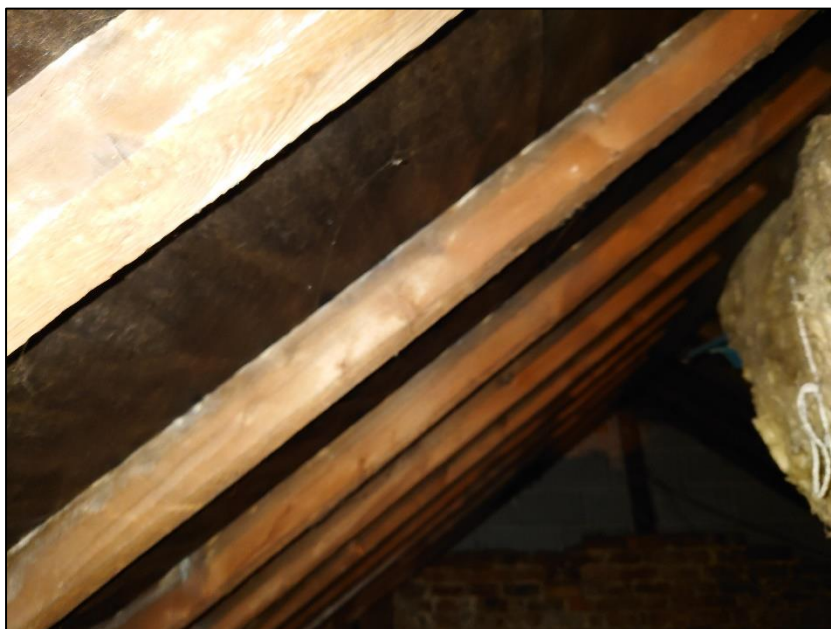
- 3.5 The property internal living spaces do not offer suitable bat roosting habitat. The property has a large and accessible roof void, which covers the expanse of the roof space. The roof void has wooden roof joists, which are without gaps or cracks for bats to exploit (see Photographs 5 and 6). The roof is lined throughout with membrane. The lining is complete, with no significant tears or rips in the lining.

*Photograph 5 showing the roof joists*

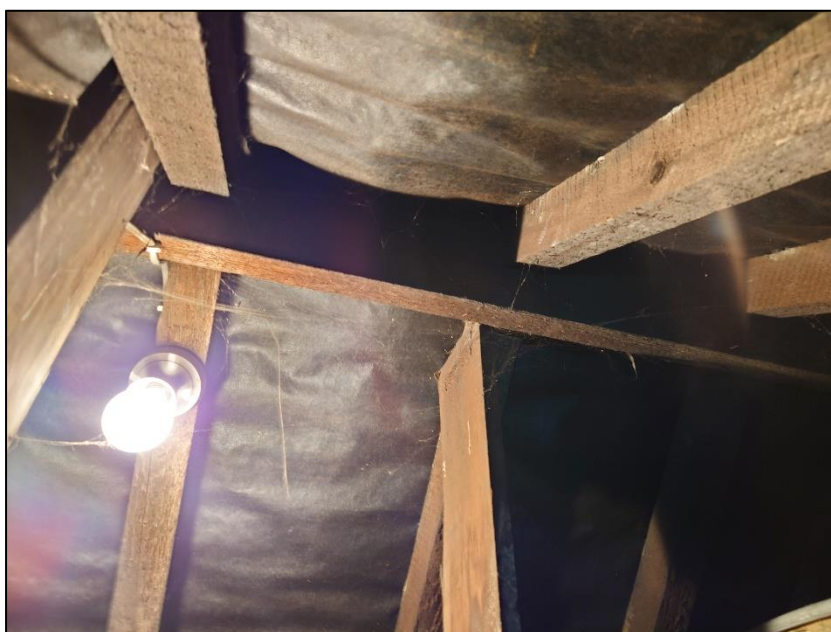
*Photograph 6 showing the roof void*

- 3.6 The roof void is fully insulated. The internal brickwork is complete and mortared, offering no suitable crevices. The ridge beam is cobwebbed throughout. No daylight is present at the roof edges, suggesting the void is sealed. No evidence of bat activity, such as bat droppings, could be found inside the property.
