### UXO RISK ASSESSMENT - 39 DEANS GATE, MANCHESTER

# STAGE 2 DETAILED UXO RISK ASSESSMENT

Report Reference: DRA-19-1118

### 39 Deansgate, Manchester

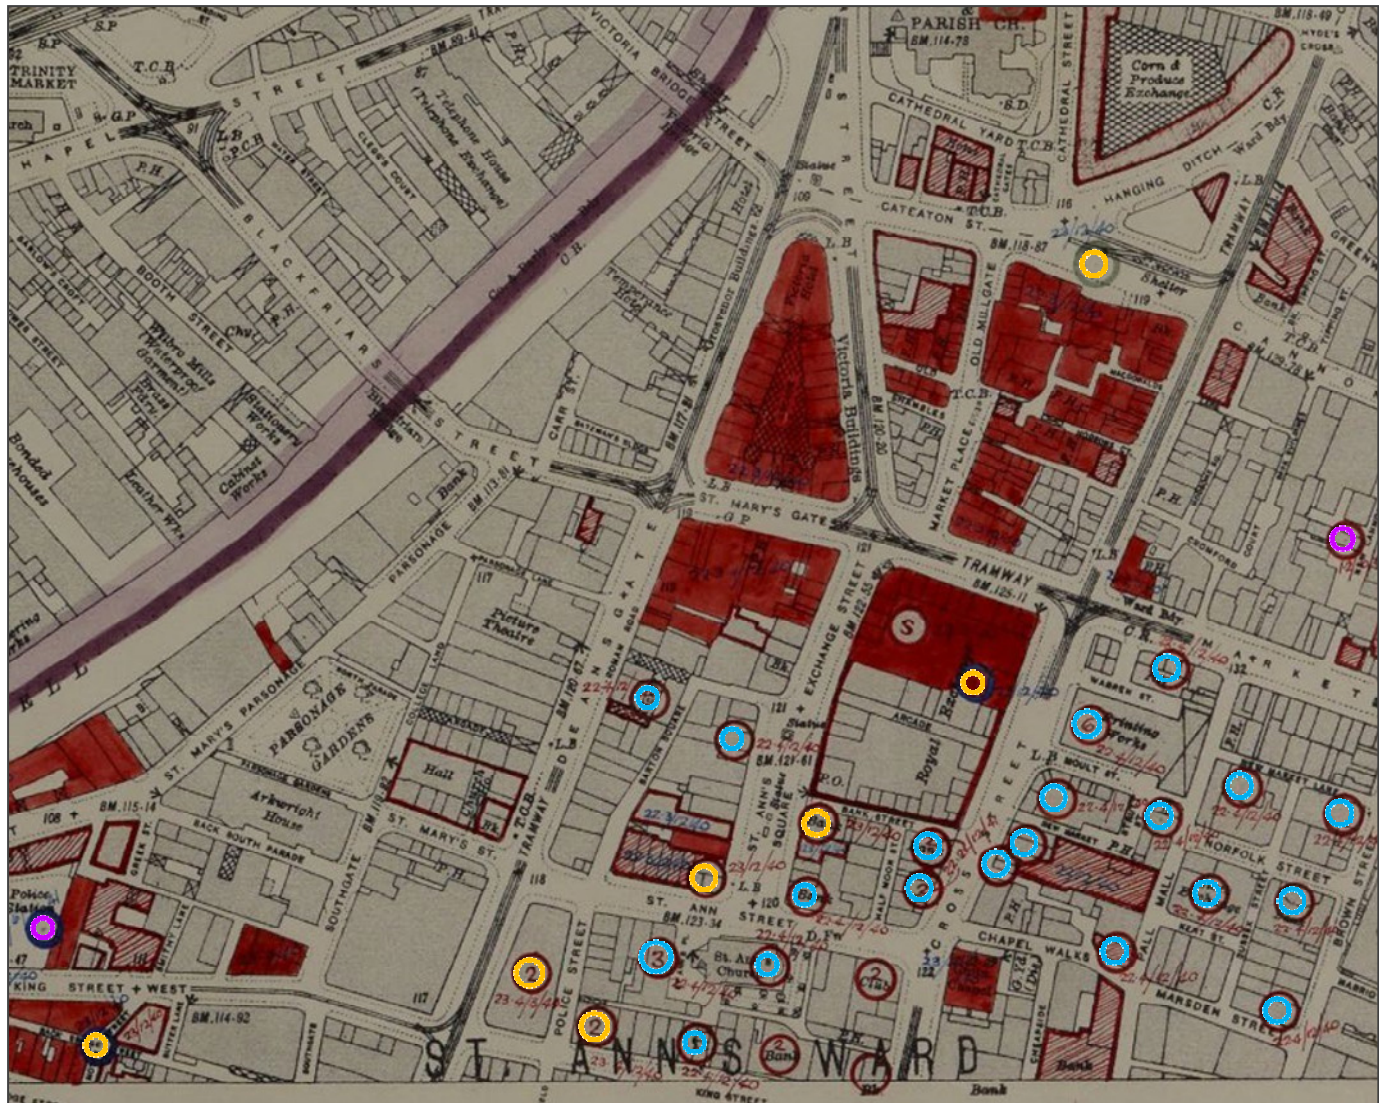
Notes:  
Each bomb strike's date of fall has been identified by coloured circles; blue (22/12/40), orange (23/12/40), and purple (01/06/41).

Some areas of damage have been labelled with a date. These have also been highlighted accordingly.

- No bomb strikes are plotted on / adjacent to *The Site*.
- However, all buildings on and adjacent to *The Site* are identified as totally destroyed, with a date label identifying this damage as occurring during the first major raid (22<sup>nd</sup> / 23<sup>rd</sup> December 1940).
- The study area was bombed during at least three separate air raids.
- Two HE parachute mines, five HE bombs, and numerous IBs are plotted within a 400m radius of *The Site*.
- The Salford Borough boundary (140m west of *The Site*) marks the edge of bomb plot map coverage. Therefore, as the 400m radius extends far into Salford Borough, it is considered highly likely that additional bombs fell within 400m of the western *Site* boundary.
- Multiple areas of bomb damage do not have a corresponding bomb strike plotted, indicating that this map is missing multiple bomb strikes.

The bomb plot / damage map shows several areas of damage with no corresponding bomb strike. Previous research has highlighted missing HE bombs on this map and therefore the possibility cannot be discounted that additional unplotted HE bombs fell within the vicinity of *The Site*. NB: during the chaos of each major raid, examples of human error in record keeping would have increased.

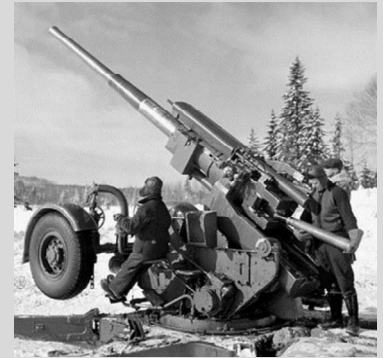
### HAA Battery - 3.7" QF Shell

**Shell Weight:** 12.7kg  
**Shell Dimensions:** 94mm x 438mm  
**Fill Weight:** 1.1kg  
**Fill Type:** TNT  
**Fuse Type:** Mechanical Time Delay fuse  
**Appearance:** Grey body, copper driving bands, brass neck  
**Rate of Fire:** 10 - 20 rpm  
**Ceiling:** 9,000 - 18,000m  
**Variants:** HE or shrapnel shells.  
 Note, the 4.5" gun was also used in an HAA role throughout the UK.

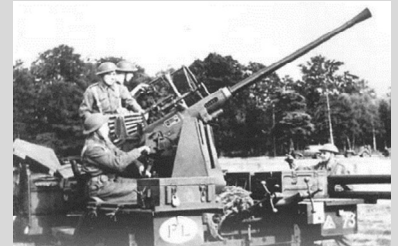
### LAA Battery - 40mm Bofors Shell

**Shell Weight:** 0.84kg  
**Shell Dimensions:** 40mm x 180mm  
**Fill Weight:** 70g  
**Fill Type:** TNT  
**Fuse Type:** Impact fuse  
**Appearance:** Grey body, copper driving bands, brass neck  
**Rate of Fire:** 120 rpm  
**Ceiling:** 7,000m  
**Variants:** HE or AP shells. Both with rear tracer compartment

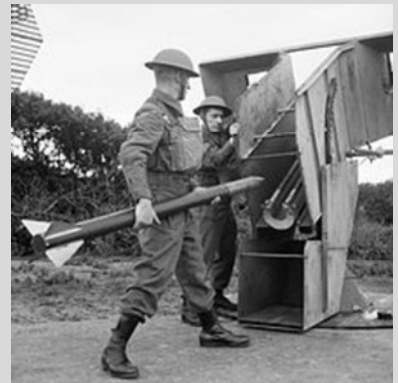
### Z Battery - 3" U.P Rocket

**Rocket Weight:** 24.5kg  
**Warhead Weight:** 1.94kg  
**Filling:** TNT warhead. Black Powder solid fuel rocket motor.  
**Fuse Type:** Mechanical Time Delay fuse  
**Rocket Dimensions:** 1,930mm x 76mm  
**Ceiling:** 6,770m  
**Operation:** Fired from single, tandem and (later) 36 x rail launchers (Z Batteries). Limited use throughout the UK.
