# Technical Note

Project: NMGH

Subject: Southern Enabling Works Phase 2 SI Technical Note

Reference: 075805-CUR-01-XX-GN-GE-  
00100\_V01\_SouthernEnablingSITechnicalNote

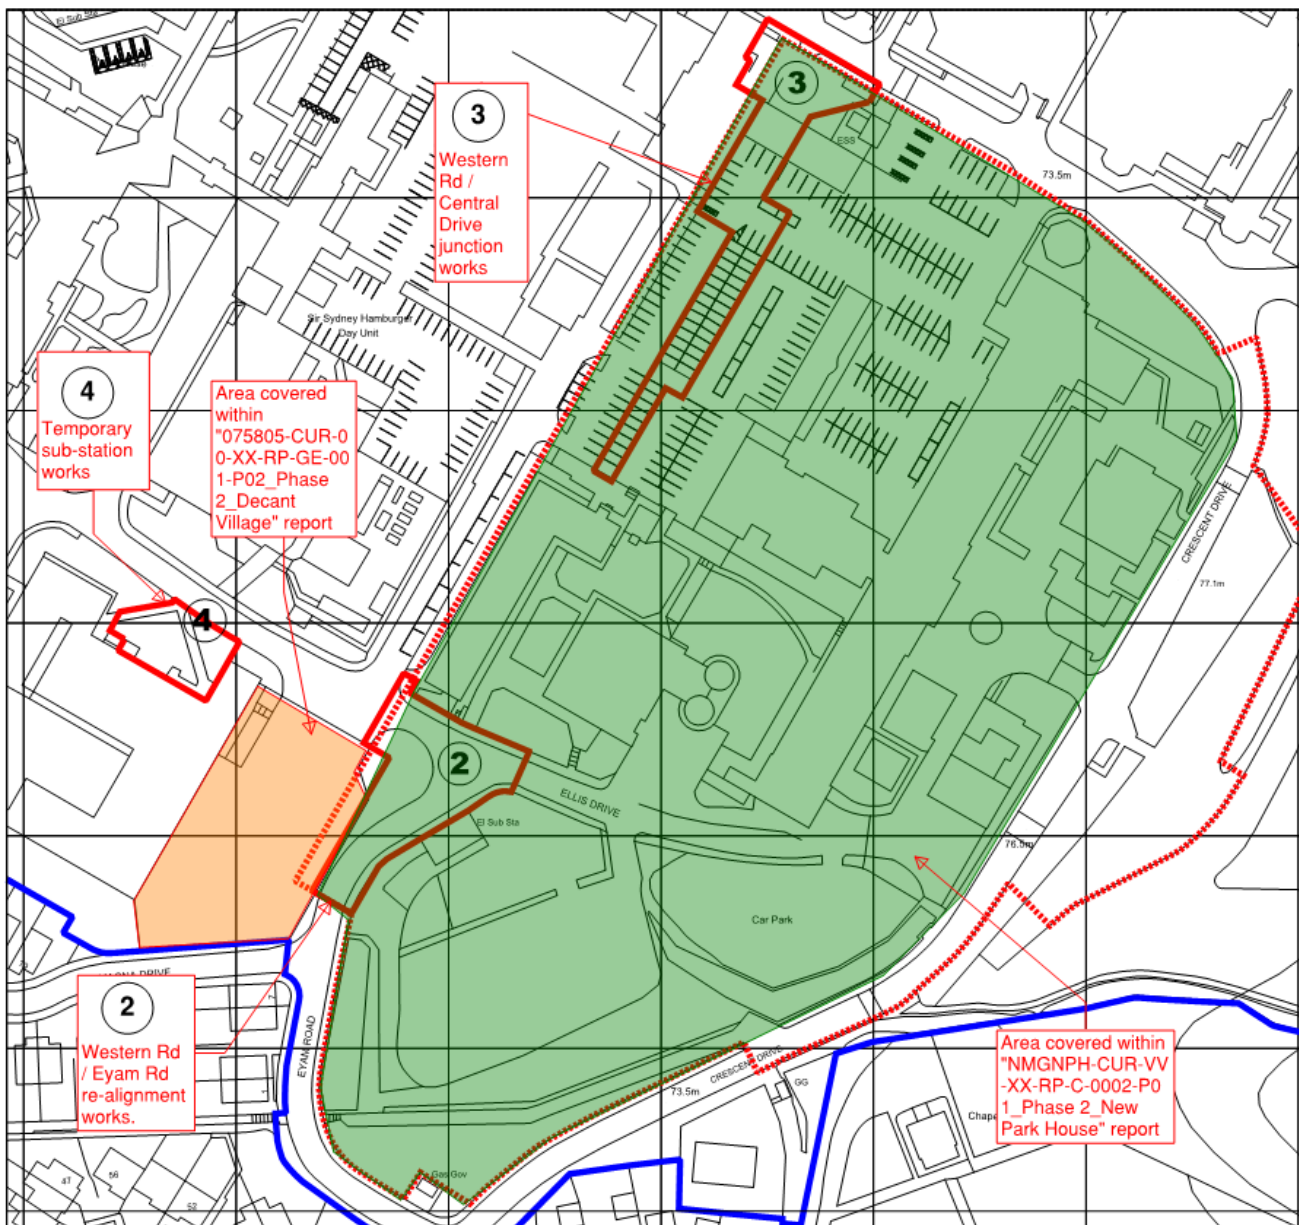
Fig 1 – Boundaries of planning application and existing geoenvironmental investigation reports

The land affected by the works is shown in figure 1.

The areas covered by each existing report, and the proposed planning application red line boundary can be seen on page 2.

As shown on figure 1, it is considered that the NMGNPH-CUR-VV-XX-RP-C-0002-P01\_Phase 2\_New Park House is most pertinent to the planning application. The executive summary findings of this report are included on pages 4 & 5.
