## Archaeological Watching Brief Report

Manchester Medieval  
Quarter Phase 1a

**Report No:**  
SA/2021/73

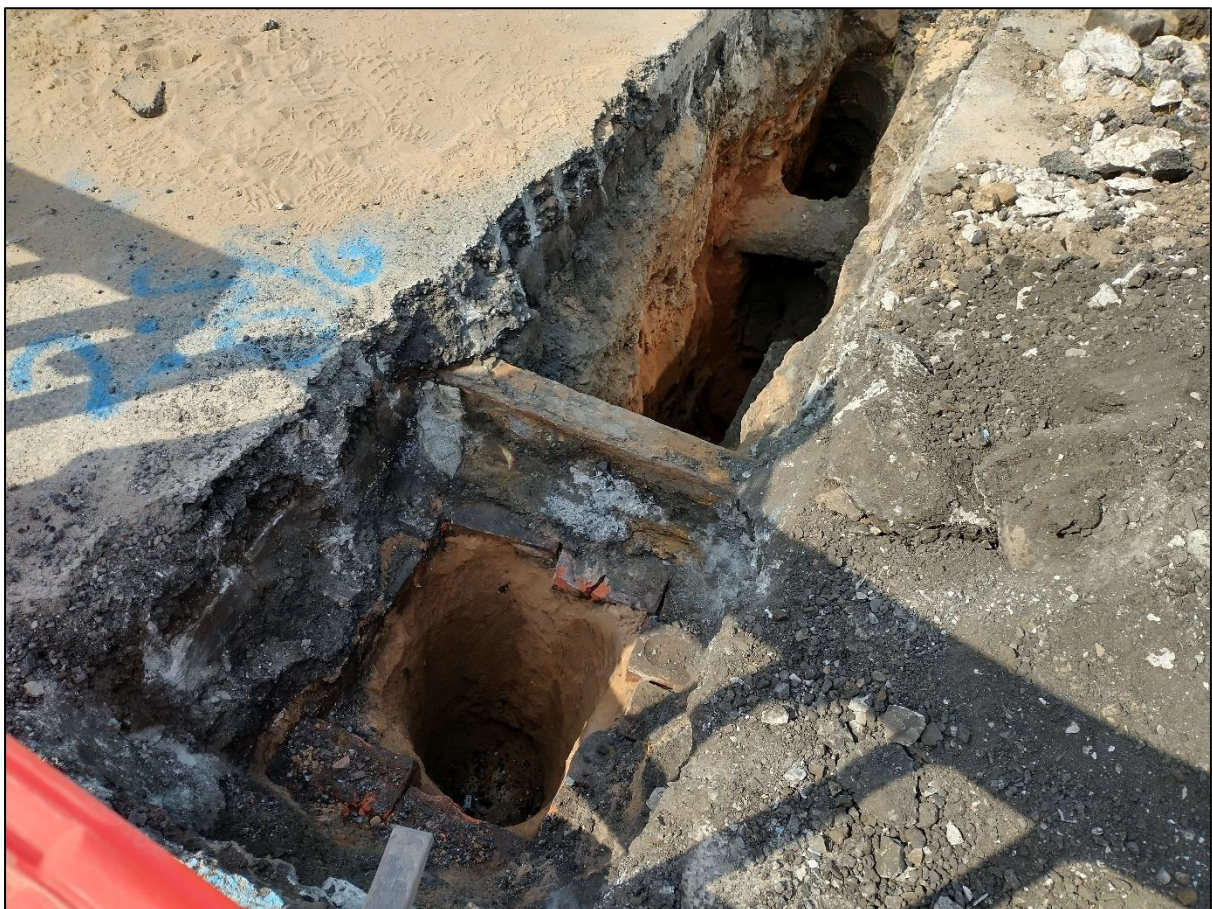
Plate 1: Tram track visible within a service trench, looking west

Within a manhole excavation towards the north end of Victoria Street (marked on Figure 2) the remains of one of the cast iron tram tracks from the Victorian tramway were encountered (Plate 1). These had been laid onto a bedding of broken slate and brick below each track, which in turn lay on very compact yellow sand.

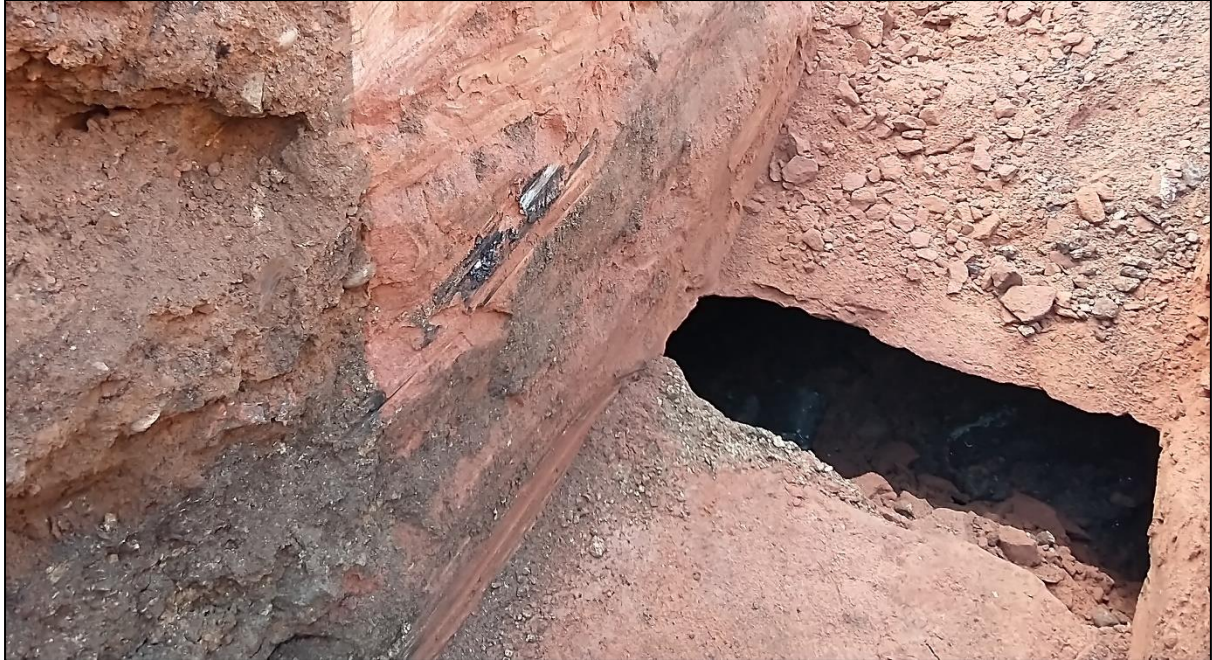
Plate 2: Natural fissure within the bedrock, looking north

Within a manhole excavation at the north end of Victoria Street (marked on Figure 2) a fissure was observed within an intact section of bedrock (Plate 2). The roof of the fissure appeared to slope down towards the river. There was no structure associated with the fissure and the rock faces did not exhibit any kind of toolmarks. It was therefore felt that this was a natural fault in the geology.

Although most of the area has been heavily truncated 'islands' of intact bedrock exist in places. Two of these 'islands' contained natural fissures, a feature common within sandstone bedrock.

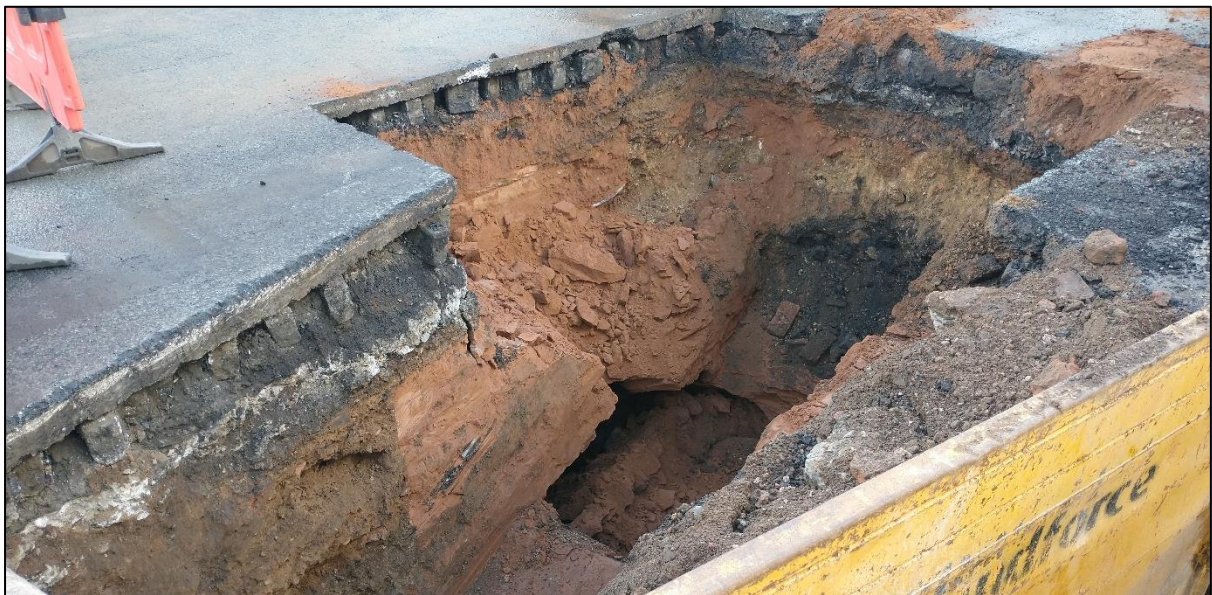
Plate 3: Natural fissure within the sandstone bedrock, looking northeast

A second fissure was observed within the eastern part of the watching brief area, within an excavation for a drain connection (Plate 3; marked on Figure 2). This did not appear to slope. It had no associated structures and exhibited no toolmarks and so was also interpreted as a natural geological fault.
