# Television Desk-Based Report - Renaker Developments in Manchester

Plot F

Renaker

October, 2021

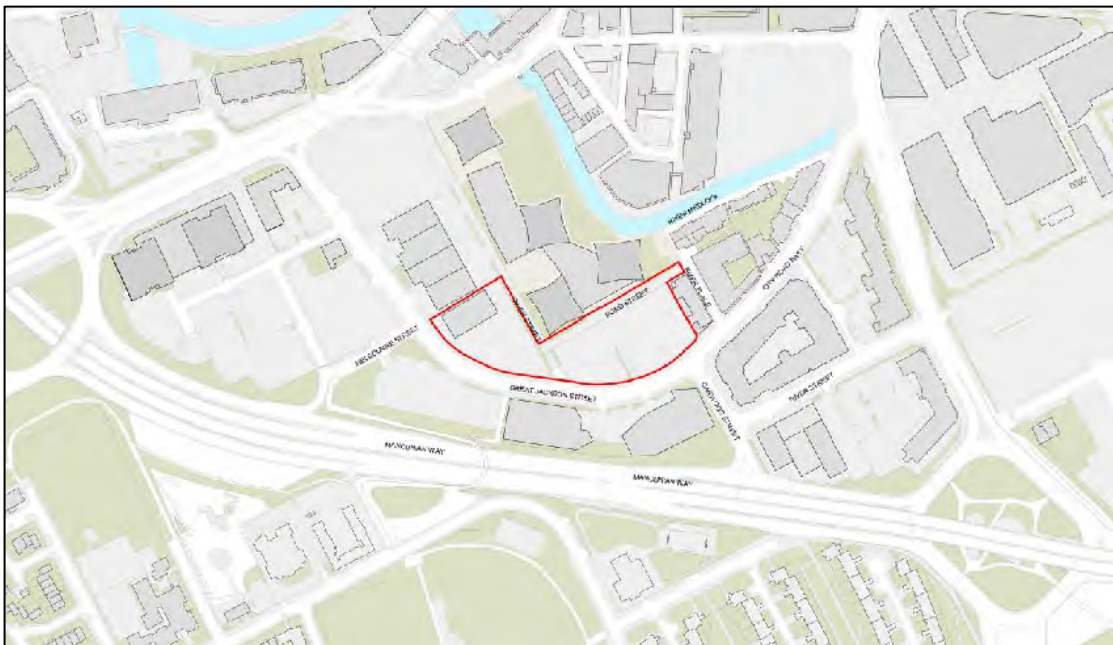
Figure 1 – Proposed development red line boundary

The red line boundary of the proposed development is shown in Figure 1<sup>2</sup> below.

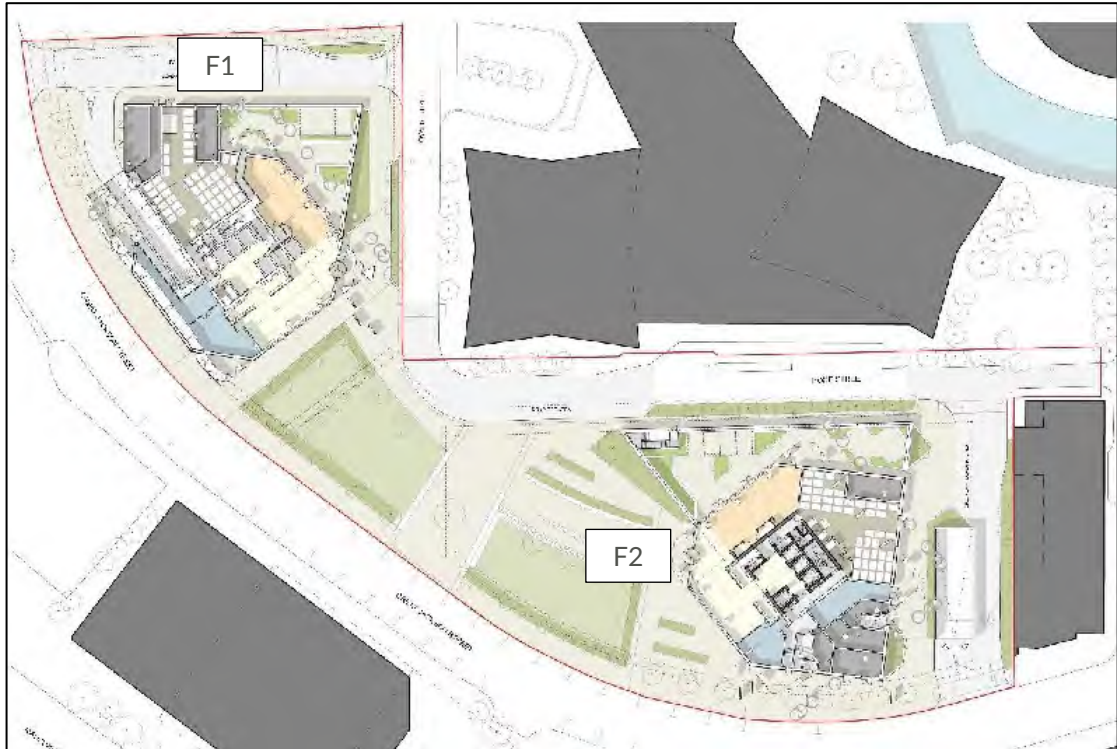
Figure 2 – Proposed development – tower locations

The locations of the proposed towers are shown in Figure 2<sup>3</sup> below. The plan is to show location of buildings only and landscaping and floorplan included is indicative.

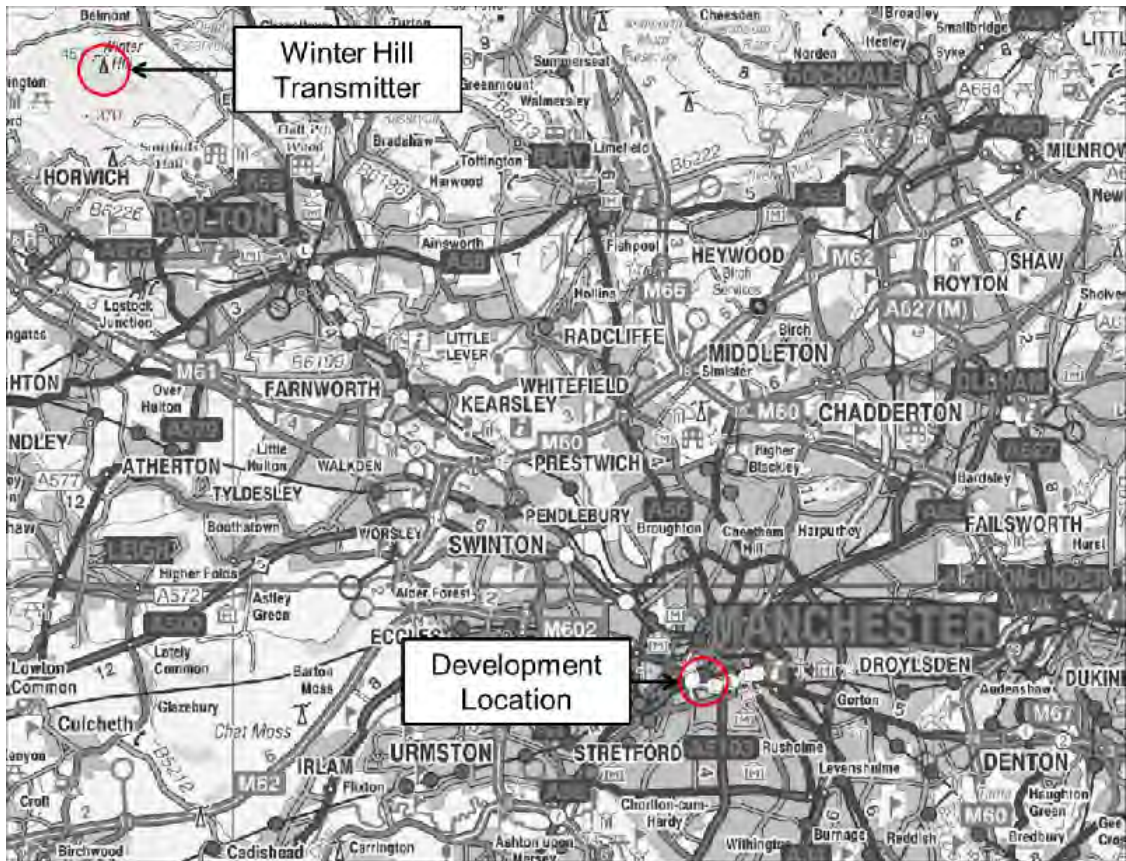
Figure 3 – Television transmitter and development location

Winter Hill is one of the UK's main television transmitters located approximately 24.3km northwest of the development (published coordinates SD66051446). The main digital services provided at the time of the last survey<sup>5</sup> are shown in Table 1 below.

Figure 3 below shows the relative location of the transmitter and the development.

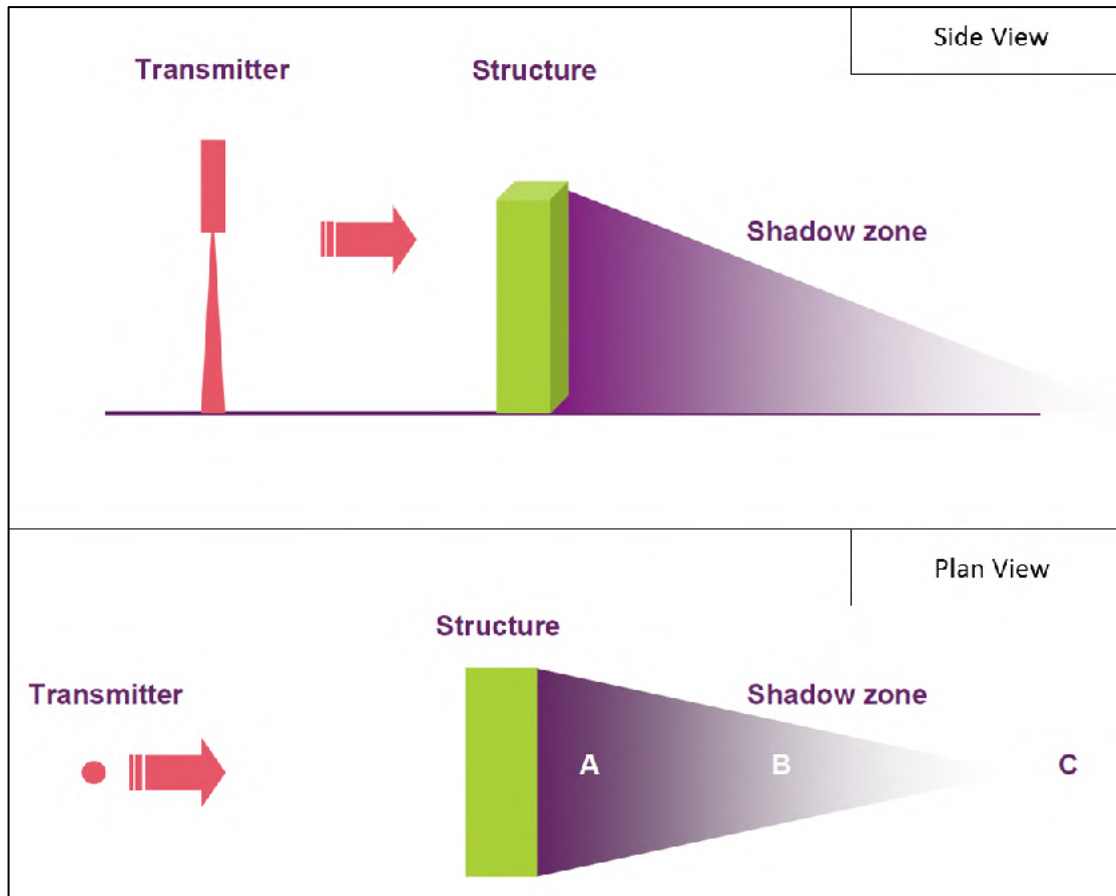
Figure 4 – Diffraction Loss Zones

*"In general, there will be three 'zones' behind the structure:*

*Zone A - close behind the structure (typically a few tens of metres) there may be a large reduction in signal level with a possible complete loss of reception*

*Zone B - further away (typically a few hundred metres) the signal reduction is less severe and the shadow will be smaller as diffraction effects partially fill in the shadow. Depending on the size of the structure, some locations could still lose reception completely*

*Zone C - some distance away (1-5km) the shadow will effectively have disappeared."*

The zones mentioned are illustrated in Figure 4<sup>7</sup> below, taken from Section 3.2 of the Ofcom guidance regarding the impact of buildings on broadcast signals.

In the case of the shadow zone, this has been modelled as having straight sides in order to be conservative. In actuality due to diffraction effects the zone would have a more triangular shape as shown in Figure 4 in the previous section.

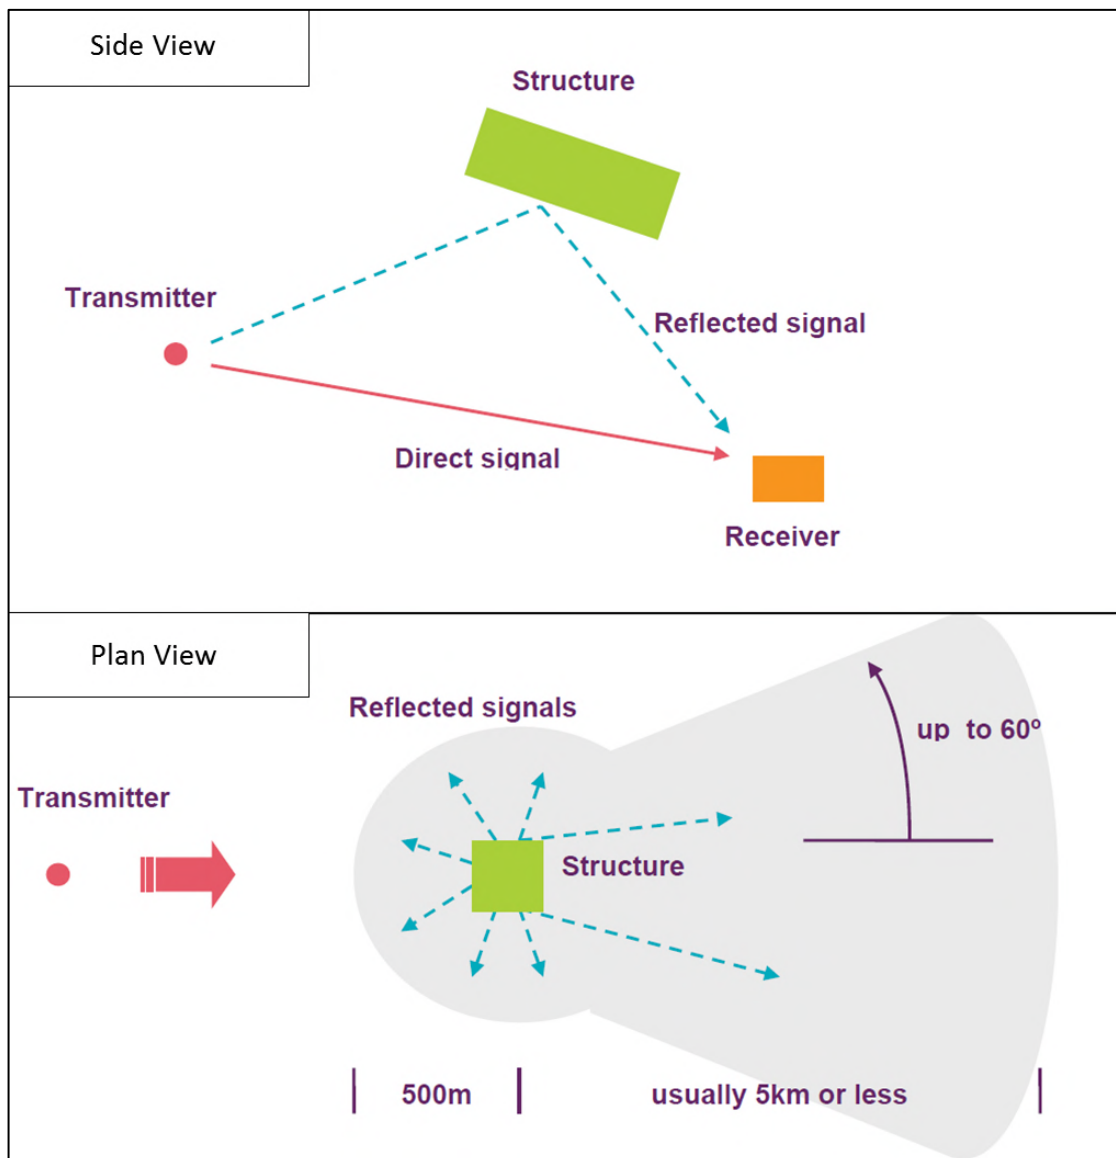
Figure 5 – Reflection Zones

For large developments with straight edges, the transmitted signal can be reflected by the building itself. This causes an effect known as ‘multipath interference’ whereby the signal is received twice by an aerial at different times. The direct signal arrives first because it has a shorter distance to travel.

Figure 5<sup>8</sup> below (taken from Section 3.3 of the Ofcom guidance referenced above) illustrates this effect.

In practice, it is considered highly unlikely that reflections will have an effect for receivers in front of the building or on either side when viewed from the location of the transmitter. For digital transmissions in particular, it is unlikely that issues will occur if the angle between the direct signal and the reflected signal is more than 30 degrees<sup>9</sup>.

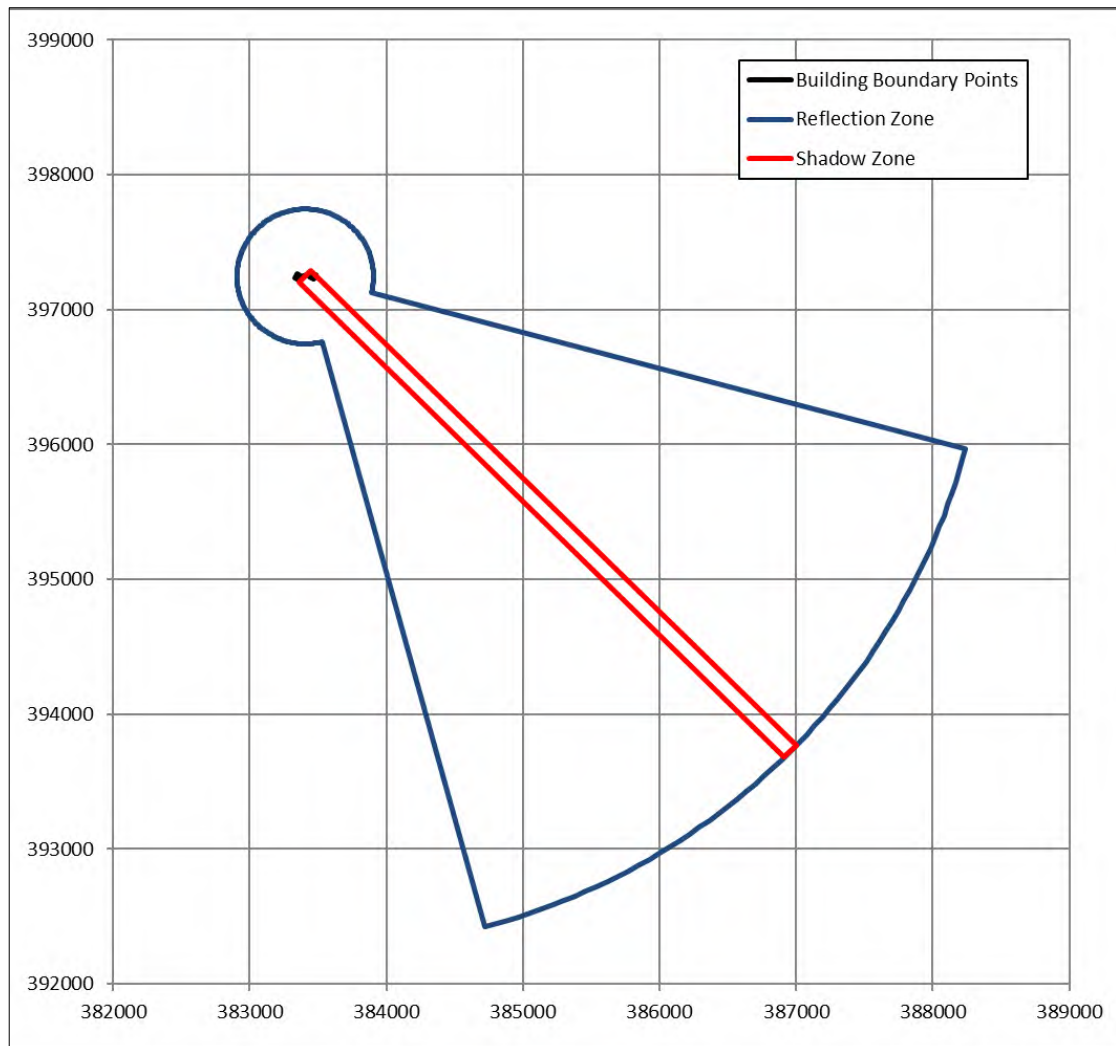
Figure 6 – Interference areas

These were defined based on the geometry of the potential interference zones as set out in the previous section. Both zones extend to a distance of 5km beyond the building in accordance with the Ofcom guidance.

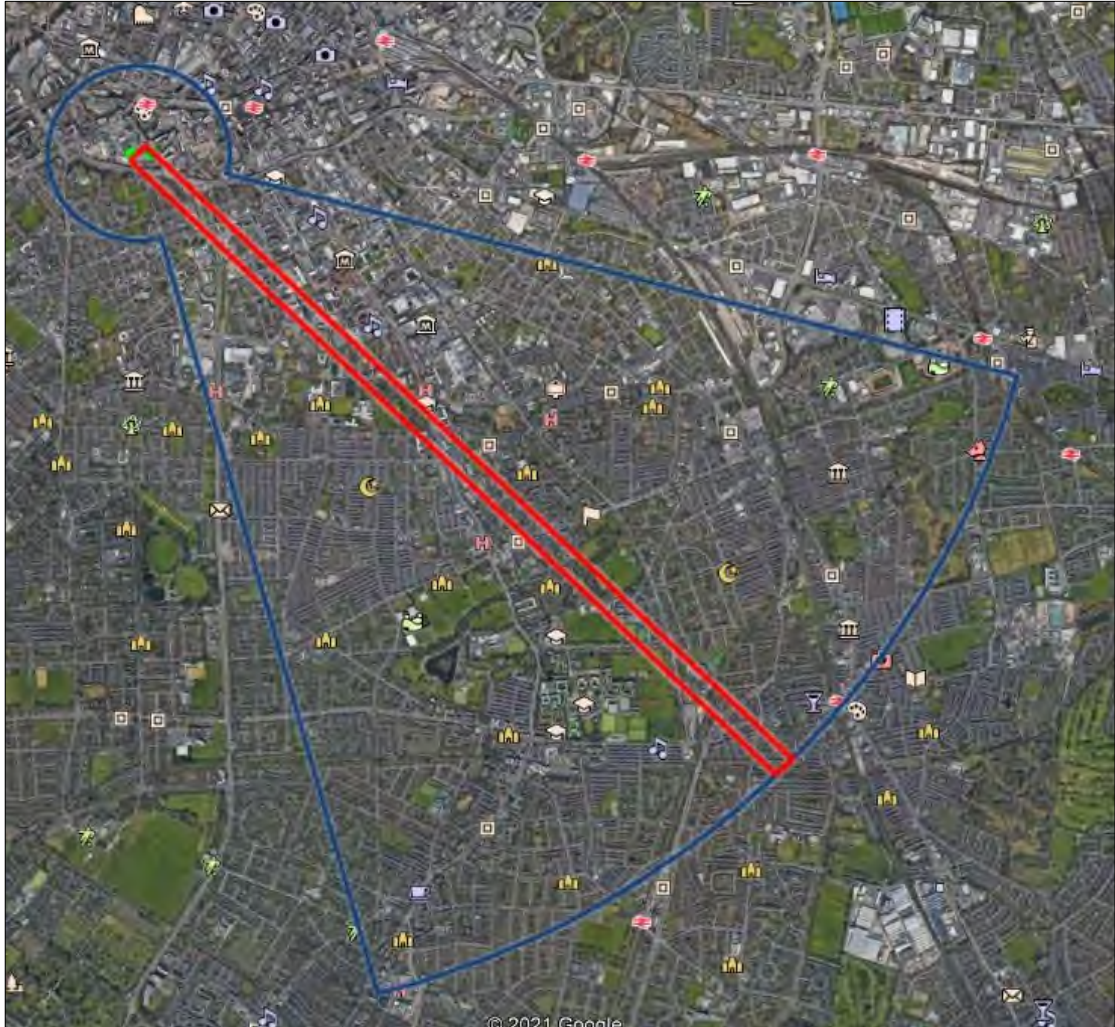
Figure 7 – Interference zones – aerial image

Figure 7<sup>10</sup> below shows the interference zones overlaid onto aerial photography of the area.

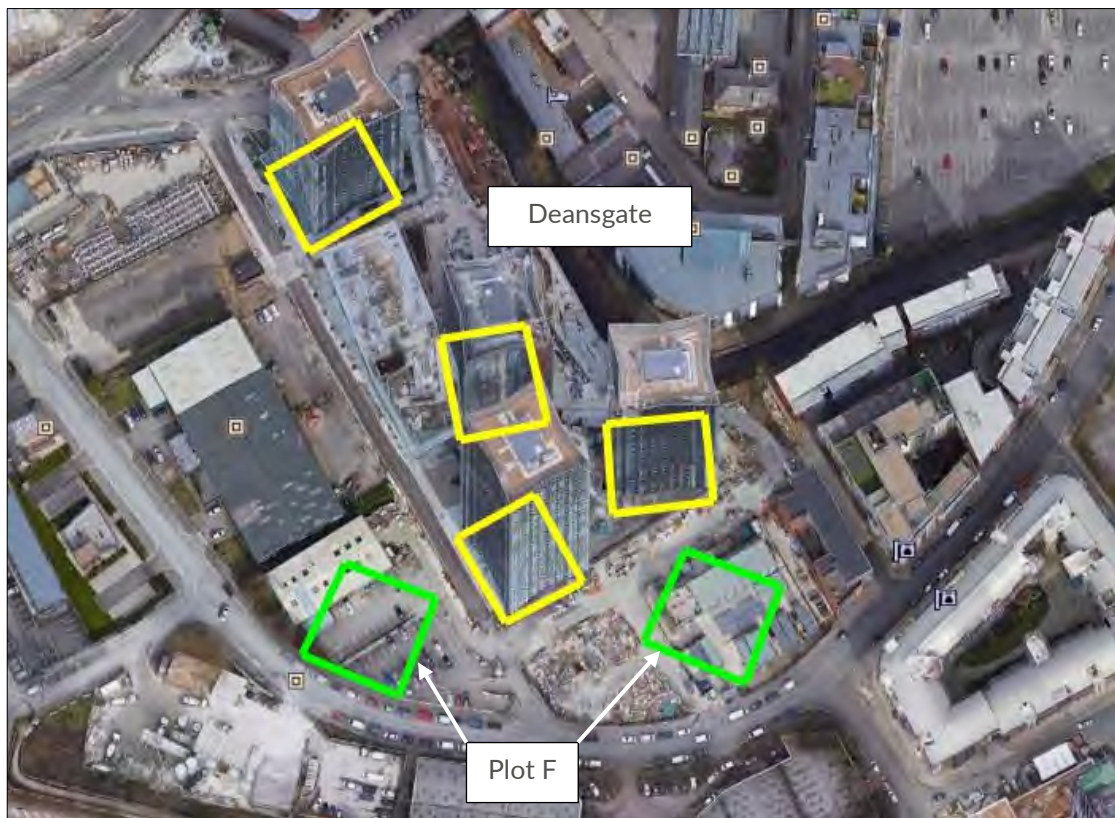
Figure 8 – Location of Deansgate Square development (yellow) relative to the Plot F (green)

The Deansgate Square development is composed of four towers located to the north of the proposed development (see Figure 8<sup>12</sup> below).

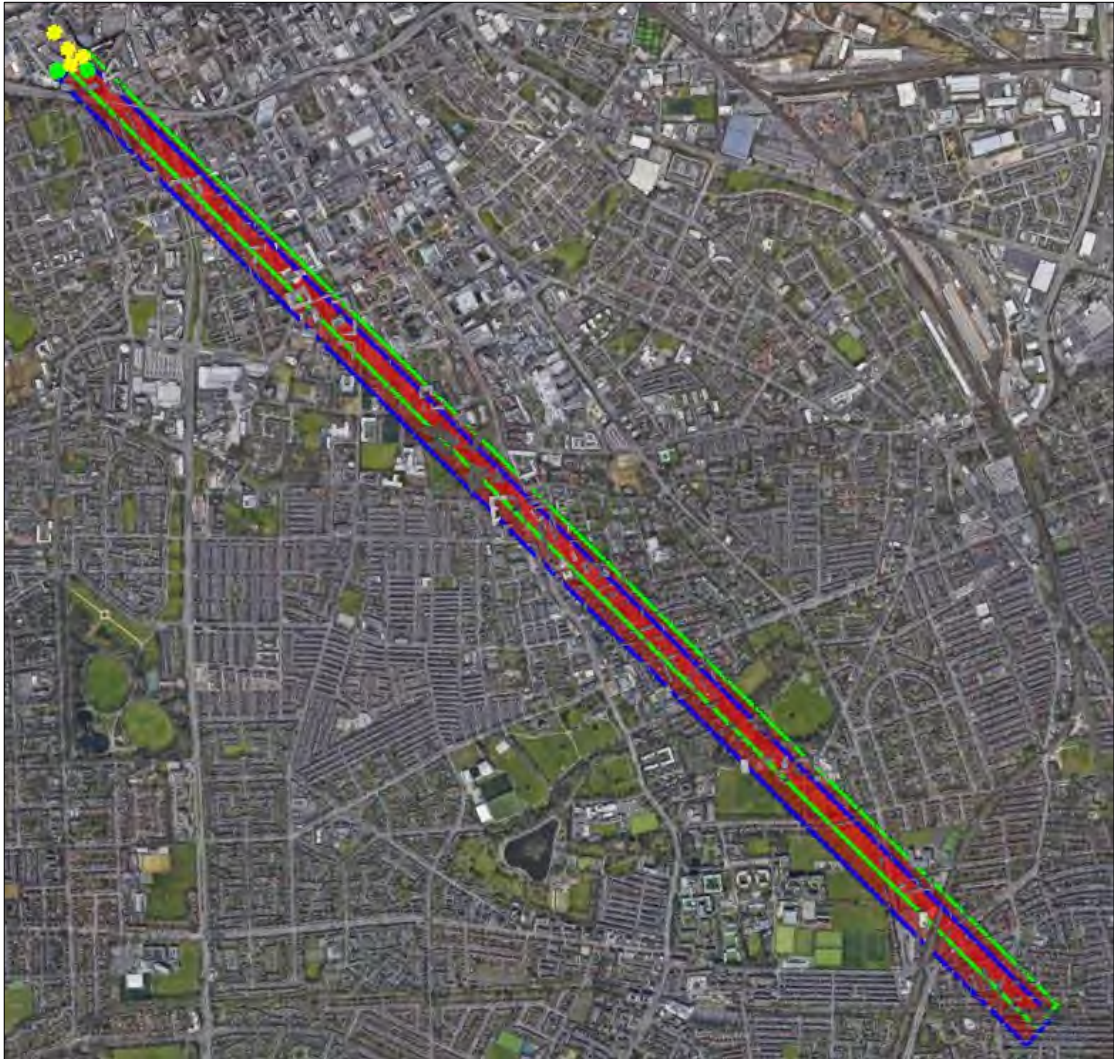
Figure 9 – Interference zones (Deansgate Square and Plot F) – aerial image

Figure 9<sup>13</sup> below shows the potential interference areas that were modelled for the development Deansgate Square (green line) and the Plot F (blue line). Since both developments are close together and are on a similar bearing with Winter Hill both shadow areas overlap.

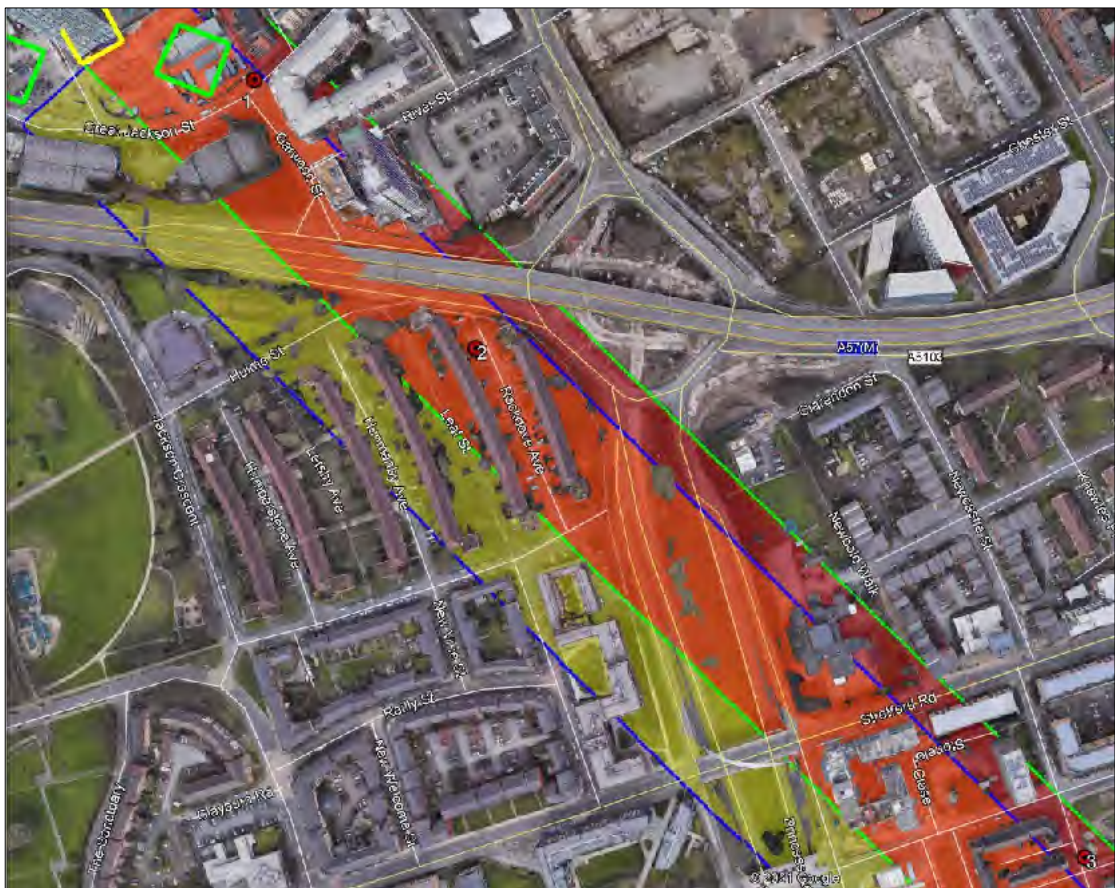
Figure 11 – Shadow areas near Plot F

The locations at greatest risk are those in the shadow zone and closest to the development (usually within 1km from the development). Therefore, impact due to Plot F at locations 1, 2 and 3 is likely. The addition of two new tower blocks will result in an increase in the shadow area width (yellow area in Figure 11<sup>23</sup>).

It is therefore expected that since the television signal strength at location 3 is of moderate-good quality, any impact might not be perceived in practice. However, signal losses are possible for locations 1 and 2.

Other locations are beyond the 1km distance from the proposed development. At this distance any impact is not expected to be significant and any reduction in signal strength is not expected to be perceived in practice.
