**Oxford Road, Manchester**

## **Remediation Verification Report**

**Report No NOR1093/004**

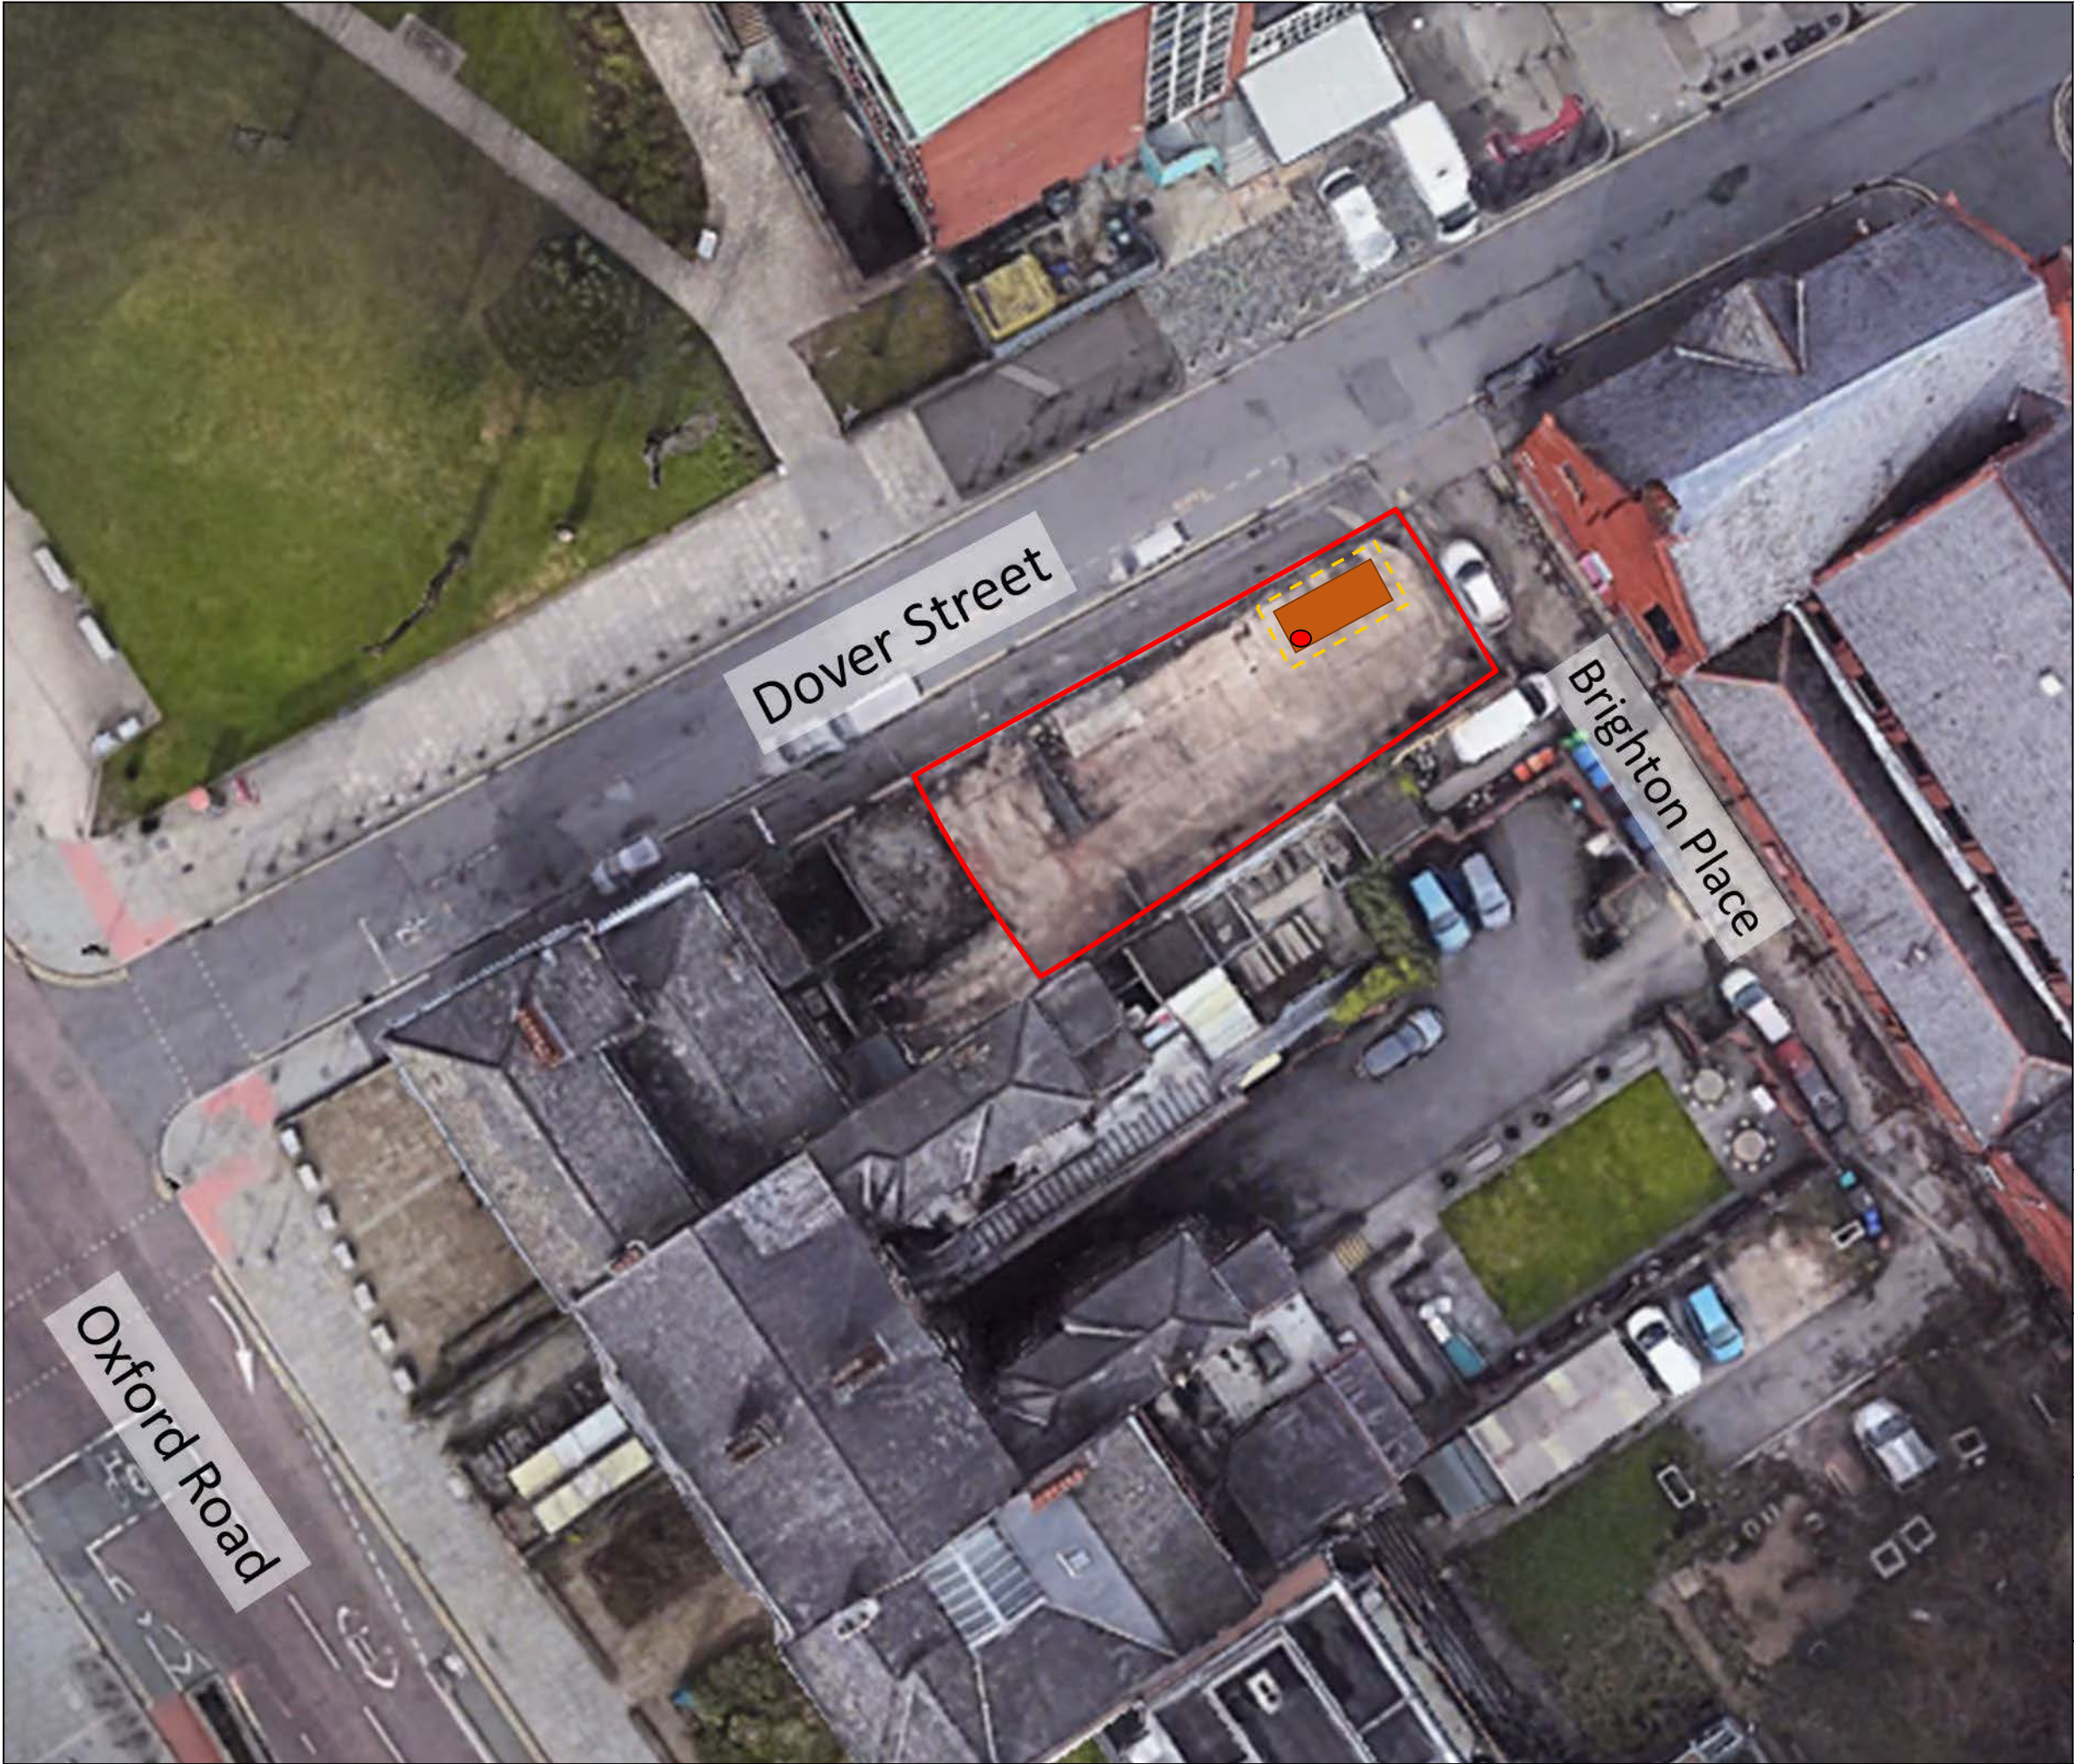
| Project No<br>NOR1093 | Figure No<br>Figure 3 |

| Figure 3 | Location of Contamination | |

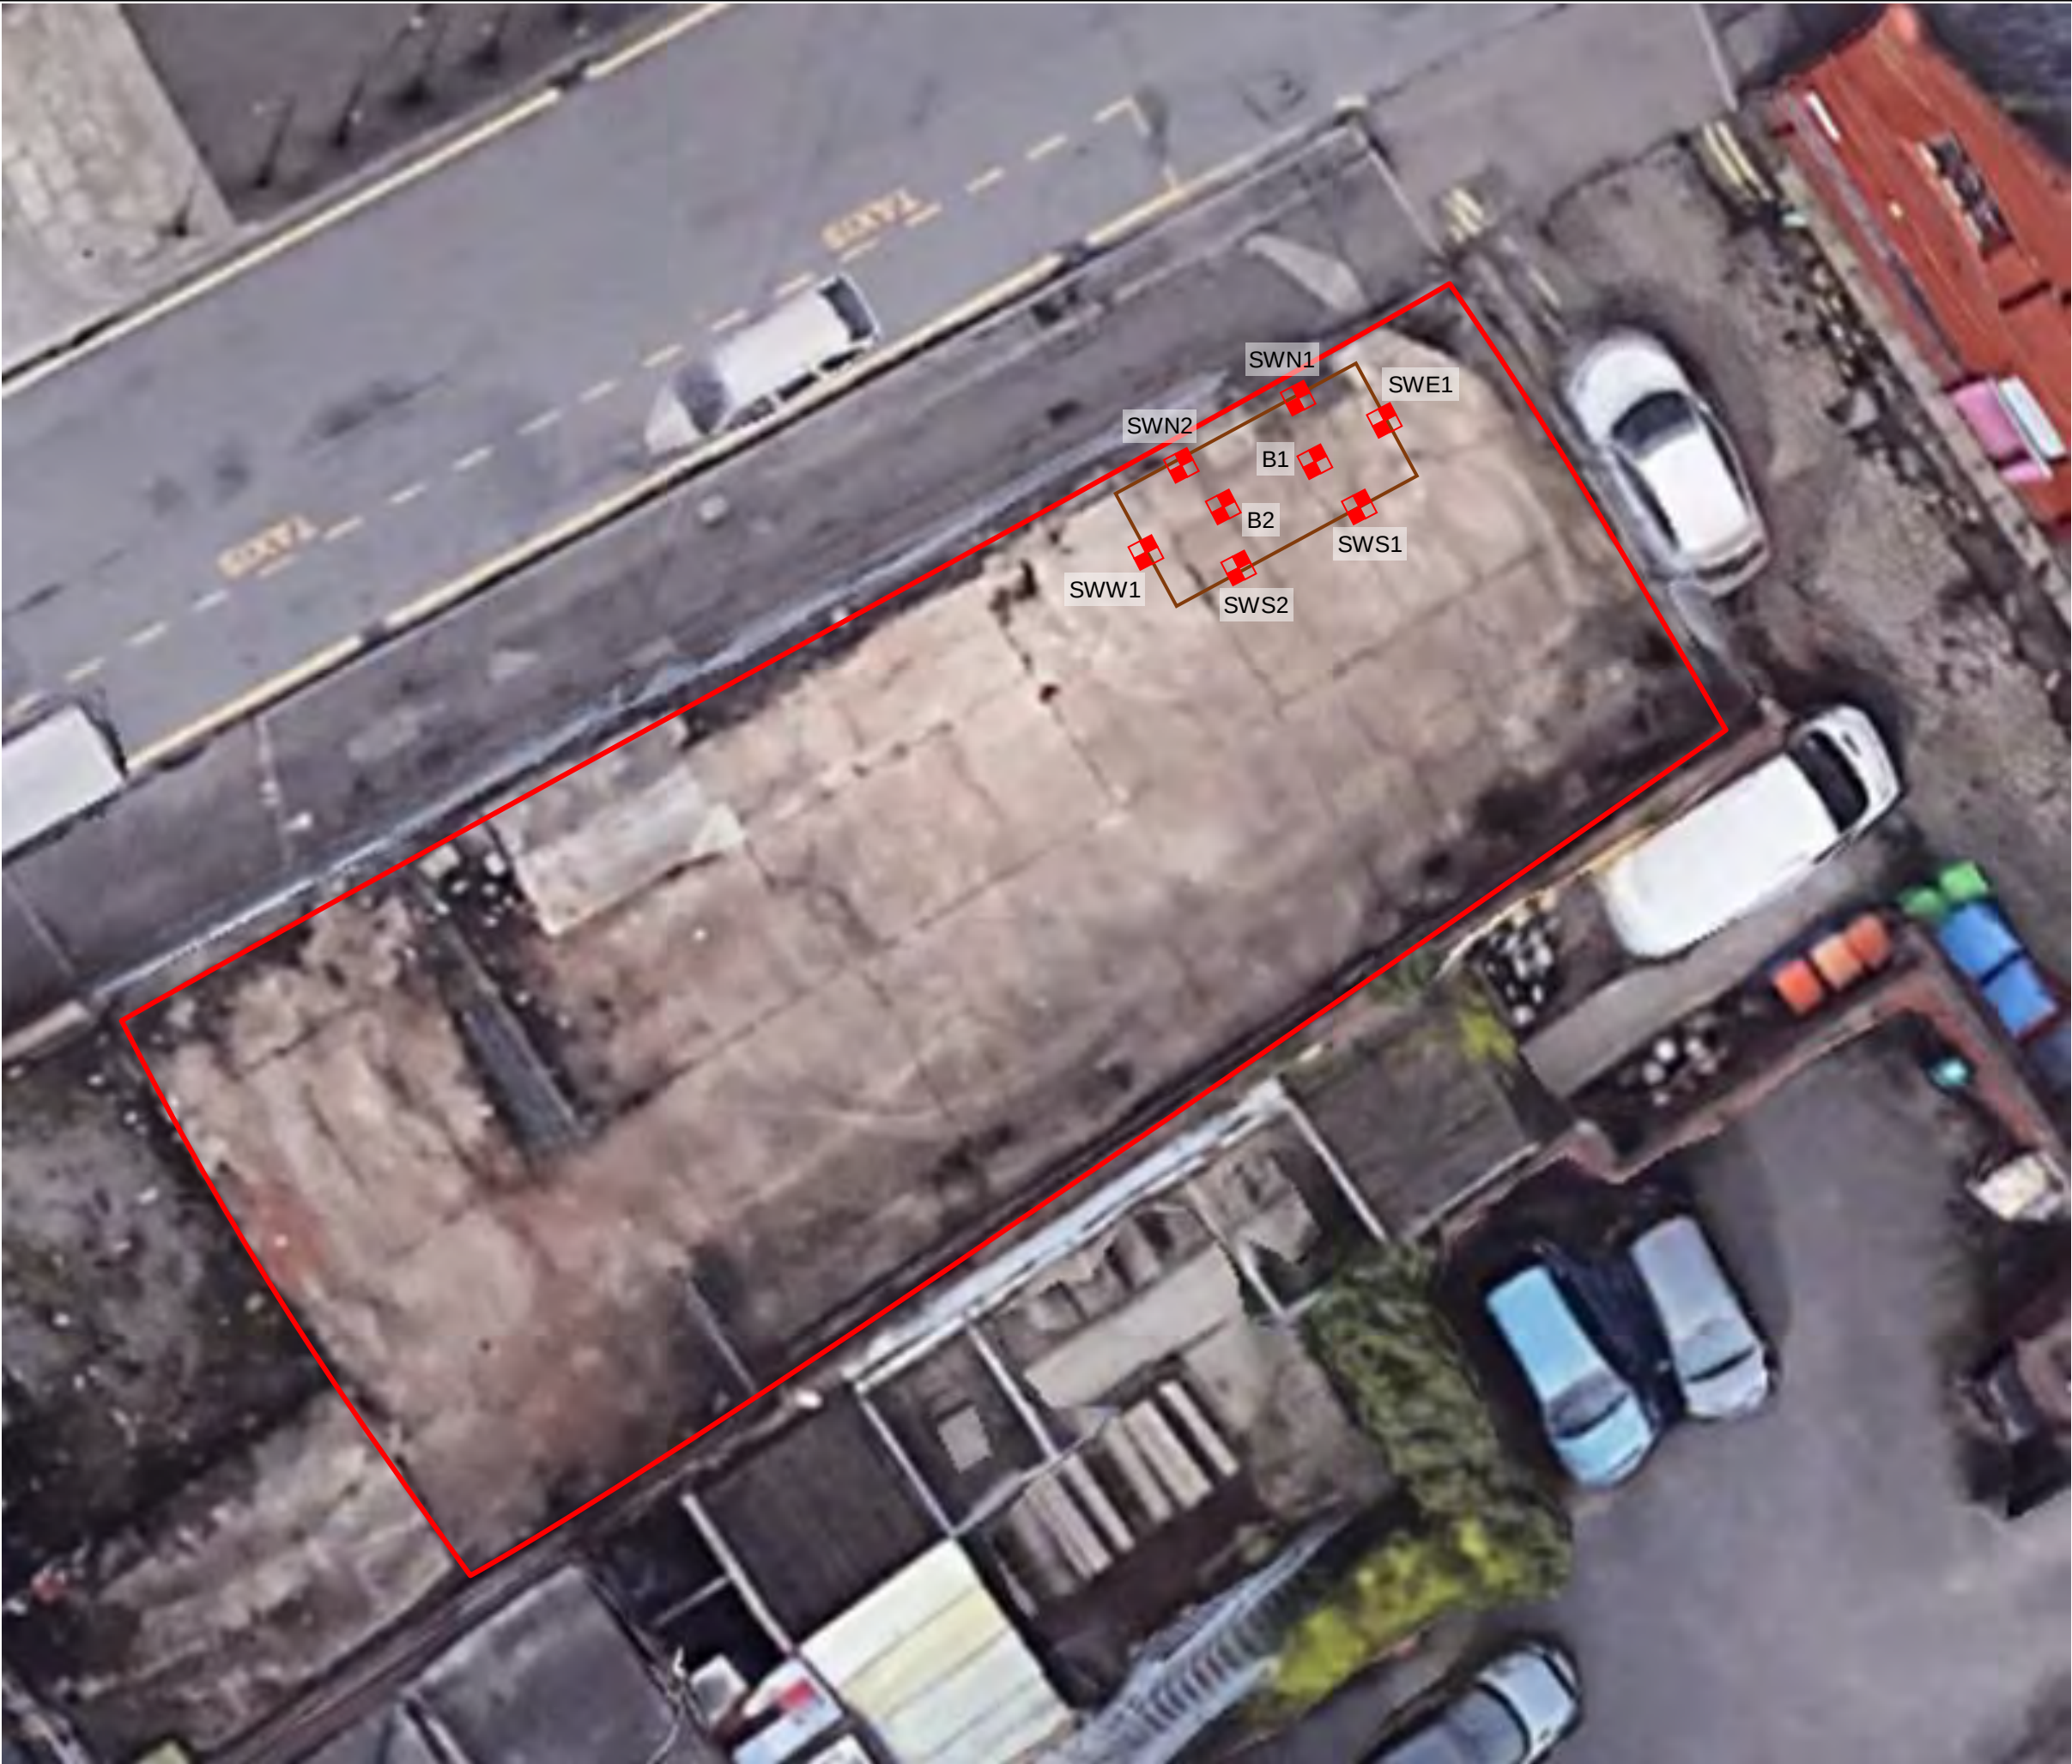
**Figure 4 Location of Tank Removal Validation Pits**

| Figure 4 | Location of Tank Removal Validation Pits | |

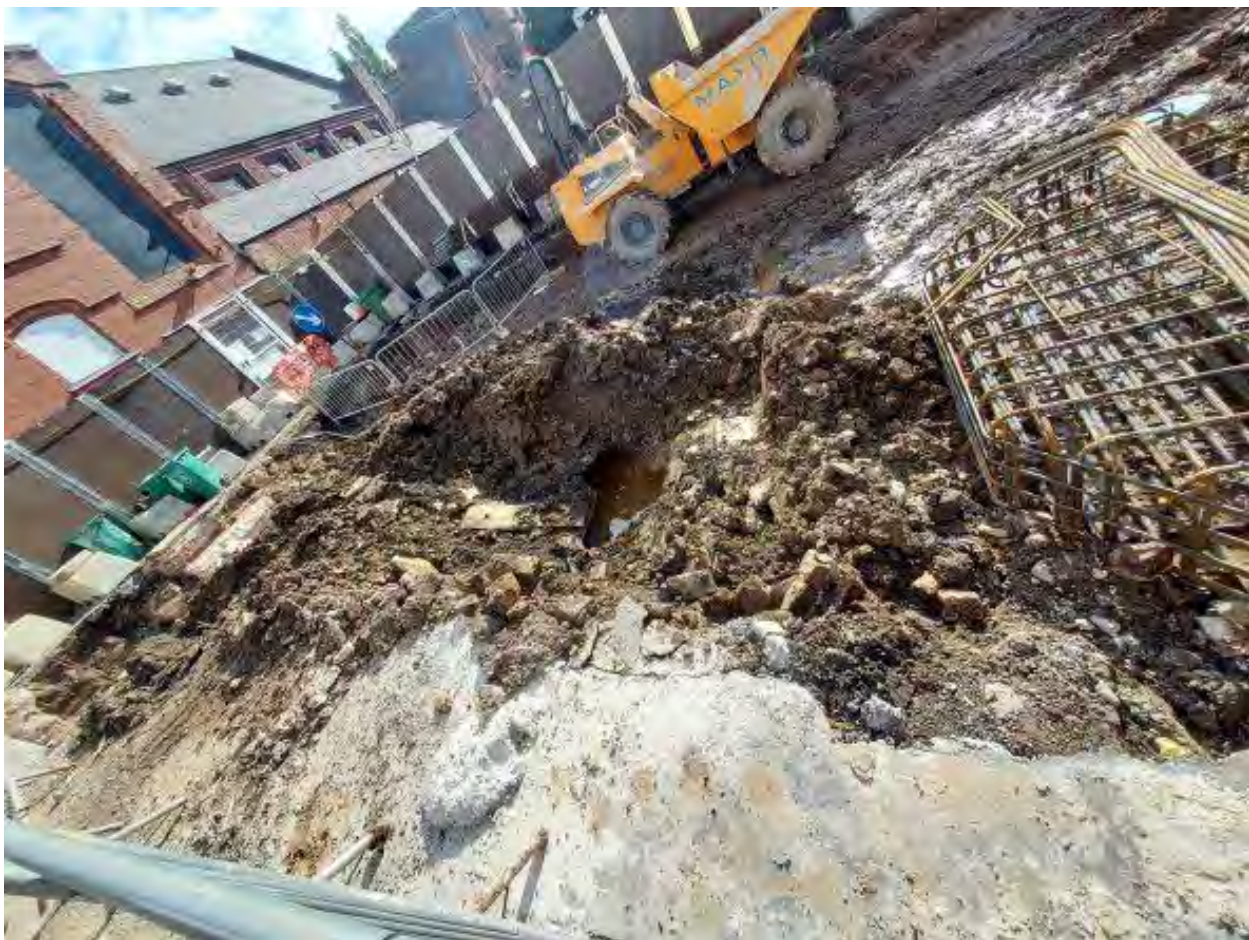
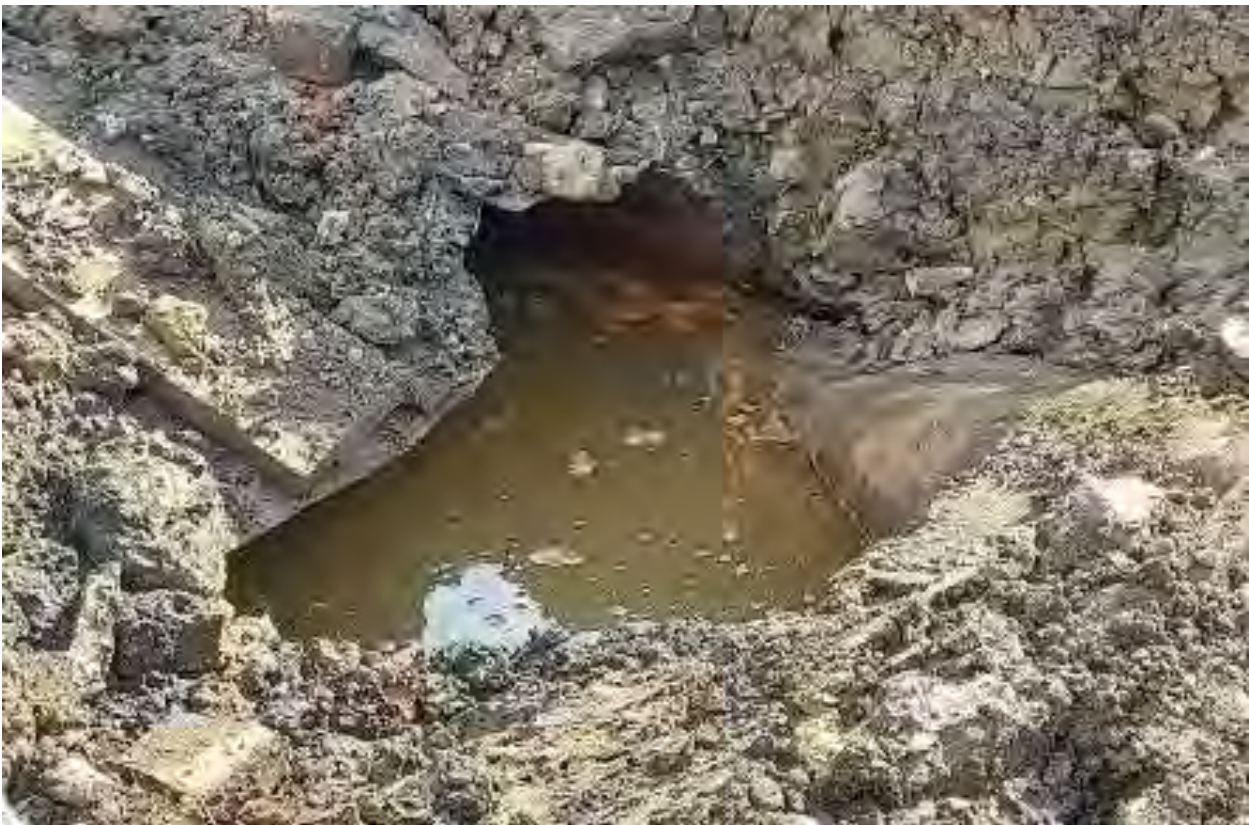
| Notes:<br>Area of UST and opening in tank prior to remediation works (7 <sup>th</sup> October) | <table><tr><td>Project</td><td>Oxford Road, Manchester</td></tr><tr><td>Project No.</td><td>NOR1093</td></tr><tr><td>Carried out for</td><td>Kier Construction - North and Scotland</td></tr></table> | Project | Oxford Road, Manchester | Project No. | NOR1093 | Carried out for | Kier Construction - North and Scotland | <table><tr><td>Plates</td></tr><tr><td>1 and 2</td></tr></table> | Plates | 1 and 2 |

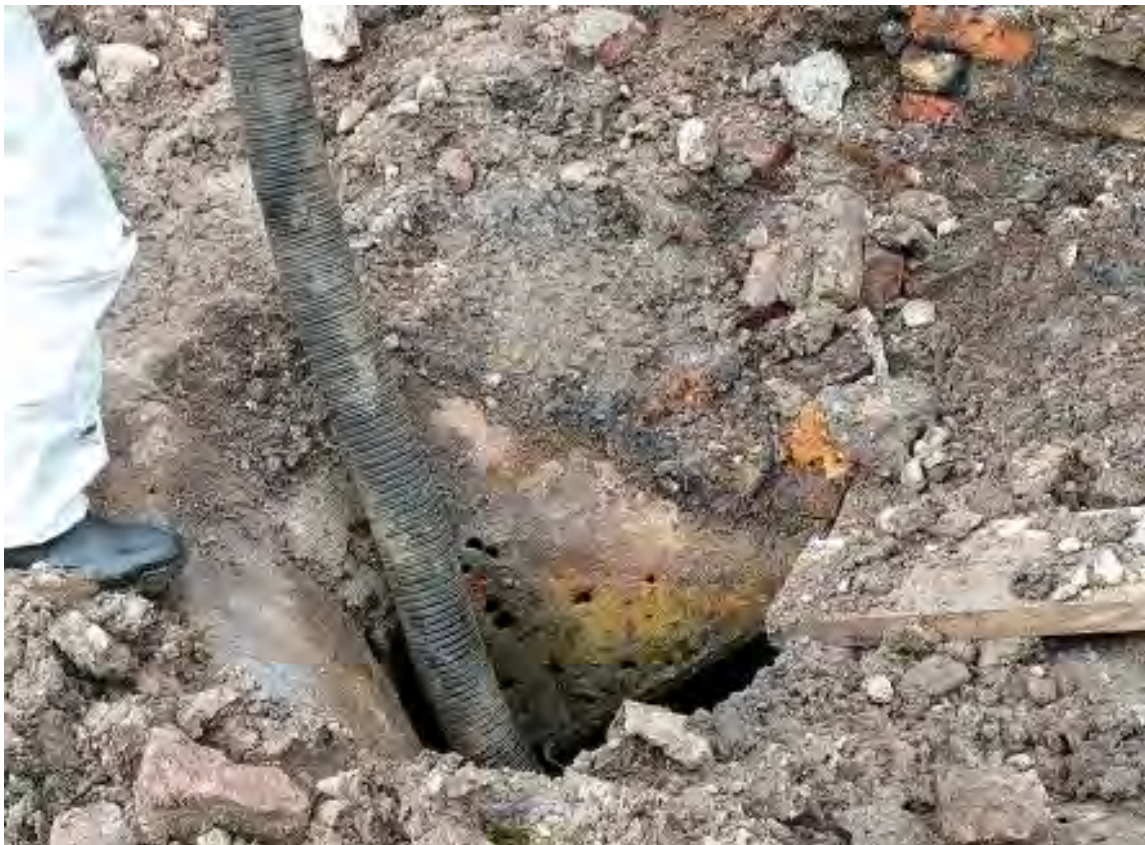
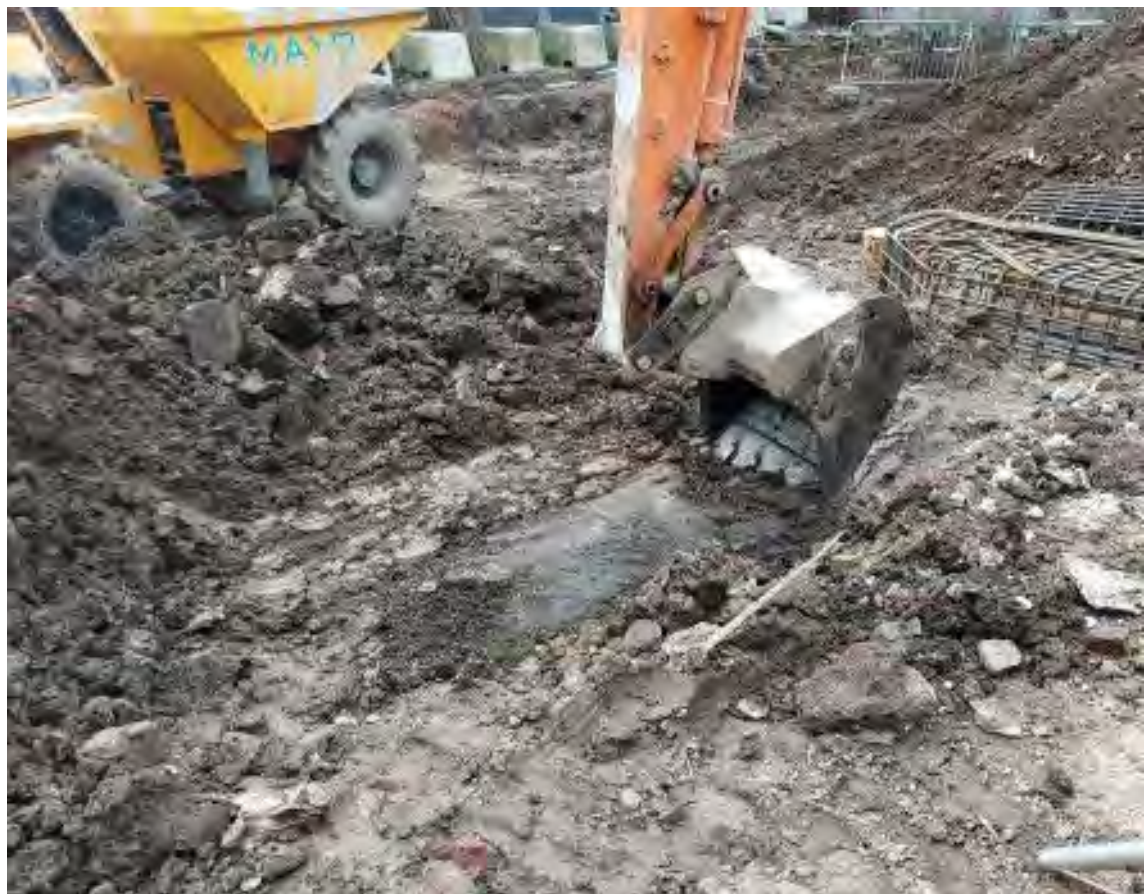
| <p>Notes:</p> <p>Initial pumping of UST and uncovering of tank (7<sup>th</sup> October)</p> | <p>Project Oxford Road, Manchester</p> <p>Project No. NOR1093</p> <p>Carried out for Kier Construction - North and Scotland</p> | <p>Plates</p> <p>3 and 4</p> |

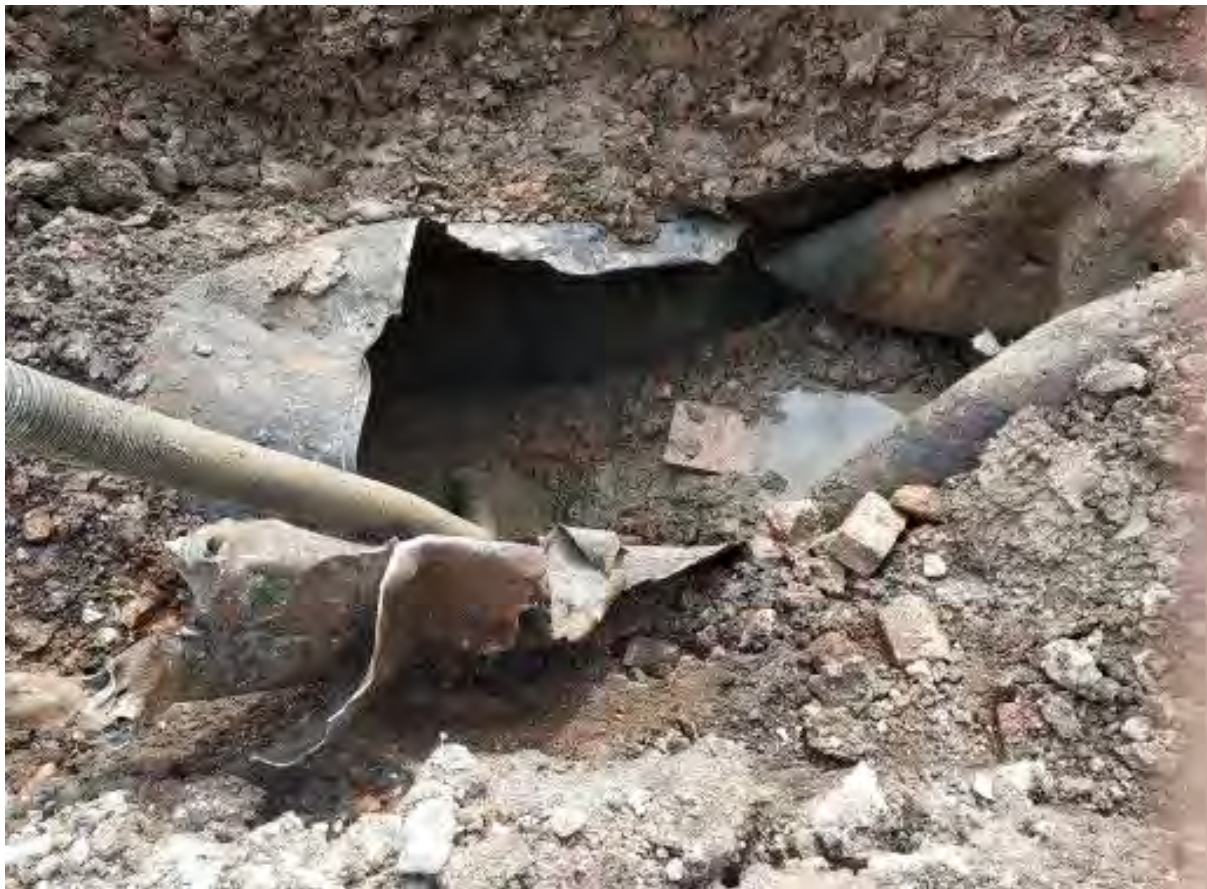
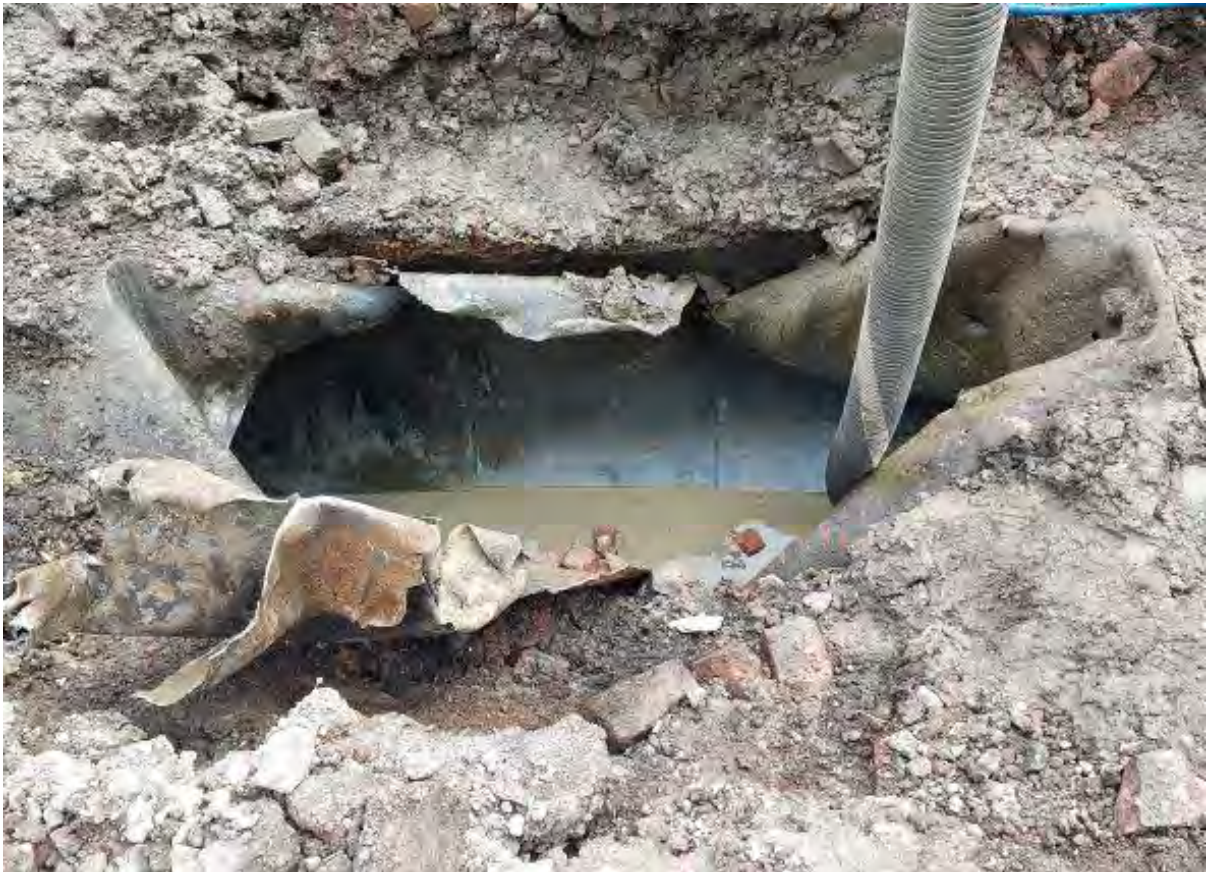
| Final stages of pumping UST (7 <sup>th</sup> October) | <b>Project No.</b> NOR1093 | |

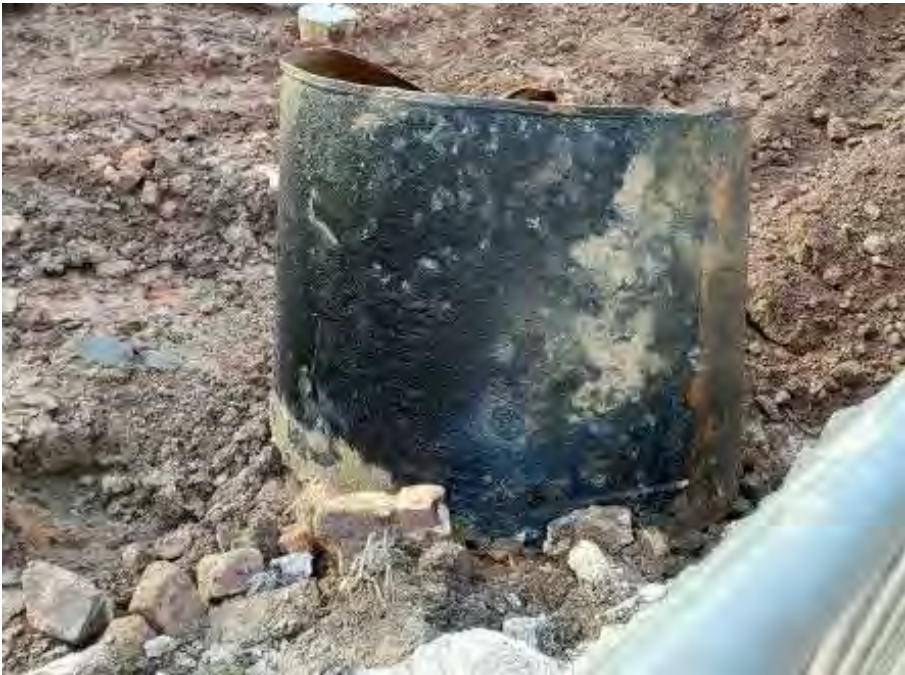
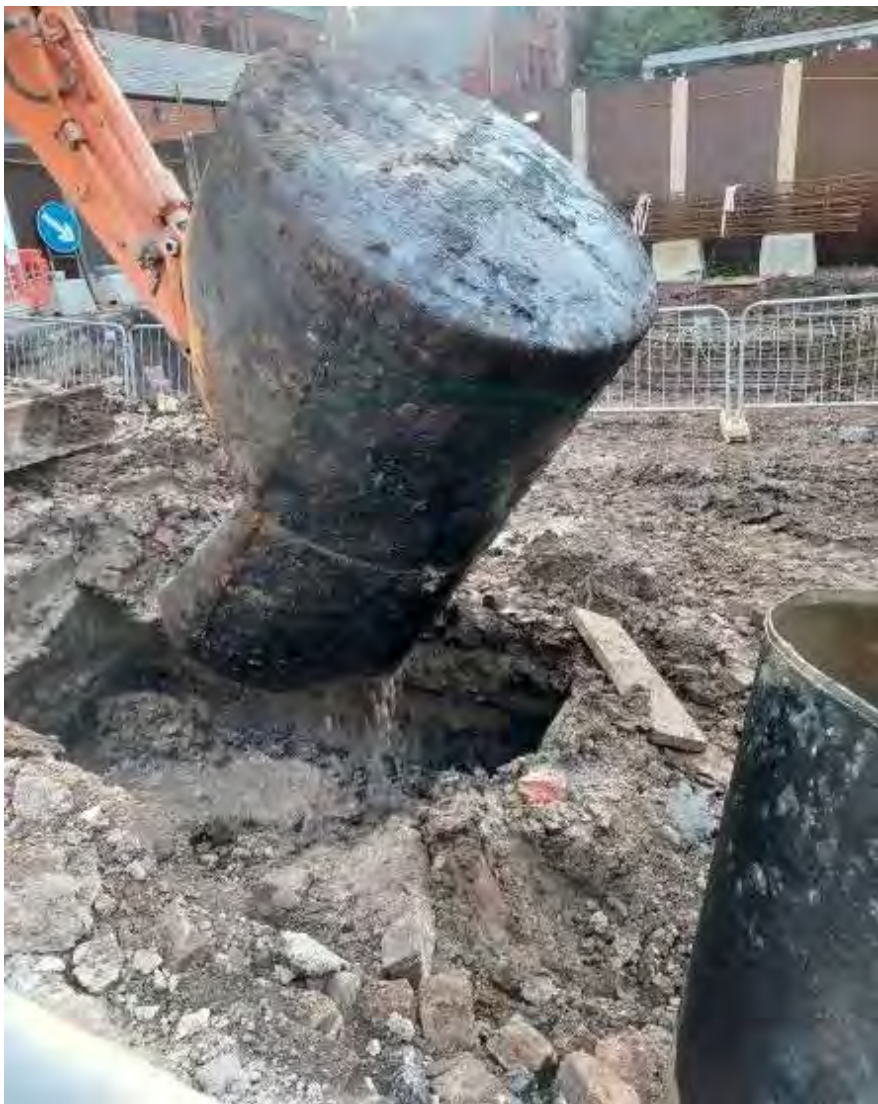
| Breaking out of the UST (8 <sup>th</sup> October) | | | | | | | | | | |

During these excavations concrete slabs, assumed to be the foundations for the tank, were discovered approximately 1 m bgl and within the surrounding layer of each sidewall. The slabs were broken out and segregated.

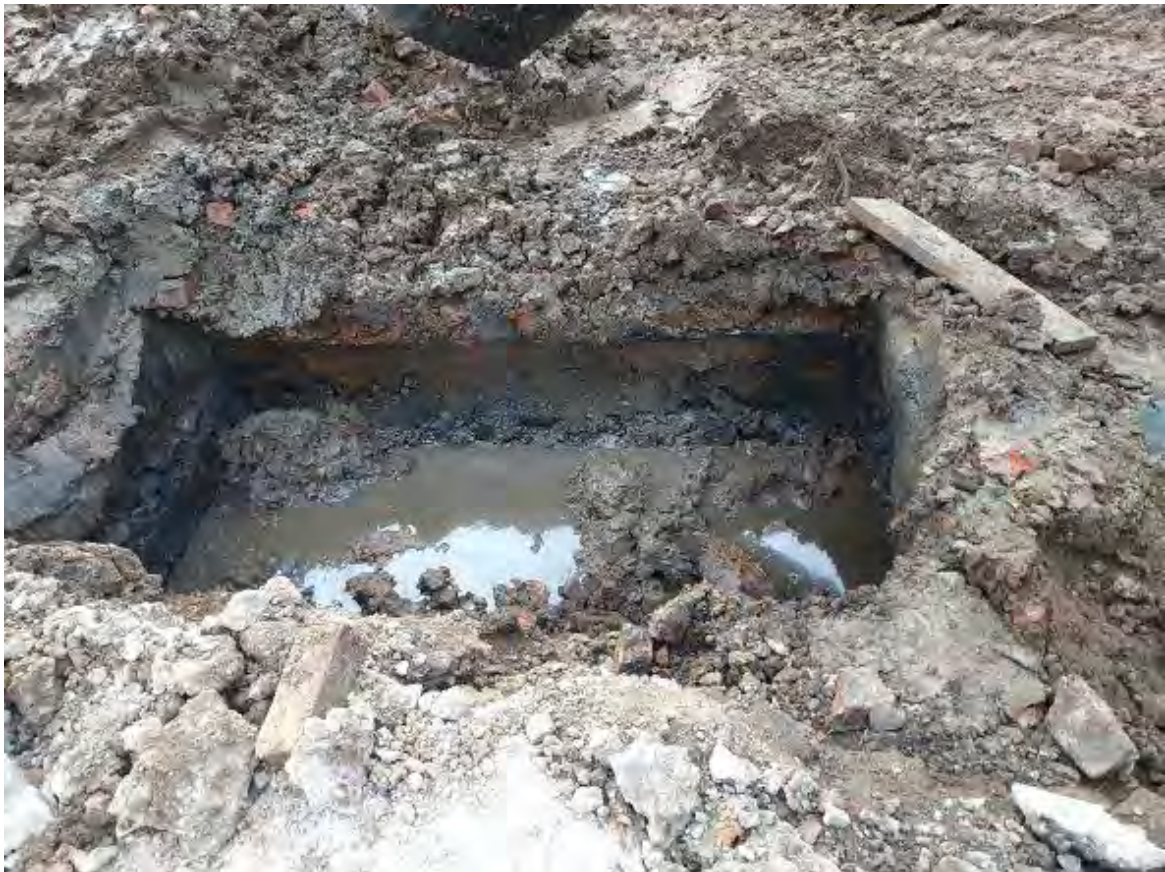
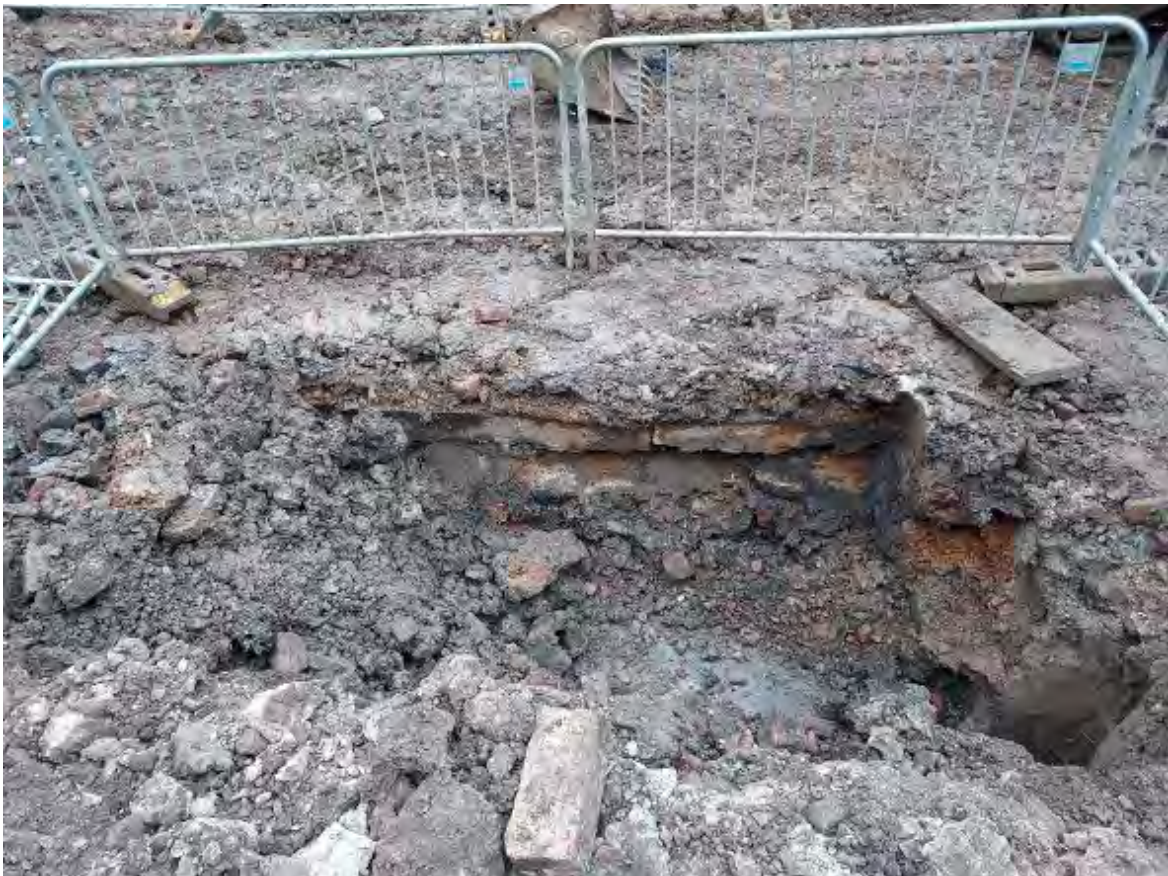
| Pit remaining following removal of UST (8 <sup>th</sup> October). Pit at start of chasing out works (13 <sup>th</sup> October) | Project No. | NOR1093 | |

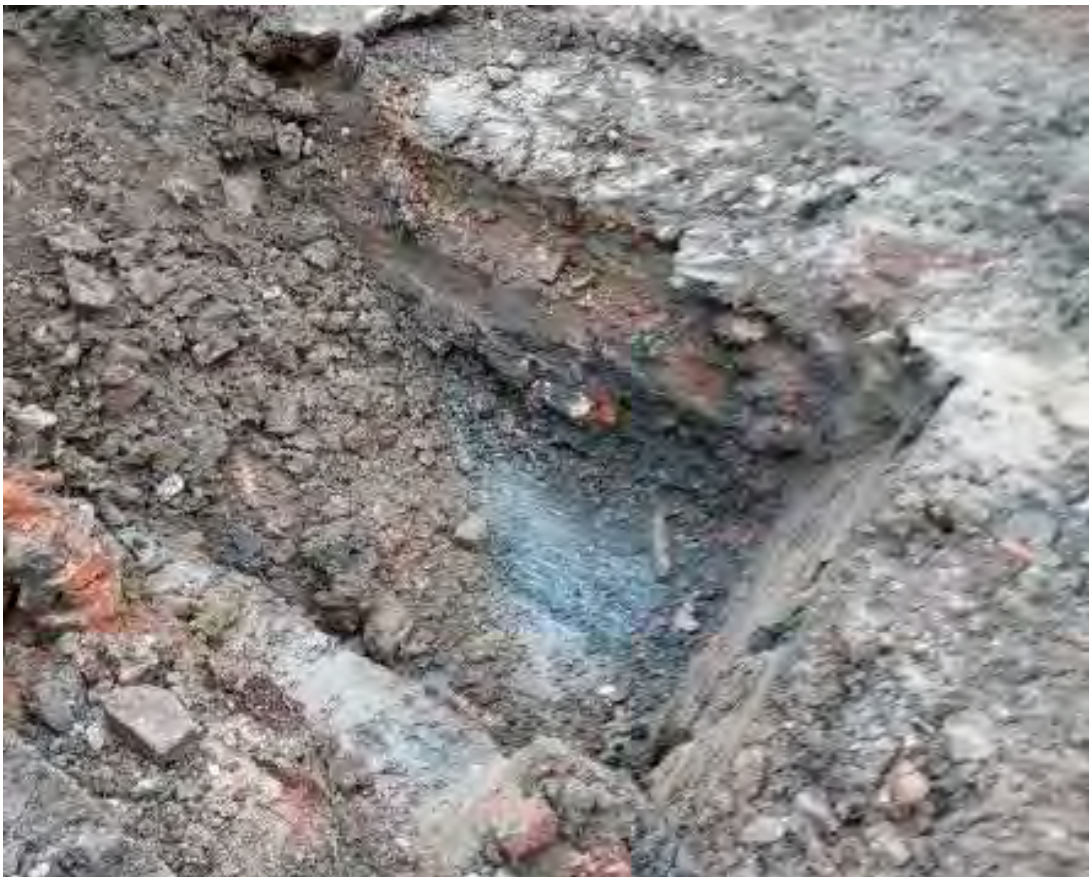
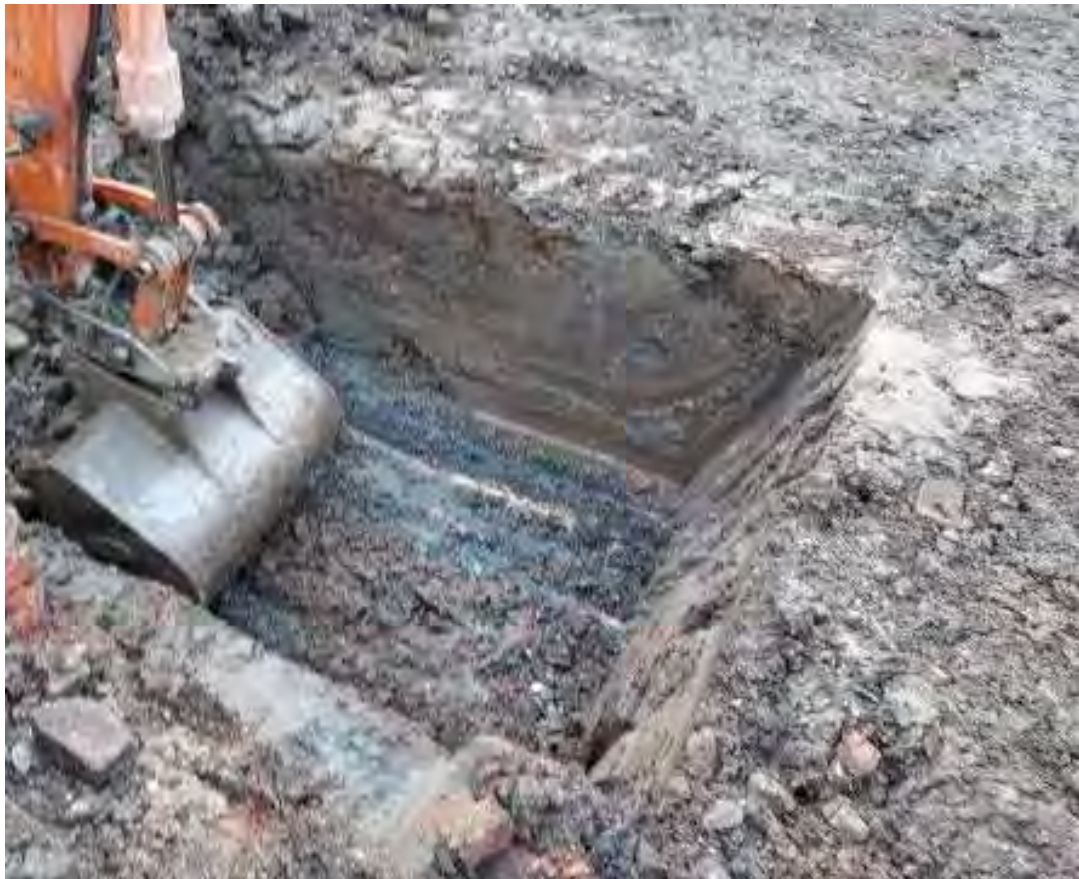
| Notes:<br>Chasing out of residual contamination following removal of UST (13 <sup>th</sup> October) | <table><tr><td>Project</td><td>Oxford Road, Manchester</td></tr><tr><td>Project No.</td><td>NOR1093</td></tr><tr><td>Carried out for</td><td>Kier Construction - North and Scotland</td></tr></table> | Project | Oxford Road, Manchester | Project No. | NOR1093 | Carried out for | Kier Construction - North and Scotland | <table><tr><td>Plates</td></tr><tr><td>9 and 10</td></tr></table> | Plates | 9 and 10 |

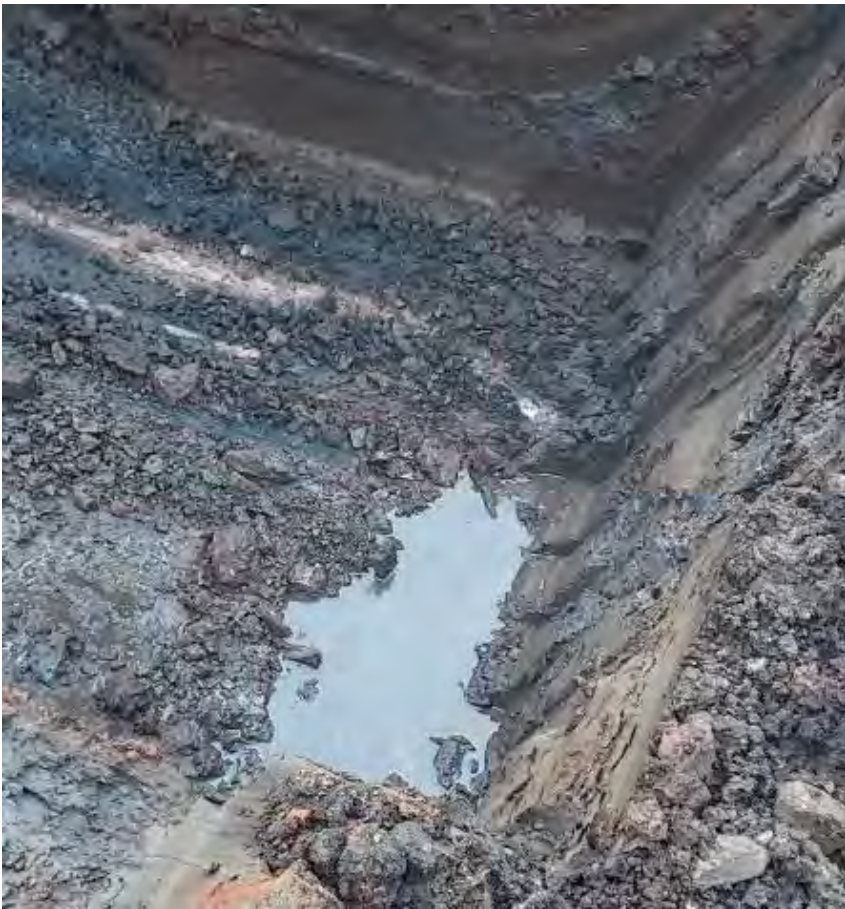
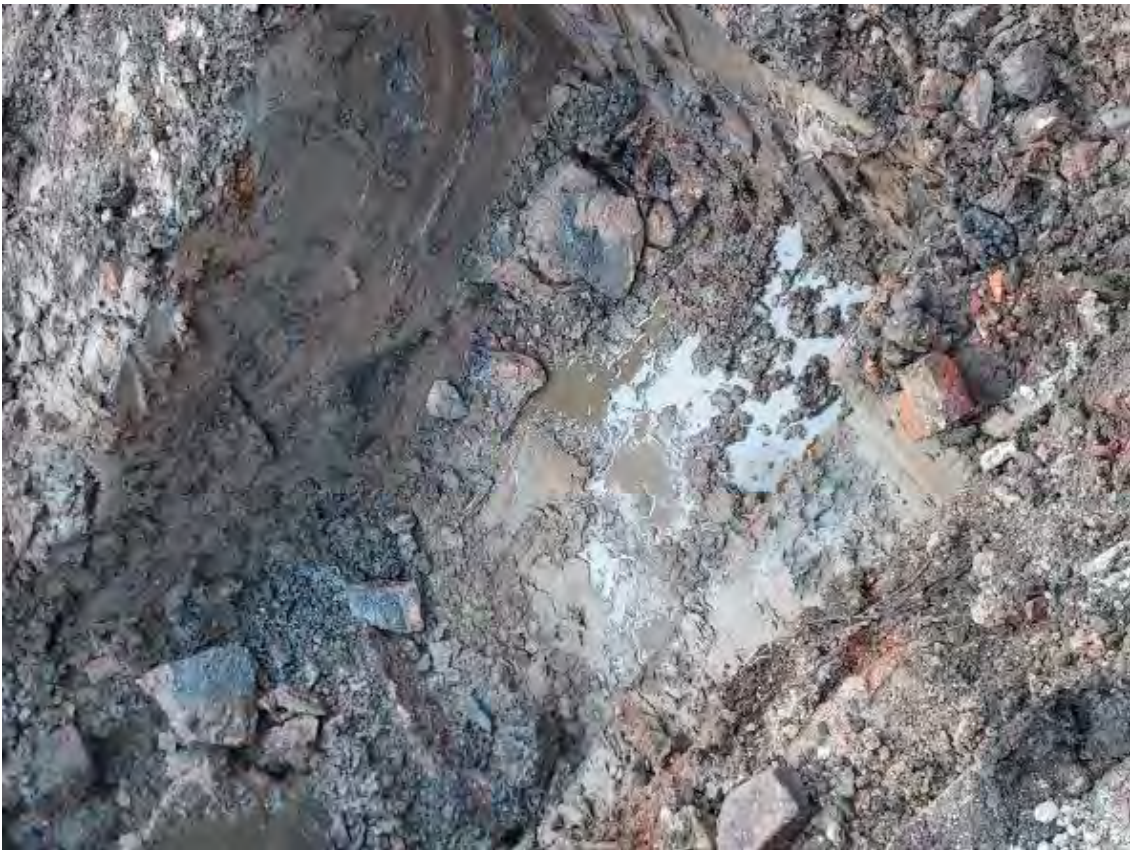
The soils immediately surrounding the tank were generally described as a black, brown and grey CLAY, overlying apparent demolition rubble, including brick and concrete fragments, overlying black coarse granular Made Ground to approximately 1 m bgl. A frequent black/grey sheen was also noted as being present within these soils and water with an oily sheen noted in the base of the excavation once the tank has been removed.

| <p>Notes:</p> <p>Water ingress showing oily sheen on surface during excavation (13<sup>th</sup> October)</p> | <p>Project Oxford Road, Manchester</p> <p>Project No. NOR1093</p> <p>Carried out for Kier Construction - North and Scotland</p> | <p>Plates</p> <p>11 and 12</p> |
