**Oxford Road, Manchester**

## **Remediation Verification Report**

**Report No NOR1093/004**

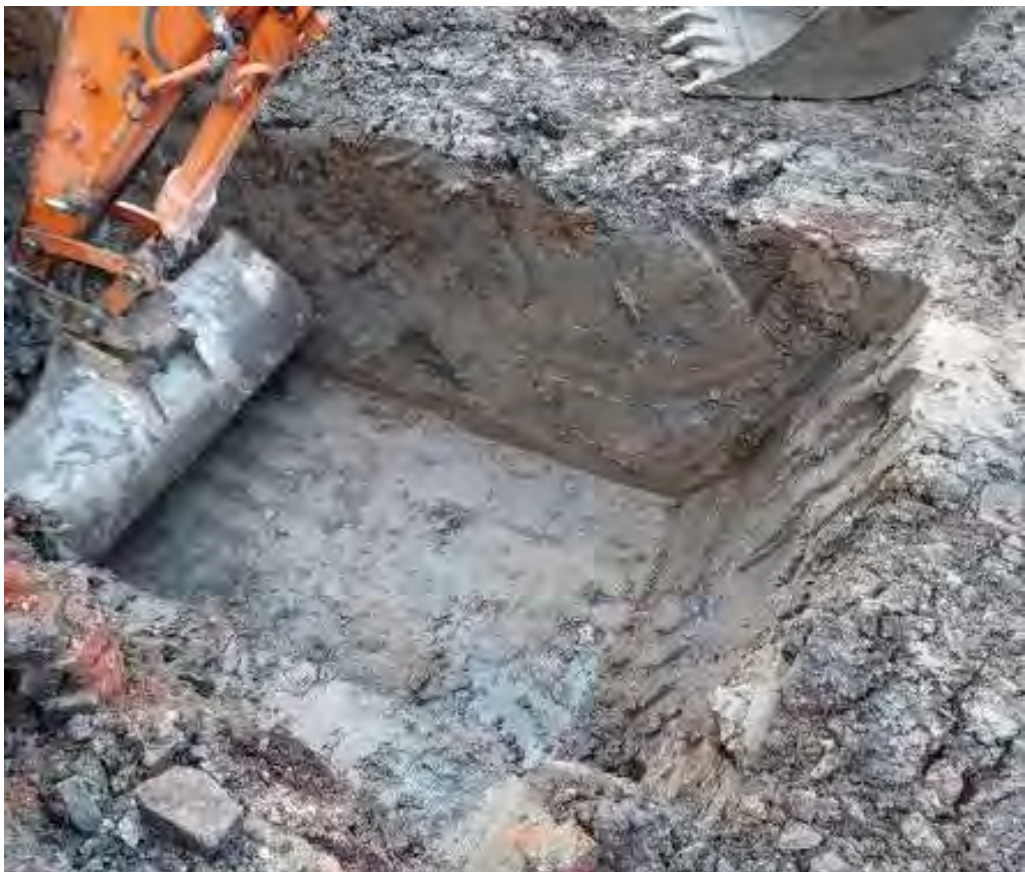
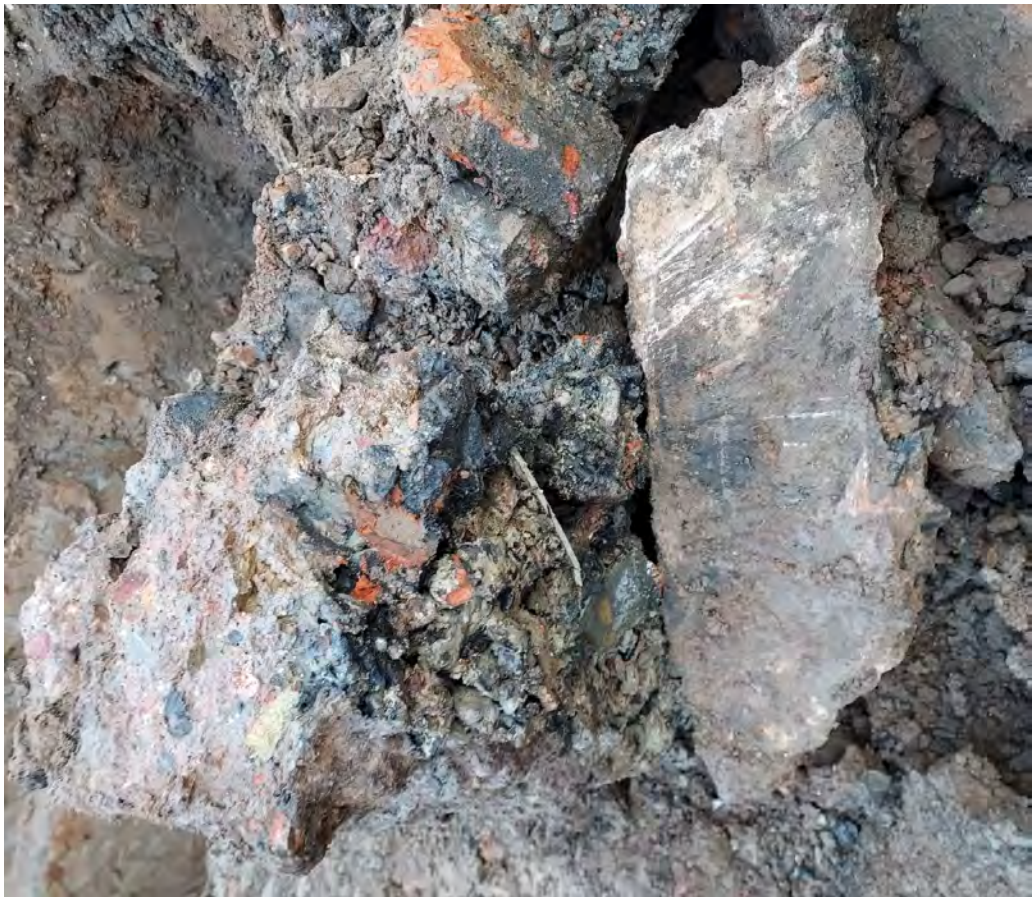
| Chasing out of residual contamination and contaminated spoil (13 <sup>th</sup> October) | <b>Project No.</b> | NOR1093 | 13 and 14 |

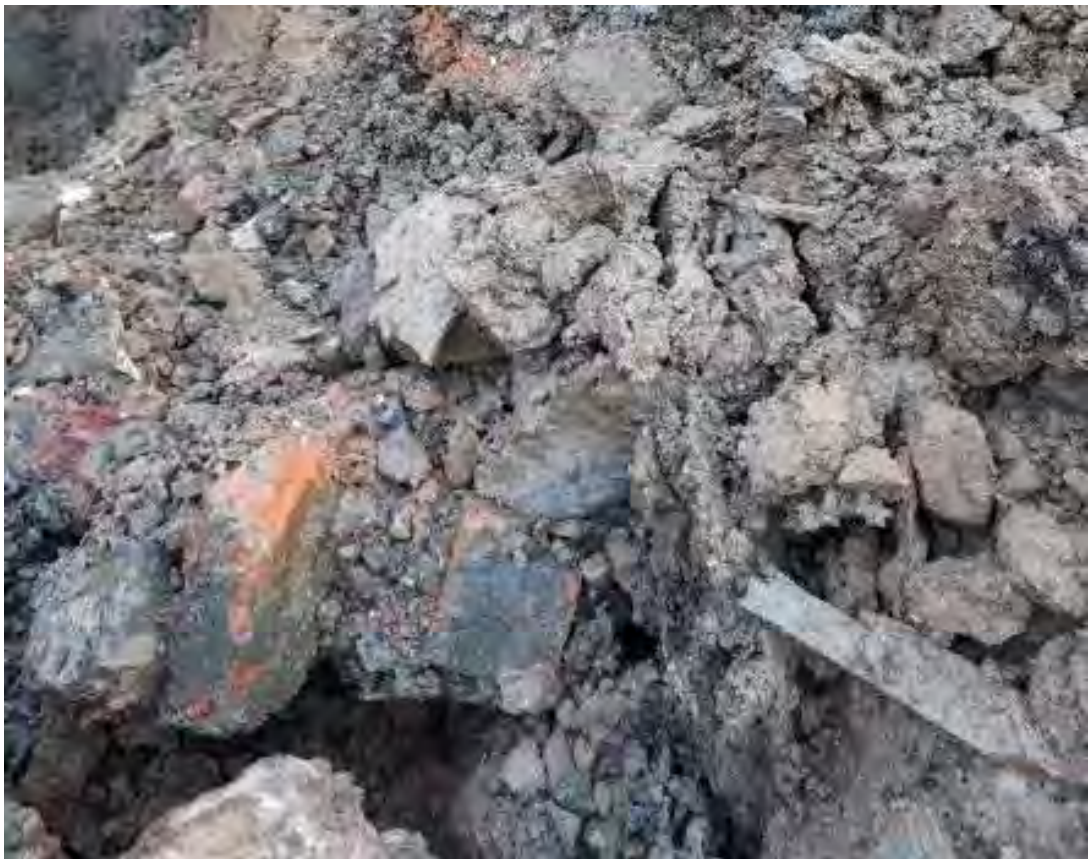
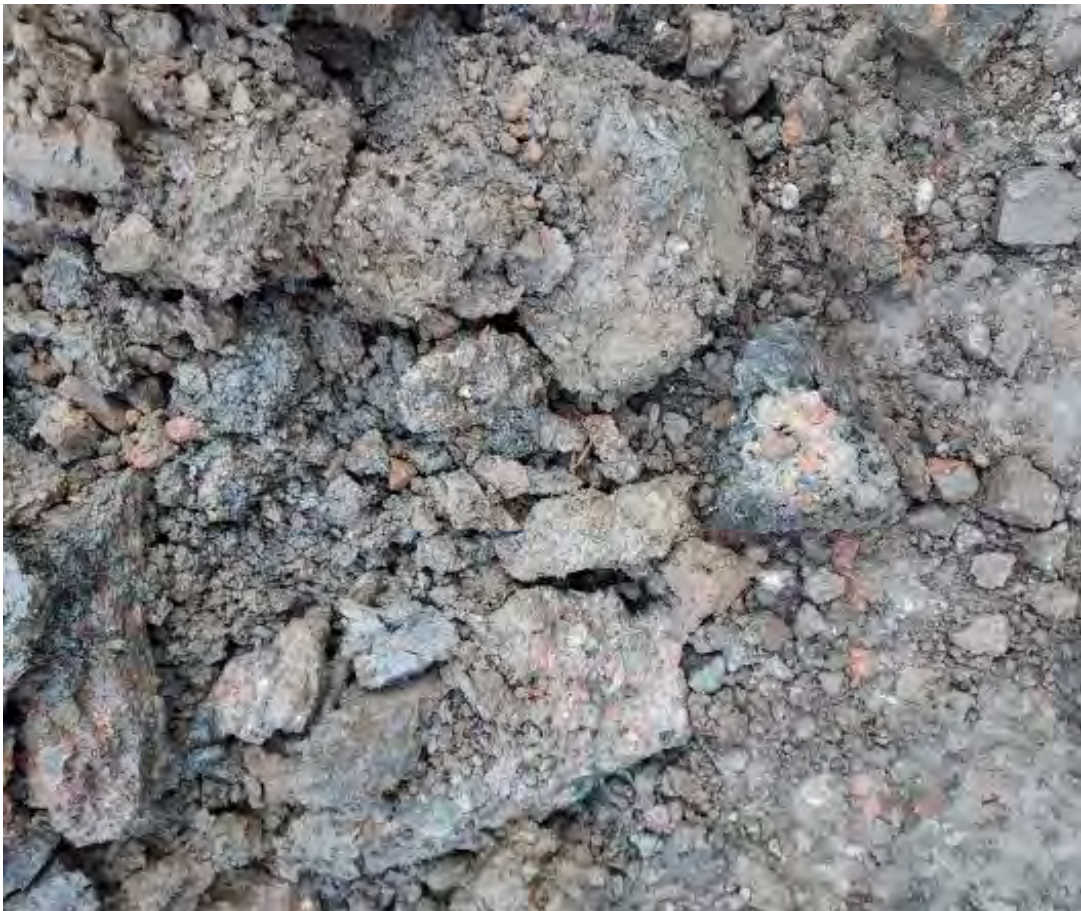
| Contaminated spoil (13 <sup>th</sup> October) | <b>Project No.</b> NOR1093 | 15 and 16 |

| Waste Description | Source | LoW Code | Receiving Facility | Waste Carrier (Carriers Licence No.) | Date of Movements | Total Weight |
|---|---|---|---|---|---|---|
| Soils and stones containing hazardous substances (TPH) | Oxford Street | 17-05-03 | Maw Green Soil Landfill Site, Maw Green Road, Crewe | J. O'Shea and Sons Ltd (CBDU90839) | 13/10/2021 | 18860 kg (1 load) |

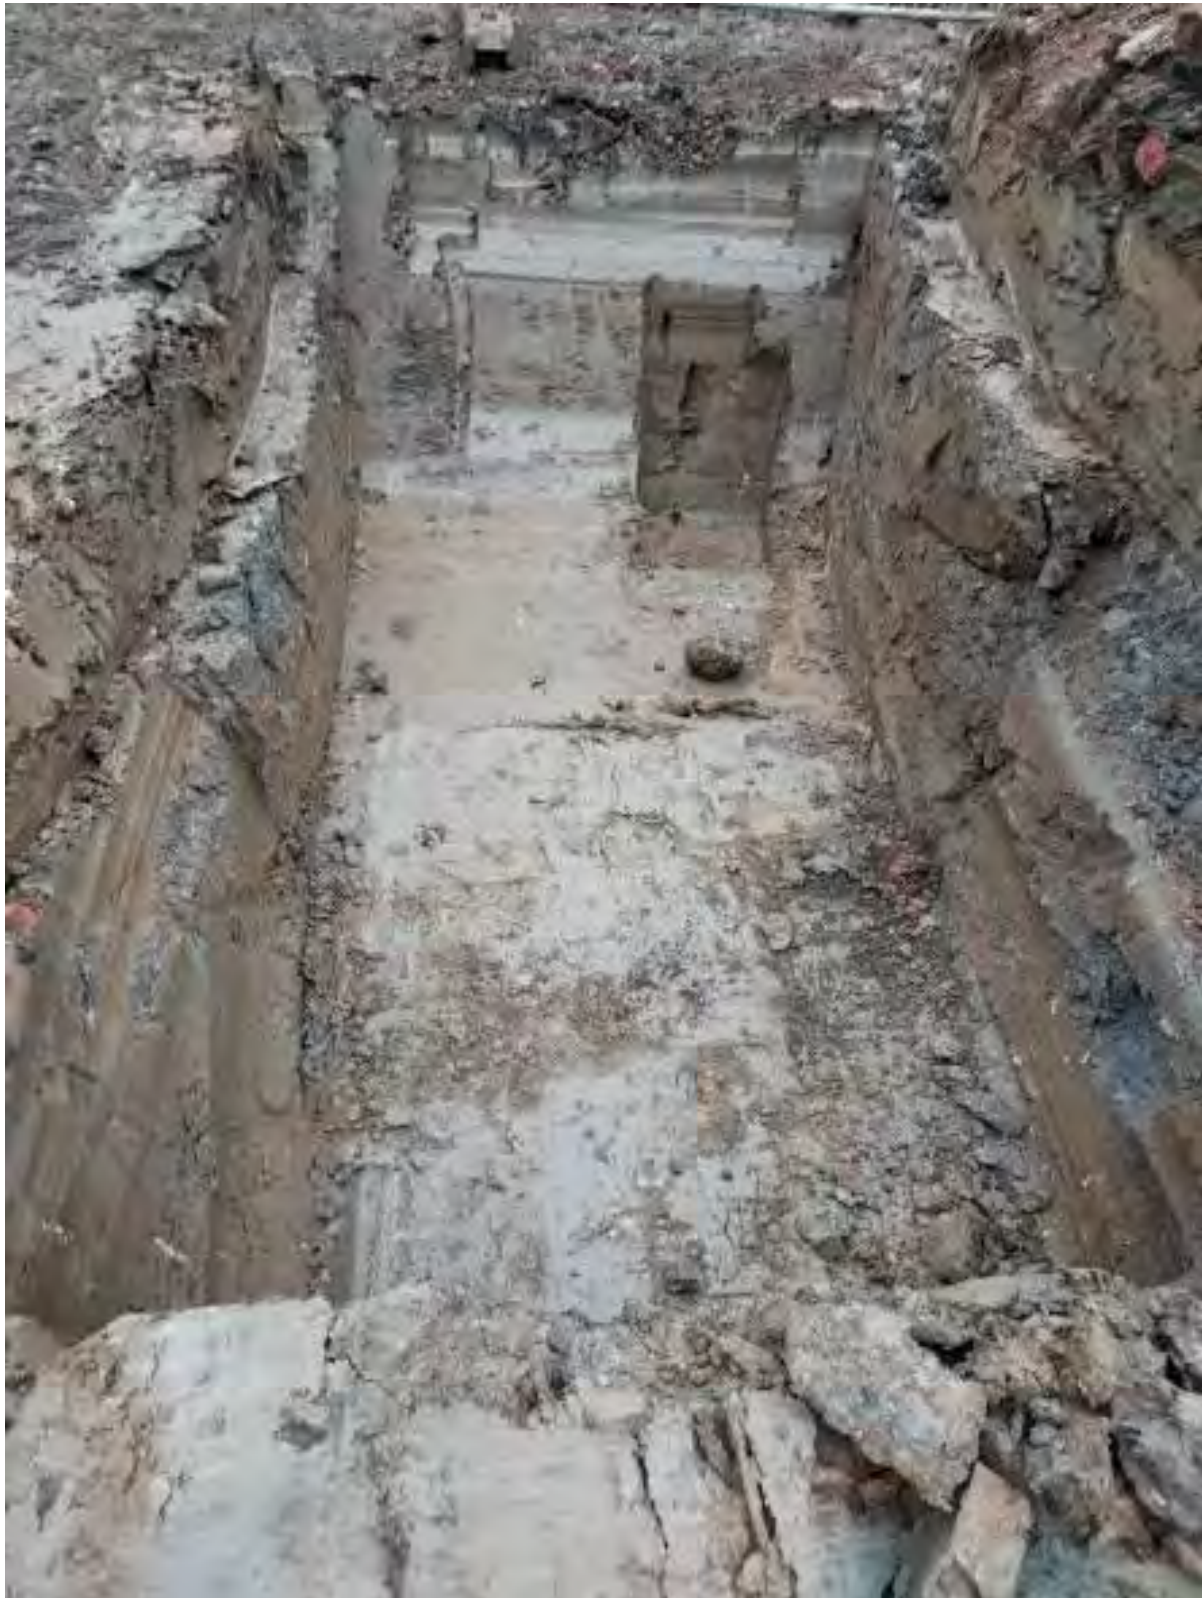
| Notes:<br>Final excavation following removal of UST and chasing out of contaminated soils (13 <sup>th</sup> October) | <table><tr><td>Project</td><td>Oxford Road, Manchester</td></tr><tr><td>Project No.</td><td>NOR1093</td></tr><tr><td>Carried out for</td><td>Kier Construction - North and Scotland</td></tr></table> | Project | Oxford Road, Manchester | Project No. | NOR1093 | Carried out for | Kier Construction - North and Scotland | <table><tr><td>Plates</td></tr><tr><td>17</td></tr></table> | Plates | 17 |

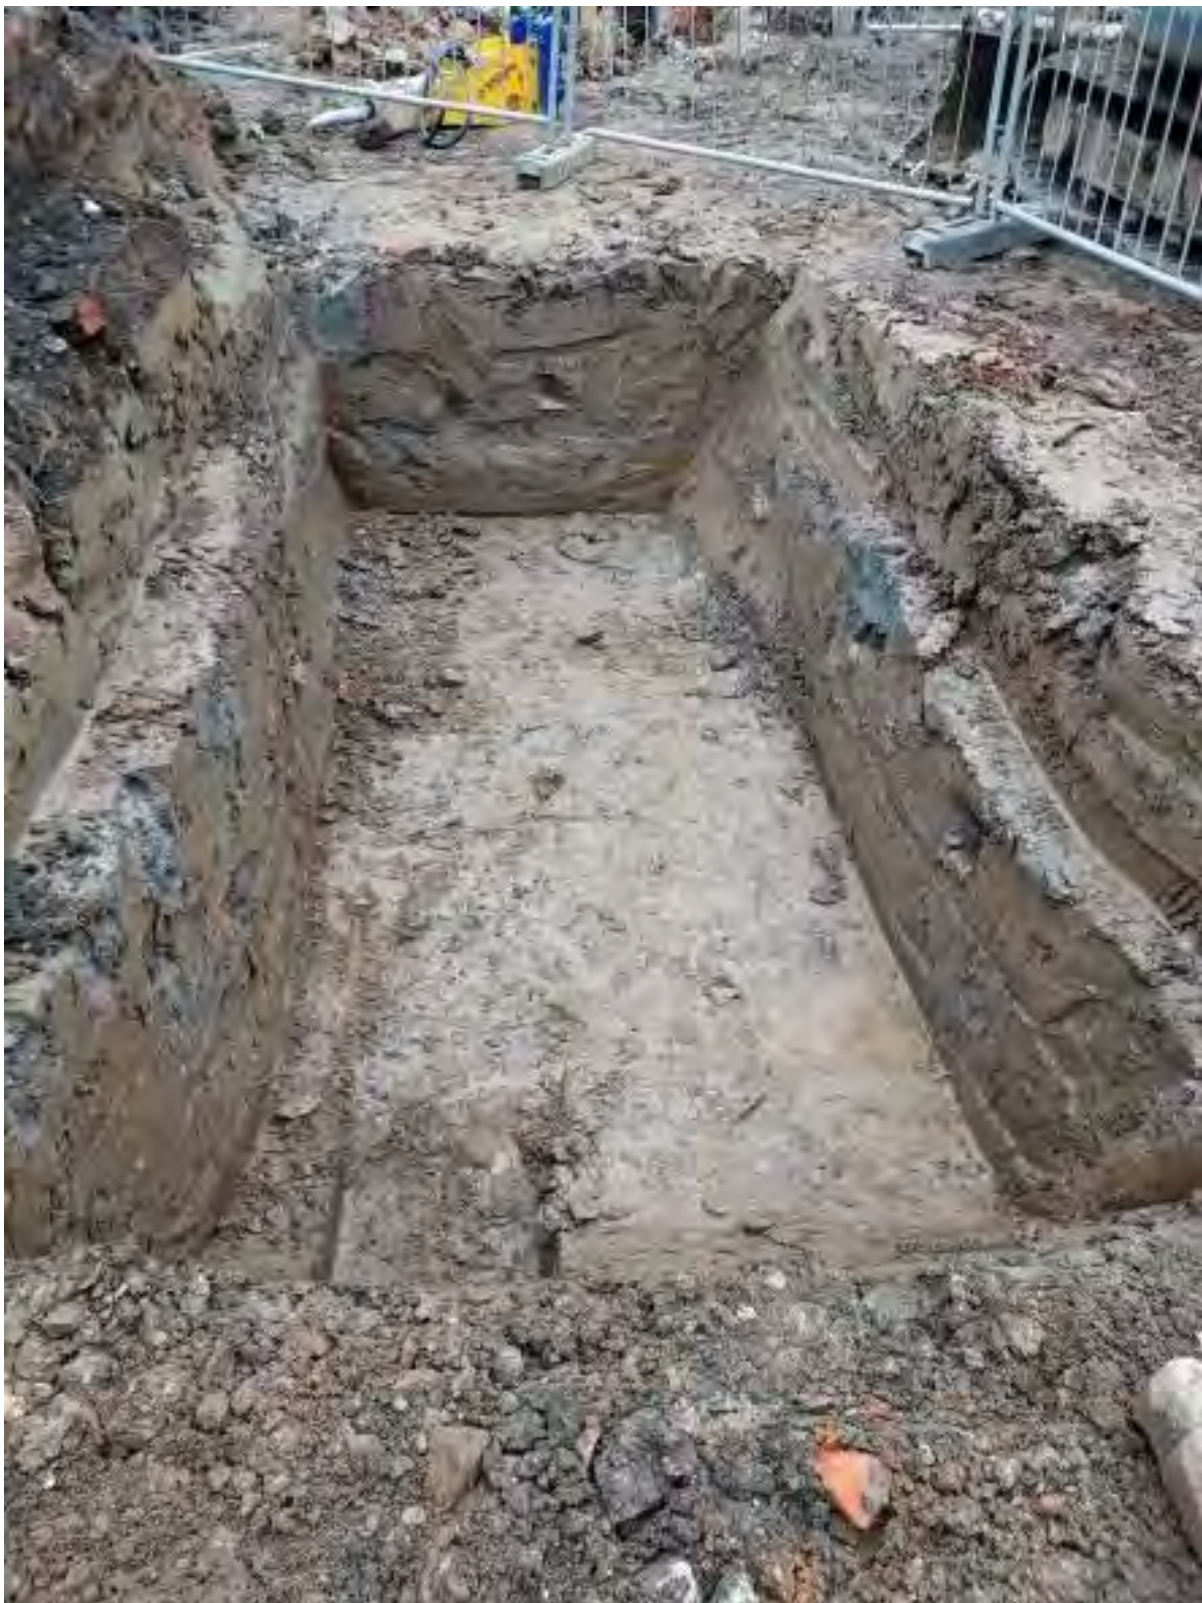
| <p>Notes:<br/>Final excavation following removal of UST and chasing out of contaminated soils (13th October)</p> | <p>Project Oxford Road, Manchester<br/>Project No. NOR1093<br/>Carried out for Kier Construction - North and Scotland</p> | <p>Plates<br/>18</p> |
