# BS3882:2015 & BS8601:2013 Report PROTOS Phase 2 Infrastructure

**Title:** BS3882:2015 & BS8601 report – PROTOS Phase 2 Infrastructure

**Client:** Peel Land and Property

**Date:** 23 September 2019

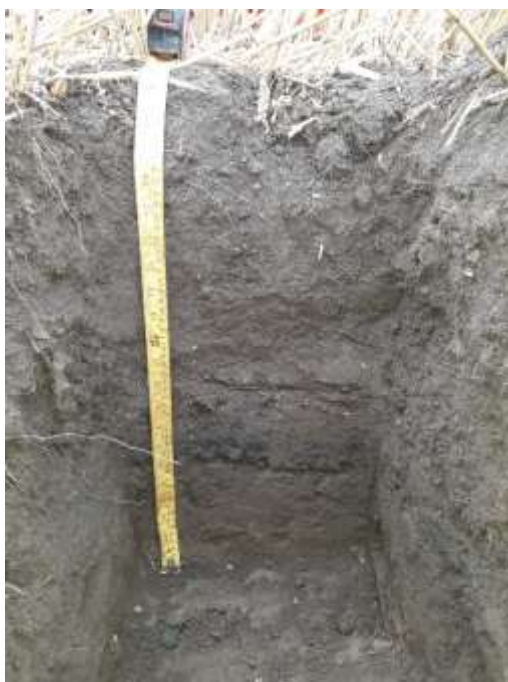
**C4 (Pit) Photo:**

| Comments: | | Many fine roots 0-40cm. Few fine roots >40cm. Very dark upper subsoil. |
