# ENABLING WORKS VERIFICATION REPORT

For  
STUBBS MEWS,

Prepared for  
URBAN SPLASH CONSTRUCTION

| LKR Document Title: | Enabling Works Verification Report |

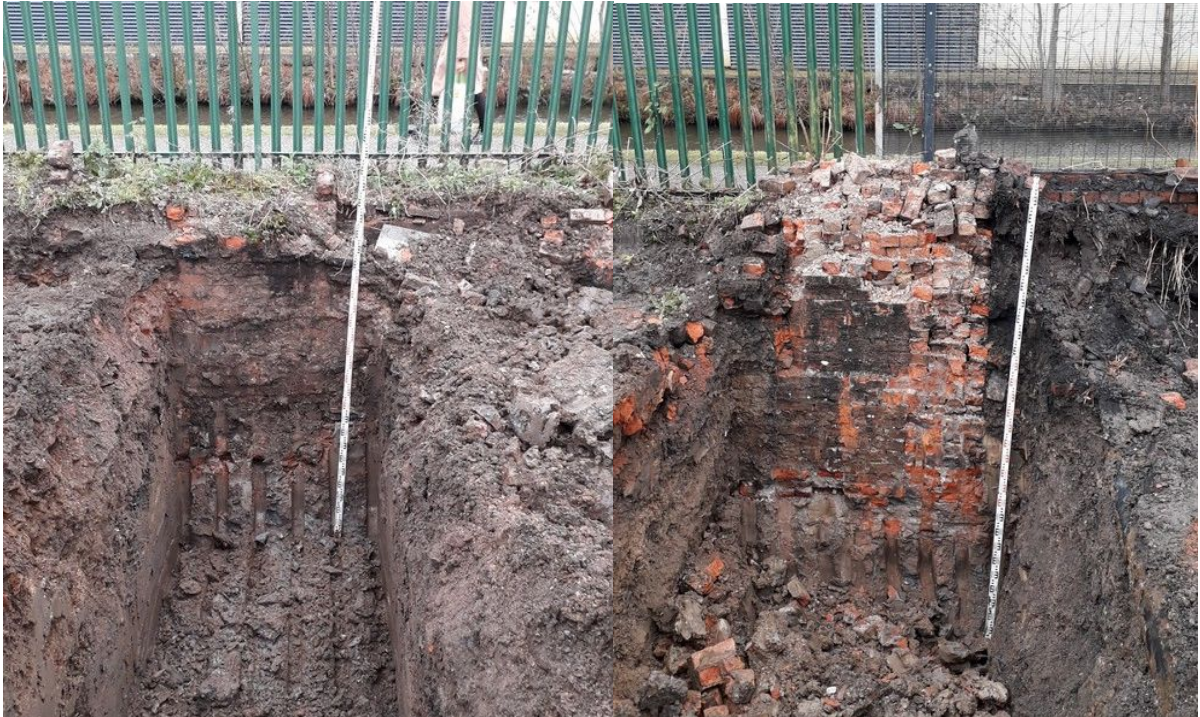
Examples of 'hit & miss' grubbing out to natural soils along site boundary adjacent to canal during Mobilisation 1.

Works adjacent to the canal (undertaken during Mobilisation 1) were done in a 'hit and miss' pattern to minimise risk to the canal tow path. Made ground was placed in layers (approximately 250mm thick) in accordance with the Client's design requirements, to reduced levels. Site generated aggregates were supplemented with imported 6F5 material to form the temporary piling mats along Carruthers Street and adjacent to the canal boundary as part of initial mobilisation works.

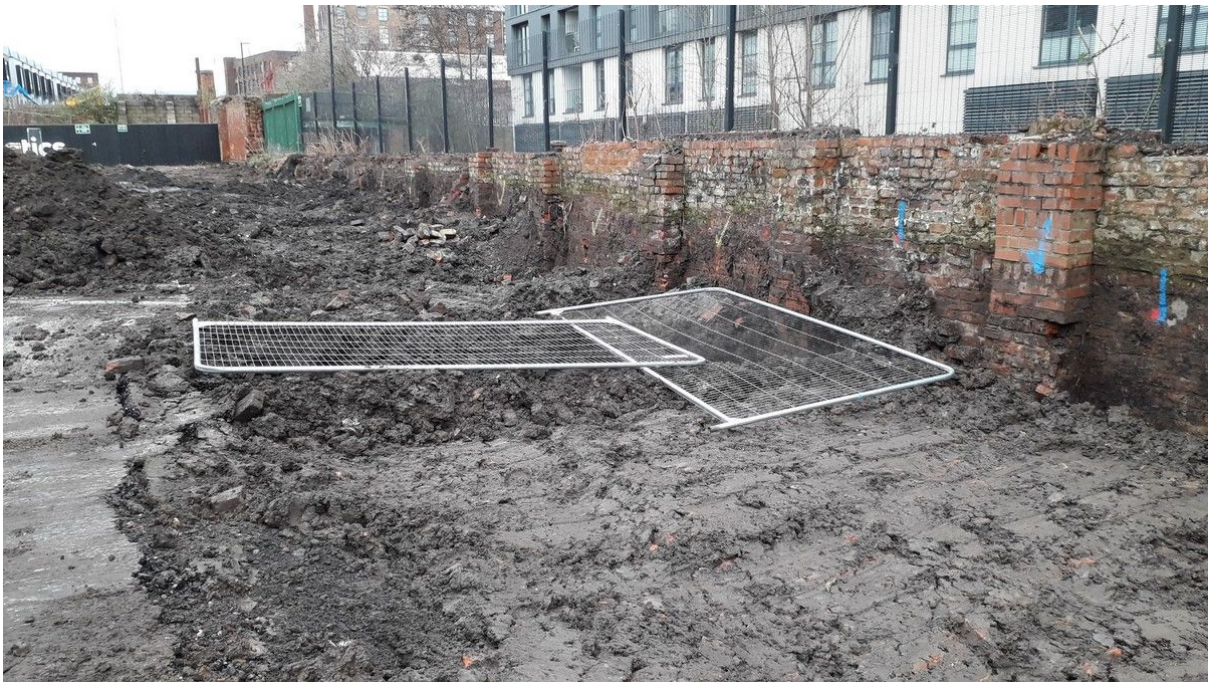
Example of grubbing out along canal side.

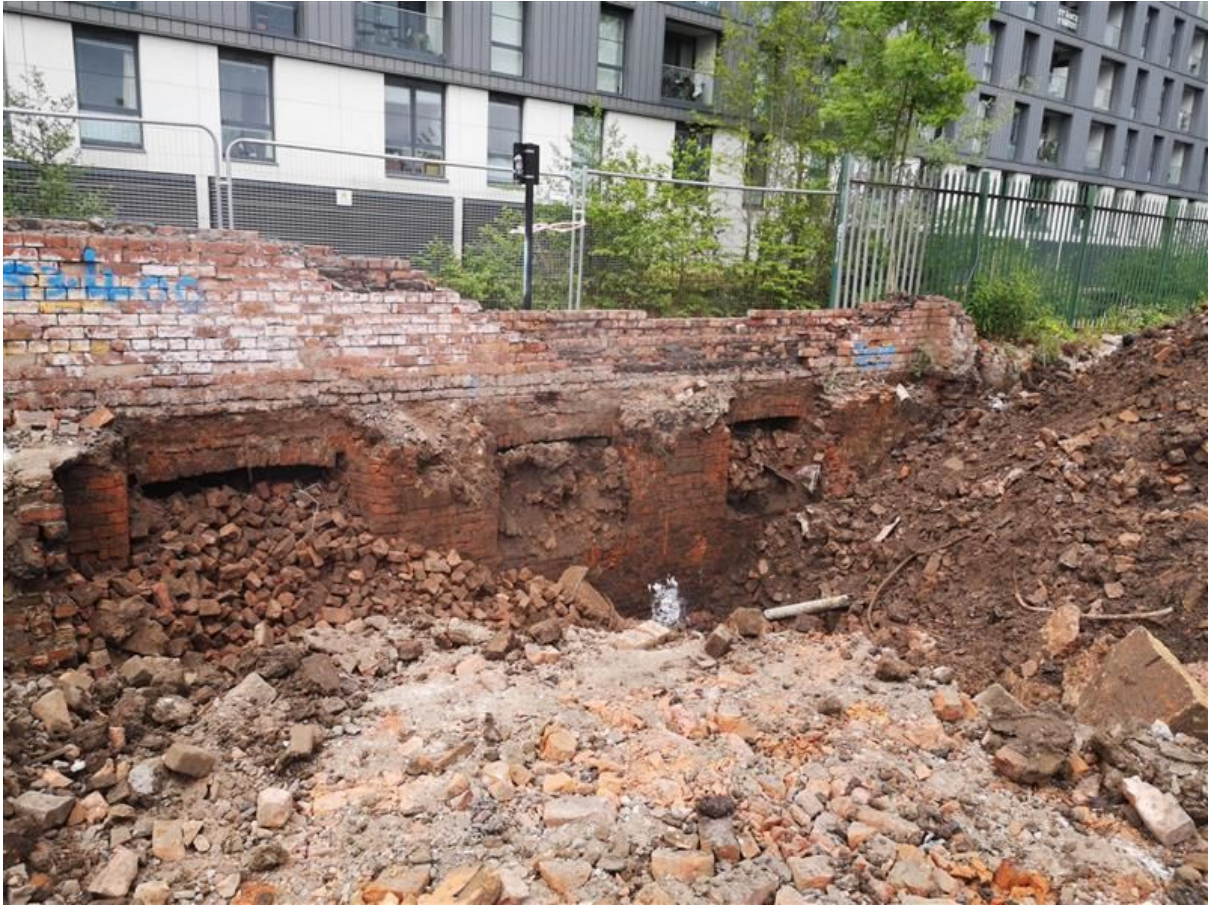
Example of grubbing out along canal side showing relict in-ground structures.

Excavations to remove relict obstructions were supervised by a remediation site manager and geo-environmental consultant. All areas of hardstanding, including buried floor slabs and walls, redundant drainage and historical foundations were broken out and excavated to stockpile.

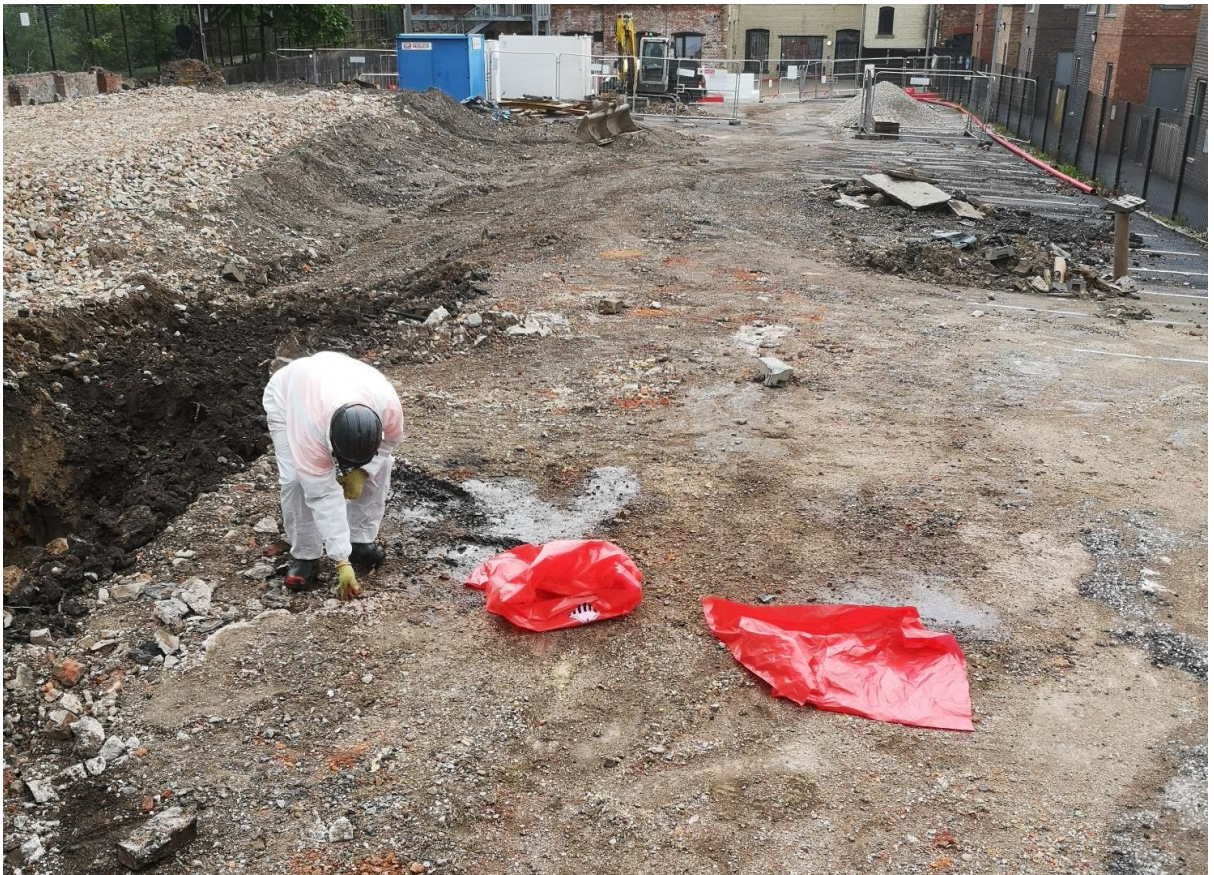
Localised hand picking of ACM by specialist.

Small amounts of cemented asbestos were identified in one localised area of made ground. A specialist contractor was used to hand pick the ACM which was bagged and removed via suitable disposal route. No other unsuspected ground conditions were noted and no significant visual/ olfactory contamination was identified.

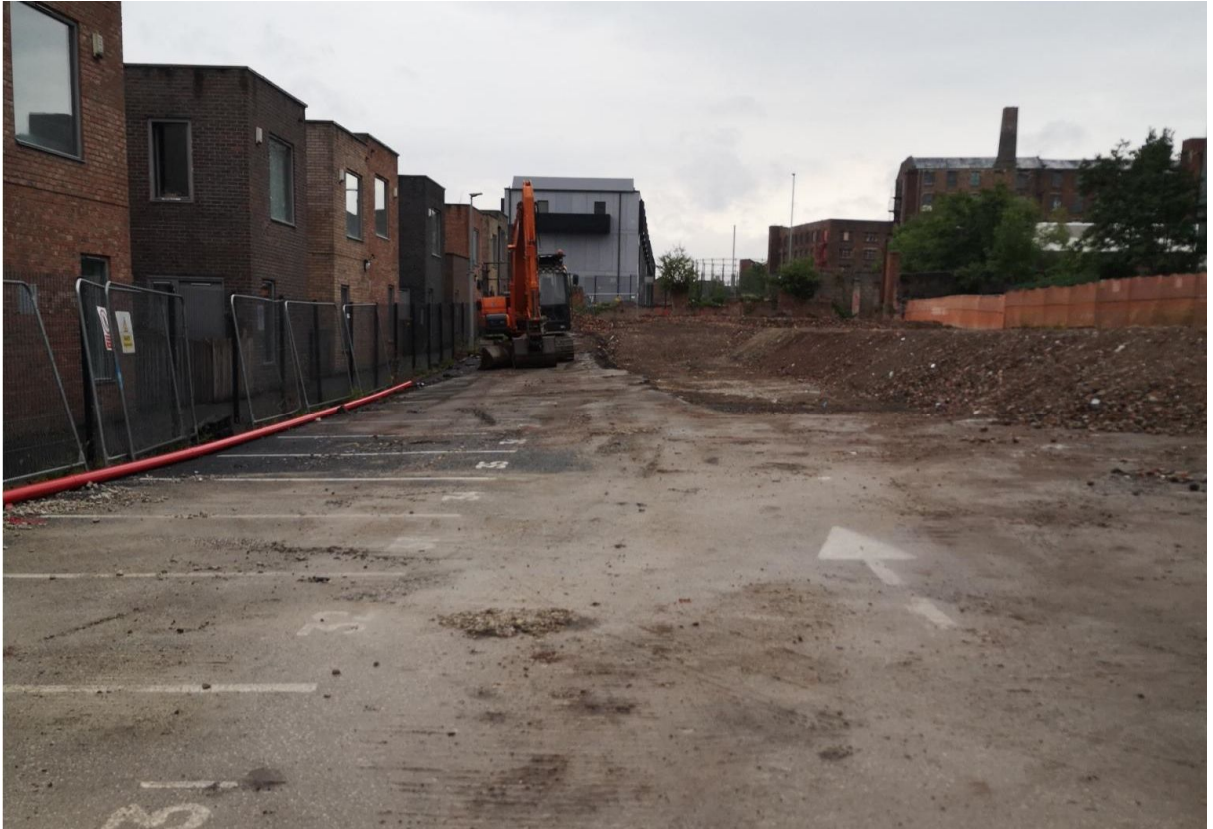
Forming temporary works piling mat for contig pile retaining wall during Mobilisation 1.

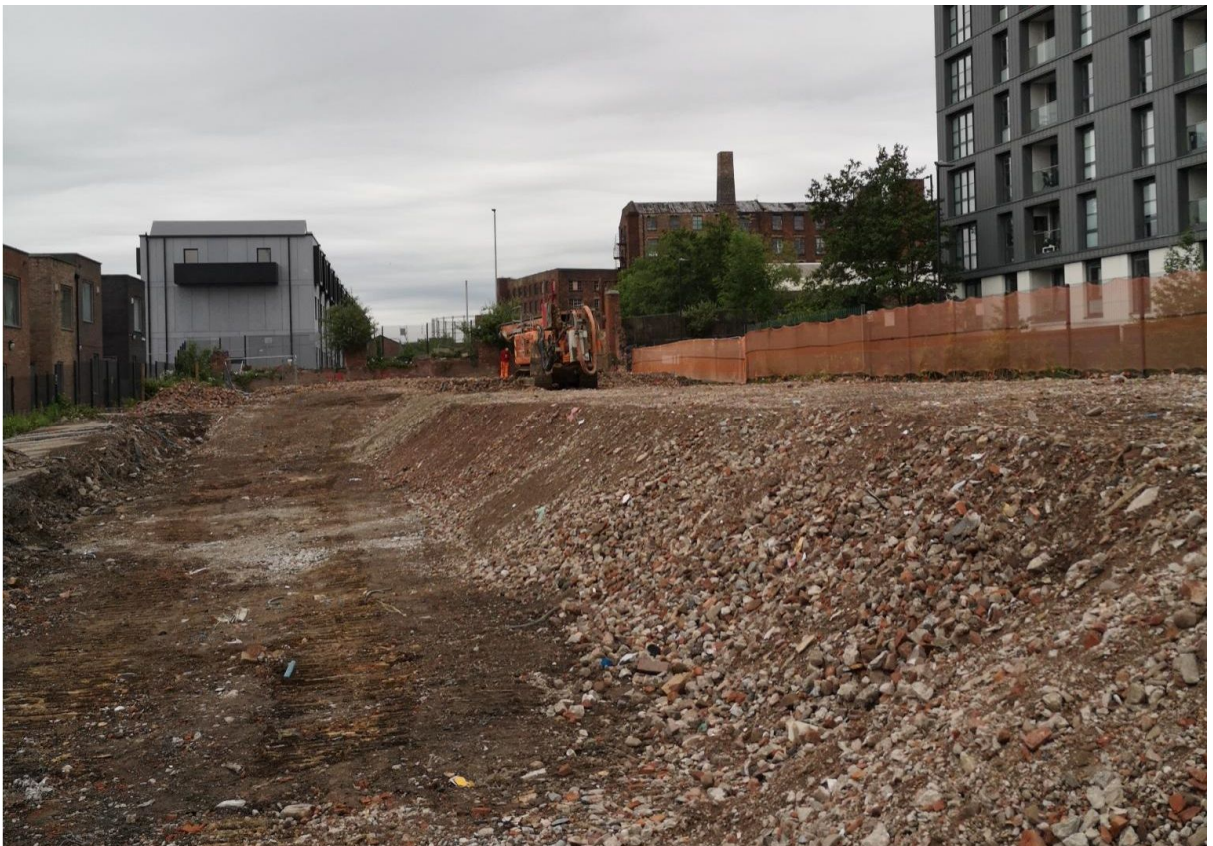
Forming temporary works piling mat for contig pile retaining wall during Mobilisation 1.

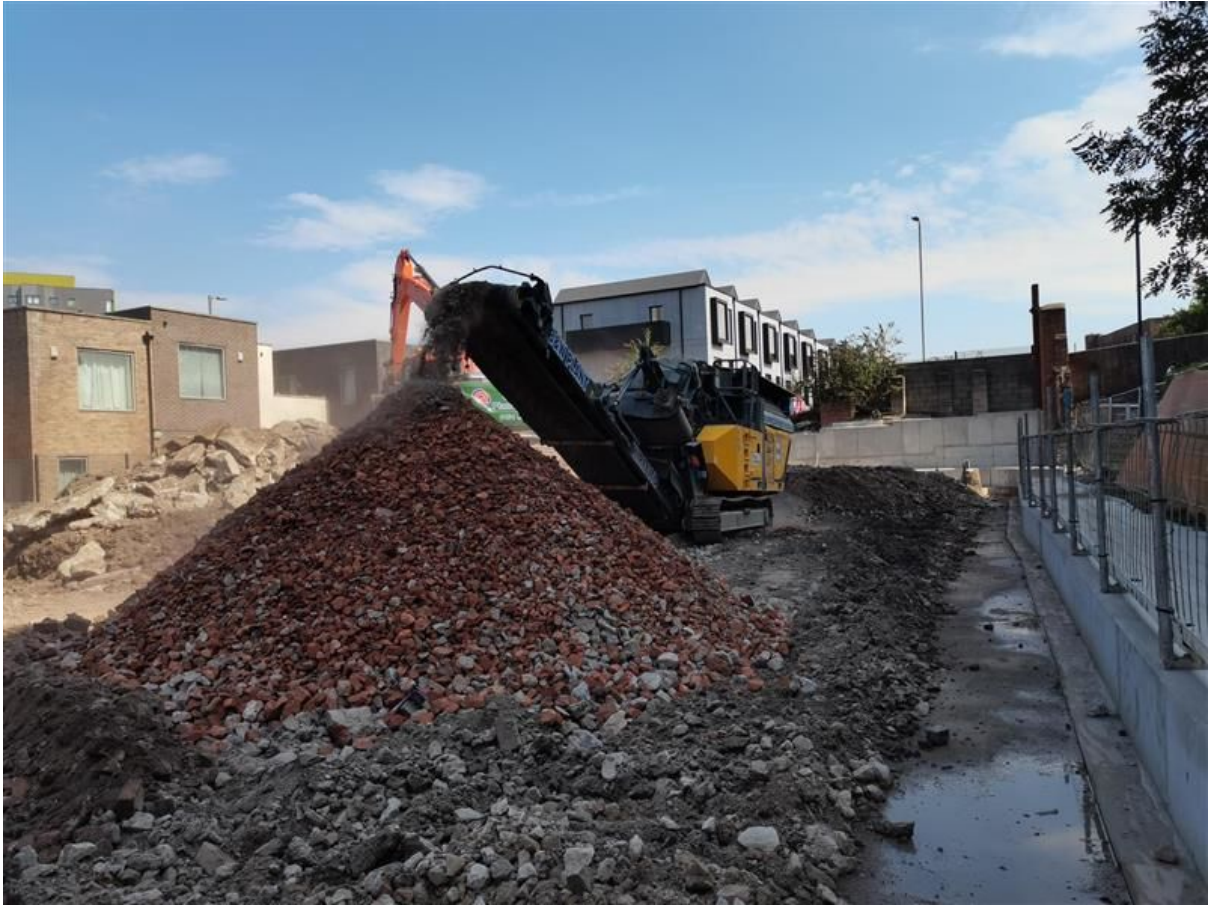
Site generated aggregates from relict structures used to form pile mats.

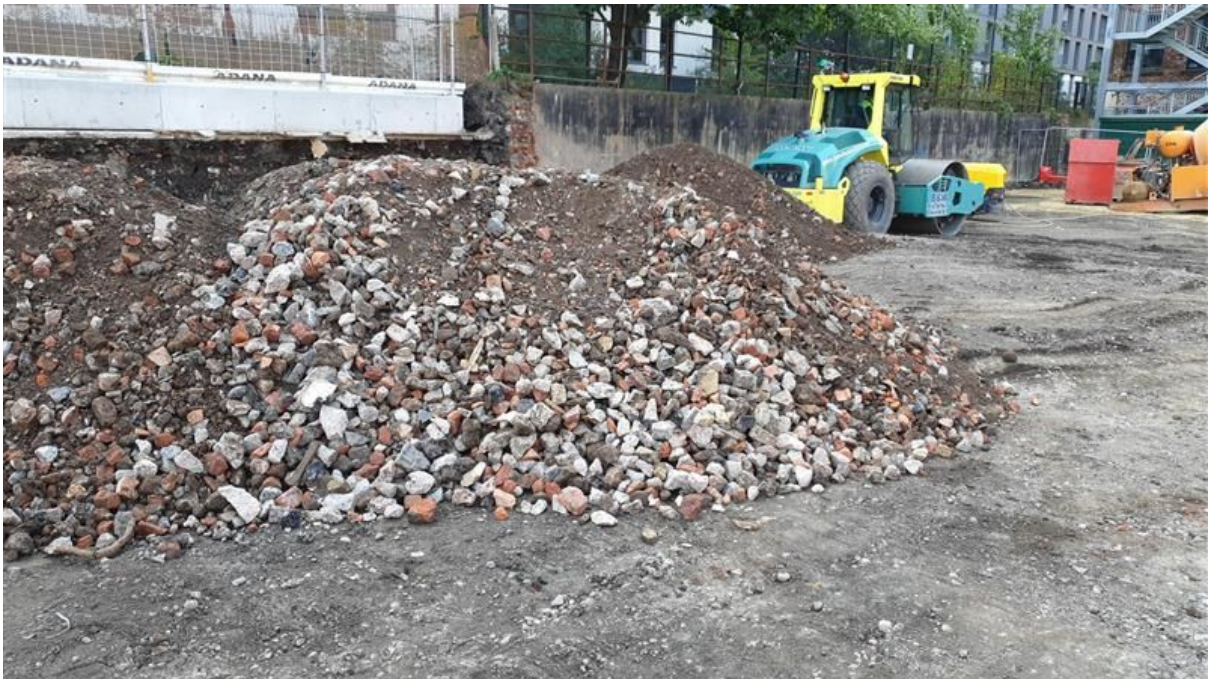
Example of site generated aggregates.

The site investigation deemed the soils on site as suitable for re-use within the proposed development. LKR undertook precautionary contamination testing on imported ('6F2 import') and site generated aggregates ('SWC01-03', 'CRV01', 'CRV03'). The watching brief did not encounter any ground conditions which were significantly different to those described in the site investigation.

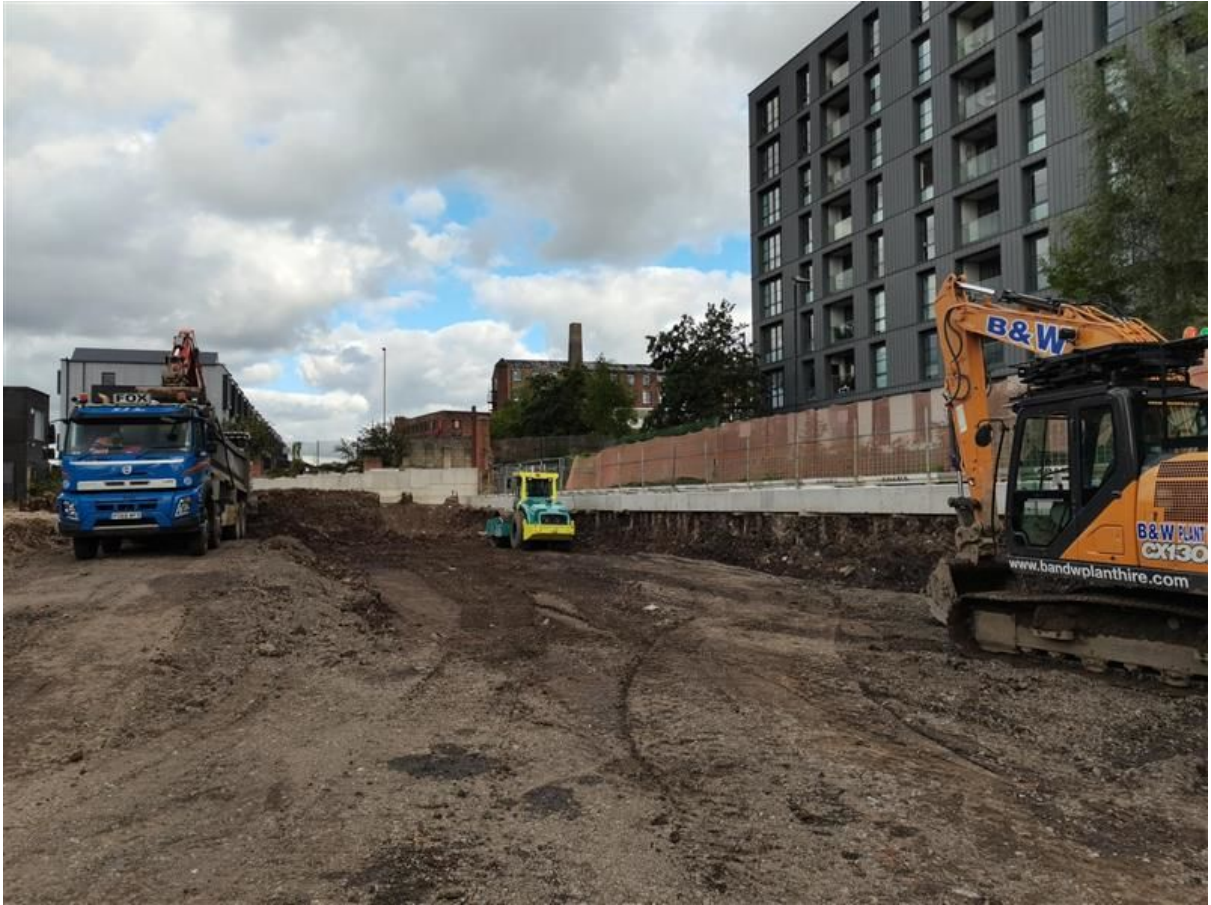
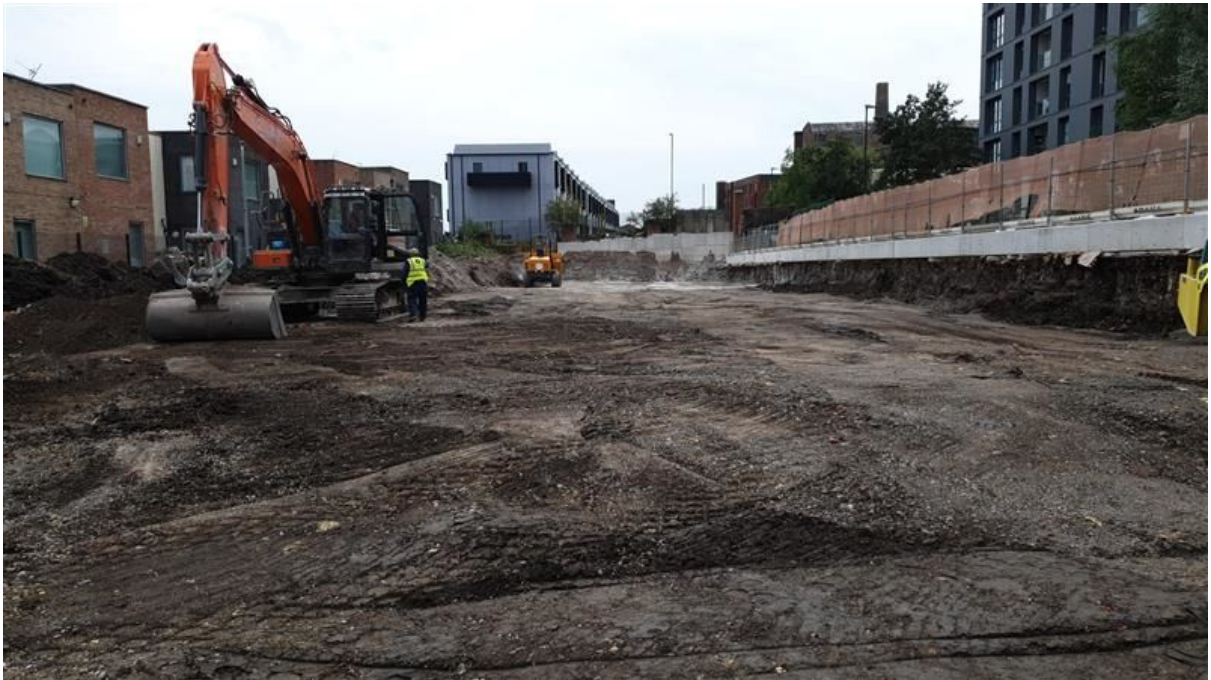
Forming site levels for permanent piling mat during Mobilisation 2.

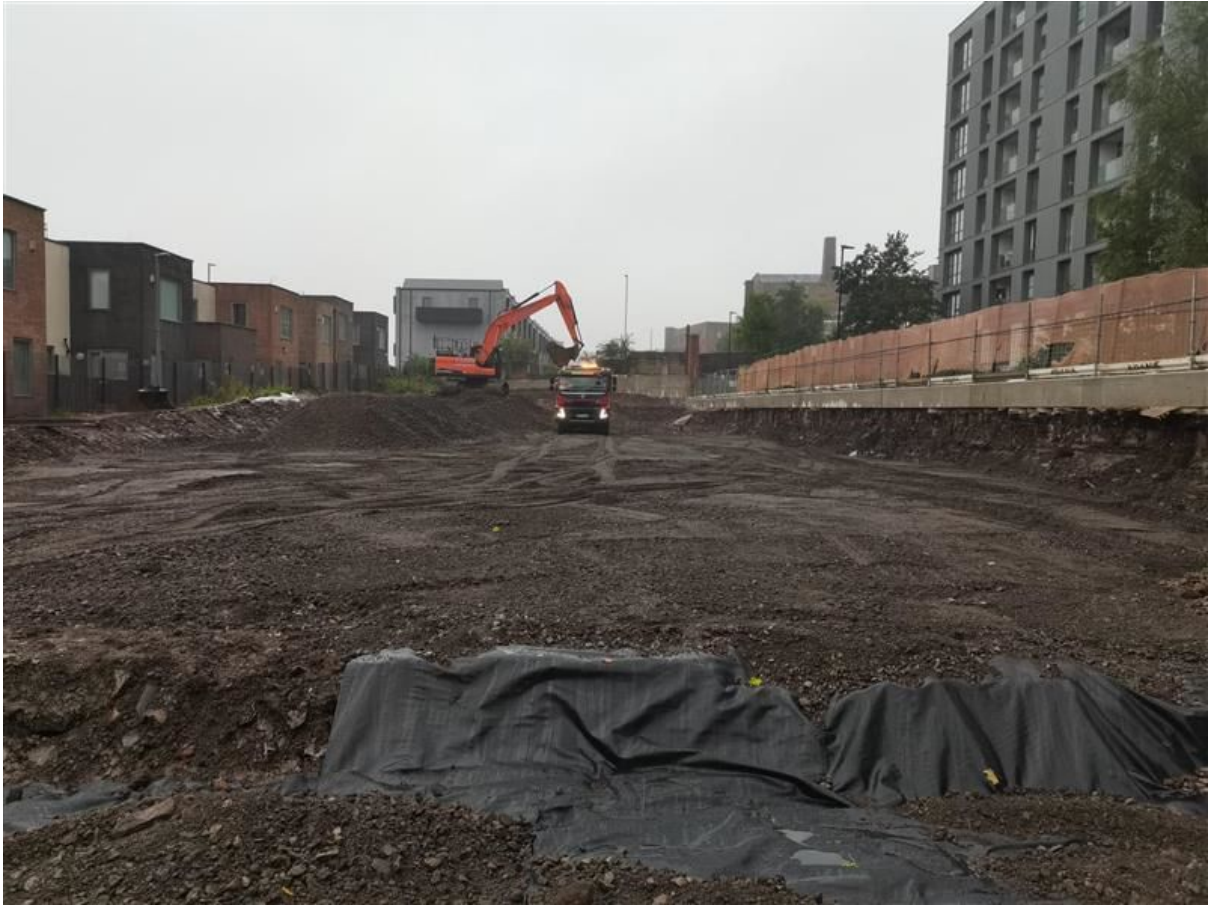
Trimming and compacting surfaces. Disposal of surplus materials.

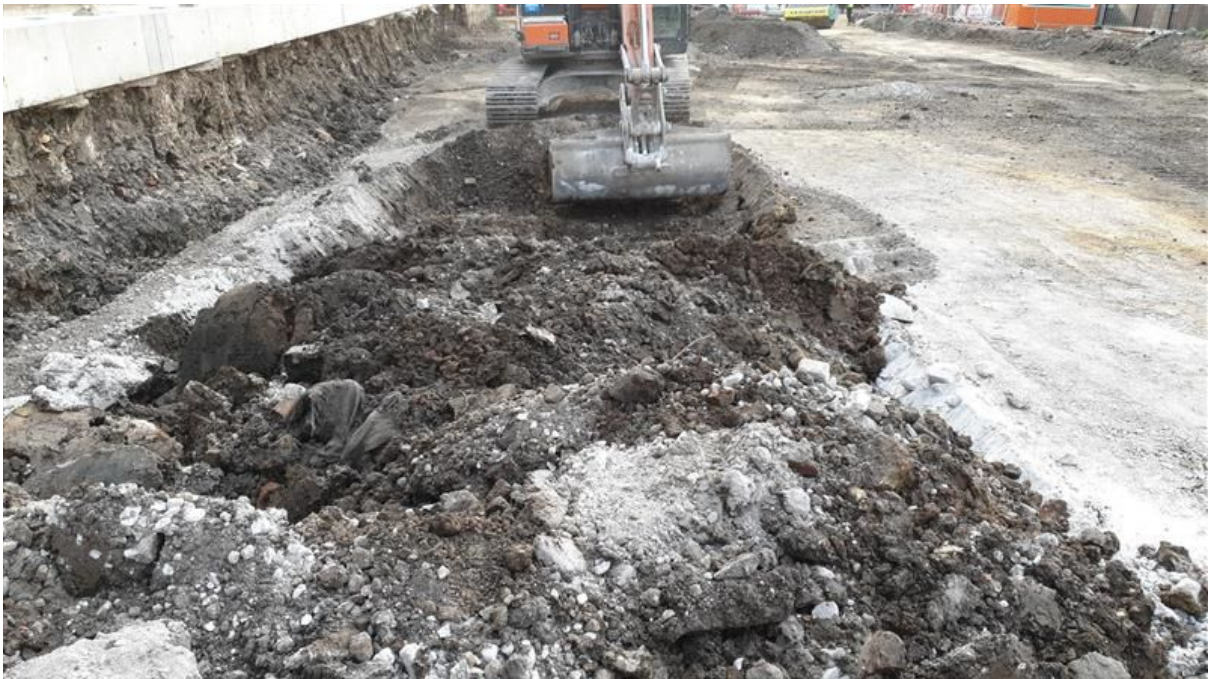
Digging out and re-engineering soft spots.

Some areas of soft made ground were encountered within the presence of perched groundwater, particularly during works undertaken adjacent to the canal as part of the initial mobilisation. Soft material was dosed with granulated lime (calcium oxide) at an approximate dose rate of 4-5% by weight.

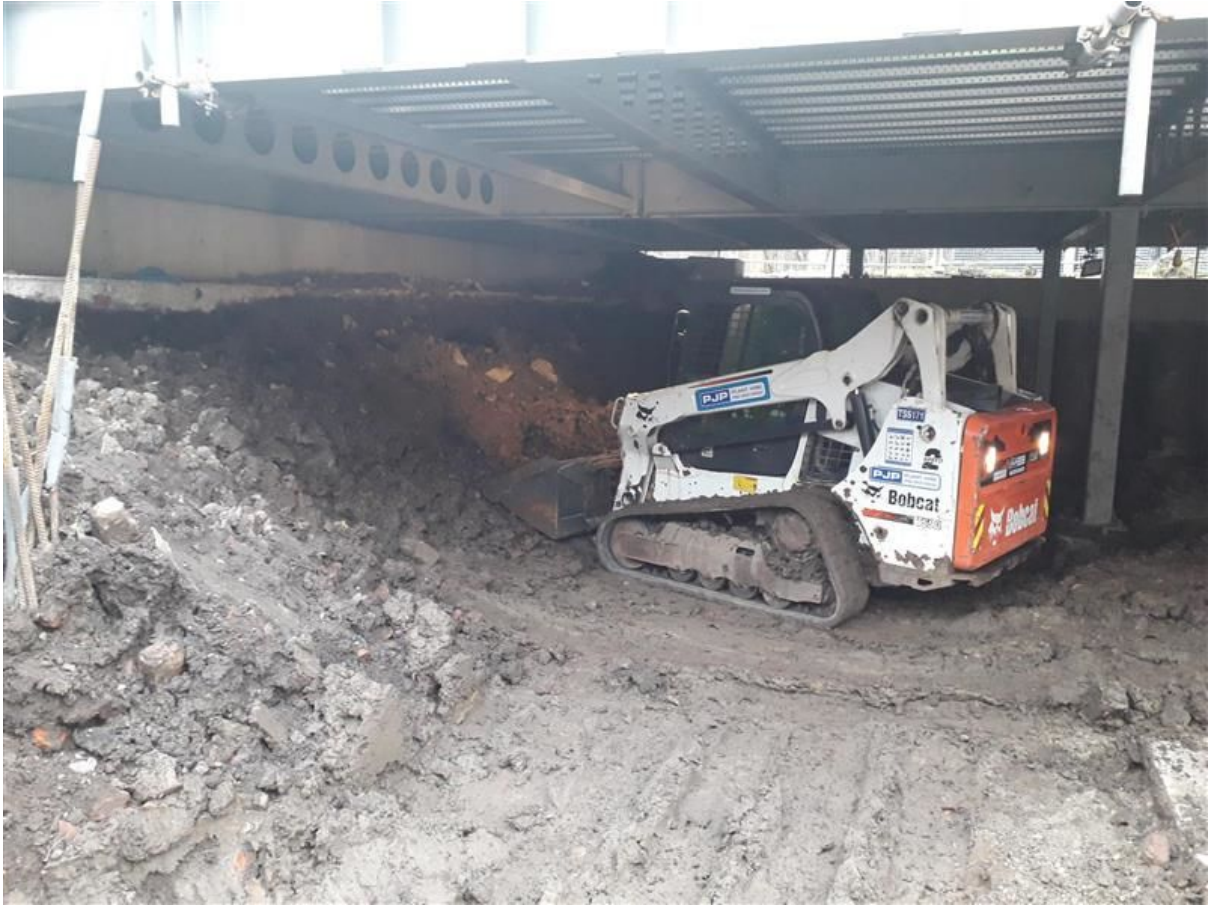
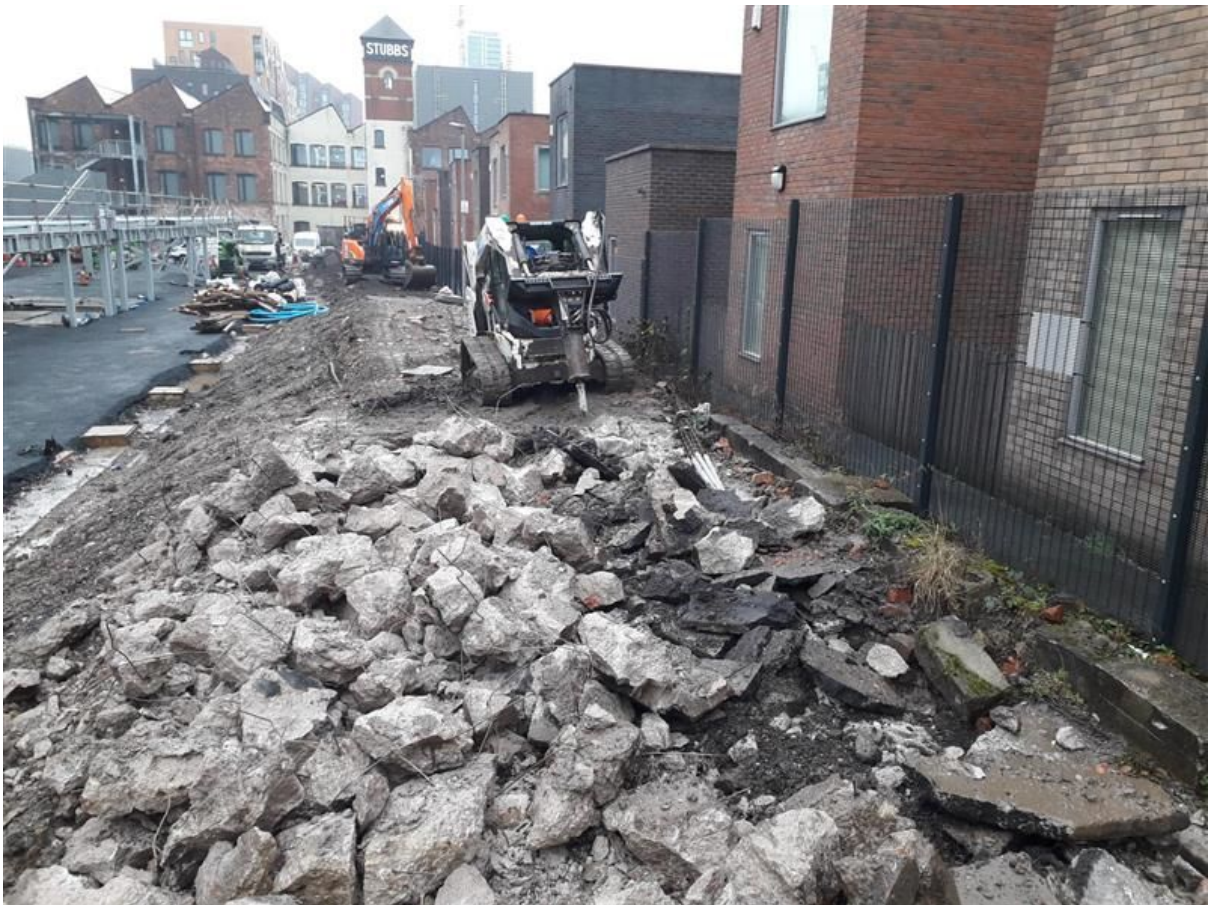
Removal of small area of concrete and retaining soil 'berm' during Mobilisation 3.

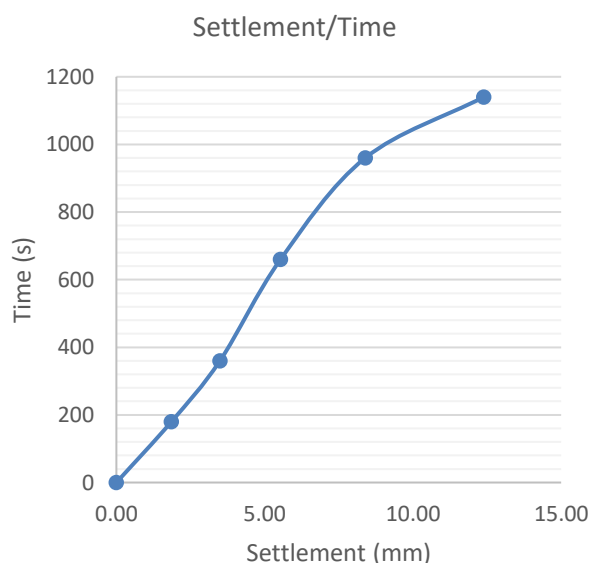
| Maximum Applied Stress (kPa): | 620 |
| Maximum Settlement (mm): | 12.39 |

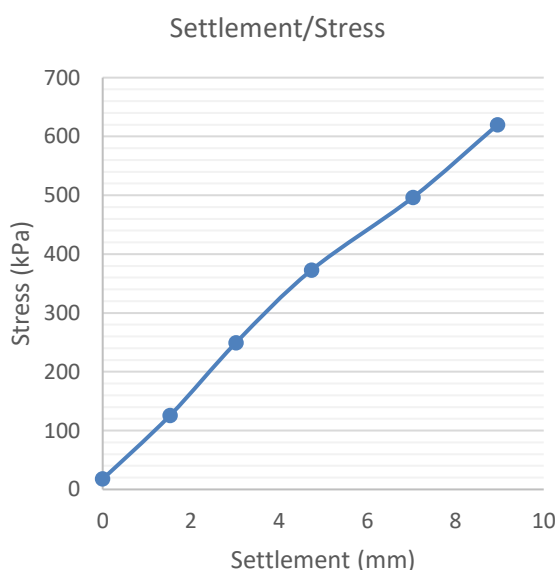
| Maximum Applied Stress (kPa): | 620 |
| Maximum Settlement (mm): | 8.95 |
