## Phase I GeoEnvironmental Desk Study

Mount Road  
Gorton

**197 -201 MOUNT ROAD  
GORTON**

**Report No. A4506/21**

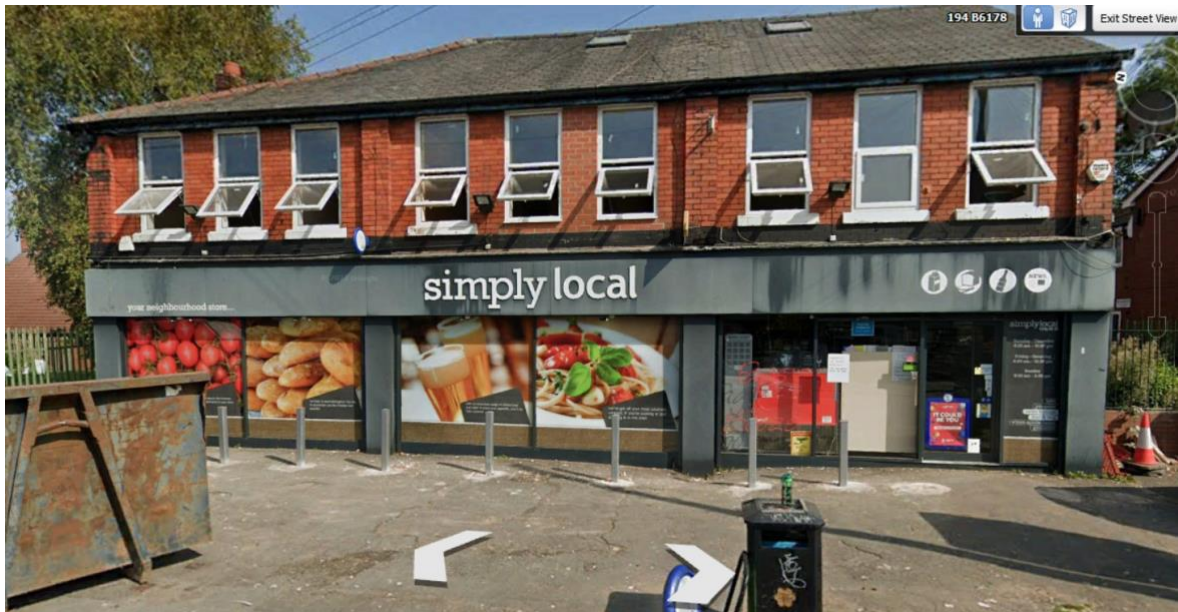
**Figure 3 Site Photograph**

- 2.5 A location plan is shown below as Figure 2, together with a recent site photograph as Figure 3 (overleaf).

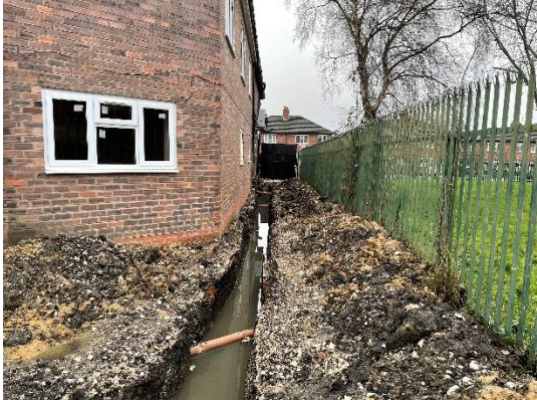
| <p><b>Plate 1 Access Route to the rear of building facing west</b></p> | <p><b>Plate 2 Area of ground to the south of the building on site facing west</b></p> |

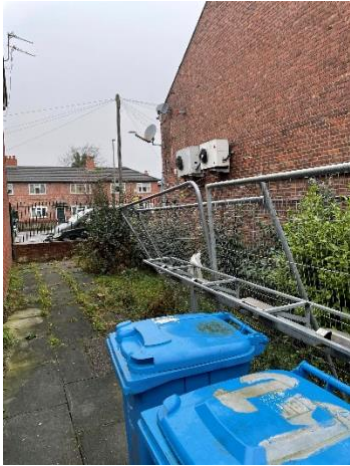
| Desk Study features checked during site visit | Feature and Information required | Present | Description / Comments |
|---|---|---|---|
| Ground Surface | <p>Are there areas of hardstanding and estimate the split between hard and soft cover? (If yes describe locations, types and conditions).</p> <p>Is there any evidence of any spillages or staining?</p> | <p><del>Yes</del>/No</p> <p><del>Yes</del>/No</p> | <p>All gravel cover</p> |

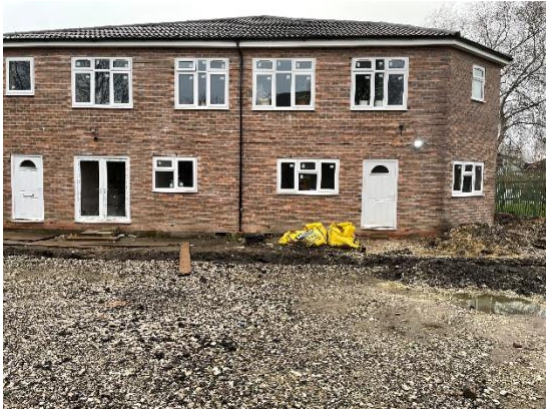
| <p><b>Plate 3 New extension to existing building from centre of site facing west</b></p> | <p><b>Plate 4 Viewing east from the rear of the building on site</b></p> |

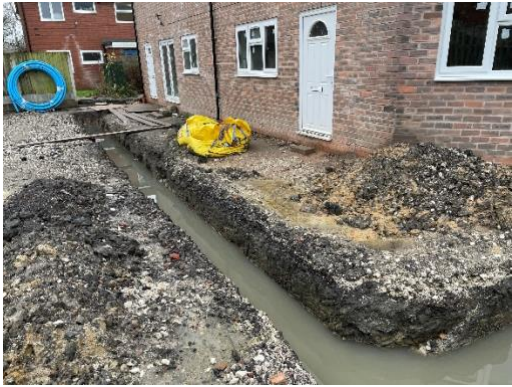
| <p><b>Plate 5 Facing south from the north boundary to rear of new extension</b></p> | <p><b>Plate 6 Front of the building looking north, showing access to site</b></p> |

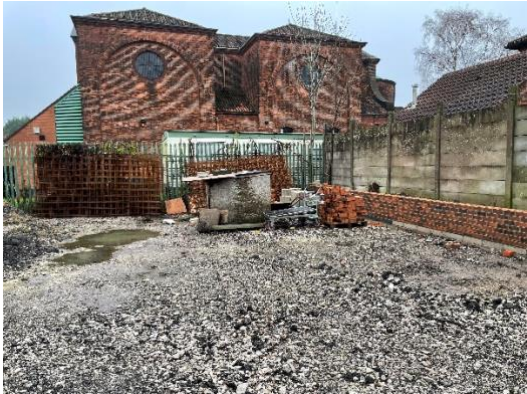
- 5.5 The site is on predominantly made ground however no contaminated material was noted.
- 5.6 The site is flat lying, gated and surrounded by palisade fencing (north side), prefab concrete fencing (south side) and wooden fencing (east side).

| <p><b>Plate 7 North boundary of the site looking north</b></p> | <p><b>Plate 8 Northeast corner of the site looking southwest</b></p> |
