# Heyrod Street

## Remediation Strategy

Curtins Ref: 075424-CUR-00-XX-RP-GE-003

Client Name: Packaged Living Limited

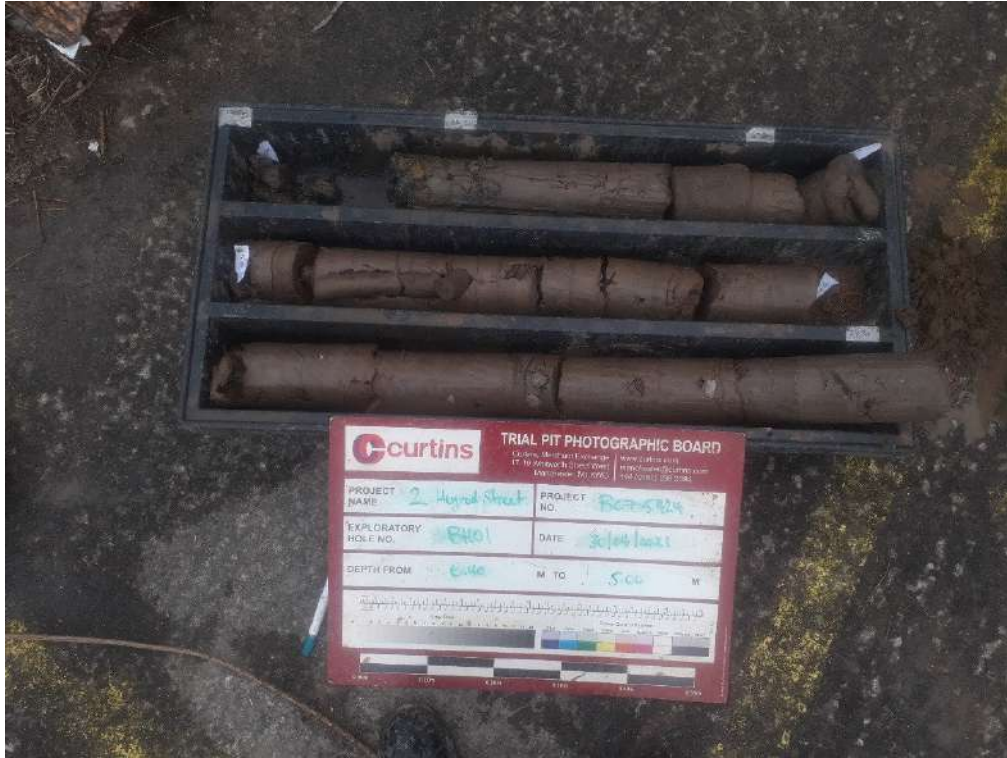
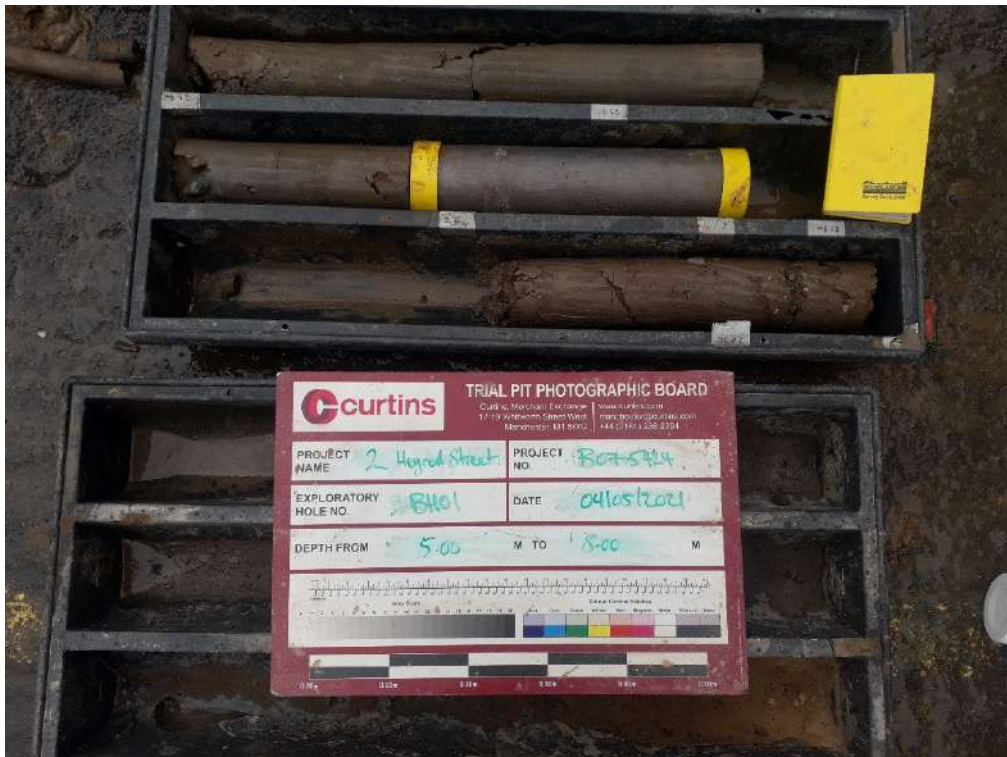
| <b>No.</b><br>1 | <b>Date:</b><br>30/04/2021 to<br>04/05/2021 | <b>Description:</b><br>BH01 Logging Photographs 0.40m to 8.00m bgl. | |

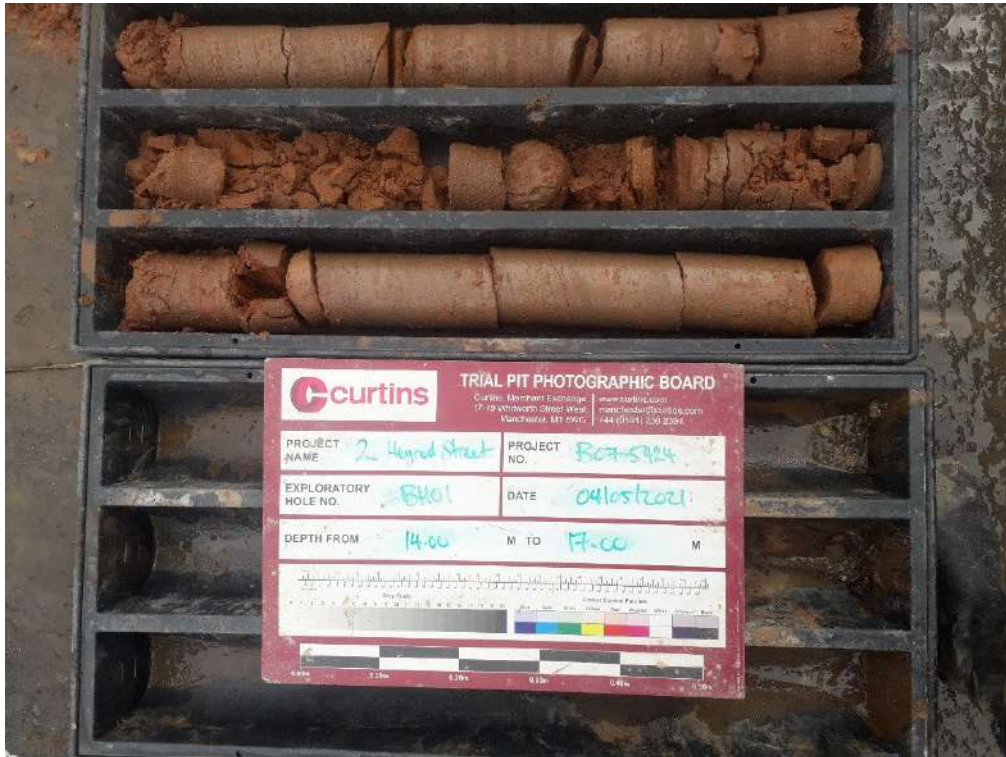
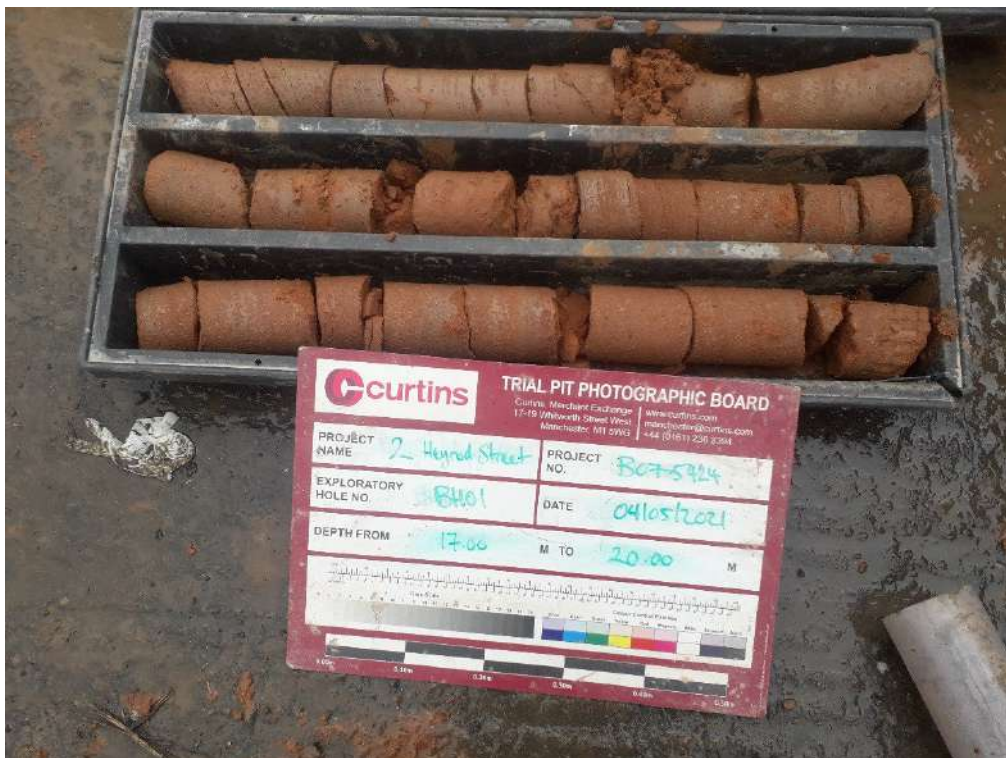
| <b>No.</b><br>3 | <b>Date:</b><br>04/05/2021 | <b>Description:</b><br>BH01 Logging Photographs 14.00m to 20.00m bgl. | |

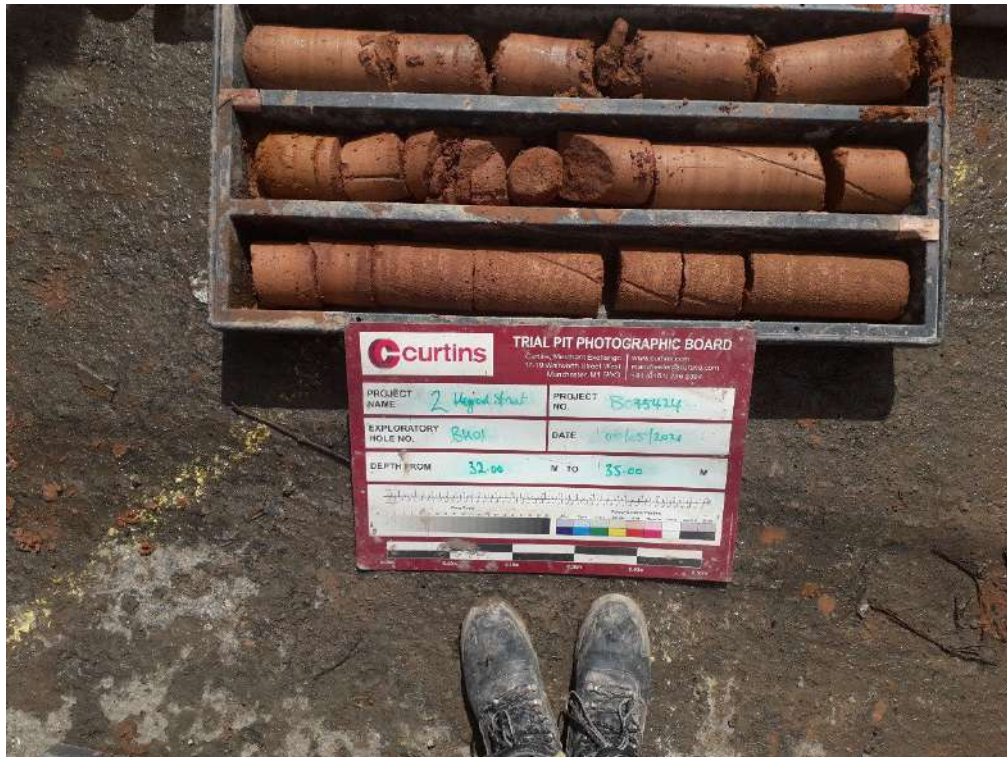
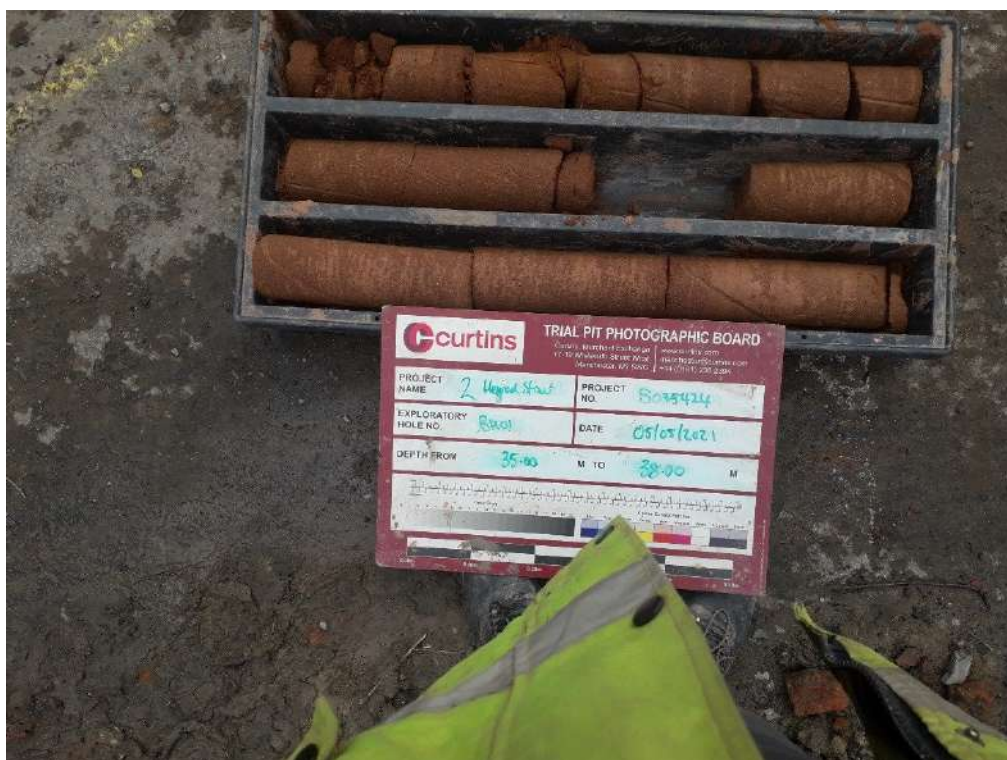
| <b>No.</b><br>6 | <b>Date:</b><br>05/05/2021 | <b>Description:</b><br>BH01 Logging Photographs 32.00m to 38.00m bgl. | |

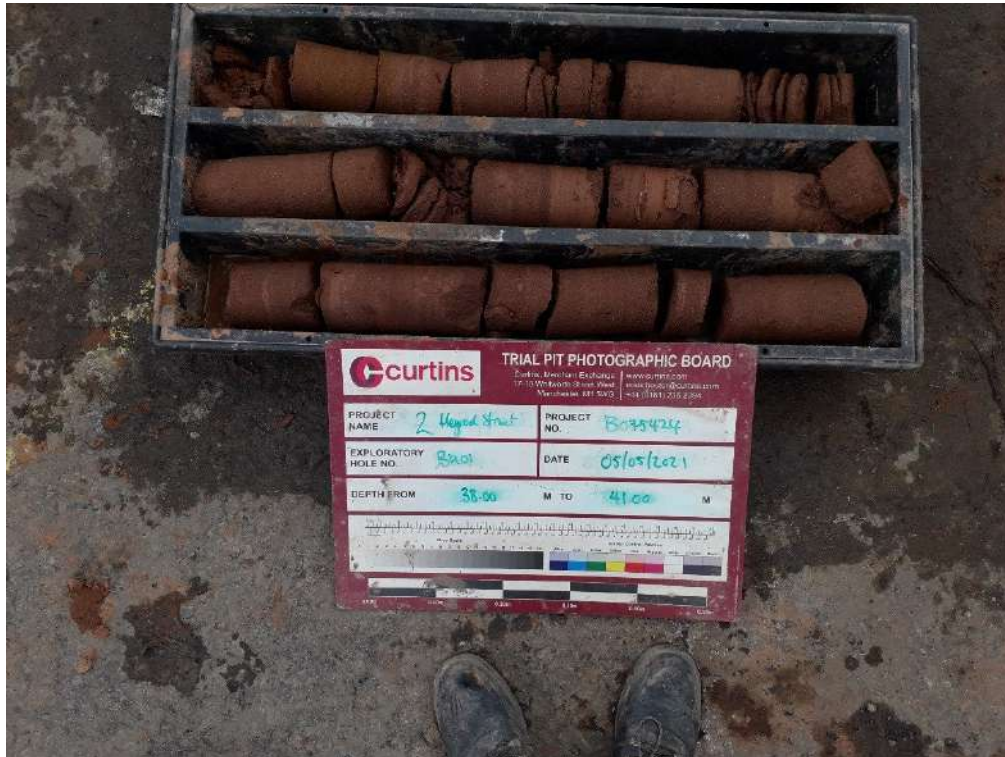
| <b>No.</b><br>7 | <b>Date:</b><br>05/05/2021 | <b>Description:</b><br>BH01 Logging Photographs 38.00m to 41.16m bgl. | |

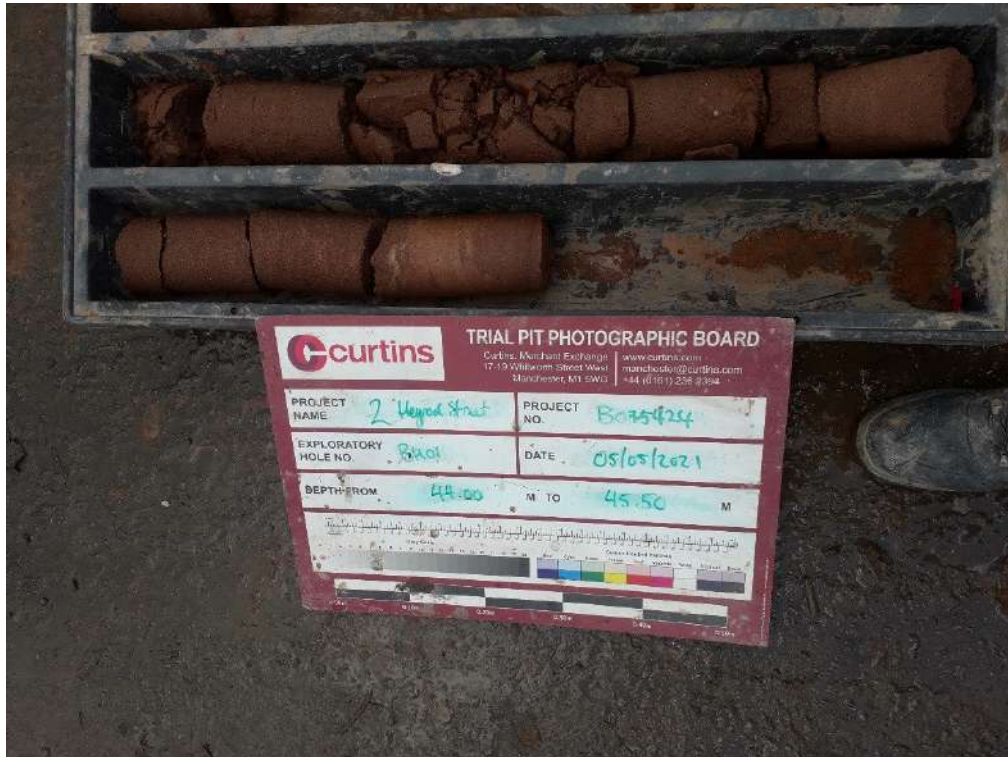
| <b>No.</b><br>7 | <b>Date:</b><br>05/05/2021 | <b>Description:</b><br>BH01 Logging Photographs 44.00m to 45.50m bgl. | |

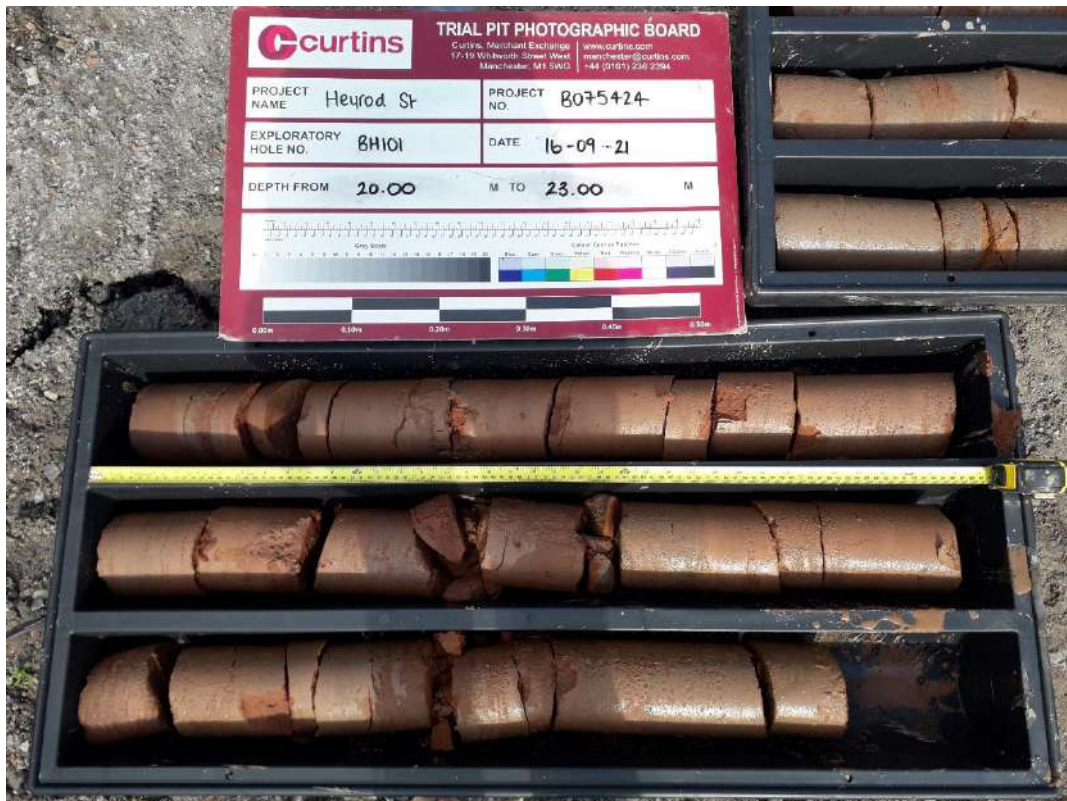
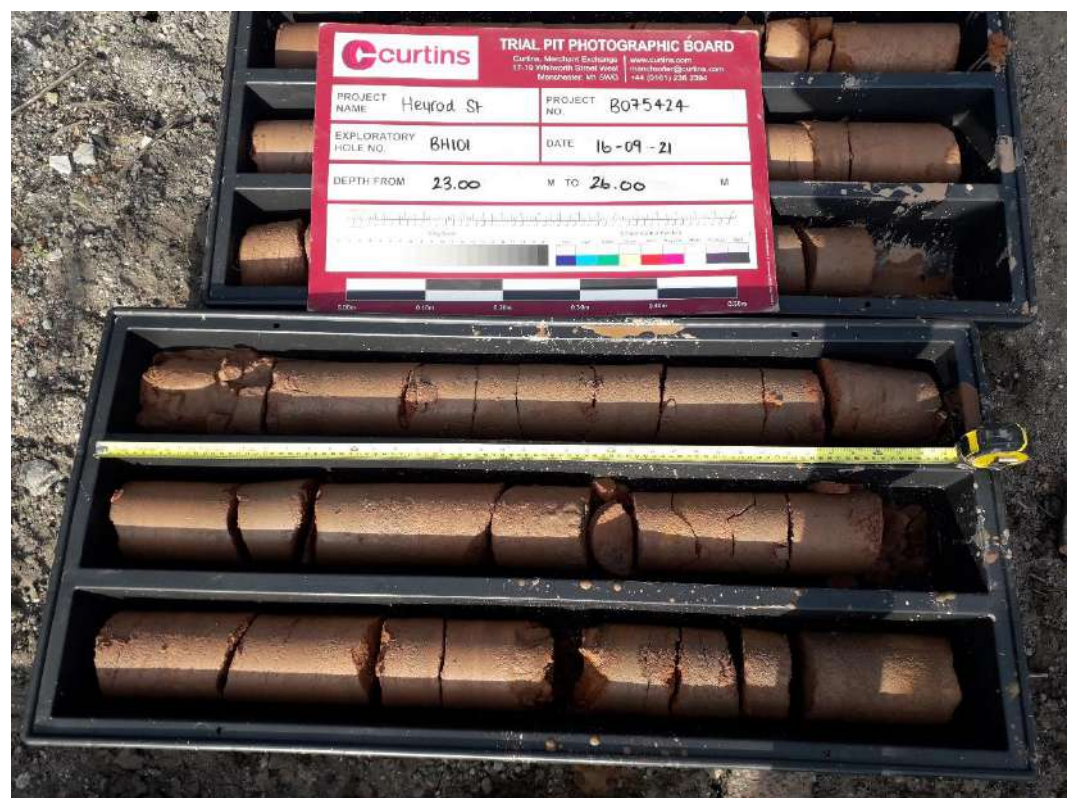
| <b>No.</b><br>2 | <b>Date:</b><br>01/02/2021 | <b>Description:</b><br>RH101 Rock Logging Photographs 20.00m to 26.00m bgl | |

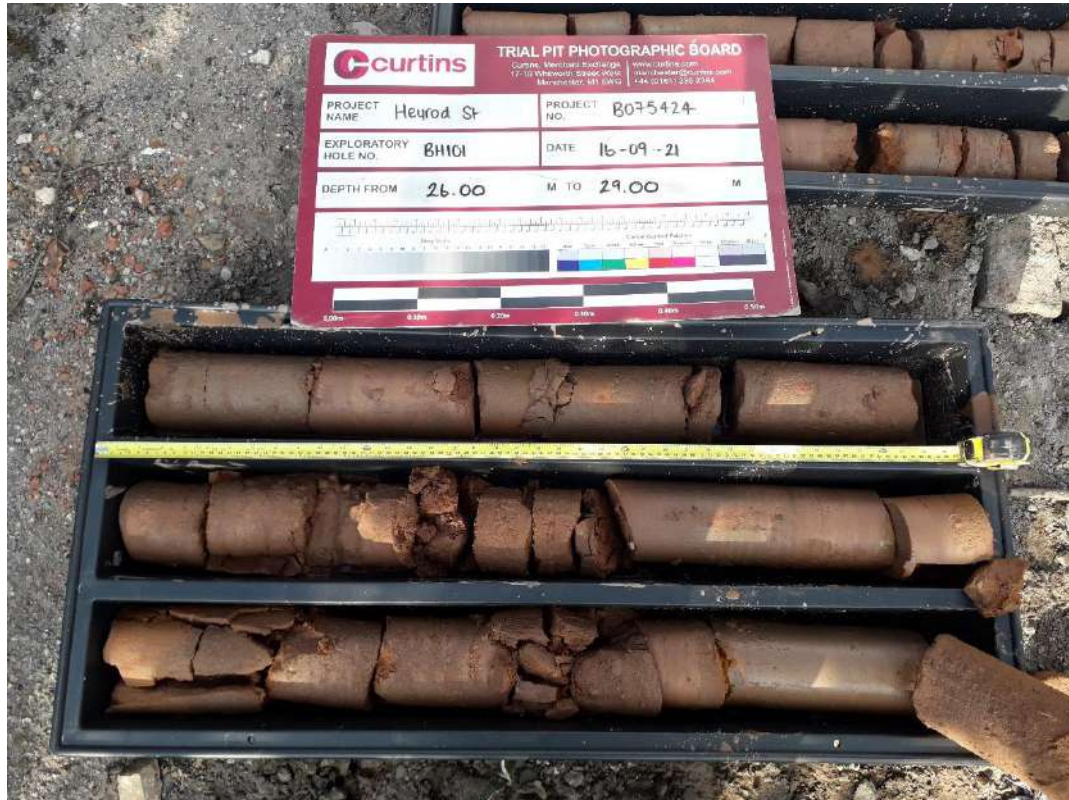
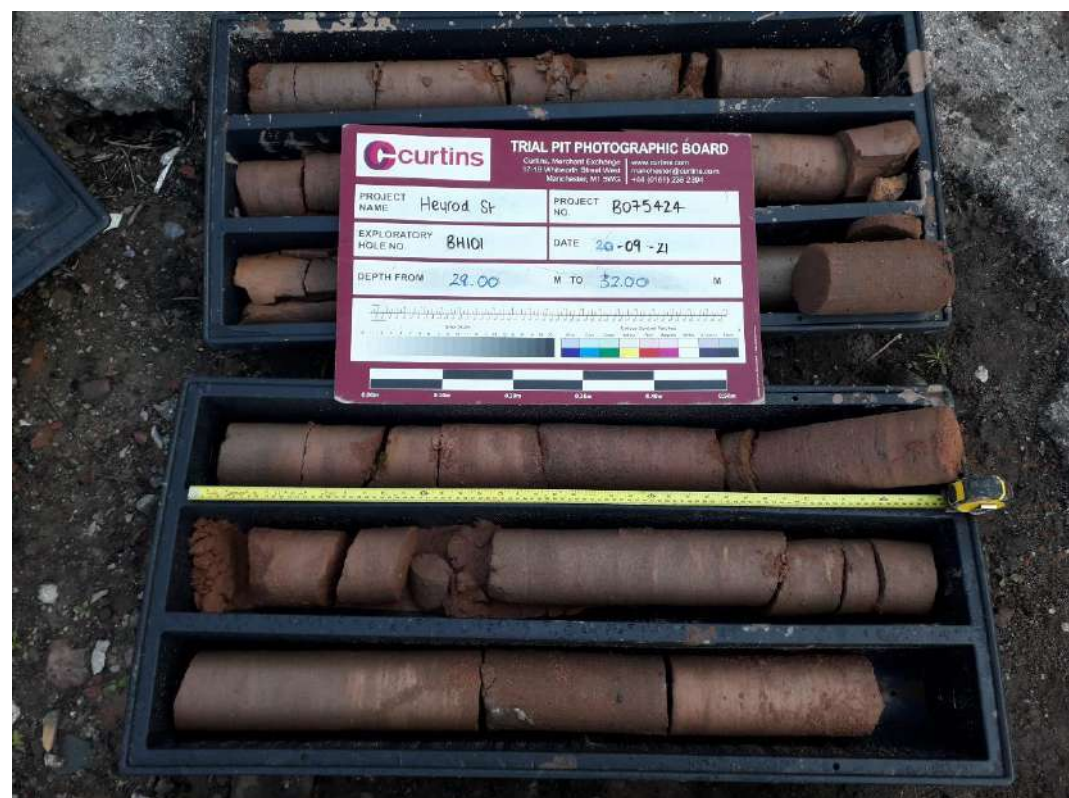
| <b>No.</b><br>3 | <b>Date:</b><br>16/09/2021 | <b>Description:</b><br>RH101 Rock Logging Photographs 26.00m to 32.00m bgl | |

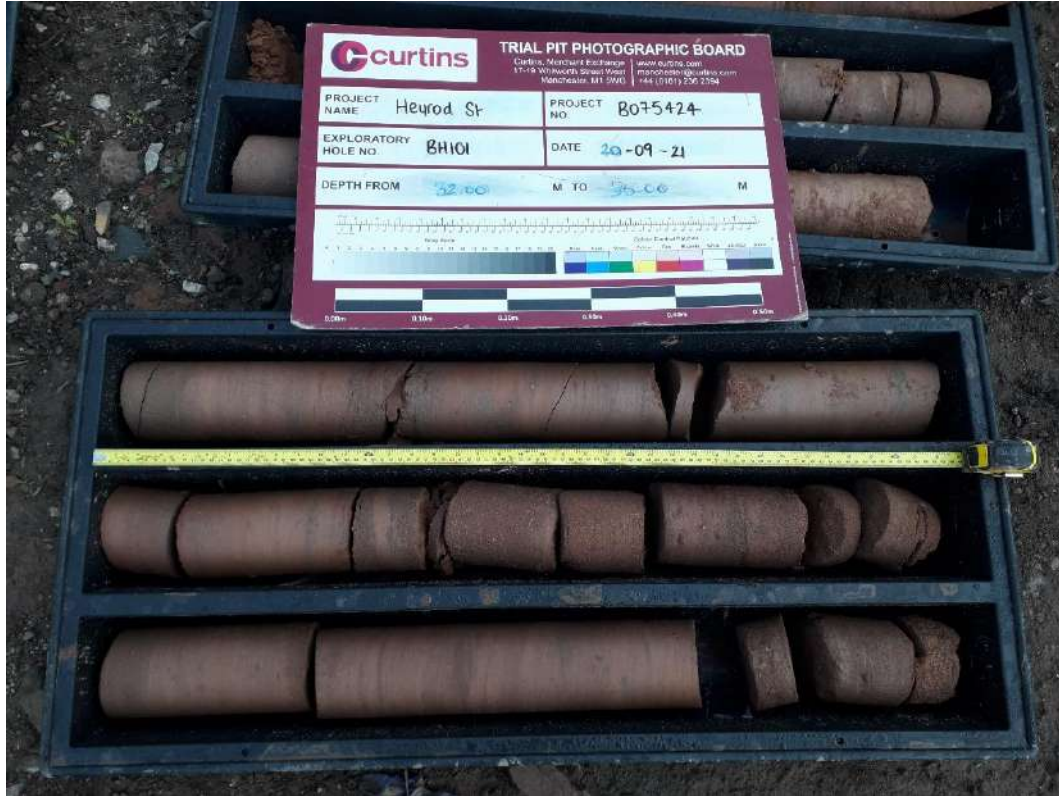
| <b>No.</b><br>4 | <b>Date:</b><br>20/09/2021 | <b>Description:</b><br>R-A2 Rock Logging Photographs 32.00m to 35.00m bgl | |

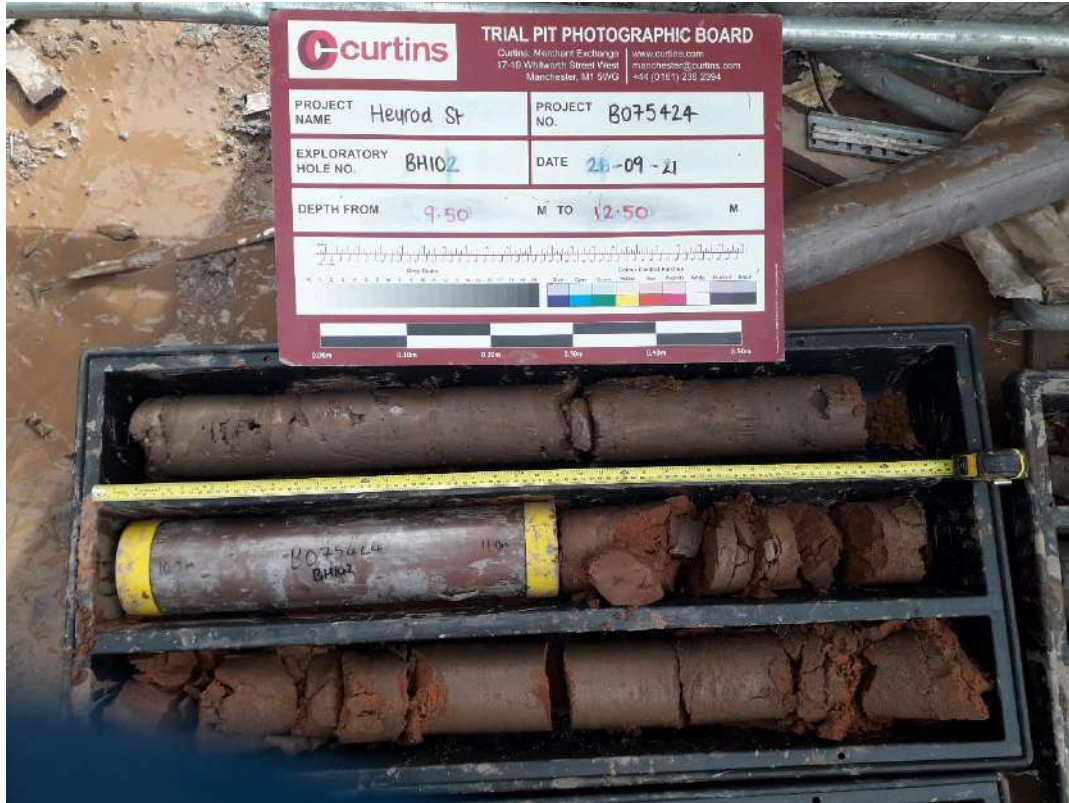
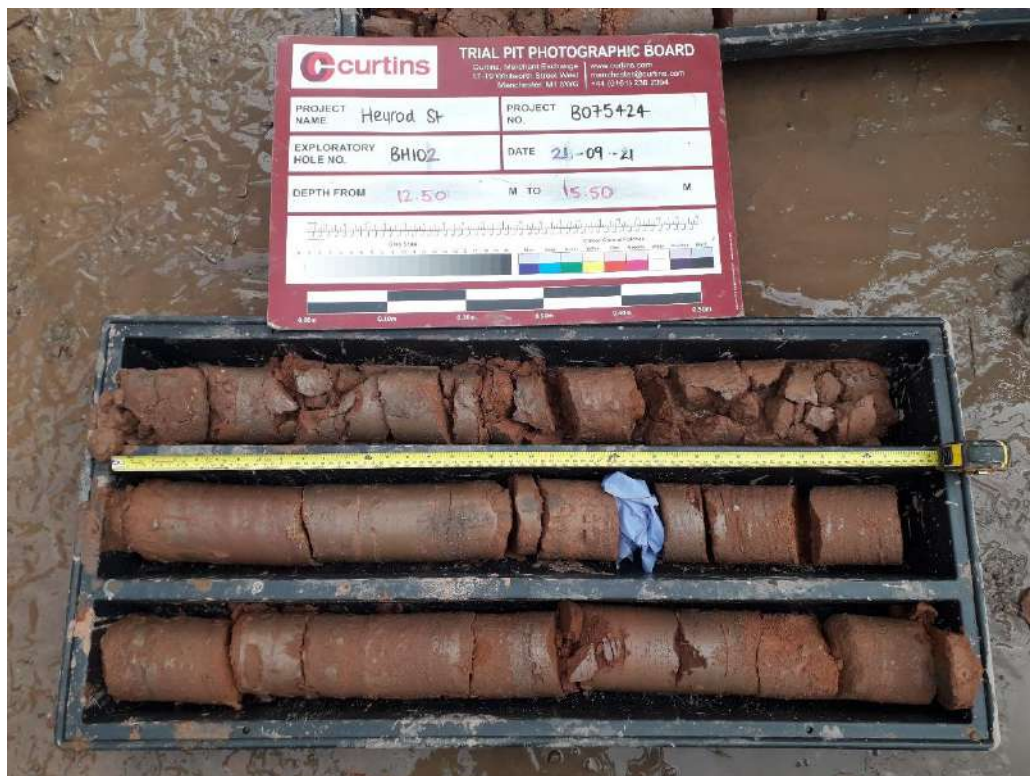
| <b>No.</b><br>5 | <b>Date:</b><br>21/09/2021 | <b>Description:</b><br>RH102 Rock Logging Photographs 9.50m to 15.50m bgl | |

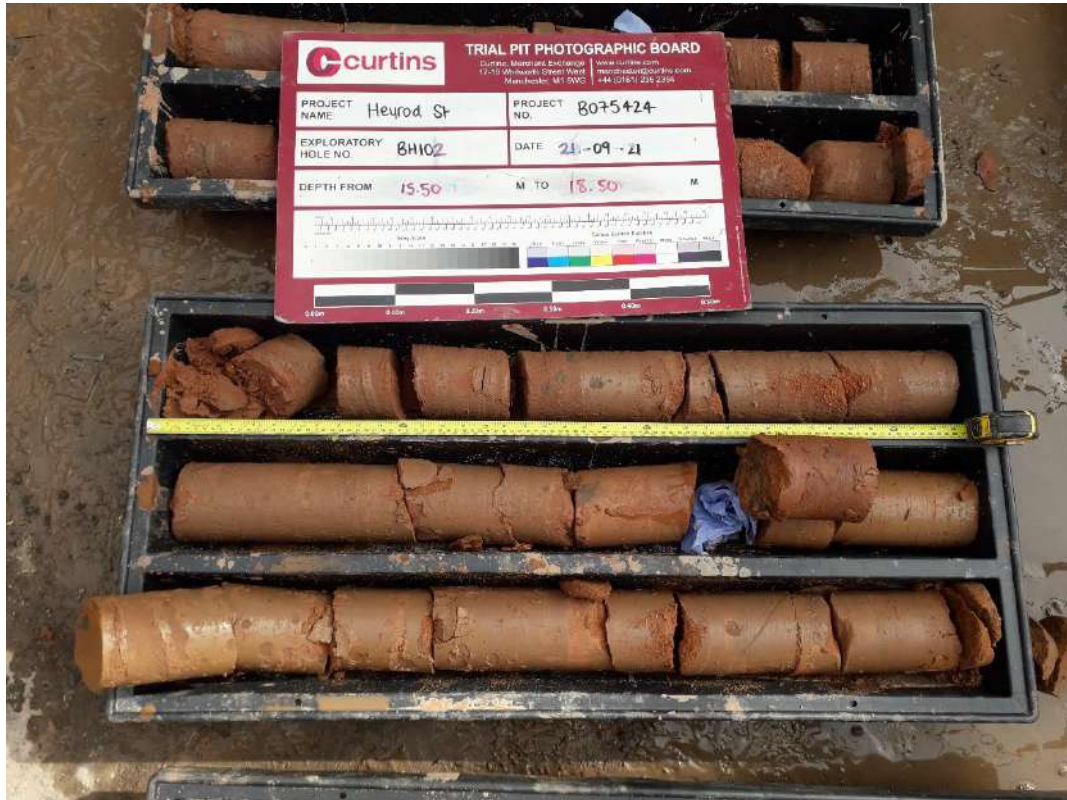
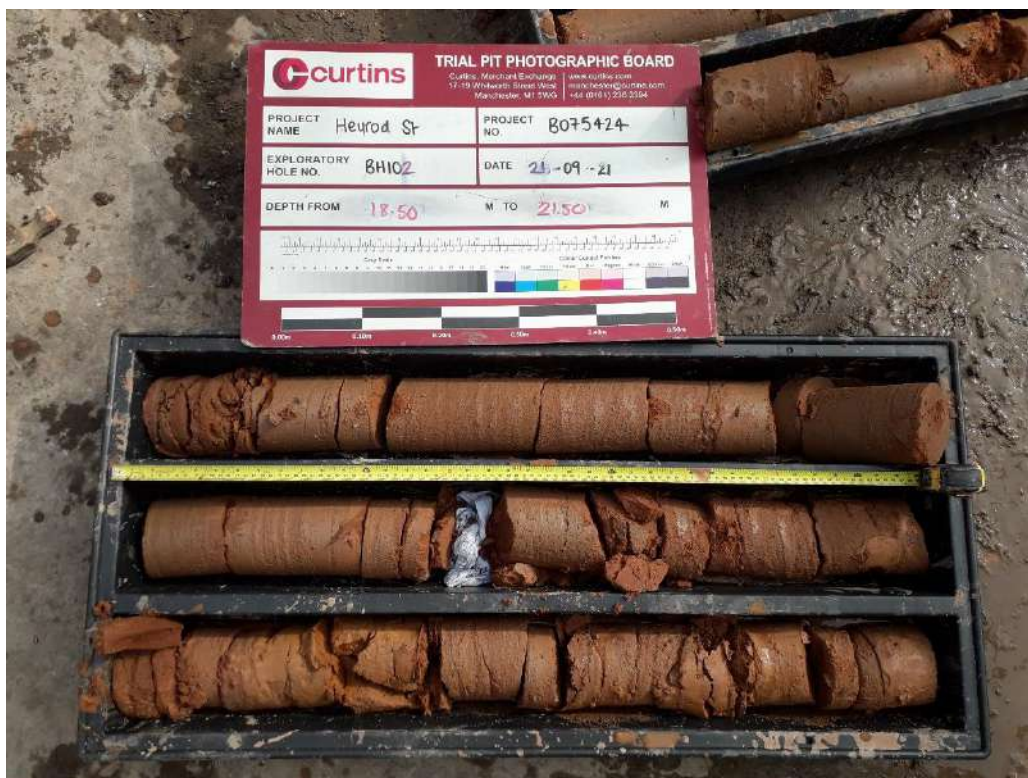
| <b>No.</b><br>6 | <b>Date:</b><br>21/09/2021 | <b>Description:</b><br>RH102 Rock Logging Photographs 15.50m to 21.50m bgl | |

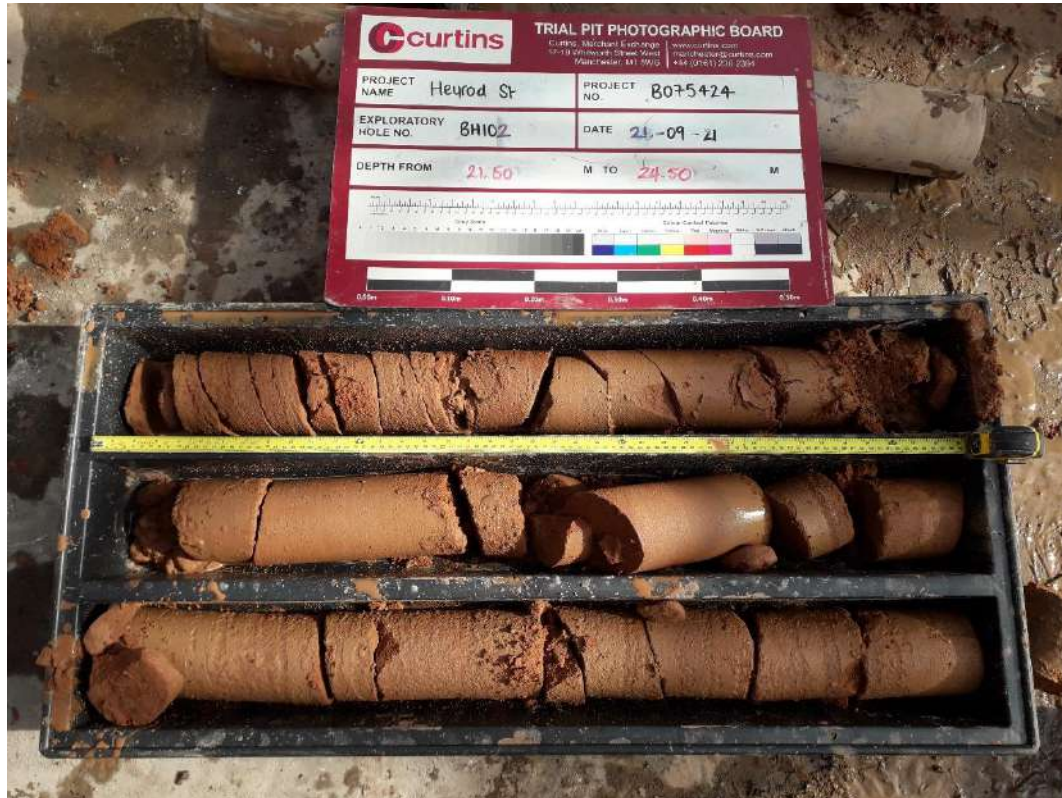
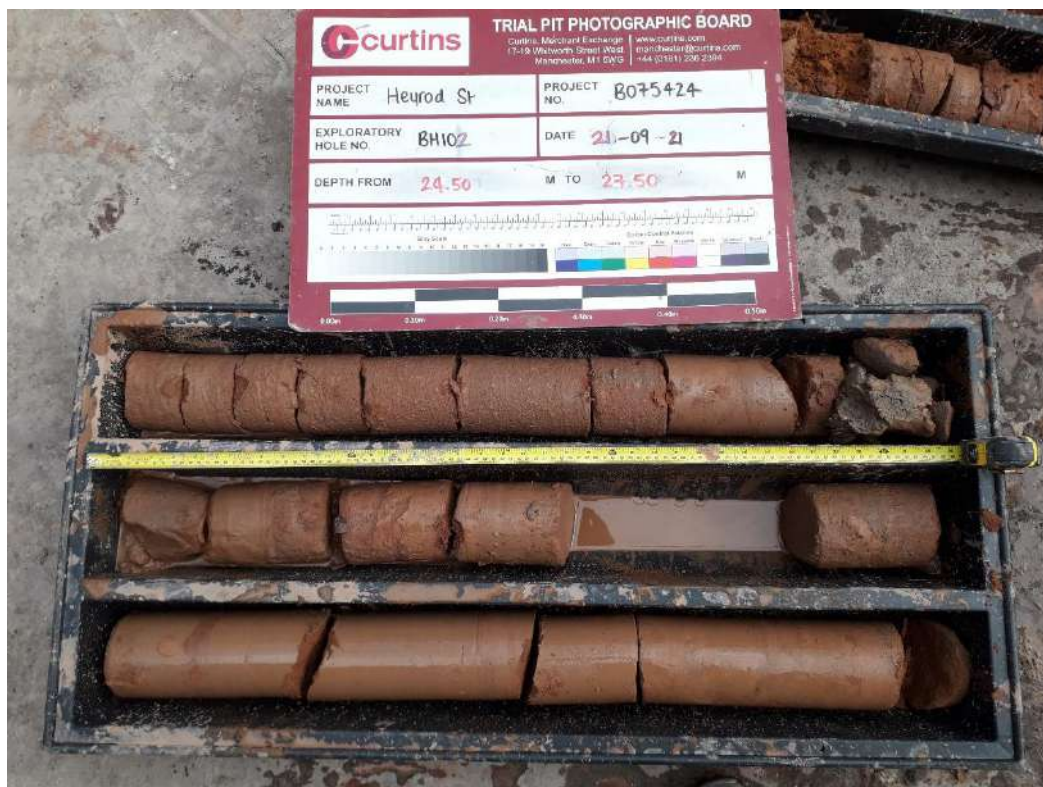
| <b>No.</b><br>7 | <b>Date:</b><br>21/09/2021 | <b>Description:</b><br>RH102 Rock Logging Photographs 21.50m to 27.50m bgl | |

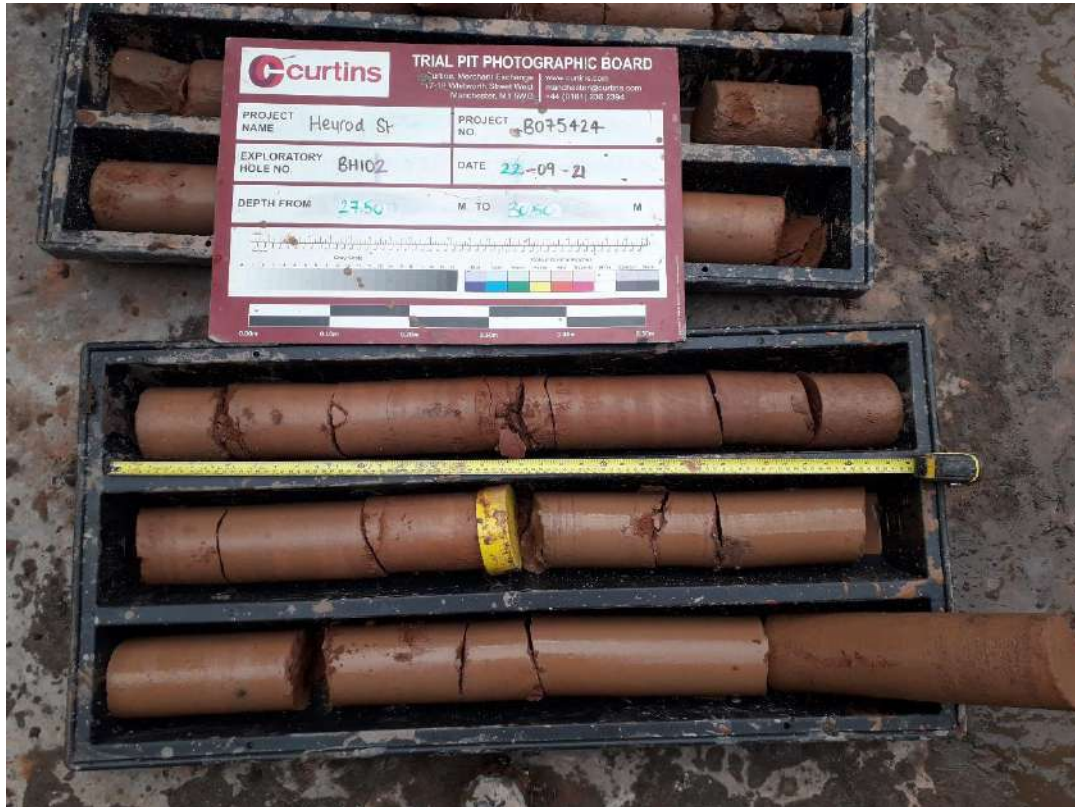
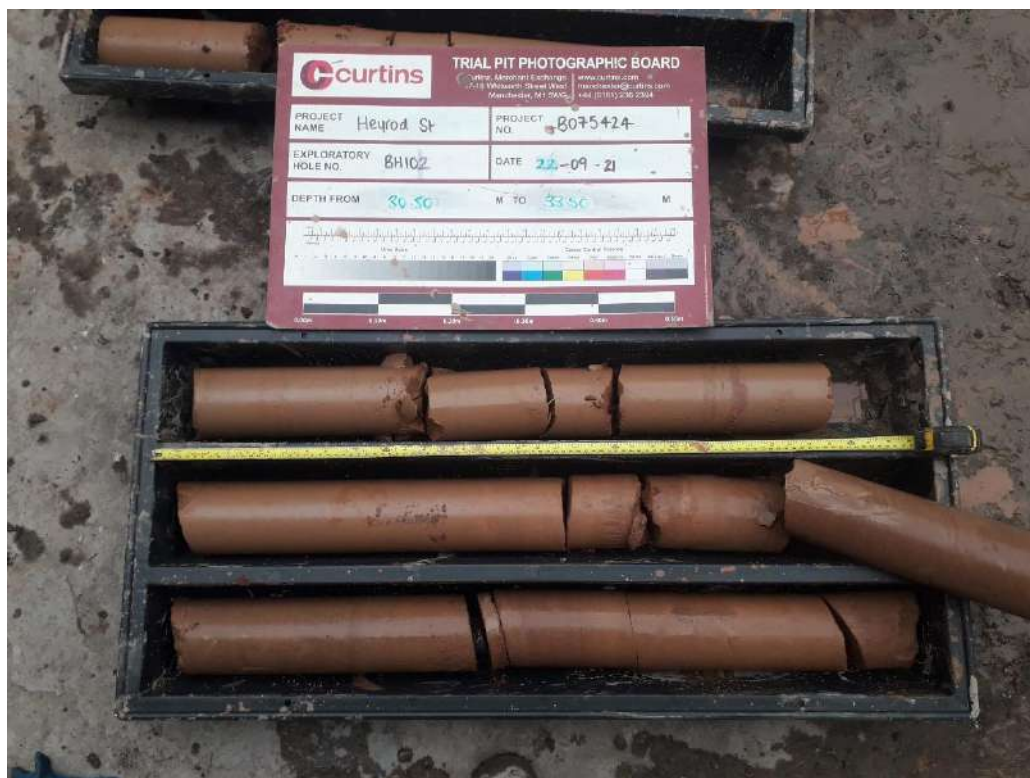
| <b>No.</b><br>8 | <b>Date:</b><br>22/09/2021 | <b>Description:</b><br>RH102 Rock Logging Photographs 27.50m to 33.50m bgl | |

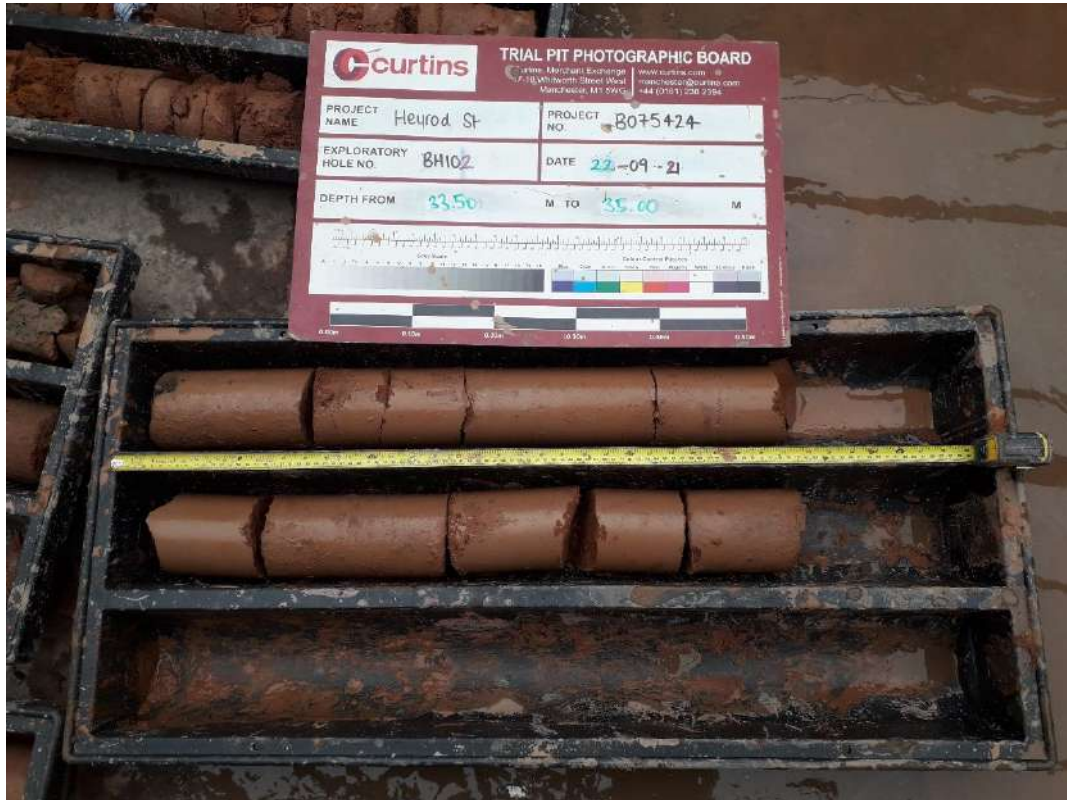
| <b>No.</b><br>9 | <b>Date:</b><br>22/09/2021 | <b>Description:</b><br>RH102 Rock Logging Photographs 33.50m to 35.00m bgl | |
