Phase I Geoenvironmental Site Assessment  
Renaissance, Manchester

Reference: 14-261-R1-1  
Date: September 2020

# PHASE I GEOENVIRONMENTAL SITE ASSESSMENT

Renaissance,  
Deansgate  
Manchester  
M3 2FE

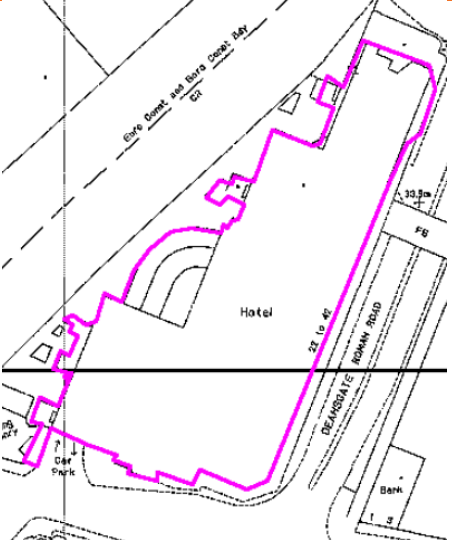
| MAP EDITION | HISTORICAL LAND USE | HISTORICAL MAP EXCERPT |
|---|---|---|
| <p>1992<br/>1:1,250</p> | <p>There are no significant changes recorded at the subject site.</p> | |

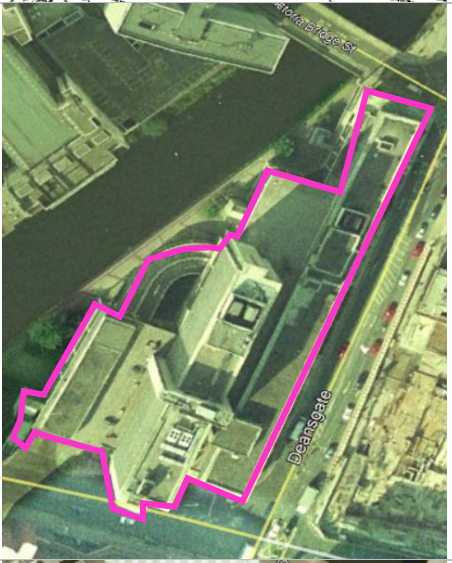
| MAP EDITION | HISTORICAL LAND USE | HISTORICAL MAP EXCERPT |
|---|---|---|
| <p>Google Earth<br/>2000</p> | <p>There are no significant changes recorded at the subject site.</p> | |

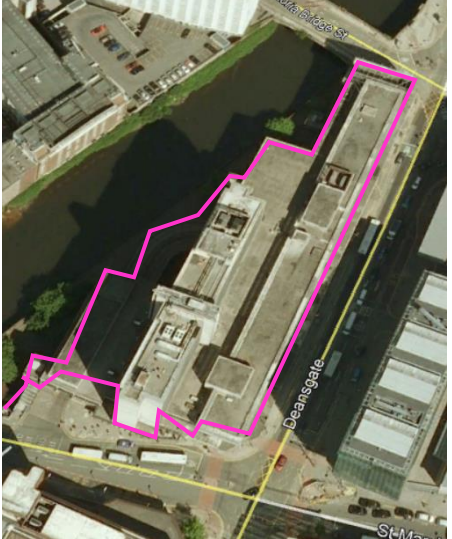
| MAP EDITION | HISTORICAL LAND USE | HISTORICAL MAP EXCERPT |
|---|---|---|
| <p>Google Earth<br/>2009</p> | <p>There are no significant changes recorded at the subject site.</p> | |

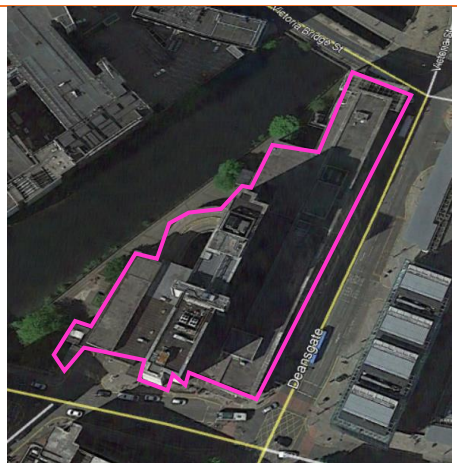
| MAP EDITION | HISTORICAL LAND USE | HISTORICAL MAP EXCERPT |
|---|---|---|
| Google Earth<br>2019 | There are no significant changes recorded at the subject site. | |

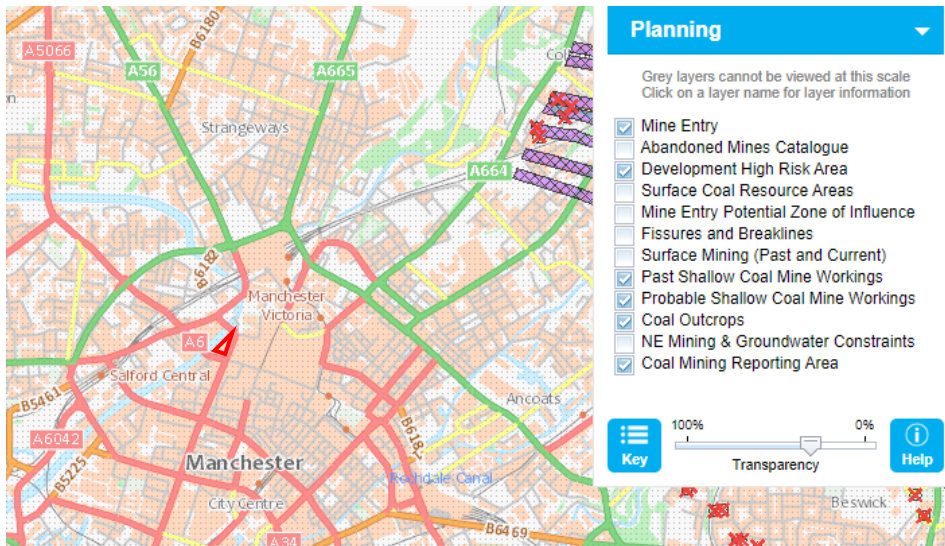
| SOURCES OF INFORMATION | SUMMARY |
|---|---|
| Coal Authority Interactive Map | <p>The site is not situated within a development high risk area. There are no mine entries recorded within 500m of the site boundary. There are also no past shallow coal mine workings or probable shallow coal mine workings or coal outcrops within 500m of the site boundary.</p> |

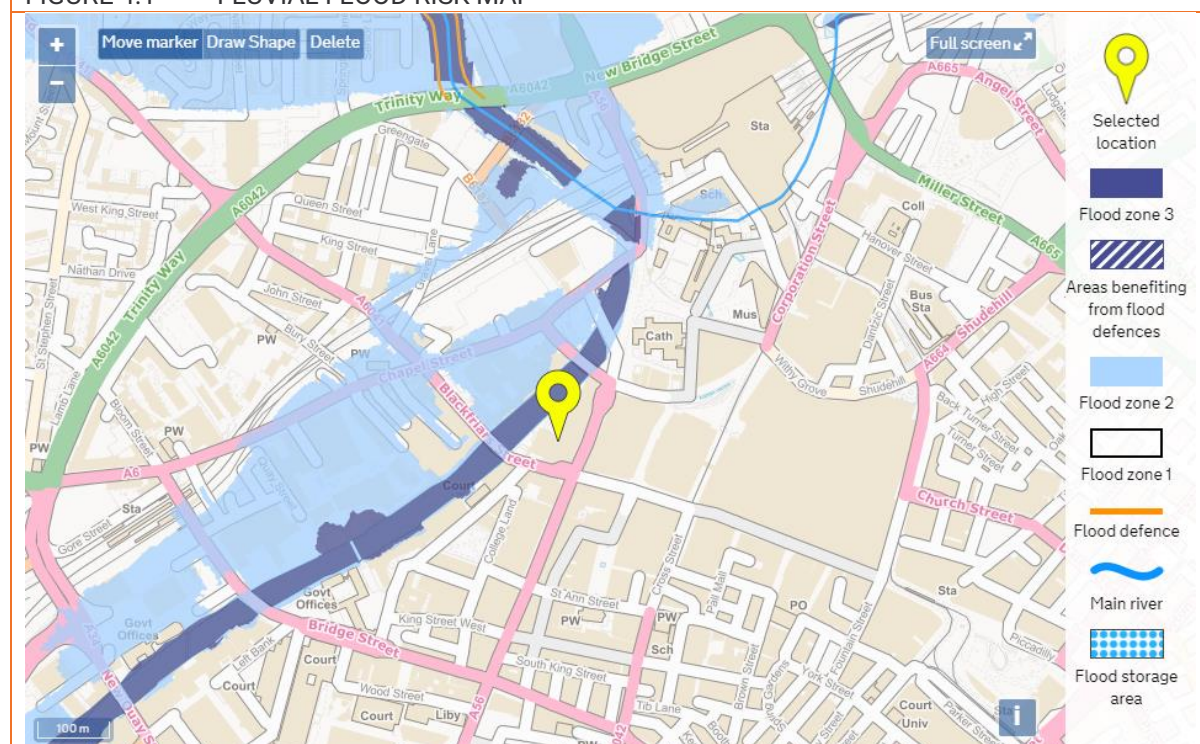
FIGURE 4.1 FLUVIAL FLOOD RISK MAP

The Fluvial Flood Risk Map is presented in Figure 4.1.

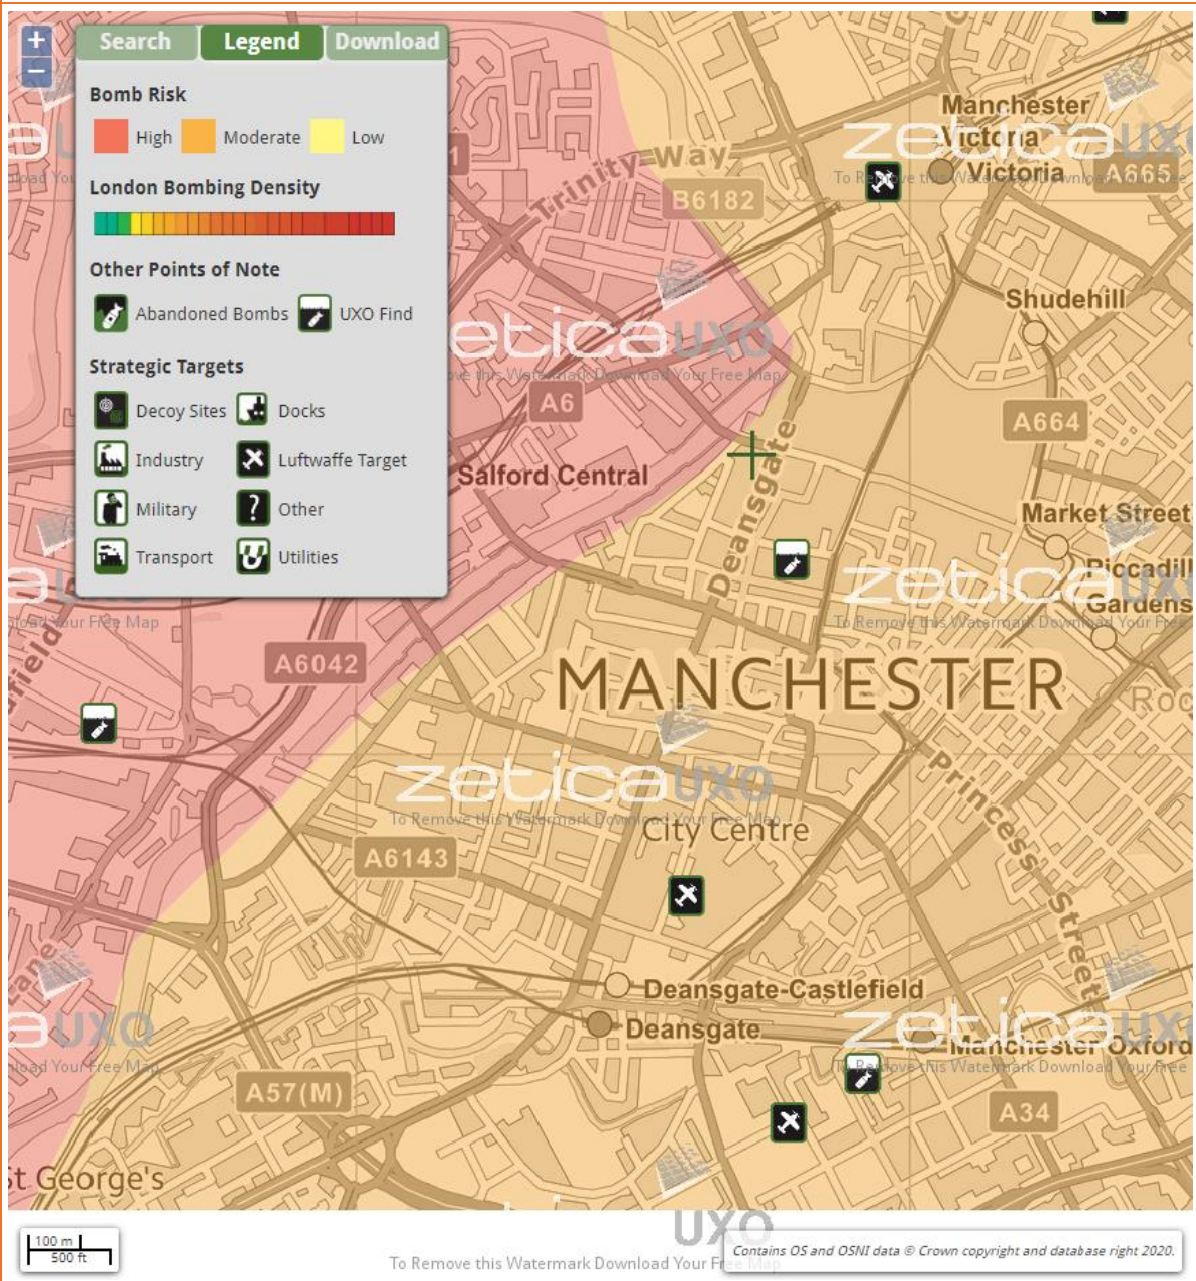
FIGURE 4.2 ZETICA UXO RISKS MAP

As the western boundary of the site is within the high-risk area, it is recommended that further detailed assessments are carried out to establish the level of risk and the potential need for mitigation.
