# The Island Site, Manchester

## Phase 2 Ground Investigation

Curtins Ref: 070298-CUR-00-XX-RP-GE-003

Issue Date: 07 October 2021

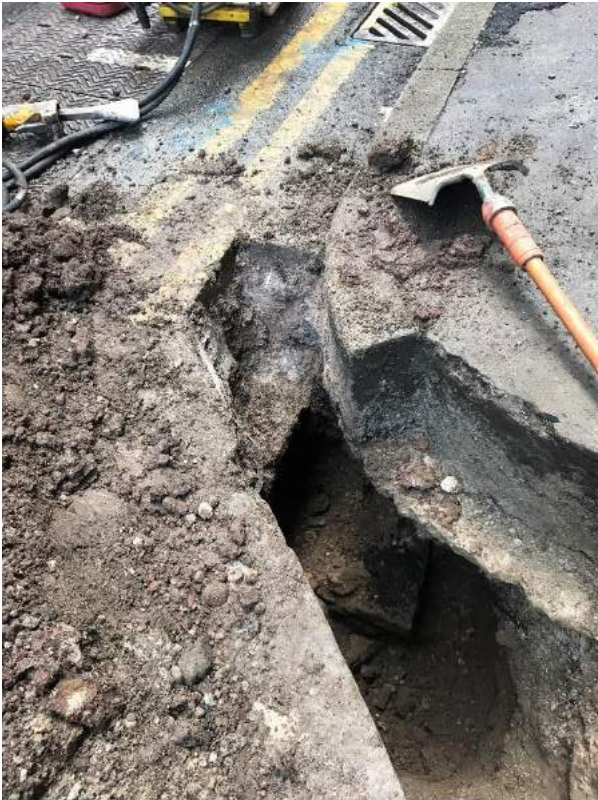
Curb to the south – facing South

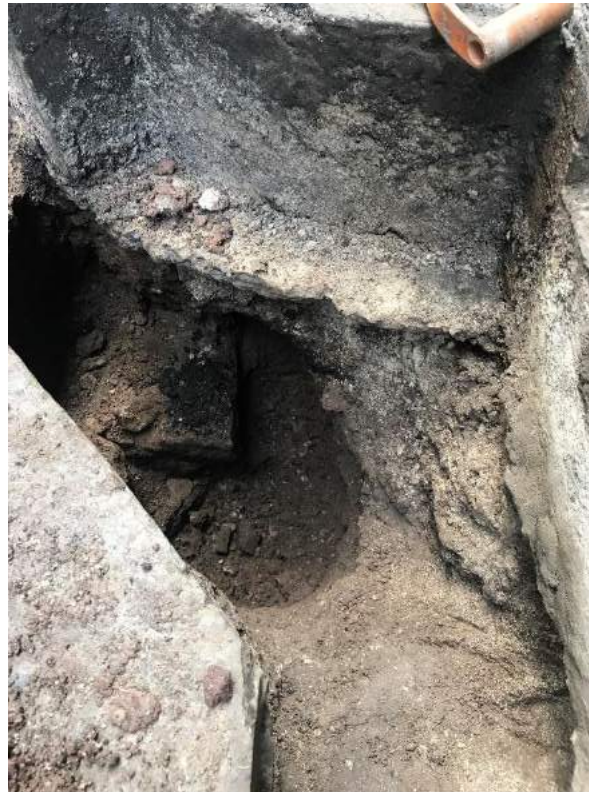
Southern curb section showing section excavated to 1.40 m – facing South

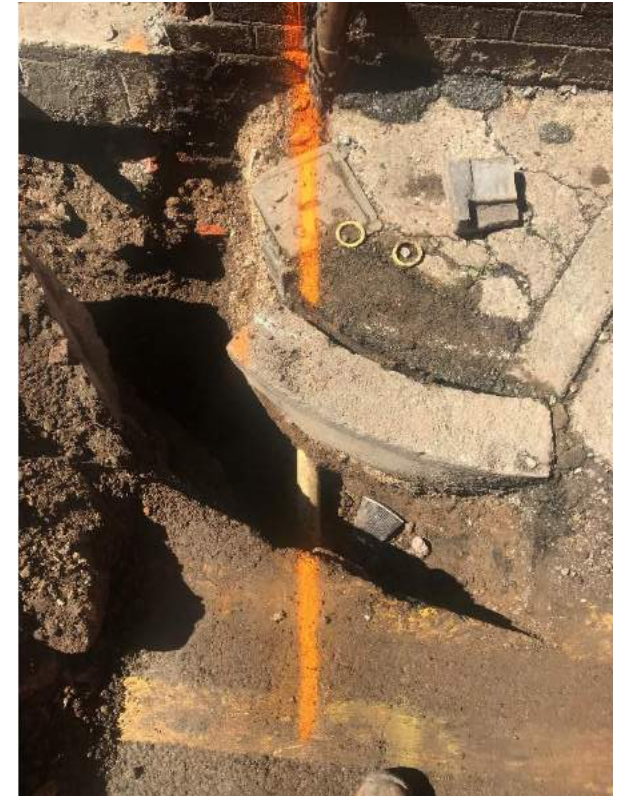
Curb to the north with gas pipe – facing West

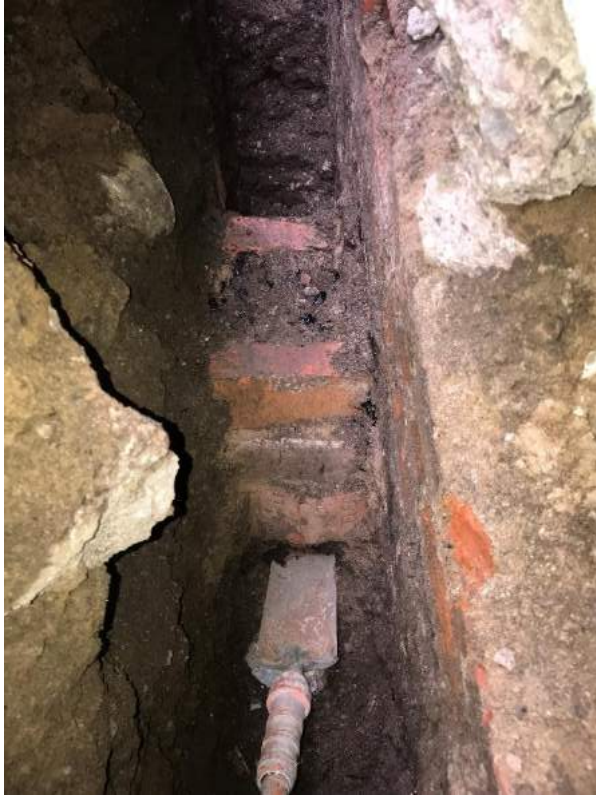
In-situ bricks encasing services – facing South

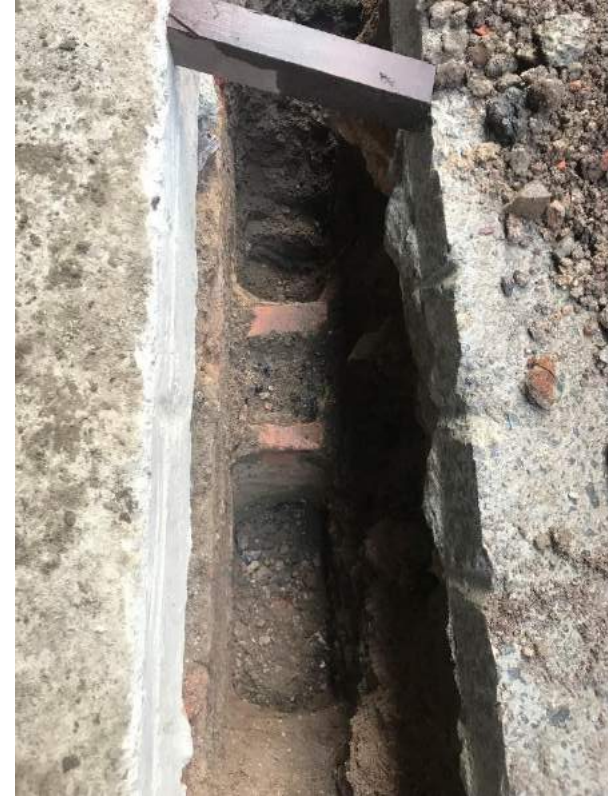
In-situ bricks encasing services – facing North

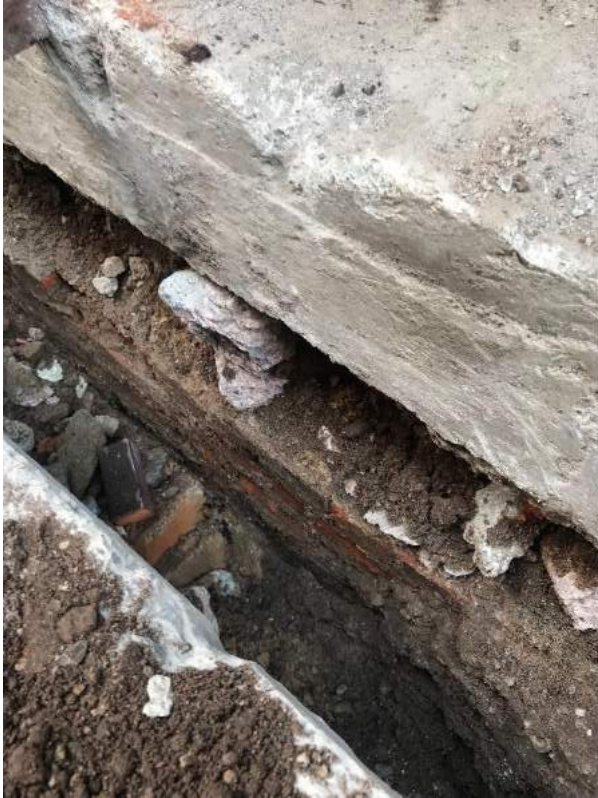
West wall of trench – facing West

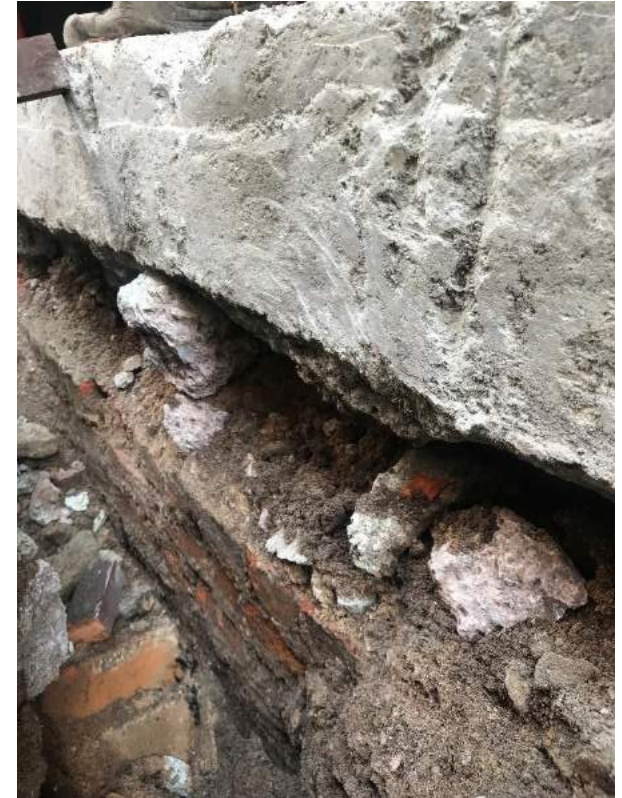
West wall of trench – facing West
