Preliminary Roost Assessment and Bat Survey Report  
Rochdale Road, Manchester

Reference: 80-394-R1-2  
Date: February 2021

Prepared for:  
**Portwood Developments Limited**

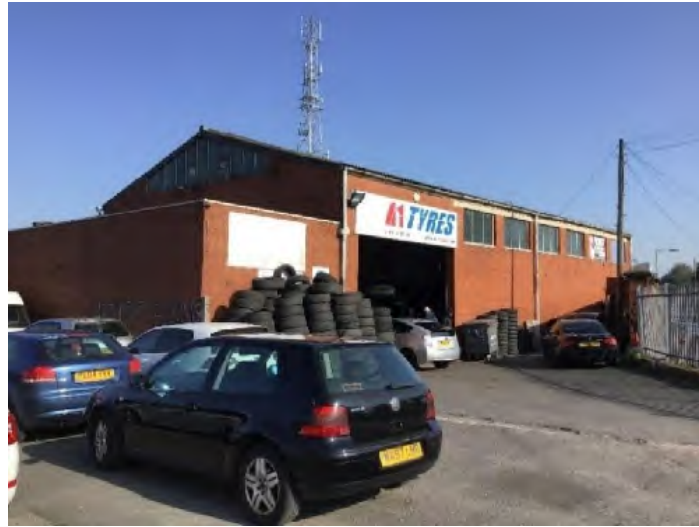
PLATE 1      SHOWING B1

Building 1 (B1) was a red brick, two storey warehouse building actively used as a tyre repair shop.

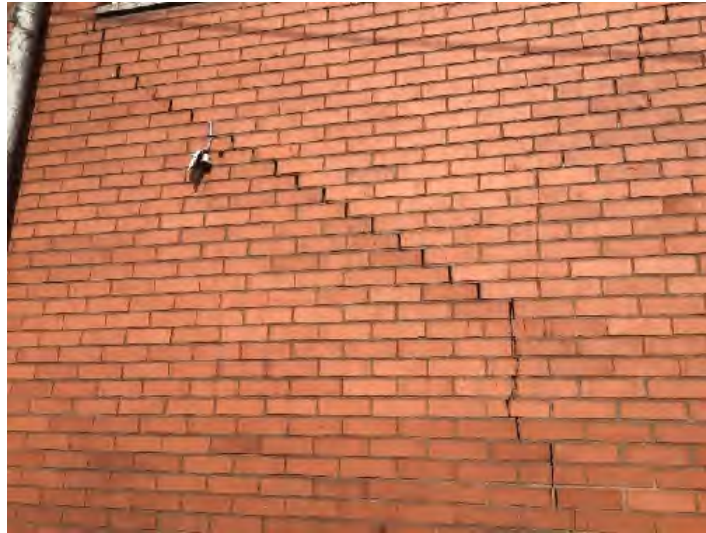
PLATE 3      SHOWING MOVEMENT CRACKS ON EXTERIOR WALLS

Movement cracks were present in the exterior brickwork, which may provide roosting opportunities for crevice dwelling bat species on an occasional basis.

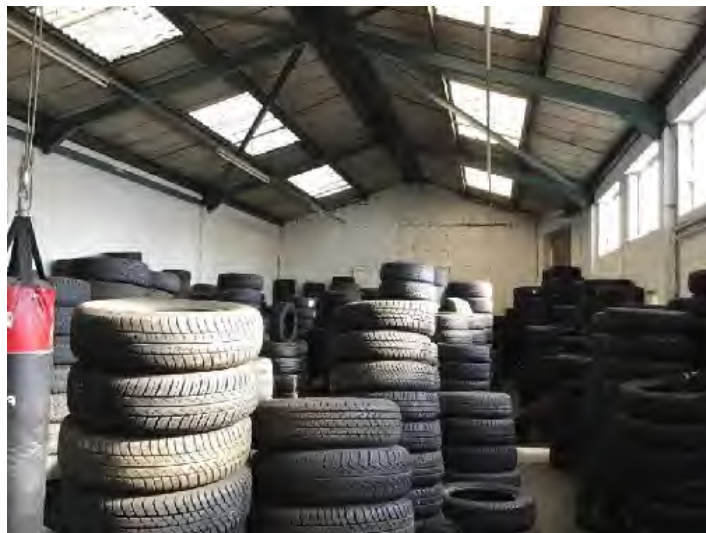
PLATE 4      SHOWING B1 INTERNALLY

Internally, B1 was constructed of exposed breeze block walls with an exposed asbestos sheeting ceiling, with no loft void present. Skylights were present allowing light into the building, reducing its suitability for bat roosting.

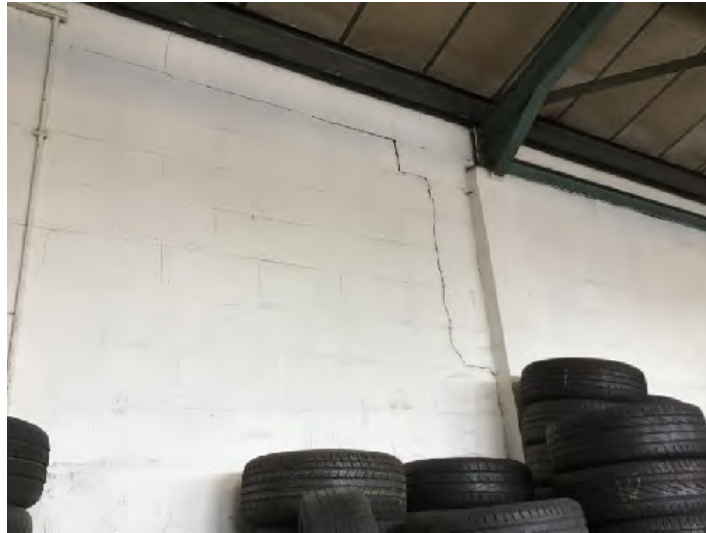
PLATE 5      SHOWING MOVEMENT CRACKS ON INTERIOR WALLS

The internal walls were mainly found to be in a good condition; however, some movement cracks were identified.

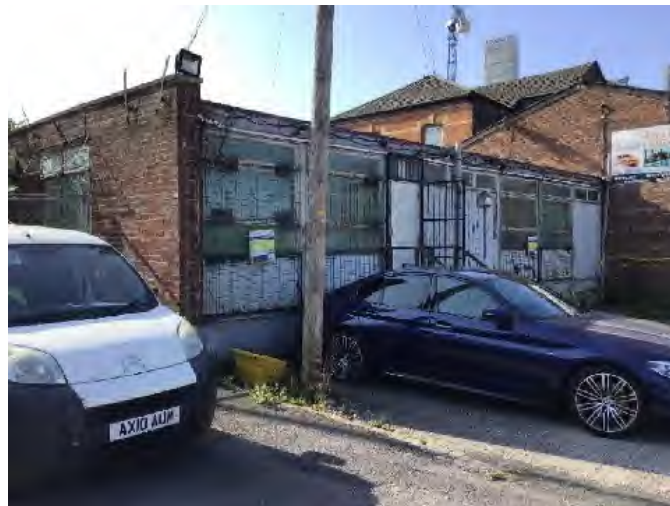
PLATE 6      SHOWING B2

Building 2 (B2) was a red brick and wooden cladding single storey office cabin, with a flat roofing felt roof.

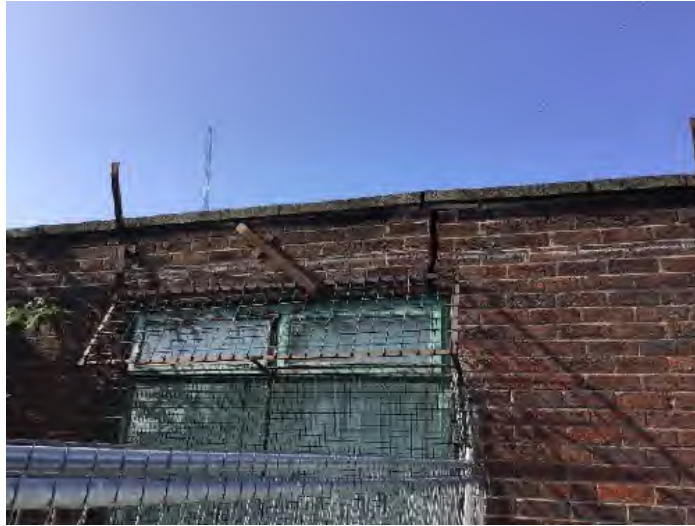
PLATE 7      SHOWING CREVICE AROUND WINDOW

A large crevice was identified surrounding a window on the eastern aspect of B2, which may have roosting opportunities for crevice dwelling bats on an occasional basis.

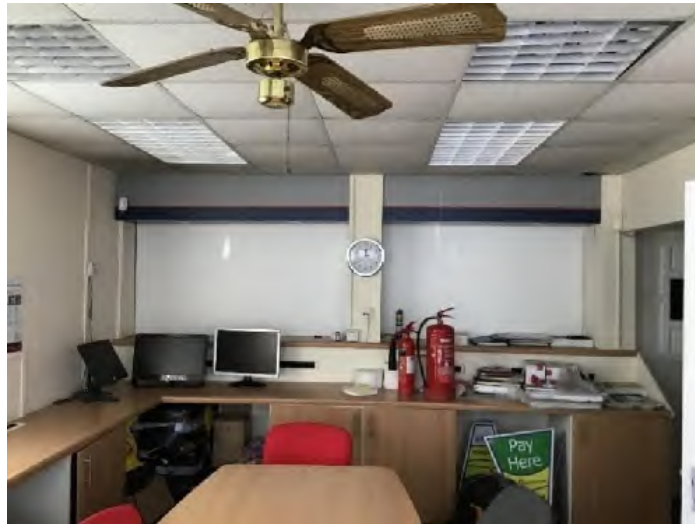
PLATE 8      SHOWING B2 INTERNALLY

Internally, B2 appeared to be a disused office, with a hung ceiling. No potential roosting features were identified internally.

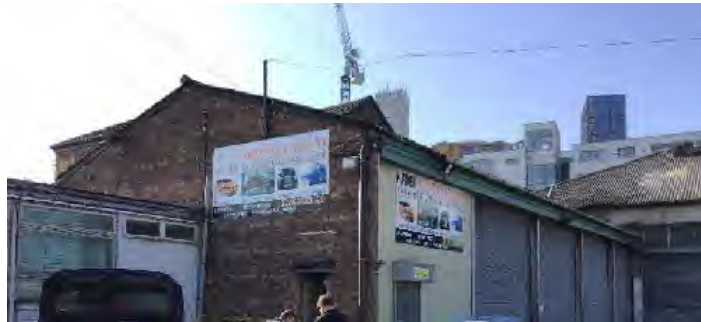
PLATE 9      SHOWING B3

B3 was a two-storey red brick warehouse with roller shutter doors present along the northern aspect of the building.

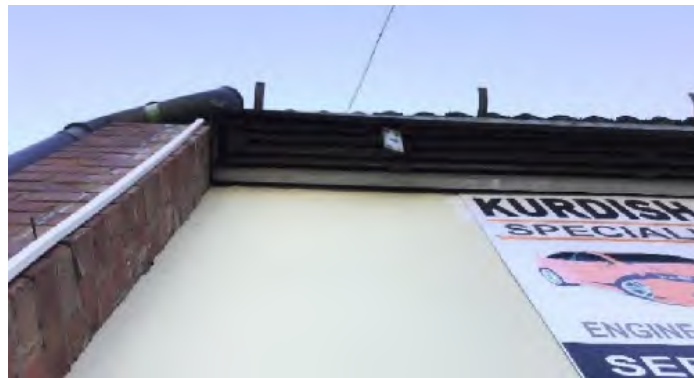
PLATE 10      SHOWING WOODEN PANELLING

Wooden panelling was present above the roller shutter doors, creating roosting opportunities for crevice dwelling bat species, on an occasional basis.

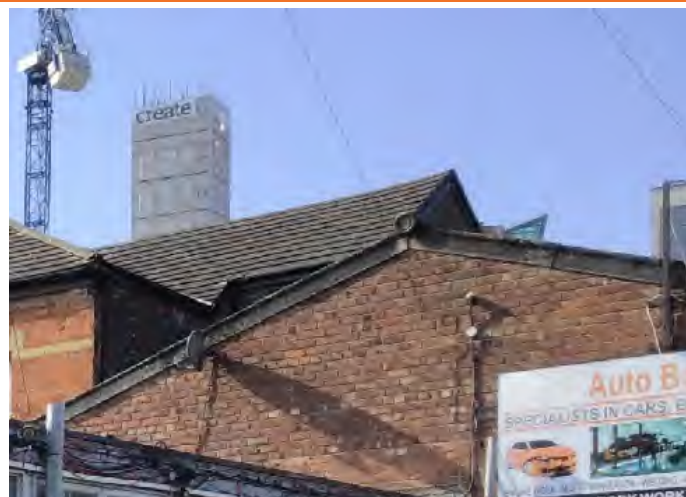
PLATE 11      SHOWING ASBESTOS SHEETING BARGE BOARD

The roof was pitched and constructed of asbestos sheeting. Where the asbestos sheeting overlapped, crevices were formed. Asbestos sheeting barge boards were also present, with crevices formed beneath the barge board and the brick walls. These crevices may provide roosting opportunities for crevice dwelling bat species on an occasional basis.

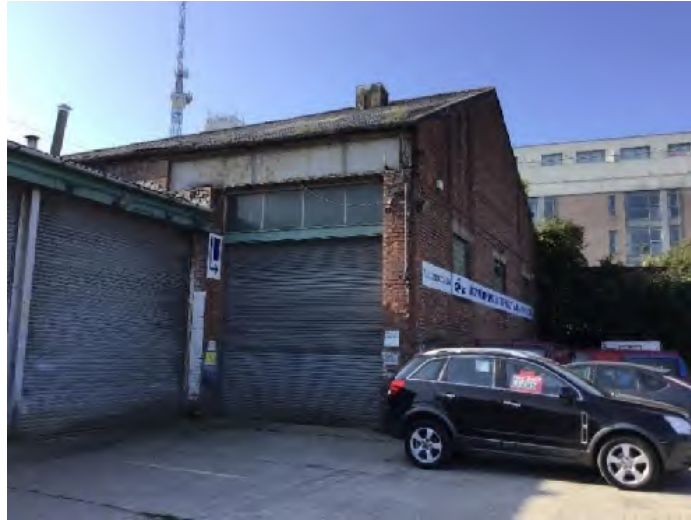
PLATE 12      SHOWING B4

Building 4 (B4) was a three-storey red brick warehouse building used as a car workshop.

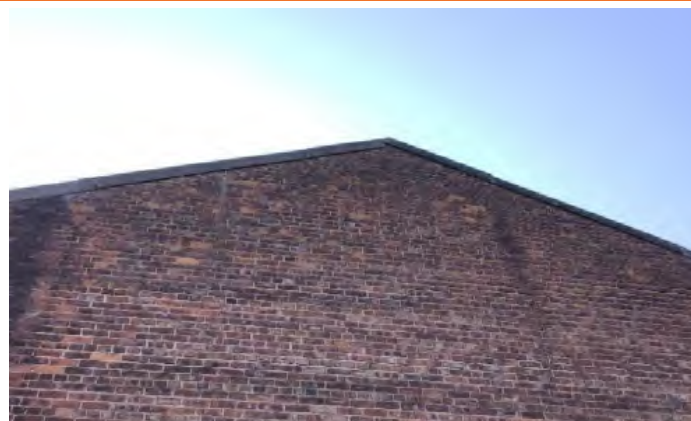
PLATE 13      SHOWING ASBESTOS SHEETING BARGE BOARD

The roof was pitched and constructed of asbestos sheeting. Where the asbestos sheeting overlapped, crevices were present. Asbestos sheeting barge boards were also present, with crevices formed between the barge board and the brick walls. These crevices may provide roosting opportunities for crevice dwelling bat species.

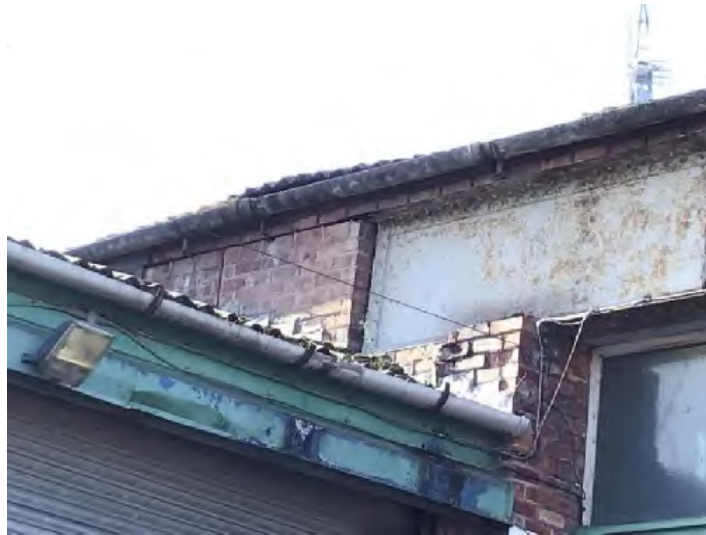
PLATE 14      SHOWING MOVEMENT CRACKS ON EXTERIOR WALLS

Movement cracks were also present in the exterior brickwork, which may provide roosting opportunities for crevice dwelling bat species on an occasional basis.

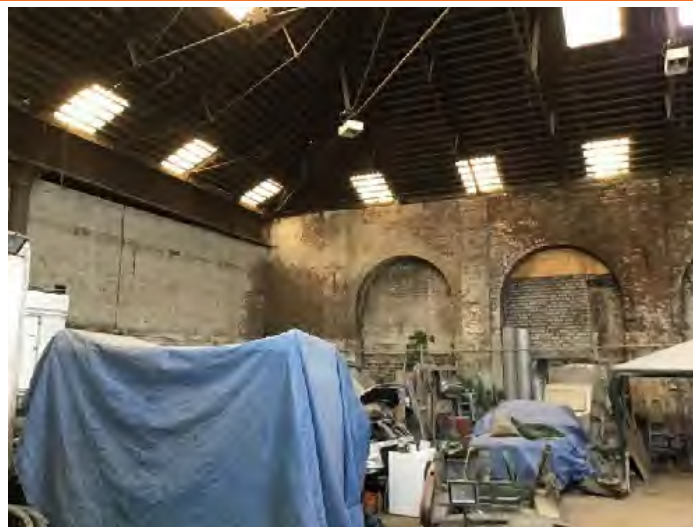
PLATE 15      SHOWING B4 INTERNALLY

Internally, B4 had exposed red brick walls and exposed asbestos sheeting roof, with skylights, exposing the building to daylight and reducing its suitability for roosting bats.

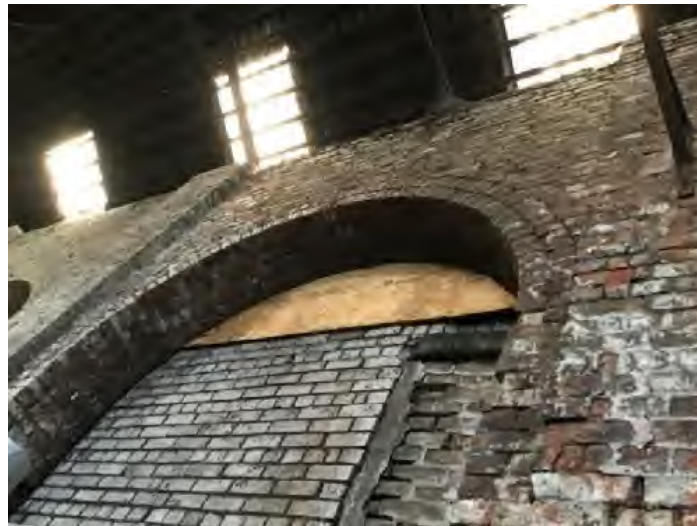
PLATE 16      SHOWING ARCHWAYS AND BOARDING

Brick arches were present on the western wall that were boarded in places. Crevices were present where the archways met the wall and behind the wooden boarding, which may form roosting opportunities for crevice dwelling bats. However, the building owner described how frequent leaking occurred over the archways, reducing their suitability for use by roosting bats.

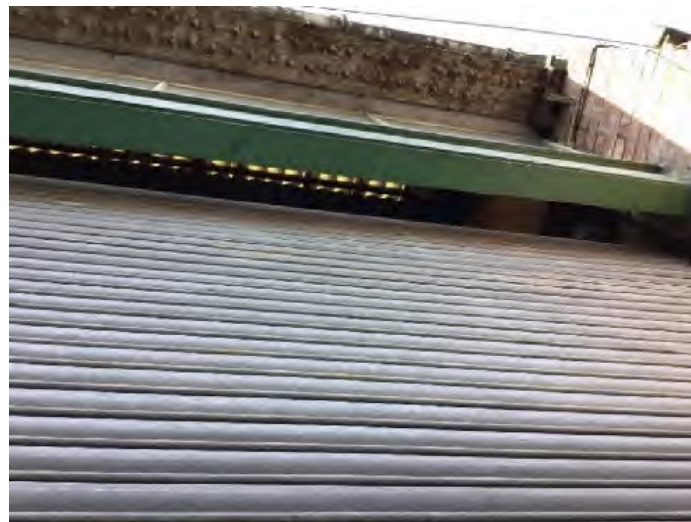
PLATE 17      SHOWING ACCESS VIA ROLLER SHUTTER DOOR

Internal access for bats was possible to B4 through a gap in the roller shutter door on the eastern aspect of the building.

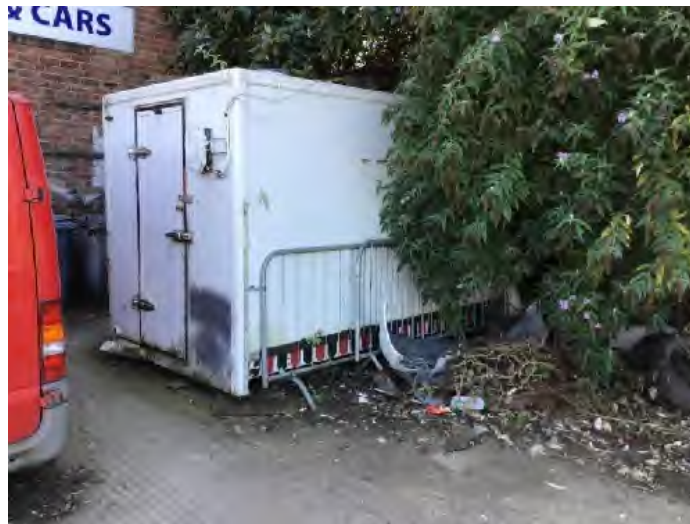
PLATE 18      SHOWING B5

Building 5 (B5) was a portable storage unit with plastic walls and a flat plastic roof. No potential roosting features were identified.

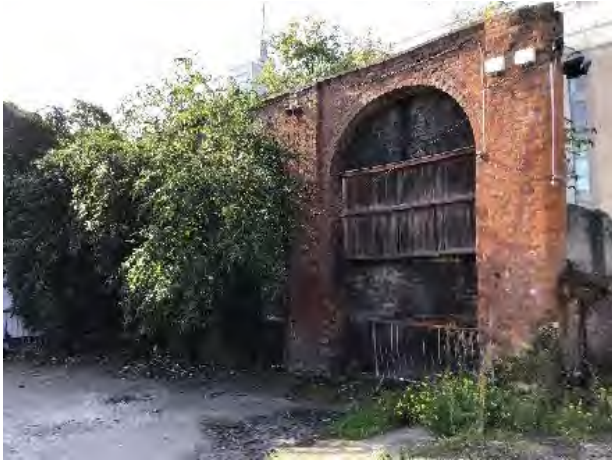
| REF. | DESCRIPTION | PHOTOGRAPH |
|---|---|---|
| <b>W2</b> | <p>W2 was constructed of red brick and extended along part of the western site boundary, adjacent to B4. It was 6 m high and had two large archways along its length. Crevices were present in the brickwork and between the archways and the wall, that may be used by crevices dwelling bat species, such as pipistrelle, on an occasional basis. Wall cotoneaster (<i>cotoneaster horizontalis</i>) was also present on this wall.</p> <p>W2 was assessed as having <b>Low</b> bat roosting potential.</p> | |

Wall cotoneaster was identified on-site at W2 and W6. As such, it is recommended, prior to the development, that the species should be eradicated following the most current guidance set out by the Environment Agency by a qualified contractor.

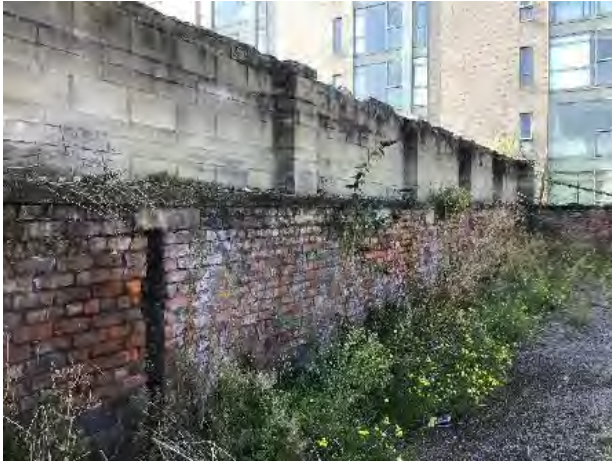
| REF. | DESCRIPTION | PHOTOGRAPH |
|---|---|---|
| <b>W3</b> | <p>W3 extended along part of the western site boundary. It was approximately 3 m high and had a red brick lower section and breeze block upper section, with no potential roosting features present.</p> <p>W3 was assessed as having <b>Negligible</b> bat roosting potential.</p> | |

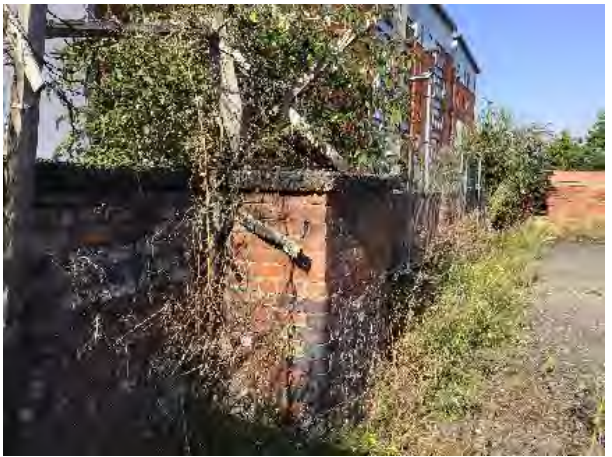
| REF. | DESCRIPTION | PHOTOGRAPH |
|---|---|---|
| <b>W4</b> | <p>W4 was present along a section of the western site boundary. It was 1.5 m high and constructed of red brick, with no potential roosting features present.</p> <p>W4 was assessed as having <b>Negligible</b> bat roosting potential.</p> | |

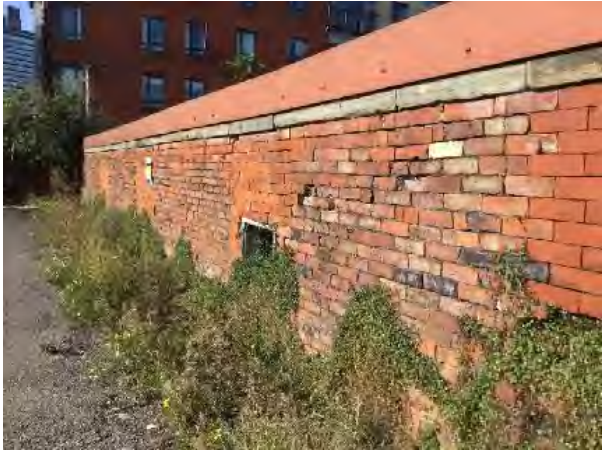
| REF. | DESCRIPTION | PHOTOGRAPH |
|---|---|---|
| <b>W5</b> | <p>W5 was present along the western extent of the northern site boundary. W5 was constructed of red brick and was approximately 1.7 m high. Crevices were present in the brickwork and meal sheeting was present at the top of the wall, forming a crevice between the sheeting and the brickwork. This may provide roosting opportunities for crevice dwelling bats on an occasional basis.</p> <p>W5 was assessed as having <b>Low</b> bat roosting potential.</p> | |

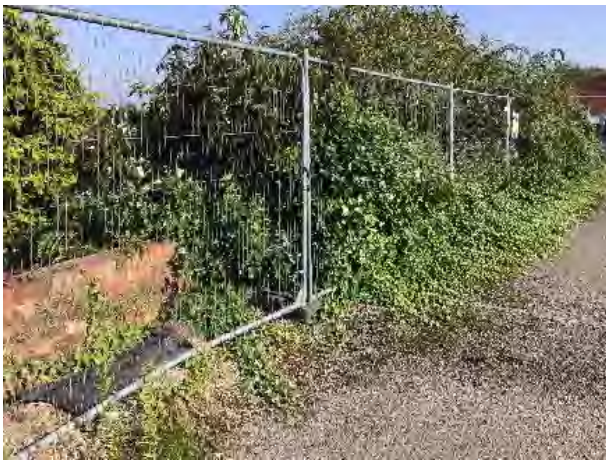
| REF. | DESCRIPTION | PHOTOGRAPH |
|---|---|---|
| <b>W6</b> | <p>W6 was present along part of the northern site boundary. It was constructed of red brick and was 0.5 m high with no potential roosting features present. Wall cotoneaster was also present on this wall.</p> <p>W6 was assessed as having <b>Negligible</b> bat roosting potential.</p> | |

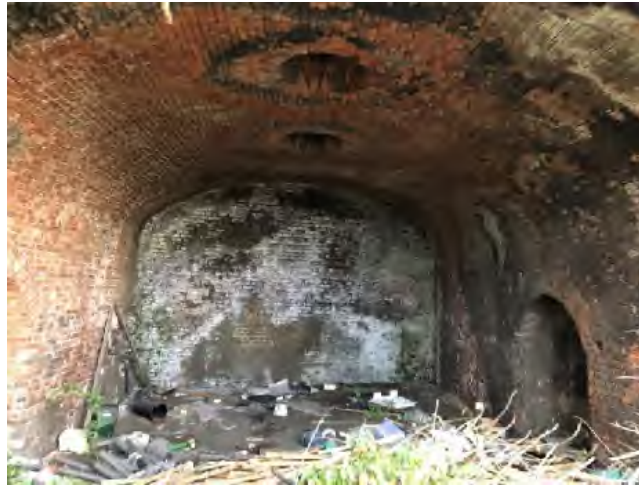
PLATE 19      SHOWING TUNNEL ENTRANCE

The tunnels had three entrances, that led to further chambers, and were entirely constructed of brick. The initial entranceways were open and vulnerable to fluctuating weather conditions and daylight, however further into the structures, conditions were dark, cold, humid, and constant. The brickwork of the tunnels was generally found to be in a good condition; however, a small number of crevices were identified. It was apparent the tunnels were not frequently visited by people, with large amounts of debris at the chamber entrances.
