# Swan House

## Ground Investigation

Curtins Ref: 077409-CUR-00-XX-RP-GE-002

Issue Date: 05 November 2021

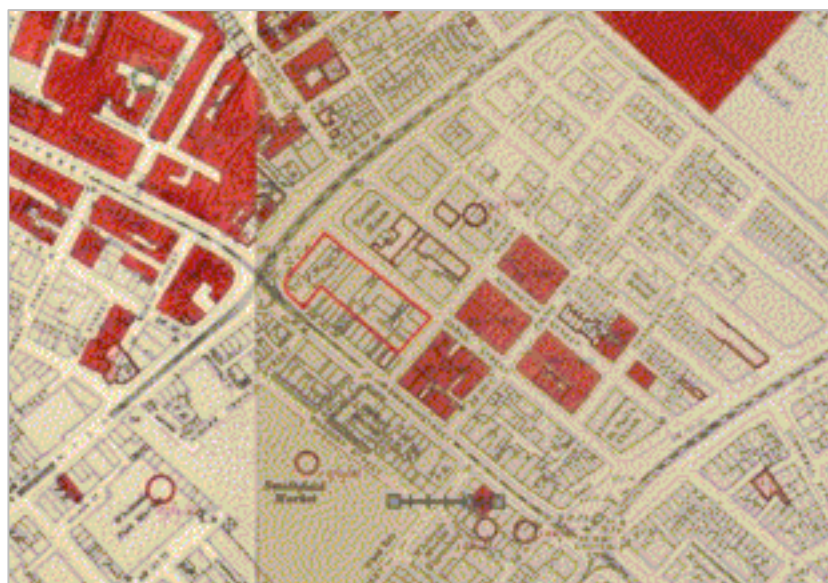
Analysis of online historical mapping shows fire bomb strikes (80m east, 100m southwest and 120m south) and demolished/damaged buildings and ruins (from 20m southeast, from 50m northwest, 70m northwest, 80m west and northeast and 100m south) surrounding the site, as shown in *Figure 2.6* below.

**Figure 2.6** – Map of bomb damage in Manchester from WWII (red line shows site boundary, red circles show locations of fire bombs, red shading shows locations of demolished buildings).  
Copyright 2016 The University of Manchester.

A Detailed Unexploded Ordnance (UXO) Risk Assessment report for the site was recently obtained on behalf of the Client with reference to the proposed construction works and is included within *Appendix G*. The report concludes a **Low** risk to construction workers from unexploded ordnance within the site's soils.

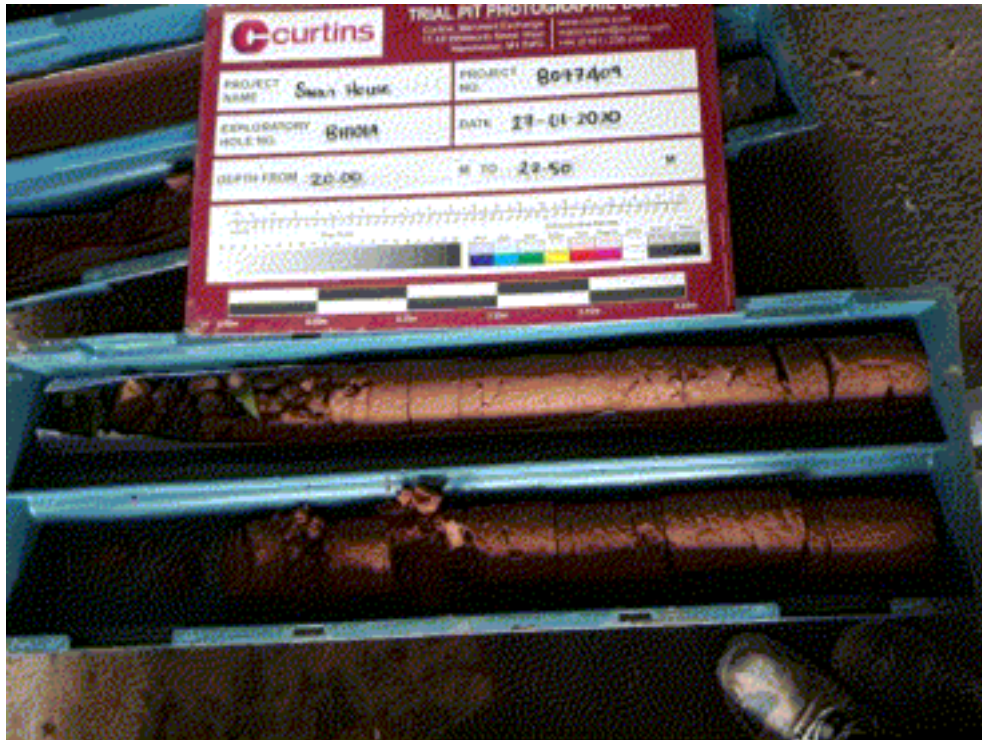
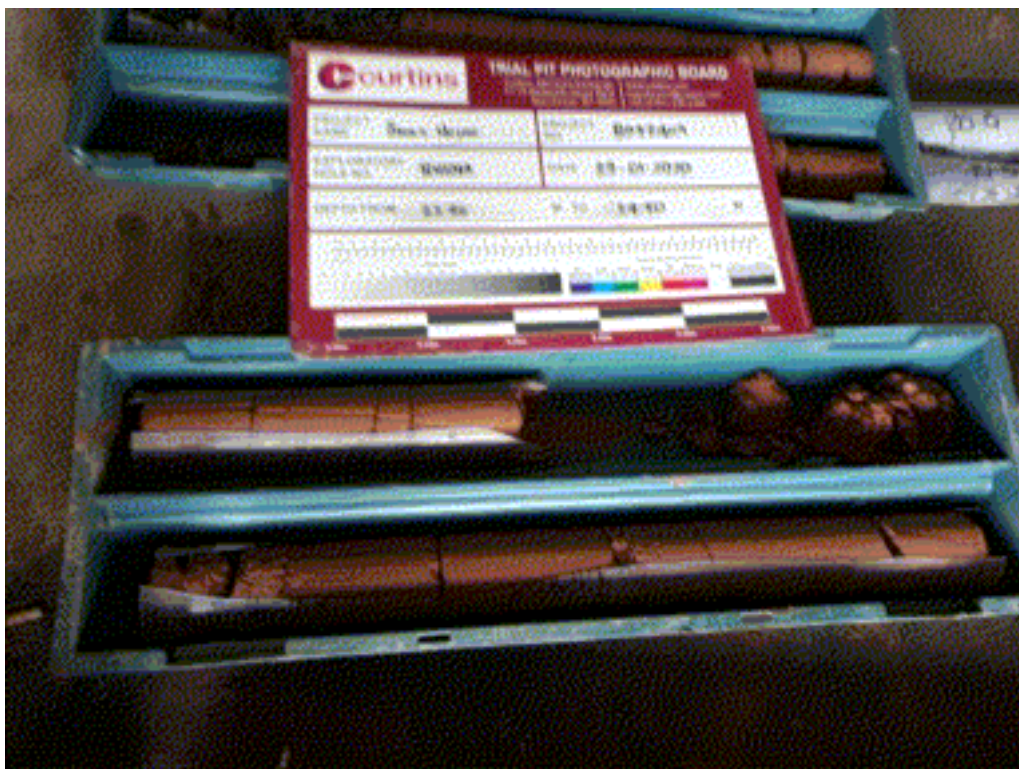
| <b>No.</b><br>1 | <b>Date:</b><br>27/01/2021 | <b>Description:</b><br>BH101A Rock Logging Photographs 20.50m to 24.50m bgl | |

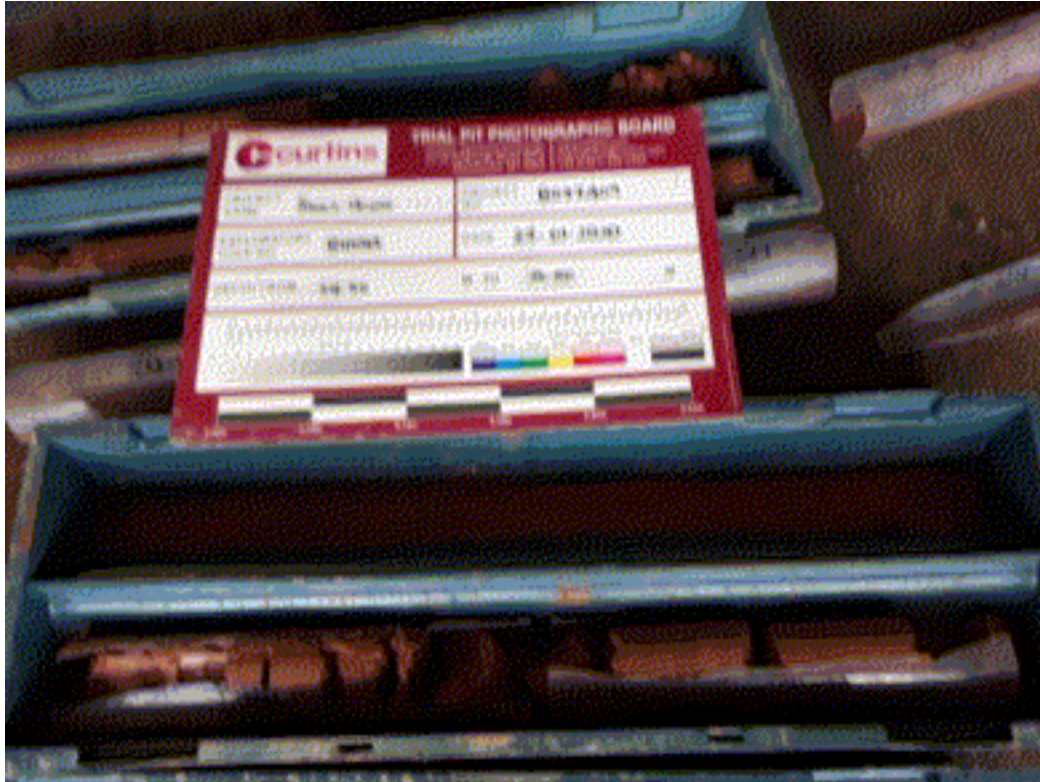
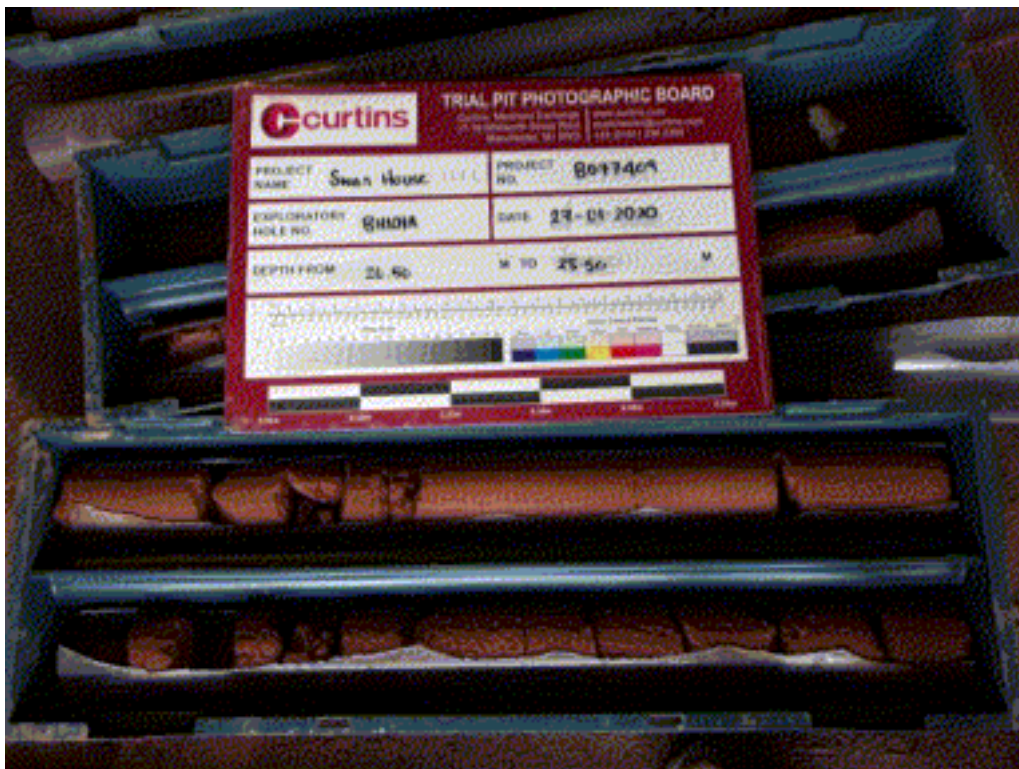
| <b>No.</b><br>2 | <b>Date:</b><br>27/01/2021 | <b>Description:</b><br>BH101A Rock Logging Photographs 24.50m to 28.50m bgl | |

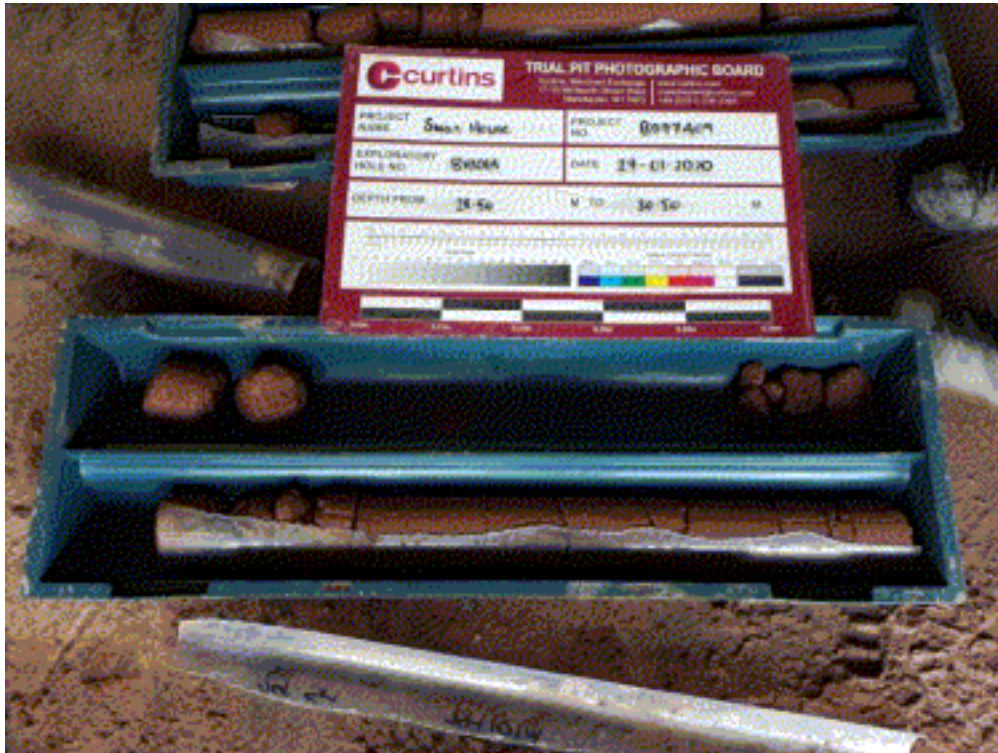
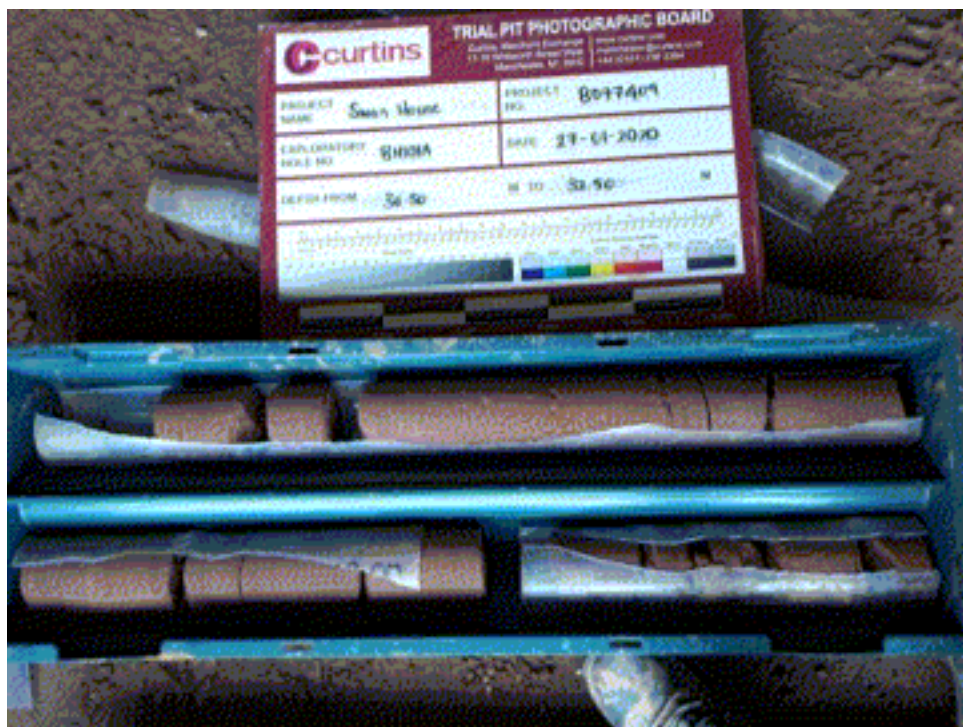
| <b>No.</b><br>3 | <b>Date:</b><br>27/01/2021 | <b>Description:</b><br>BH101A Rock Logging Photographs 28.50m to 32.50m bgl | |

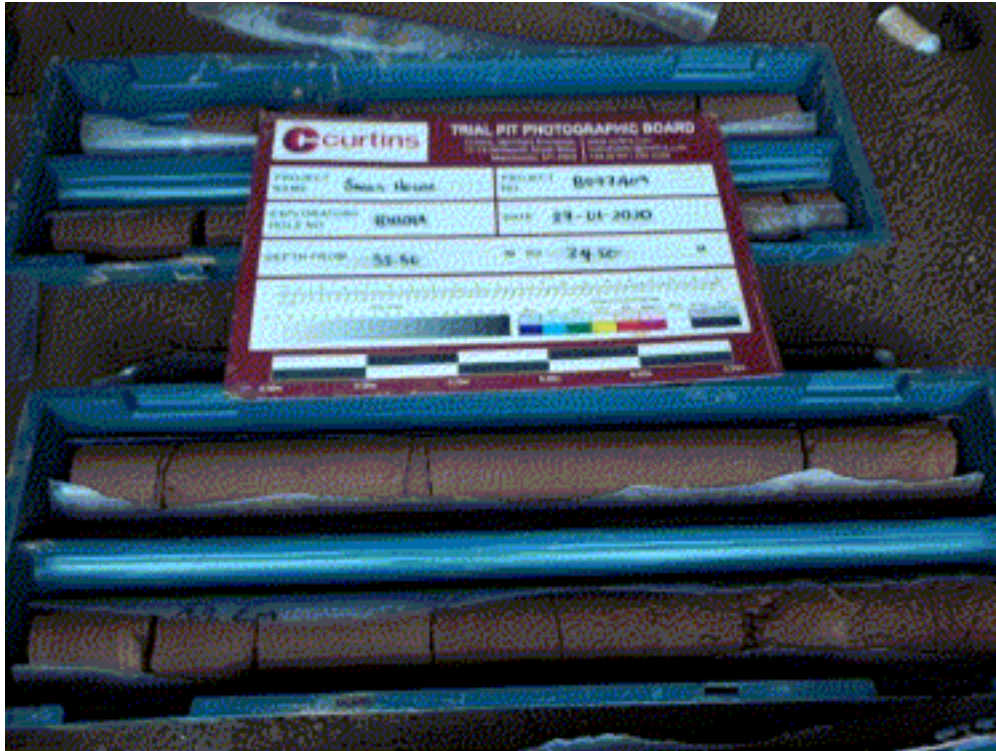
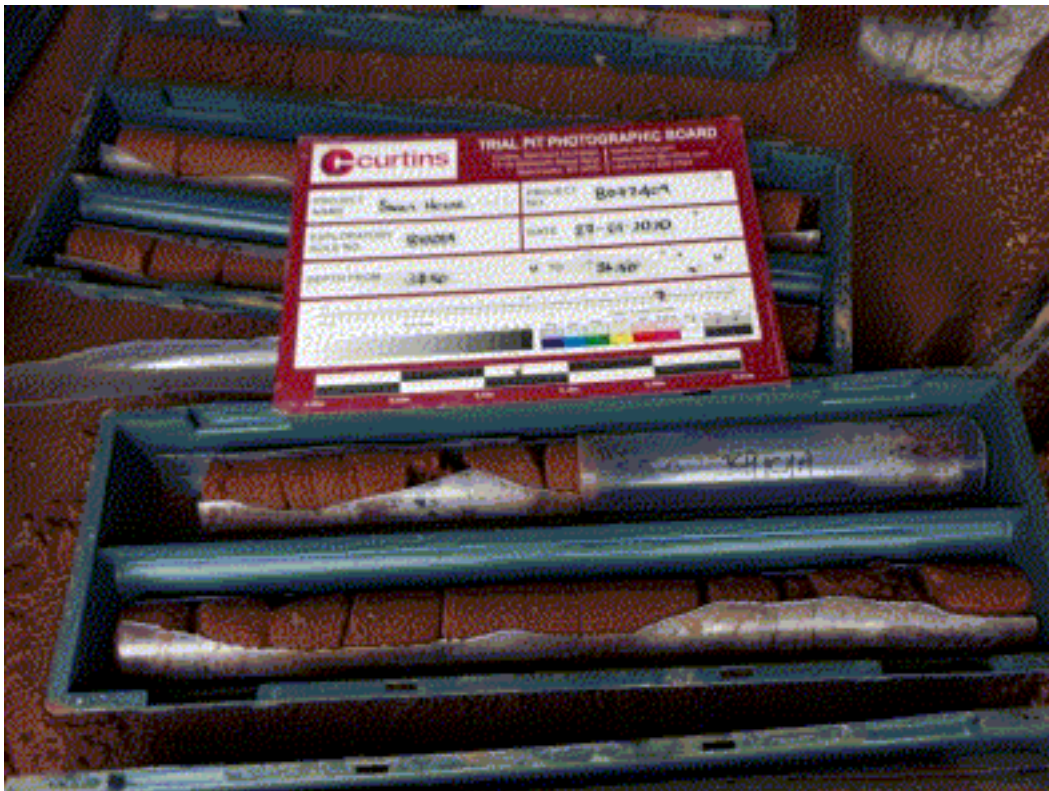
| <b>No.</b><br>4 | <b>Date:</b><br>27/01/2021 | <b>Description:</b><br>BH101A Rock Logging Photographs 32.50m to 36.50m bgl | |

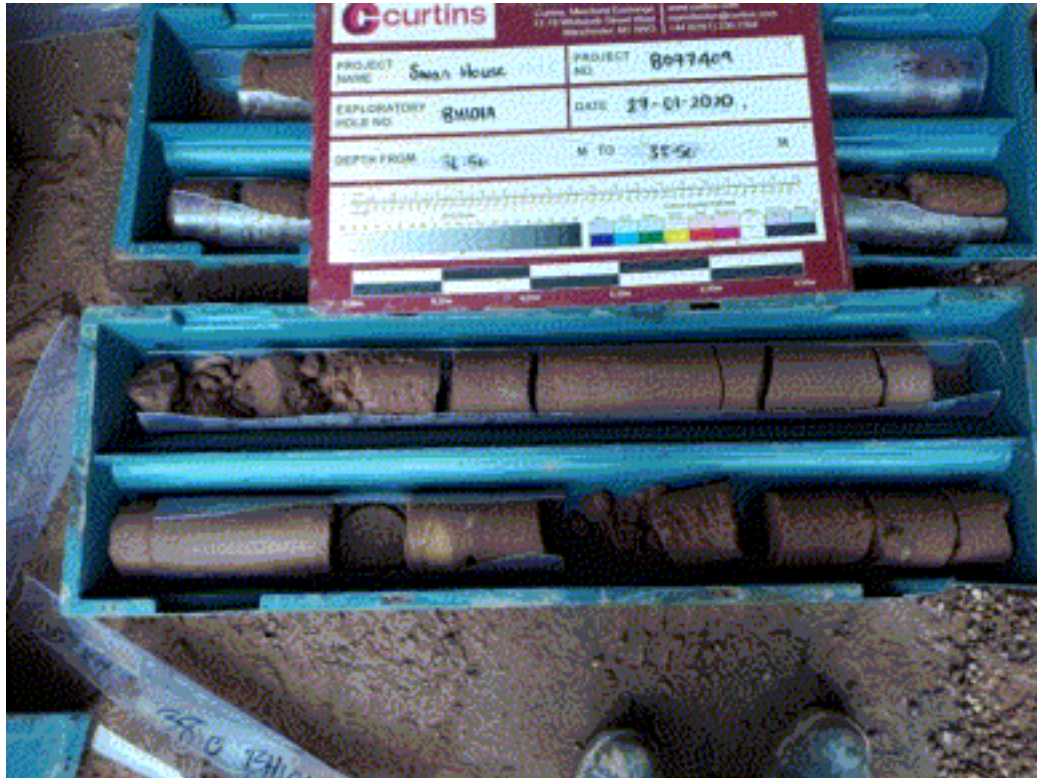
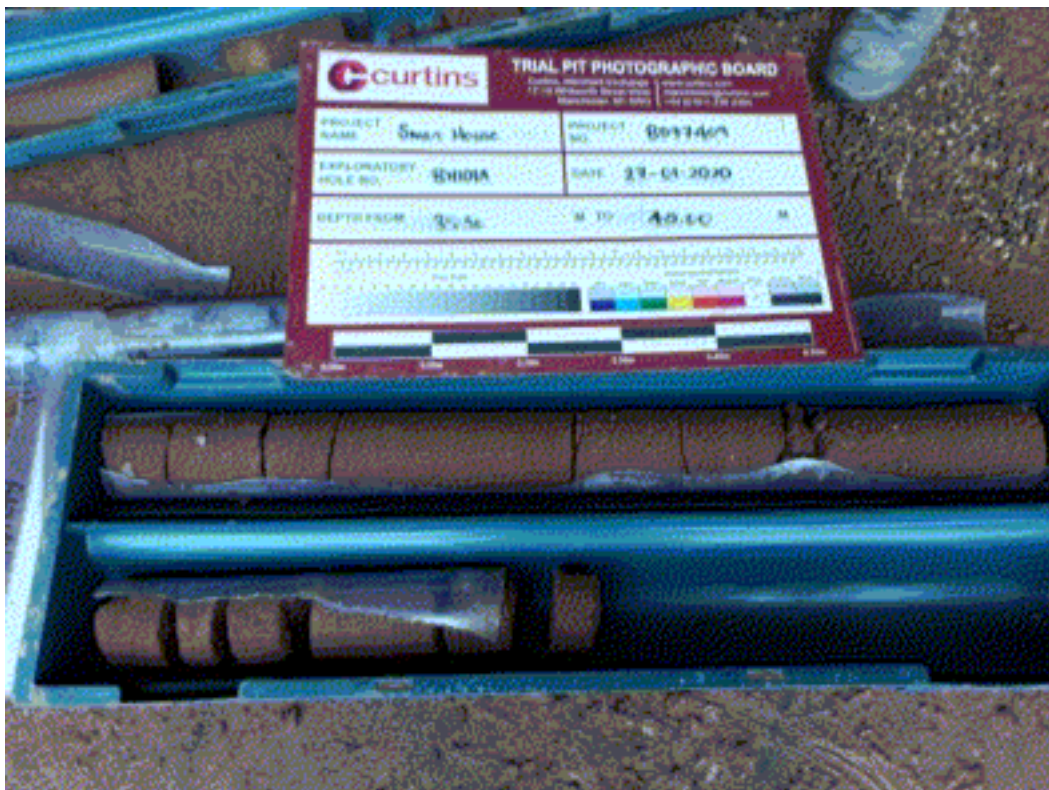
| <b>No.</b><br>5 | <b>Date:</b><br>27/01/2021 | <b>Description:</b><br>BH101A Rock Logging Photographs 36.50 to 40.50m | |

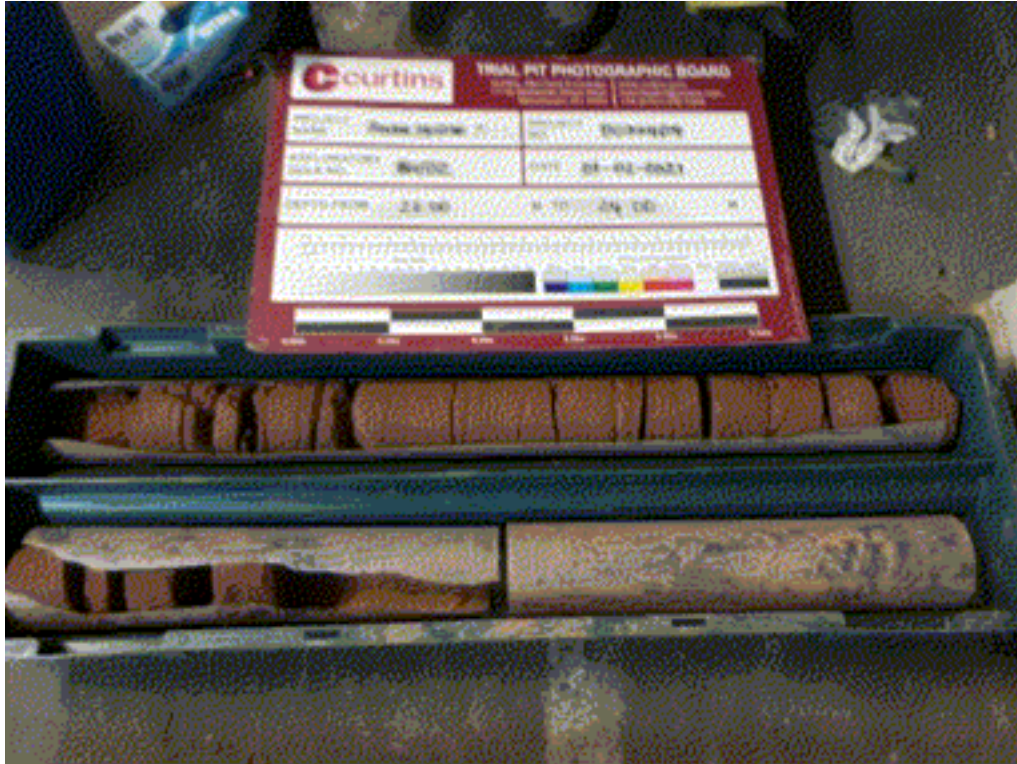
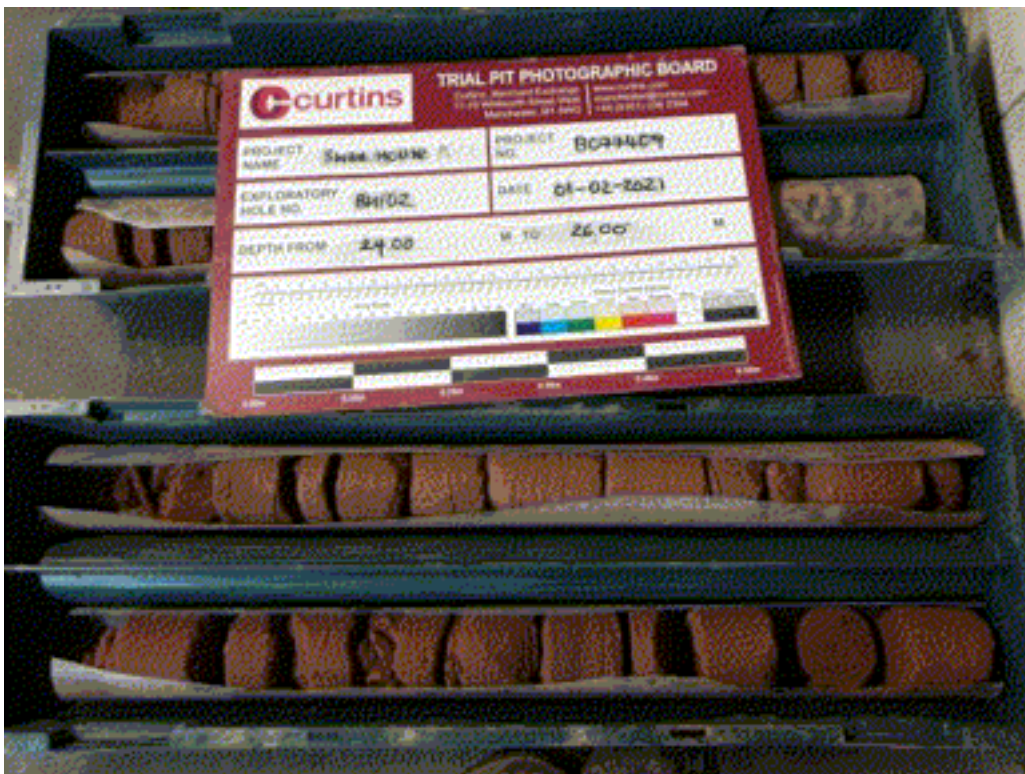
| <b>No.</b><br>6 | <b>Date:</b><br>01/02/2021 | <b>Description:</b><br>BH102 Rock Logging Photographs 22.00 to 26.00m | |

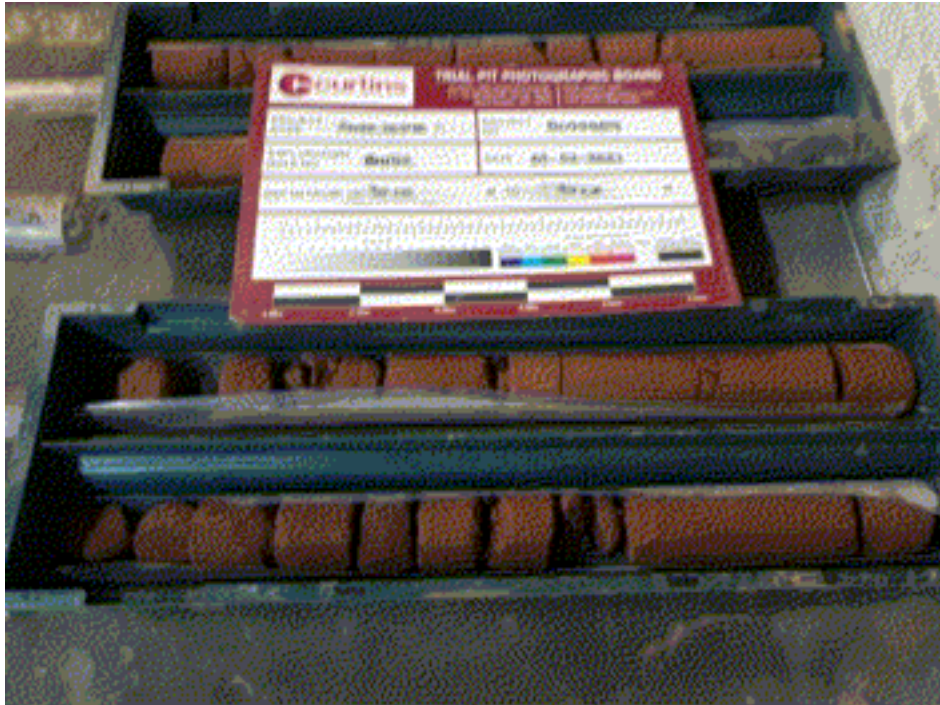
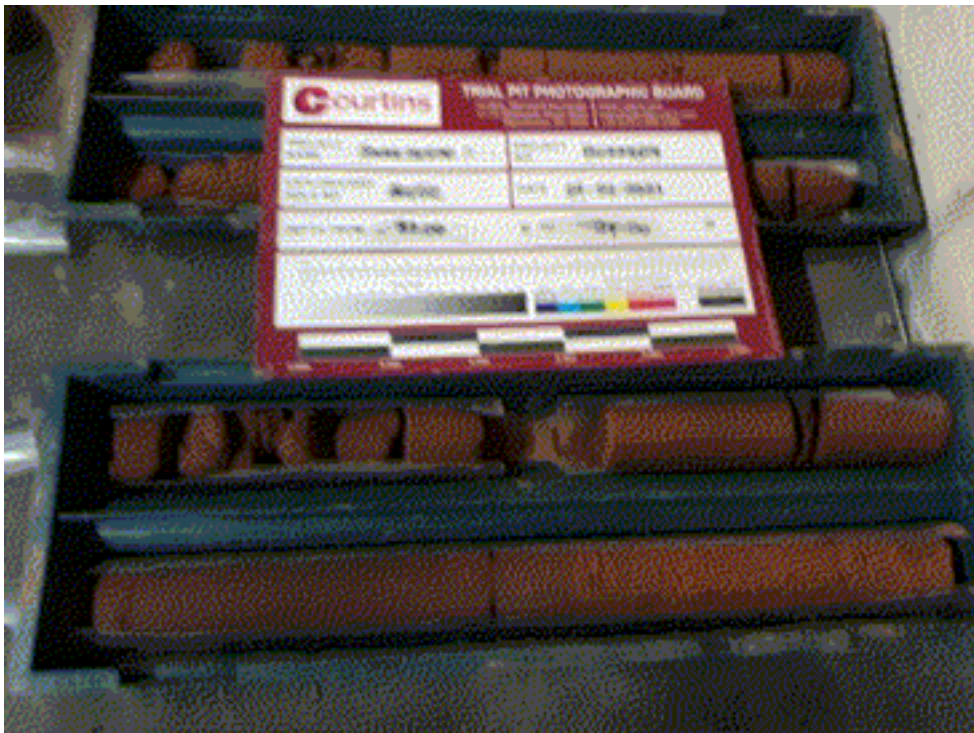
| <b>No.</b><br>8 | <b>Date:</b><br>01/02/2021 | <b>Description:</b><br>BH102 Rock Logging Photographs 30.00 to 34.00m | |

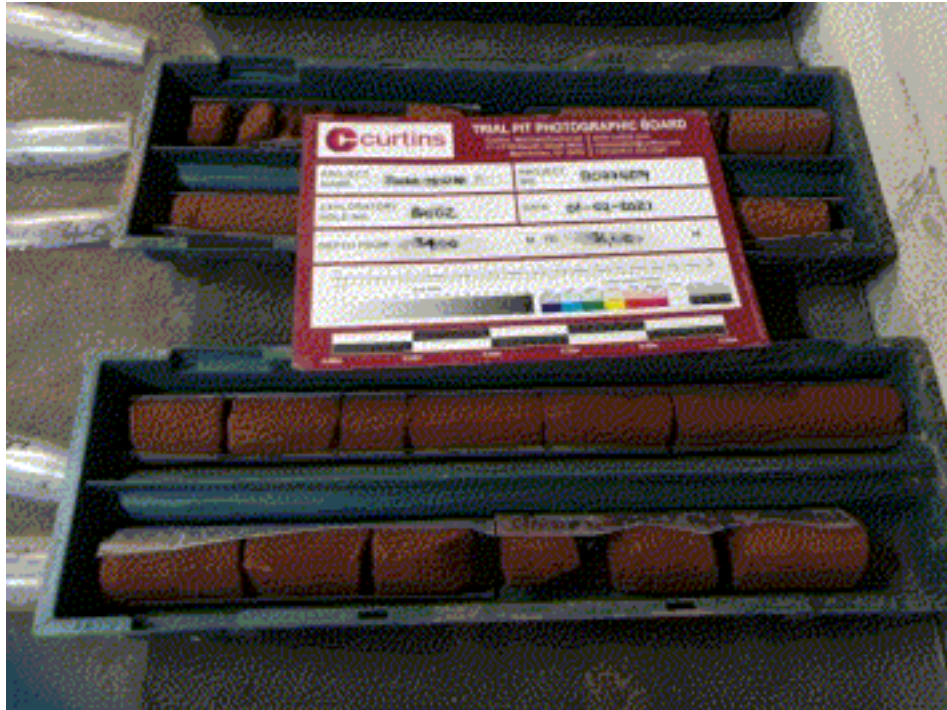
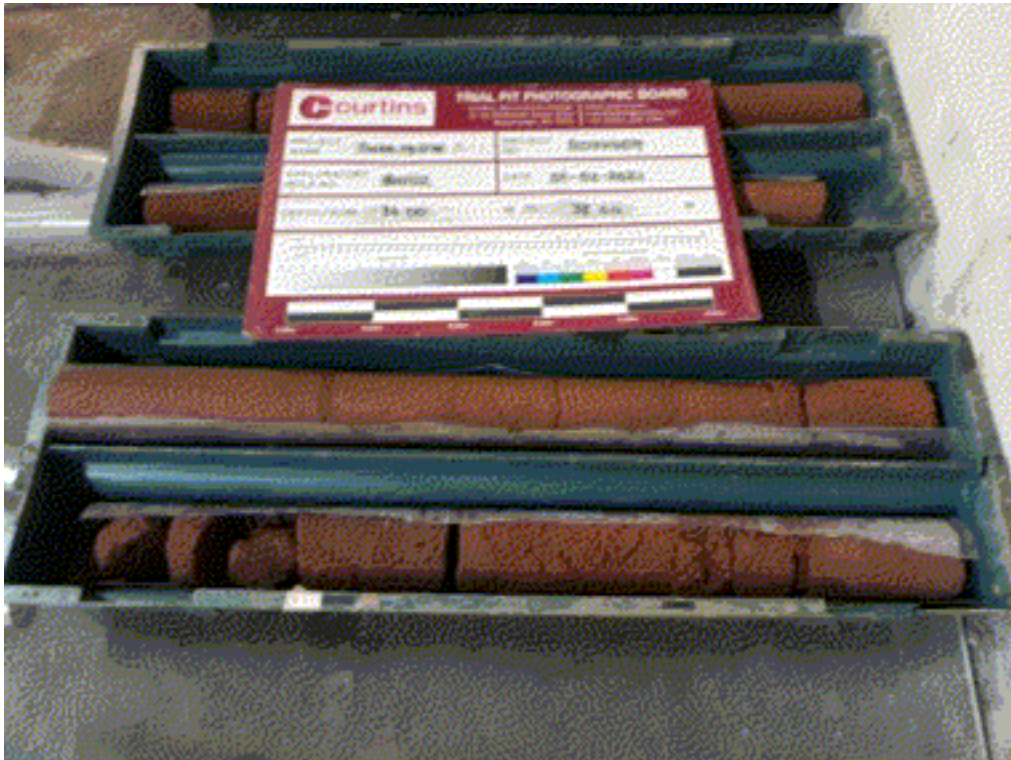
| <b>No.</b><br>9 | <b>Date:</b><br>01/02/2021 | <b>Description:</b><br>BH102 Rock Logging Photographs 34.00 to 38.00m | |

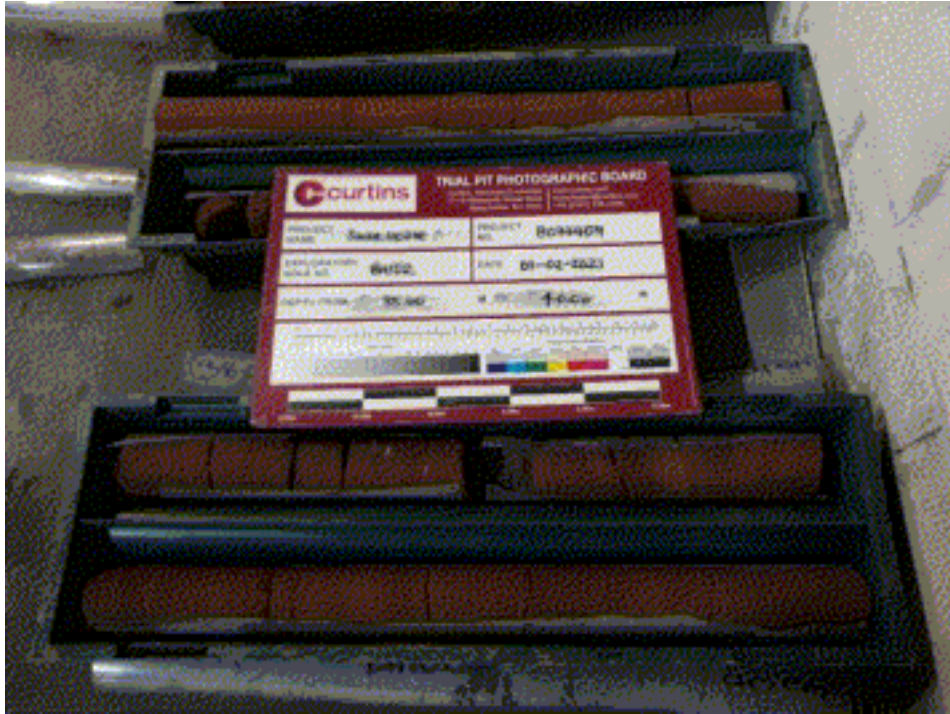
| <b>No.</b><br>10 | <b>Date:</b><br>01/02/2021 | <b>Description:</b><br>BH102 Rock Logging Photographs 38.00 to 40.00m | |

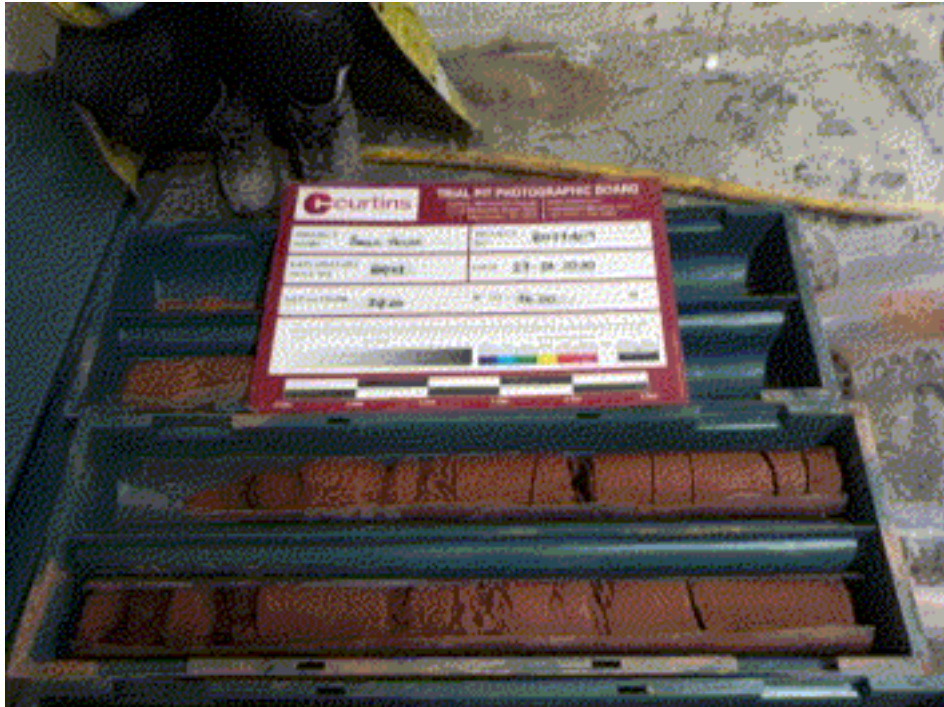
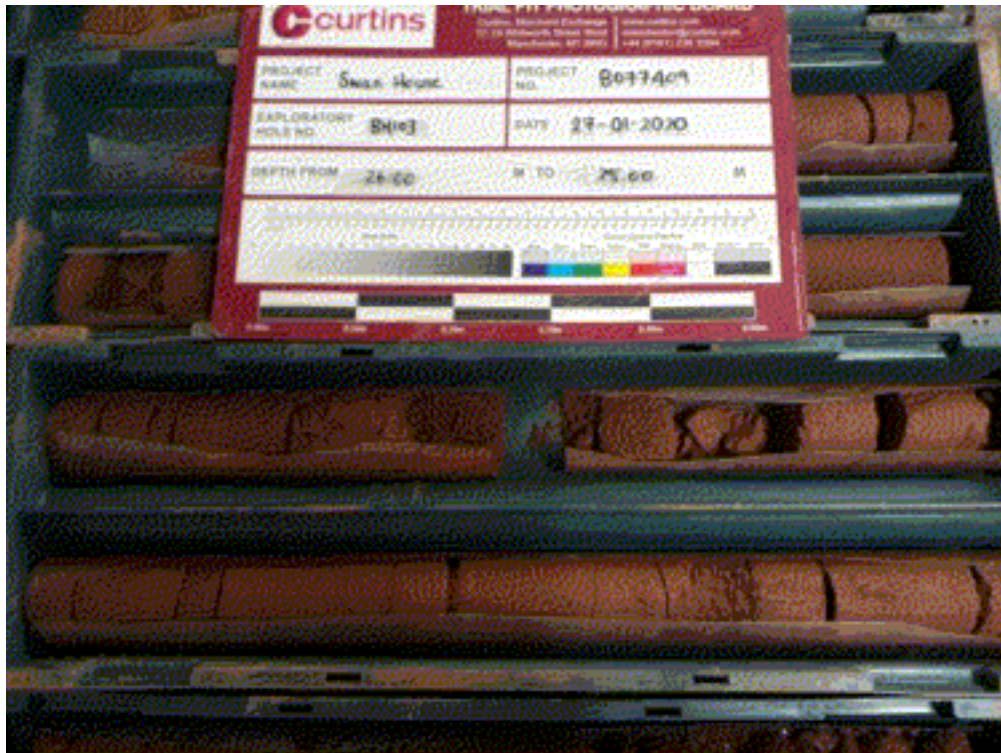
| <b>No.</b><br>11 | <b>Date:</b><br>27/01/2021 | <b>Description:</b><br>BH103 Rock Logging Photographs 24.00 to 28.00m | |

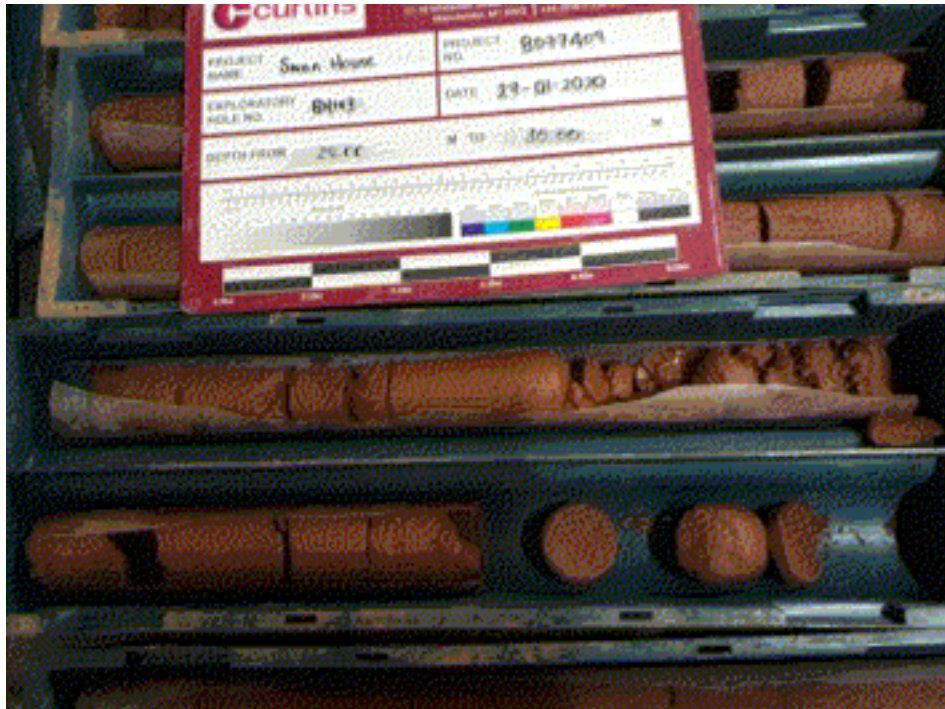
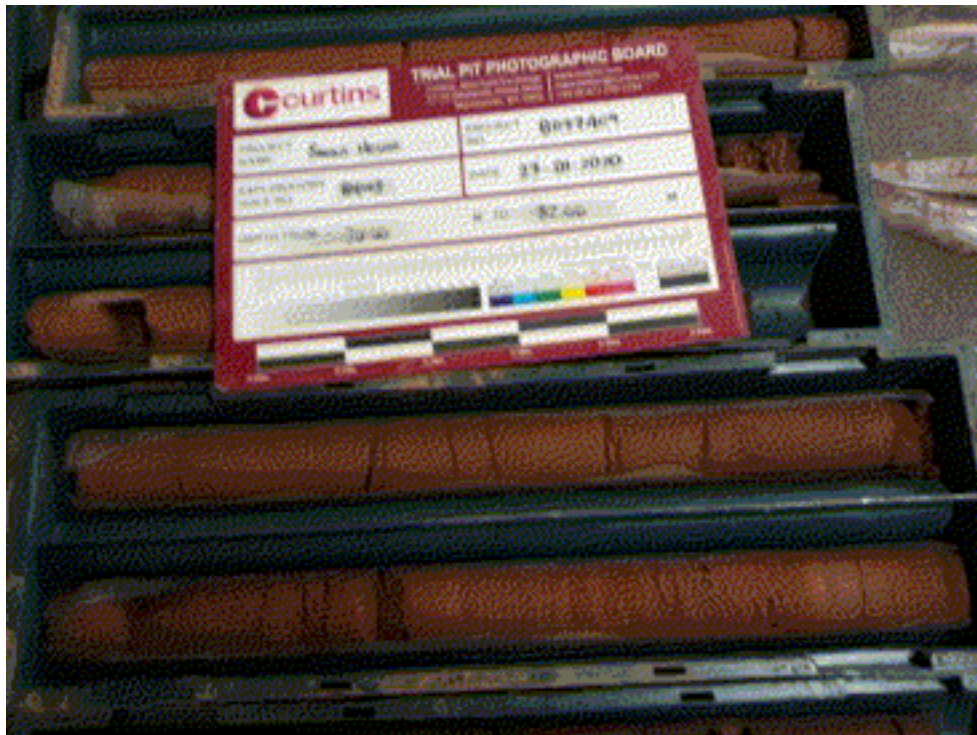
| <b>No.</b><br>12 | <b>Date:</b><br>27/01/2021 | <b>Description:</b><br>BH103 Rock Logging Photographs 28.00 to 32.00m | |

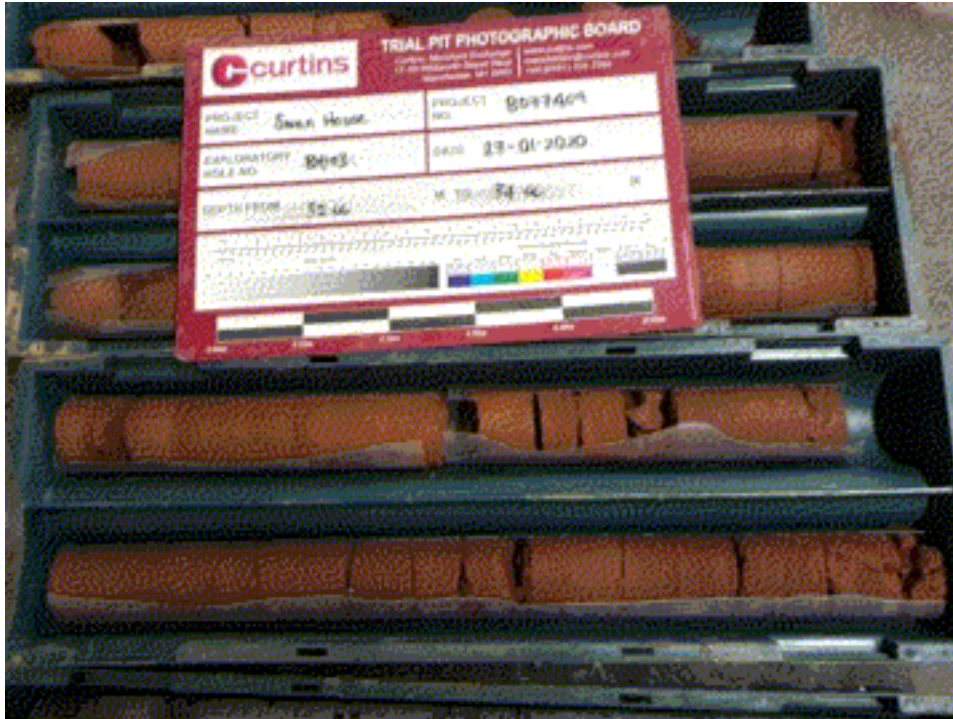
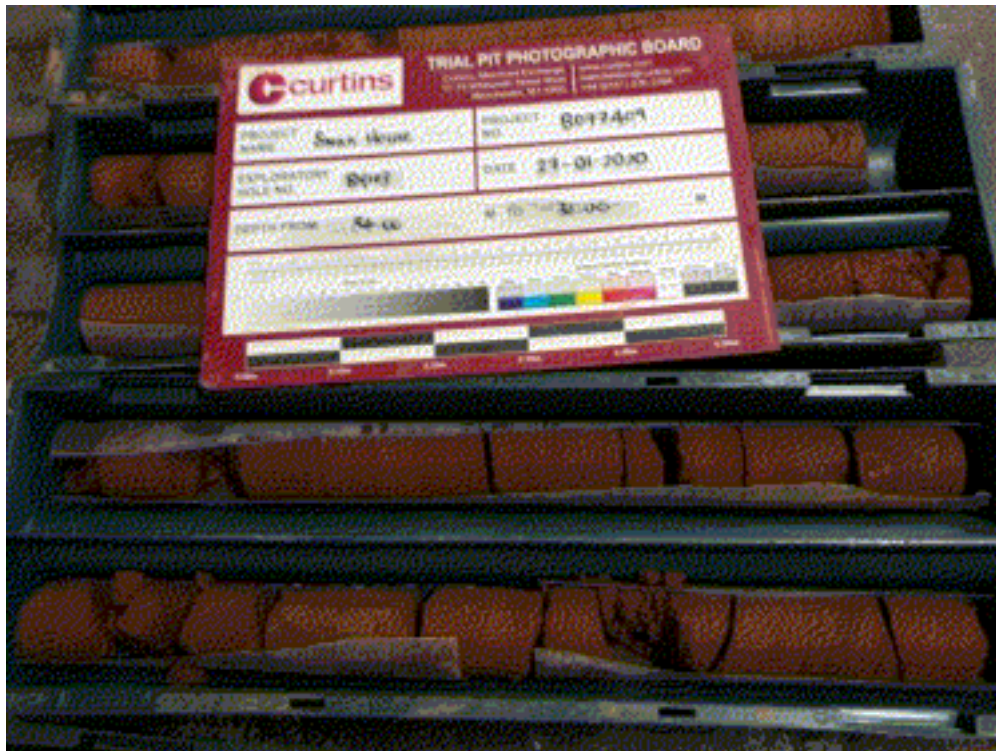
| <b>No.</b><br>13 | <b>Date:</b><br>27/01/2021 | <b>Description:</b><br>BH103 Rock Logging Photographs 32.00 to 36.00m | |

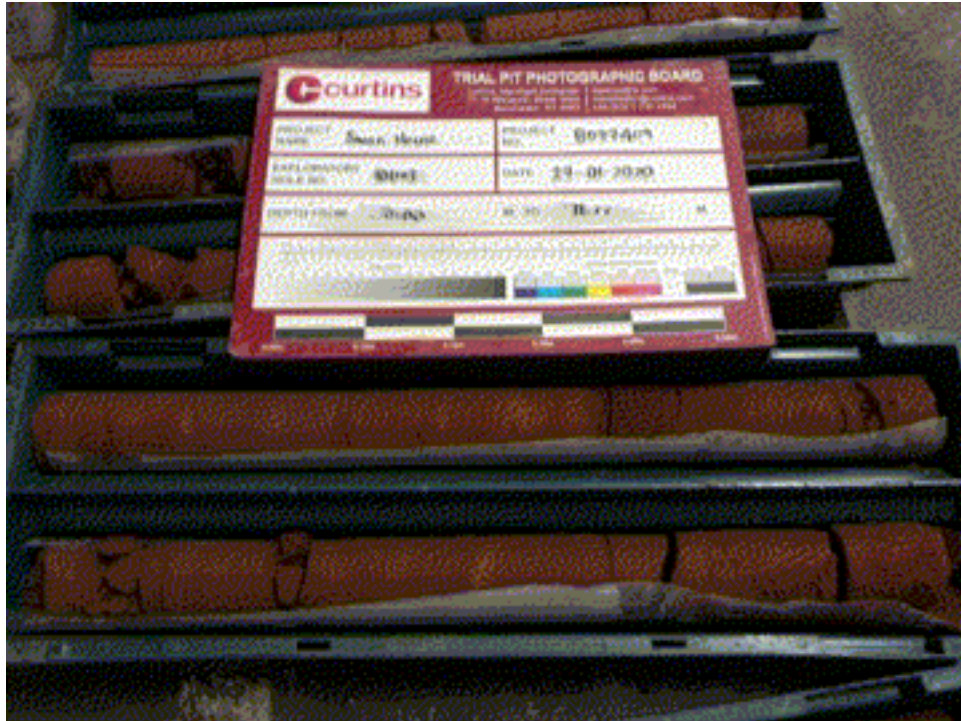
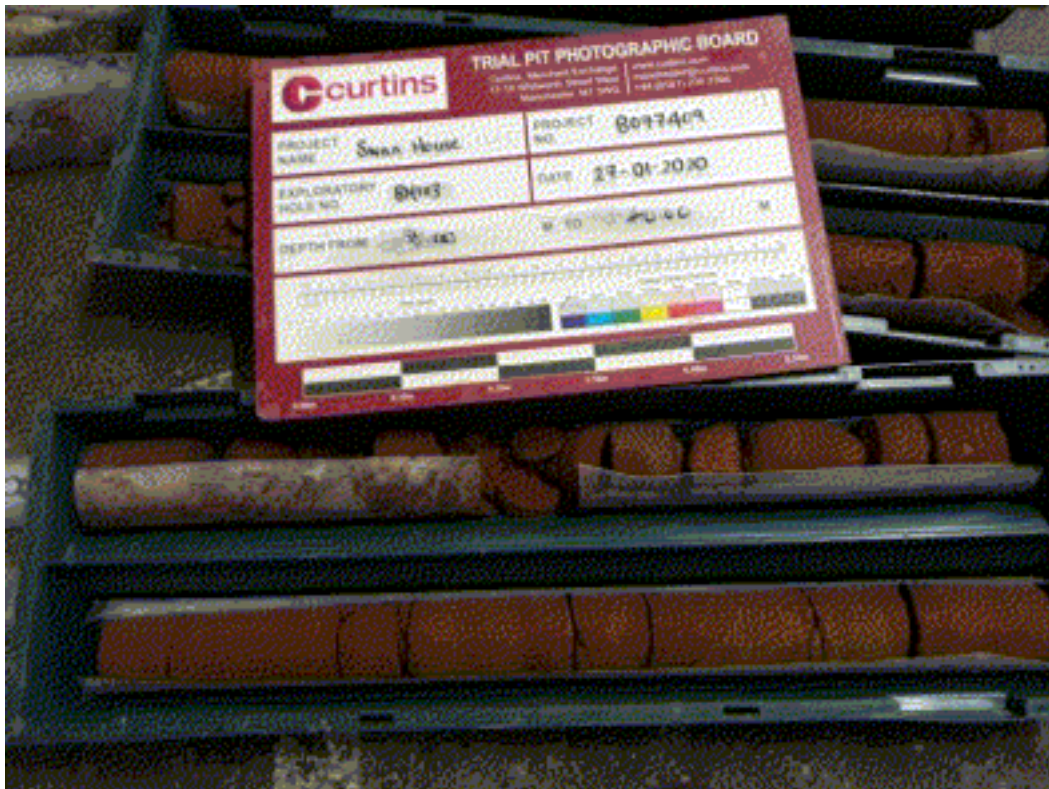
| <b>No.</b><br>14 | <b>Date:</b><br>27/01/2021 | <b>Description:</b><br>BH103 Rock Logging Photographs 36.00 to 40.00m | |

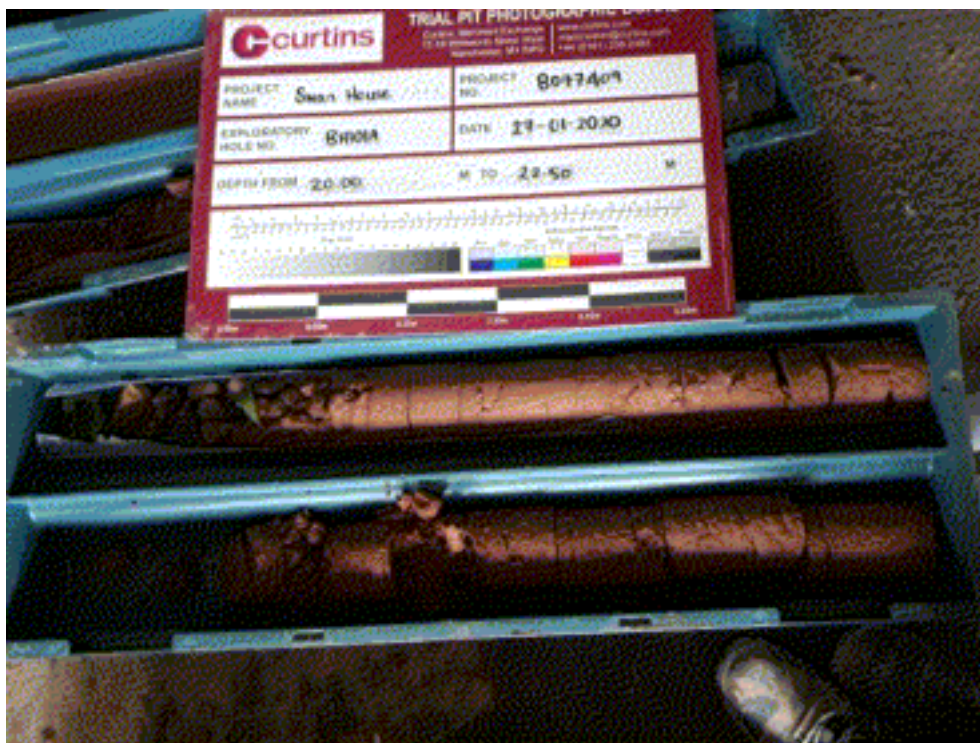
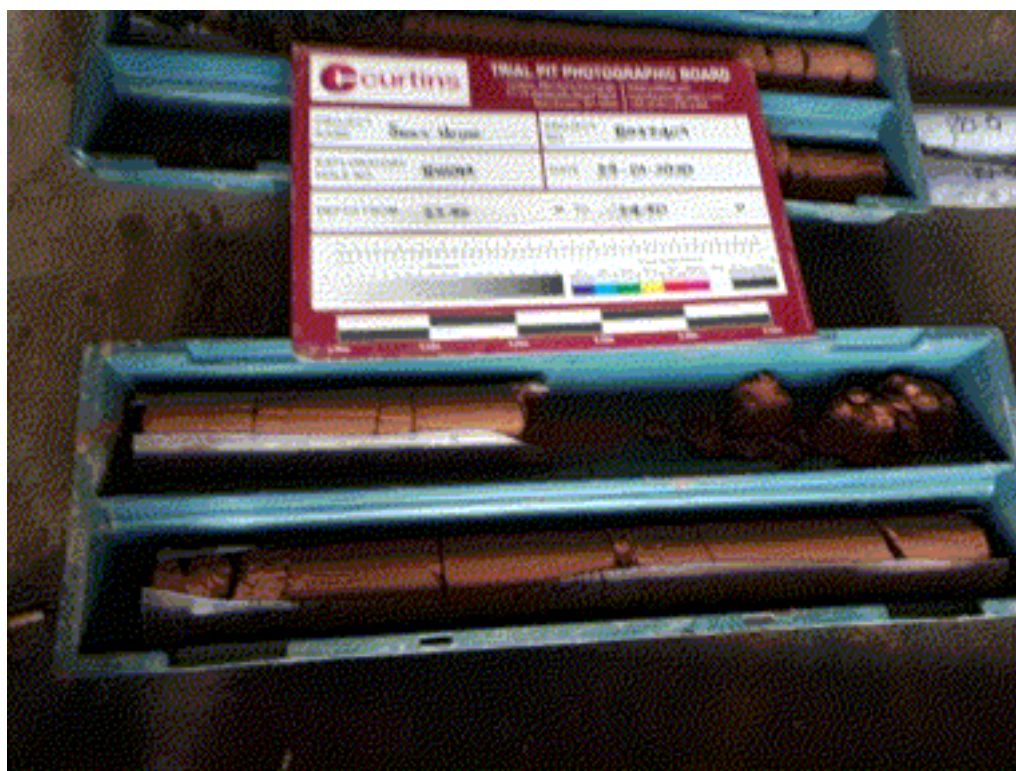
| <b>No.</b><br>1 | <b>Date:</b><br>27/01/2021 | <b>Description:</b><br>BH101A Rock Logging Photographs 20.50m to 24.50m bgl | |

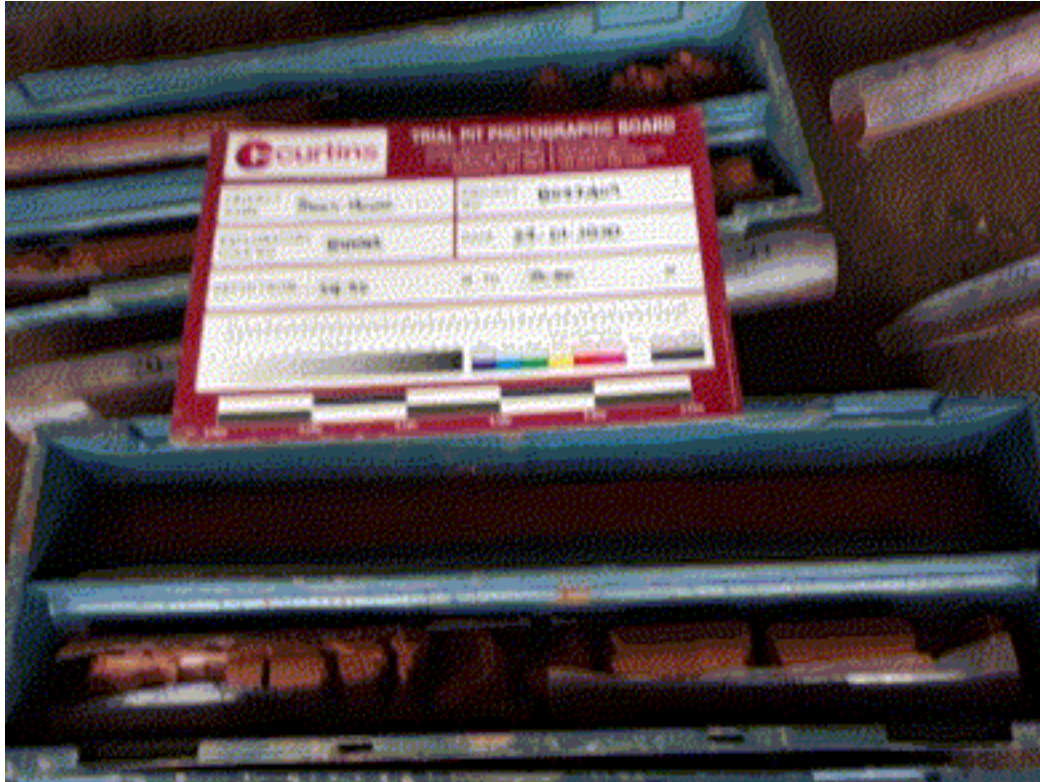
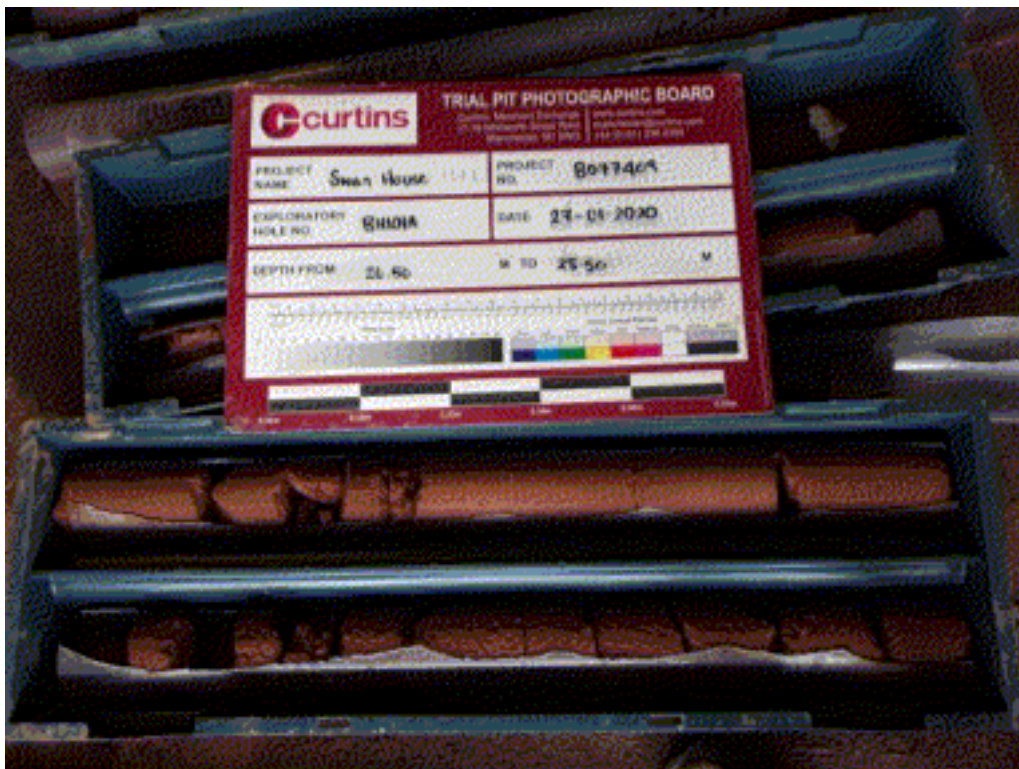
| <b>No.</b><br>2 | <b>Date:</b><br>27/01/2021 | <b>Description:</b><br>BH101A Rock Logging Photographs 24.50m to 28.50m bgl | |
