# Swan House

## Ground Investigation

Curtins Ref: 077409-CUR-00-XX-RP-GE-002

Issue Date: 05 November 2021

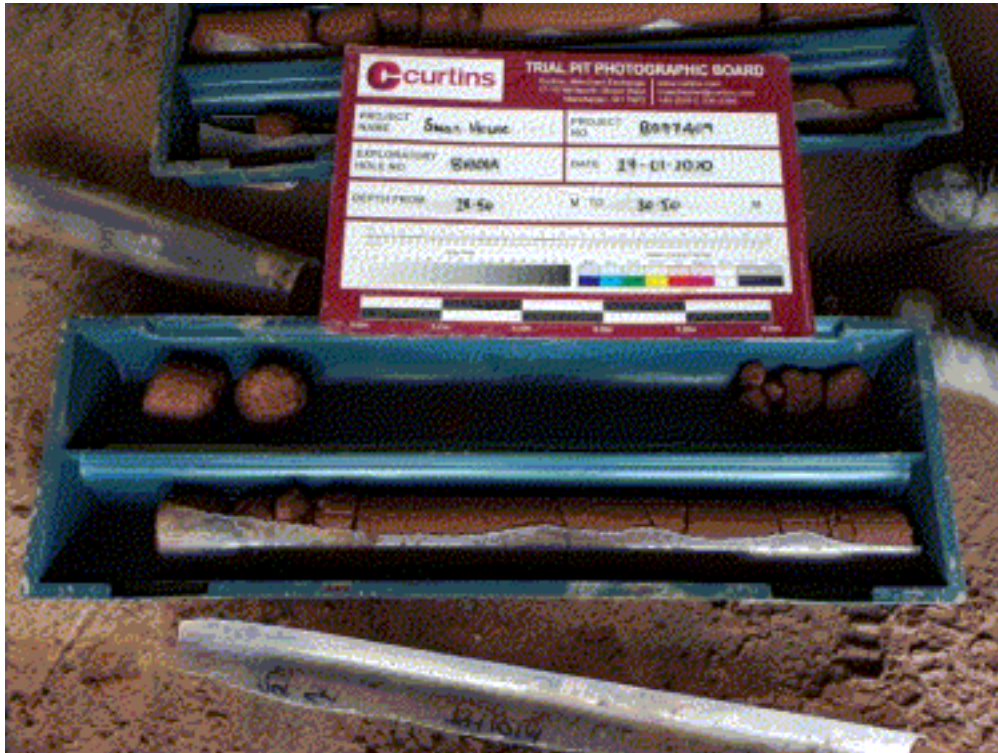
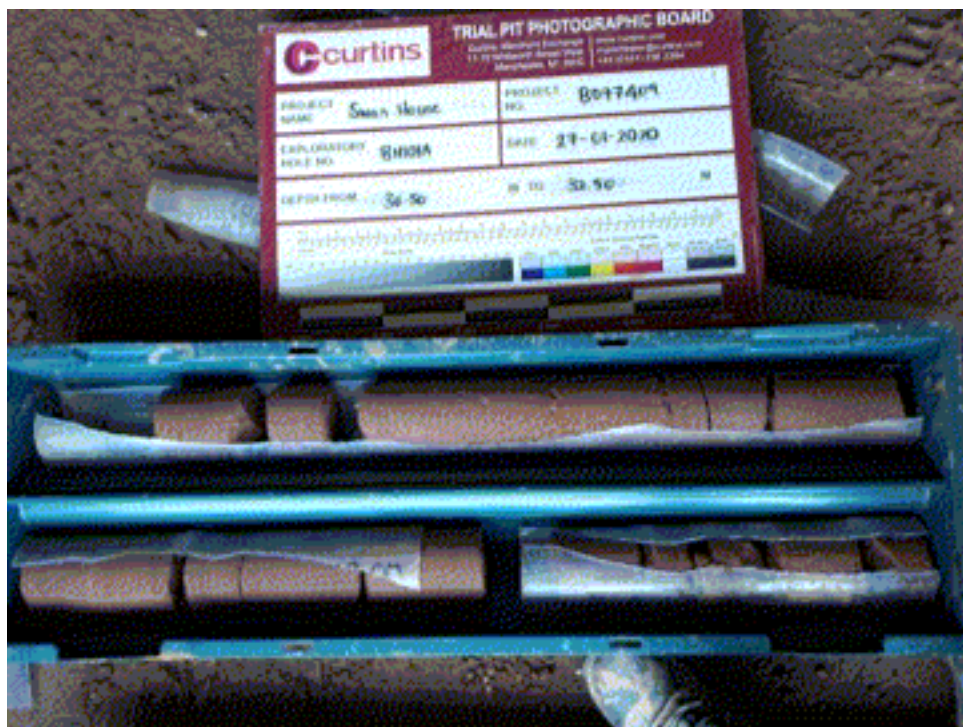
| <b>No.</b><br>3 | <b>Date:</b><br>27/01/2021 | <b>Description:</b><br>BH101A Rock Logging Photographs 28.50m to 32.50m bgl | |

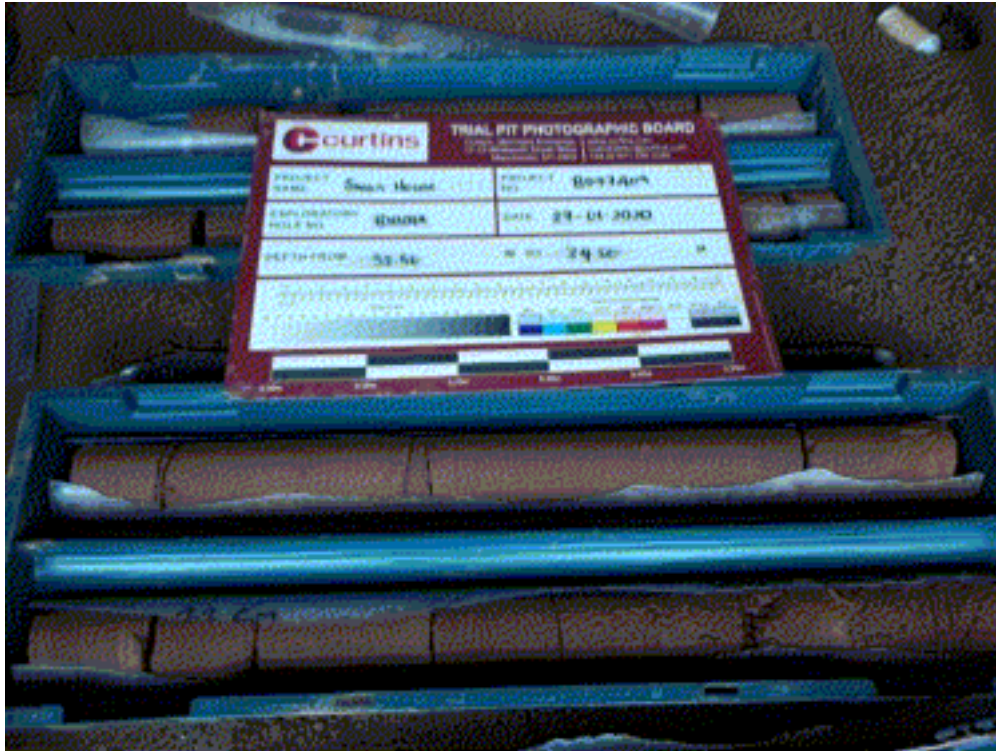
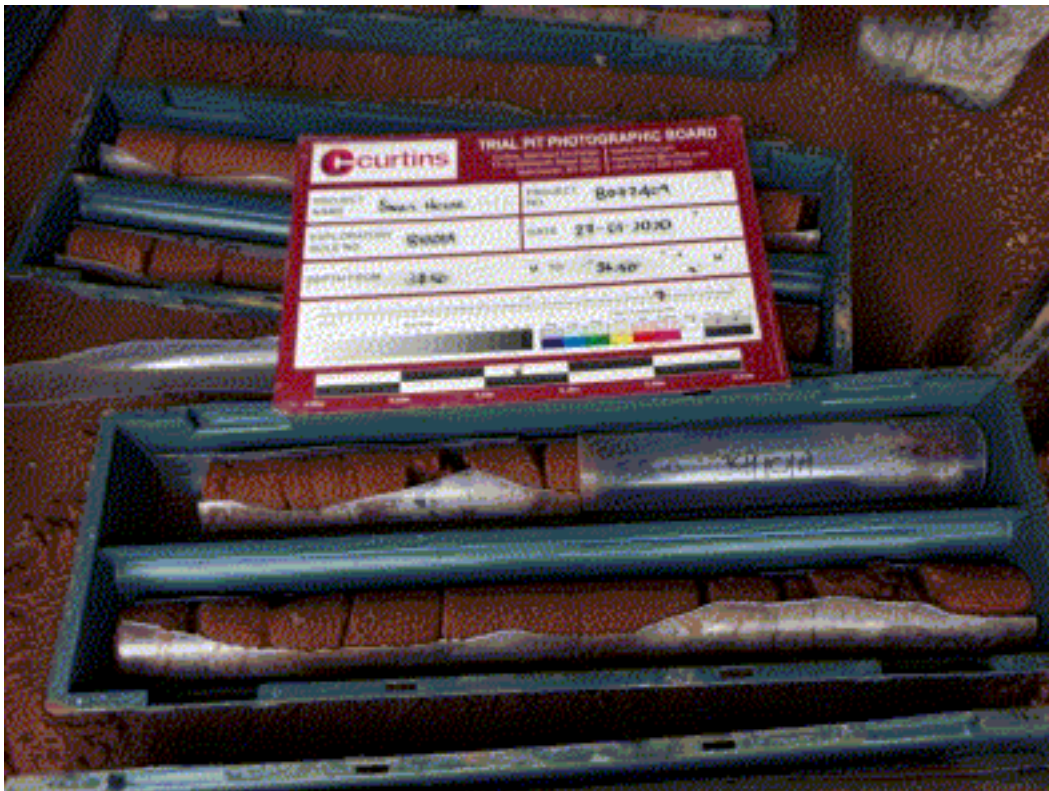
| <b>No.</b><br>4 | <b>Date:</b><br>27/01/2021 | <b>Description:</b><br>BH101A Rock Logging Photographs 32.50m to 36.50m bgl | |

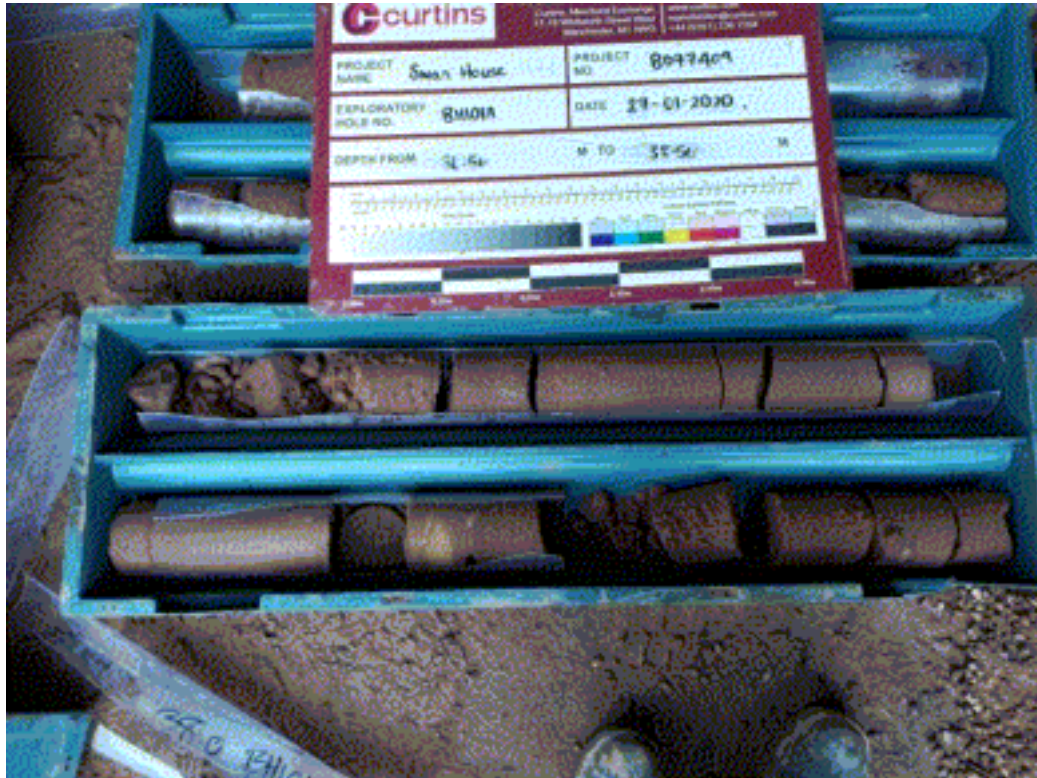
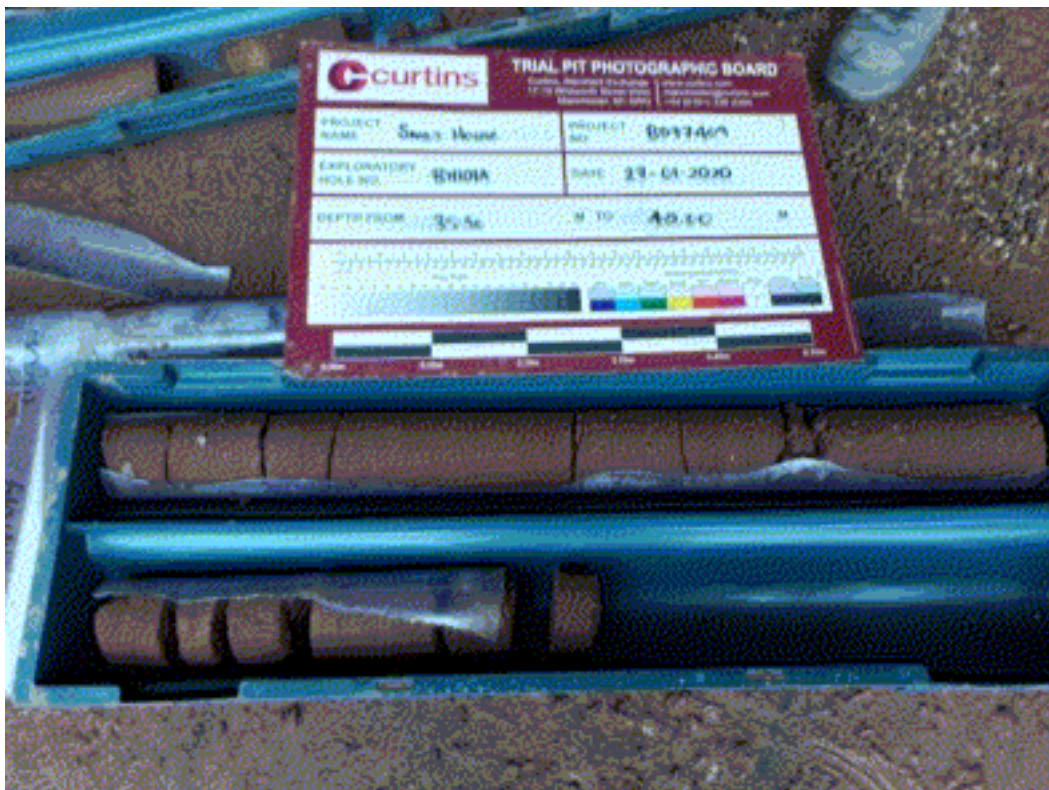
| <b>No.</b><br>5 | <b>Date:</b><br>27/01/2021 | <b>Description:</b><br>BH101A Rock Logging Photographs 36.50 to 40.50m | |

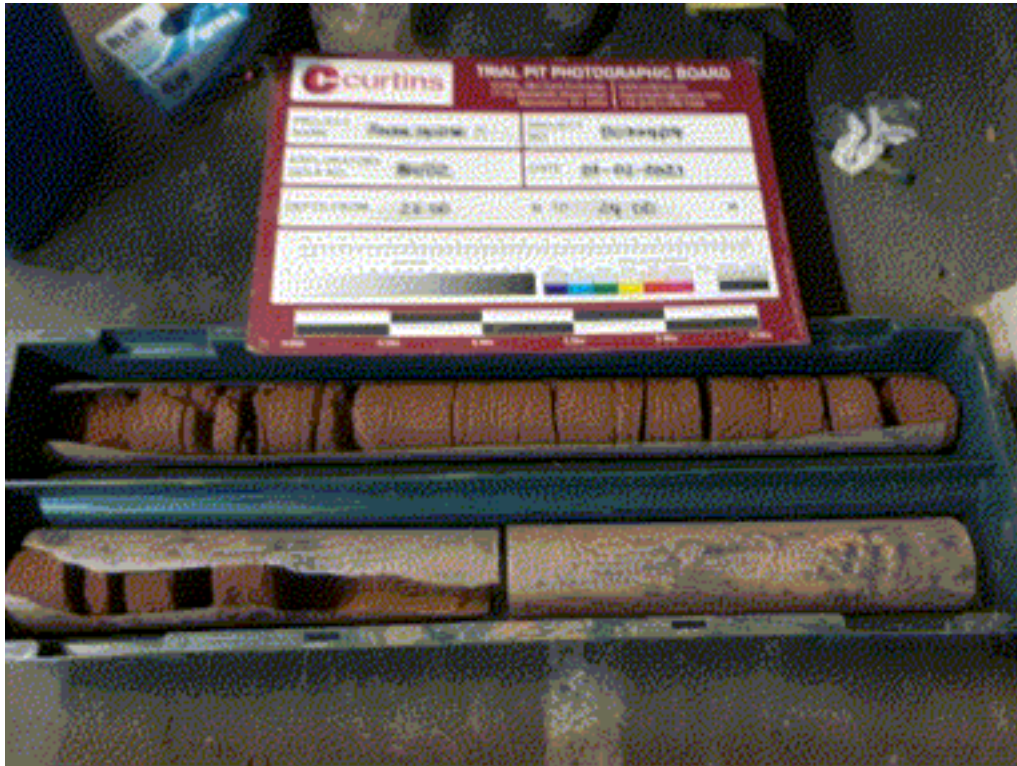
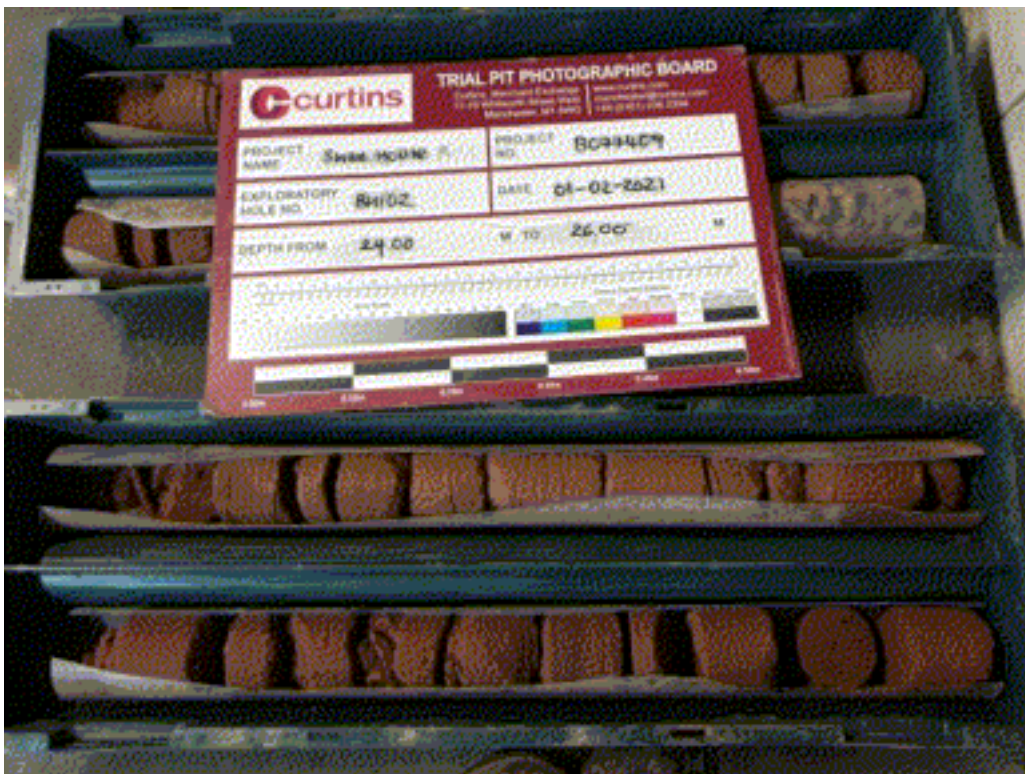
| <b>No.</b><br>6 | <b>Date:</b><br>01/02/2021 | <b>Description:</b><br>BH102 Rock Logging Photographs 22.00 to 26.00m | |

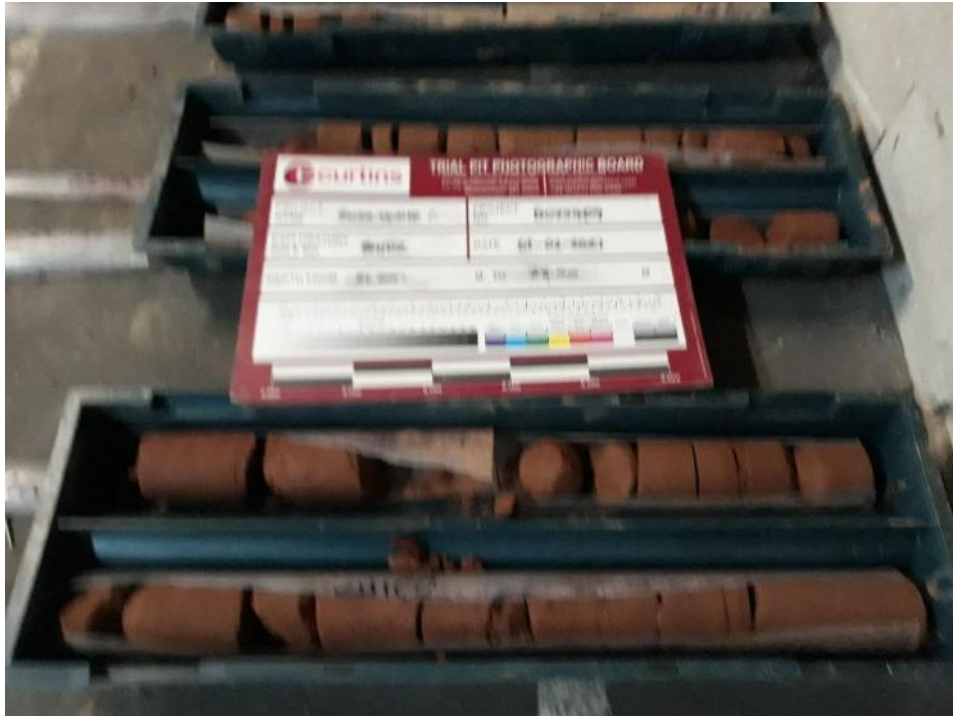
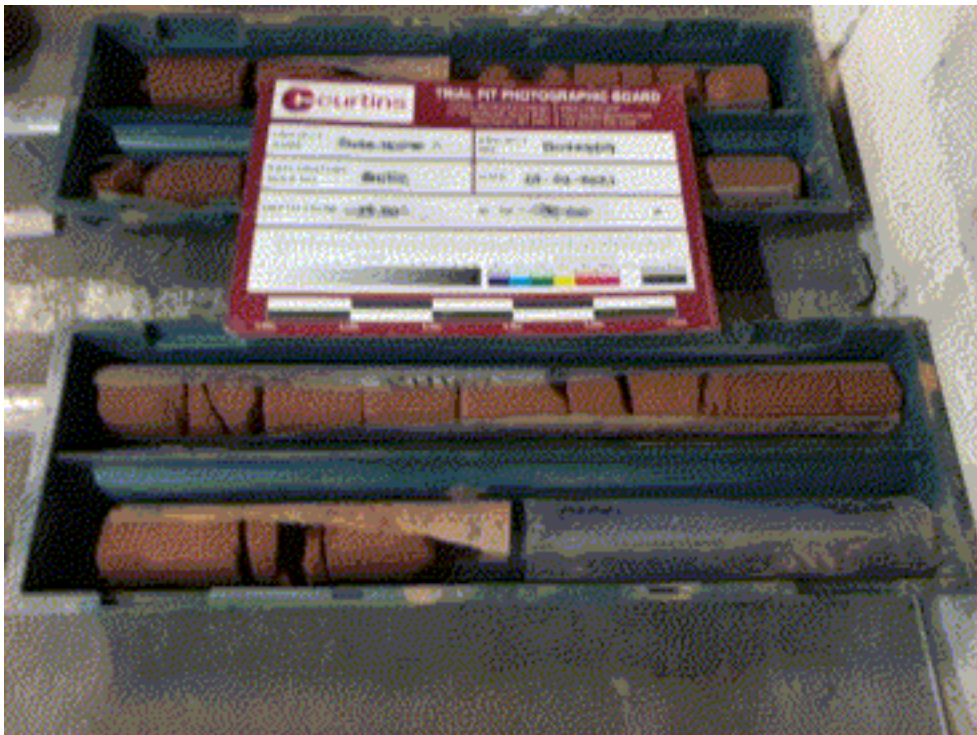
| <b>No.</b><br>7 | <b>Date:</b><br>01/02/2021 | <b>Description:</b><br>BH102 Rock Logging Photographs 26.00 to 30.00m | |

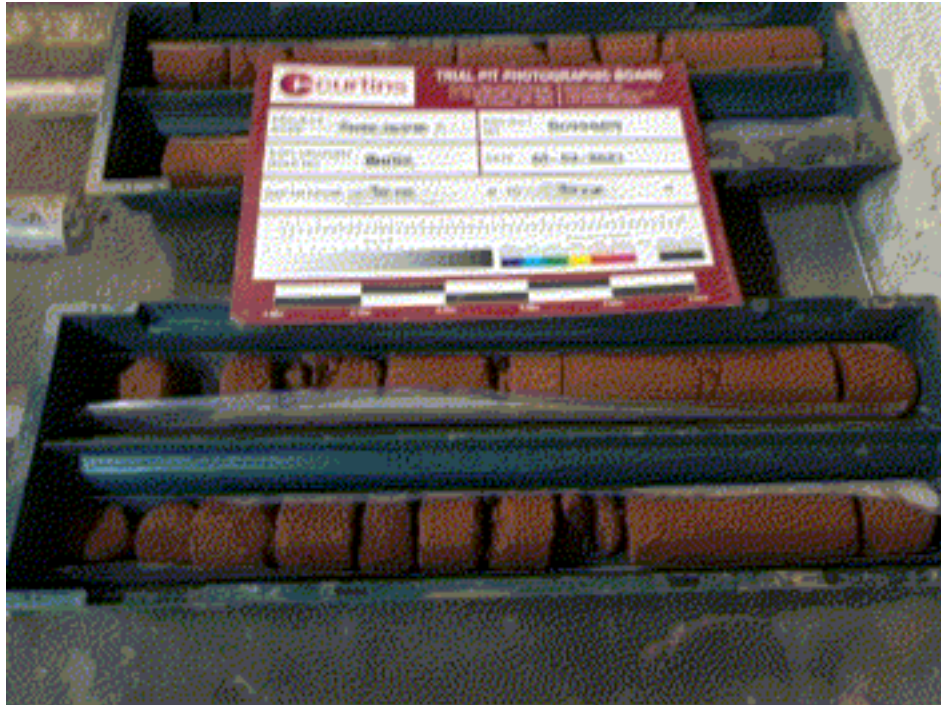
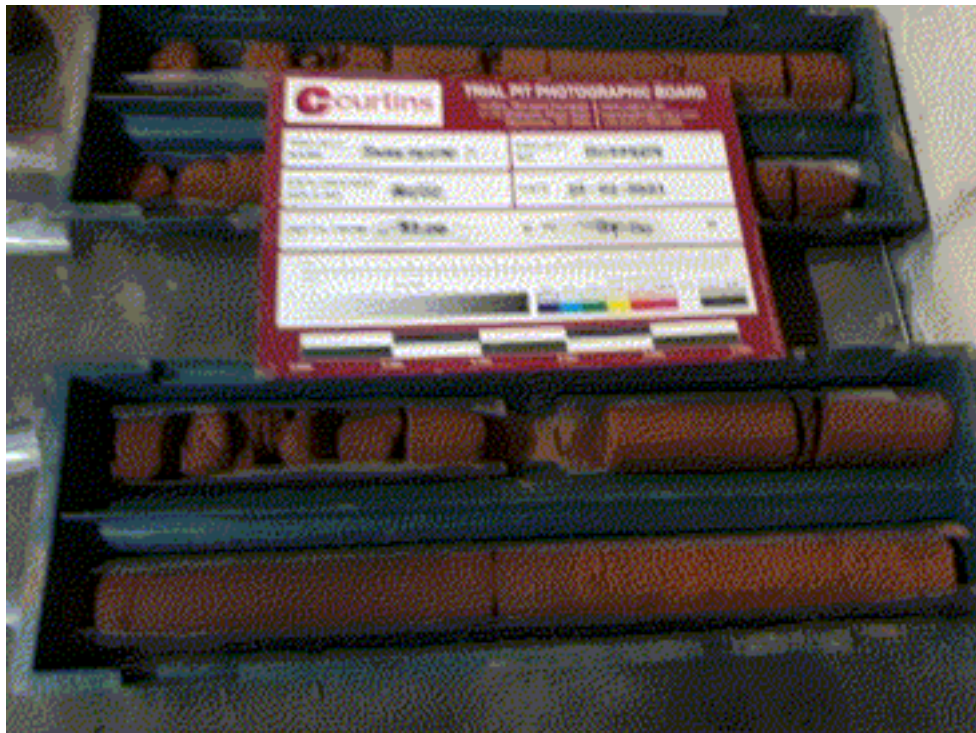
| <b>No.</b><br>8 | <b>Date:</b><br>01/02/2021 | <b>Description:</b><br>BH102 Rock Logging Photographs 30.00 to 34.00m | |

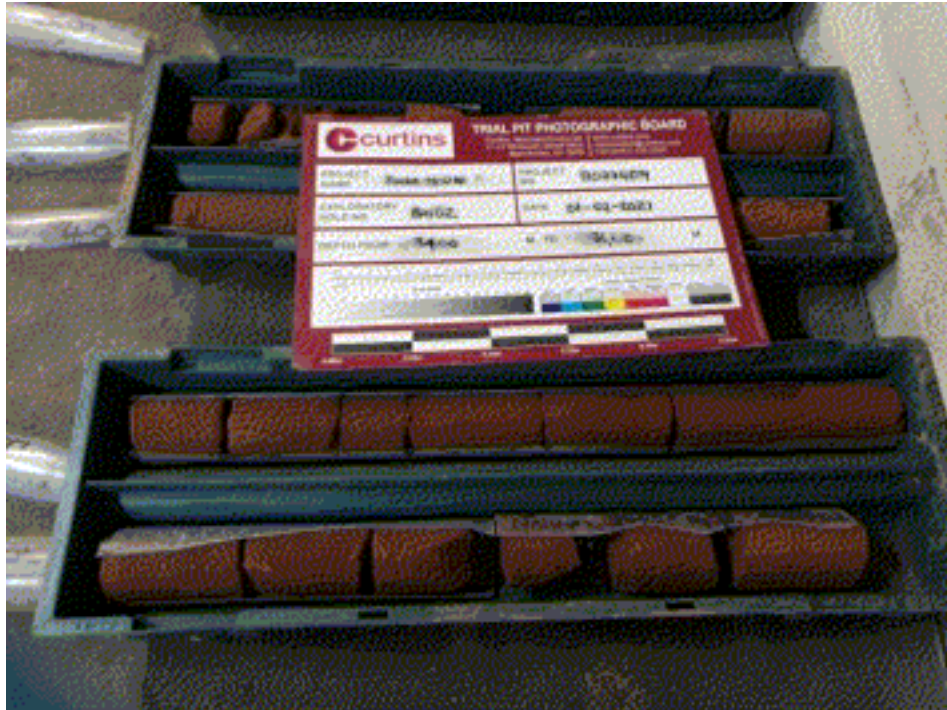
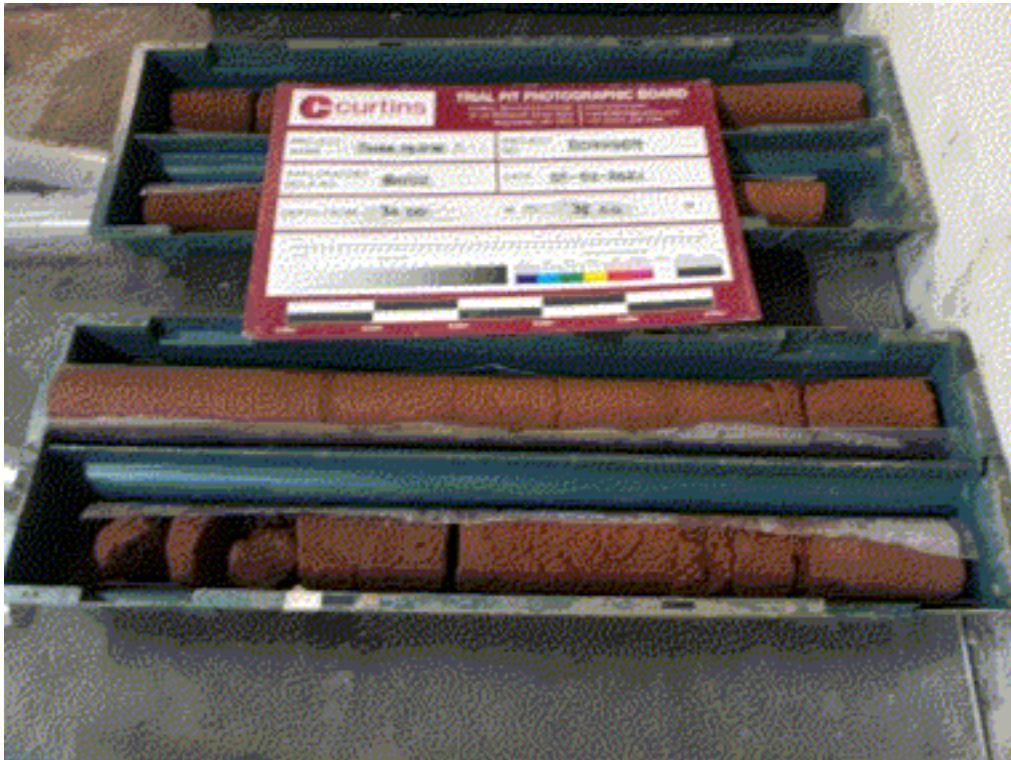
| <b>No.</b><br>9 | <b>Date:</b><br>01/02/2021 | <b>Description:</b><br>BH102 Rock Logging Photographs 34.00 to 38.00m | |

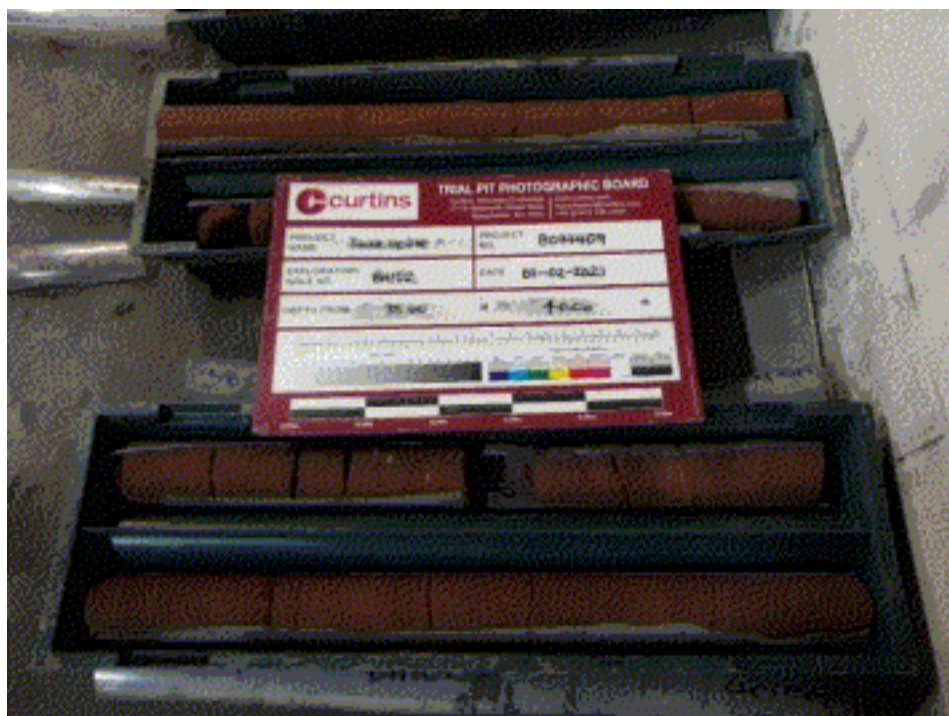
| <b>No.</b><br>10 | <b>Date:</b><br>01/02/2021 | <b>Description:</b><br>BH102 Rock Logging Photographs 38.00 to 40.00m | |

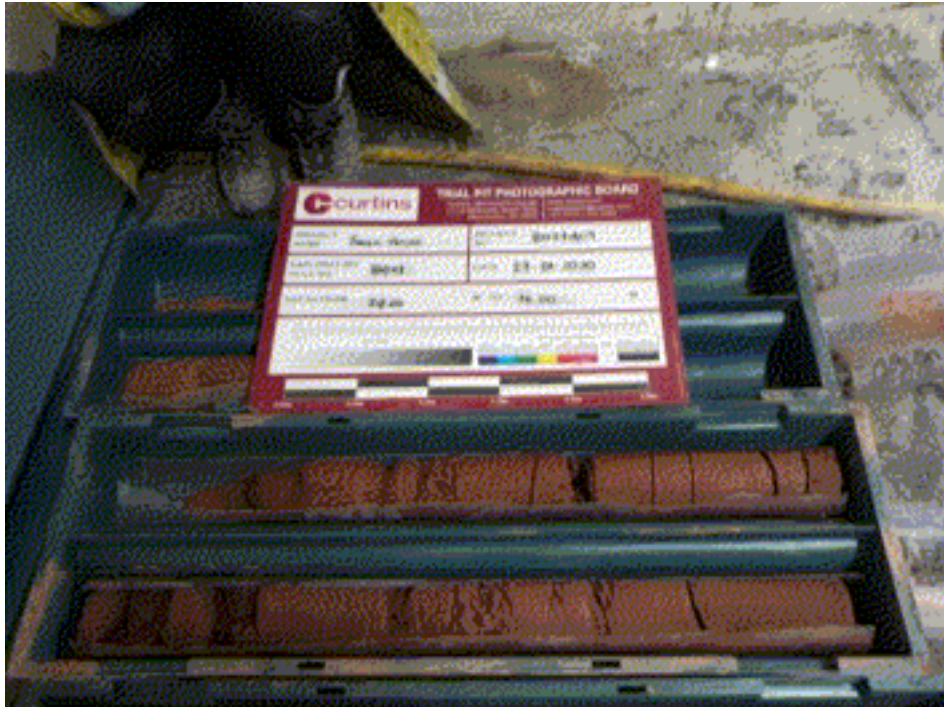
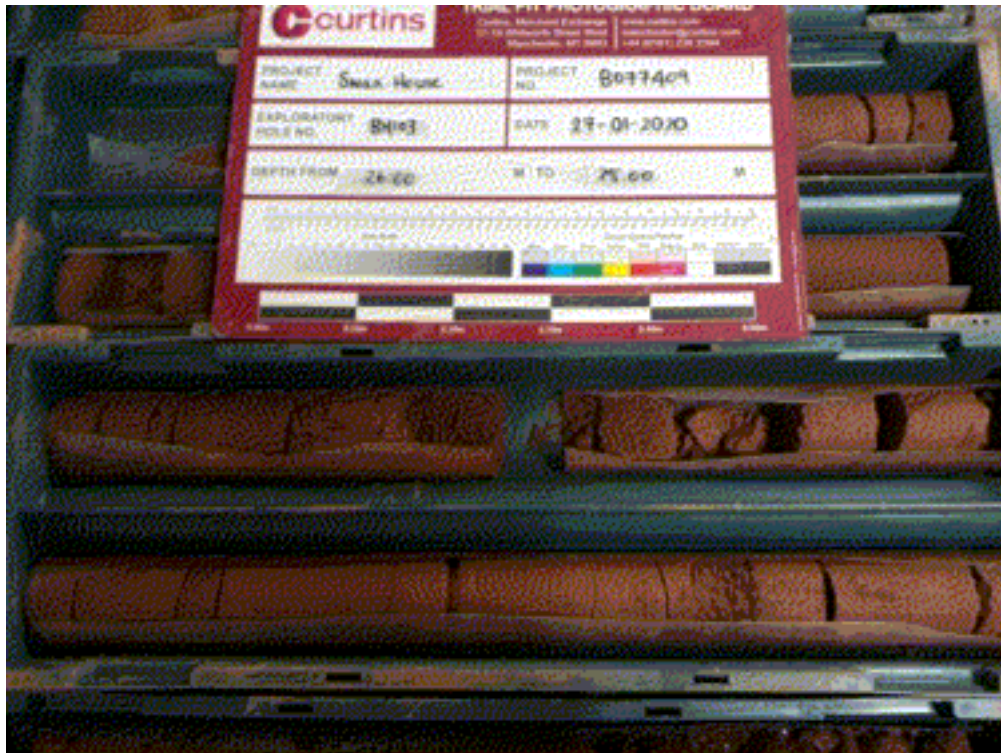
| <b>No.</b><br>11 | <b>Date:</b><br>27/01/2021 | <b>Description:</b><br>BH103 Rock Logging Photographs 24.00 to 28.00m | |

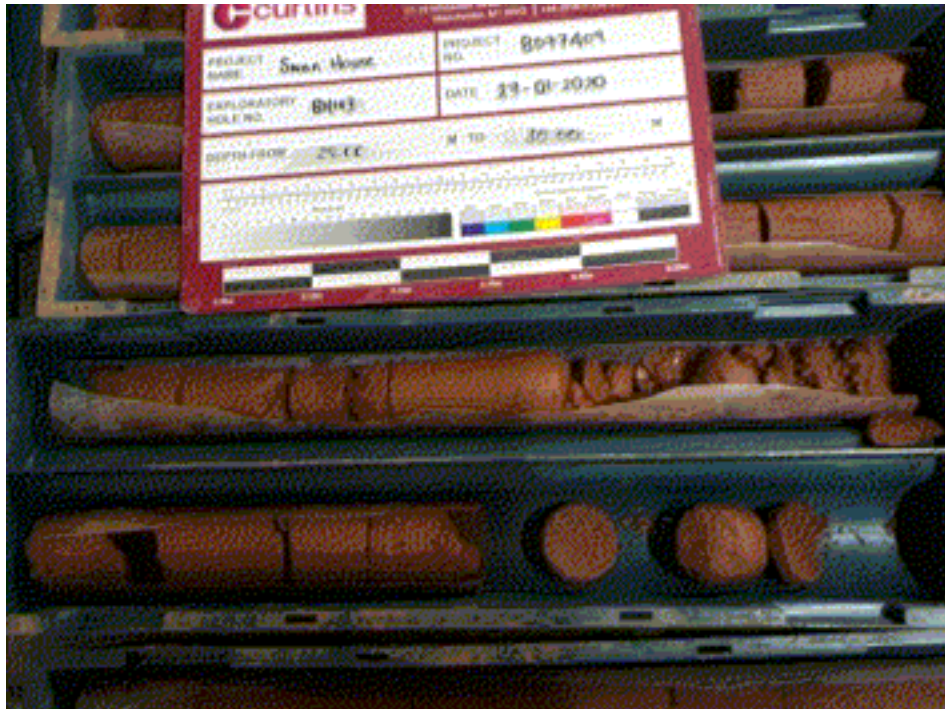
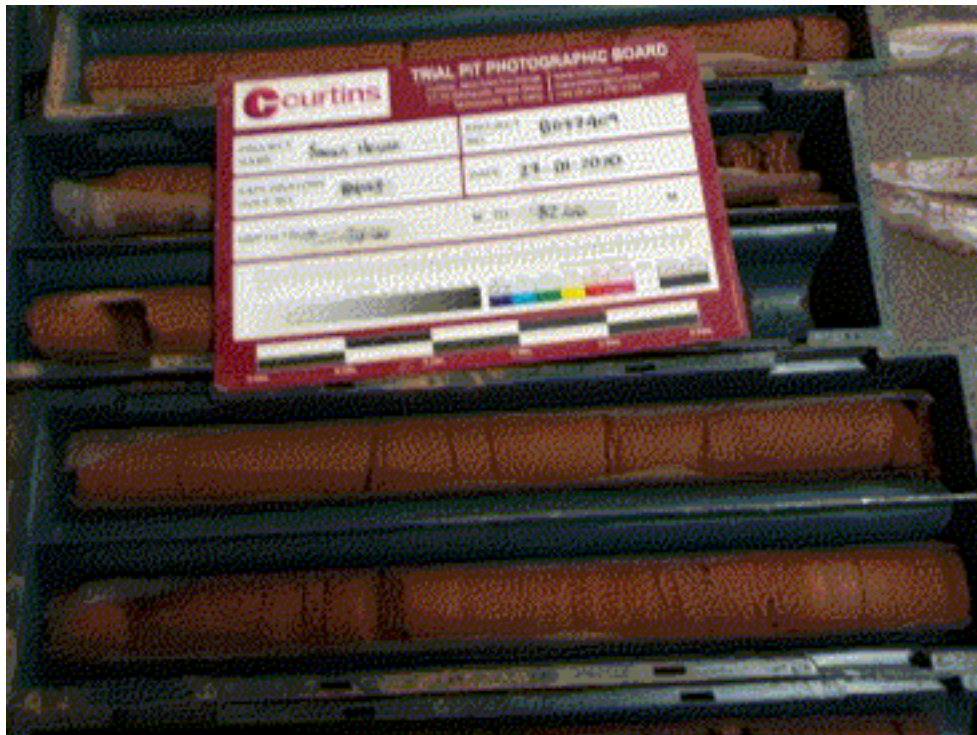
| <b>No.</b><br>12 | <b>Date:</b><br>27/01/2021 | <b>Description:</b><br>BH103 Rock Logging Photographs 28.00 to 32.00m | |

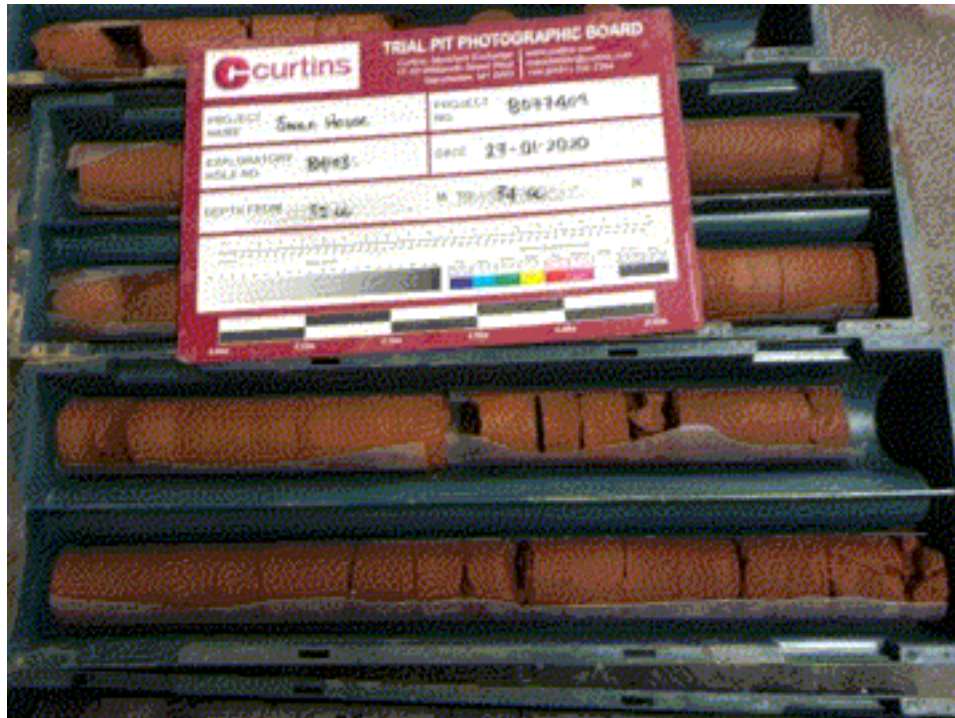
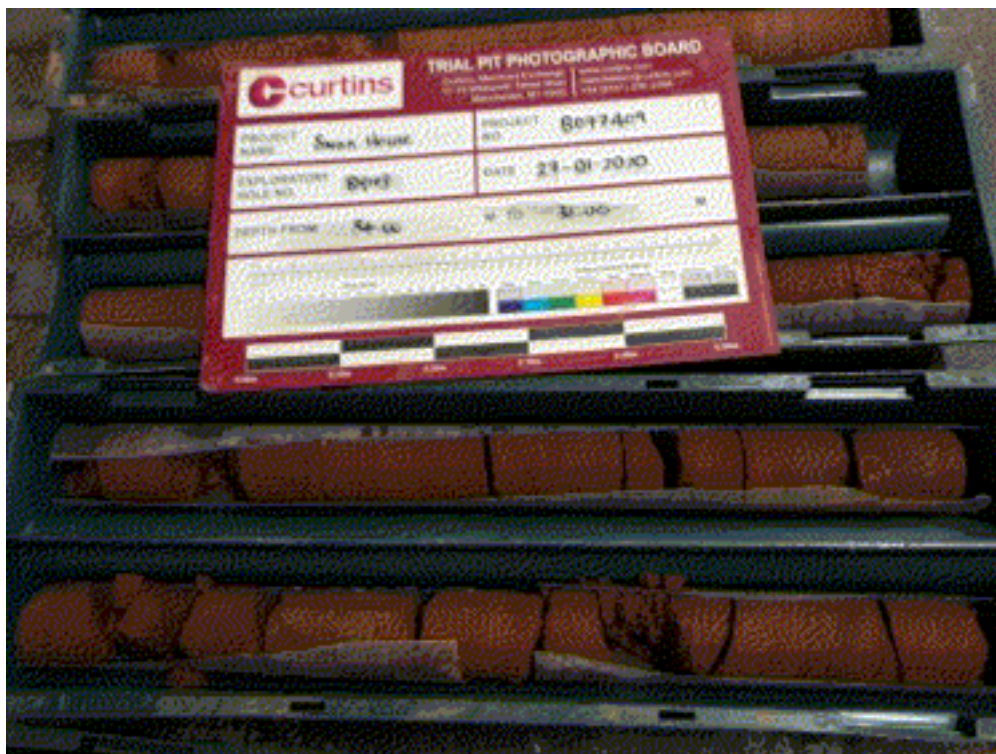
| <b>No.</b><br>13 | <b>Date:</b><br>27/01/2021 | <b>Description:</b><br>BH103 Rock Logging Photographs 32.00 to 36.00m | |

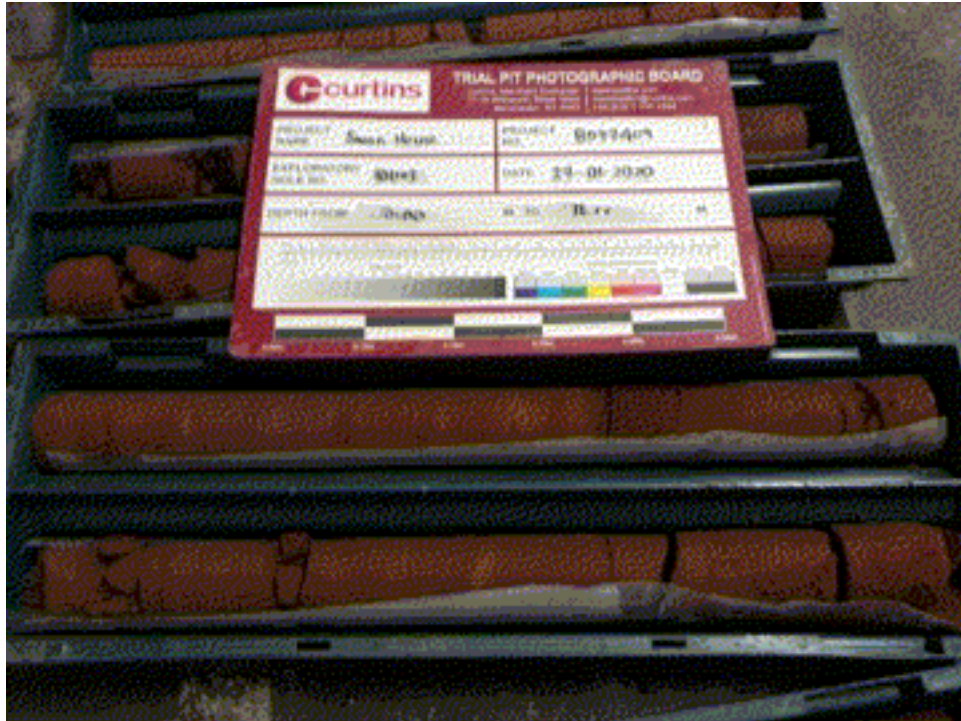
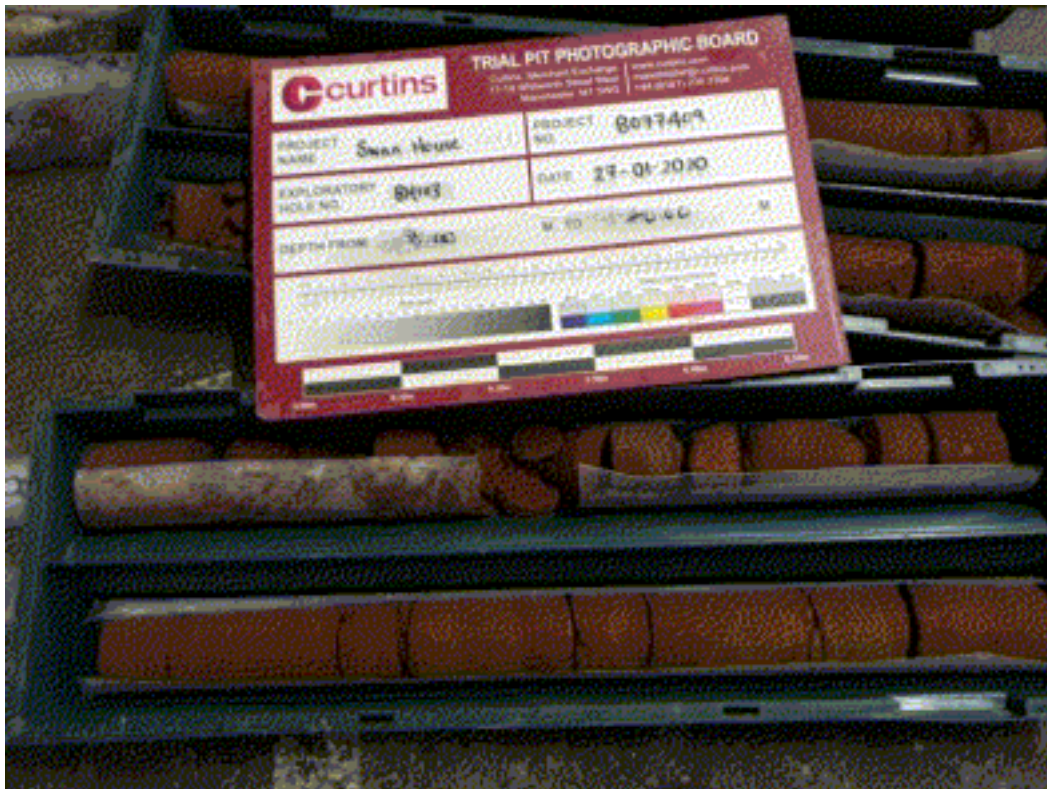
| <b>No.</b><br>14 | <b>Date:</b><br>27/01/2021 | <b>Description:</b><br>BH103 Rock Logging Photographs 36.00 to 40.00m | |
