# Oldham Road, Newton Heath

## Ground Investigation

Curtins Ref: 074031-CUR-00-XX-RP-GE-002

Site Address: Land either side of YES GROUP, 1290 – 1328, Oldham Road, Newton Heath, Manchester

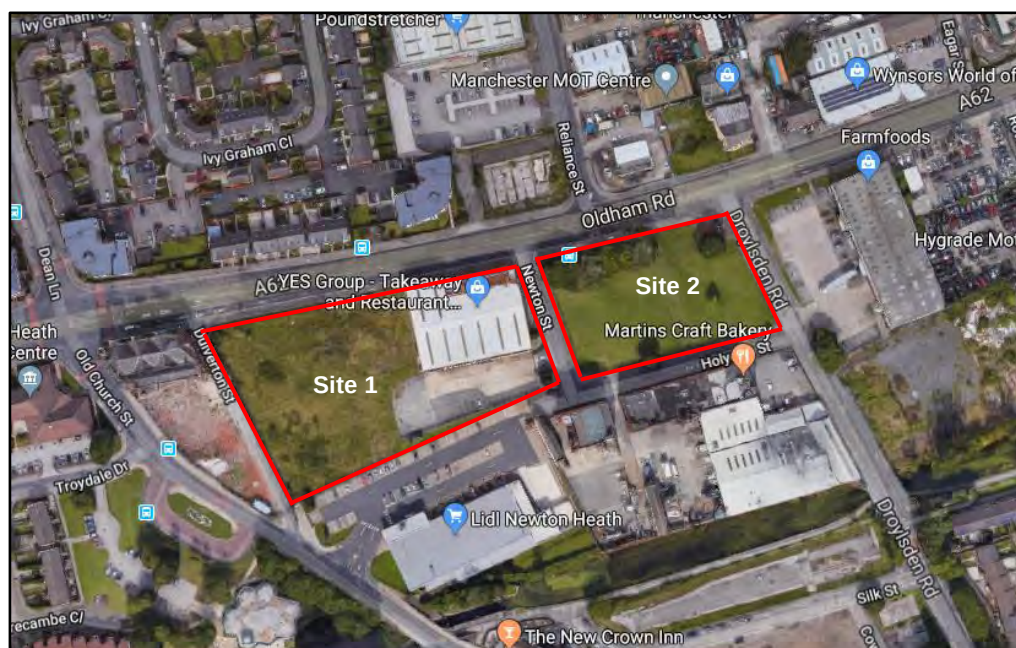
Figure 2.1a – Site Location Plan (Site 1 and 2)

To the west of Newton Street, referred to as Site 1 in this report and seen in Figure 2.1a, the site is currently occupied by a warehouse present in the north with hardstanding forming carparking for the warehouse in the south. To the west of the warehouse is grassed with denser vegetation. The whole of the western area is fenced off to the public. The site east of Newton Street, referred to as Site 2 in this report and seen in Figure 2.1a, is grassed with a few trees present in the north and is open to the public.

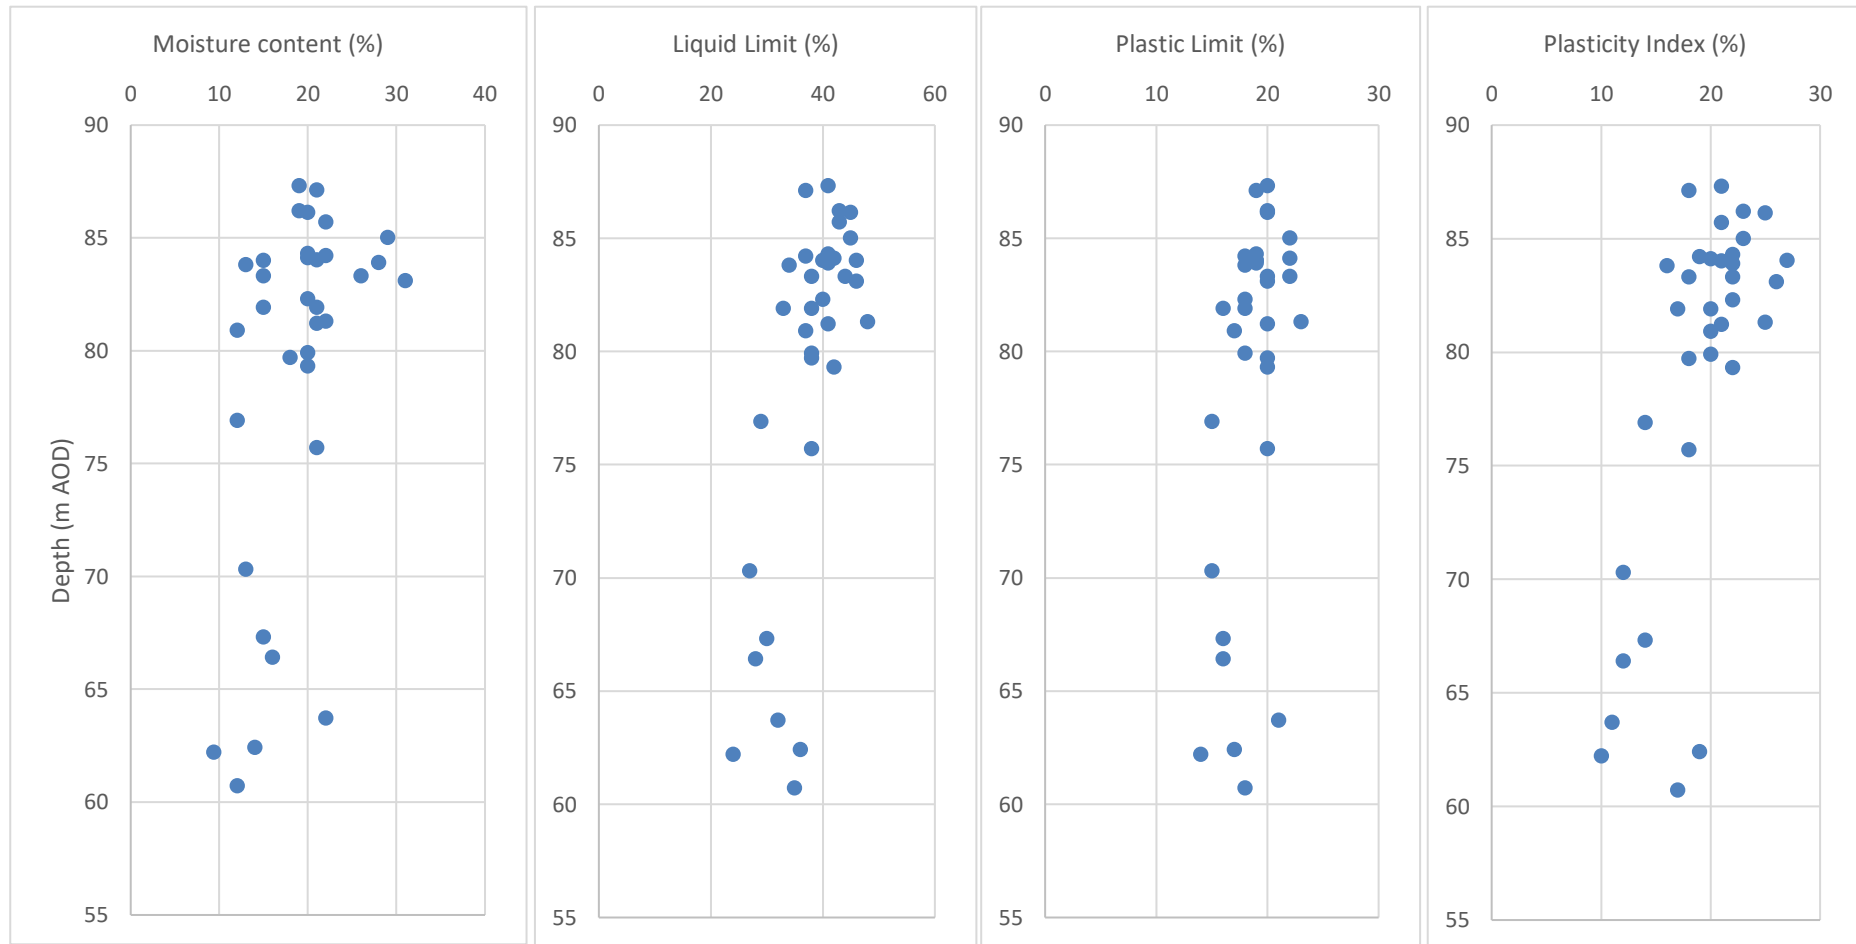
**Figure 6.2.1a – Summary of Atterberg Test Results**

The Atterberg Test results indicate a clayey soil with low to intermediate plasticity. The Plasticity Indices were generally between 10% and 27% with a decrease in plasticity index from 80.00m AOD. A high moisture content, liquid limit and plasticity index were recorded in WS05 at 2.50m bgl. The results of Atterberg Limits are presented on *Figure 6.2.1a* and *Casagrande graphs* are presented in *Appendix D*.

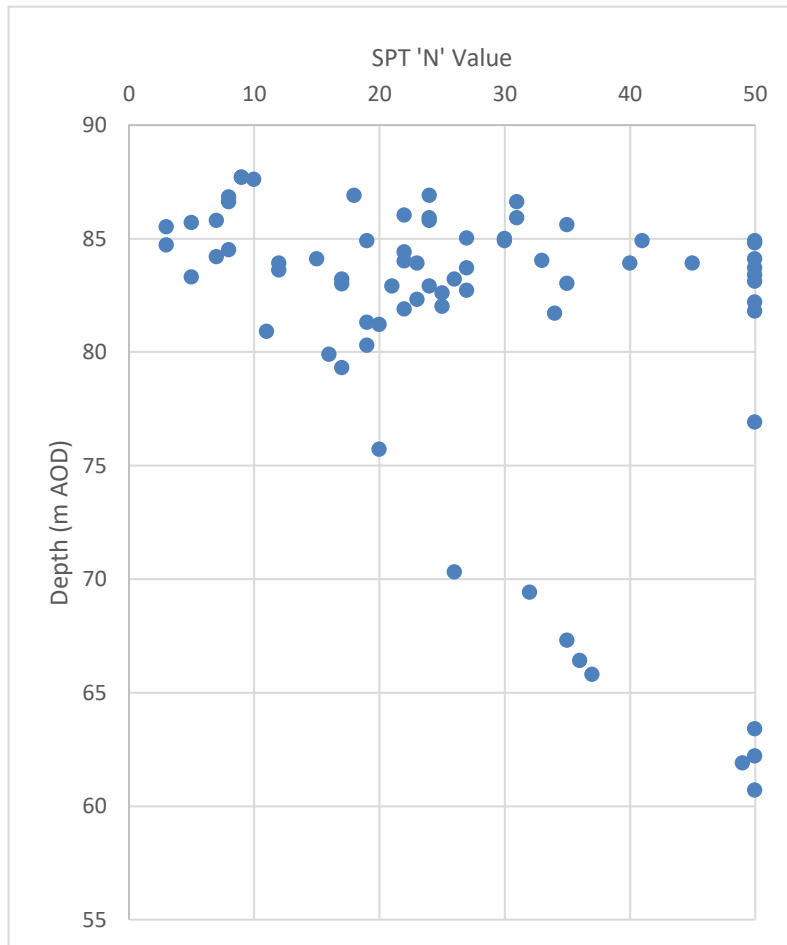
**Figure 6.2.1b – Standard Penetration Test vs. Depth**

The SPT 'N' results indicates variable stratum comprising soft to very stiff deposits. A typical increase in stiffness is observed with depth, *Figure 6.2.1b*.

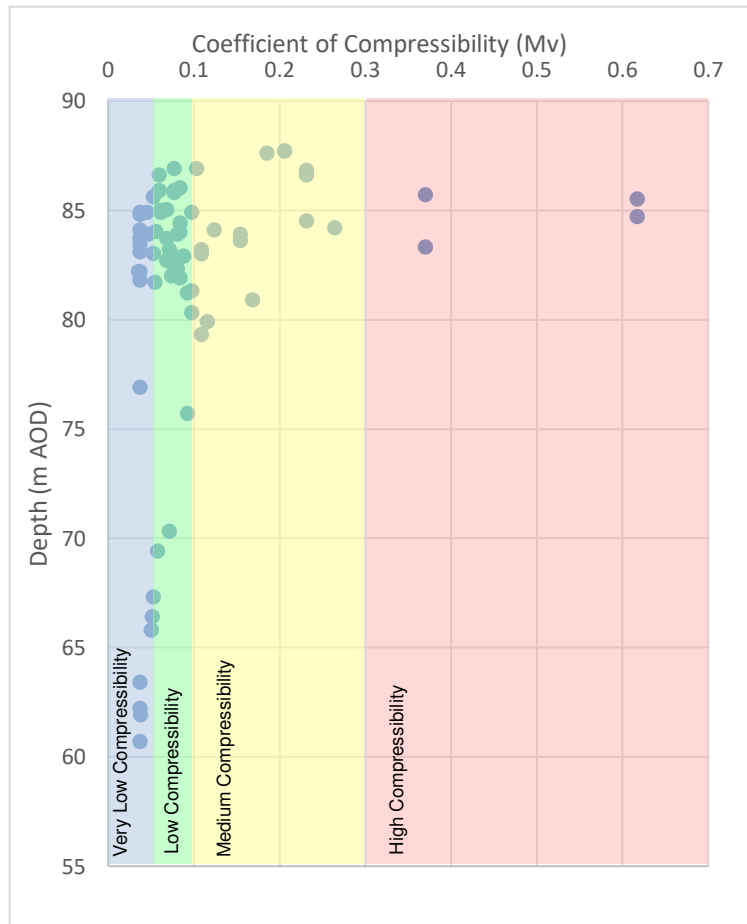
**Figure 6.2.1d** – Estimated Volume Compressibility Coefficients ( $M_v$ ) vs Depth

Using an  $f_2$  factor of 0.54 for an average plasticity index of 19%,  $M_v$  values typically range between 0.036 and 0.61  $\text{m}^2/\text{MN}$  indicating very low to high compressibility. The high compressibility material are recorded in shallow soils. Most results indicate a low to medium compressibility clay, *Figure 6.2.1d*.

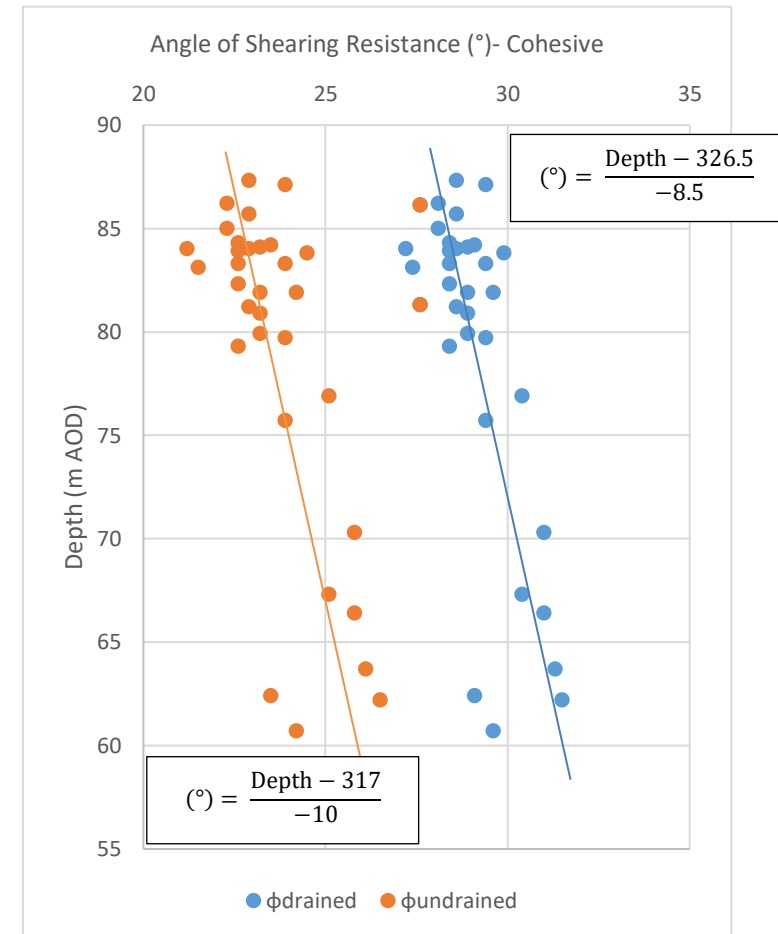
**Figure 6.2.1e** – Angle Shearing Resistance (Cohesive) vs Depth

The Angle of Shearing Resistance,  $\phi'$ , for the cohesive Glacial Till has been derived from the correlation with Plasticity Indices (Ref. 10). The values are shown in *Figure 6.2.1e*.

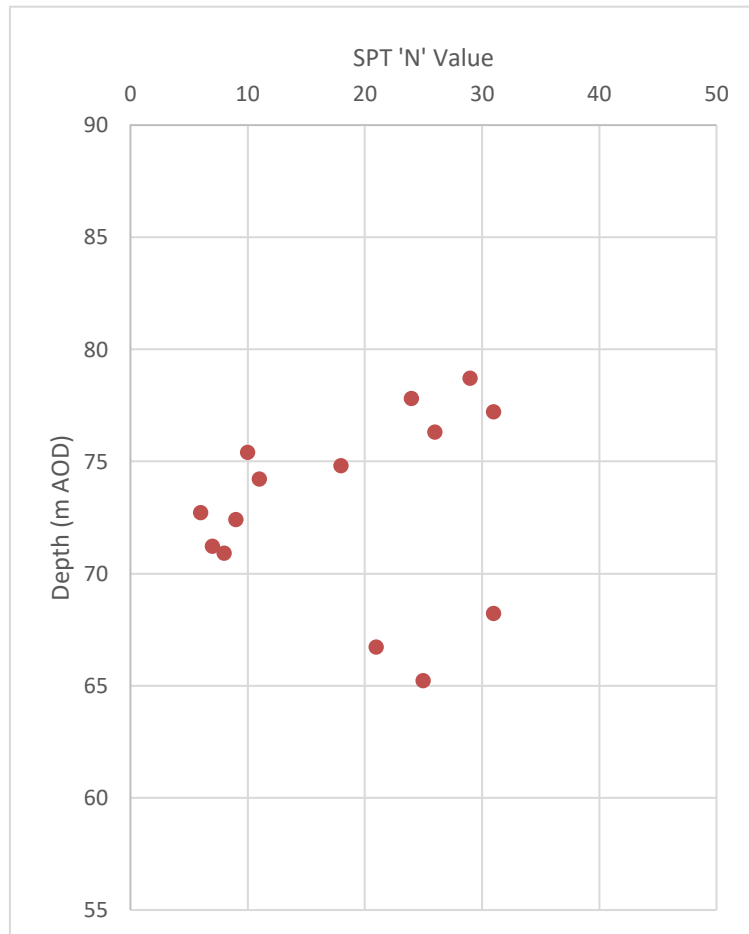
**Figure 6.2.2a** – Standard Penetration Test vs. Depth

Fourteen SPT 'N' values were recorded in the granular strata, ranging between 6 and 31. The SPT 'N' values indicate loose to dense deposits identifying variable ground conditions across the site. The results are shown in *Figure 6.2.2a*.

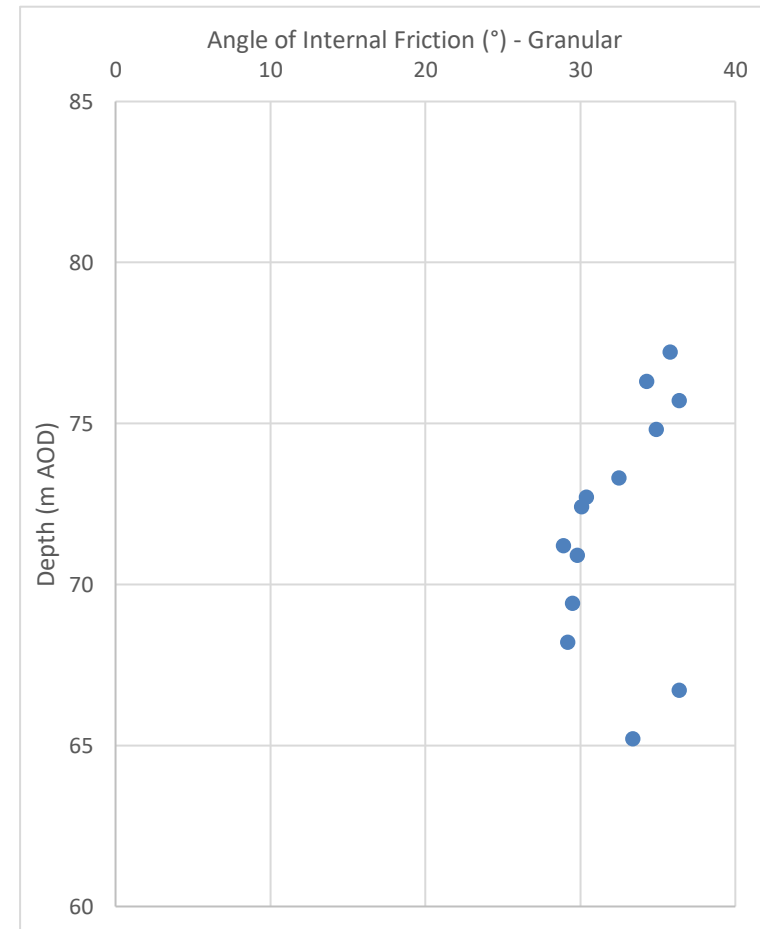
**Figure 6.2.2b** – Angle of Internal Friction (Granular) vs Depth

A moderately conservative characteristic Angle of Shearing Resistance ( $\phi'$ ) has been derived from correlation with SPT N values (Peck et al, 1967, Ref 11) and a review of published values. The results are shown in *Figure 6.2.2b*.

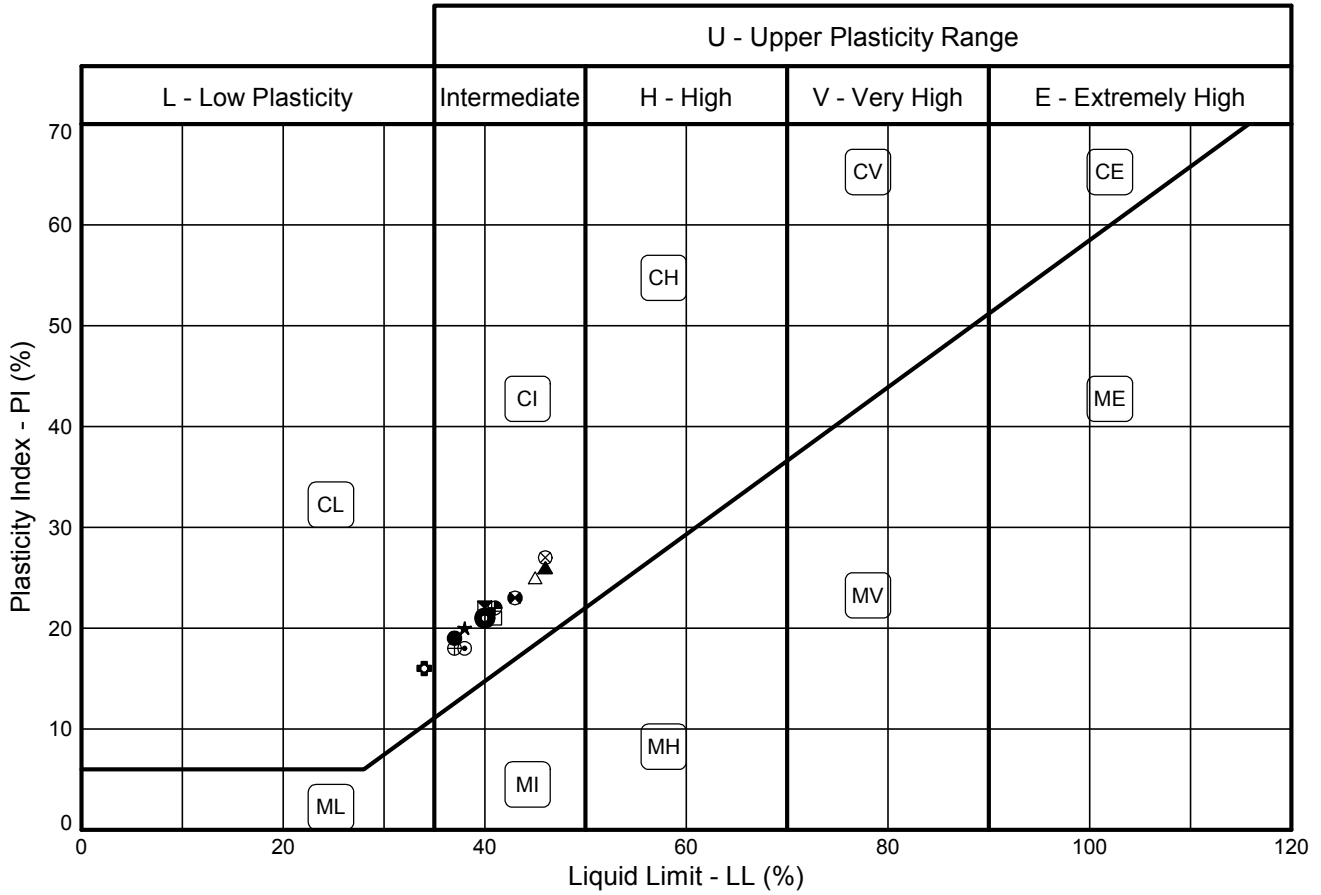
# PLASTICITY CHART - PI Vs LL

In accordance with BS5930:2015  
Testing in accordance with BS1377-2:1990

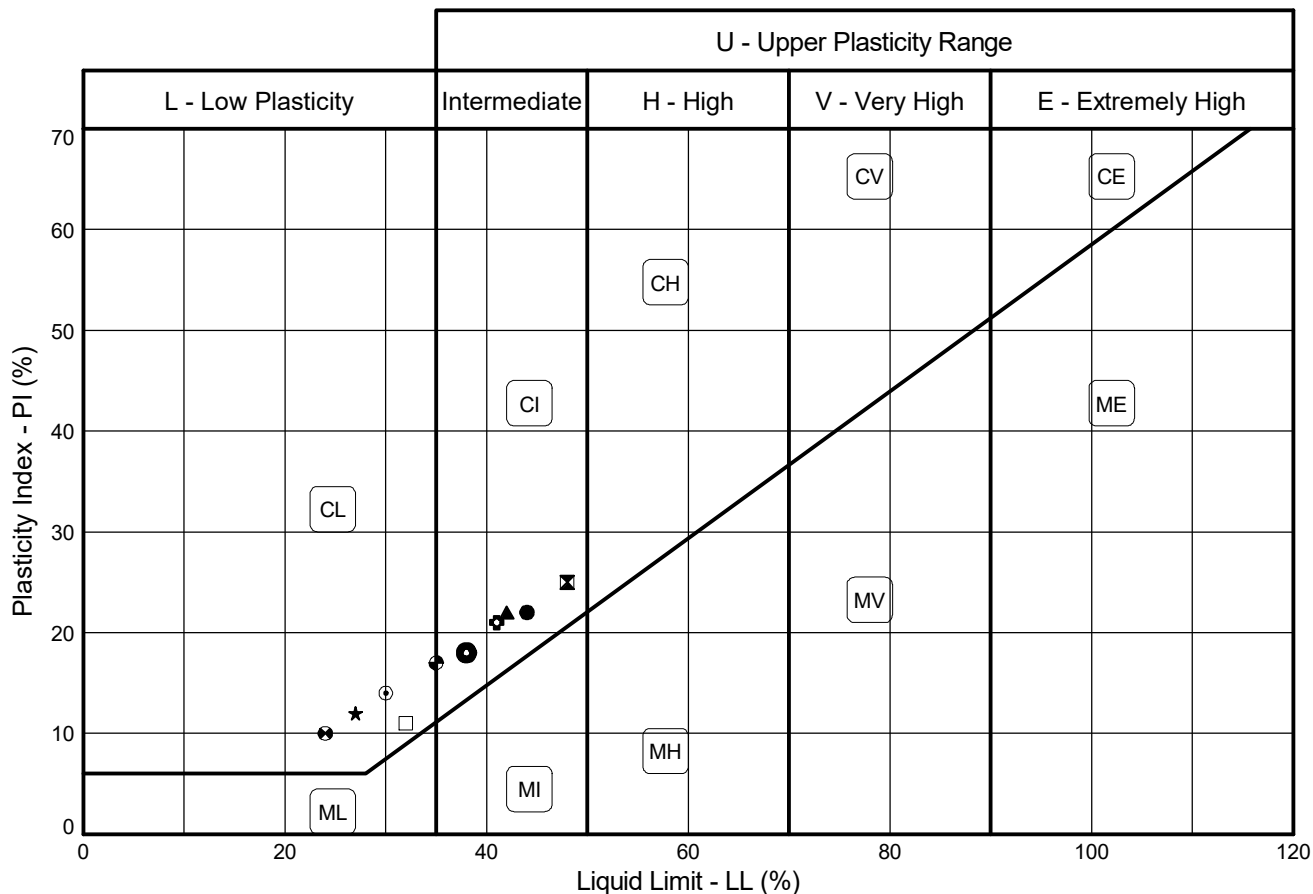
# PLASTICITY CHART - PI Vs LL

In accordance with BS5930:2015  
Testing in accordance with BS1377-2:1990

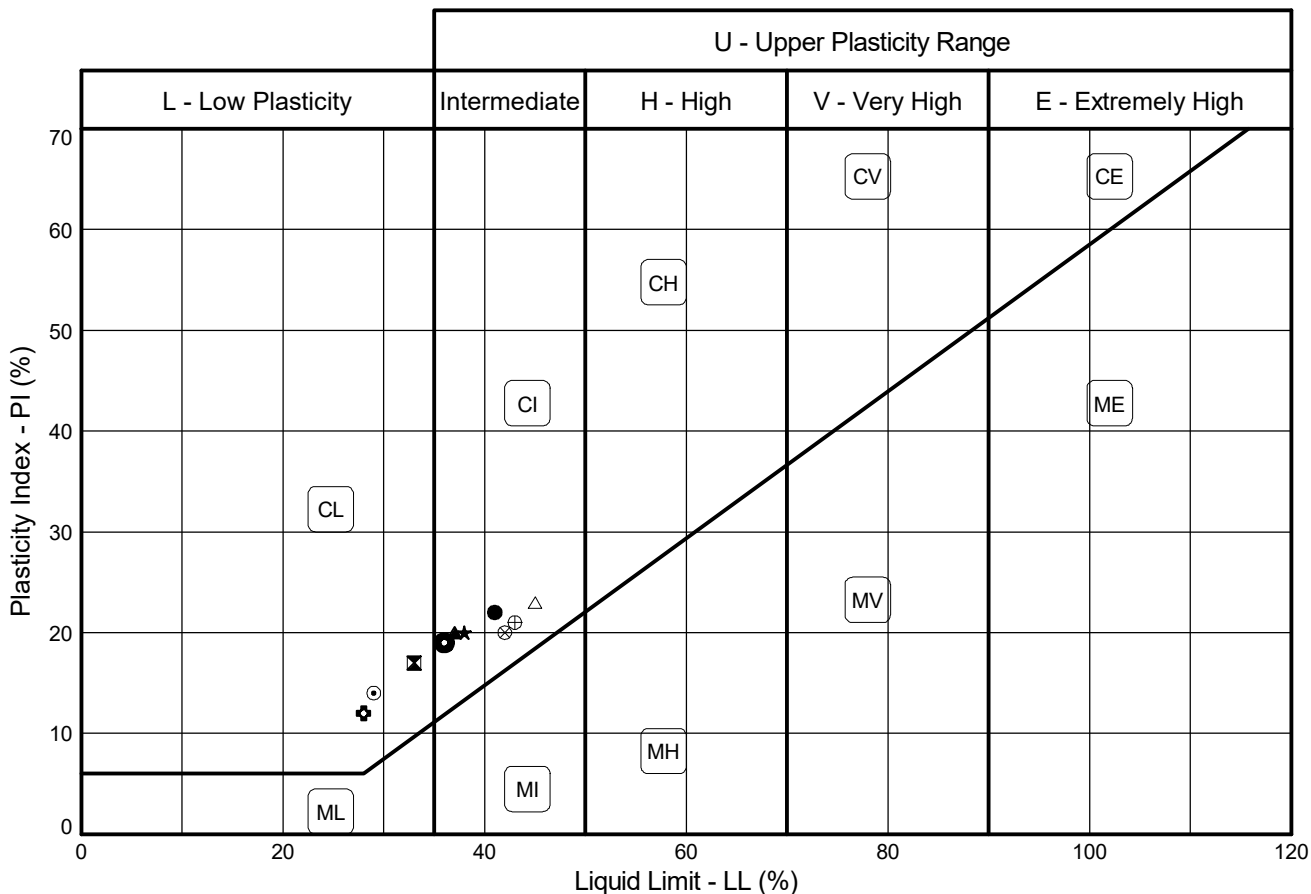
# PLASTICITY CHART - PI Vs LL

In accordance with BS5930:2015  
Testing in accordance with BS1377-2:1990

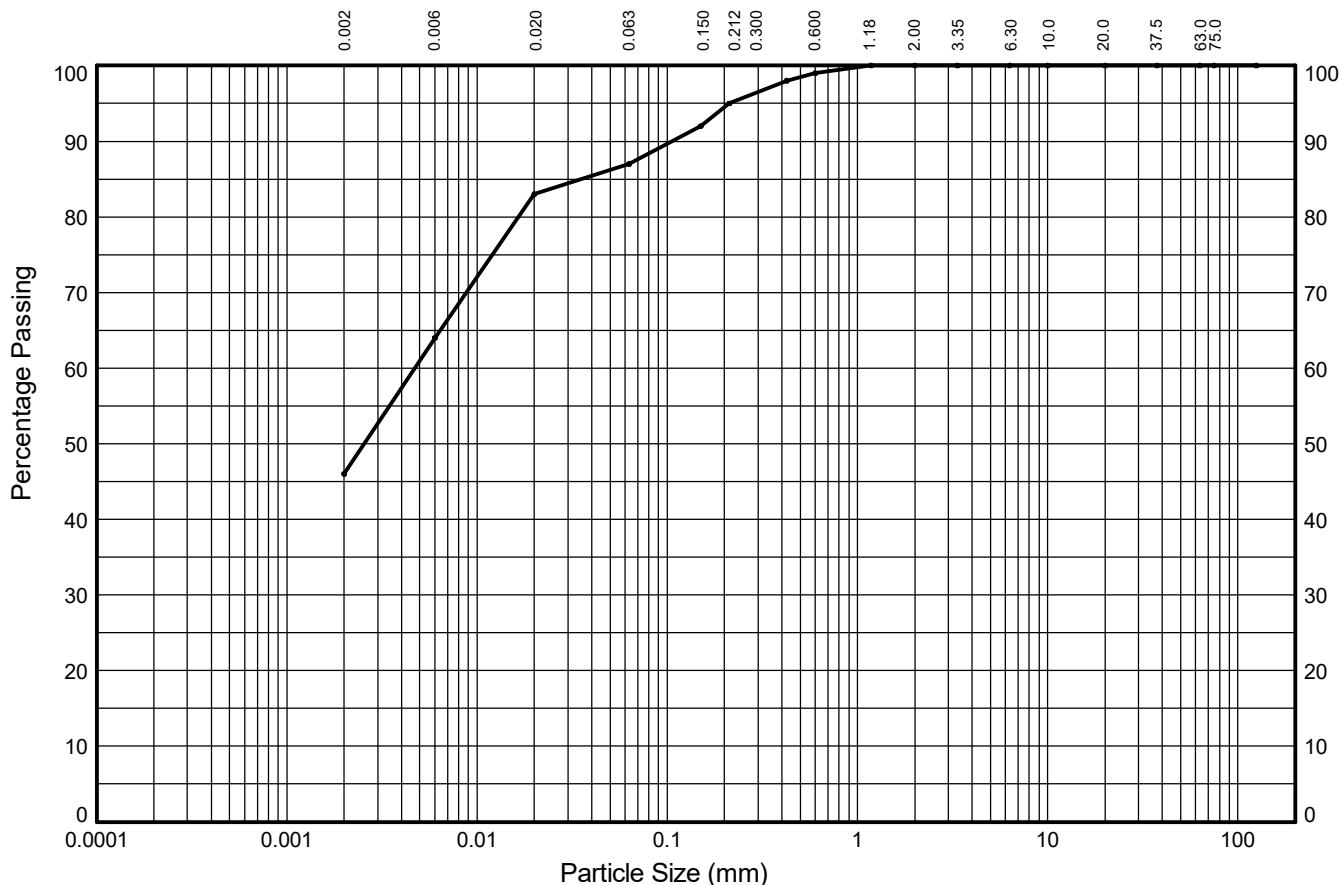
Position ID: **CP101** Sample Ref: **20/09769/3** Sample Type: **D** Depth (m): **6.00**

In accordance with clauses 9.2, 9.4 of BS1377:Part 2:1990

| CLAY | fine | medium | coarse | fine | medium | coarse | fine | medium | coarse | COBBLES |
|---|---|---|---|---|---|---|---|---|---|---|
| | 18% | 19% | 4% | 7% | 5% | 1% | 0% | 0% | 0% | |
