# 54-58 Great Ancoats Street Disabled Access Arrangements

This note has been prepared by Nexus Planning on behalf of La Petite Mort Tattoos Ltd, to outline the access arrangements in support of a planning application submitted to Manchester City Council for a change of use at the second floor of 54-58 Great Ancoats Street, Manchester. We are submitting floorplans of the ground floor and first floor alongside this note to support our findings.

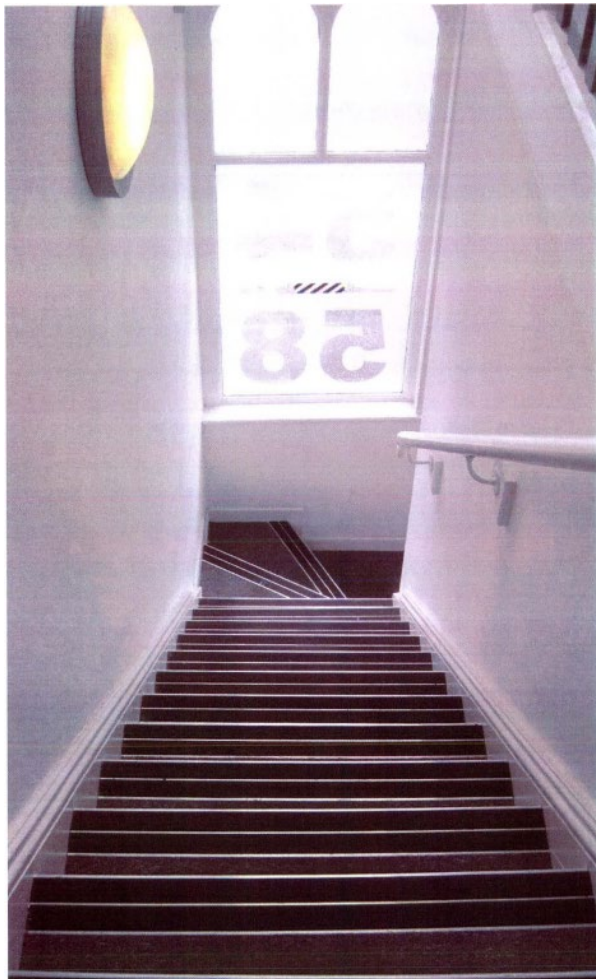
Photograph 1: Stairs leading to first floor

The existing stairwell (see Photograph 1) is also too narrow and with winders at the lower level and the small landing (see Photograph 3) at the upper level along with the two steps up into the proposal (see Photograph 2); there is insufficient space to install any means of stair lift and provide sufficient access both onto and off a stair lift.

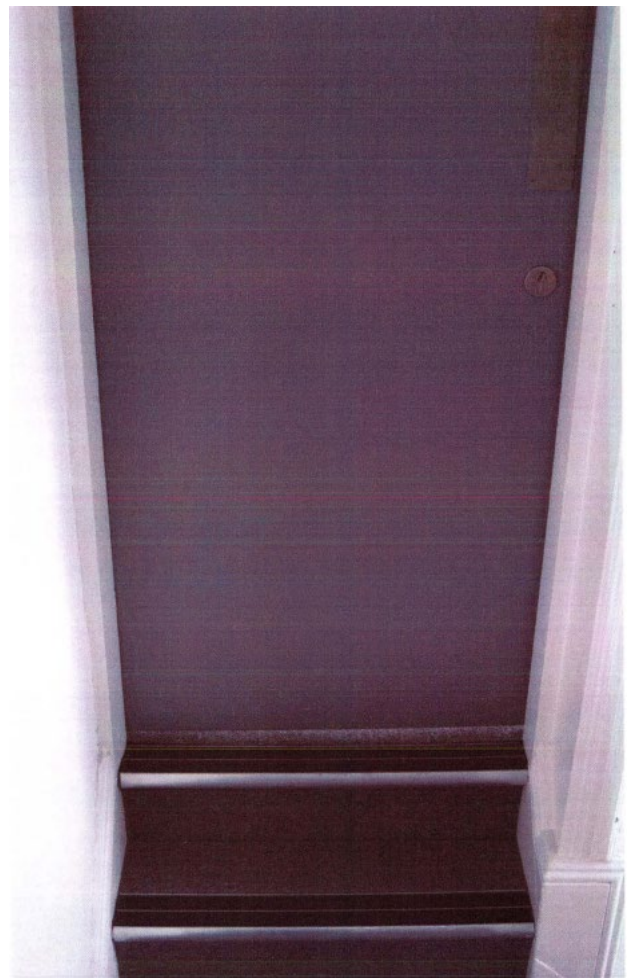
Photograph 2: Two steps to first floor entrance

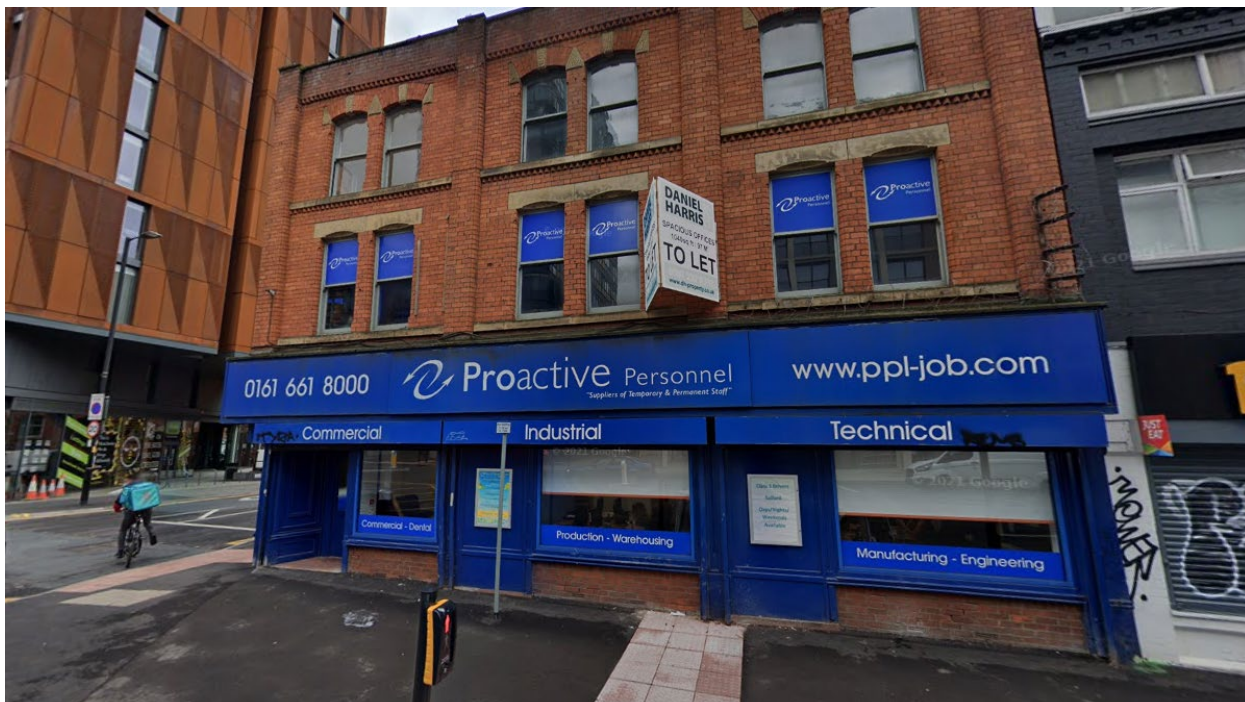
Photograph 4: Existing front elevation

The proposed change of use will inherit the existing property's approved arrangements with respect to all users, equal and convenient access to the building and spaces, and public transport network (see attached Photographs 4 and 5).

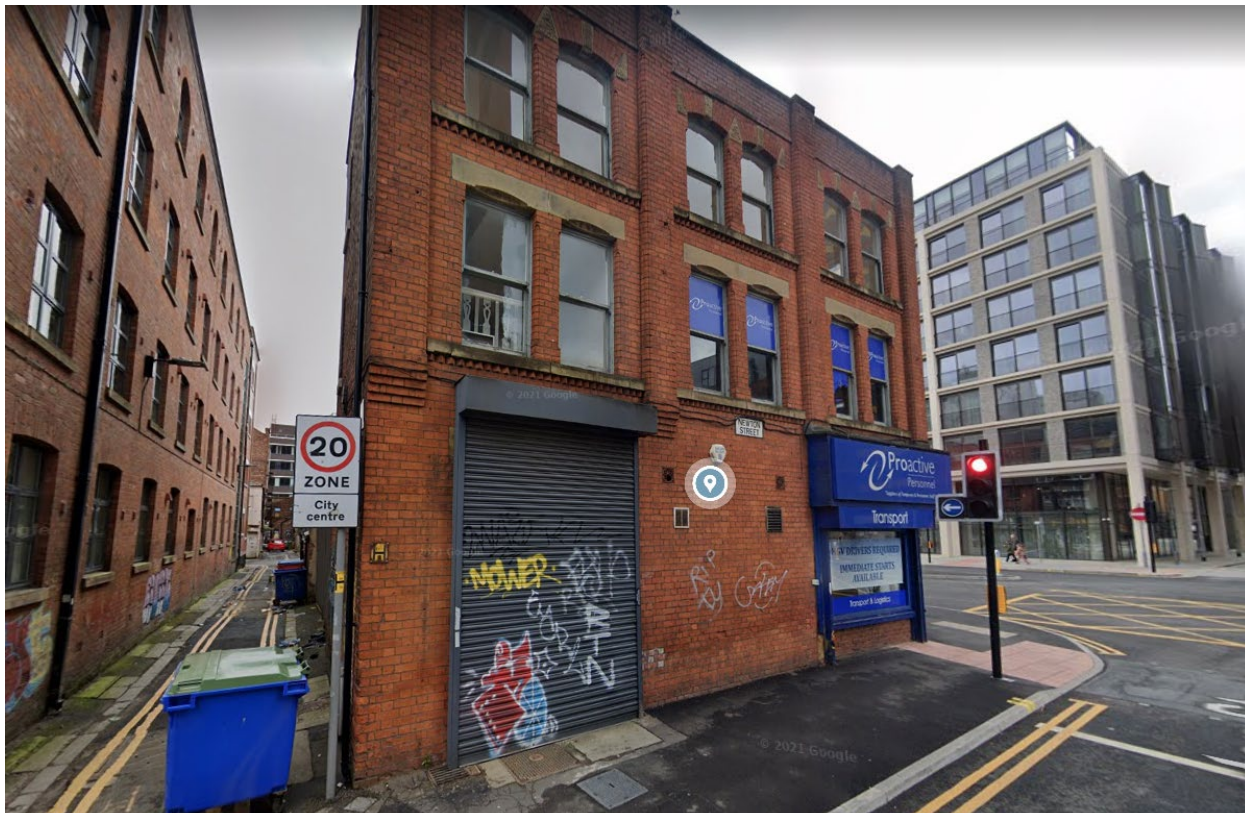
Photograph 5: Existing side elevation
