## Ground Investigation Report

Proposed artificial 3G pitch

Didsbury High School, Manchester

Document Title: Ground Investigation Report  
Document no.: STT-5478M-G01 Rev B  
Date: November 2021  
Client: McArdle Sports Tec

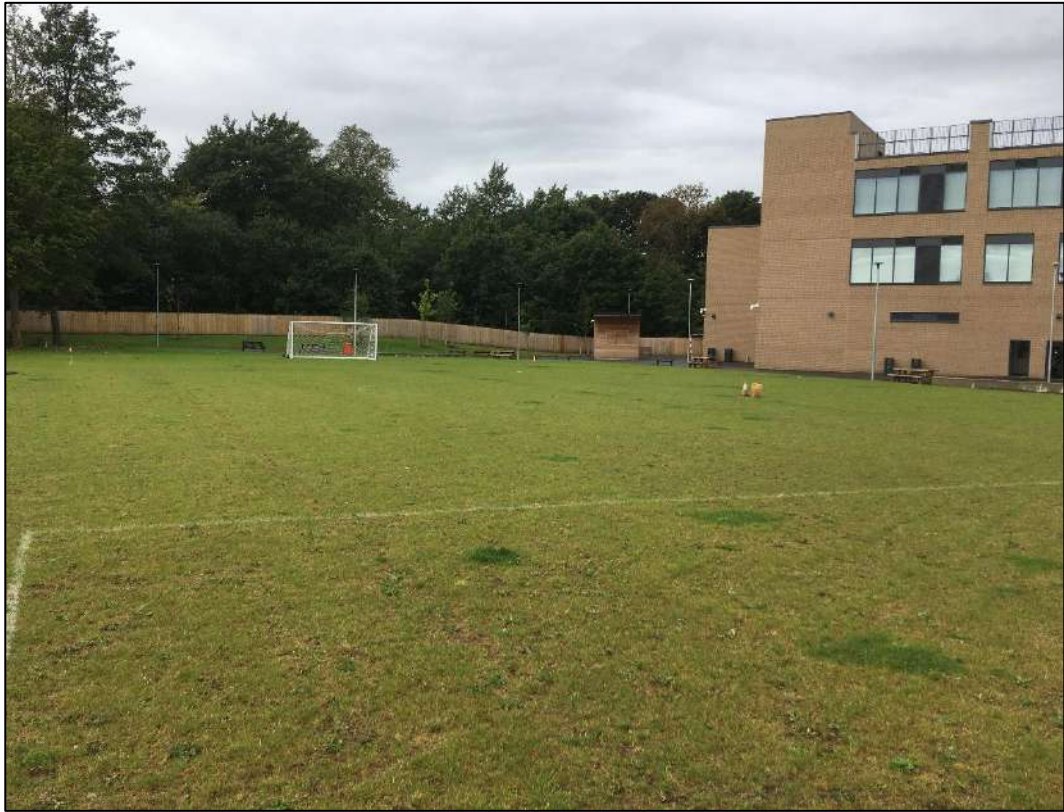
*Figure 1-1 At northeast of pitch looking towards the southwest*

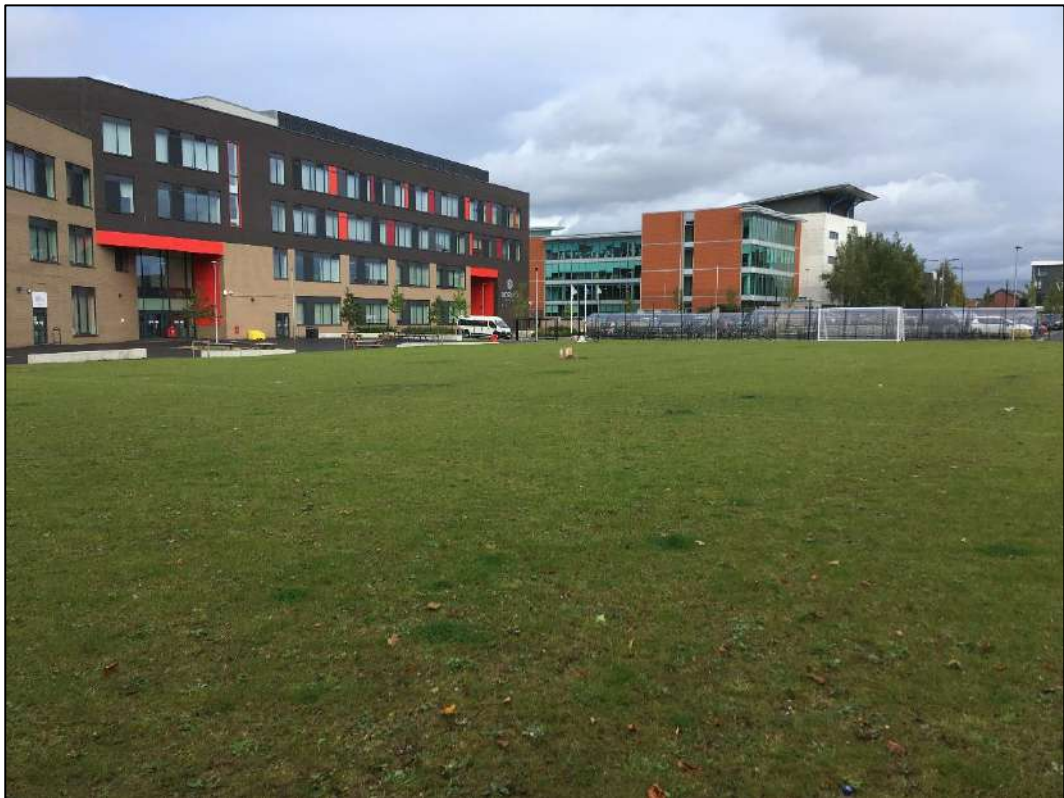
*Figure 1-2 At southeast of pitch looking towards the northwest*

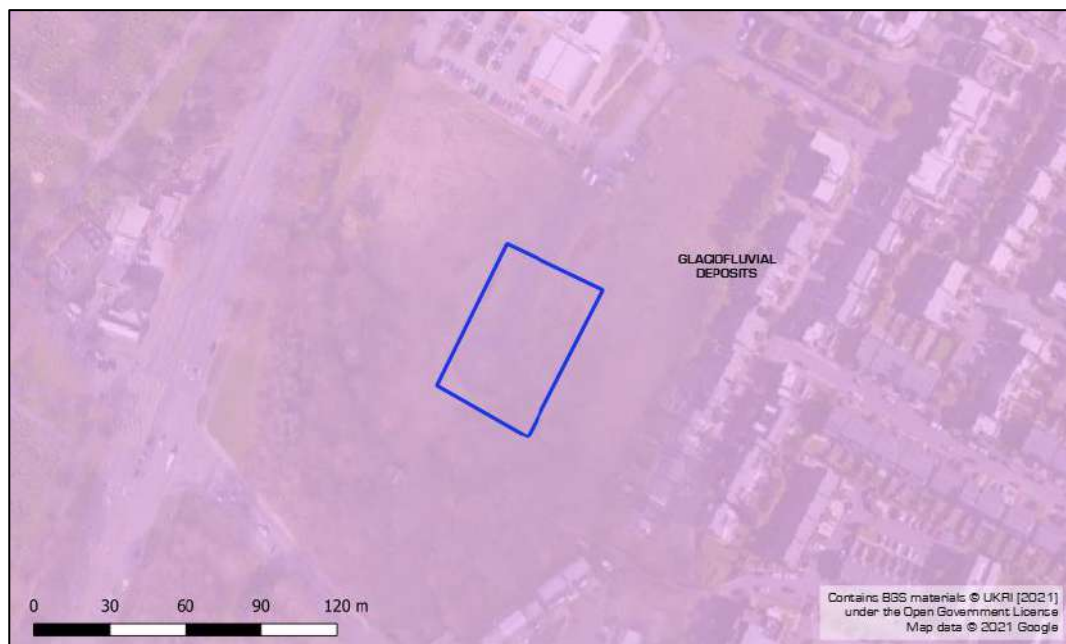
Figure 2-1 *Superficial geology*  
Map data © 2020 Google. Contains BGS materials © UKRI [2021]

2.2.2 The table below summarises recorded geological conditions on site:

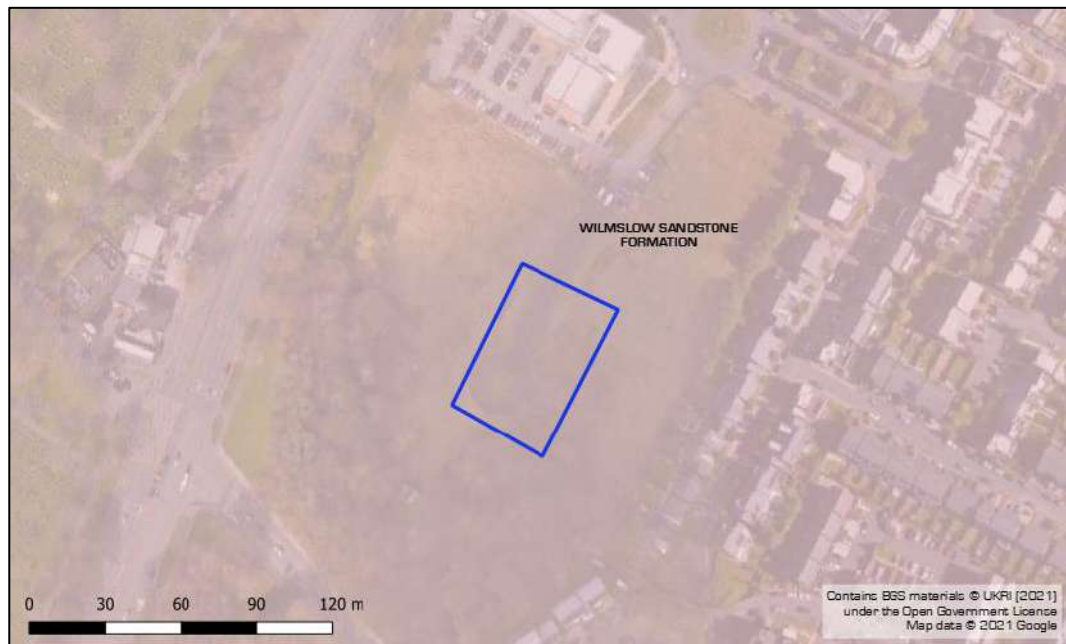
Figure 2-2 Bedrock geology

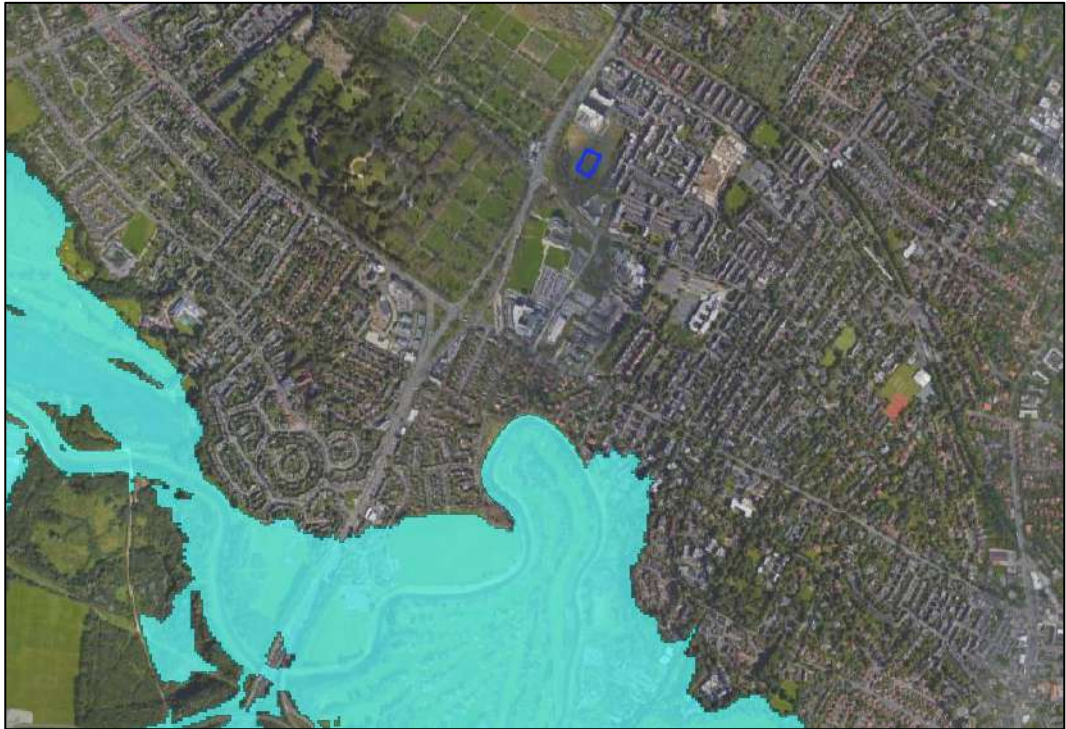
Figure 2-3 EA Flood Map for Planning (Rivers and Sea) and OS River Map  
© OpenStreetMap. © Environment Agency database 2018. © Ordnance Survey data. 2021

- 2.4.3 The above figure shows the site is located within a Flood Zone 1, indicating a low probability of flooding. It should be noted that this information does not constitute a site-specific Flood Risk Assessment and one may be required for the scheme.

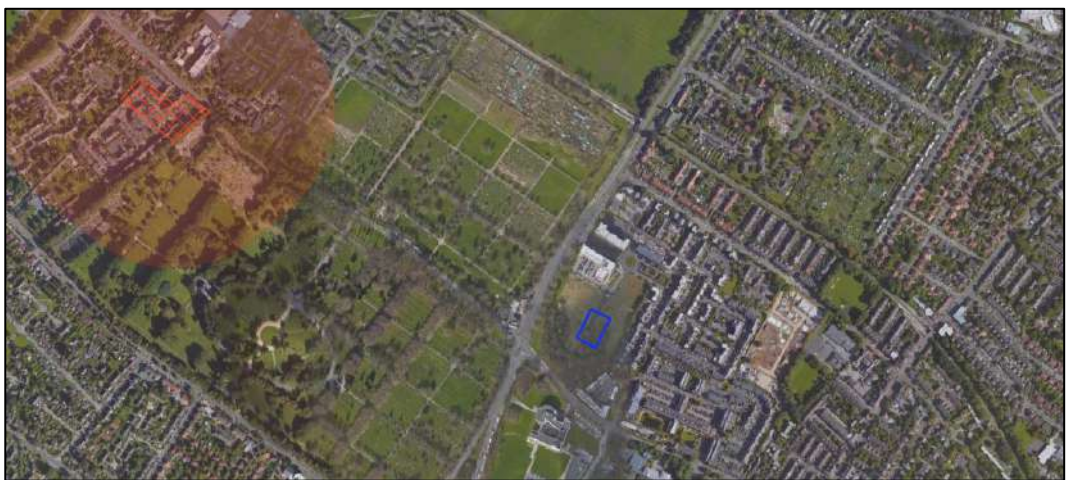
- 2.5.1 Based on available data, there are no recorded historical or current landfill sites on or adjacent to the subject site. Neither are they recorded to be present within 250m of the site's boundaries.

Figure 2-4 Landfill site with 250m buffer zones.  
© OpenStreetMap. © Environment Agency database 2018. © Ordnance Survey data. 2021

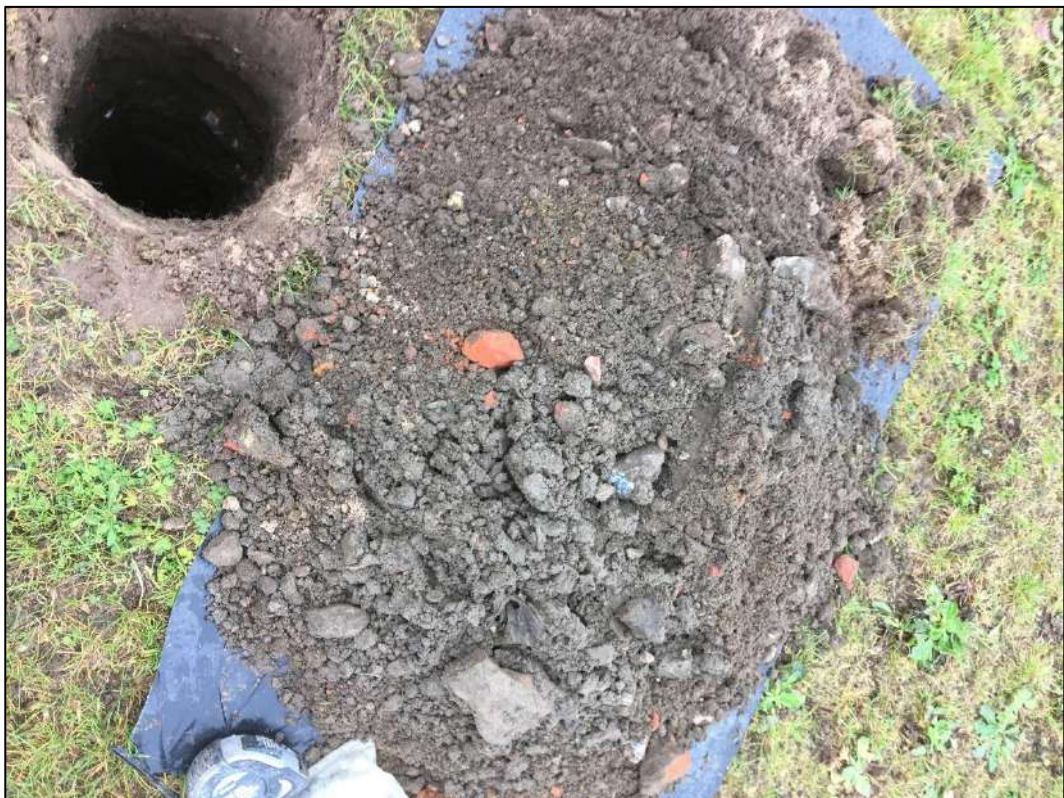
- 4.1.3 Made Ground was recorded beneath the Topsoil and typically comprised of loose brown slightly clayey slightly gravelly fine to medium sand with gravels of fine to coarse angular to subangular brick, clayware, concrete, plastic, asphalt and rare metal. Cobbles of brick and concrete were also locally recorded within hand pits.

Figure 4-1 Made Ground deposits excavated from HP02 (eastern centre of pitch)

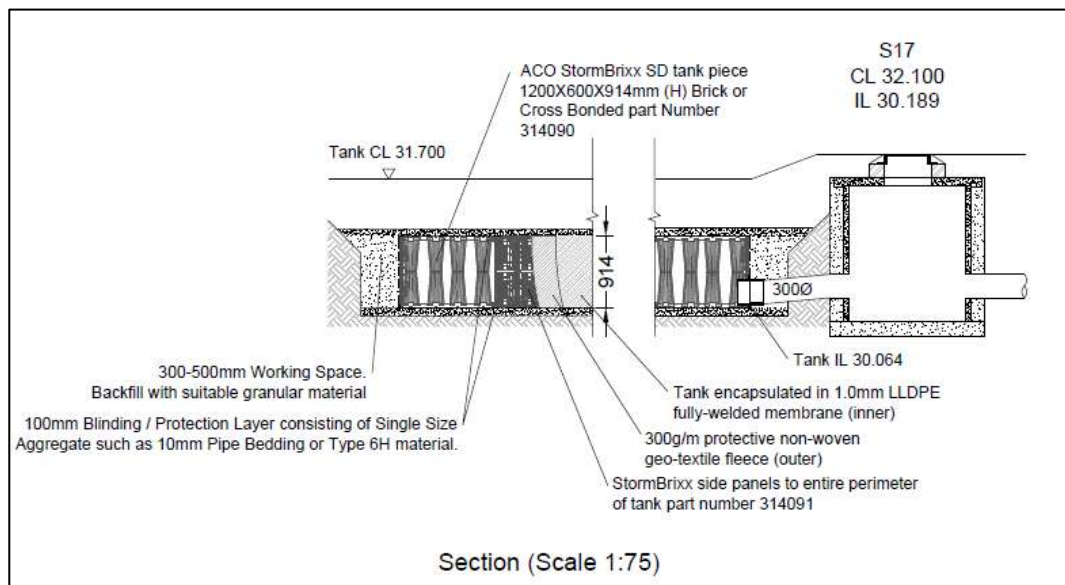
4.1.6.2 A schematic drawing of the attenuation tank is provided below, whilst its approximate location is presented on Drawing 01.

Figure 4-2 Schematic drawing on below ground attenuation tank

4.1.6.1 As part of the fieldwork investigation the top depth of the below ground attenuation tank was established within two of the hand pits excavated (HP01 and HP02). In both cases the geotextile layer to the attenuation tank was observed. Details are provided within the below table.

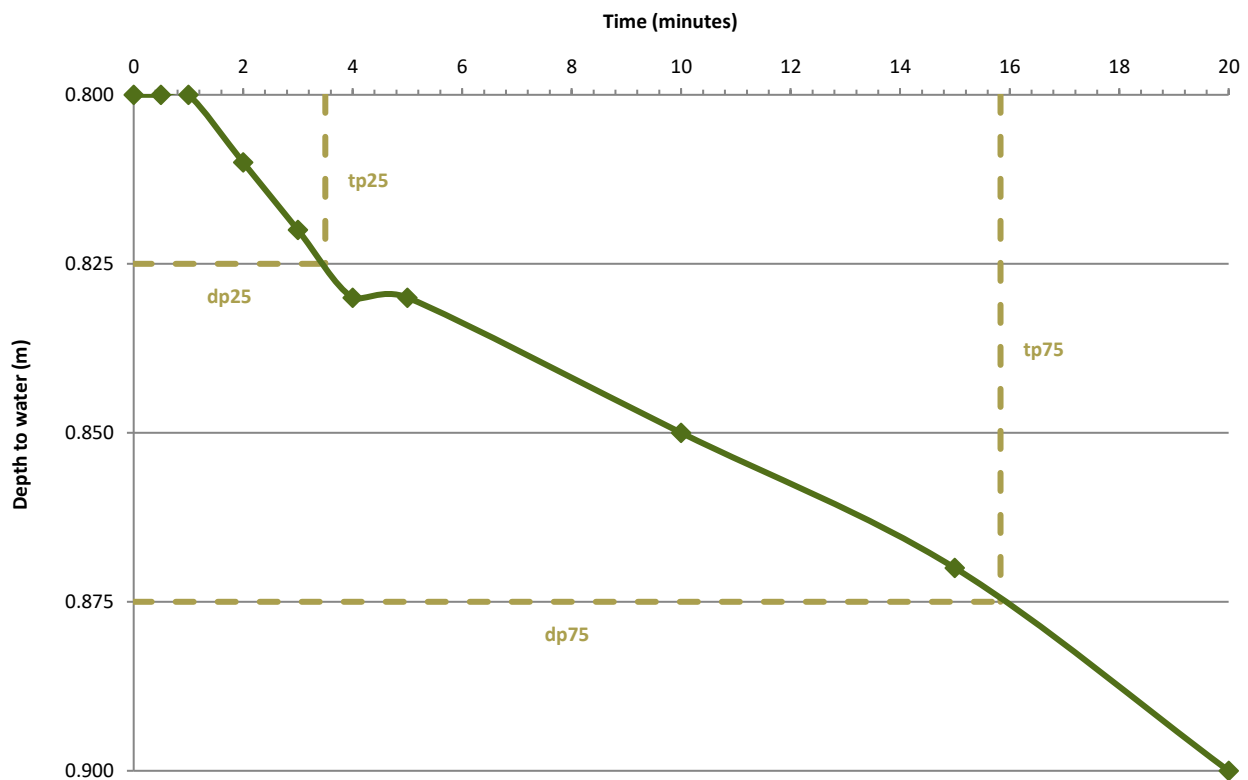
## Soil infiltration test (following principles of BRE Digest 365 2016)

| <b>f</b> | <b>Soil infiltration rate</b> | <b>3.72E-05 m/s</b> |

- 7.4.1 The Made Ground soils were encountered as a granular material, which typically exhibit good permeability. Indicative infiltration testing was undertaken in HP03 between depths of 0.57m and 0.9m and the infiltration rate was recorded between  $2.90 \times 10^{-5}$  m/s and  $3.72 \times 10^{-5}$  m/s.

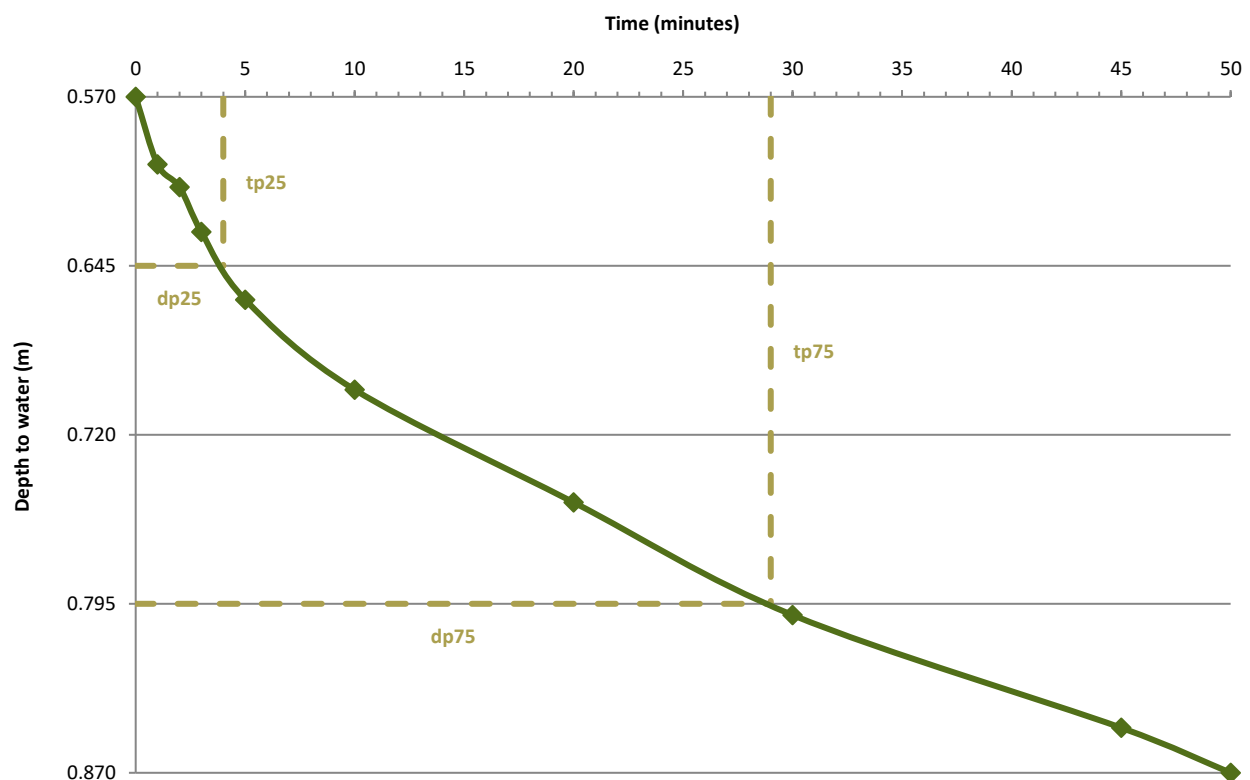
## Soil infiltration test (following principles of BRE Digest 365 2016)

| <b>f</b> | <b>Soil infiltration rate</b> | <b>2.90E-05 m/s</b> |

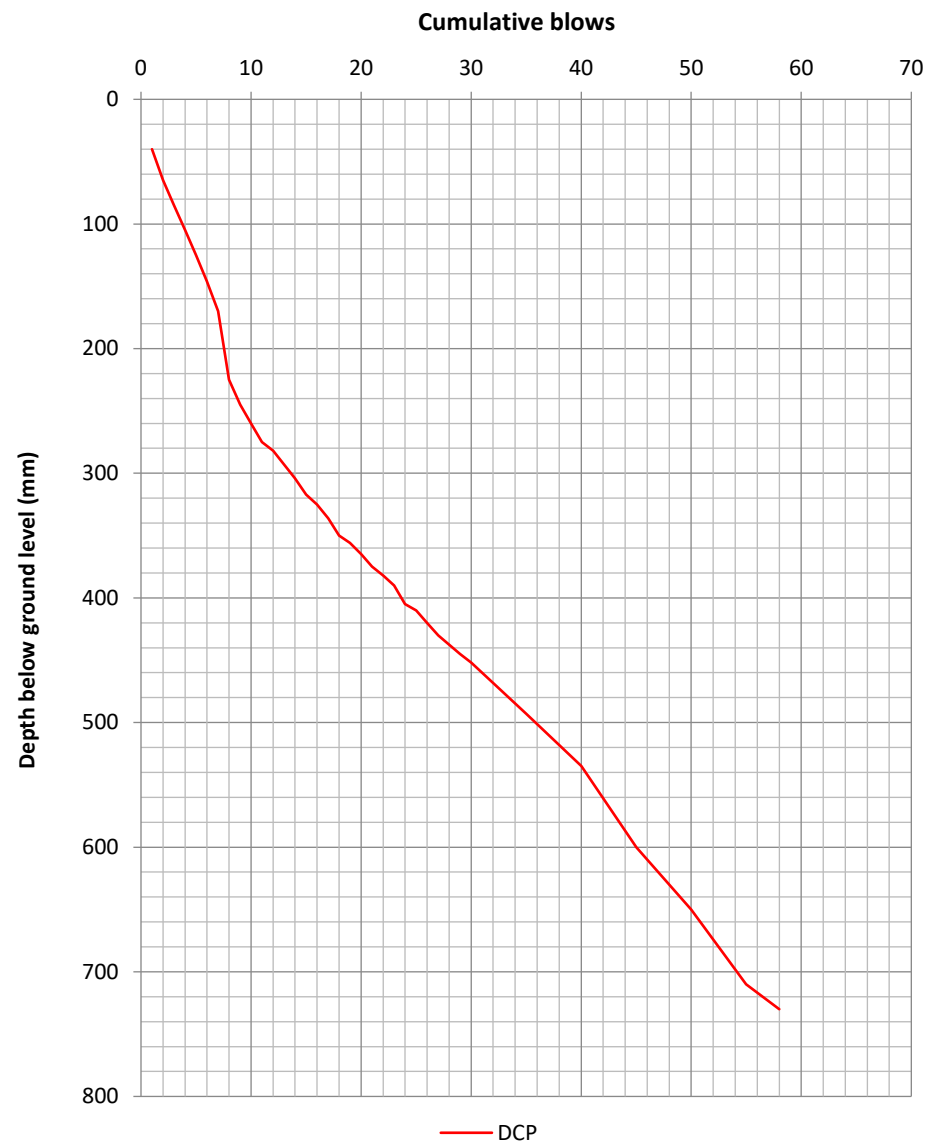
Plot showing number of blows against depth

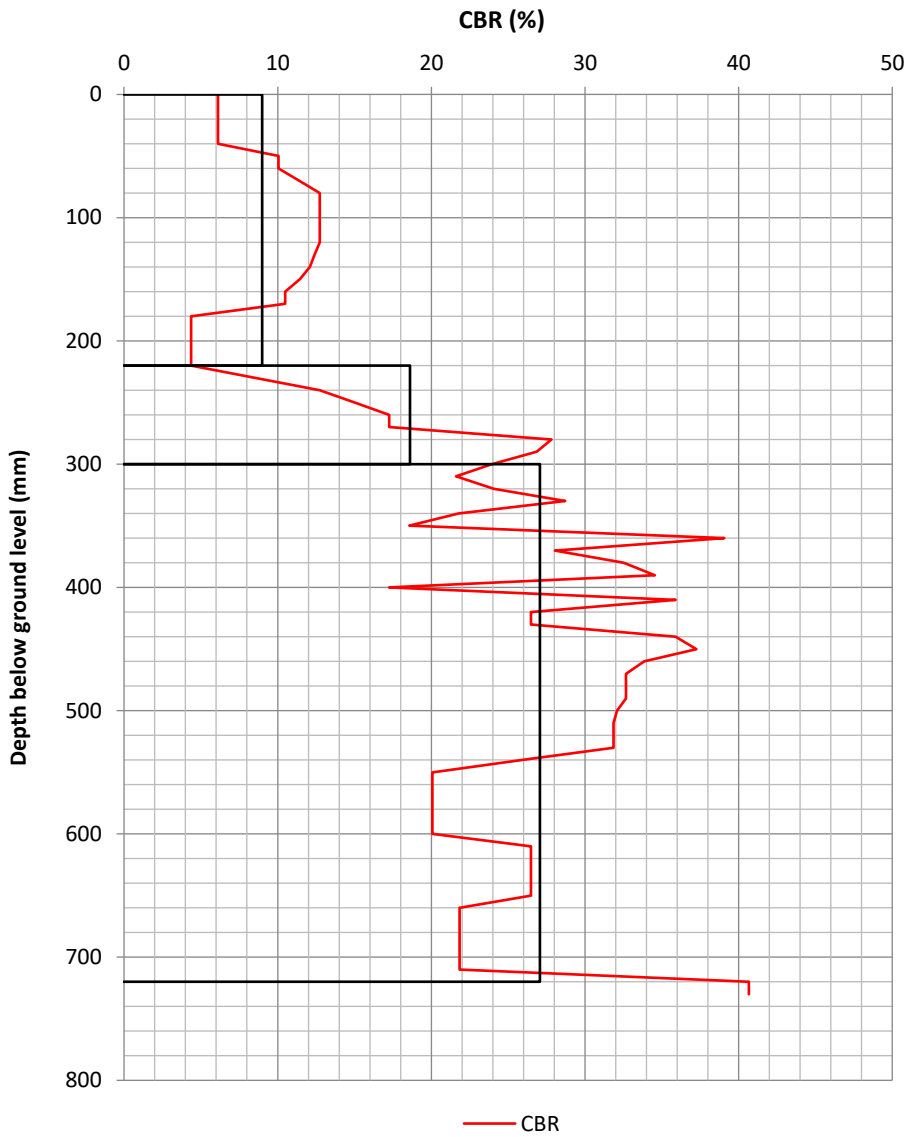
Plot showing CBR (%) against depth

- 7.3.1 We have determined CBR value for the proposed artificial pitch foundations using in-situ Dynamic Cone Penetrometer testing following the methodology defined by the Highways England Document CS229 Data for Pavement Assessment. The results are presented in Appendix C and the location of test positions are shown on Drawing 01.
