## Phase II Geo-environmental Site Assessment

Grimshaw Lane Plots 1 & 2  
Manchester  
M40 2BA  
April 2021

423207.0000.0001

| Document Title: | Phase II Geo-environmental Site Assessment |

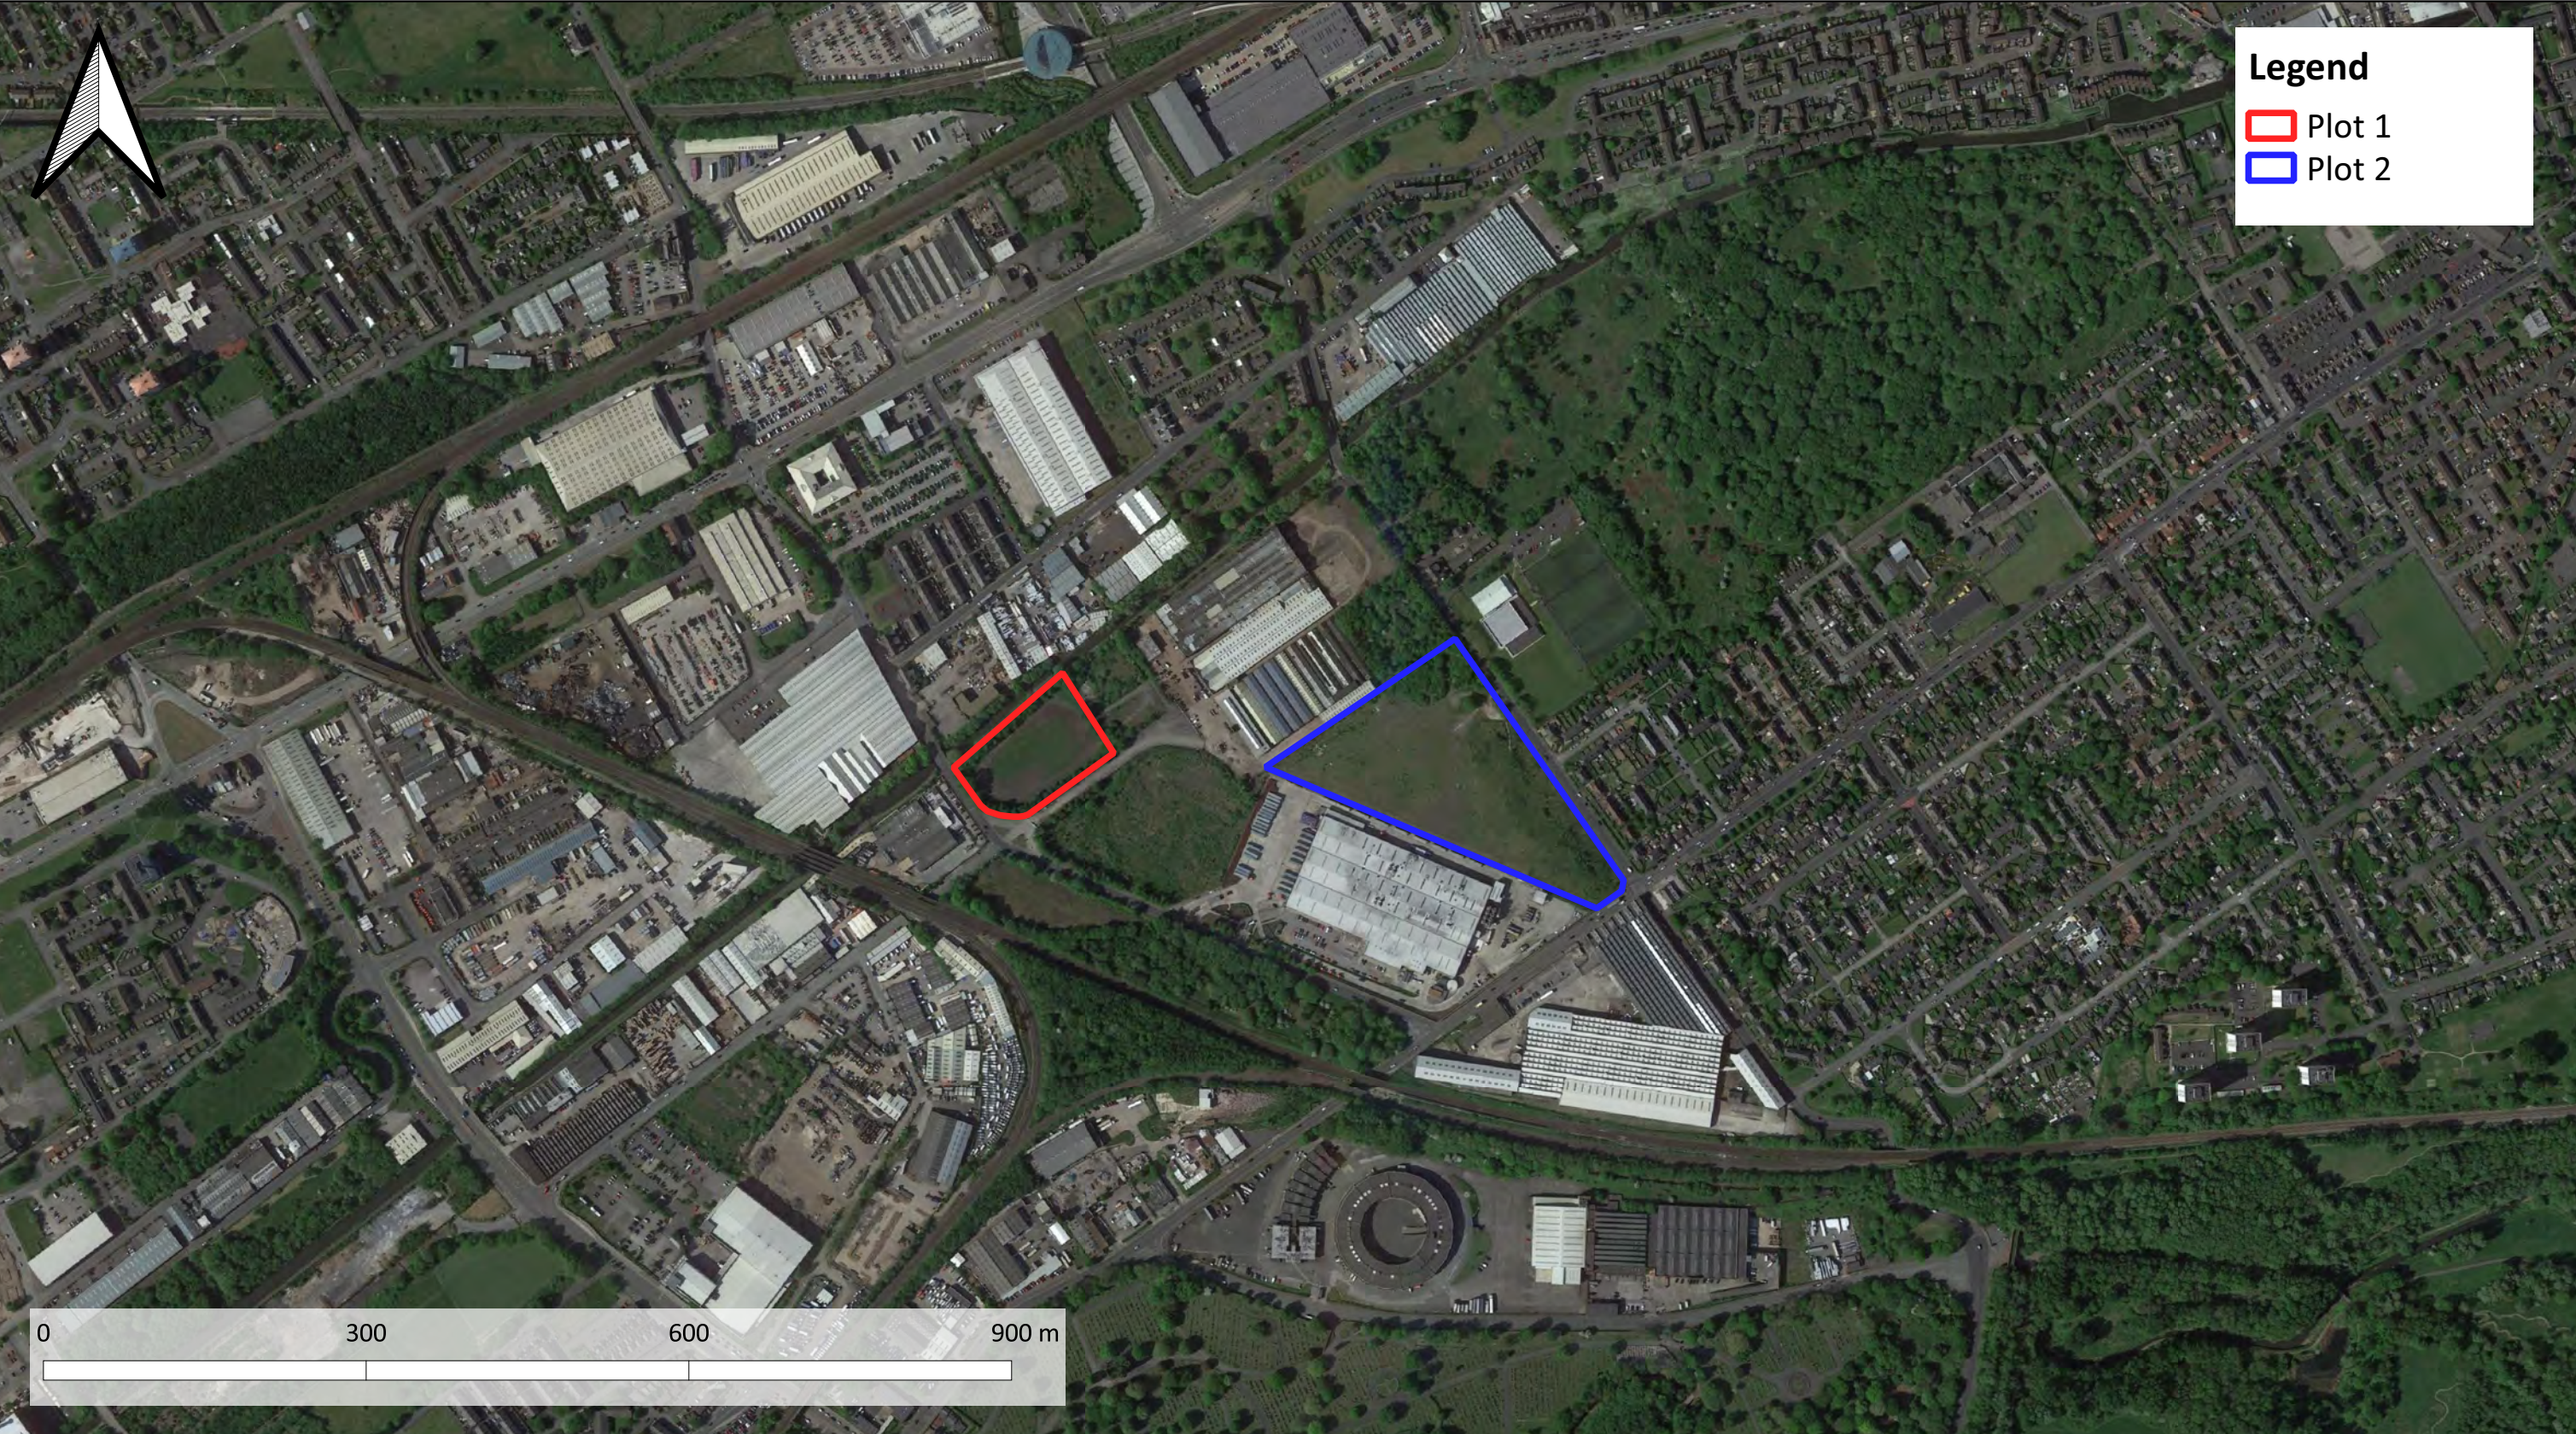
A Proposed Development Plan is presented as Figure 2 in Annex A. It should be noted that this redevelopment plan includes Mathers Foundry (previously investigated by TRC) as well as Plots 1 and 2. This report should be read in conjunction with the following reports:

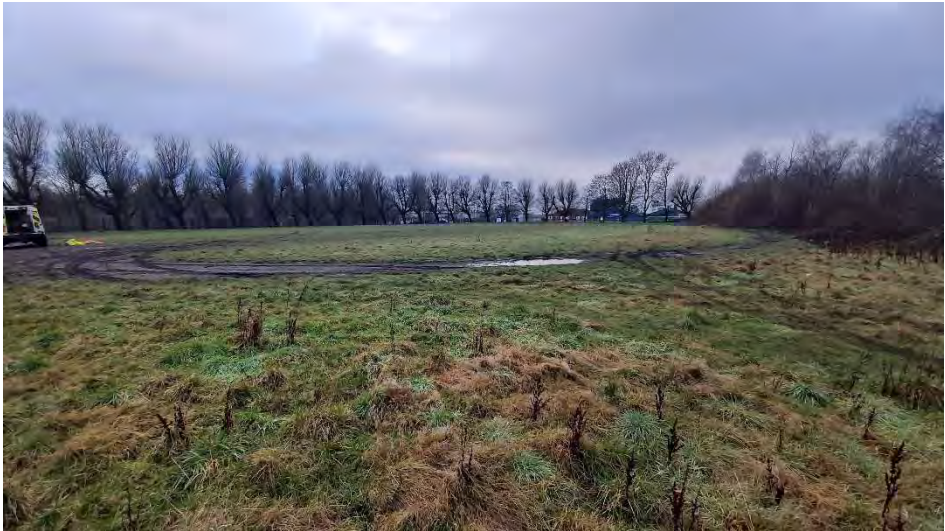
| Photo No.<br>1 | Date<br>03/02/2021 | | |

| <b>Description:</b><br>Overview of Grimshaw lane Plot 1, looking west | | | |

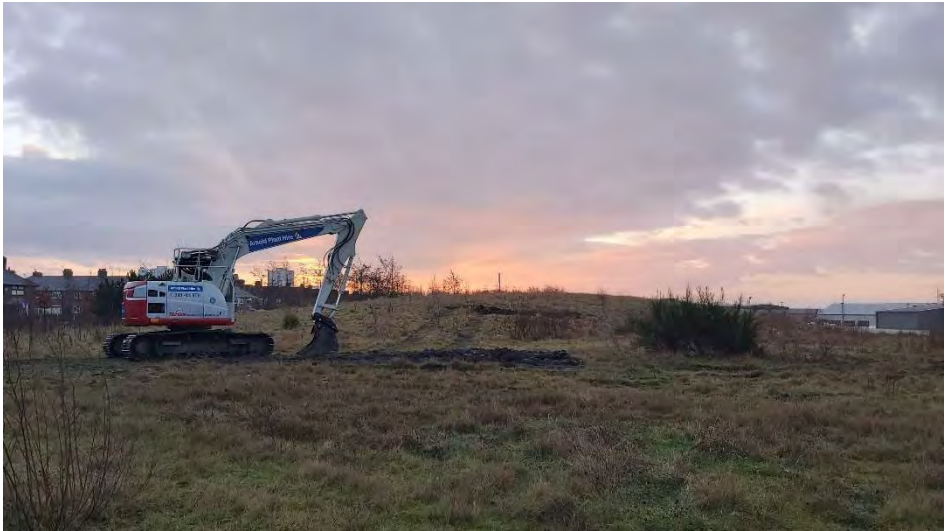
| Photo No.<br>2 | Date<br>04/02/2021 | | |

| <b>Description:</b><br>Overview of Grimshaw lane Plot 2, looking east | | | |

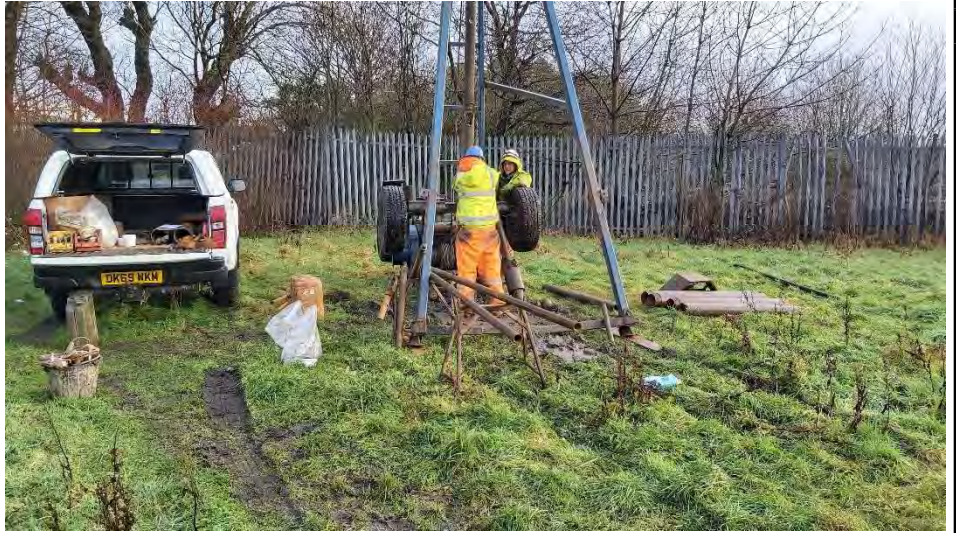
| <b>Photo No.</b><br>3 | <b>Date</b><br>03/02/2021 | | |

| <b>Description:</b><br>Drilling Borehole CP101 | | | |

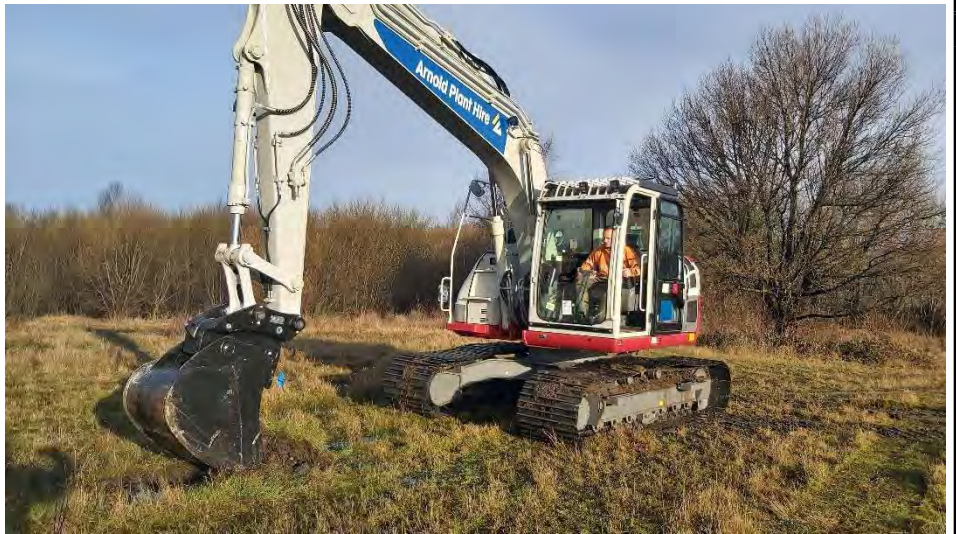
| <b>Photo No.</b><br>4 | <b>Date</b><br>04/02/2020 | | |

| <b>Description:</b><br>Excavating Trial Pit TP302 | | | |

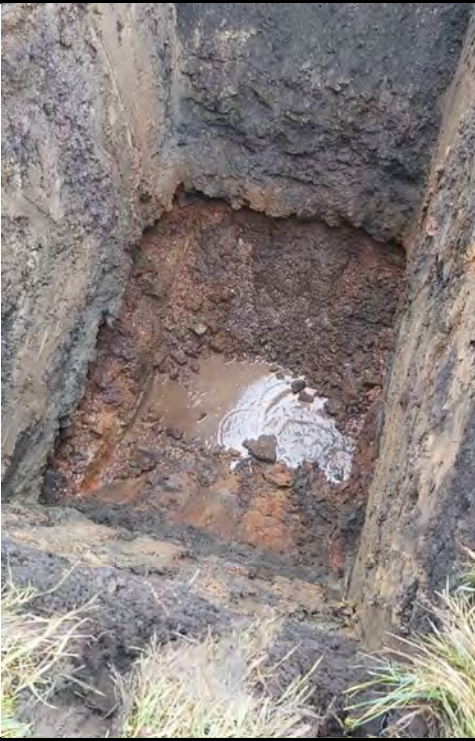
| Client Name: | | Site Location: | | Project No.: |
|---|---|---|---|---|
| 5 | 04/02/2021 | | | |

| Client Name: | | Site Location: | | Project No.: |
|---|---|---|---|---|
| <b>Description:</b><br>Excavating TP101 | | | | |

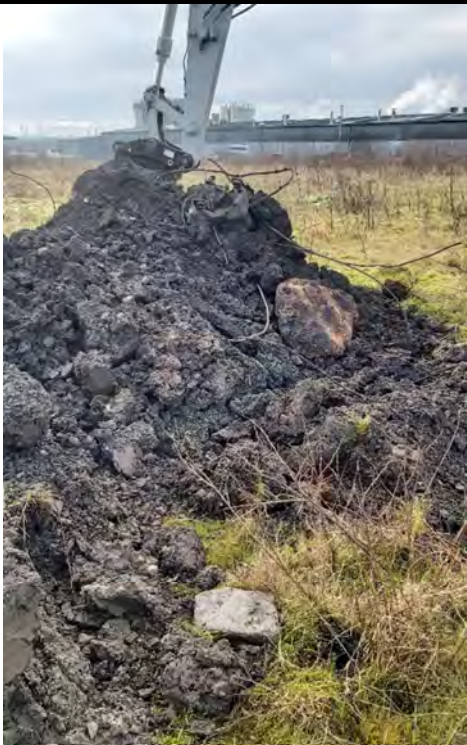
| Client Name: | | Site Location: | | Project No.: |
|---|---|---|---|---|
| 6 | 05/02/2021 | | | |

| Client Name: | | Site Location: | | Project No.: |
|---|---|---|---|---|
| <b>Description:</b><br>Excavating TP304. Extensive made ground including loose metal and rebar is visible in the arisings. | | | | |

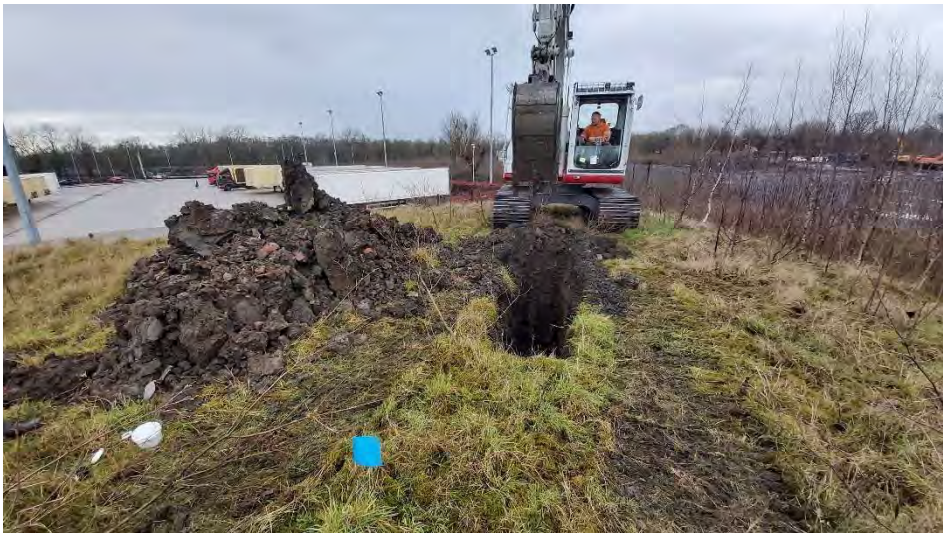
| <b>Photo No.</b><br>7 | <b>Date</b><br>05/02/2020 | | |

| <b>Description:</b><br>Excavating TP305. | | | |

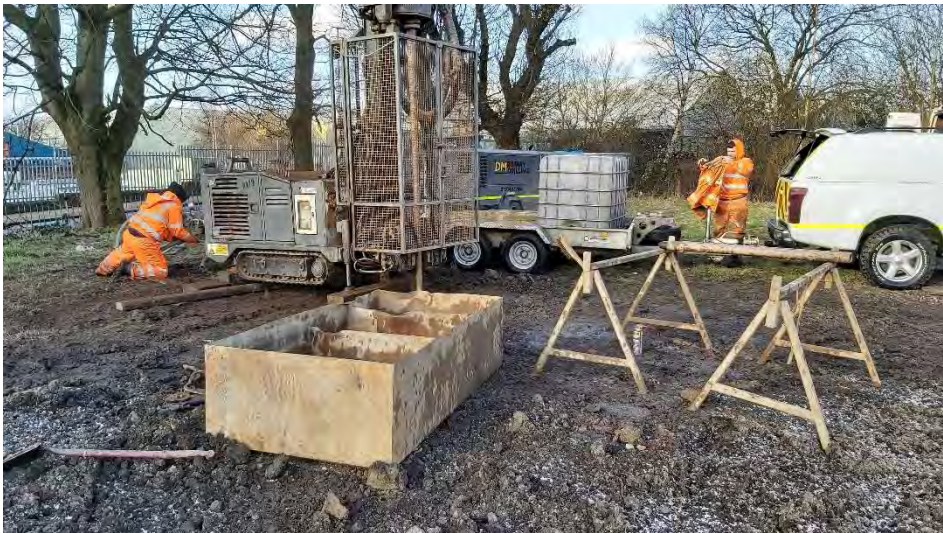
| <b>Photo No.</b><br>8 | <b>Date</b><br>08/02/2020 | | |

| <b>Description:</b><br>Excavating RC01. | | | |
