Our Ref: BEK/19661/211027/CGL/P46

**Residential Development at Ilk Street and Alpine Street, Clayton- PLOT 46**

BEK Enviro (BEK) has been commissioned by The Casey Group (CG) to supervise and validate the remediation works required at the above site.

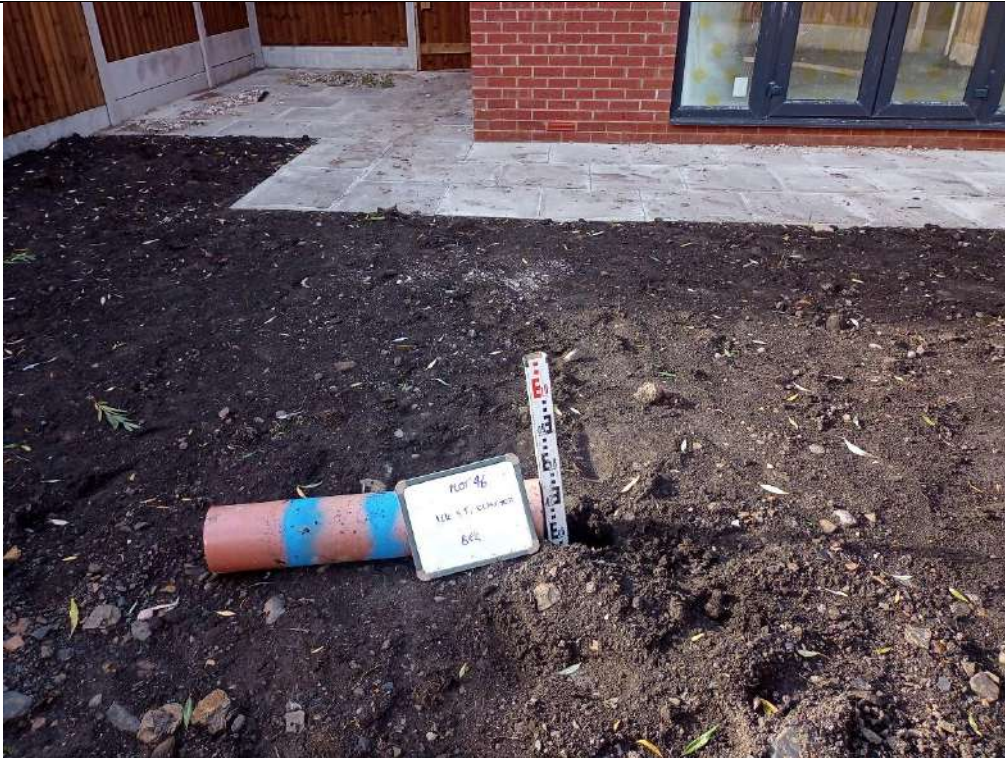
Following placement of the validated soils by CG, an engineer from BEK carried out spot checks and can confirm that the capping layer for Plot 46 comprises in excess of 600 mm of suitably clean validated soils. The capping soils overly a geotextile membrane at the base. Photographs showing capping thickness are provided within Annex E.

Photograph 1: Validation of Garden Capping Thickness

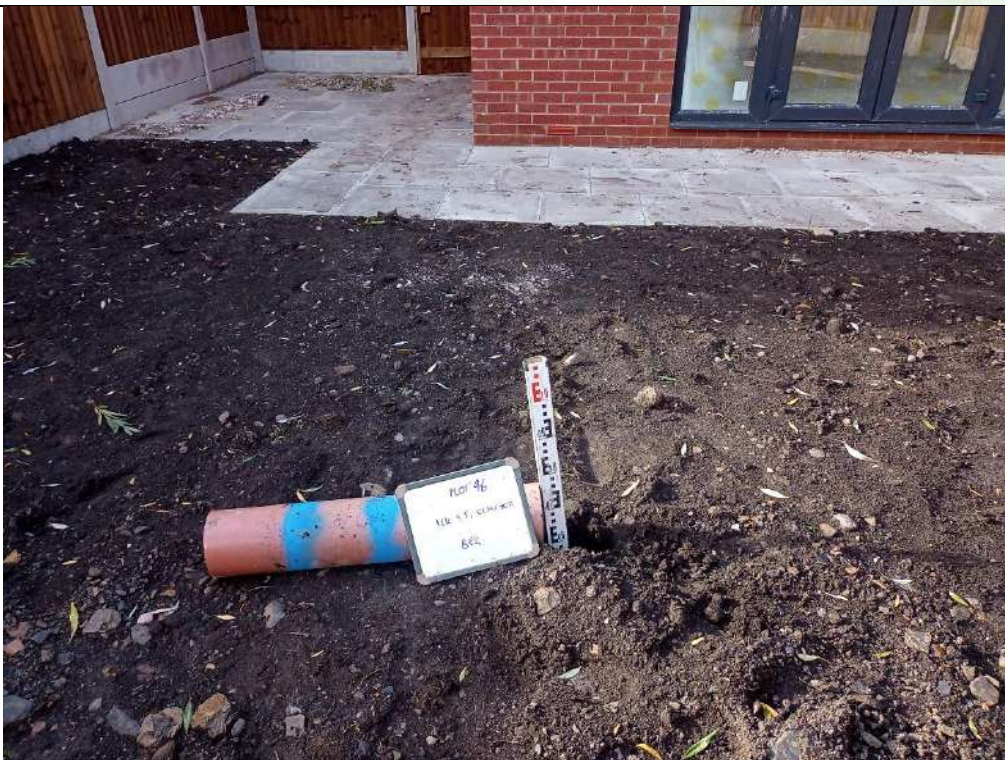
Photograph 2: Validation of Garden Capping Thickness

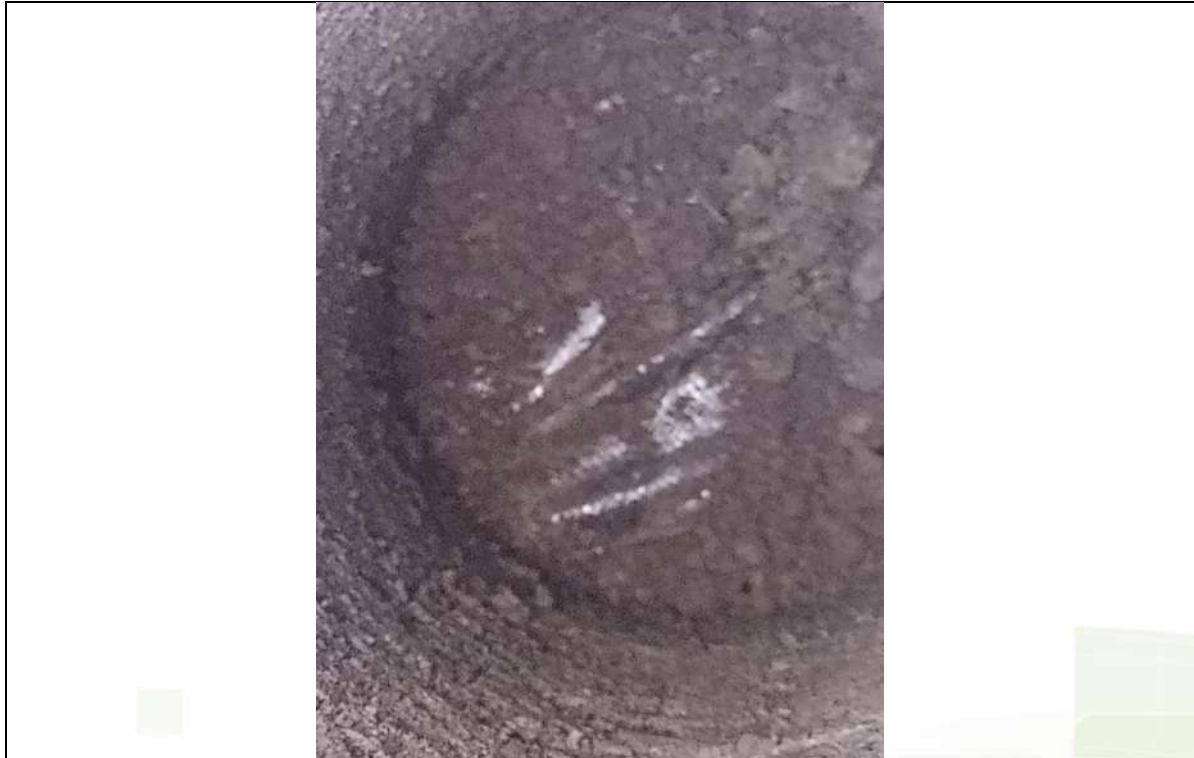
Photograph 3: Validation of Geotextile Membrane

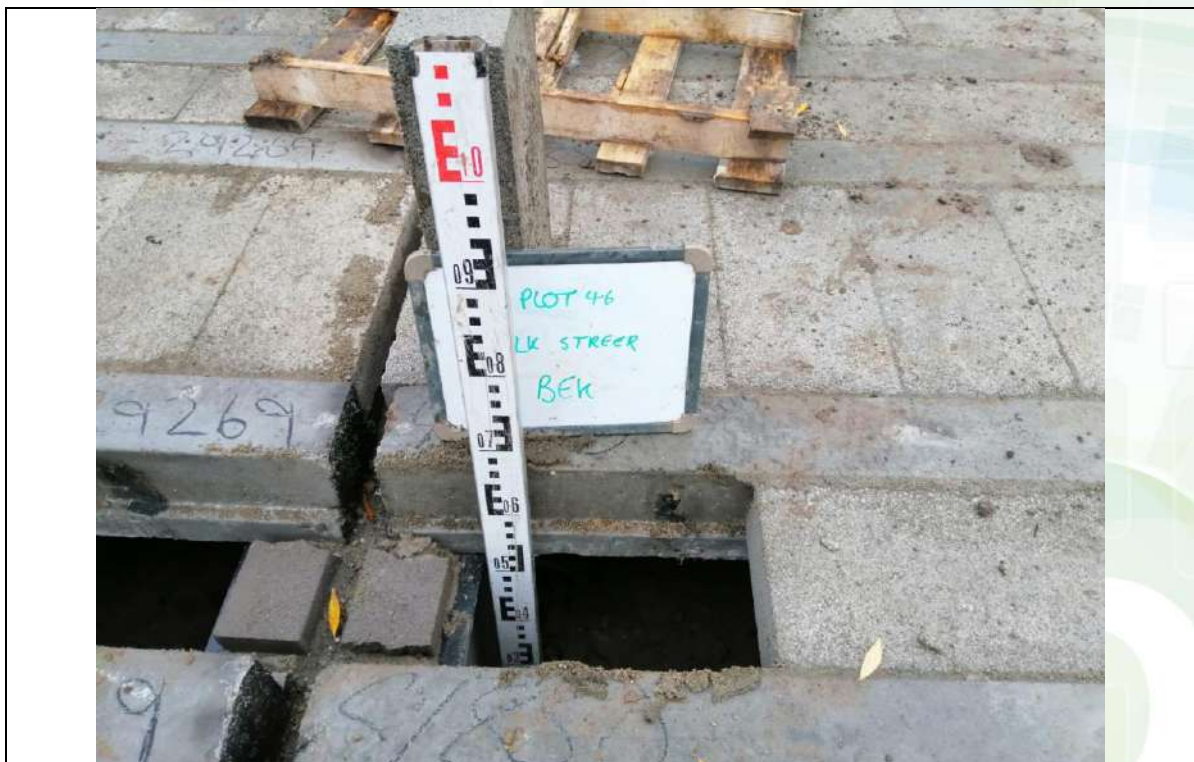
The sub-floor void and the installation of the membrane has been validated and BEK can confirm the gas measures incorporated into the foundation design of Plot 46 conforms to the specified requirements. The membrane installation was verified by an Engineer from BEK who has attended the Verification of Gas Protection Systems Course delivered by CL:AIRE Training Course.

Photograph 4: Validation of Sub-Floor Void Space (min 150 mm)

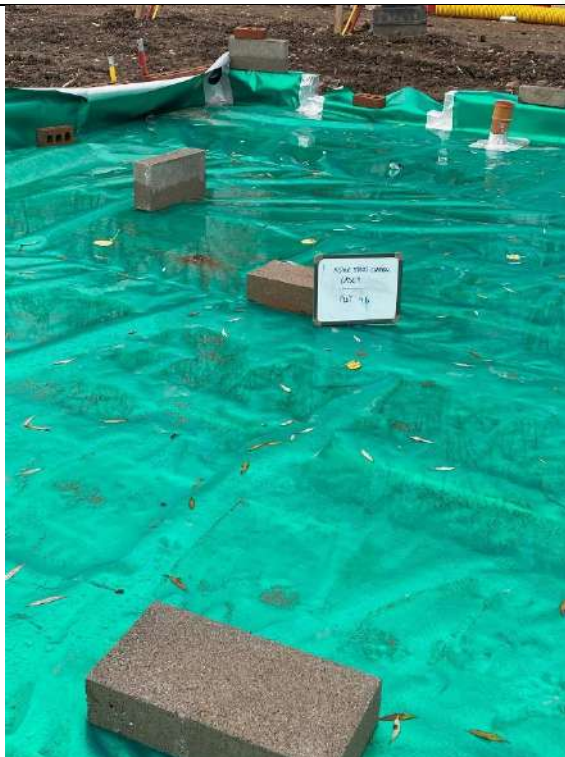
CG commissioned Reeve-Tec Membranes Limited to install the gas membranes at the site, who have used the Protech GM Super gas membrane which is considered suitable for use. A copy of the data sheet for this membrane is presented in Annex C. The completed gas validation proforma for this plot is presented in Annex D and validation photographs are presented in Annex E.

**Photograph 5: Validation of Gas Membrane Installation**

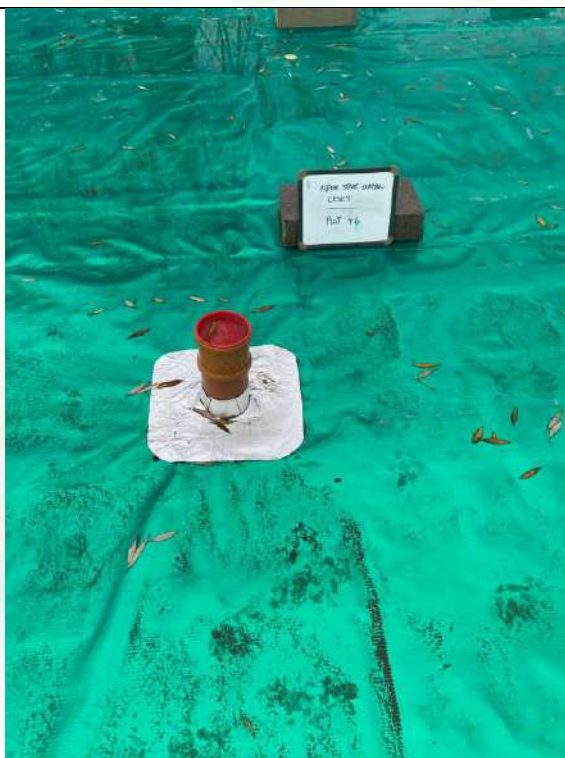
**Photograph 6: Validation of Gas Membrane Installation**
