Our Ref: BEK/19661/211027/CGL/P48

**Residential Development at Ilk Street and Alpine Street, Clayton- PLOT 48**

BEK Enviro (BEK) has been commissioned by The Casey Group (CG) to supervise and validate the remediation works required at the above site.

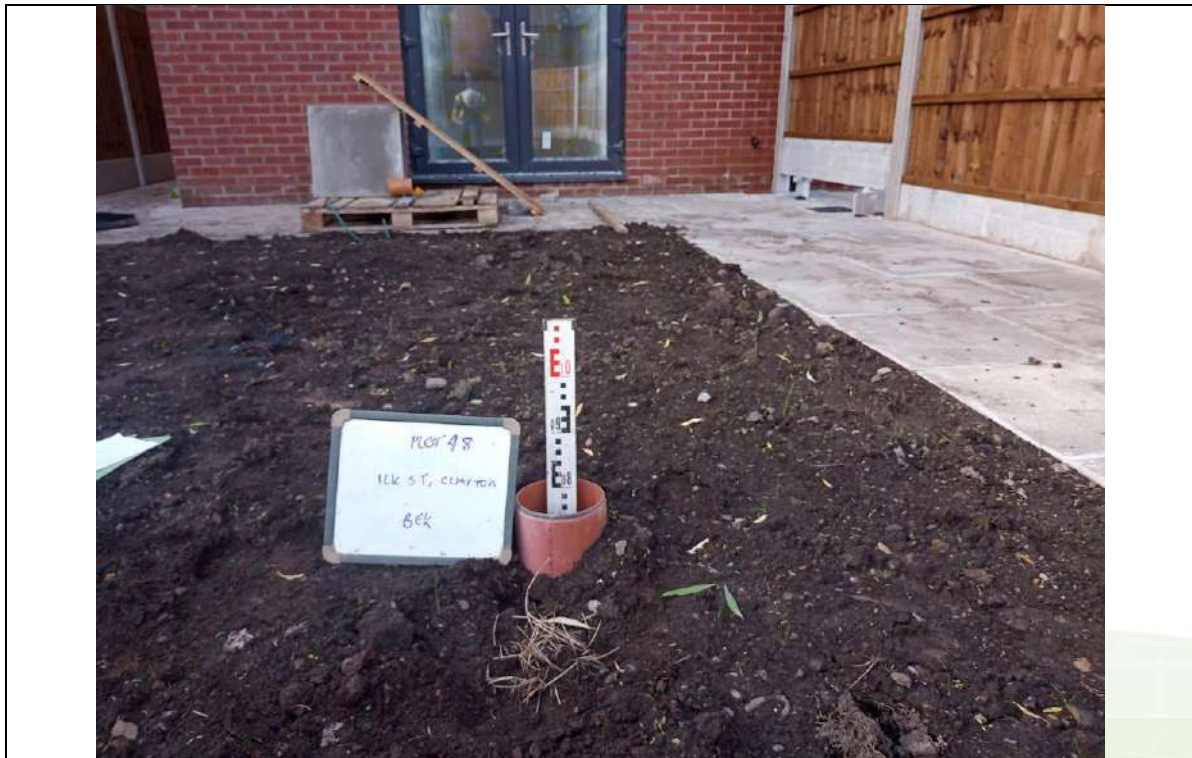
Photograph 1: Validation of Garden Capping Thickness

Following placement of the validated soils by CG, an engineer from BEK carried out spot checks and can confirm that the capping layer for Plot 48 comprises in excess of 600 mm of suitably clean validated soils. The capping soils overly a geotextile membrane at the base. Photographs showing capping thickness are provided within Annex E.

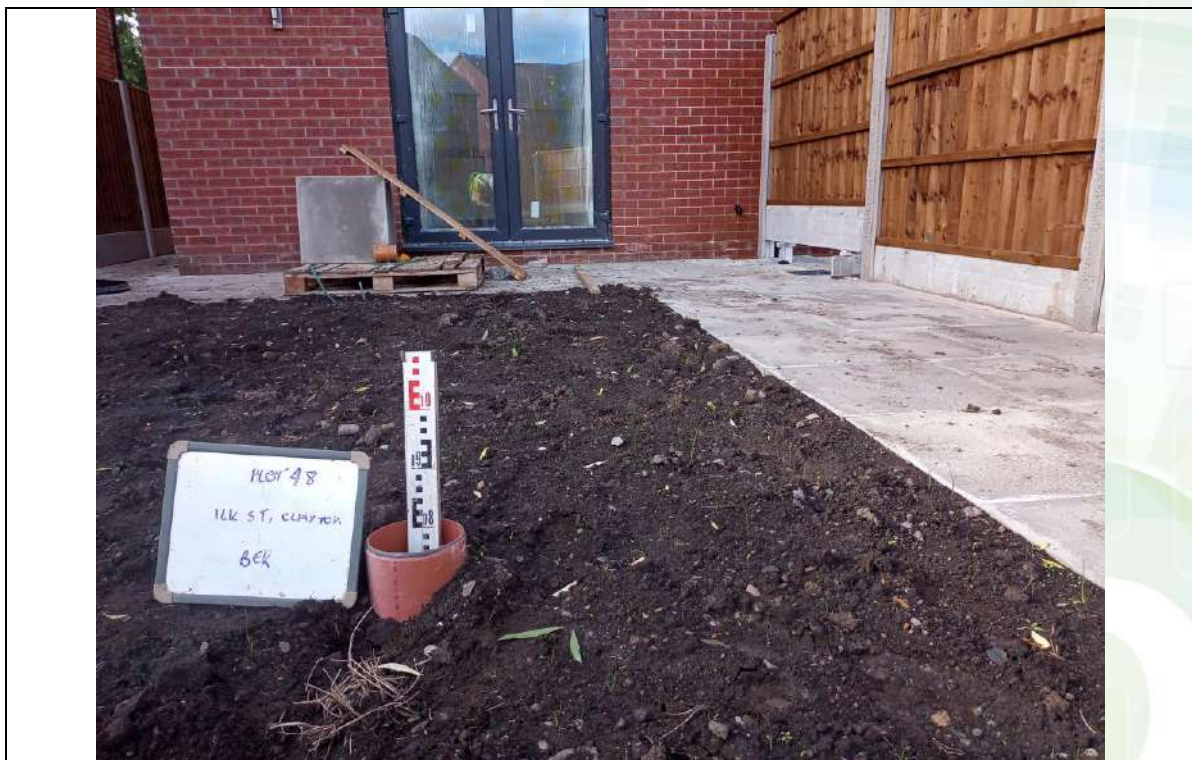
Photograph 2: Validation of Garden Capping Thickness

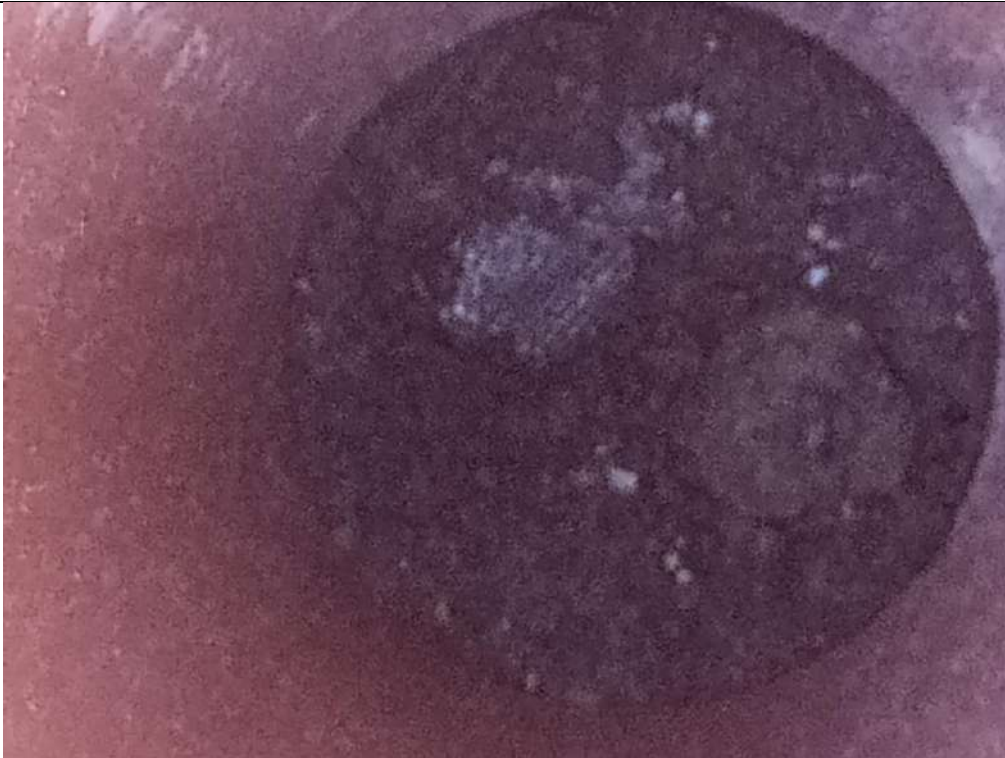
Photograph 3: Validation of Geotextile Membrane

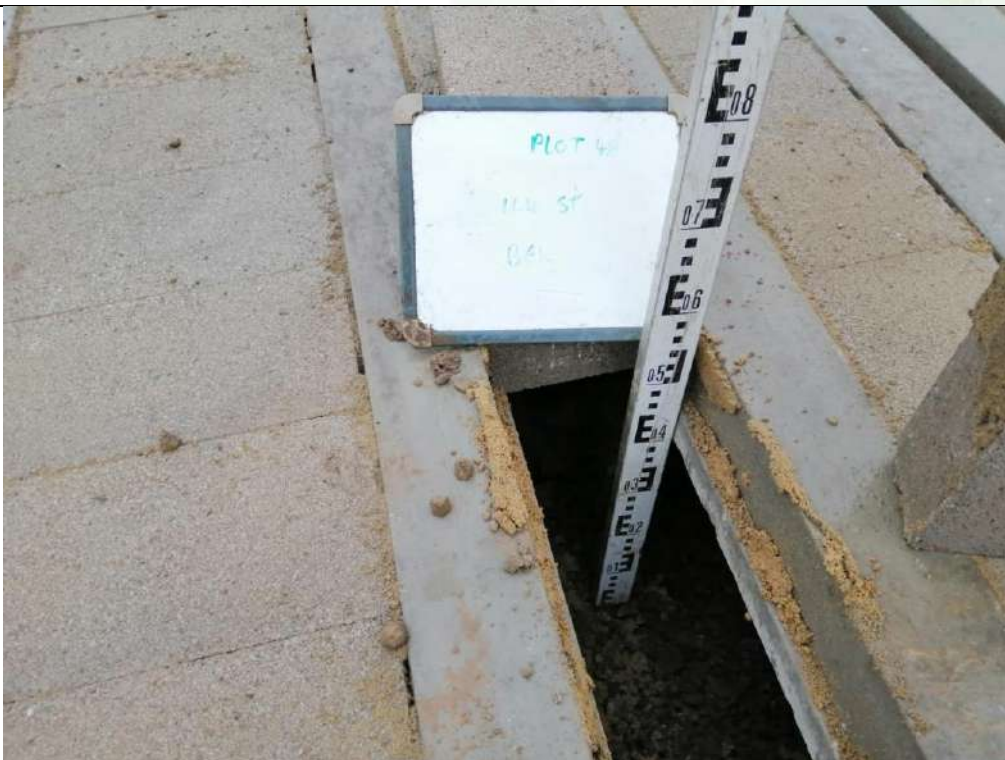
Photograph 4: Validation of Sub-Floor Void Space (min 150 mm)

The sub-floor void and the installation of the membrane has been validated and BEK can confirm the gas measures incorporated into the foundation design of Plot 48 conforms to the specified requirements. The membrane installation was verified by an Engineer from BEK who has attended the Verification of Gas Protection Systems Course delivered by CL:AIRE Training Course.

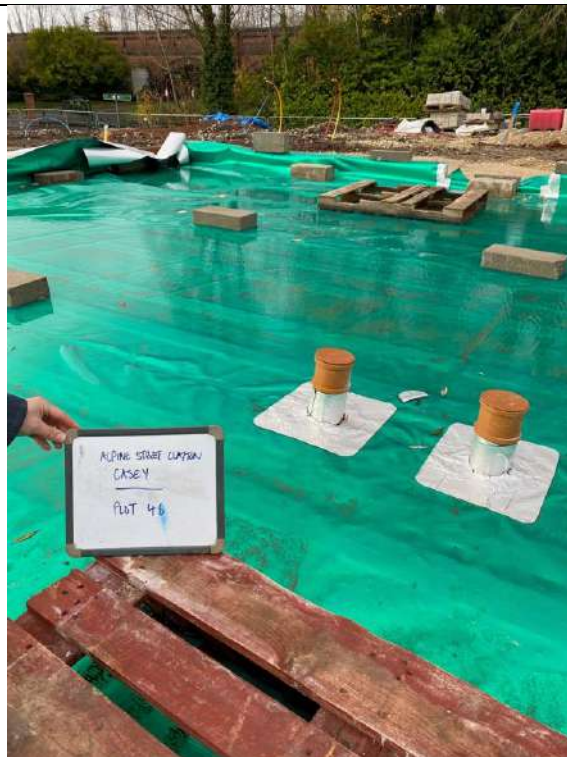
Photograph 5: Validation of Gas Membrane Installation

CG commissioned Reeve-Tec Membranes Limited to install the gas membranes at the site, who have used the Protech GM Super gas membrane which is considered suitable for use. A copy of the data sheet for this membrane is presented in Annex C. The completed gas validation proforma for this plot is presented in Annex D and validation photographs are presented in Annex E.

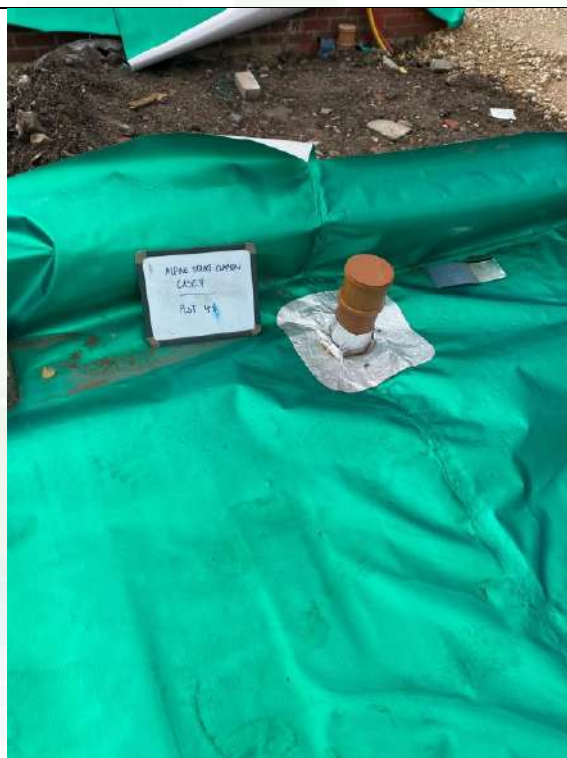
Photograph 6: Validation of Gas Membrane Installation
