## Land at Ilk Street And Alpine Street, Clayton

### Verification Report

Report Ref: BEK-19661-3

November 2021

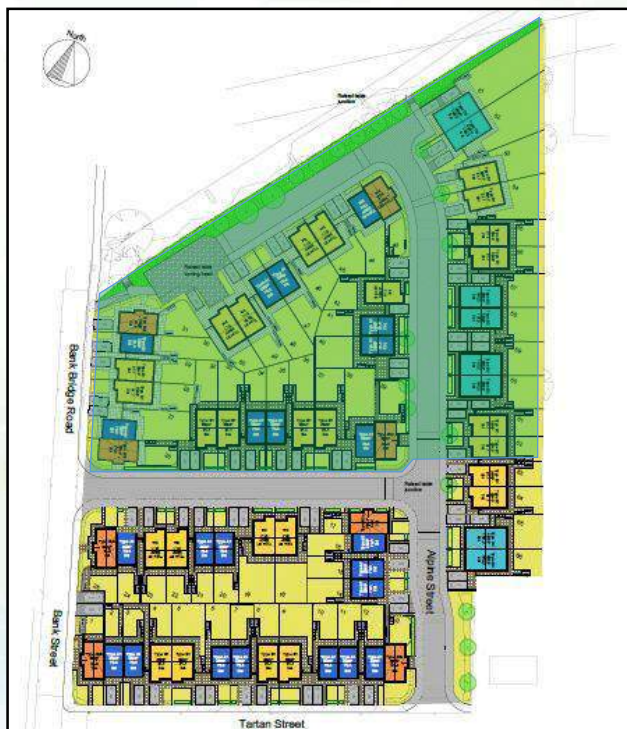
**Figure 1:** Plots Where Garden Capping is Required (highlighted Green)

2.1.2 Due to the potential contamination, Terra Consult recommend that clean cover in garden areas is required in the northern zone of the site. No remediation is required for the southern zone of the site. The Plots that need garden capping are highlighted green in Figure 1 below and listed in the adjacent table.

2.1.3 The gardens within Plots 26 to 62 (of the current development layout plan – see Figure 1) will need to be capped with a minimum of 600 mm of clean suitable soils (minimum 450 mm topsoil overlying 150 mm subsoil).

- 2.1.4 Any soft landscaped areas in the vicinity of Plots 26 to 62 will need to be capped with a minimum of 450 mm of clean suitable soils.
- 2.1.5 Soils used in the capping system will need to be tested and assessed and ensure suitability for use. The soils will be placed on a geo-membrane to act as a marker layer and prevent mixing. All soil used in the capping system will need to be imported. Final capping thickness will also need to be validated.

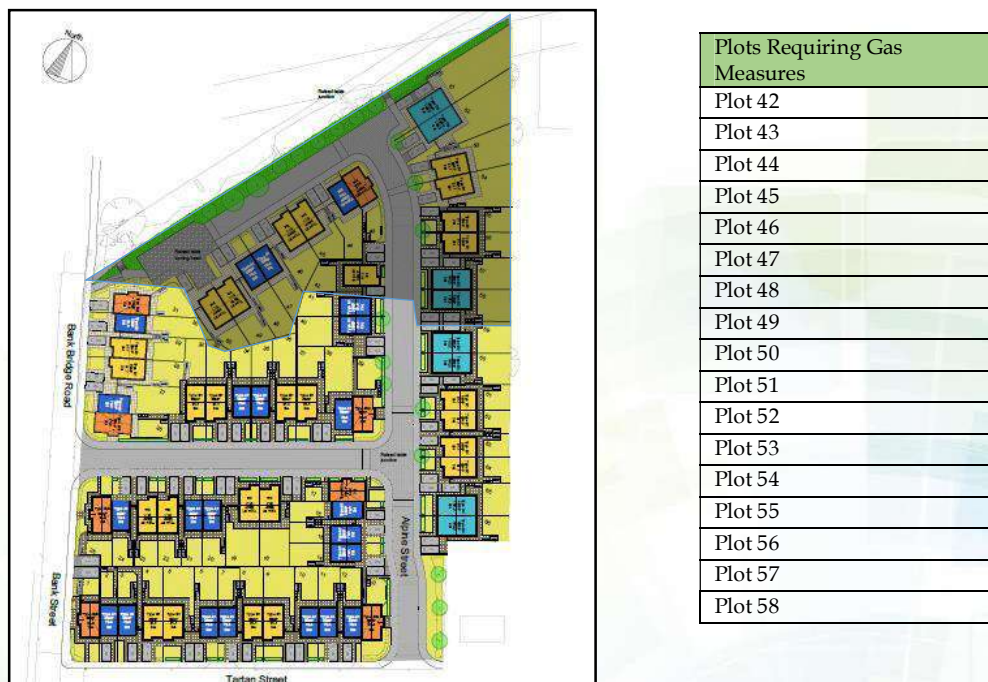
**Figure 2: Plots That Require Gas Mitigation Measures (highlighted blue)**

2.2.1 With respect to risks from ground gas at the site, Terra Consult identified Characteristic Situation 2 (CS2) ground gas conditions have been identified in the northern zone of the site and mitigation measures need to be incorporated into these buildings. The affected plots are highlighted in blue in Figure 3 below and listed in the adjacent Table.

2.2.2 On the basis of the assessment of the potential risks from ground gas, mitigation measures which adhere to Characteristic Situation 2/Amber 1 of CIRIA C665 will be required in Plots 42 to 58.

2.2.3 The following ground gas mitigation measures should be incorporated into all new builds at the site:

(i) Reinforce concrete cast in-situ floor slab (suspended, non-suspended or raft) with at least 1200 g damp proof membrane and underfloor venting

(ii) Beam and block or pre-cast concrete and 2000 gauge damp proof membrane/reinforced gas membrane and underfloor venting.

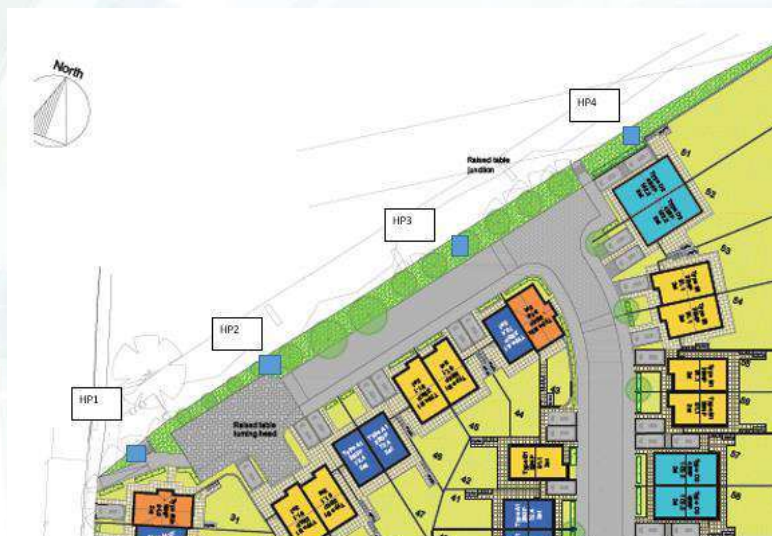
**Figure 3.** Locations of Hand Excavated Trial Holes used to validated capping thickness in POS Areas

- 3.3.13 Capping layer thickness was checked by BEK within the POS Areas in the vicinity of Plots 26 to 62 to ensure the required thickness had been achieved. This was undertaken by excavating a series of trial holes (HP1 to HP4 – shown in Figure 3) to ensure the correct construction of the capping system and confirm capping thickness.
- 3.3.14 BEK can confirm that the soft landscaped POS Areas in vicinity of Plots 26 to 62 are capped with a minimum of 450 mm of clean soils (generally 450 mm topsoil).
- 3.3.15 A series of photographs showing the capping thickness are presented in Appendix E.
