# Geo-Environmental Assessment

**Ladybarn Park Road, Manchester, M40 4NR**

**Presented to Manchester City F.C. City in the Community Foundation**

Delta-Simons Project No. 18-1673.04

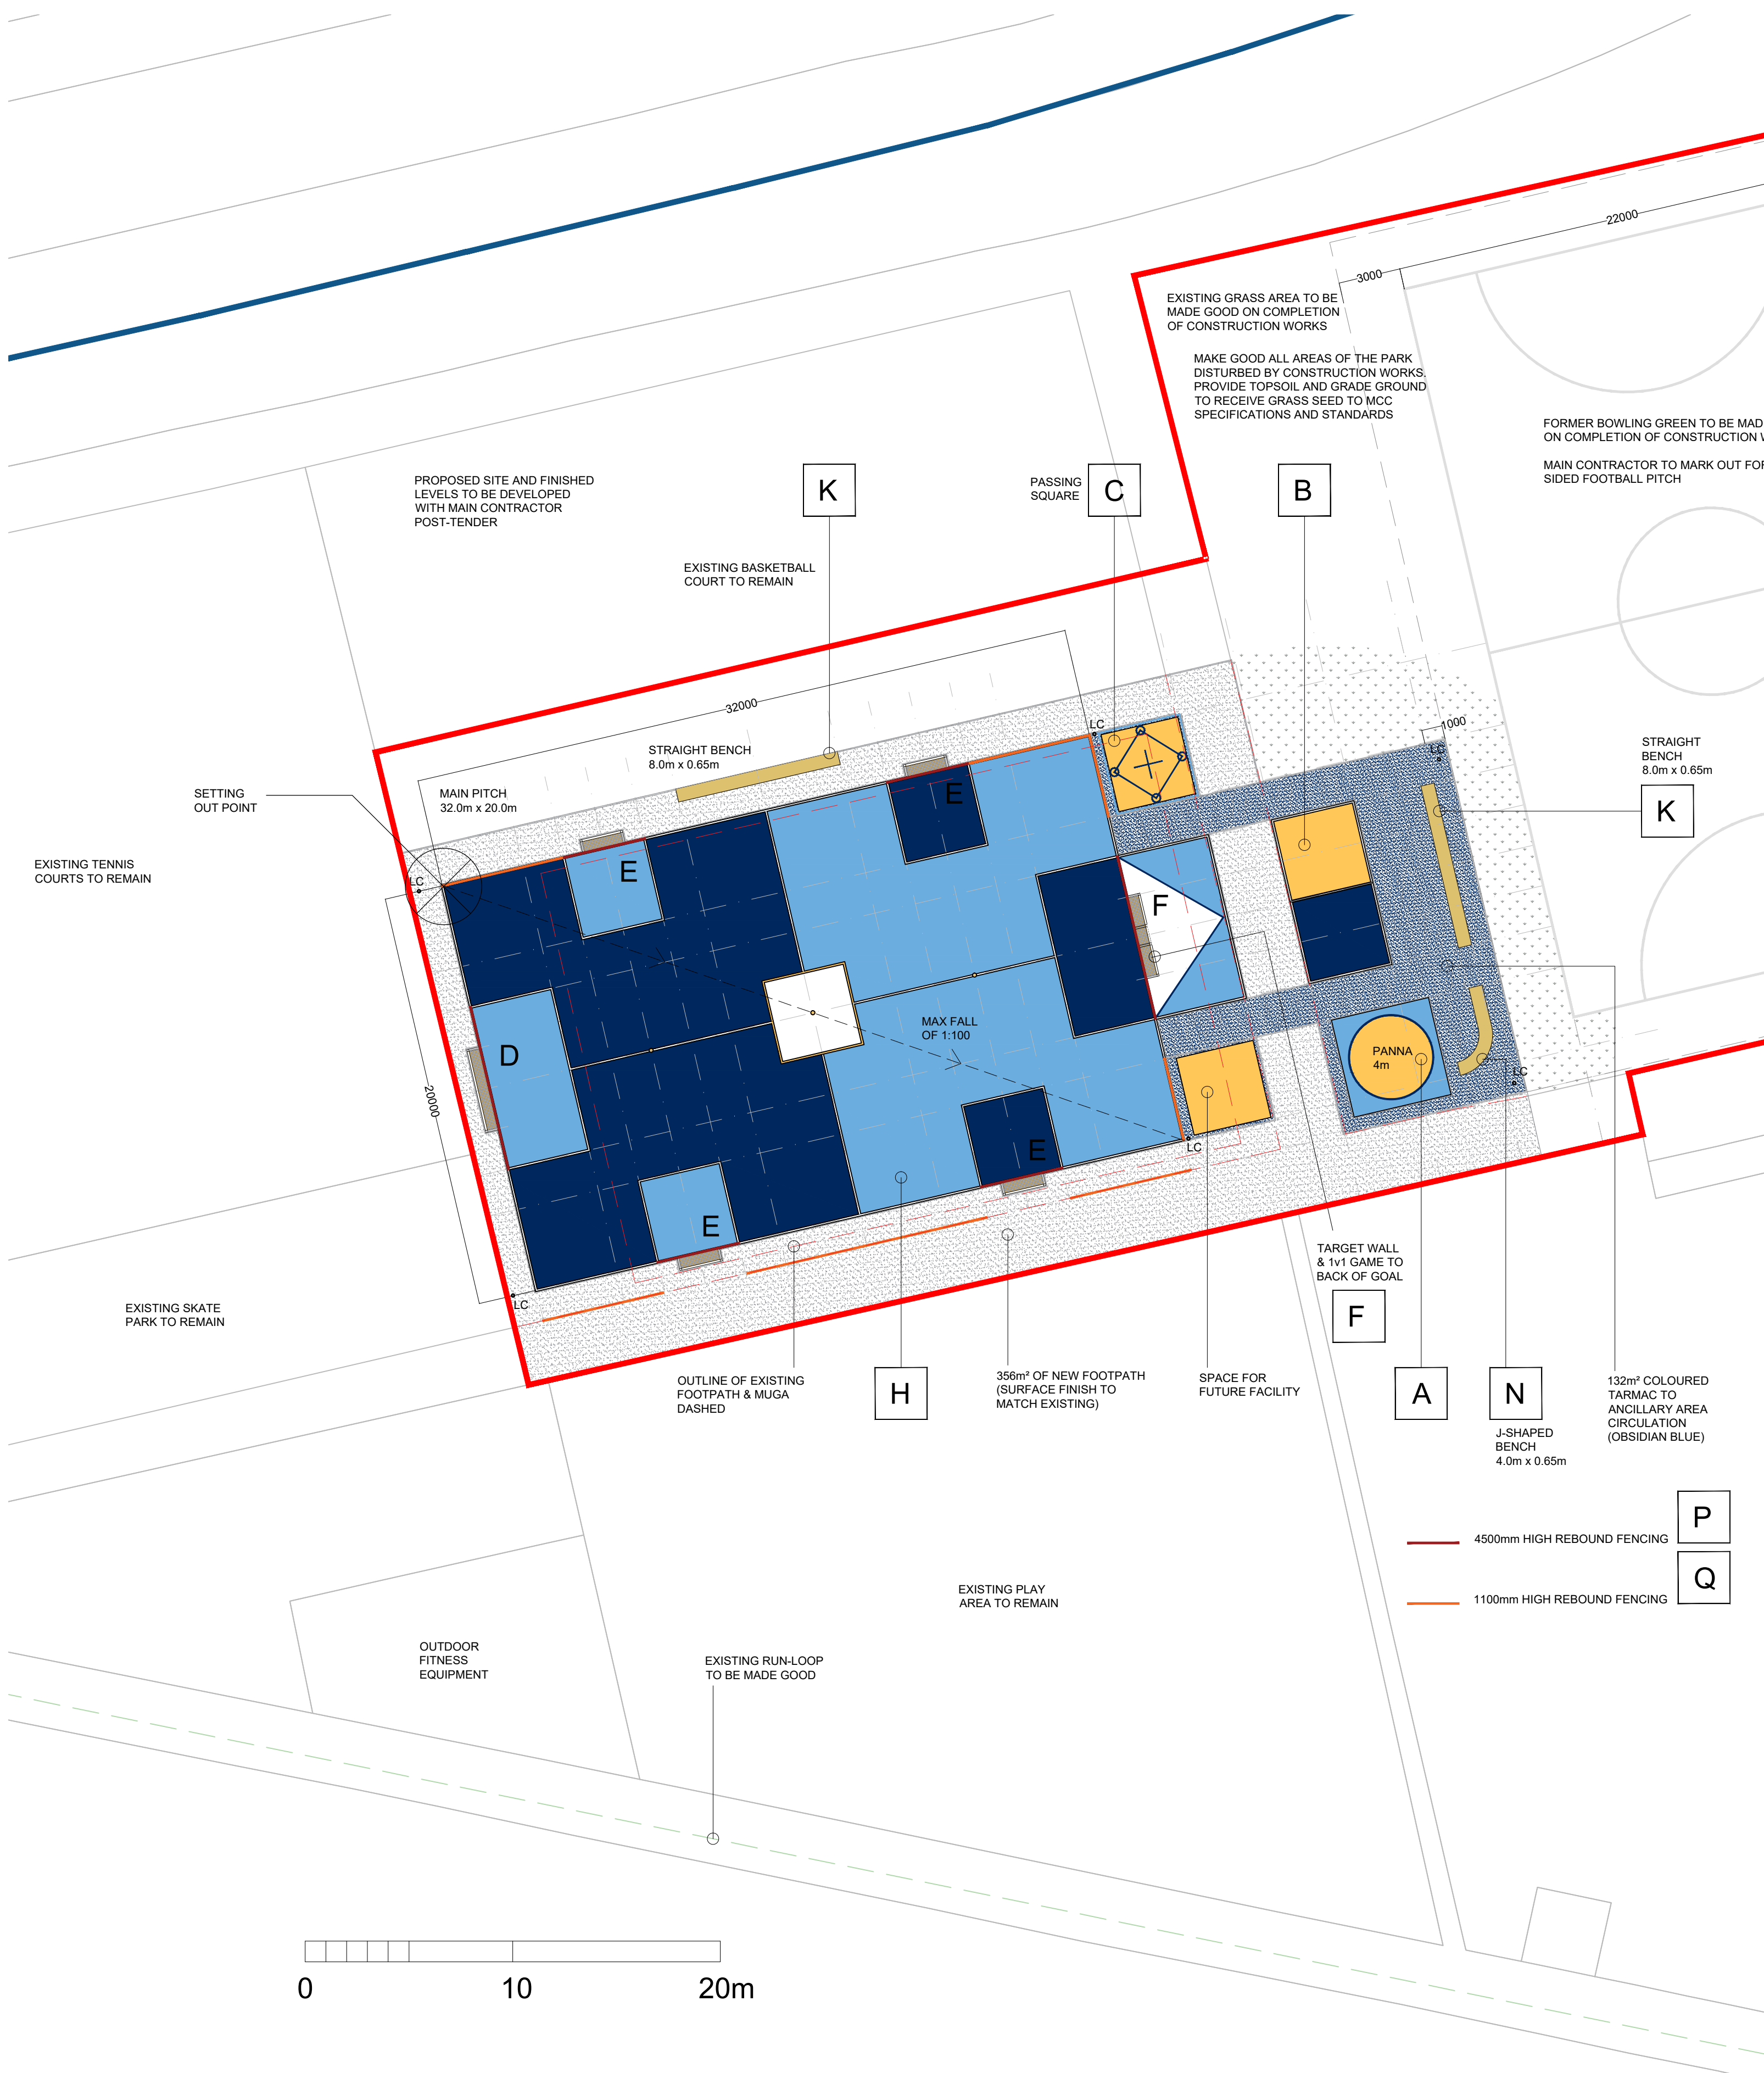
## Drawing 1 – Proposed Development Plan

It is understood from the drawing provided by the Client (included as Drawing 1) that the proposed development comprises the construction of a new Multi-Use Games Area (MUGA) and associated footpaths within the existing park.

| <b>Proposed Development</b> | <p>The proposed development of the Site comprises the construction of a new Multi-Use Games Area (MUGA) and associated footpaths in the north of the Site within the existing park and existing MUGA area.</p> <p>The proposed development plan is presented in Drawing 1. Identified human and built environment receptors (R) relevant to the proposed development comprise:</p> <ul style="list-style-type: none"> <li>▲ Construction workers.</li> <li>▲ Third parties during construction (adjacent Site users and adjacent residents).</li> <li>▲ Future Site users and maintenance workers.</li> <li>▲ The Built Environment (new buildings and infrastructure/utilities).</li> </ul> | | |
