**Residential Development at Ilk Street and Alpine Street, Clayton- PLOT 47**

BEK Enviro (BEK) has been commissioned by The Casey Group (CG) to supervise and validate the remediation works required at the above site.

## PLOT 47

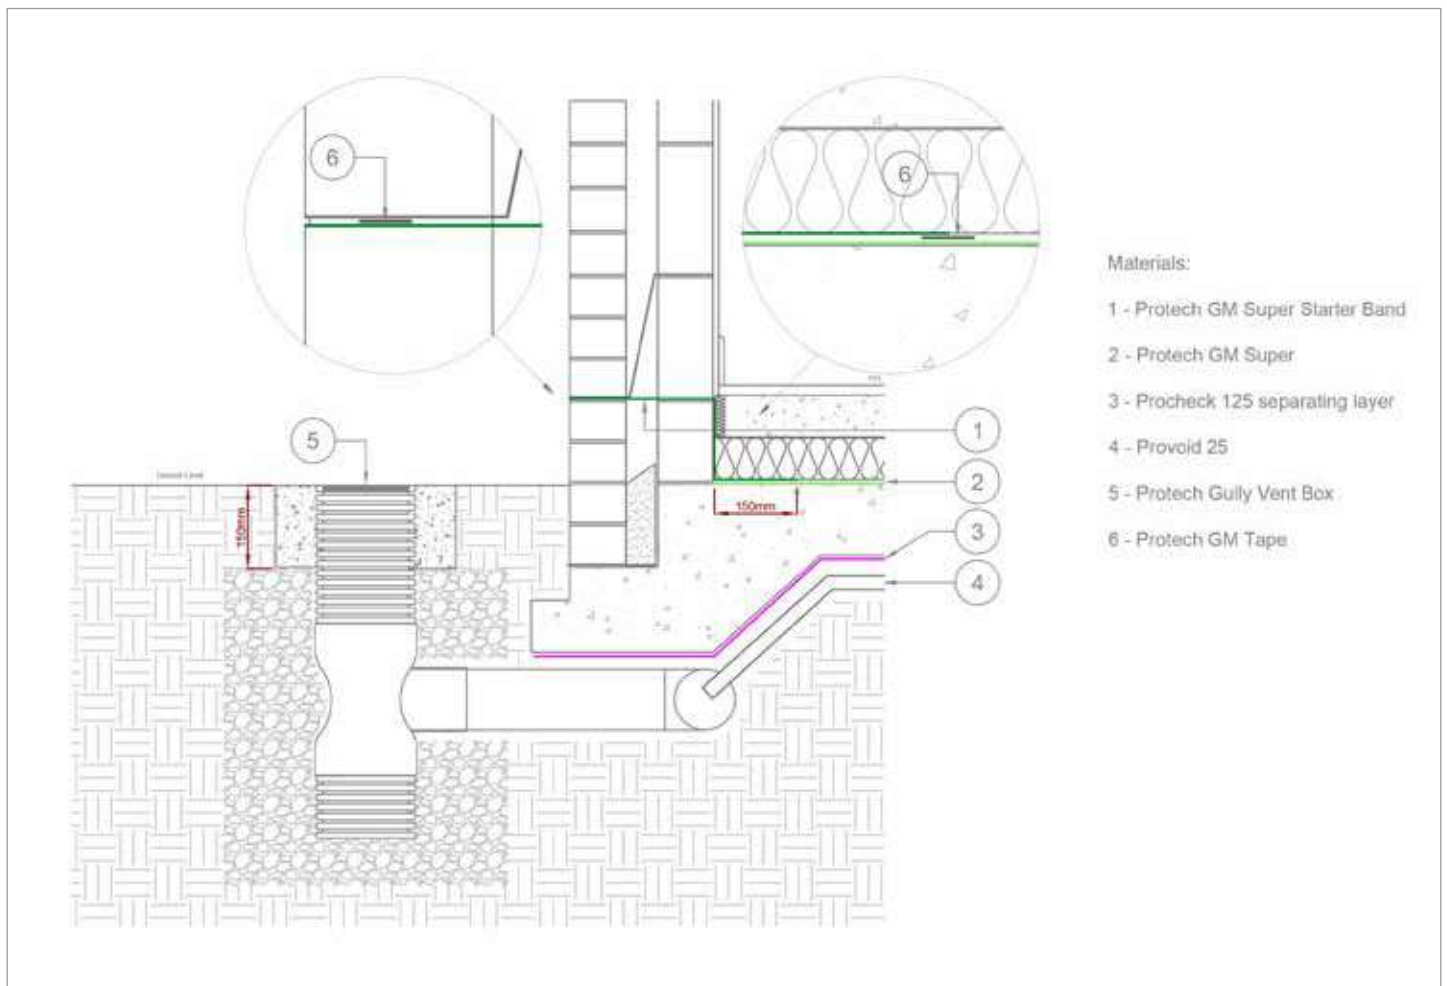
The Starter Band goes through the cavity with an architectural DPC or cavity tray which should be fixed with Protech GMTape in order to stop a creation of a slip plane.

On a solid wall internal wall construction there is no requirement for any additional DPC or protection to the Starter Band. When used in a cavity wall a separate cavity tray or architectural DPC is recommended to protection the spanning section of the Starter Band from damage from mortar spots and other debris created during construction. This cavity tray would be installed in the same course and fixed to Protech GMTape again to prevent a creation of a slip plane.

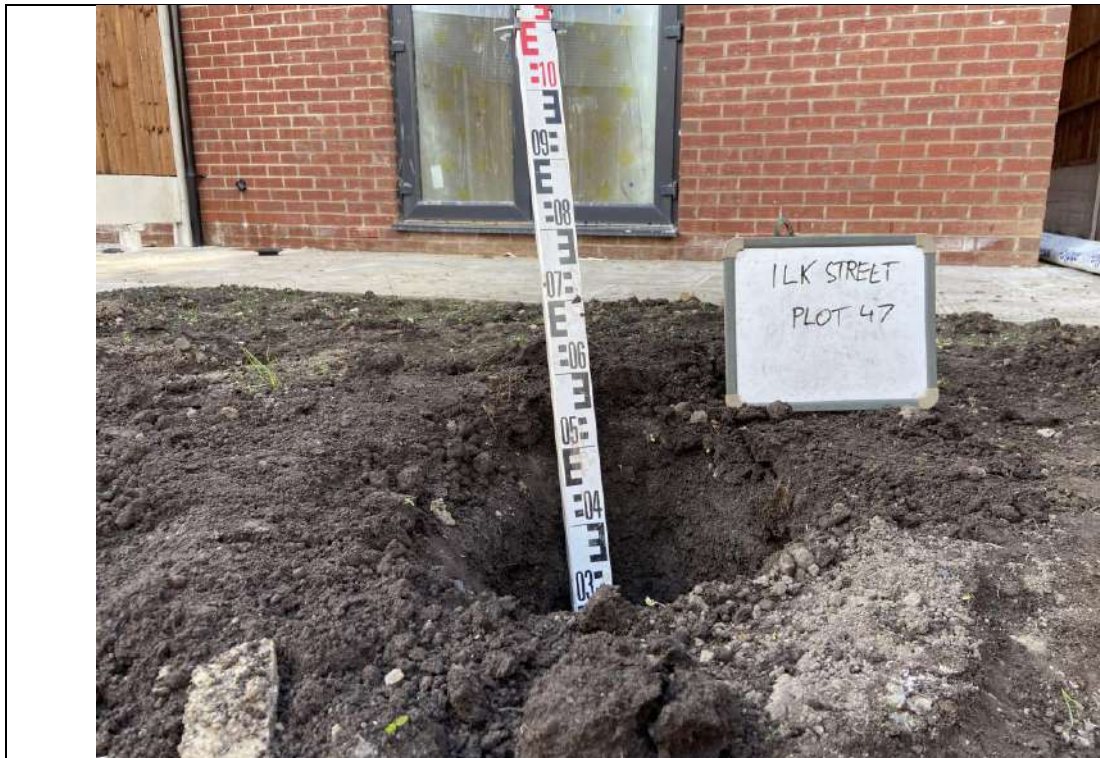
Photograph 1: Validation of Garden Capping Thickness

Following placement of the validated soils by CG, an engineer from BEK carried out spot checks and can confirm that the capping layer for Plot 47 comprises in excess of 600 mm of suitably clean validated soils. The capping soils overly a geotextile membrane at the base. Photographs showing capping thickness are provided within Annex E.

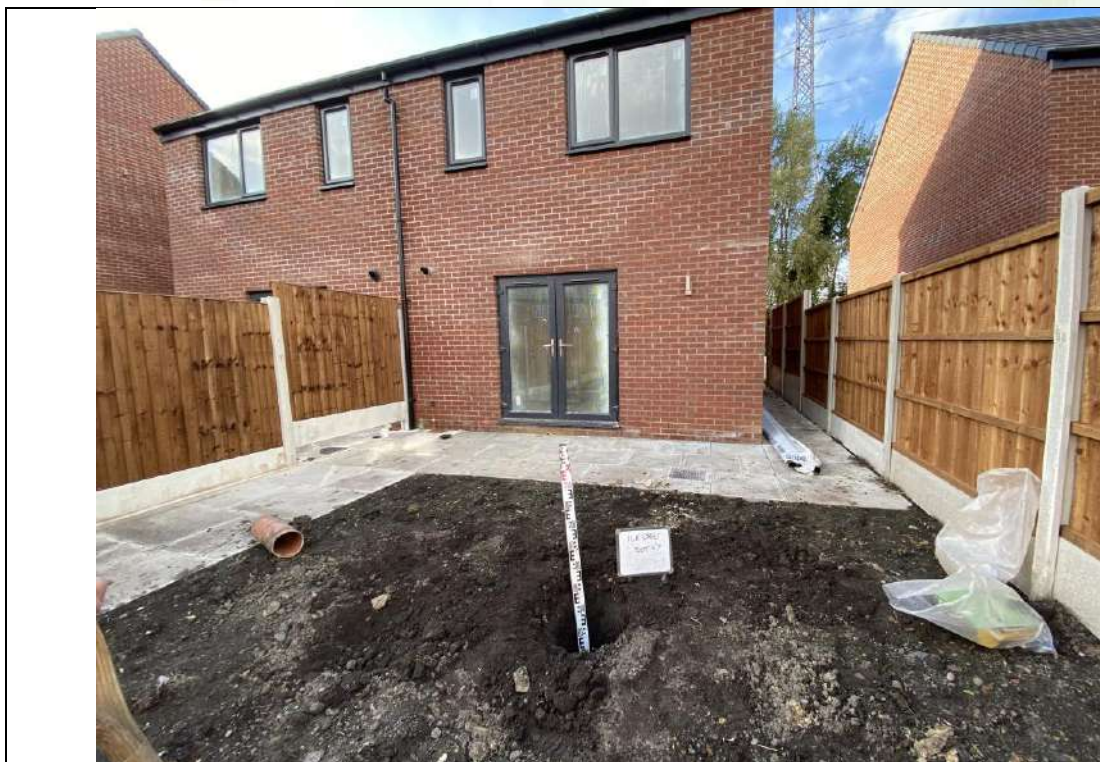
Photograph 2: Validation of Garden Capping Thickness

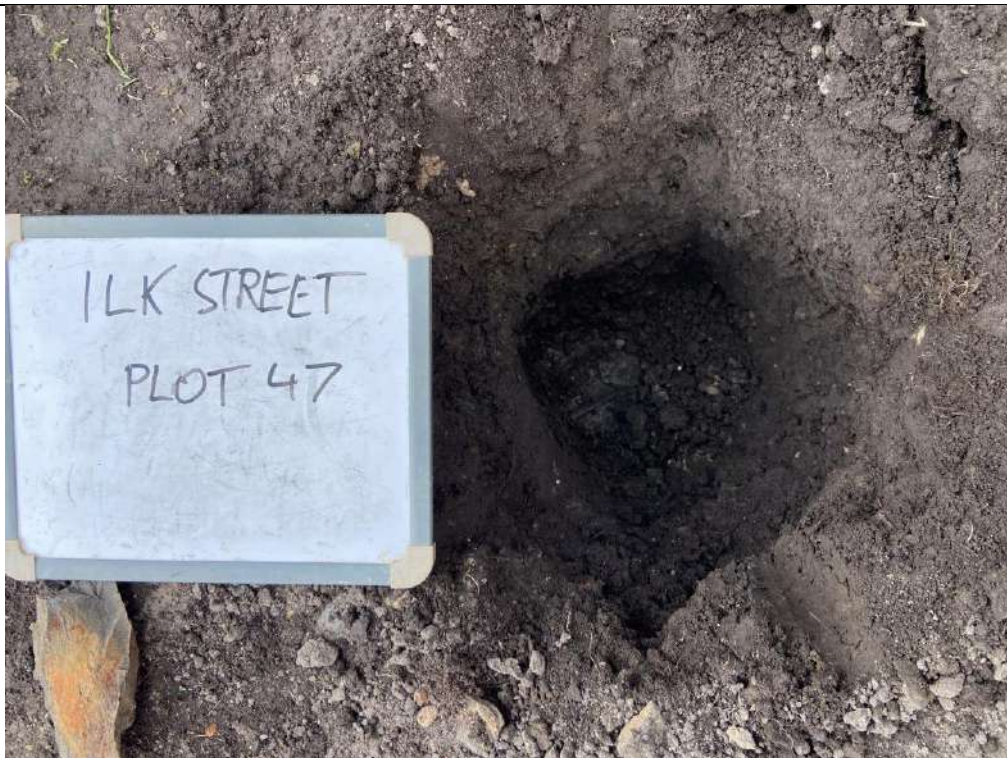
Photograph 3: Validation of Geotextile Membrane

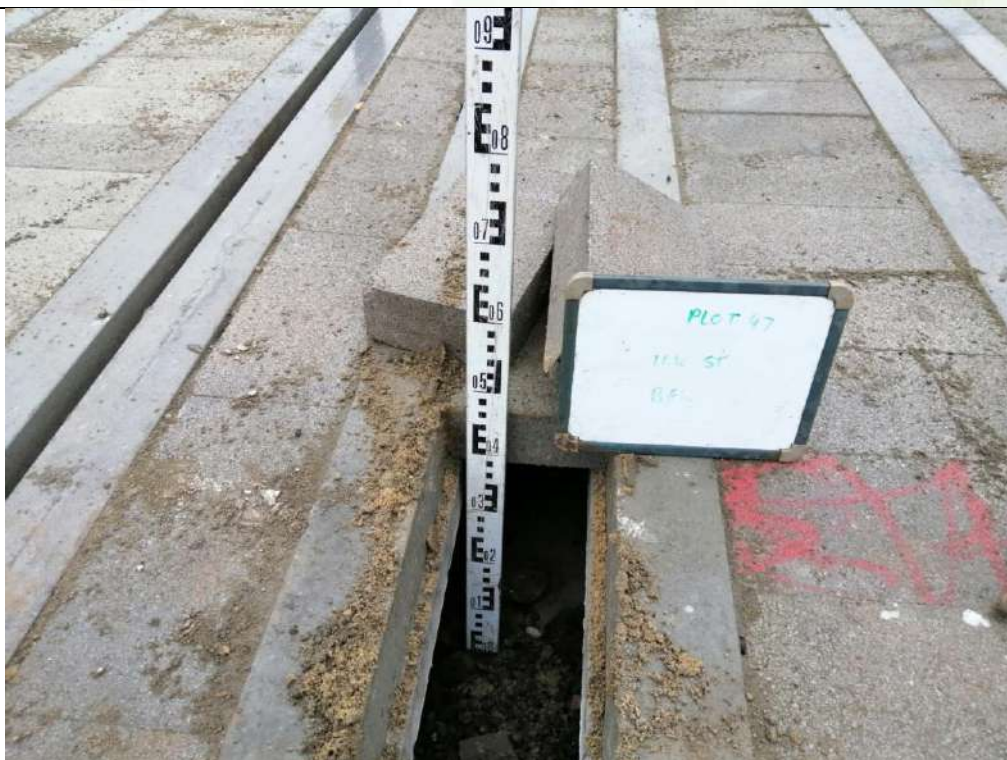
Photograph 4: Validation of Sub-Floor Void Space (min 150 mm)

The sub-floor void and the installation of the membrane has been validated and BEK can confirm the gas measures incorporated into the foundation design of Plot 47 conforms to the specified requirements. The membrane installation was verified by an Engineer from BEK who has attended the Verification of Gas Protection Systems Course delivered by CL:AIRE Training Course.

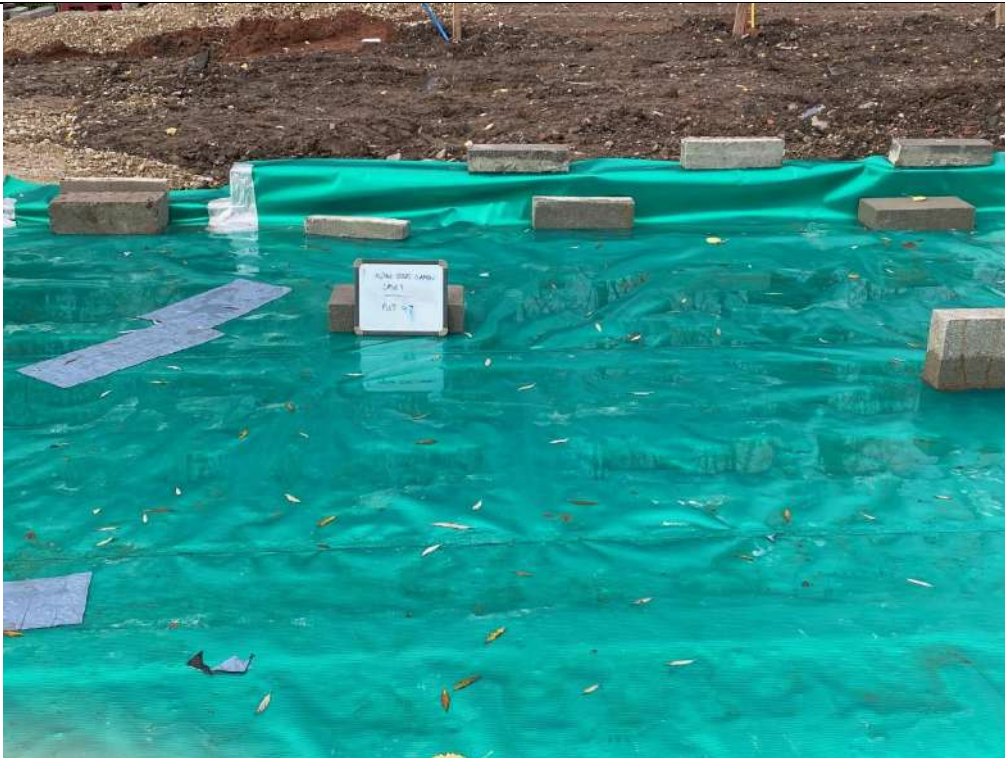
**Photograph 7: Validation of Gas Membrane Installation**

CG commissioned Reeve-Tec Membranes Limited to install the gas membranes at the site, who have used the Protech GM Super gas membrane which is considered suitable for use. A copy of the data sheet for this membrane is presented in Annex C. The completed gas validation proforma for this plot is presented in Annex D and validation photographs are presented in Annex E.

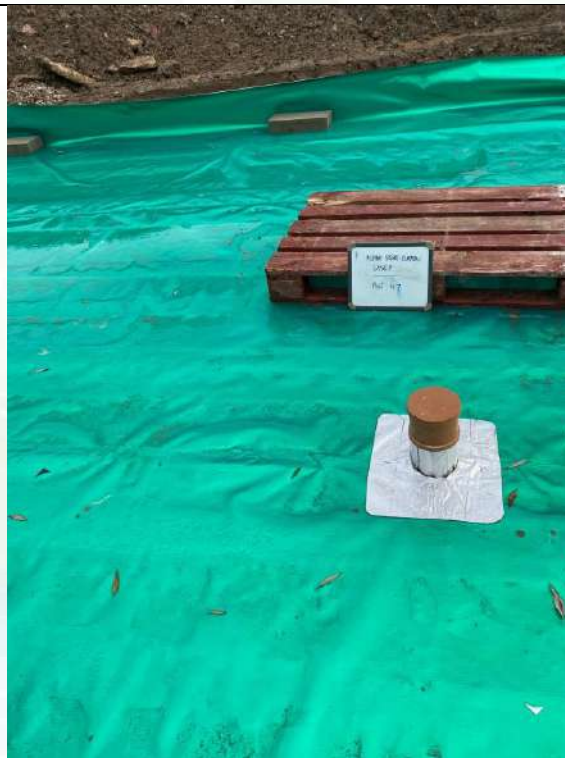
**Photograph 8: Validation of Gas Membrane Installation**
