## GeoEnvironmental Investigation

Moxley Road

Crumpsall

**Report Ref: A4255/21**

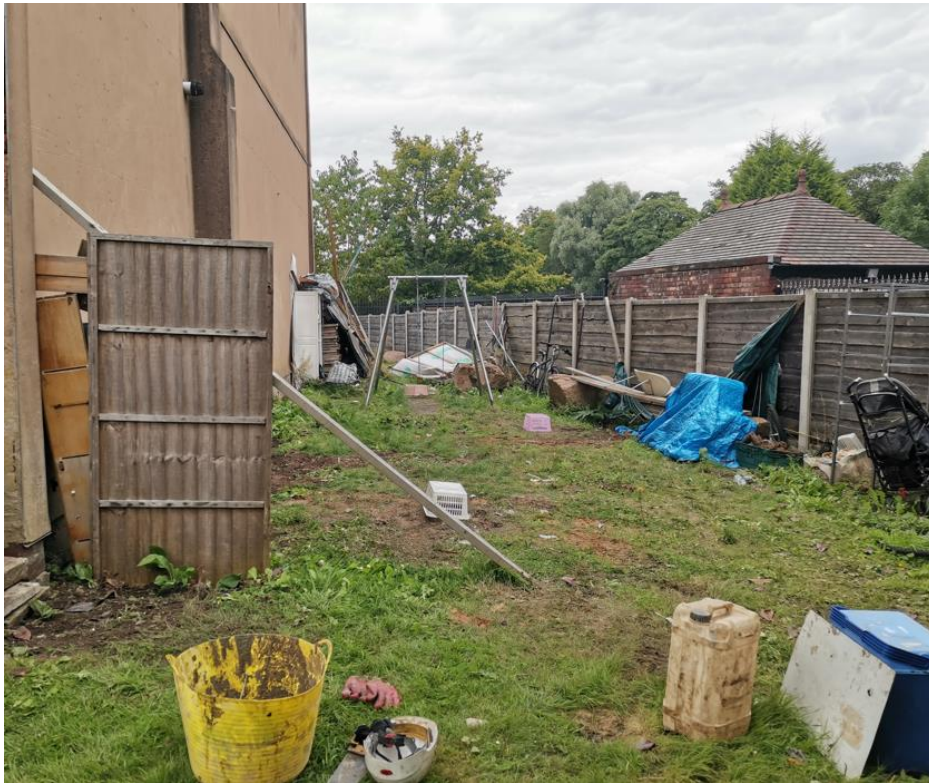
Photograph taken across the site viewing north

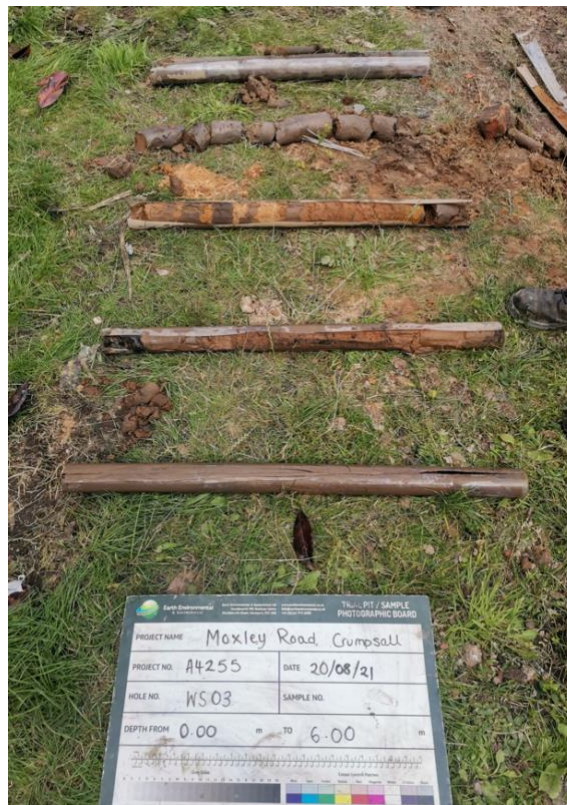
Photograph taken showing soils recovered from WS03

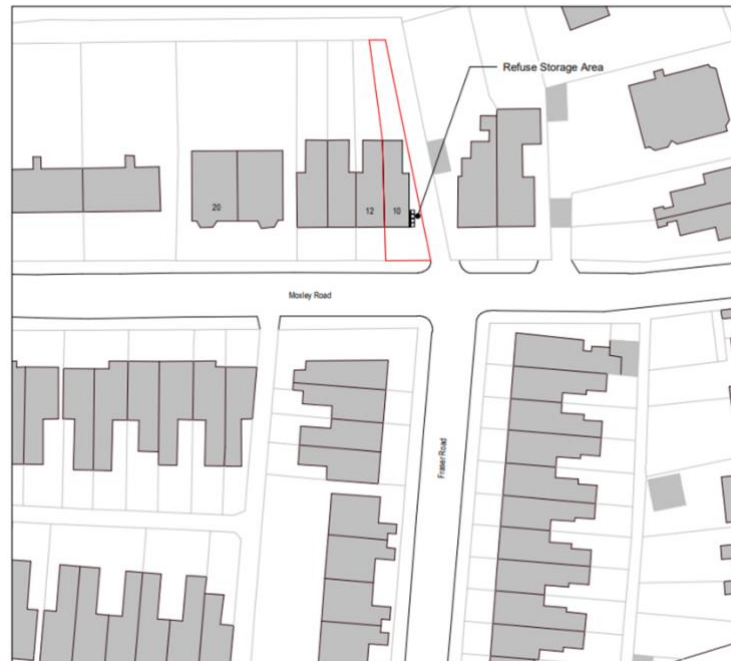
**Figure 3: Proposed Development Plan**

It is understood that the client intends to construct a residential development on the site comprising a three storey, end terrace dwelling house. The development will consist of 5no. bedrooms and front and rear gardens.

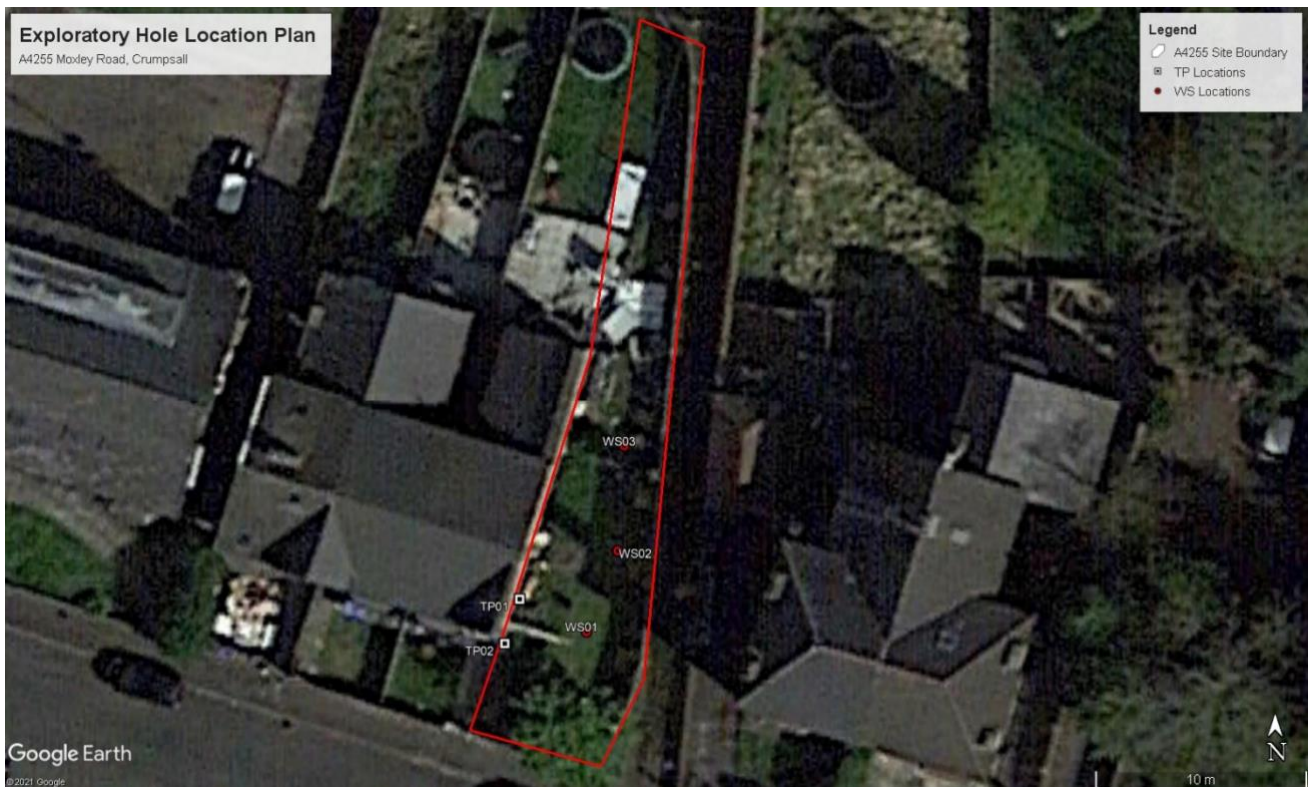
**Figure 4: Exploratory Hole Location Plan**

An Exploratory Hole Location Plan is presented as Figure 4, below.
