**Buildings 2, 3 and 10, Portugal Street East, Manchester M1 2WW**

## **UPDATED LICENSED BAT SURVEY AND ASSESSMENT**

**December 2021**

**[ERAP (Consultant Ecologists) Ltd ref: 2021-383]**

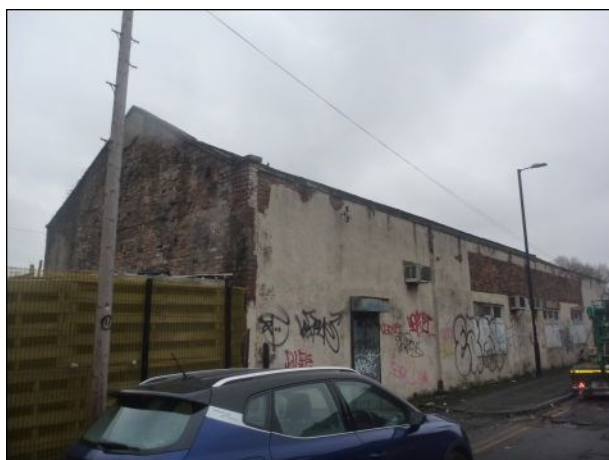
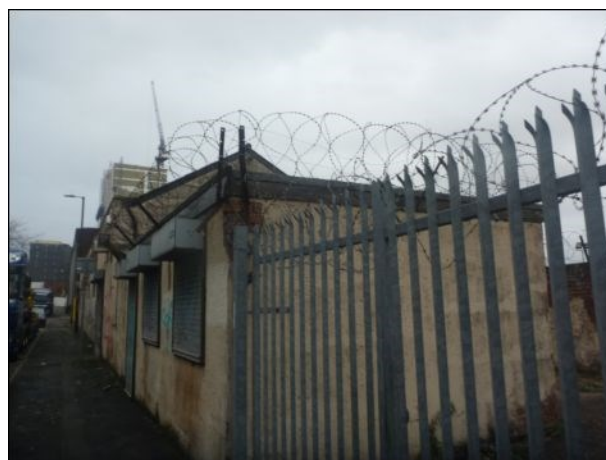
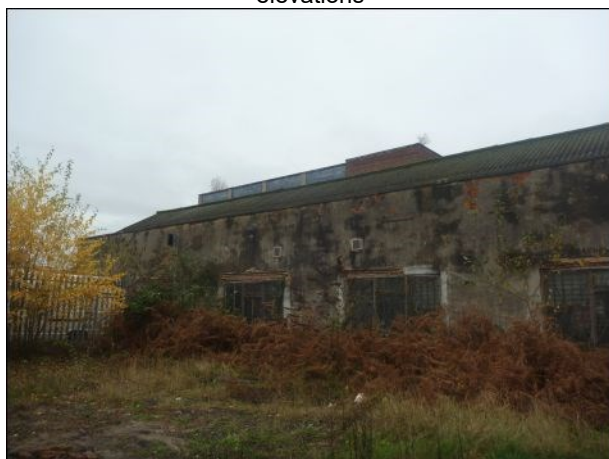
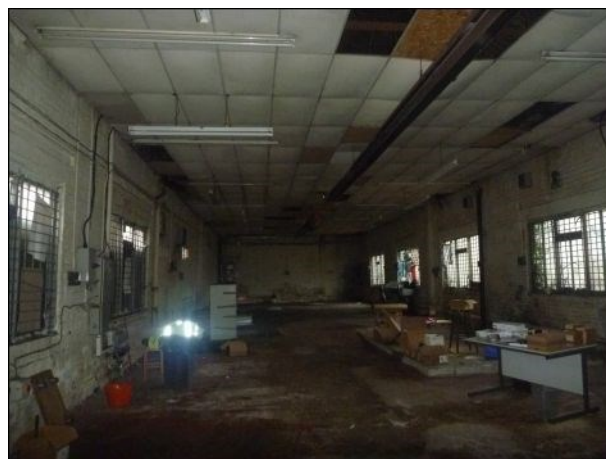
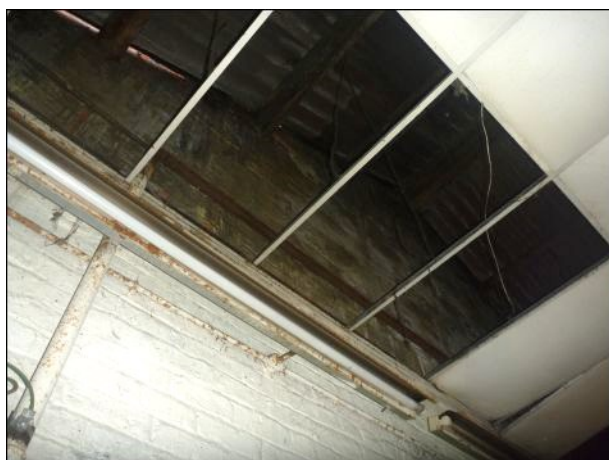
- 3.2.2 Refer to **Photos 1 to 5**. The building is now disused but otherwise remains as described in the previous ecology reports. No bats or signs of bats were detected at the building. Building 2 remains of negligible suitability for use by roosting bats. The presence of roosting bats is reasonably discounted at Building 2.

**Photo 1:** Building 2, north-eastern and north-western elevations

**Photo 2:** Building 2, south-western elevation

**Photo 3:** Building 2, south-eastern elevation

**Photo 4:** Building 2, internal area

**Photo 5:** Building 2, north-eastern gable end

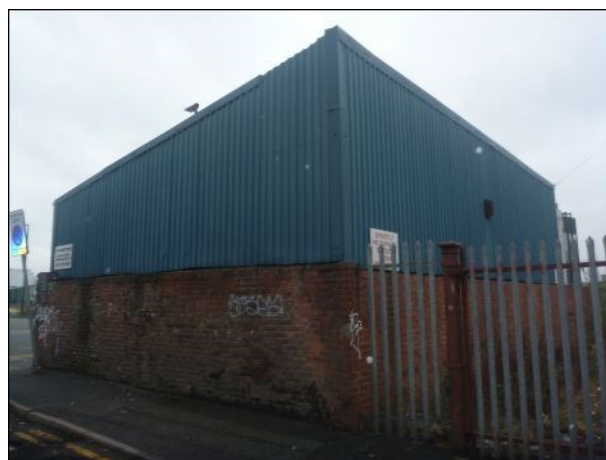
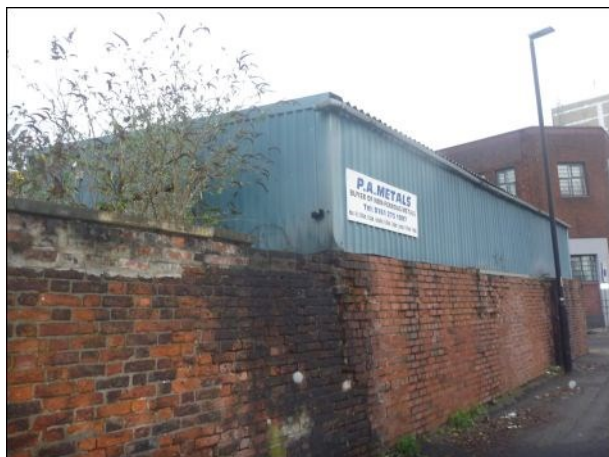
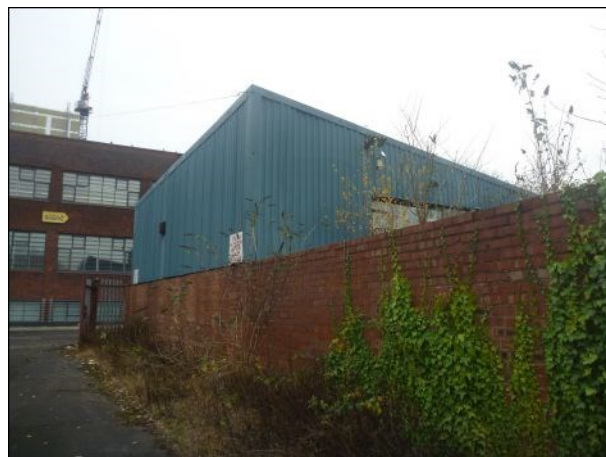
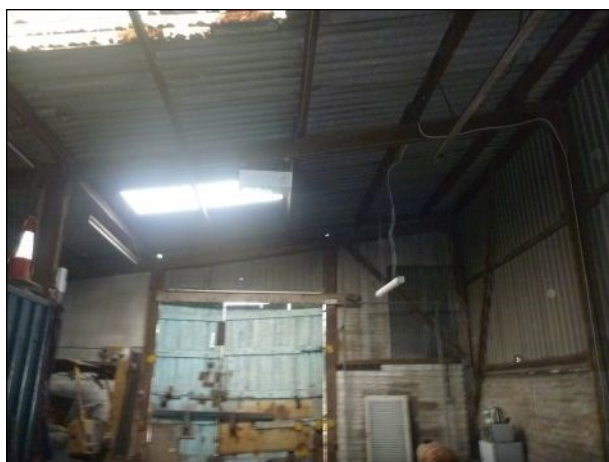
- 3.2.3 Refer to **Photos 6 to 9**. The building remains as described in the previous ecology reports. No bats or signs of bats were detected at the building. Building 3 remains of negligible suitability for use by roosting bats. The presence of roosting bats is reasonably discounted at Building 3.

**Photo 6:** Building 3, north-eastern and north-western elevations

**Photo 7:** Building 3, south-eastern elevation

**Photo 8:** Building 3, north-western elevation

**Photo 9:** Building 3, internal area

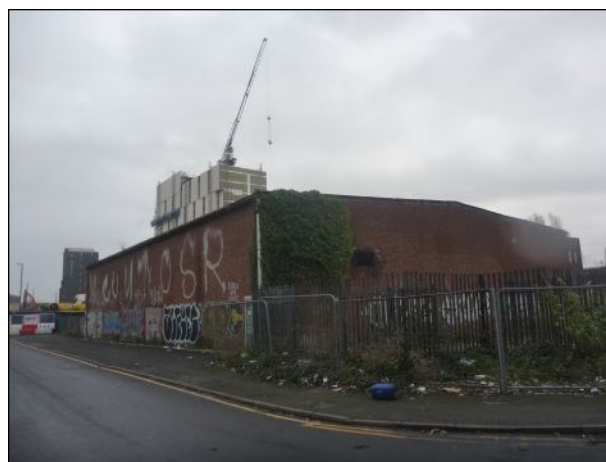
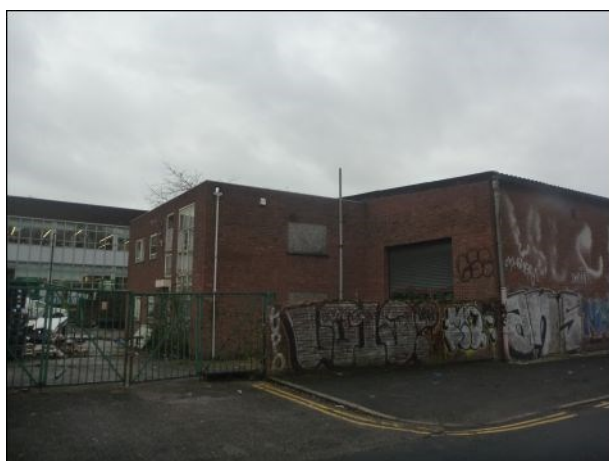
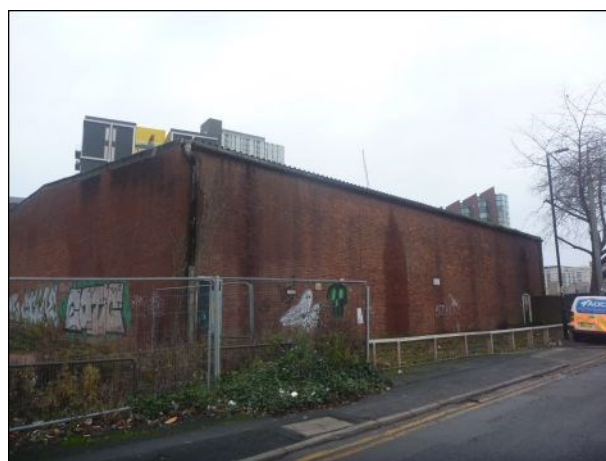
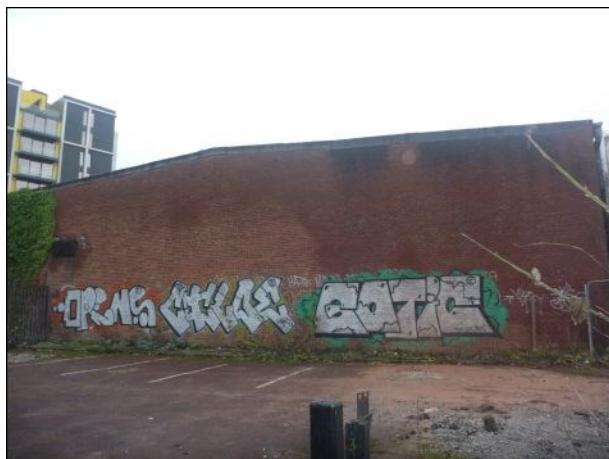
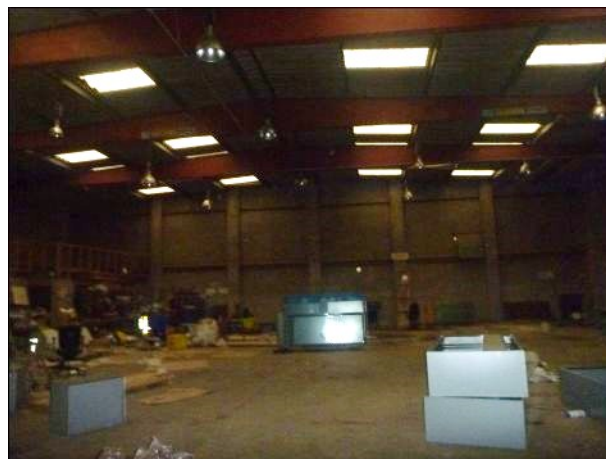
- 3.2.4 Refer to **Photos 10 to 14**. The building has suffered minor water damage at its north-eastern end, but otherwise remains as described in the previous ecology reports. No bats or signs of bats were detected at the building. Building 10 remains of negligible suitability for use by roosting bats. The presence of roosting bats is reasonably discounted at Building 10.

**Photo 10:** Building 10, south-western and north-western elevation

**Photo 11:** Building 10, north-eastern elevation

**Photo 12:** Building 10, south-eastern elevation

**Photo 13:** Building 10, south-western elevation

**Photo 14:** Building 10, internal area
