Our Ref: BEK/19661/211101/CGL/P44

**Residential Development at Ilk Street and Alpine Street, Clayton- PLOT 44**

BEK Enviro (BEK) has been commissioned by The Casey Group (CG) to supervise and validate the remediation works required at the above site.

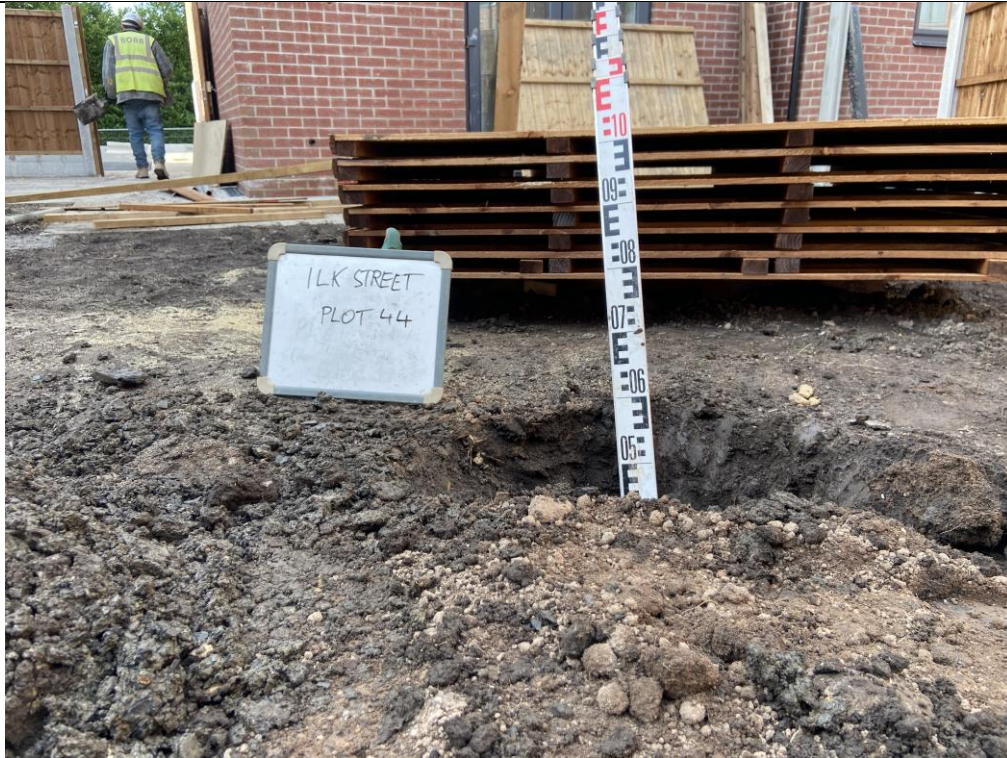
Following placement of the validated soils by CG, an engineer from BEK carried out spot checks and can confirm that the capping layer for Plot 44 comprises in excess of 600 mm of suitably clean validated soils. The capping soils overly a geotextile membrane at the base. Photographs showing capping thickness are provided within Annex E.

Photograph 1: Validation of Garden Capping Thickness

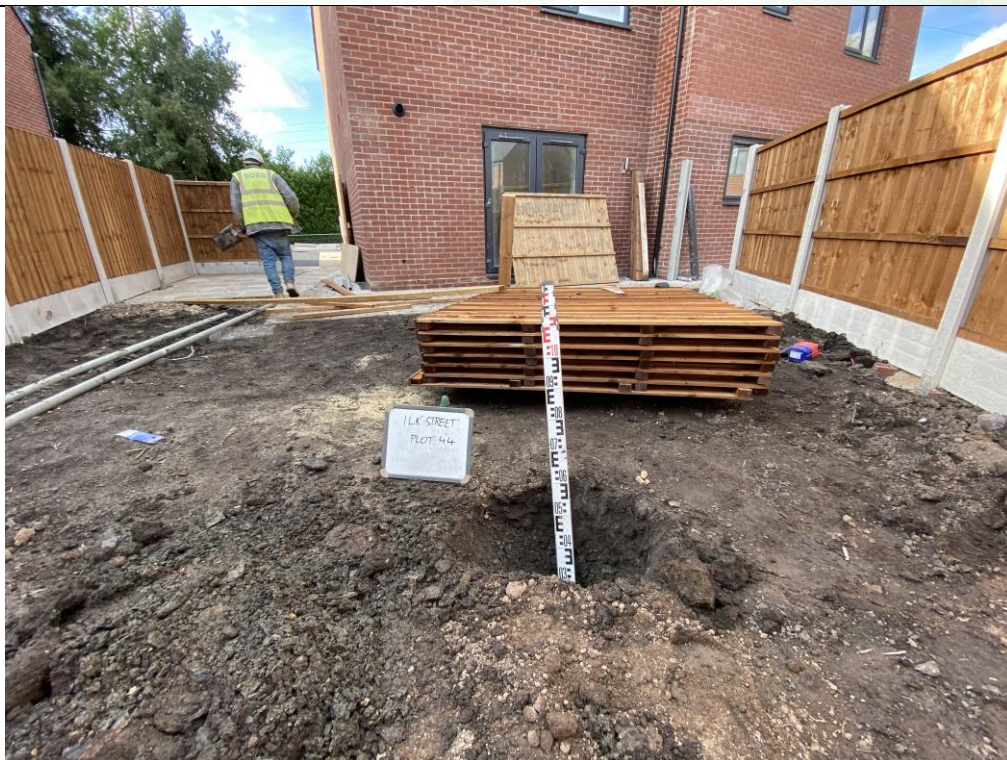
Photograph 2: Validation of Garden Capping Thickness

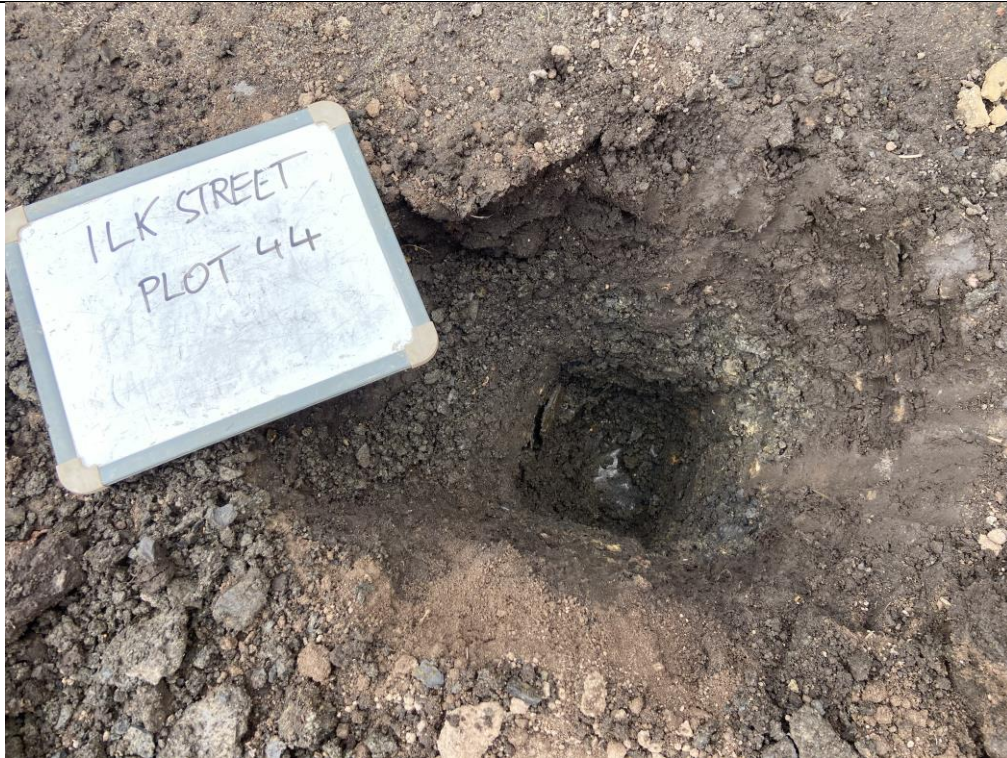
Photograph 3: Validation of Geotextile Membrane

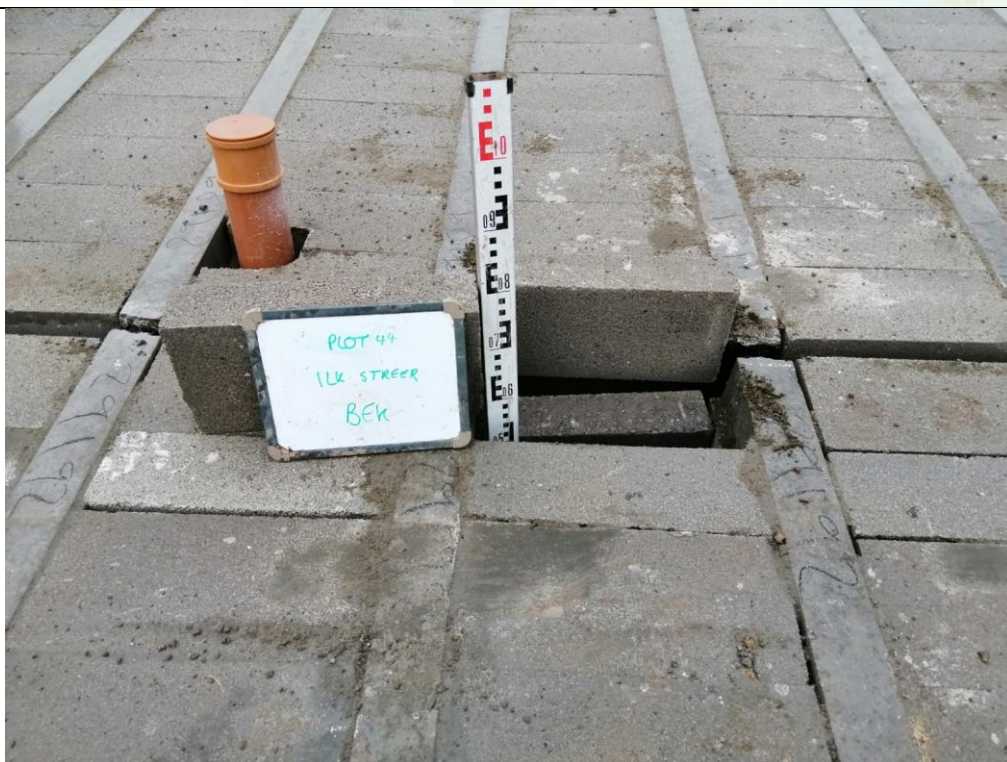
The sub-floor void and the installation of the membrane has been validated and BEK can confirm the gas measures incorporated into the foundation design of Plot 44 conforms to the specified requirements. The membrane installation was verified by an Engineer from BEK who has attended the Verification of Gas Protection Systems Course delivered by CL:AIRE Training Course.

Photograph 4: Validation of Sub-Floor Void Space (min 150 mm)

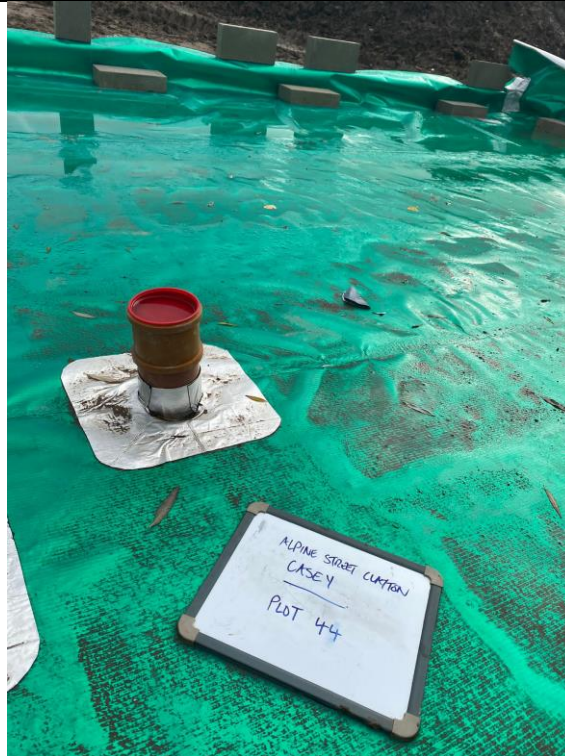
CG commissioned Reeve-Tec Membranes Limited to install the gas membranes at the site, who have used the Protech GM Super gas membrane which is considered suitable for use. A copy of the data sheet for this membrane is presented in Annex C. The completed gas validation proforma for this plot is presented in Annex D and validation photographs are presented in Annex E.

Photograph 5: Validation of Gas Membrane Installation

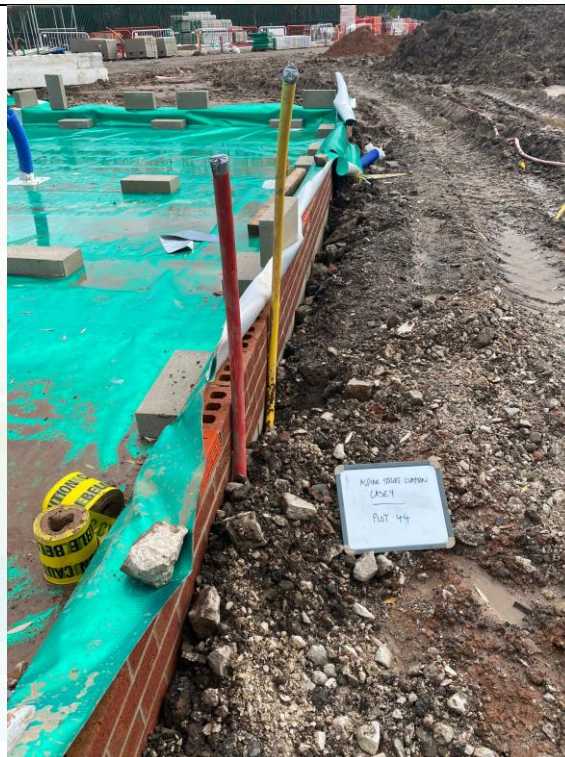
Photograph 6: Validation of Gas Membrane Installation

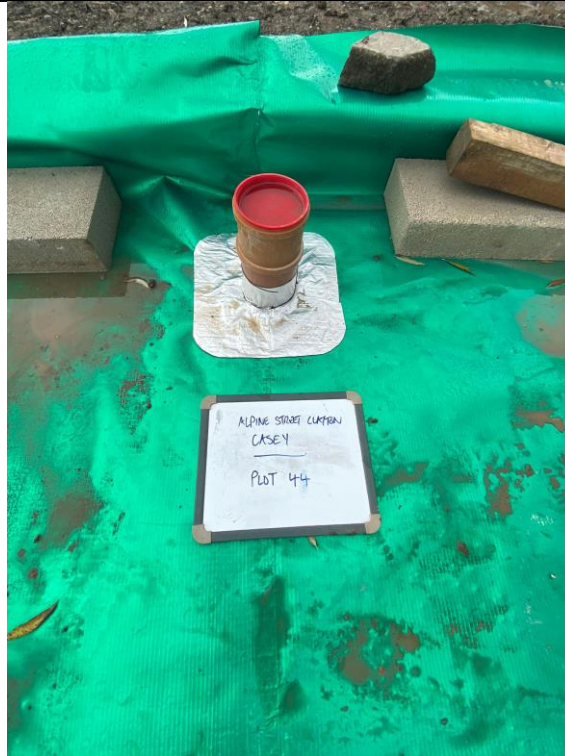
**Photograph 7: Validation of Gas Membrane Installation**

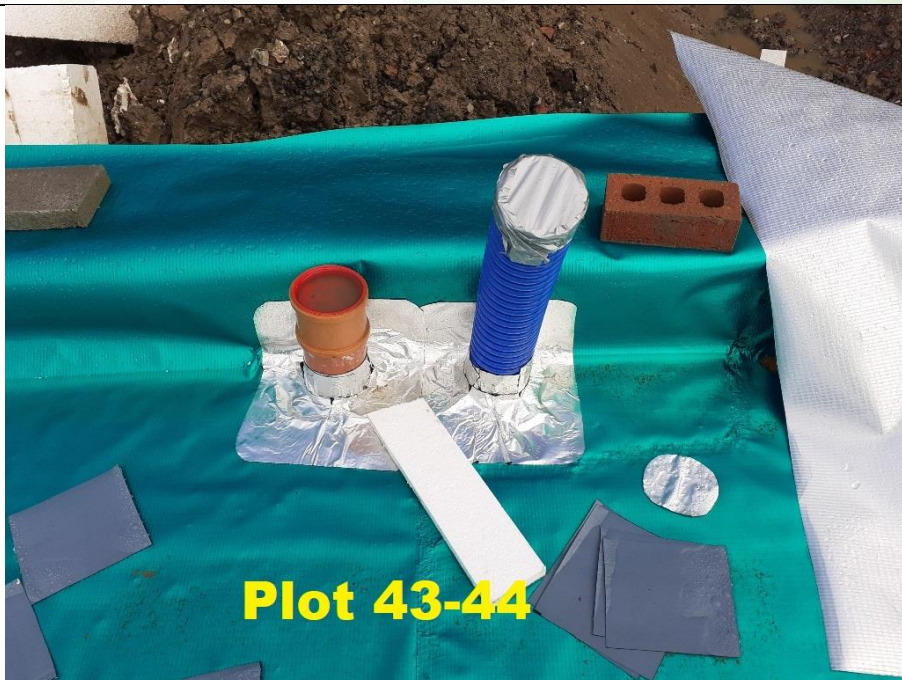
**Photograph 8: Validation of Gas Membrane Installation** (Please note, plots 43 and 44 are semidetached and were validated together. Gas membranes are satisfactory within both plots)
