# Lincoln Square, Manchester

## Summary of Archaeological Watching Brief Works

### 21<sup>st</sup> October 2021

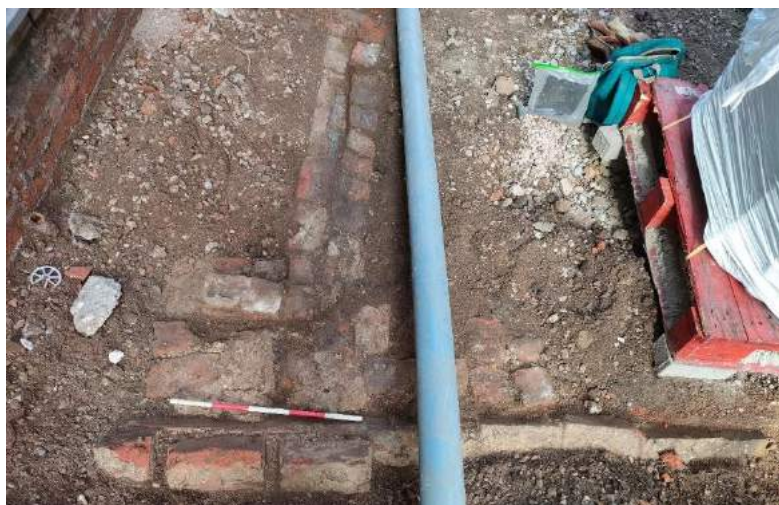
At 20m from the west end of Area A (Deansgate end), a brick feature was found. It consisted of a 25cm wide brick wall that measured 2.5m in length and ran parallel with the street. It was made from handmade bricks (23x7x11cm) and lime mortar. The wall turned southwards towards the current building (Centurion House) and was truncated at 35cm from the building. The main length of the wall was 75cm away from the building. Halfway along the length was a patch of black ash mortar which could be evidence of a repair or reuse of older bricks. At the eastern end at right angles to the wall was what looked like a drainage channel, with the short section of wall forming the west edge. It had a brick base and the east edge was made from 2 courses of bricks laid at a slope. The internal width of the channel was 28cm and the external width was 50cm. The drain feature's total remaining length was 1.8m. The southern end of the channel was truncated by the current building's foundations at a distance of 35cm.

*Drain feature in Area A*

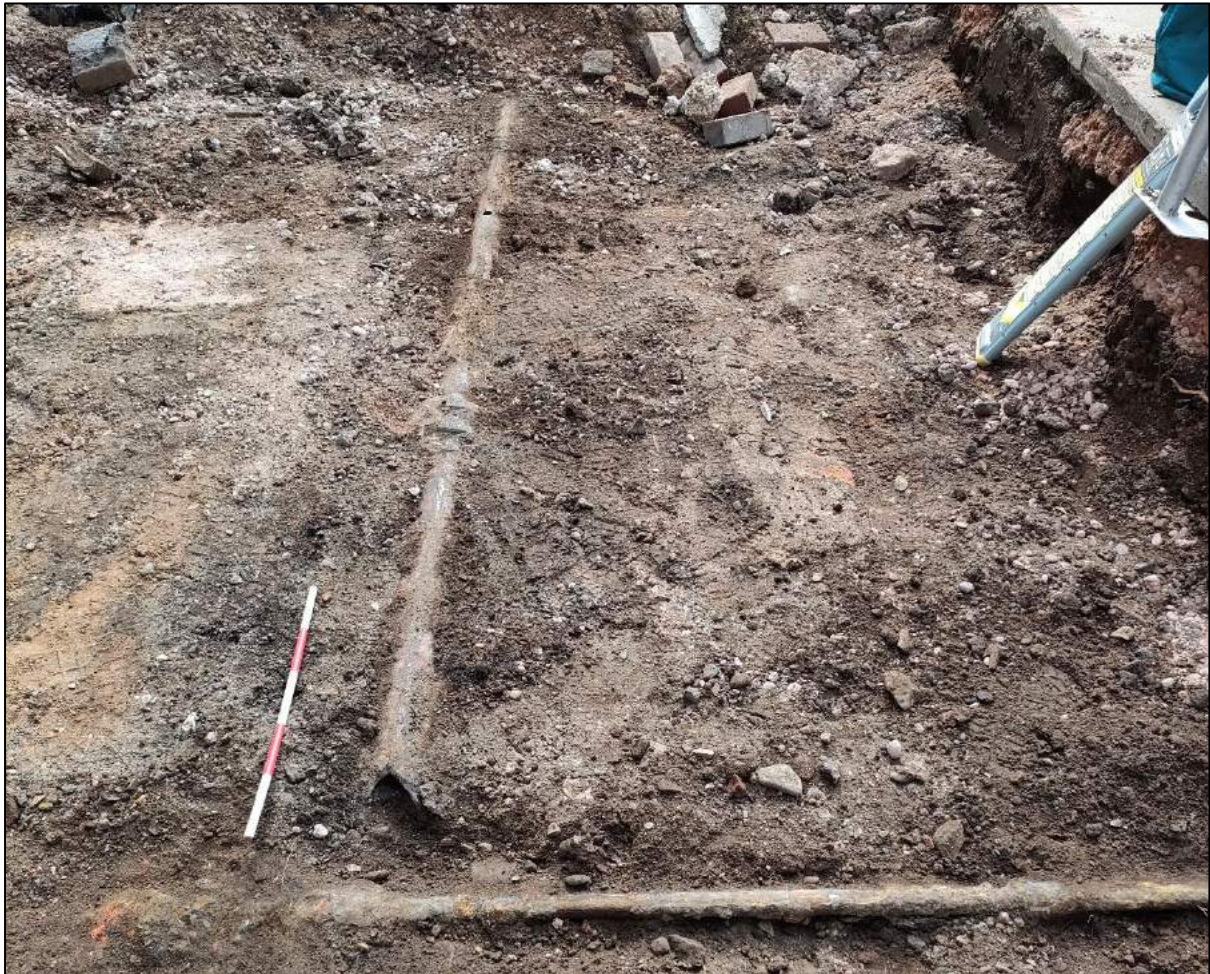
Iron pipes were found in Brazennose St (green structure on map) The N-S one was 2.5cm in diameter and the E-W one was 10cm in diameter. The wider pipe was truncated by the narrower one. The narrow pipe disappears into the S side.

*Iron pipes found in Area A*

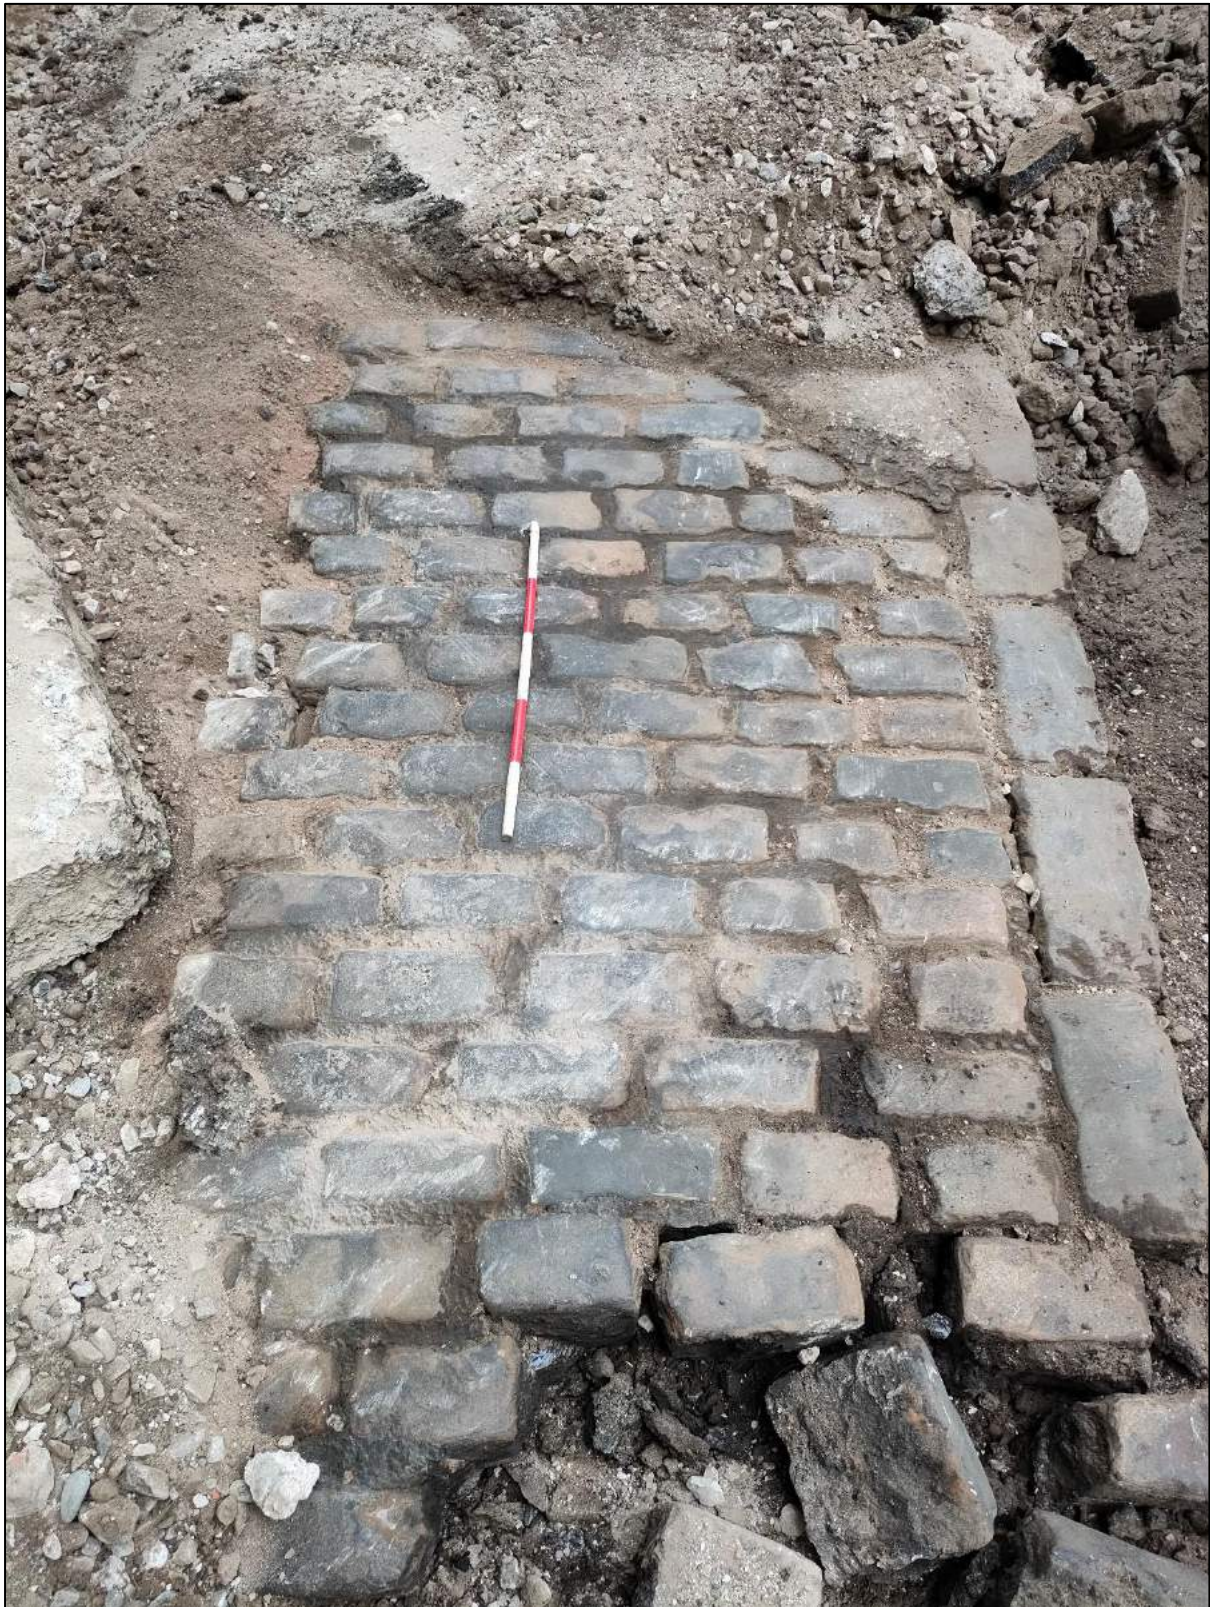
Several other patches of setts were revealed along Brazennose St near the NE corner of Lincoln Square. These varied in size due to truncation by modern services and trees. One particular area of setts was larger than the surrounding ones with dimensions of 1.3m wide by 2.5m long. Another area slightly to the north of the large area still had the kerbstones intact. The kerb was approximately 1.2m from the current buildings on the north side of Brazennose St.

*One of the patches of setts from along Brazennose St with kerbstones.*

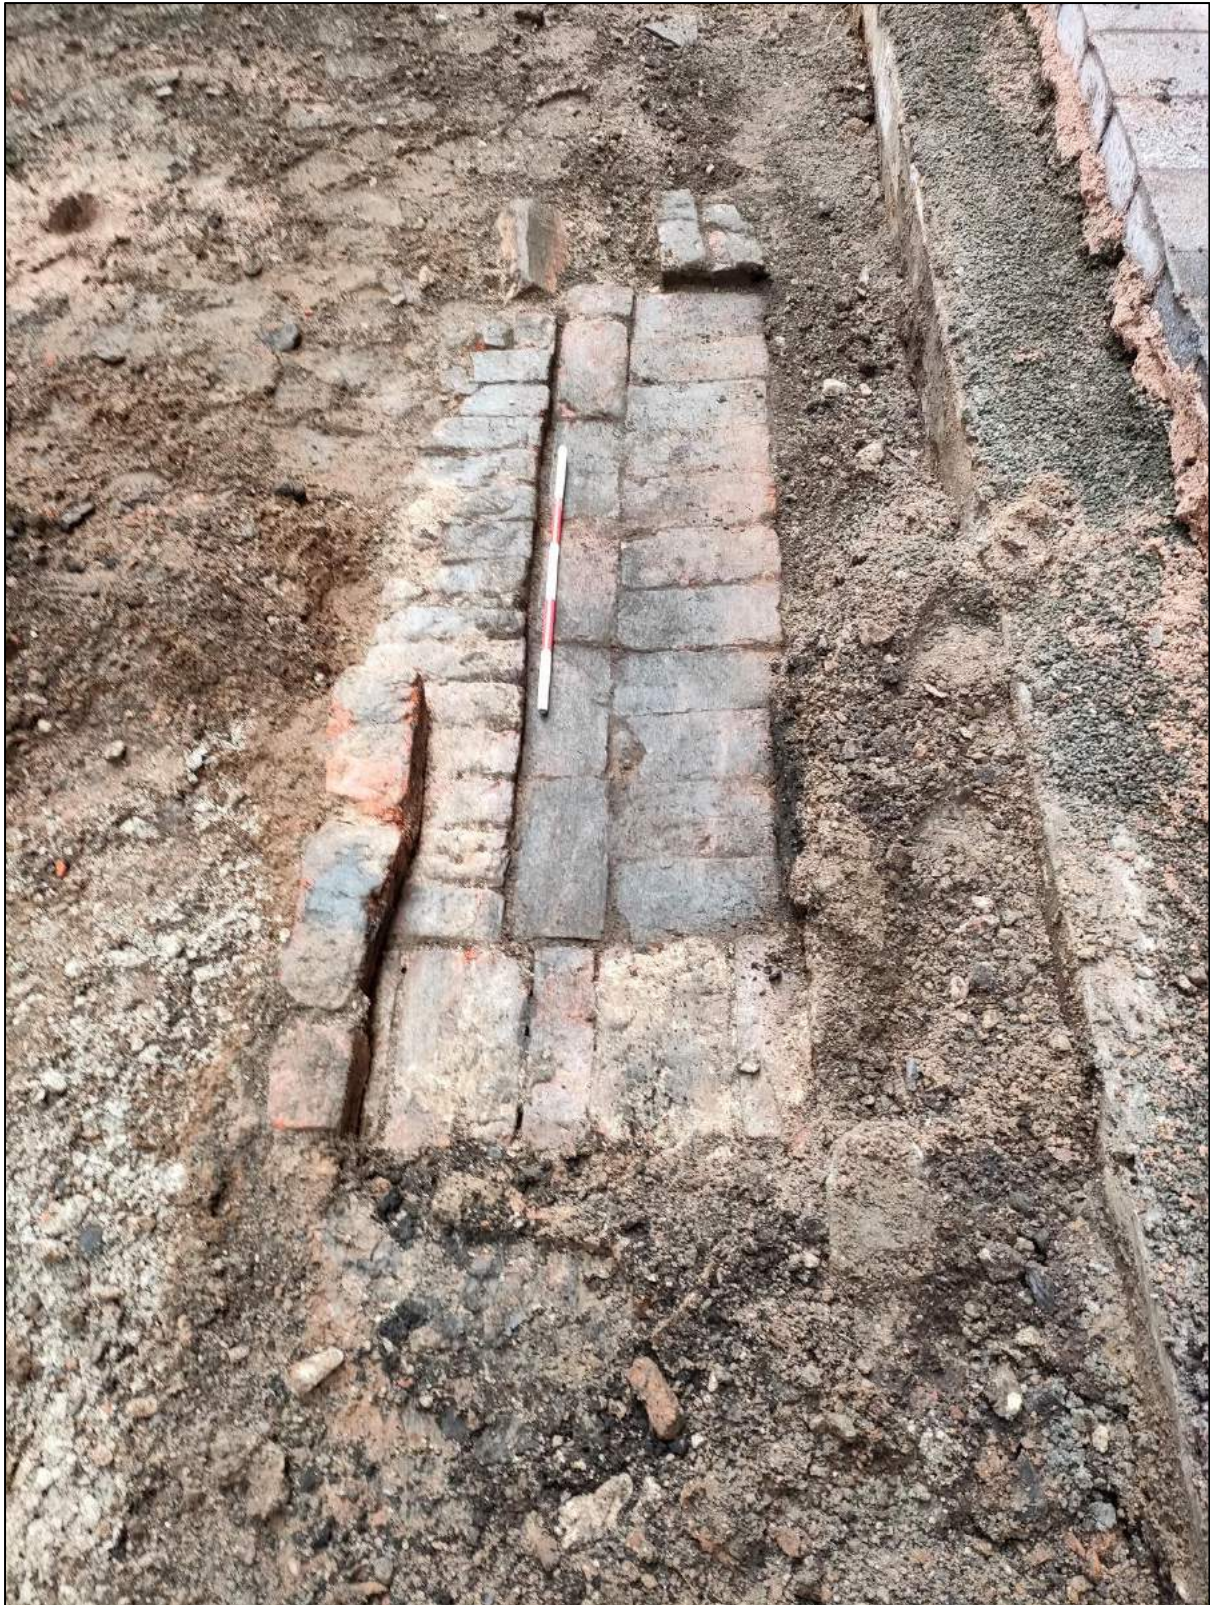
A brick structure was found that was 20cm away from the current building, in the centre of the first bay of the covered pavement. It consisted of handmade bricks and lime mortar with a maximum of 2 courses surviving. It appeared to be a double skin wall around a brick surface.

*Brick surface bounded by a wall*

At the west end of the surface was an area of black silty material around 10cm thick and staining the surface black. The wall had a width of 25cm, and the outer dimensions of the structure were 165cm long by 57cm wide. There was mainly one course remaining with 3 bricks left from the second course. The structure was laid on sand and the foundation trench

was packed with clay. This appears to be located in front of what was No 44 Brazennose St on the 1850s OS map.

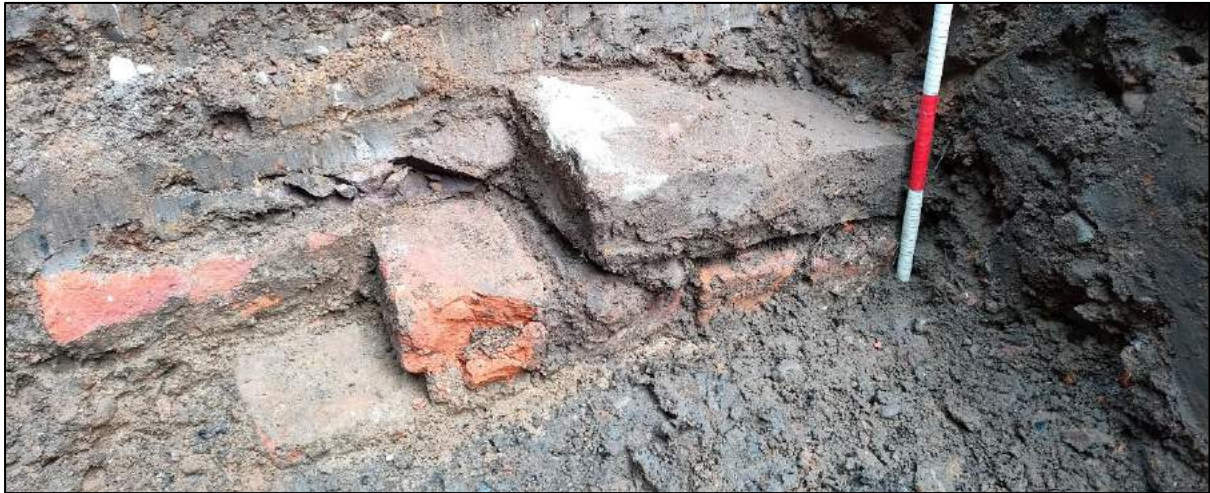
While excavating a pit for a drainage gully, a doorstep and brick wall were found at a depth of 1.3m. 2 courses of bricks and one stone step. The depth and position in the middle of Mulberry St/Brazennose St junction may suggest they predate the current layout of the streets. (purple square on accompanying sketch)

*Close up of doorstep*

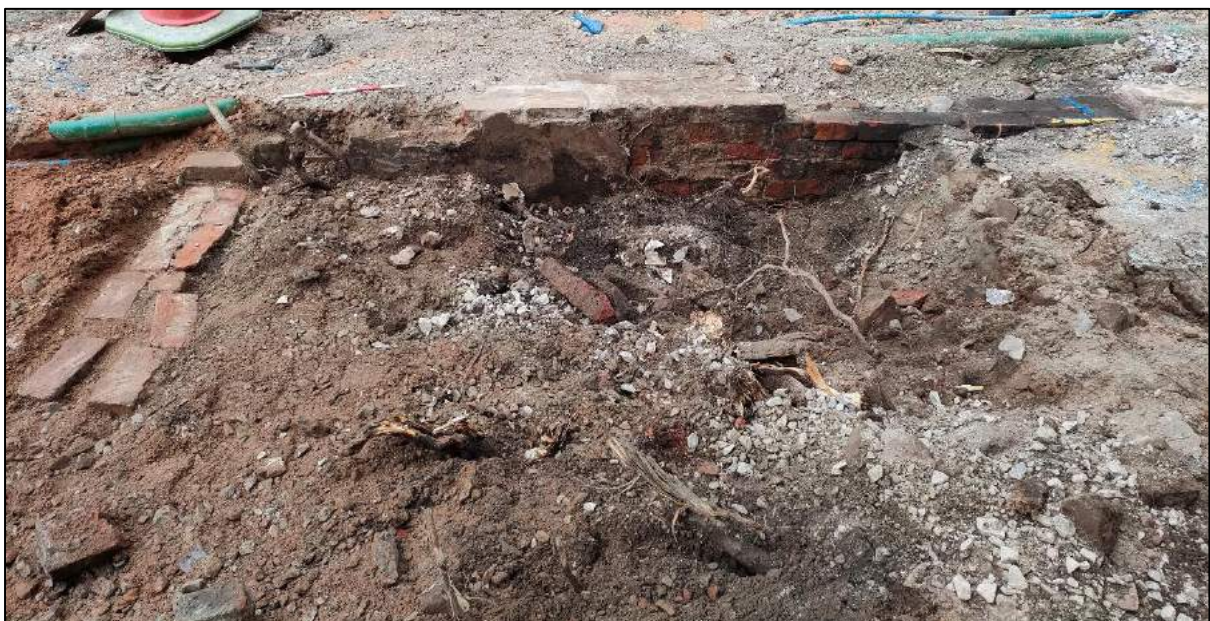
At the NE corner of Lincoln Square, a small area of brickwork was revealed. It formed an L shape and was at least 5 courses high. It is presumed that this is a single wall build round a corner, but it is impossible to determine due to modern services having been installed directly on to the E-W line of bricks. It looks to be the NE corner of No 34 Brazennose St as depicted on the 1850s OS map. This was later found to run intermittently along the full length of the Brazennose St edge of Lincoln Square, partly under green Virgin Media conduits.

*E-W wall with render, dividing wall and plumbing*

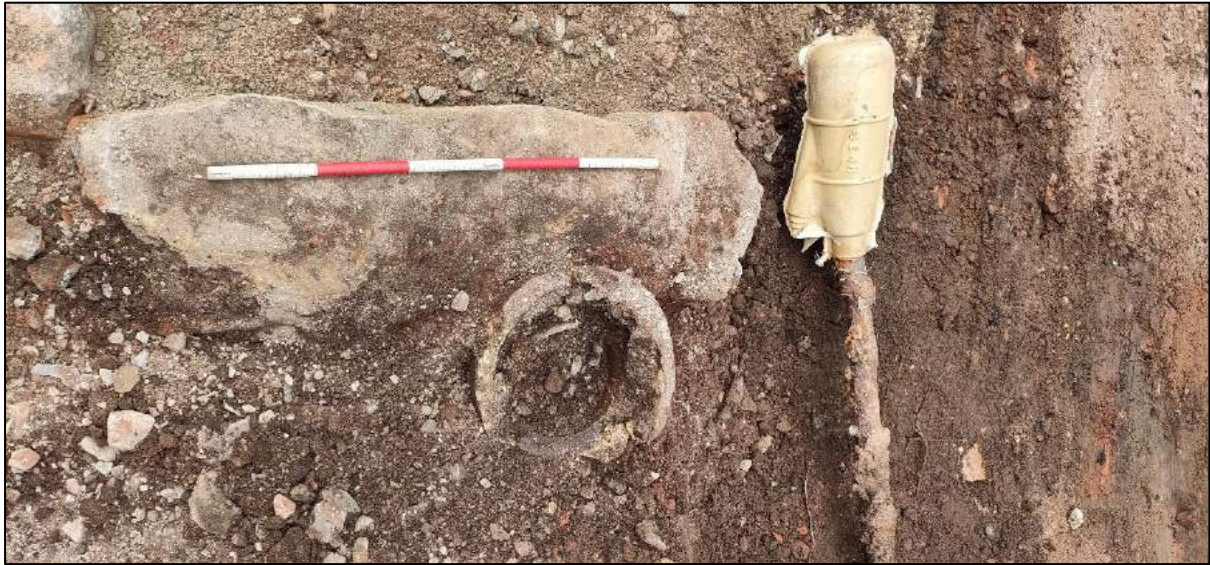
A stone capped drain was found on N side of brick corner/extension of E-W wall. On the E side of the stone cap was a vertical ceramic soil pipe, possibly a privy.

*Stone capped drain and soil pipe (W at top)*

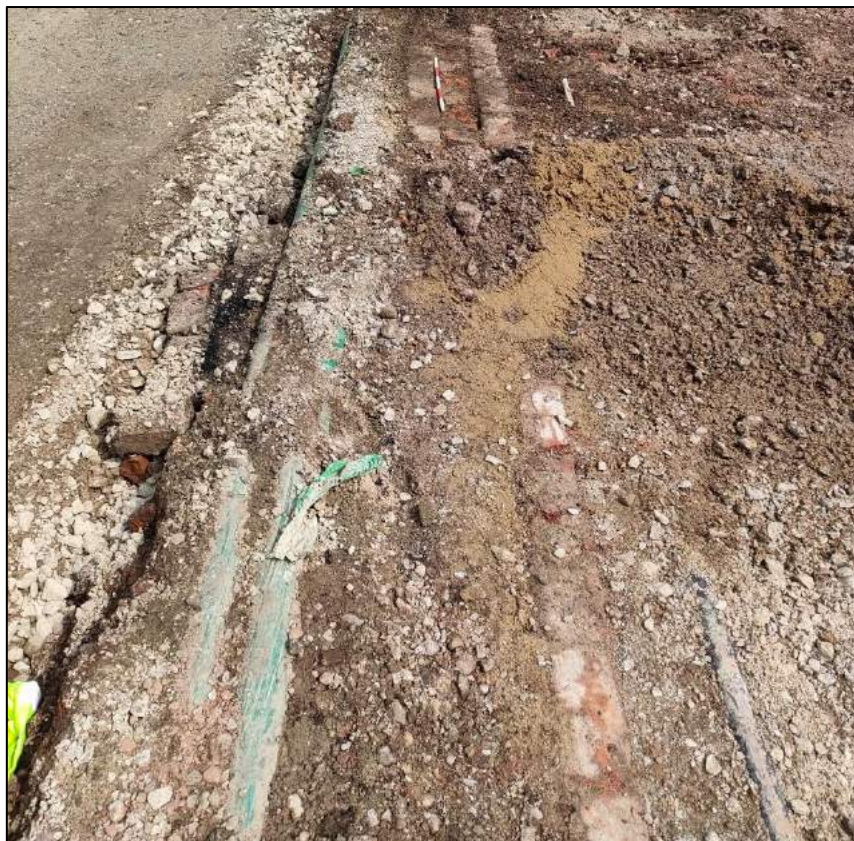
There were visible protrusions on the N side, possibly fire places, coal chutes and/or cellar lights.

The possible coal chute was built from 3 courses of brick surrounding a black deposit. The structure was 80cm in length.

*E-W wall, possible coal chute on left of green Virgin conduits*

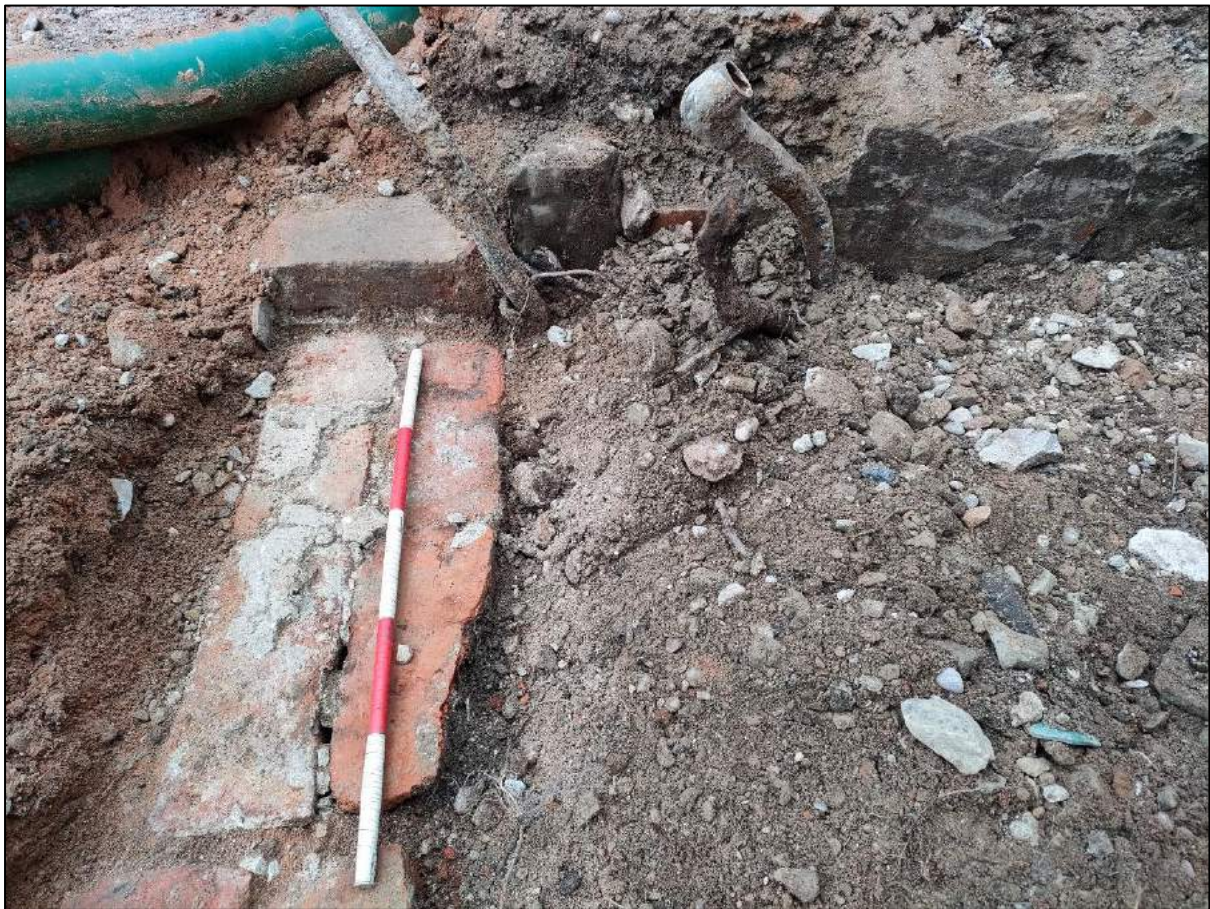
At a distance of 4.4m from the NE corner was a stone set into the E-W wall. This looked to be a continuation of the corner along Brazennose St and appeared to be the north facing buildings fronting Brazennose St on the 1850s mapping. This section of wall was 2.96m in length including the stone. It had a varying width with a max of 36cm. It varied between two and three bricks wide. The wall and stone were not quite aligned with the original brick corner. This part of the wall at least 6 courses high and render was still remaining in parts. The maximum height was 50cm and the maximum length of this section was 4m. This is a probable continuation of N facing Brazennose St damaged and truncated by modern services. A dividing wall abutted the E-W wall to the south and extended for 1.1m, width 24cm. This N-S wall was truncated by a tree ring. In the corner on the east side of the dividing wall was an old waterpipe, presumably part of the plumbing within the house.

The E-W wall may have been complete at depth, but the excavation limit did not allow for this to be established

*Dividing wall and plumbing*

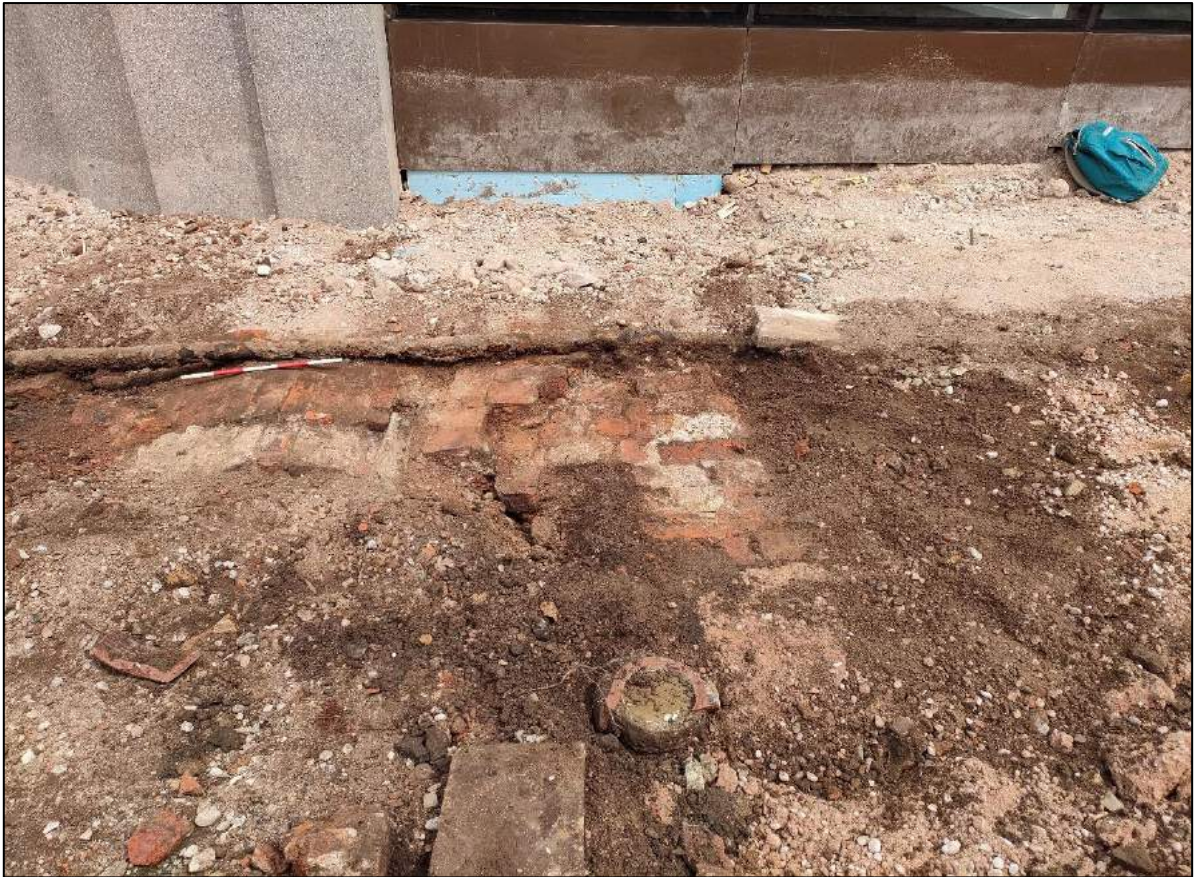
A pair of vault roofs were found on the N side of Brazennose St. The total length of the structure remaining was 9.05m. The eastern vault roof was 0.9m wide and the western one was 1.1m wide. The central junction box measured 96cm x 25cm. (This may be the remains of what Wilm was talking about with the listed junction box) The electricity cable was wrapped in oiled linen and the junction box covered with bitumen.

*Brazennose St vaults looking N*

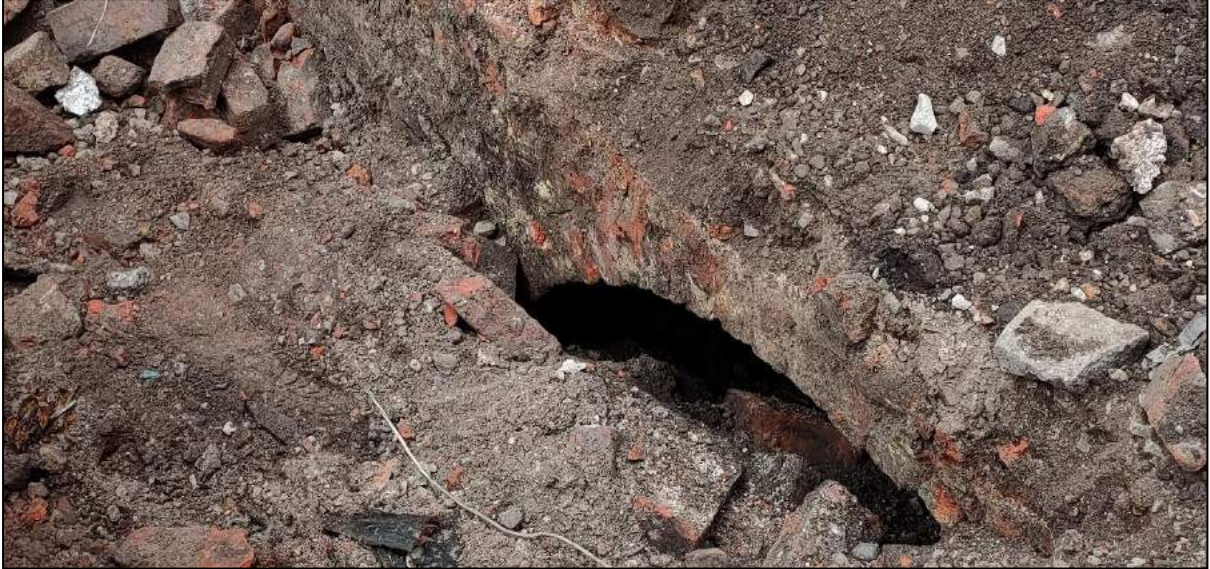
Immediately to the north of the cobbles area was a cellar with two arched alcoves built into the east wall in an E-W orientation. The arches were approximately 1.5m wide (The cellar was not fully excavated so can only estimate the width), and 1.3m in depth. The height of the arches was estimated to be around 1.1m. The cellar was constructed using hand made bricks and lime mortar, and the back wall of the alcoves was painted with a pale blue lime wash.

*Cellar vault roof looking NE*

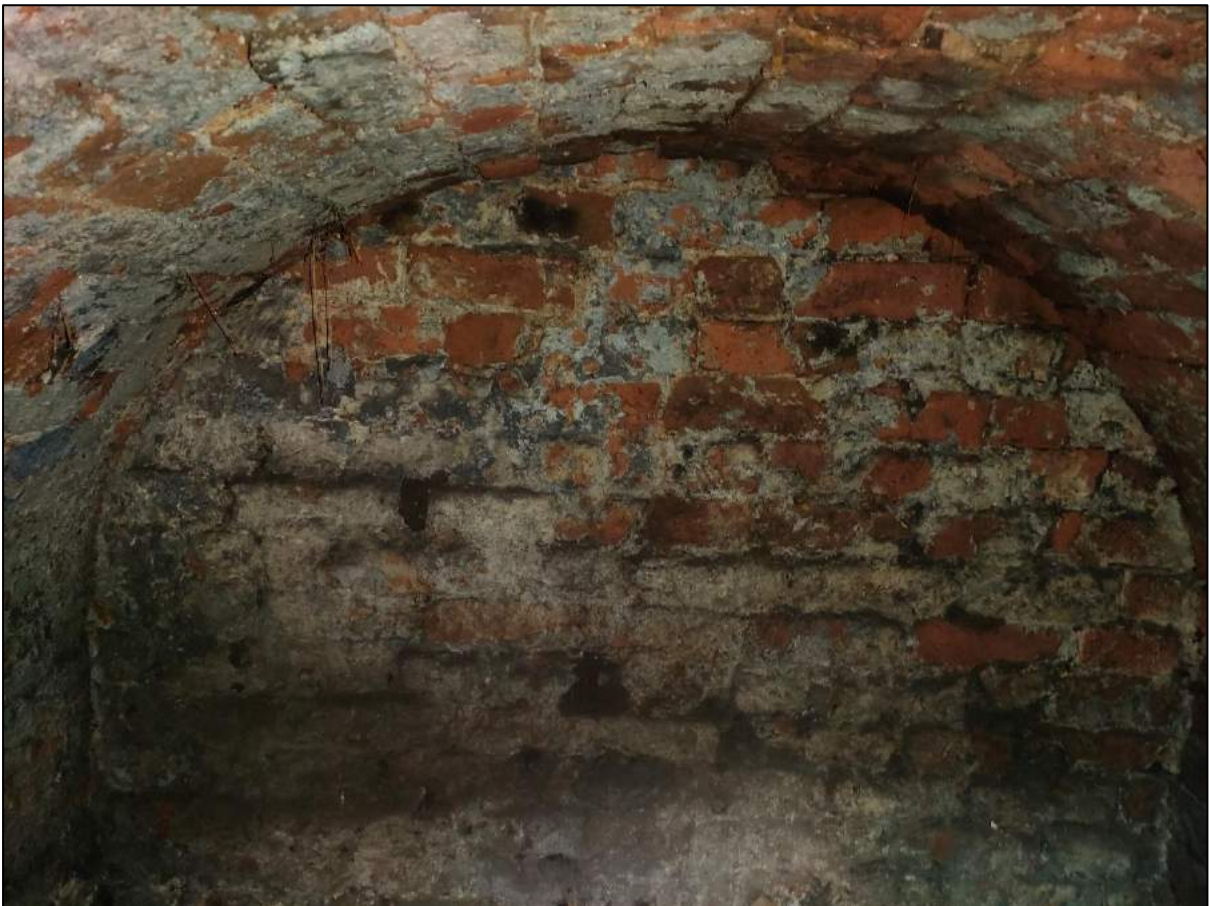
*Inside arch showing limewash looking E*

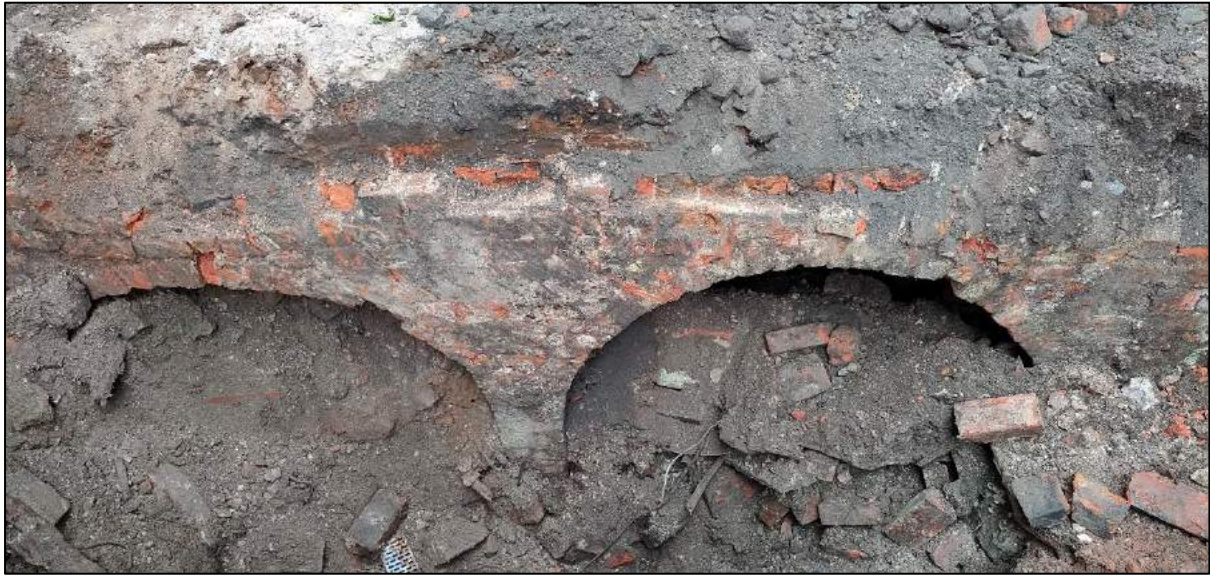
*The 2 arches fully revealed. The brick floor is visible at the bottom centre.*

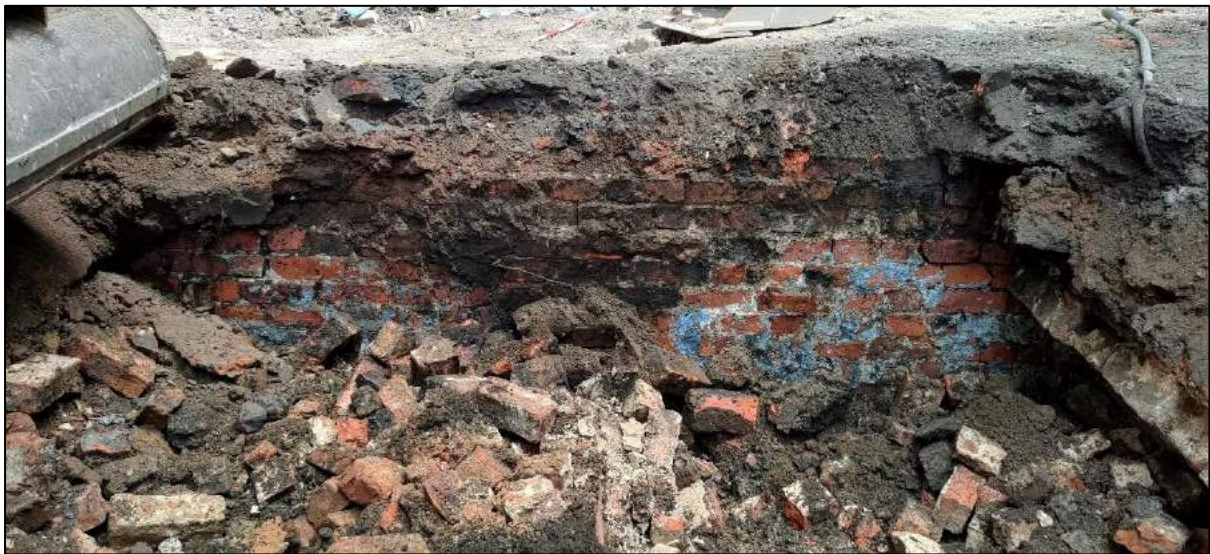
*Dividing wall between the two arches removed.*

As the cellar was to be packed, the arch rooves were broken through and it could be seen that the dividing wall and roof structure was not keyed into the east wall of the cellar. Above the arches were a 2m long iron pipe (dia 20cm) and a ceramic pipe abutting it at either end. Alongside the iron pipe on the east side was another iron pipe that had been halved lengthways to form a U shaped channel. The ceramic ware at the south end of the cellar seemed to link up with a possible toilet as there was a broken vertical soil pipe visible in the ground and a broken toilet base was found in the cellar fill. The pipes were set into very compact rubble so could be of a later date than the cellar construction. The upper layers of the arch roof seem to have been removed and the rubble and pipes laid with only one course of arch roof below. This theory also fits with the fact that a N-S dividing wall visible at the north end of the cellar survives to a higher level than that of the pipes.

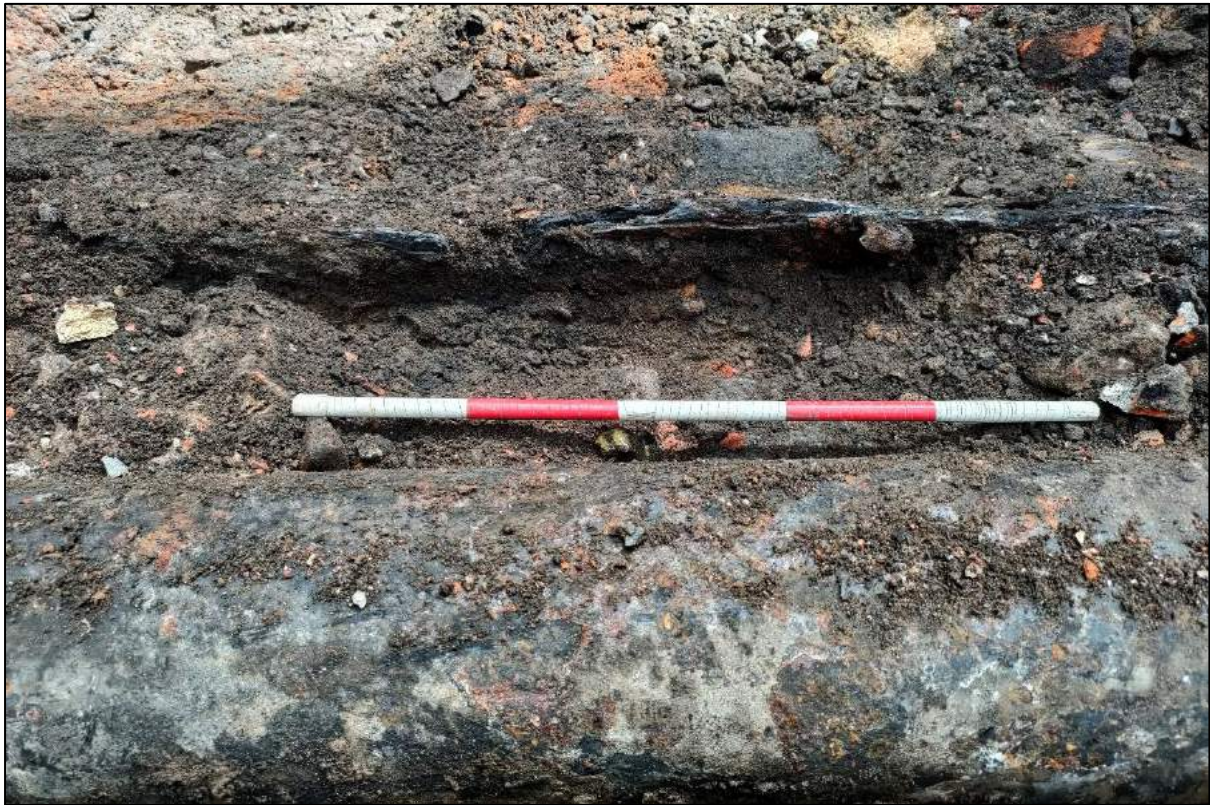
*Cast iron pipe (bottom) and half pipe (top)*

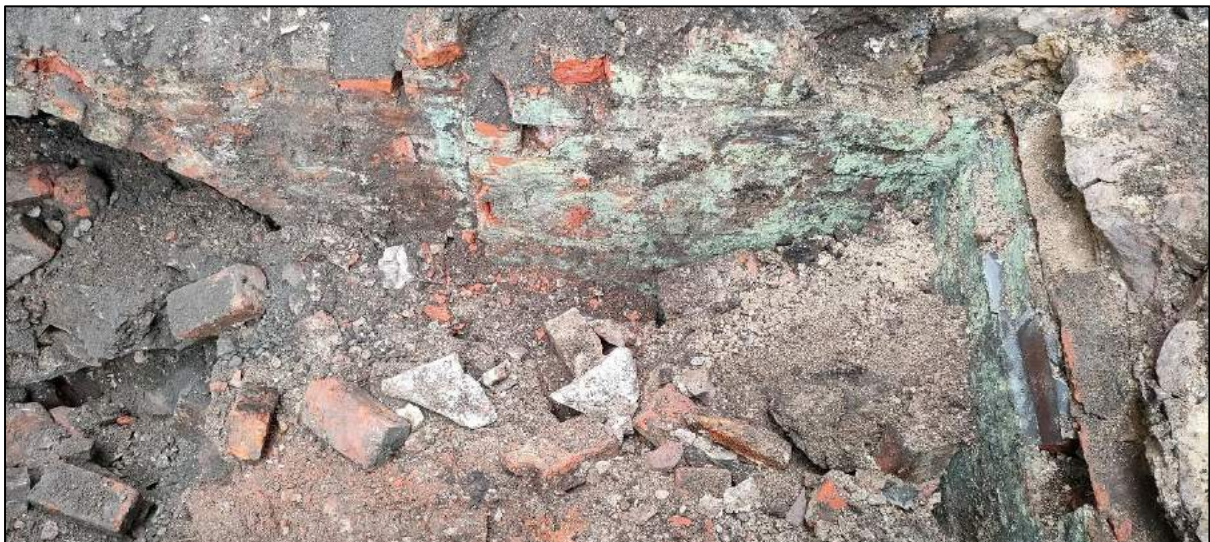
At the south end of the cellar was a truncated E-W dividing wall 1.1m from the south wall visible in the east facing section. This extended beyond the limit of the excavated part of the cellar. The visible part of the south wall and the east wall up to the arches were painted with a pale green lime wash.

*Pale green limewash in SE corner*

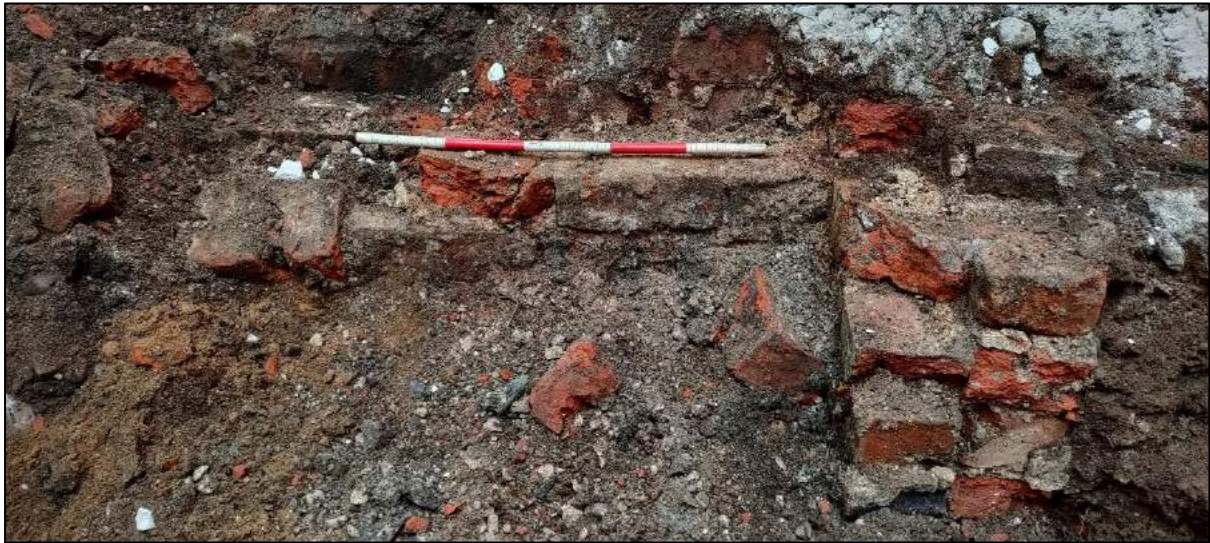
The cellar seemed to continue west beyond a truncated N-S dividing wall at the north end, but it was not established how far due to a line of trees subject to a preservation order preventing further excavation. An empty concrete tree ring was visible in the east facing section.

*North end of the cellar showing N-S dividing wall.*

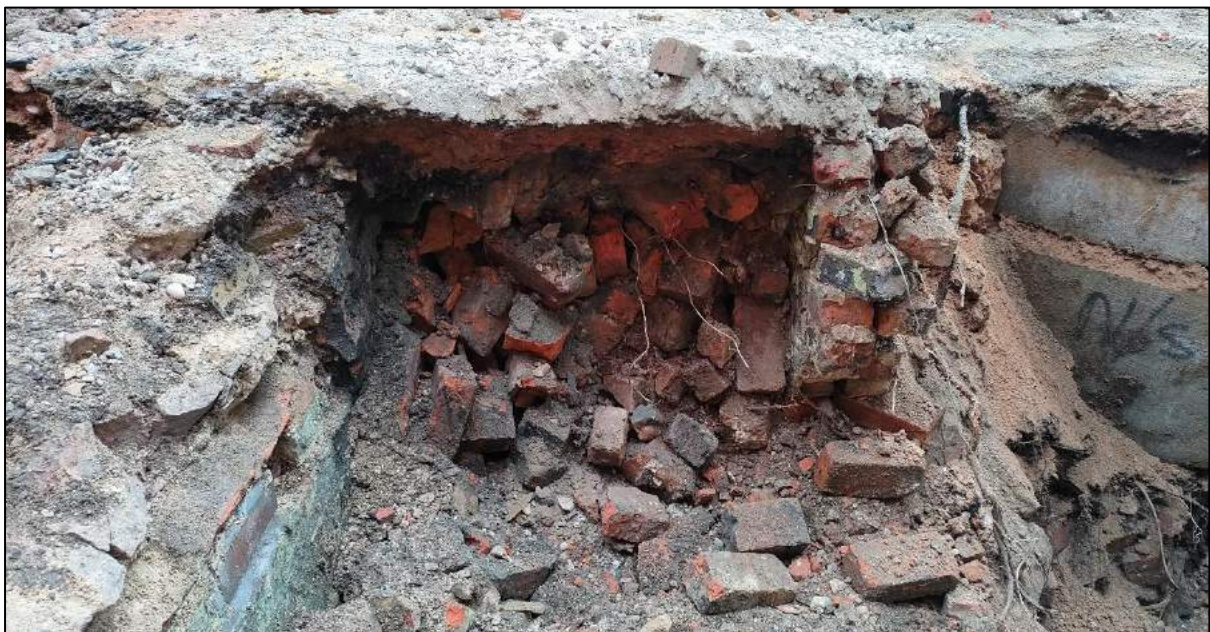
*Dividing wall at S end of cellars looking W.*

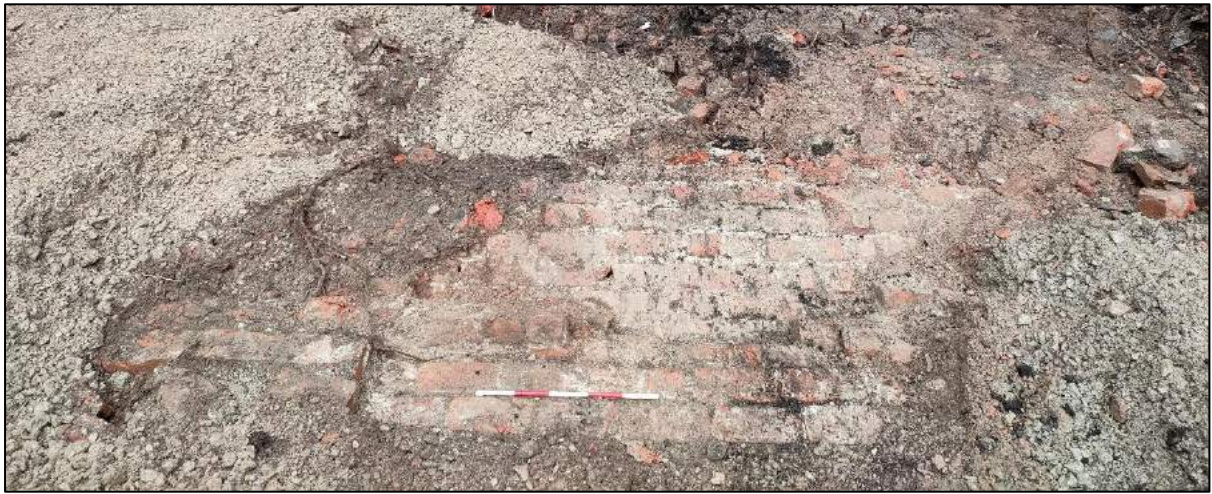
Close to the vaulted cellars in Area C, on the other side of the northern wall was another cellar vault running perpendicular to the original ones. These were not dug out but as they were of the same construction, it can be assumed that they were the same depth and with a brick floor.

*Vault found running in a N-S direction to the north of the excavated cellar.*

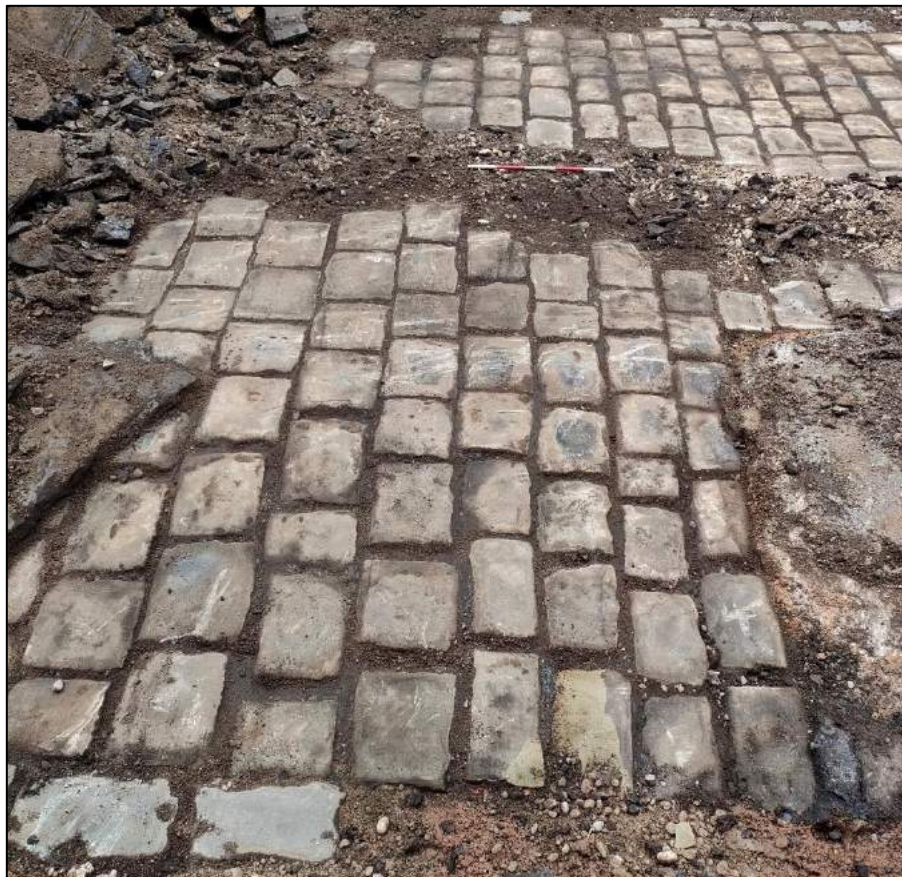
Setts were found on Mulberry St. covering a large area, width 3.65m, length 23.2m with kerb stones on both sides and truncated along full length down the middle. Setts begin 2.6m from N end of Veenoo building.

*Flattened setts in the centre of the road and rounded ones at the sides*

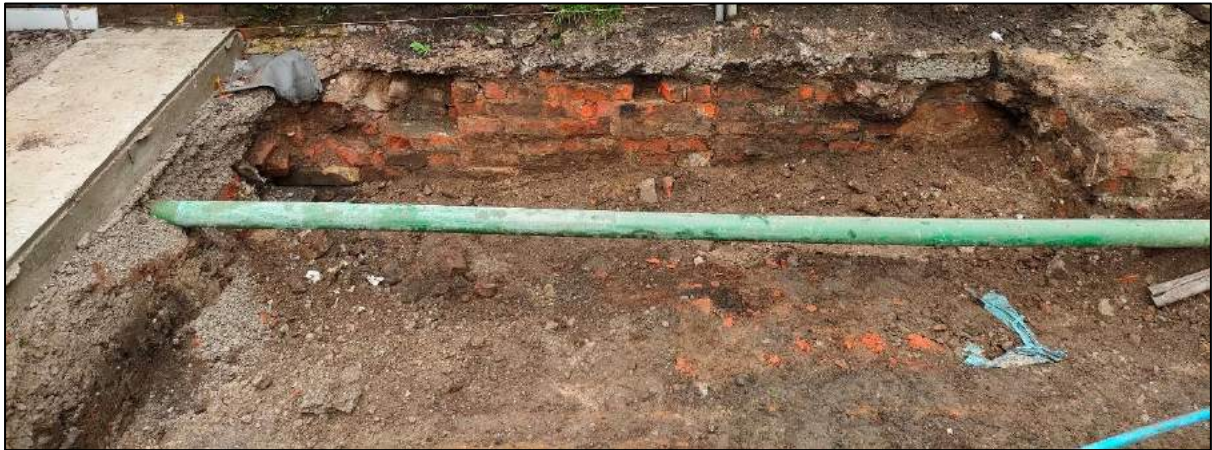
On the western side of Lincoln Square, four planters were dug out to a depth of 1m. Planter 1 (on map) contained a layered fill of varying grades of gravel and crushed brick. Along the western edge of the planter was a handmade brick wall surviving to a height of 7 courses in places. The wall ran for 3.4m from the SW corner of the planter and then turned east for 50cm, turned N for 2.5m before turning W and disappearing into the section. The hollow created by the turning wall was filled with concrete and may represent a cellar light. At 1.26m to the N of the wall was another short wall of a similar construction protruding from the section in an easterly direction. This may be a fireplace cheek.

*N-S wall in Planter 1 with possible cellar light on the right.*

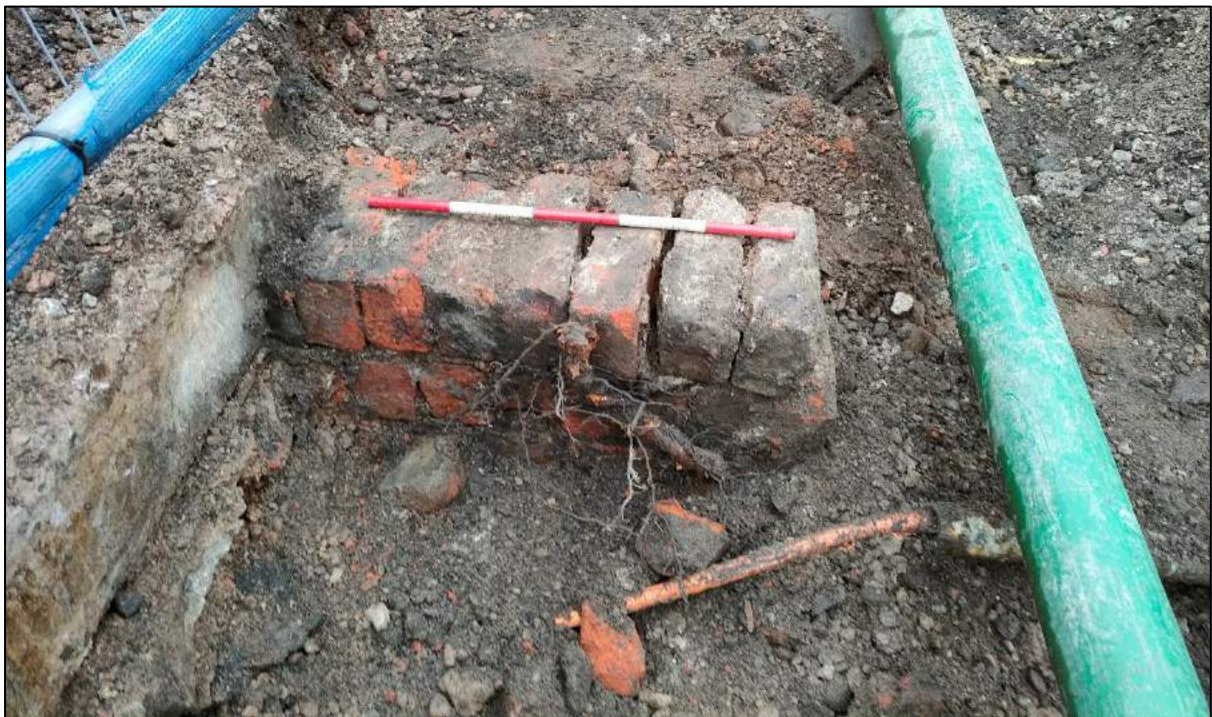
*Possible fireplace cheek.*

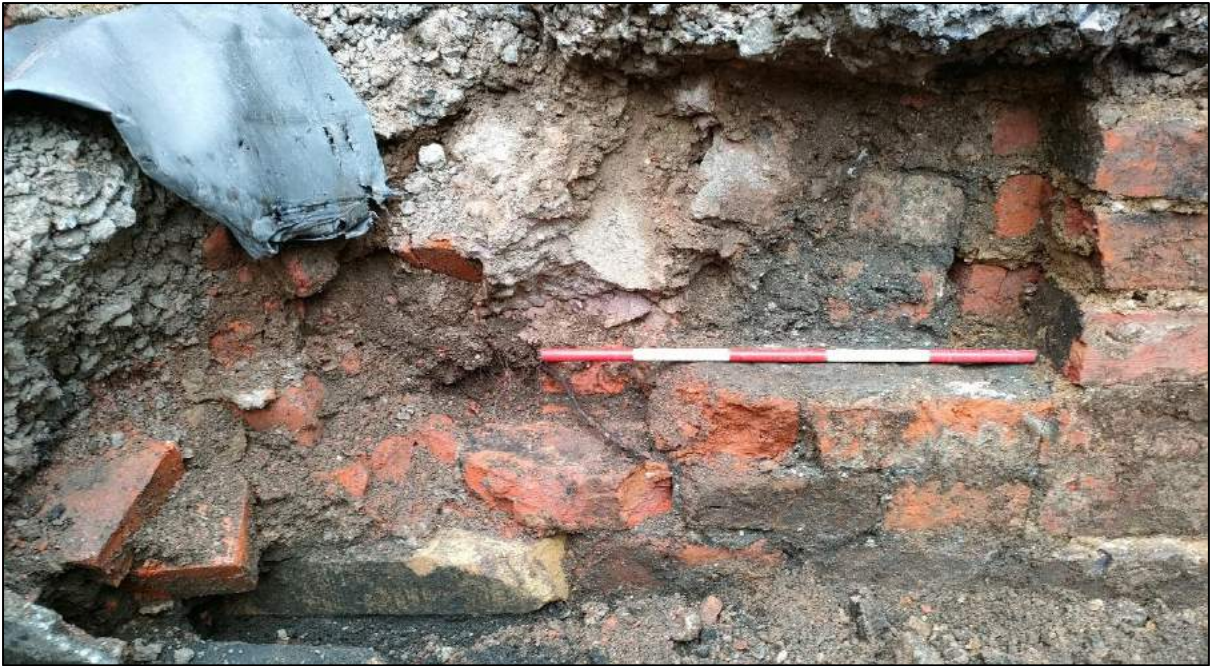
Along the southern edge of the planter, the N-S wall turned east and ran for 50cm before being truncated by a Virgin Media cable. In the SW corner embedded in the N-S section of the wall was a yellow sandstone block with a black sooty material on the facing side. This may represent a coal chute as the wall above it was very rubble like as if a fill.

*Stone block in SW corner of planter 1*
