# Lincoln Square, Manchester

## Summary of Archaeological Watching Brief Works

### 21<sup>st</sup> October 2021

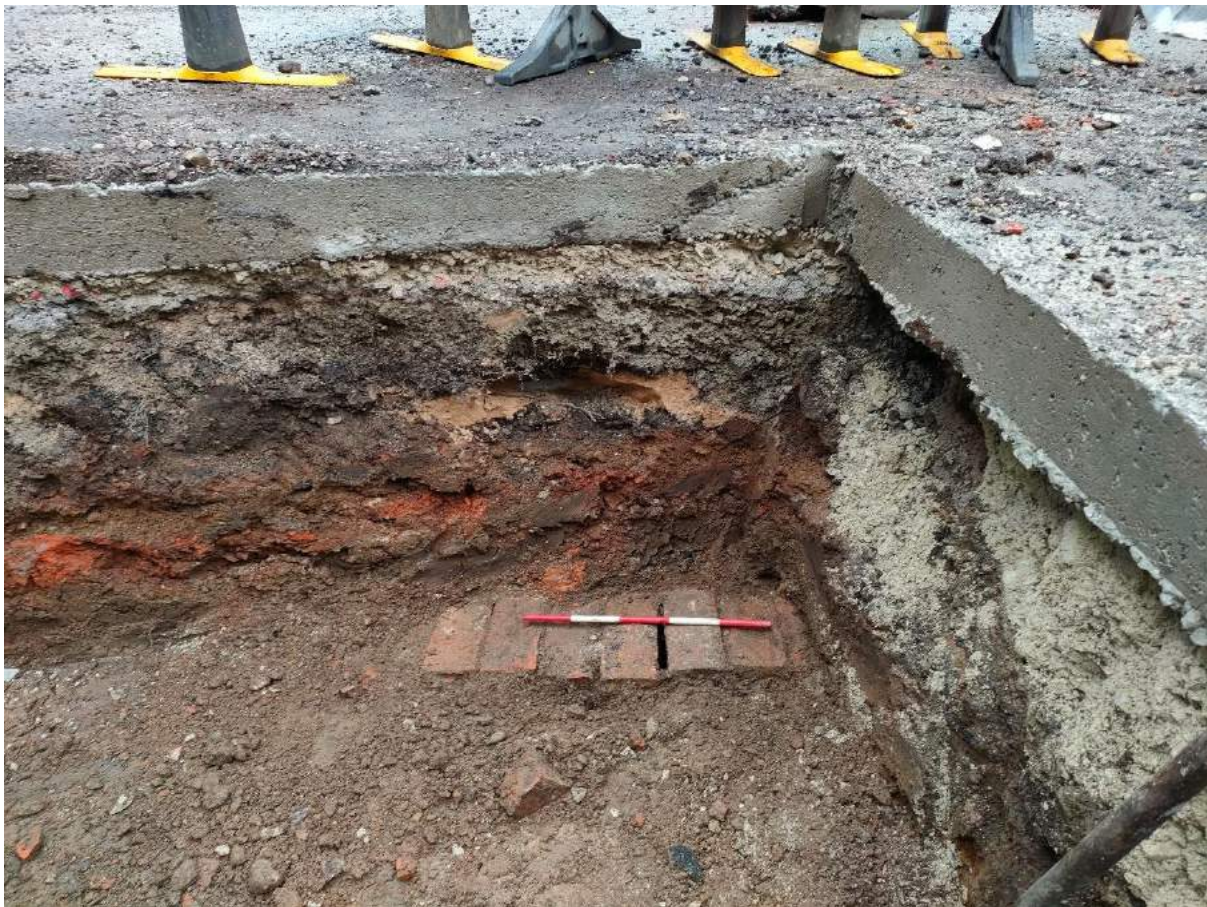
At the easternmost extent of the planter was a brick drainage channel, visible for 80cm. The channel was brick walled to a depth of 15cm and had no base. The mud in the bottom of the channel had a white substance coating it. The channel was capped with bricks.

*Drain channel prior to lifting the caps.*

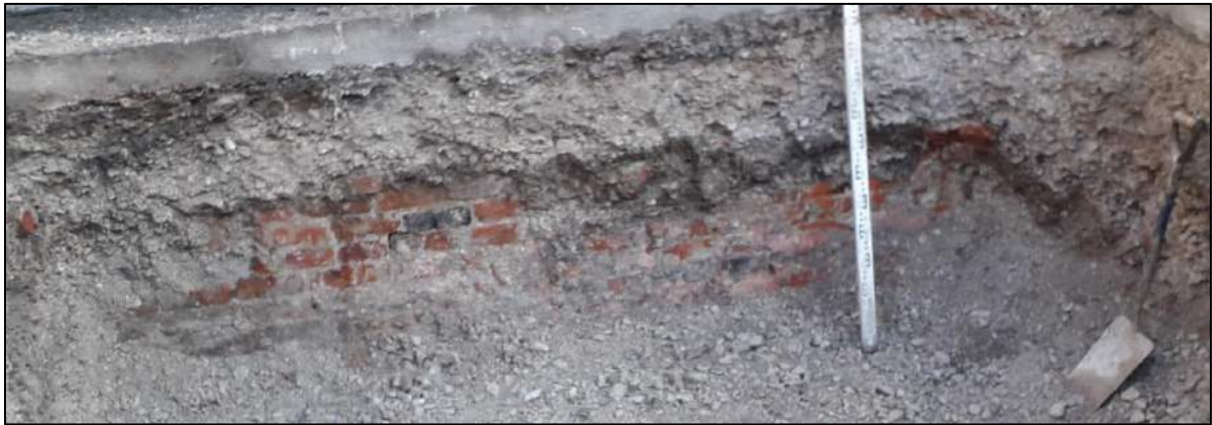
Planter 4 (on map) had a wall running along its northernmost edge that had 6 courses visible.

*Wall in Planter 4 looking N*

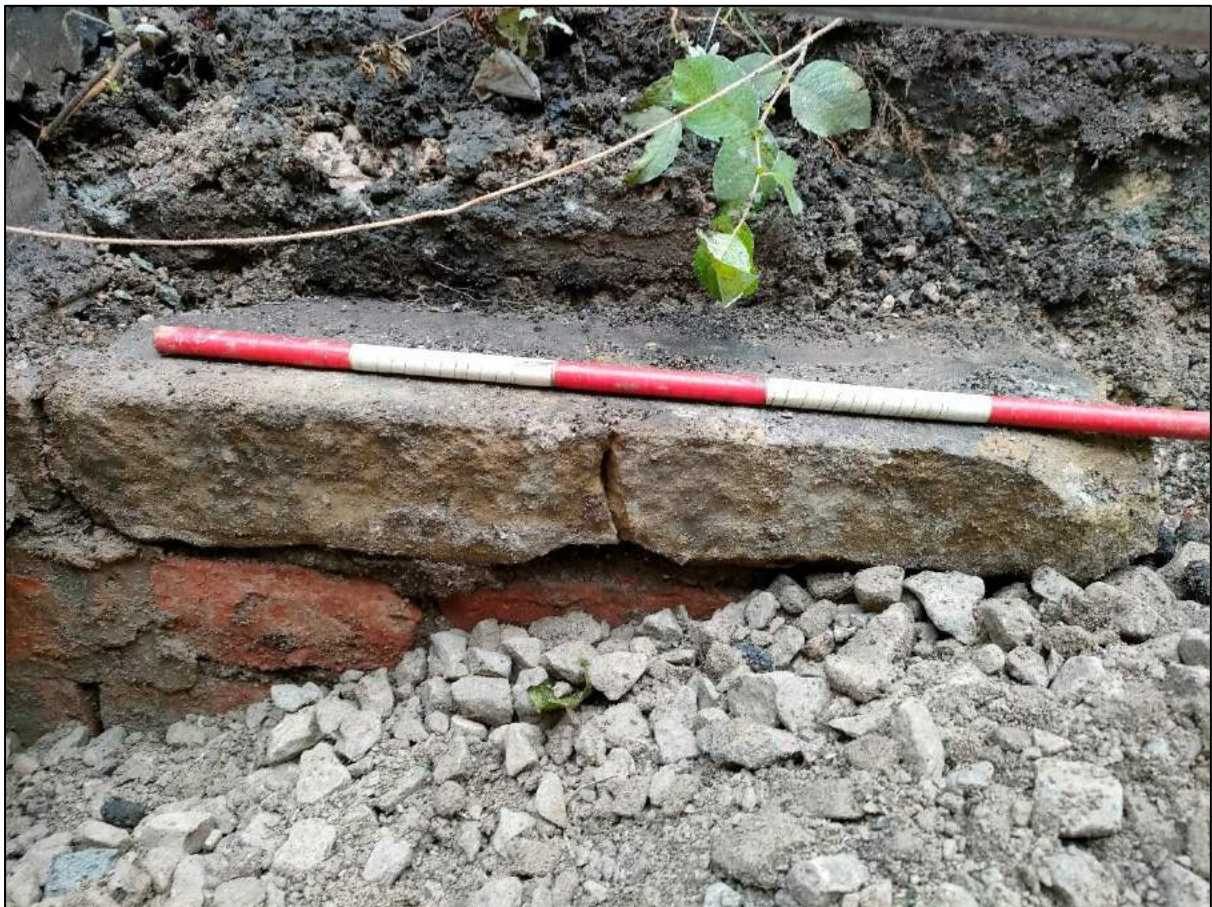
On the northern side of Queen St next to the car park was a brick drain that was around 2m deep and ran towards Deansgate. It was blocked by concrete.

The walls of the drain were 24cm wide and the north side had yellow sandstone caps. The width of the drain channel was 45cm.

*Northern side of large drain next to carpark wall showing sandstone caps*

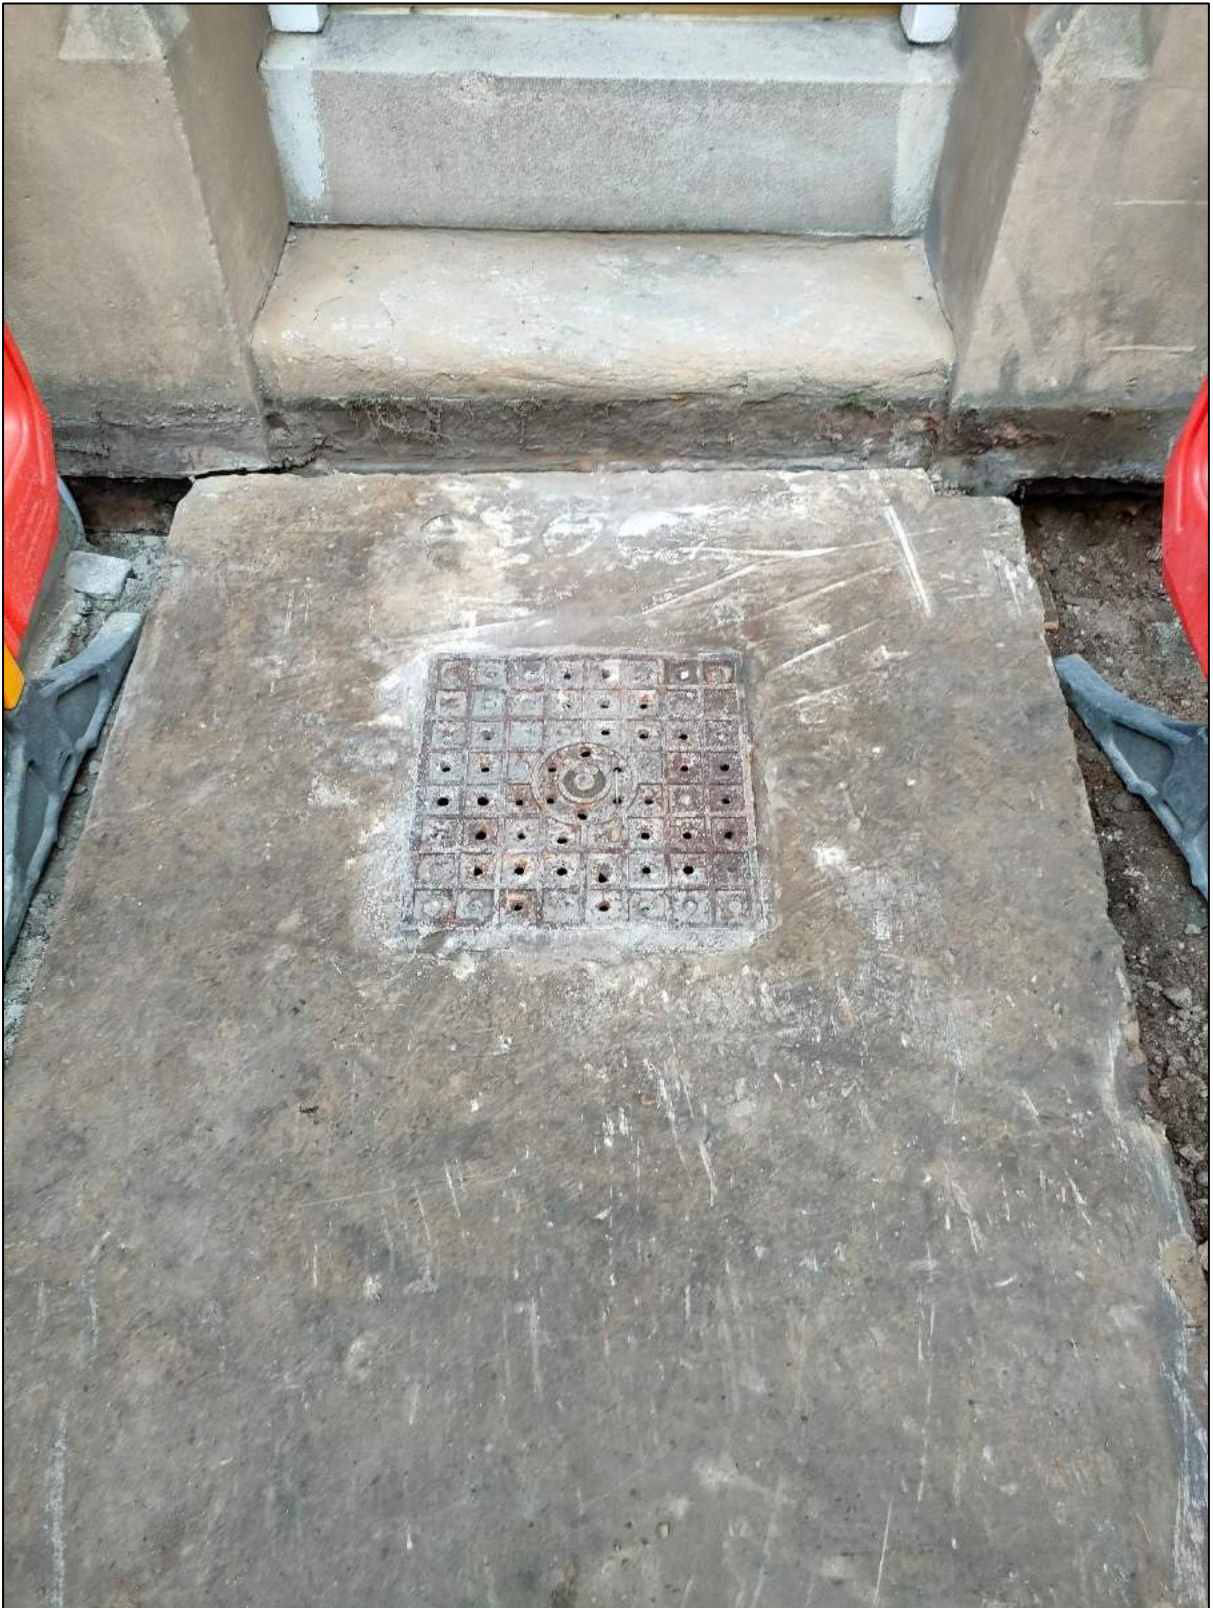
Outside the vicarage belonging to the Hidden Gem church on Mulberry St, in front of the door, a cellar drop was found under the existing paving. This was a cast iron square cover set into a large stone slab.

*Cellar drop outside the vicarage.*
