# Verified View Methodology

Type 4 | AVR Level 0, 1 & 3

This document has been prepared to explain the process of generating verified views (also referred to as accurate visual representations (AVR)) for the proposed development at Renaissance Hotel, Manchester.

Renaissance Hotel, Manchester  
Verified Views  
October 2021 v1.0 DRAFT

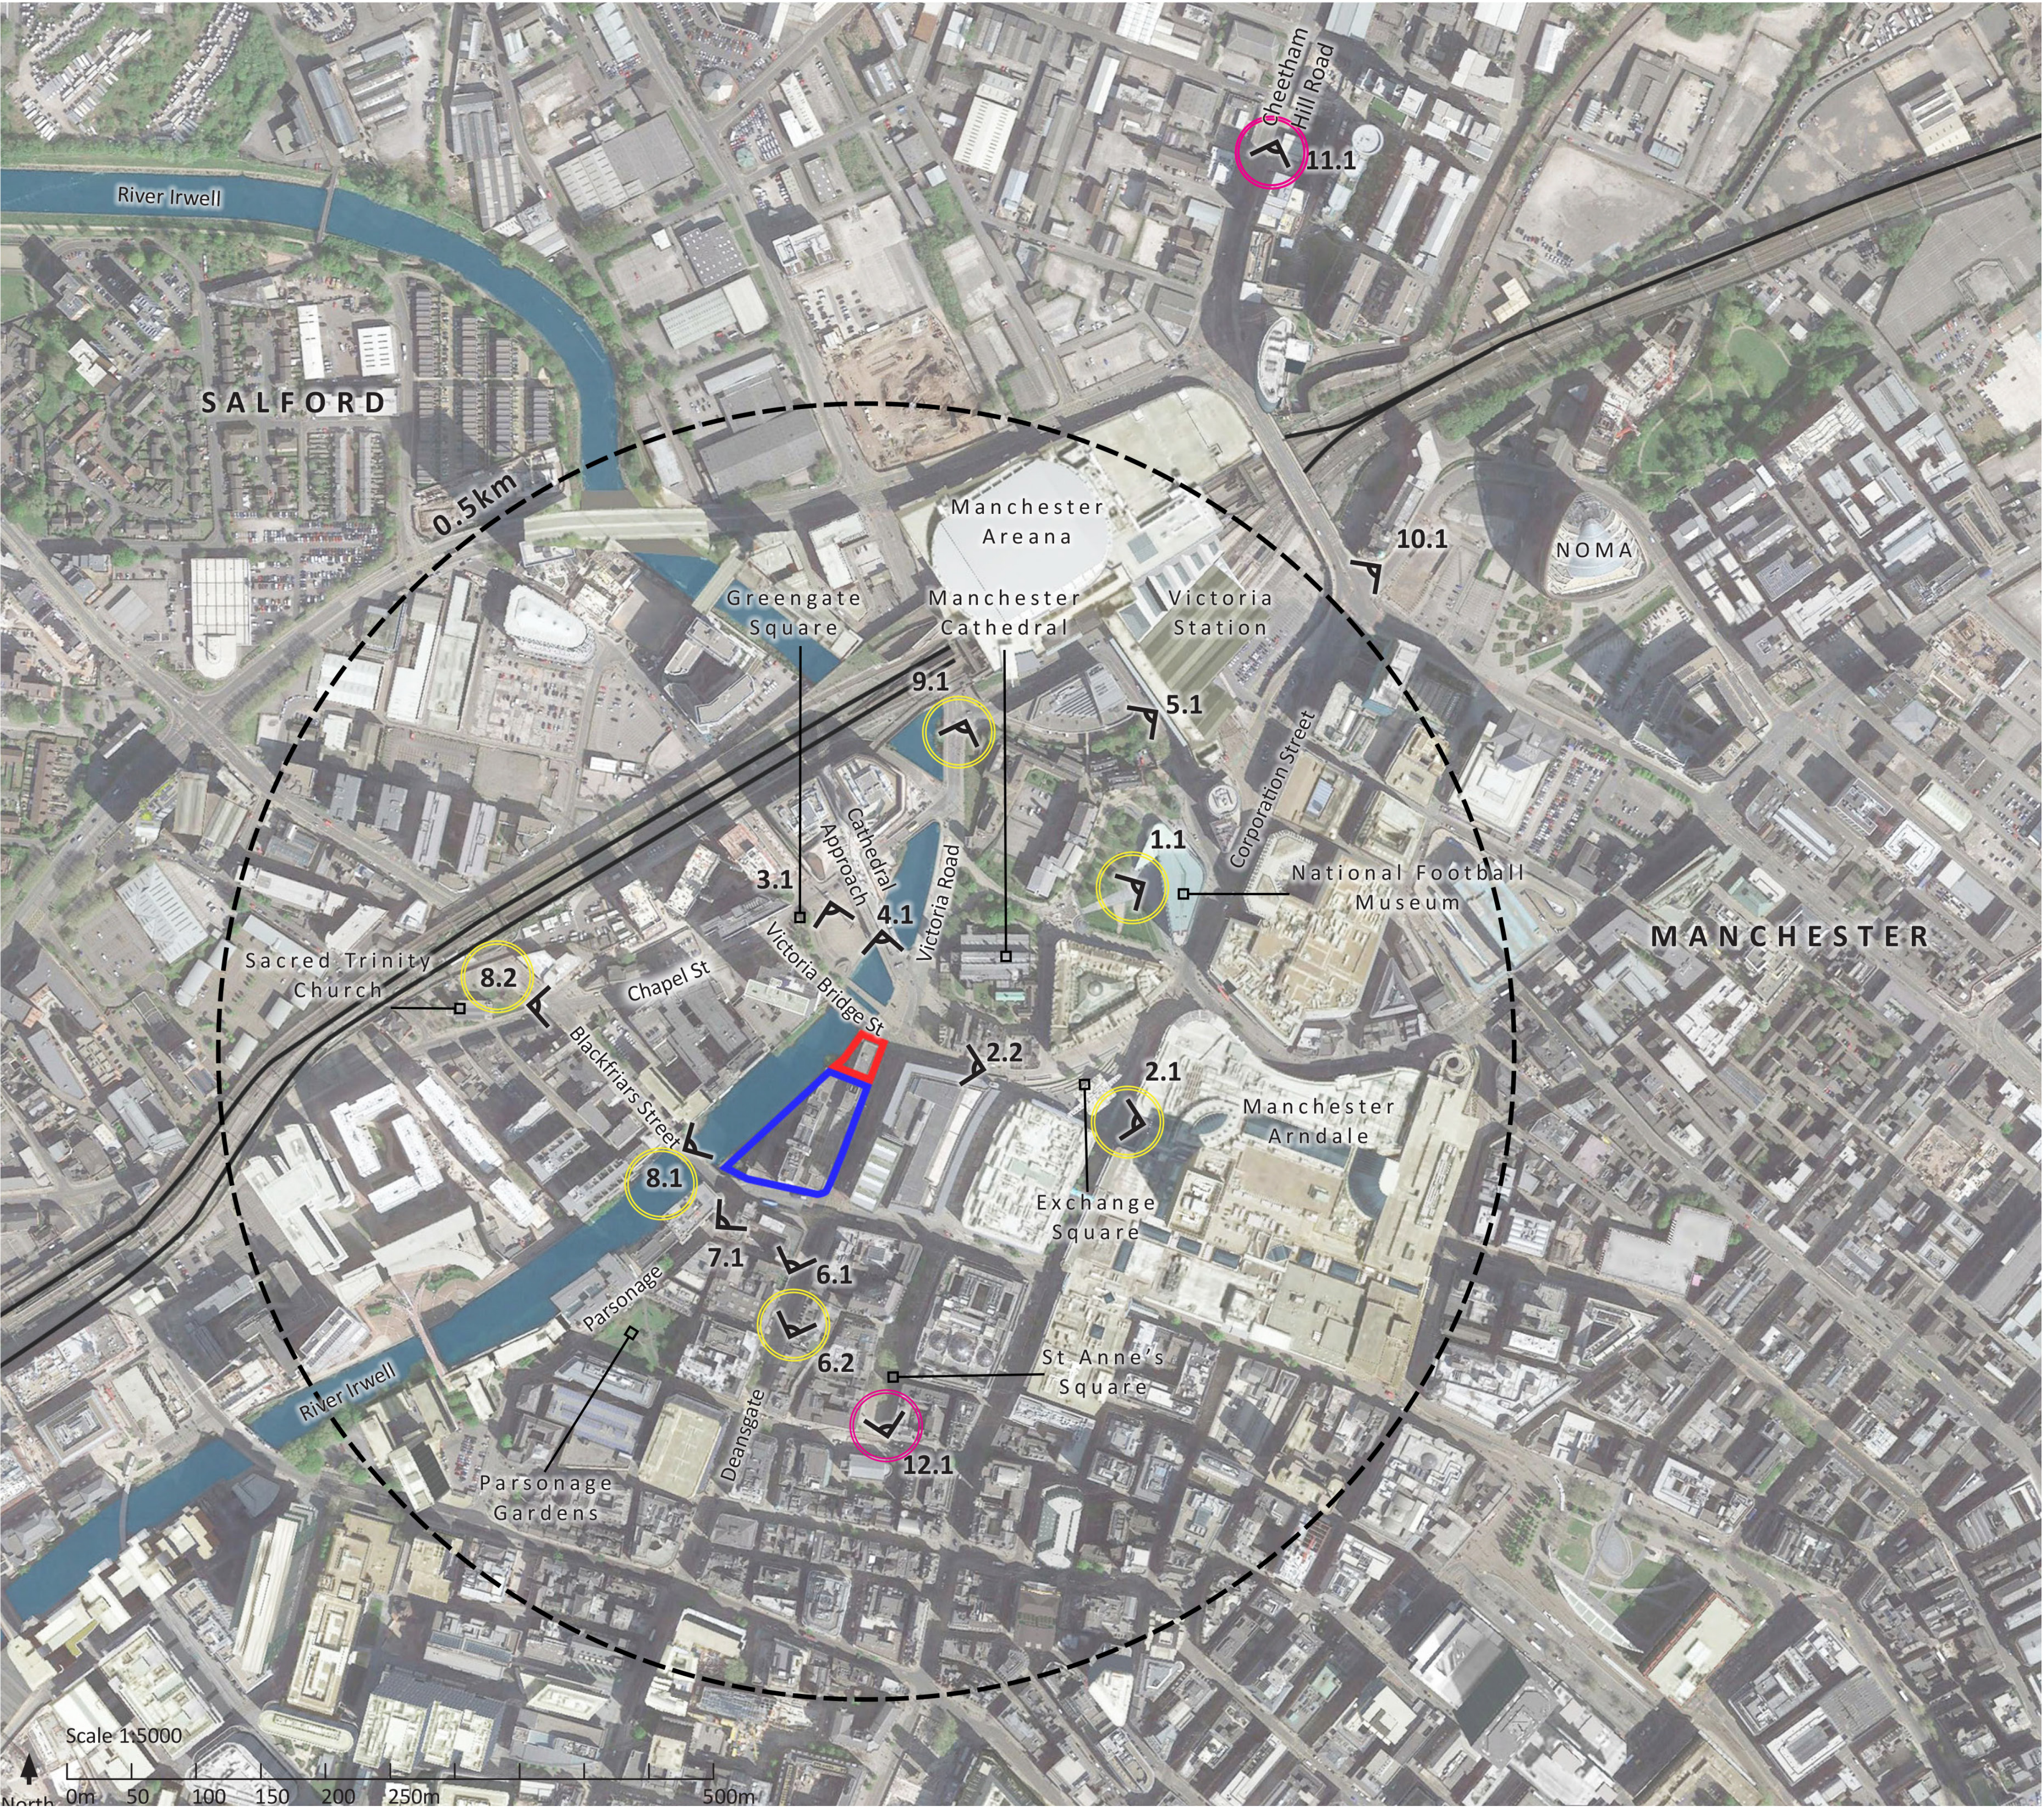
Photo Viewpoint Locations

- 1.1 Cathedral Gardens
- 2.1 Exchange Square
- 6.2 Deansgate/ A56 (north bound)
- 8.1 - 8.2 Blackfriars Street
- 9.1 Victoria Road/ A56 (south bound)
- 11.1 Cheetham Hill Road
- 12.1 St Anne's Square

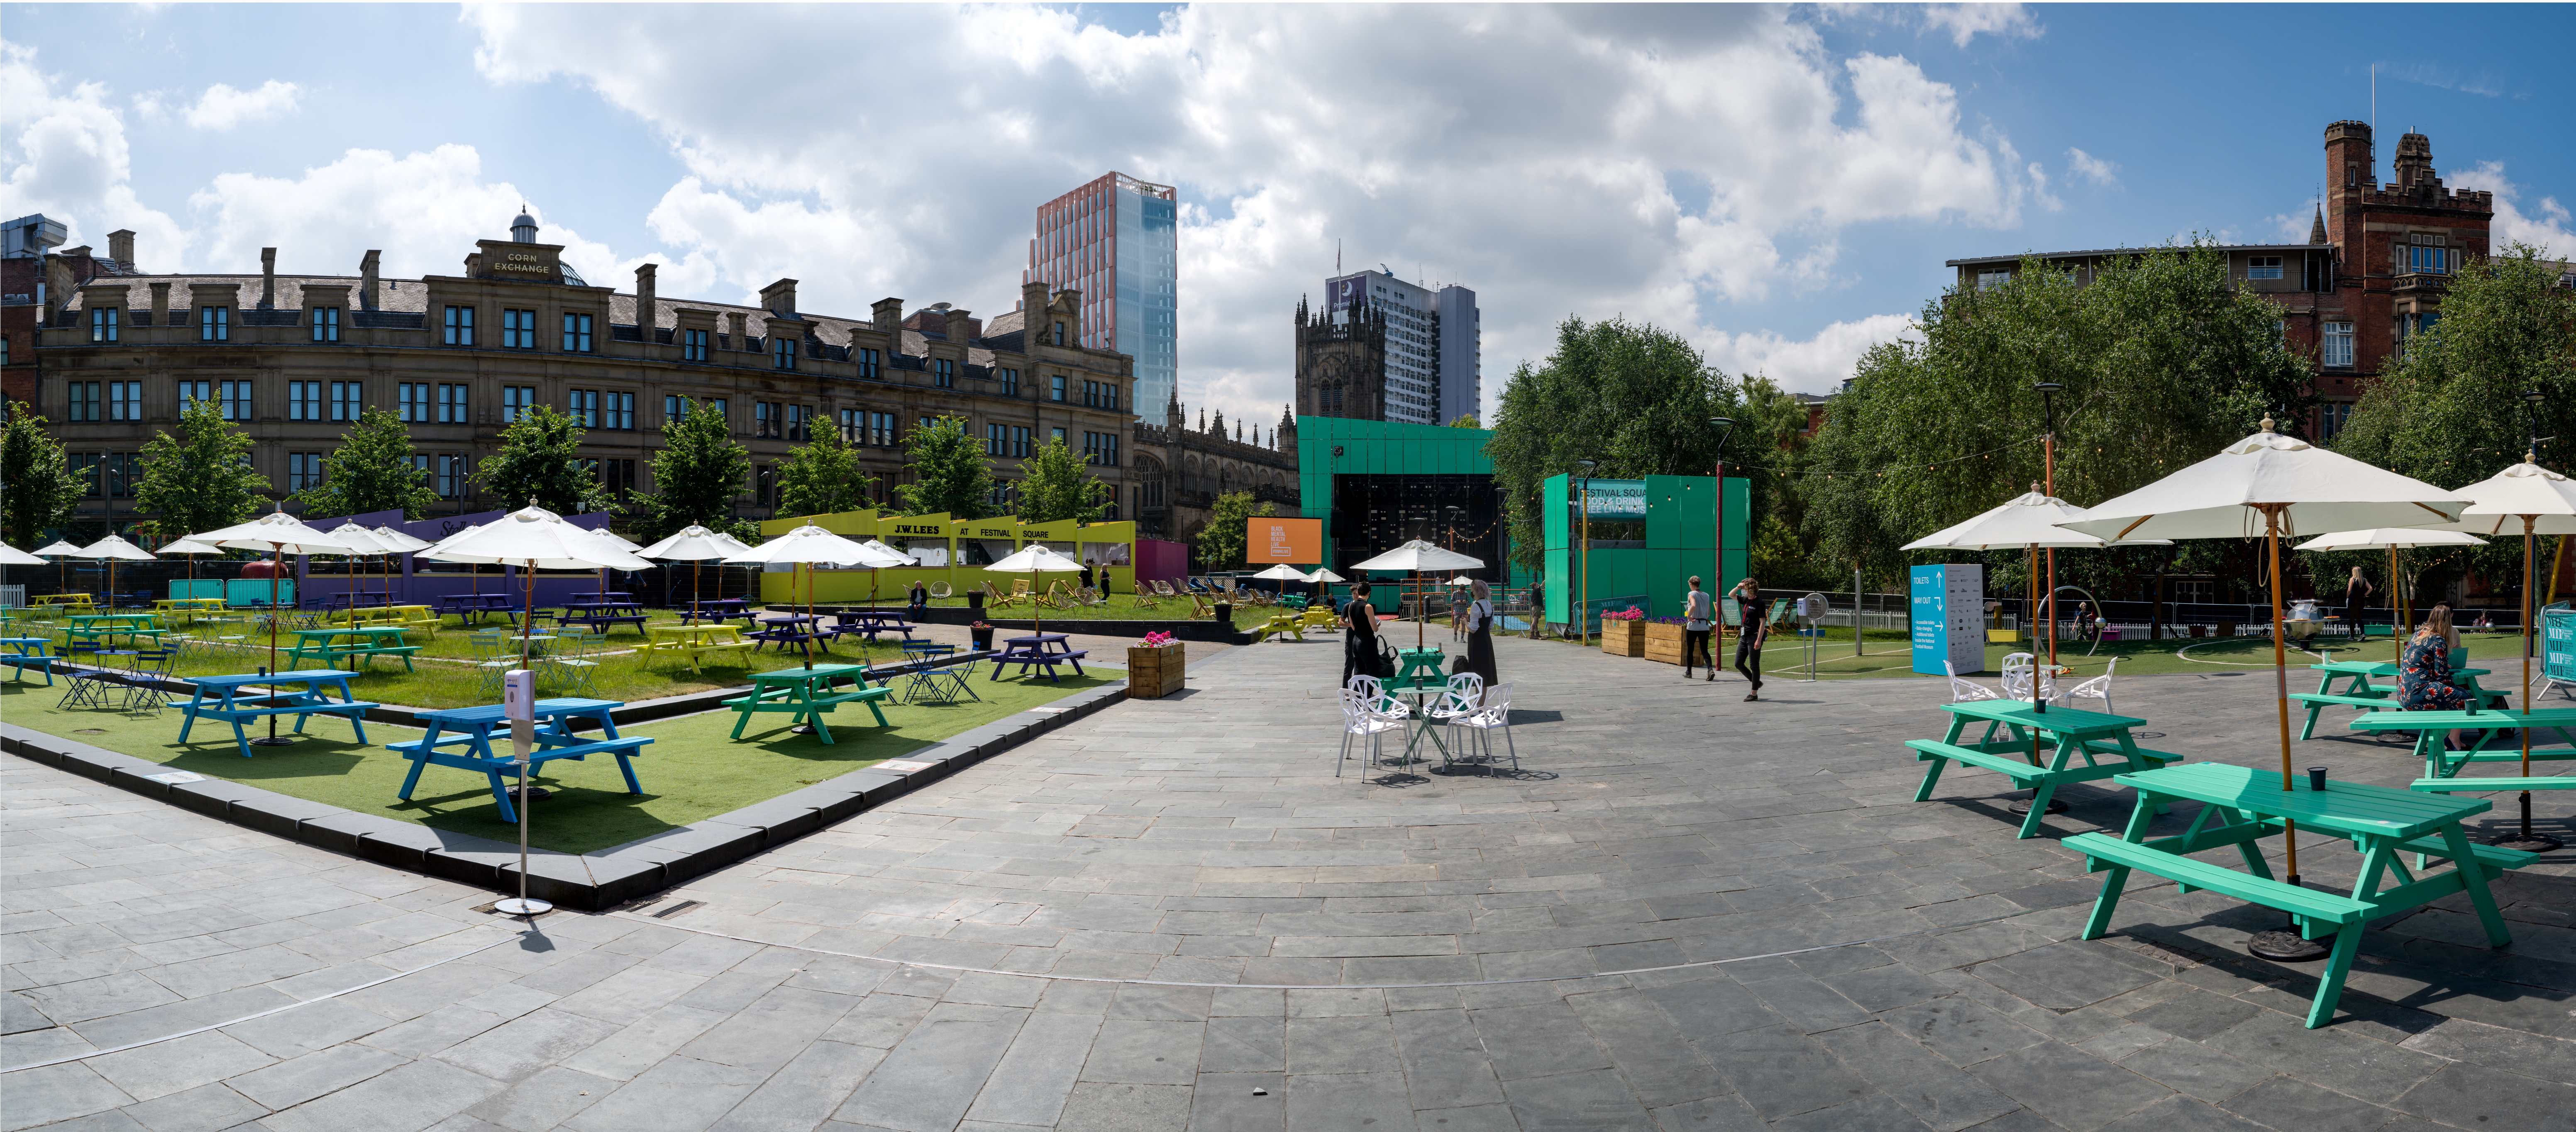
Viewpoint 1.1 - Cylindrical Projection Panorama | Type 4 | AVR Level 3

HFOV 122.9°

Photo Captured | 01/07/2021 @ 14:04  
Camera Location | E 384005.755, N 398804.025 @ 37.281m AOD  
Camera's Nodal Point Height From Ground | 1.6m  
Direction of View | 238° from N  
Distance to Nearest Site Boundary | 232m  
Camera Model | Nikon Z6ii, Full Frame Sensor  
Camera Lens | Nikon Nikkor Z S-Line 35mm

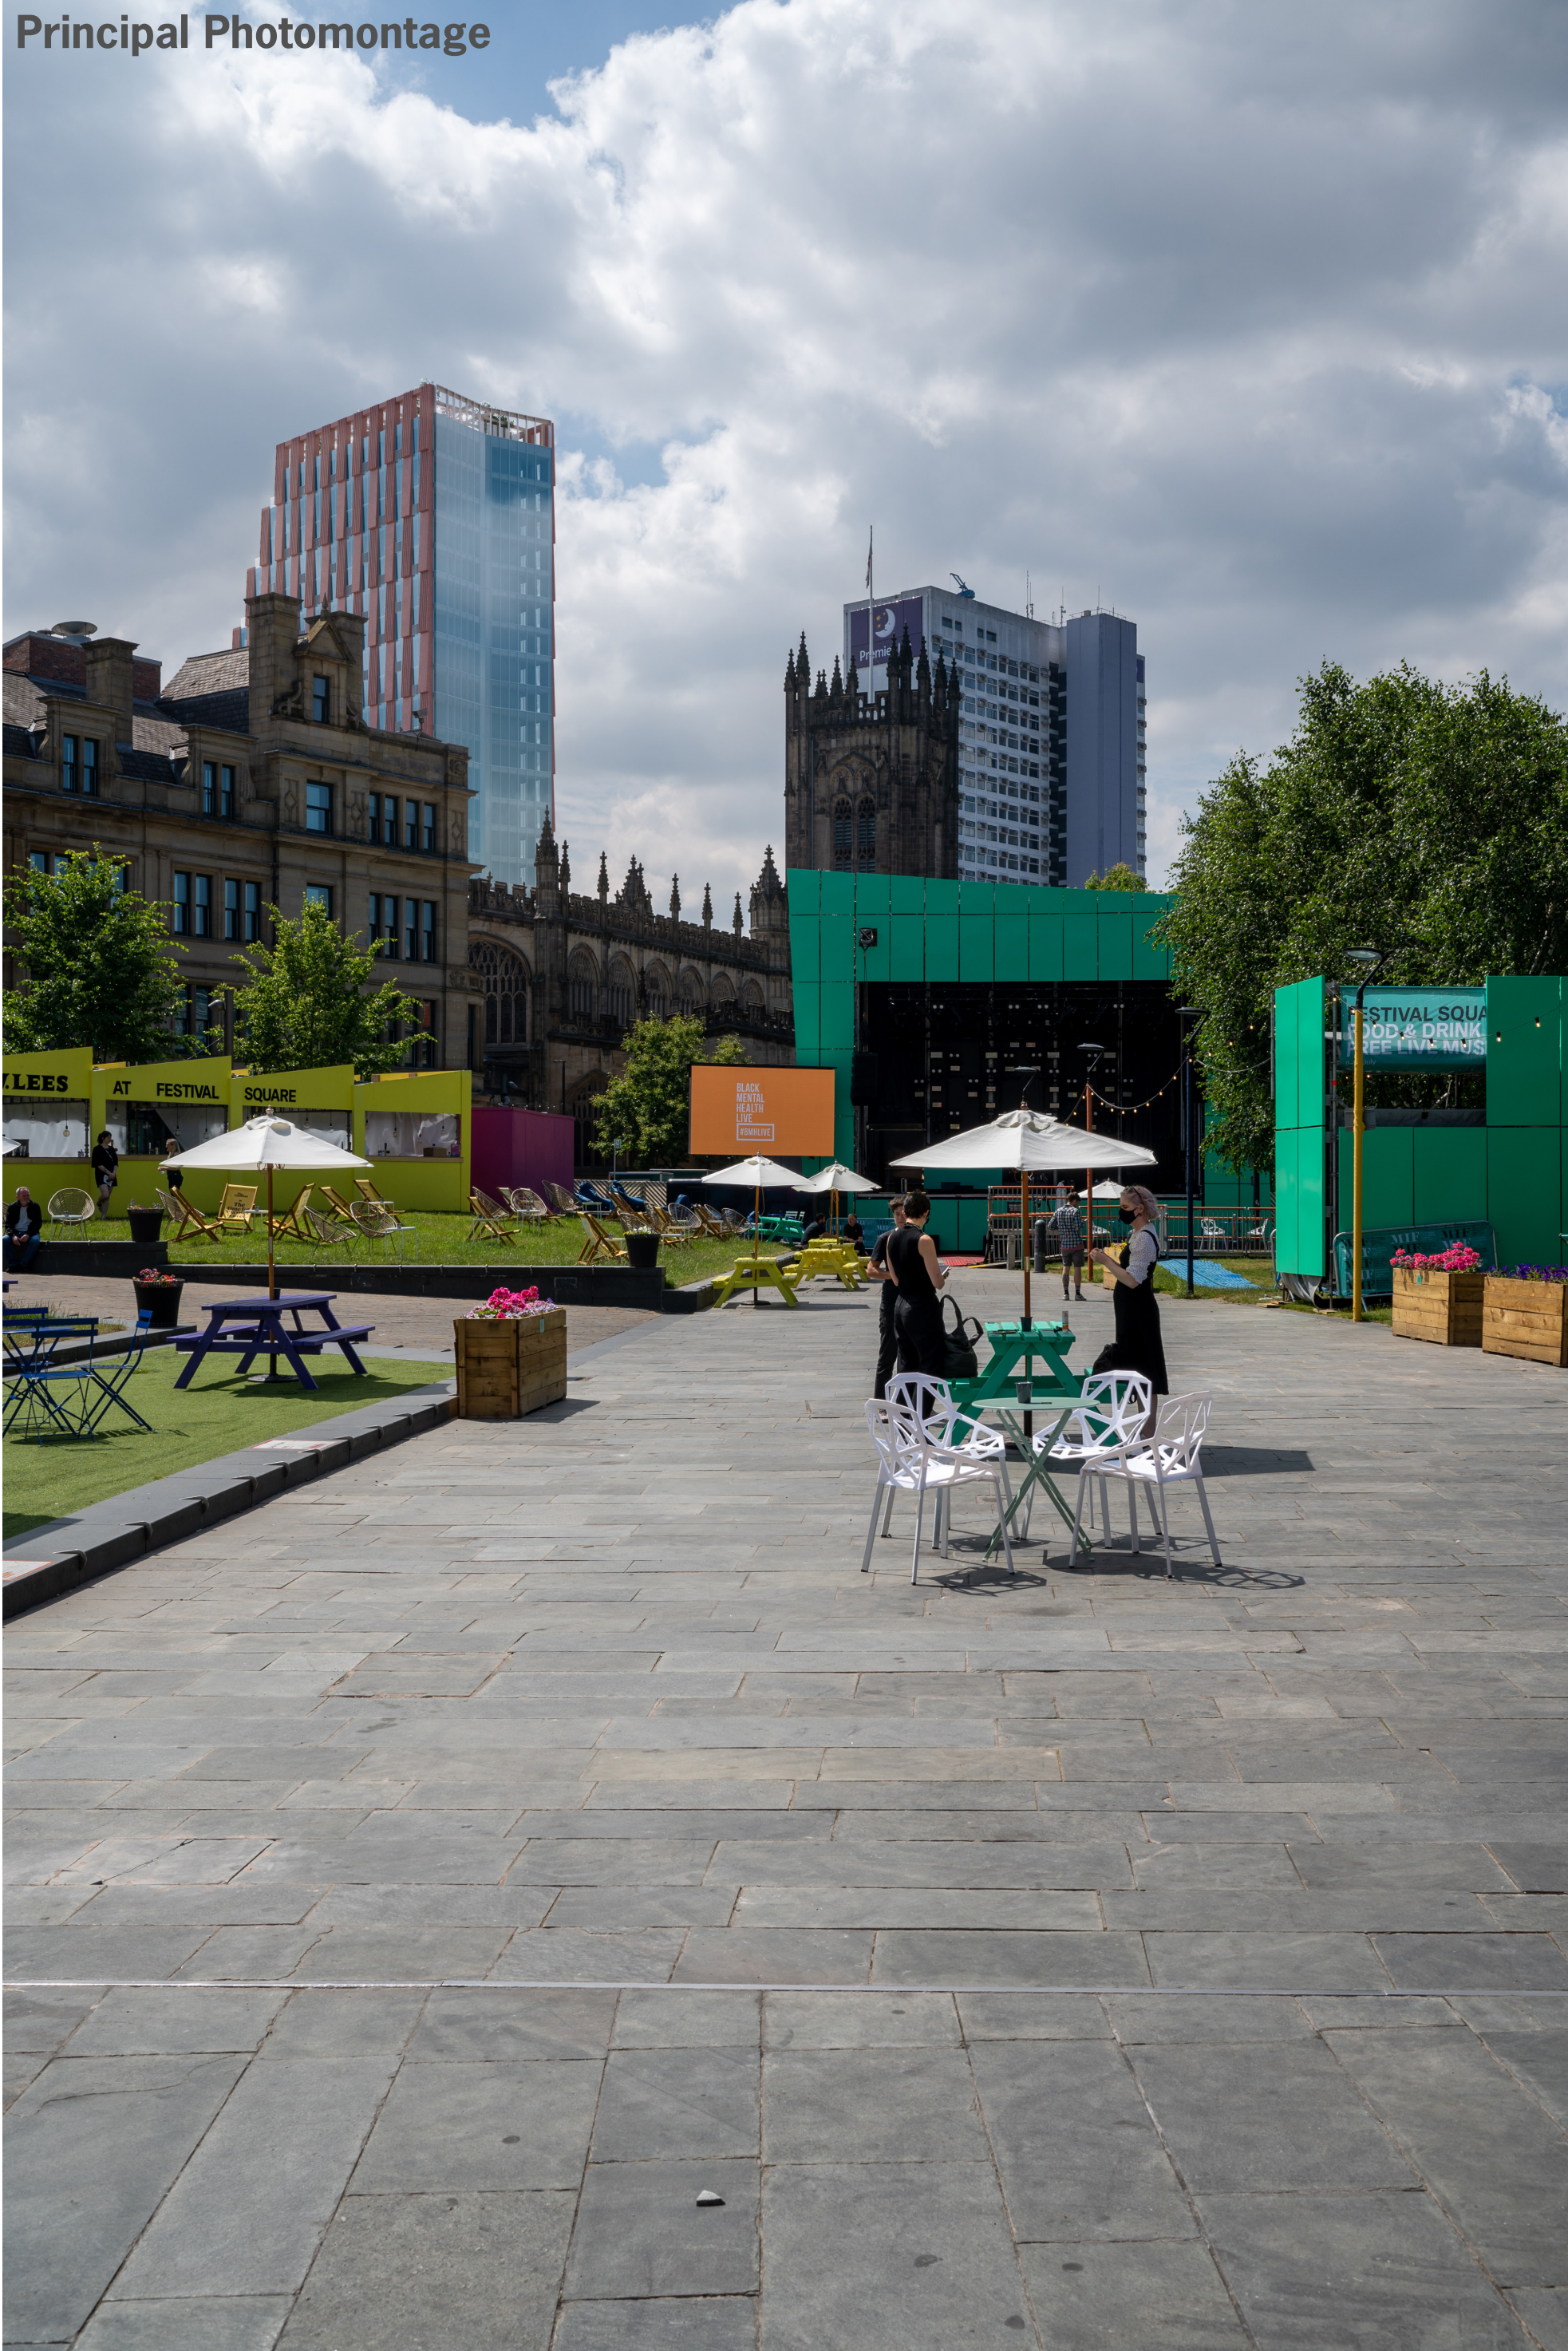
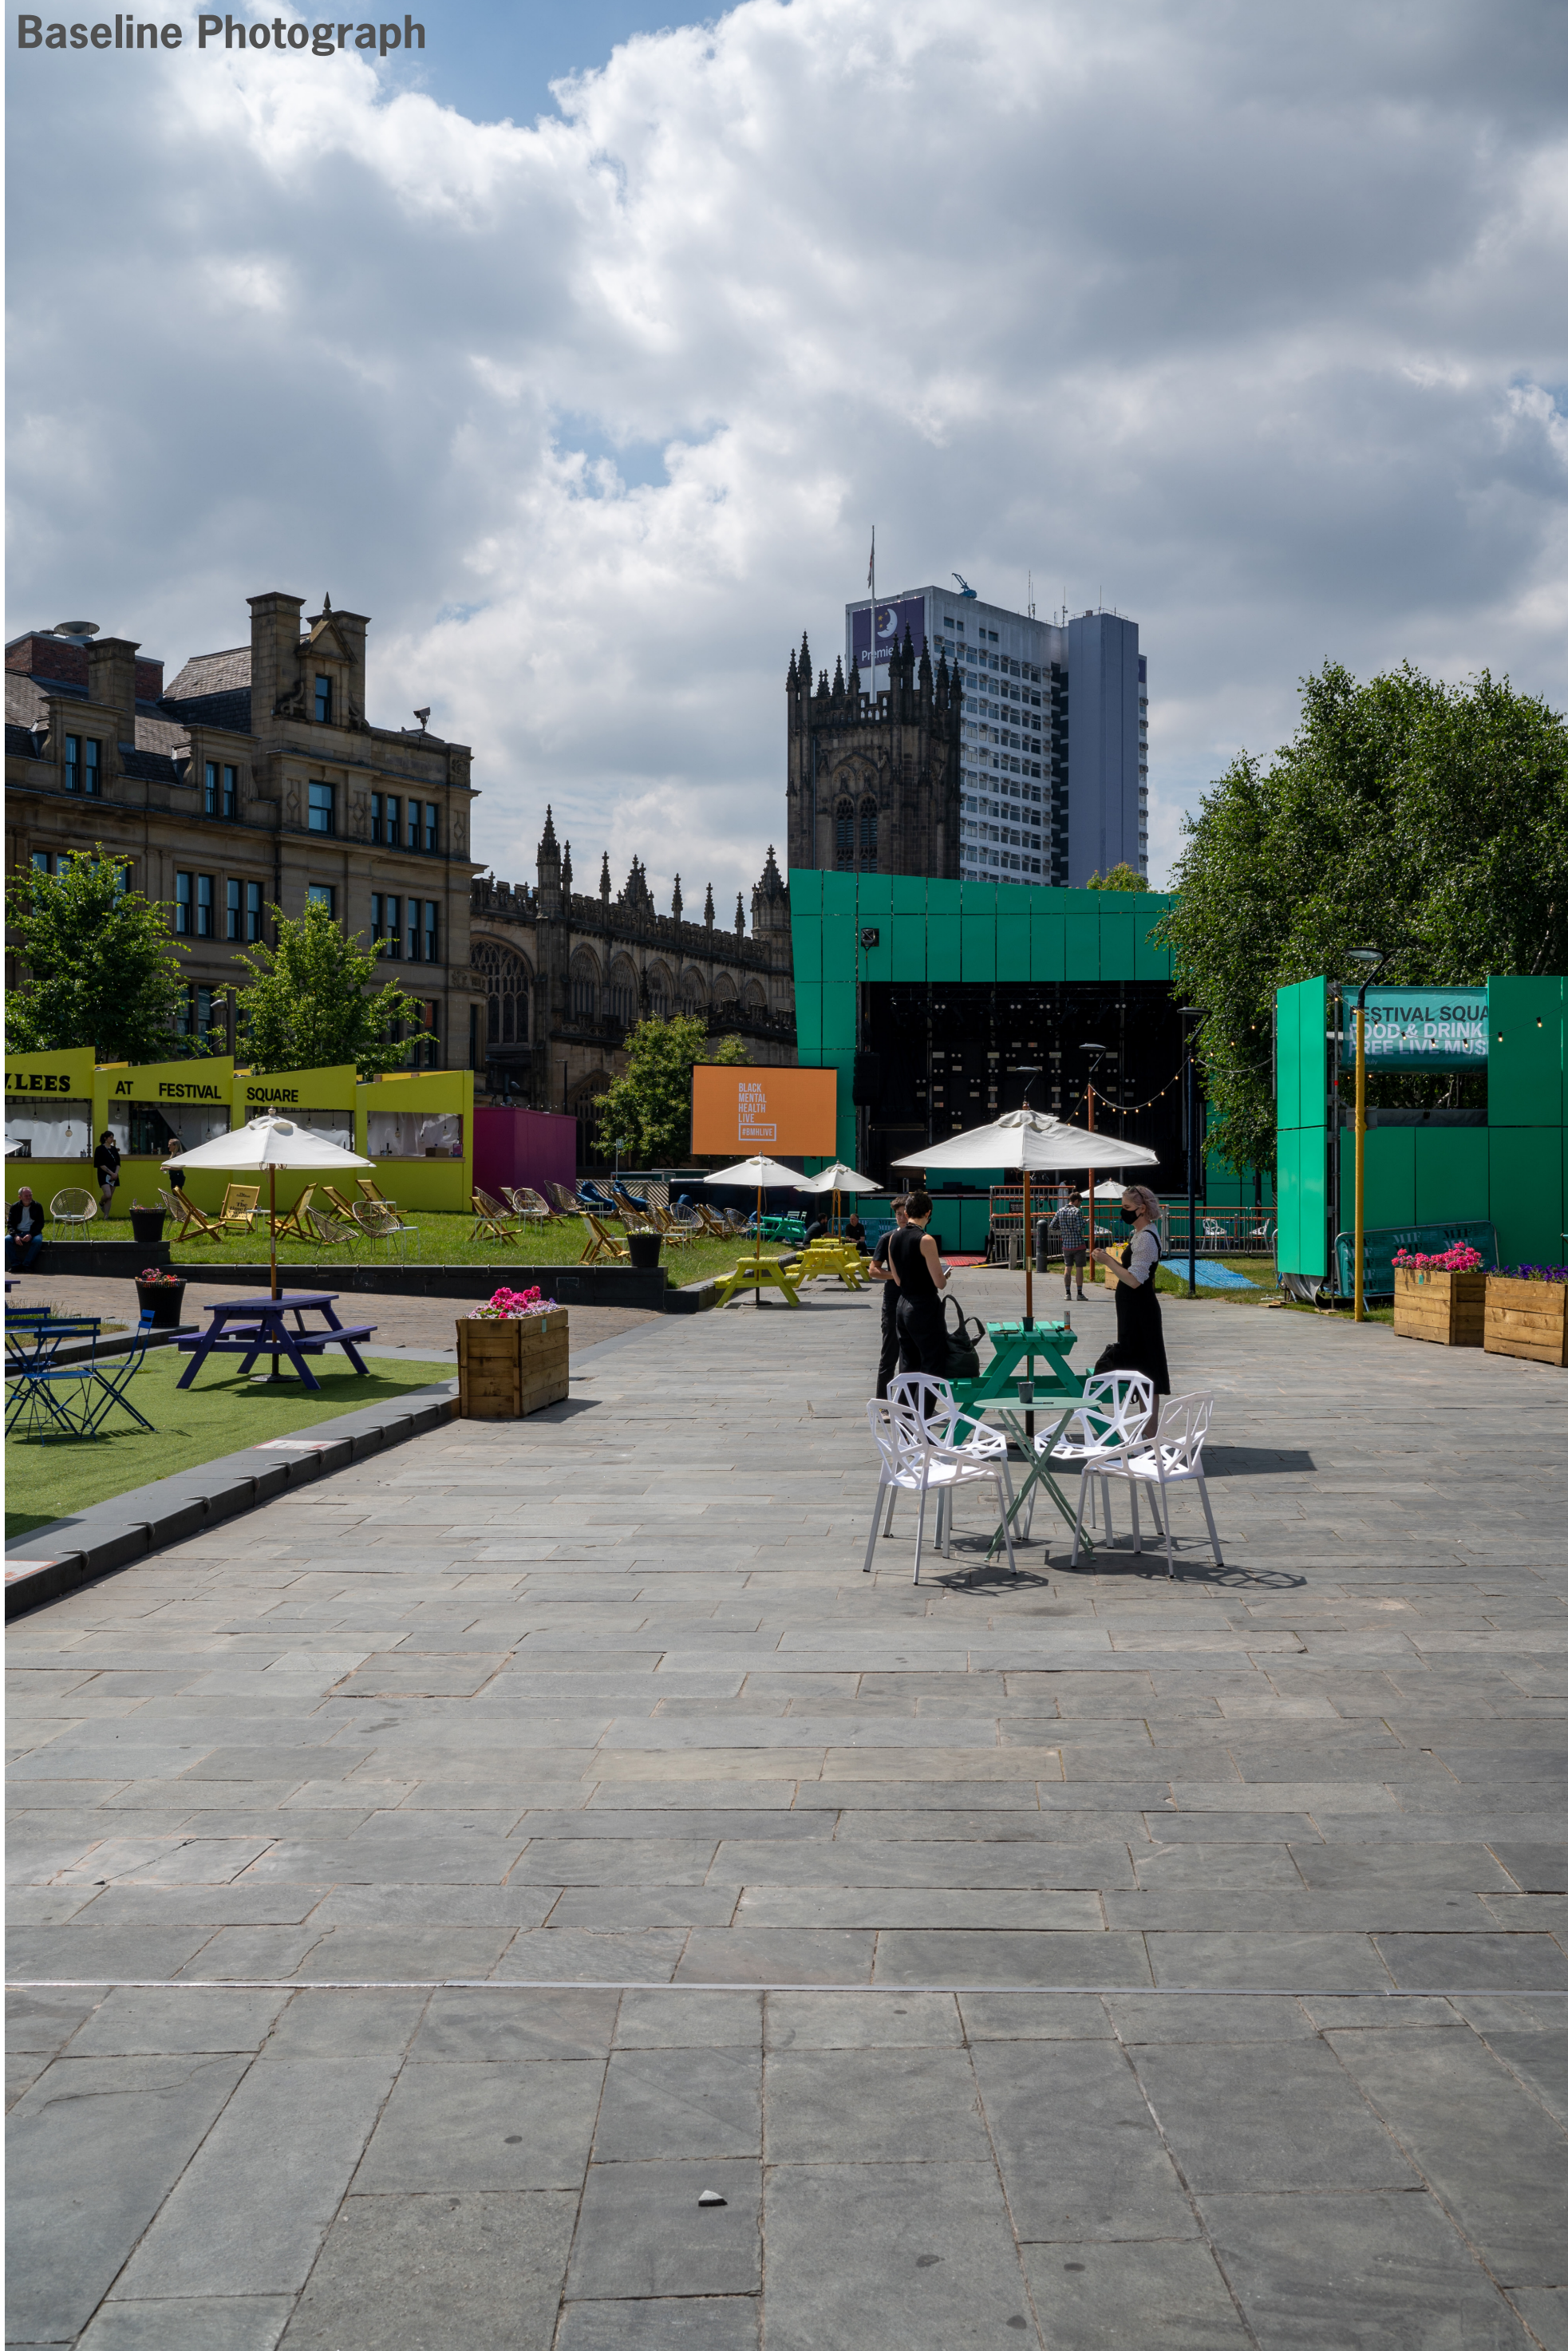
Viewpoint 1.1 - Principal Photomontage | Type 4 | AVR Level 3

Enlargement 100% at A1 sheet size

HFOV 37.8°

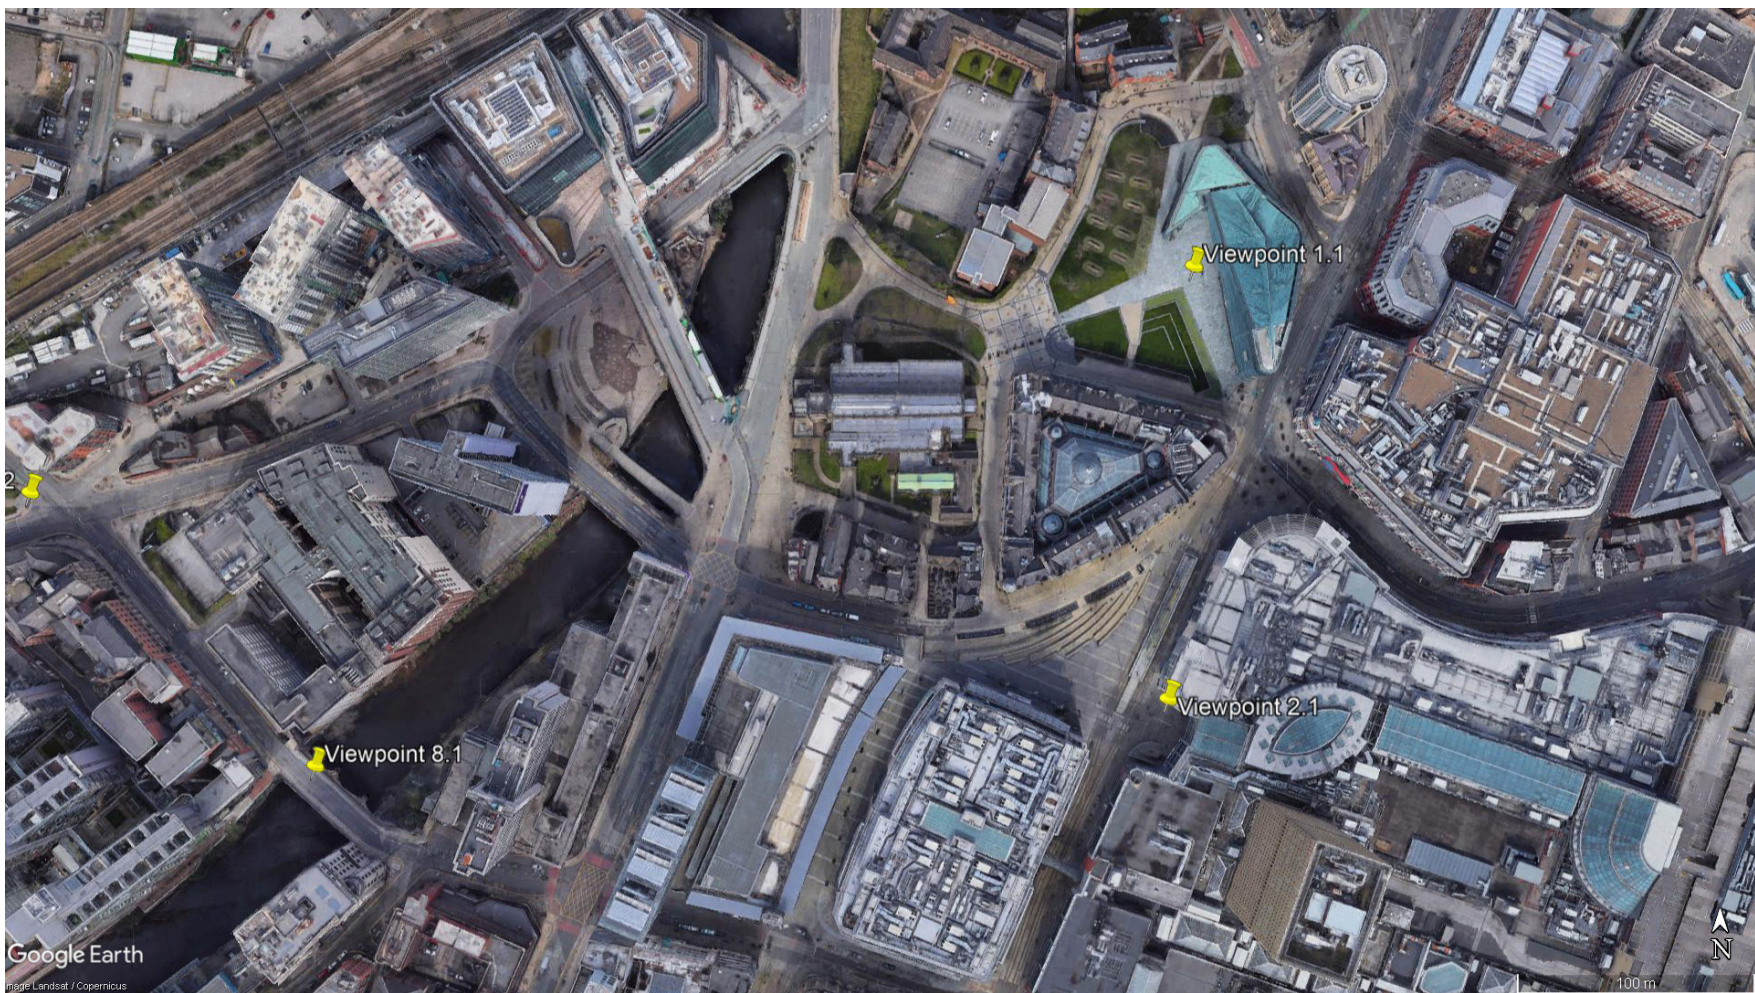
Photo Captured | 01/07/2021 @ 14:04  
Camera Location | E 384005.755, N 398804.025 @ 37.281m AOD  
Camera's Nodal Point Height From Ground | 1.6m  
Direction of View | 238° from N  
Distance to Nearest Site Boundary | 232m  
Camera Model | Nikon Z6ii, Full Frame Sensor  
Camera Lens | Nikon Nikkor Z S-Line 35mm  
Additional Location Info | Camera nodal point centred on the bottom left corner of 'Martin Peters' ground plaque.  
Located outside the front entrance to the Football Museum.

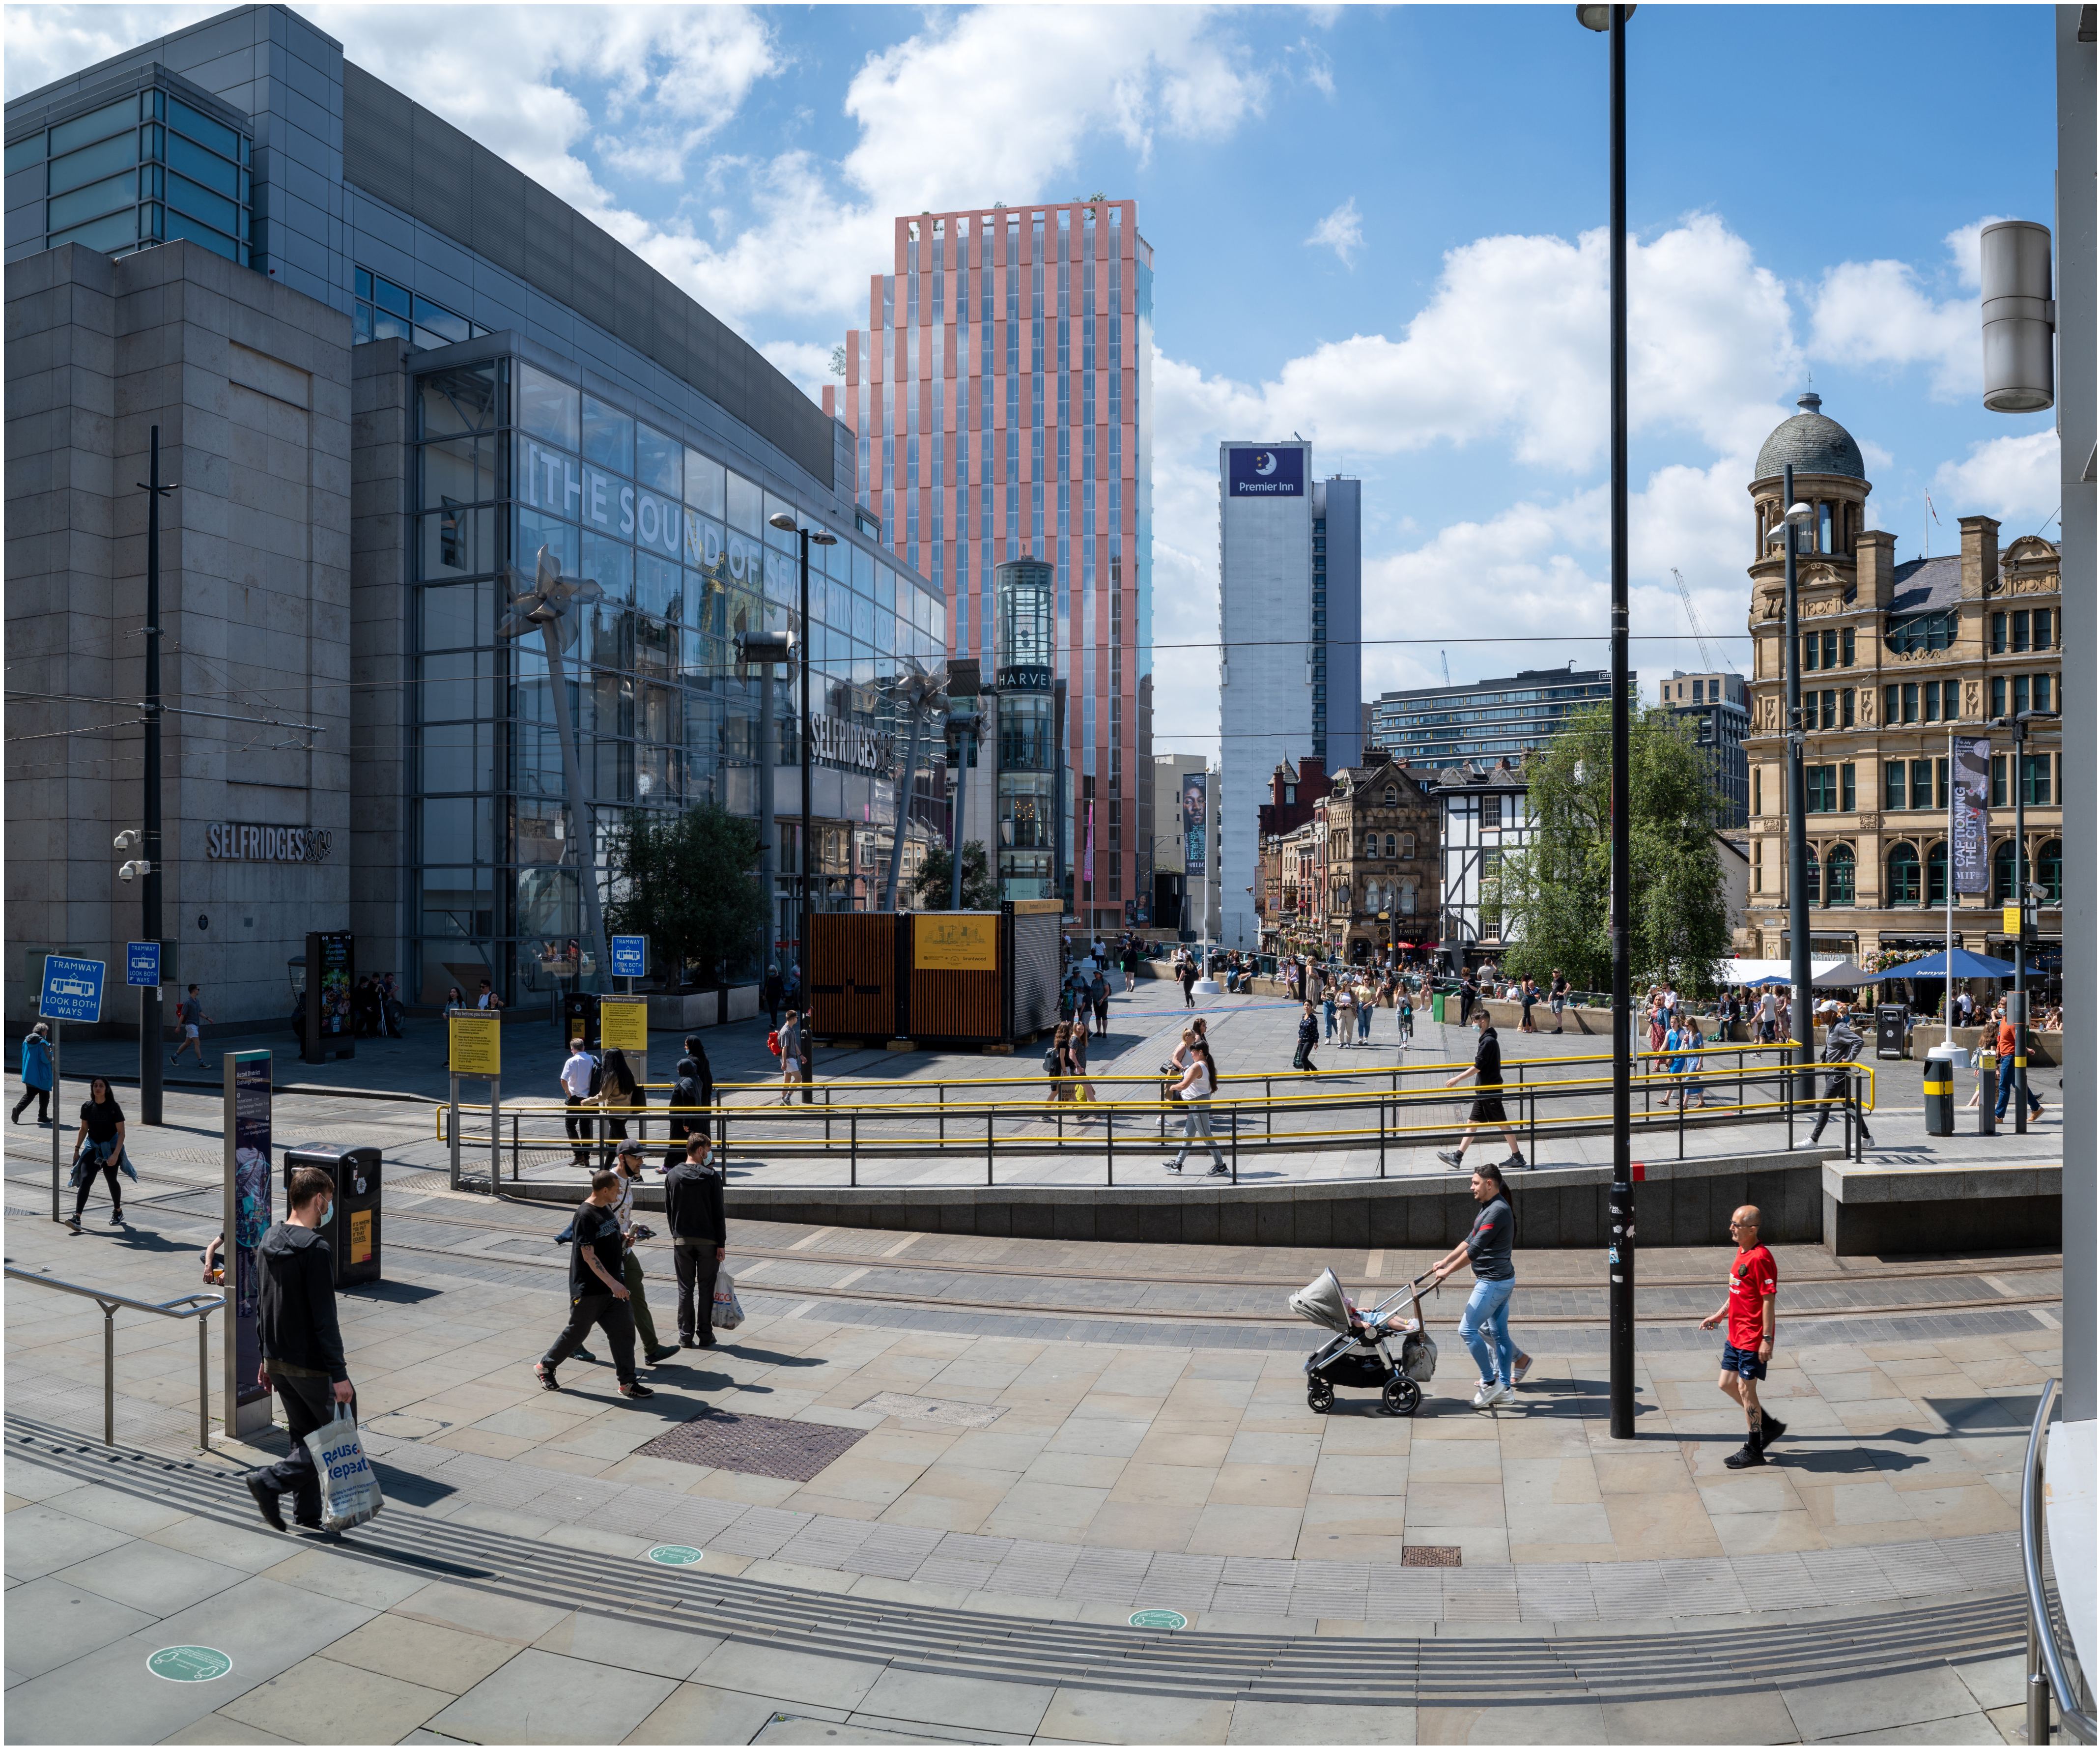
HFOV 64.9°

**Photo Captured** | 01/07/2021 @ 14:35  
**Camera Location** | E 383999.266, N 398627.208 @ 41.221m AOD  
**Camera's Nodal Point Height From Ground** | 1.604m  
**Direction of View** | 220° from N  
**Distance to Nearest Site Boundary** | 206m  
**Camera Model** | Nikon Z6ii, Full Frame Sensor  
**Camera Lens** | Nikon Nikkor Z S-Line 35mm
