# Verified View Methodology

Type 4 | AVR Level 0, 1 & 3

This document has been prepared to explain the process of generating verified views (also referred to as accurate visual representations (AVR)) for the proposed development at Renaissance Hotel, Manchester.

Renaissance Hotel, Manchester  
Verified Views  
October 2021 v1.0 DRAFT

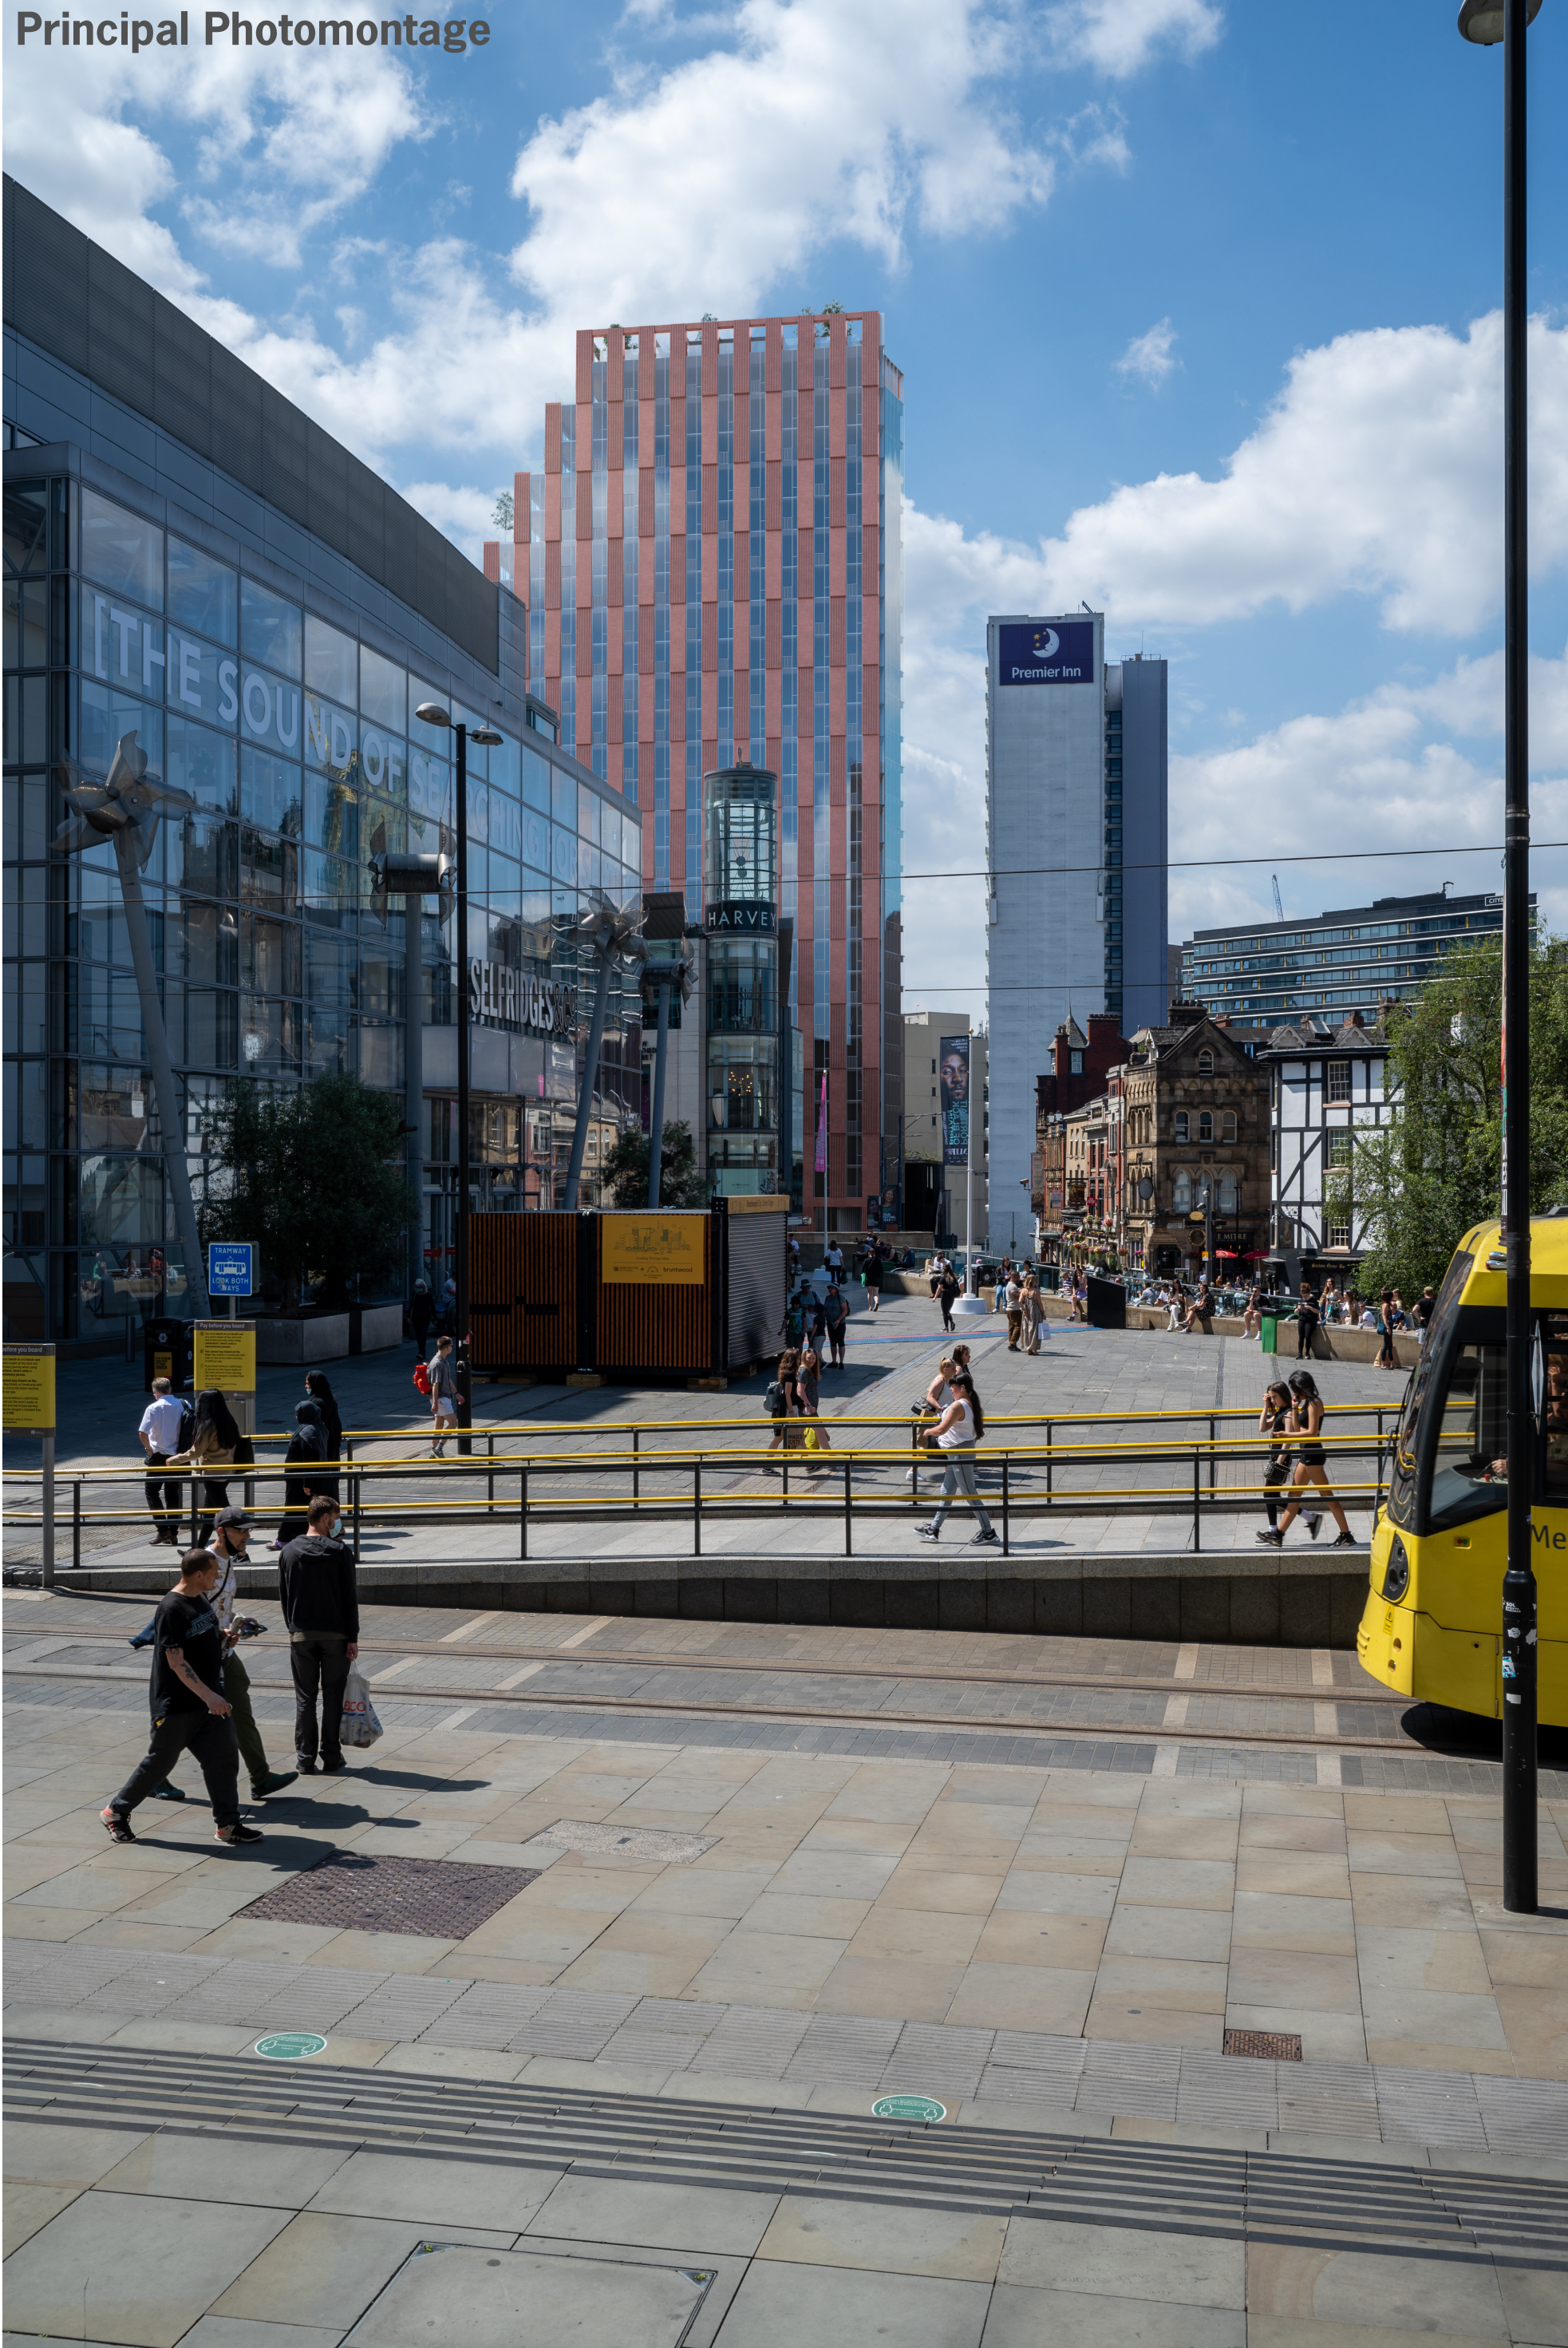
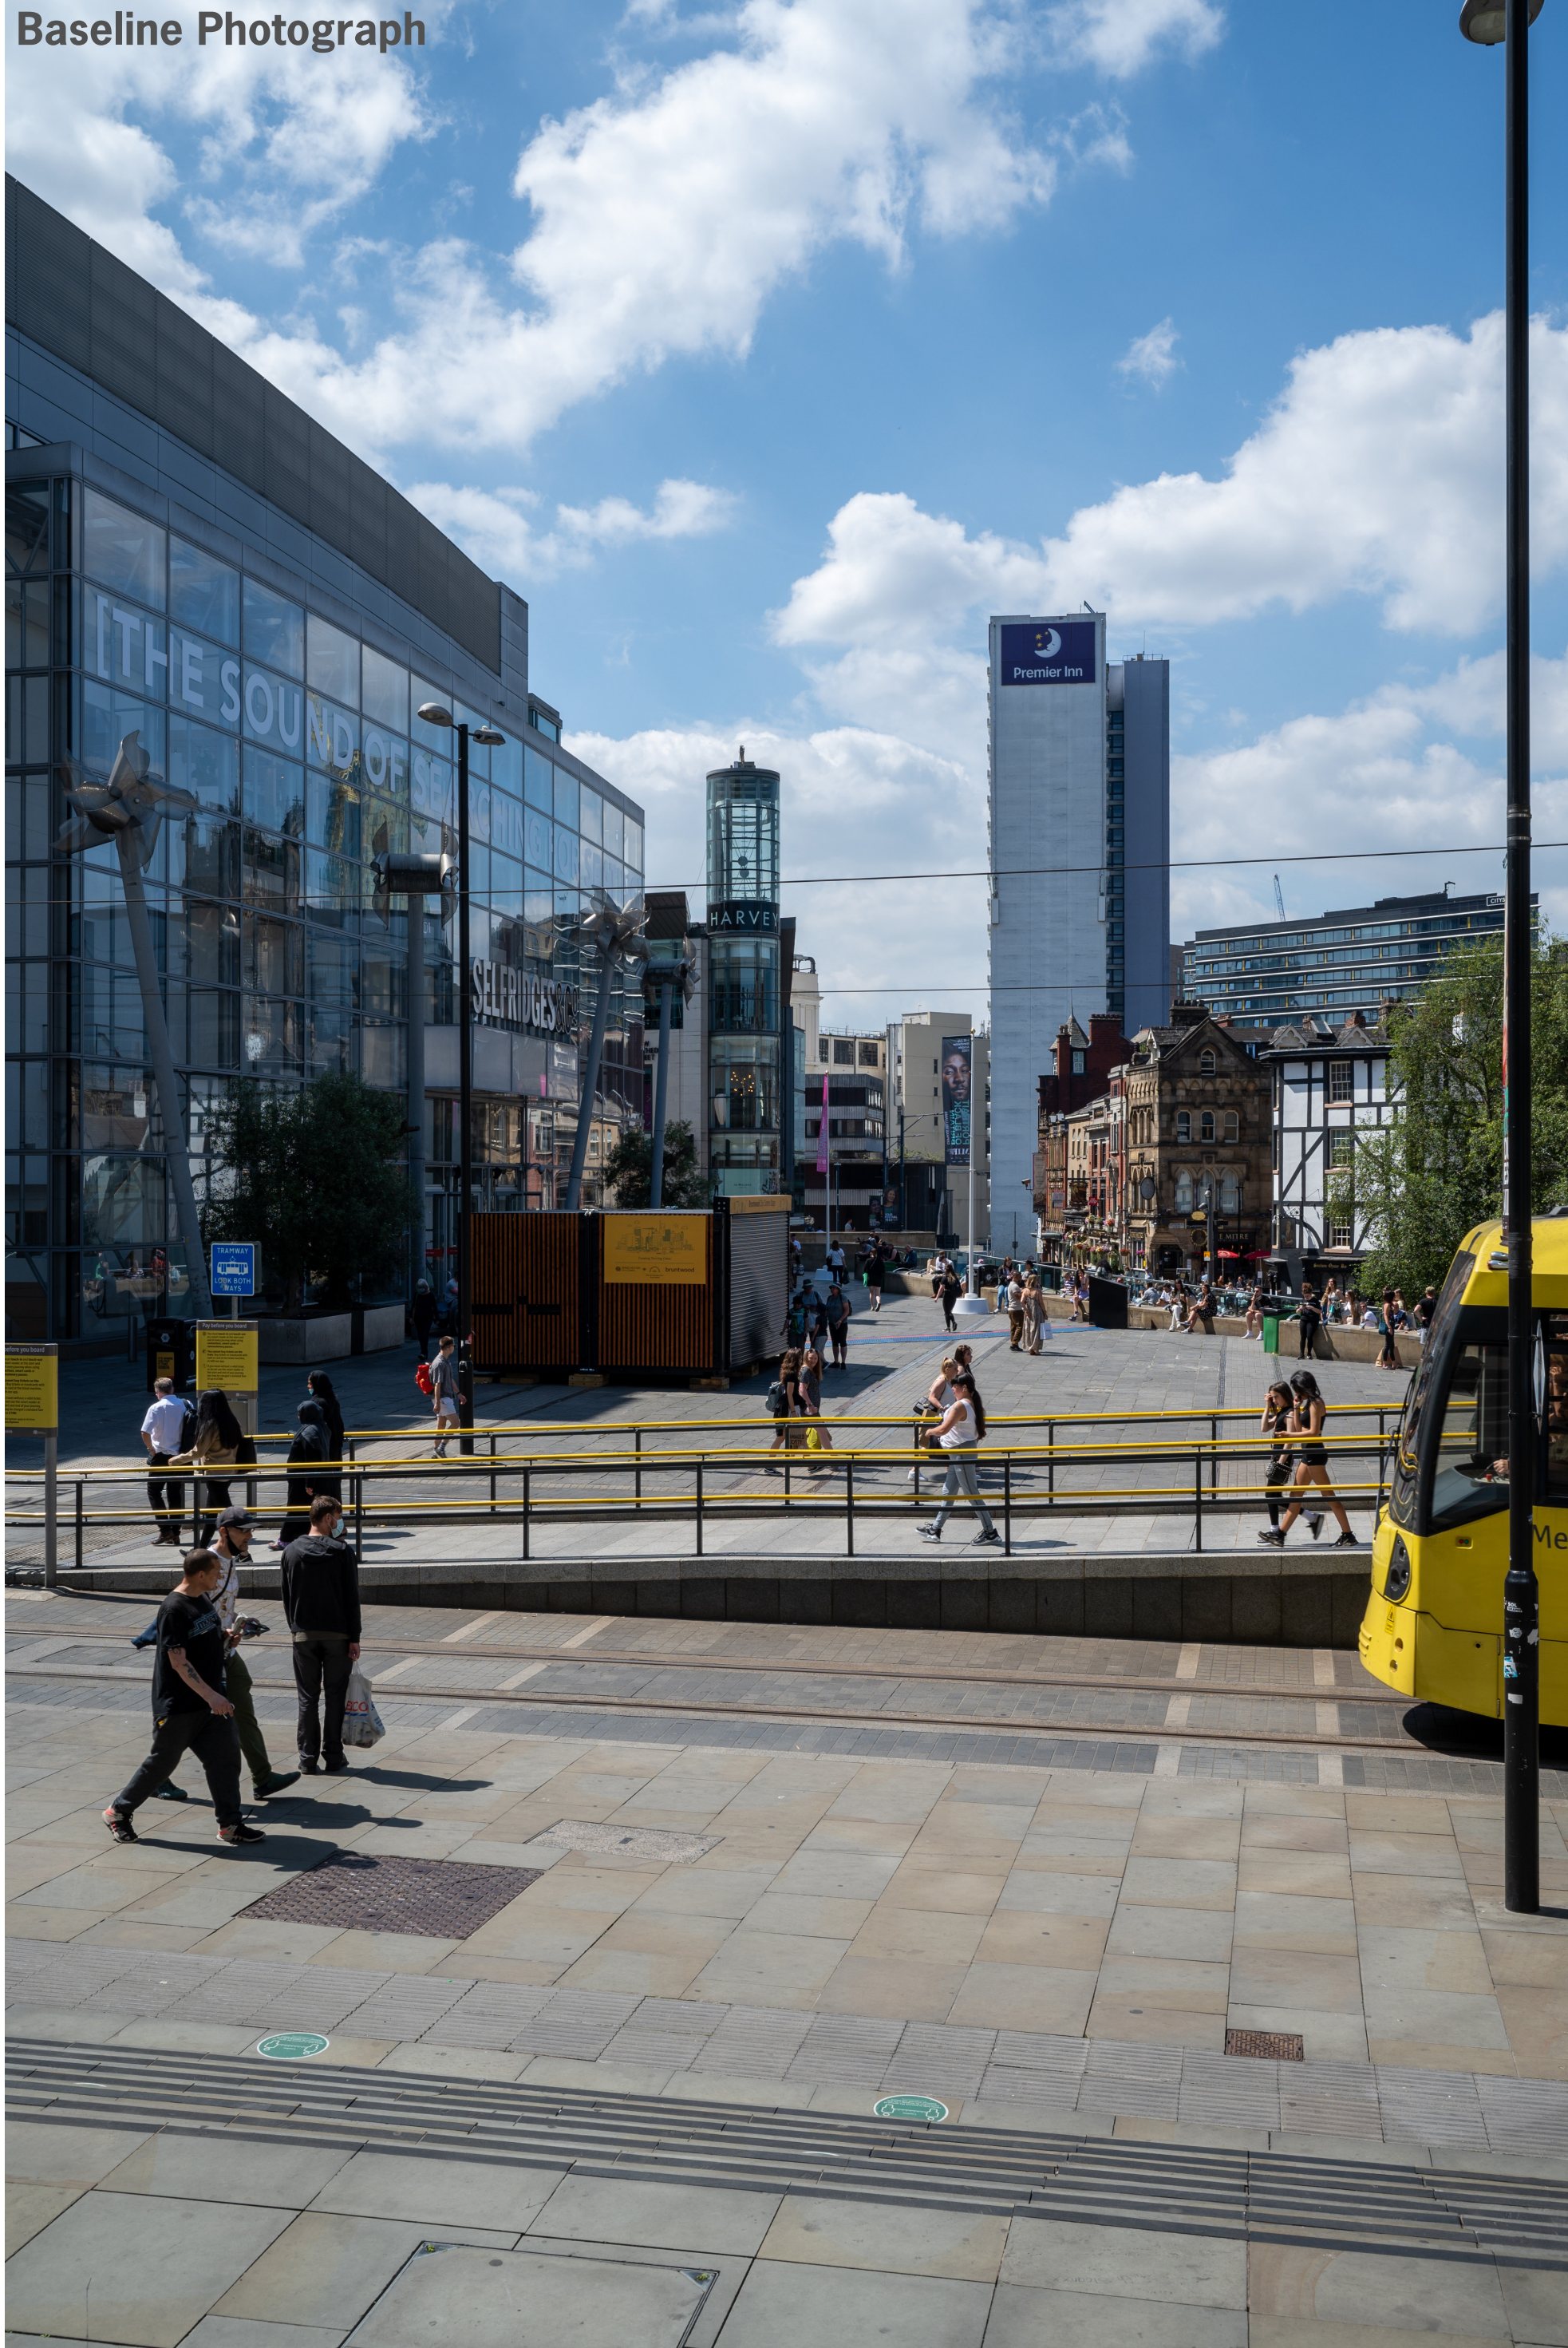
Enlargement 100% at A1 sheet size

**Photo Captured** | 01/07/2021 @ 14:35  
**Camera Location** | E 383999.266, N 398627.208 @ 41.221m AOD  
**Camera's Nodal Point Height From Ground** | 1.604m  
**Direction of View** | 220° from N  
**Distance to Nearest Site Boundary** | 206m  
**Camera Model** | Nikon Z6ii, Full Frame Sensor  
**Camera Lens** | Nikon Nikkor Z S-Line 35mm

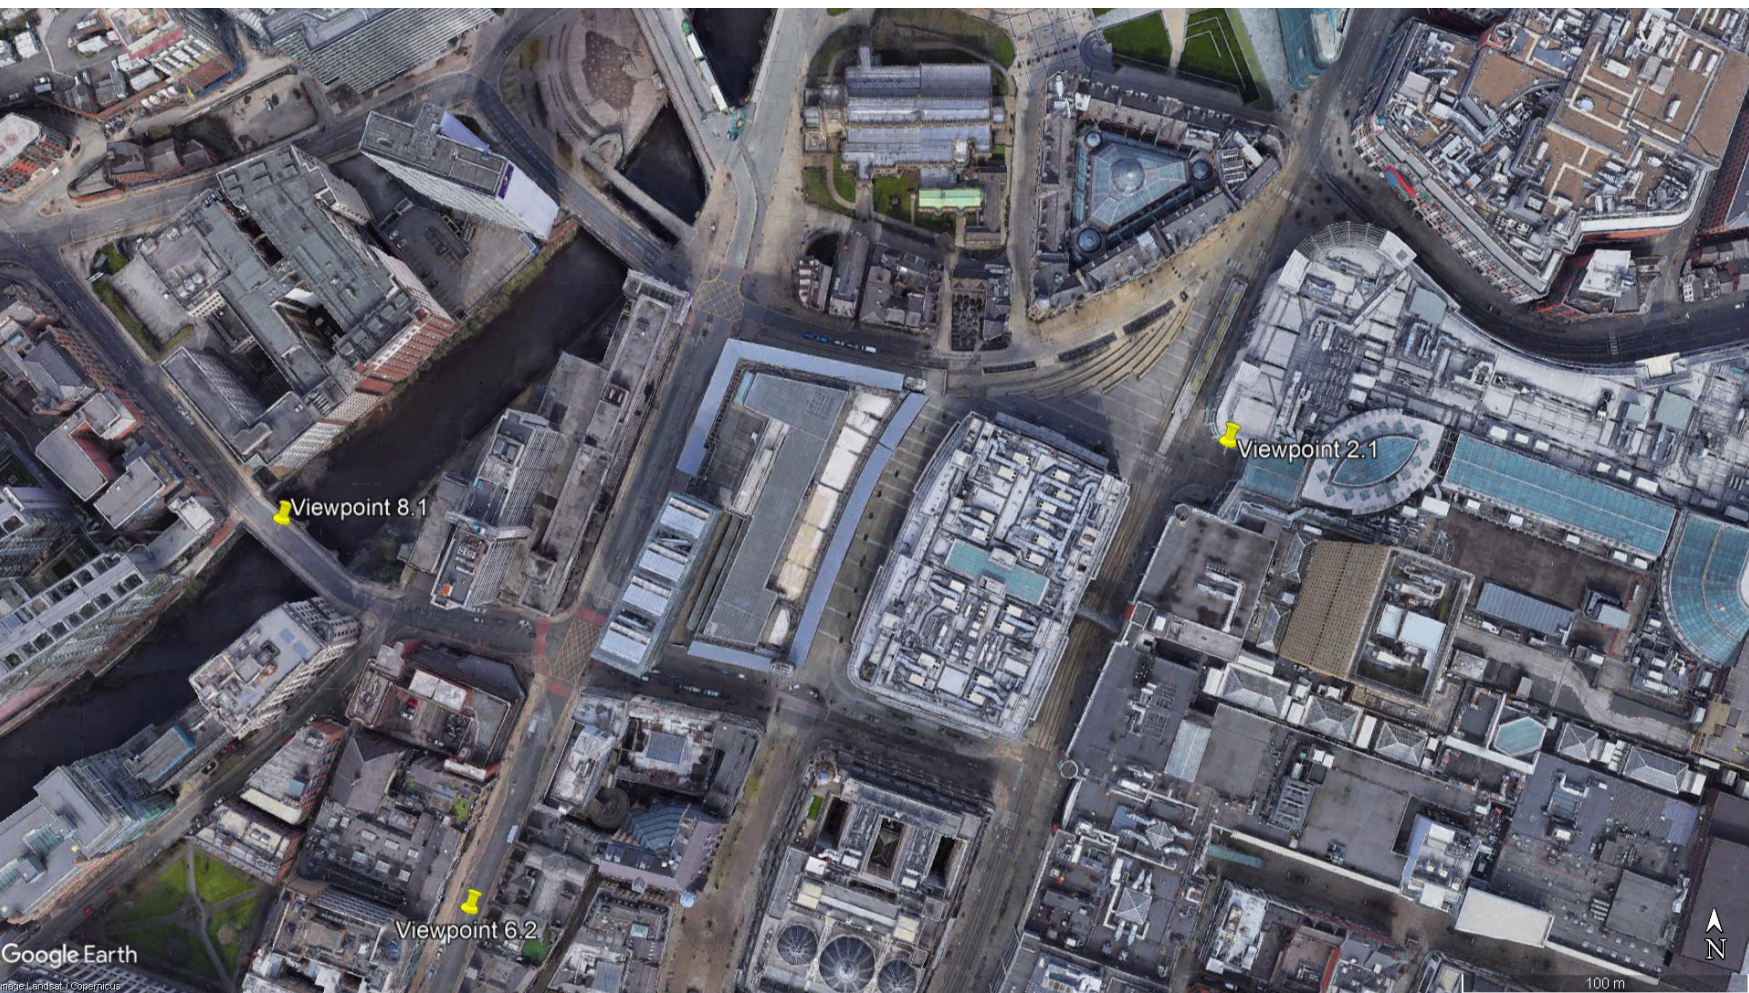
Camera Location

**Photo Captured** | 01/07/2021 @ 14:35  
**Camera Location** | E 383999.266, N 398627.208 @ 41.221m AOD  
**Camera's Nodal Point Height From Ground** | 1.604m  
**Direction of View** | 220° from N  
**Distance to Nearest Site Boundary** | 206m  
**Camera Model** | Nikon Z6ii, Full Frame Sensor  
**Camera Lens** | Nikon Nikkor Z S-Line 35mm  
**Additional Location Info** | Camera nodal point centred on the corner of the third paver from the wall, adjacent to the tactile paver as shown in photo. Located on the top step of the entrance to the Arndale Shopping Centre.

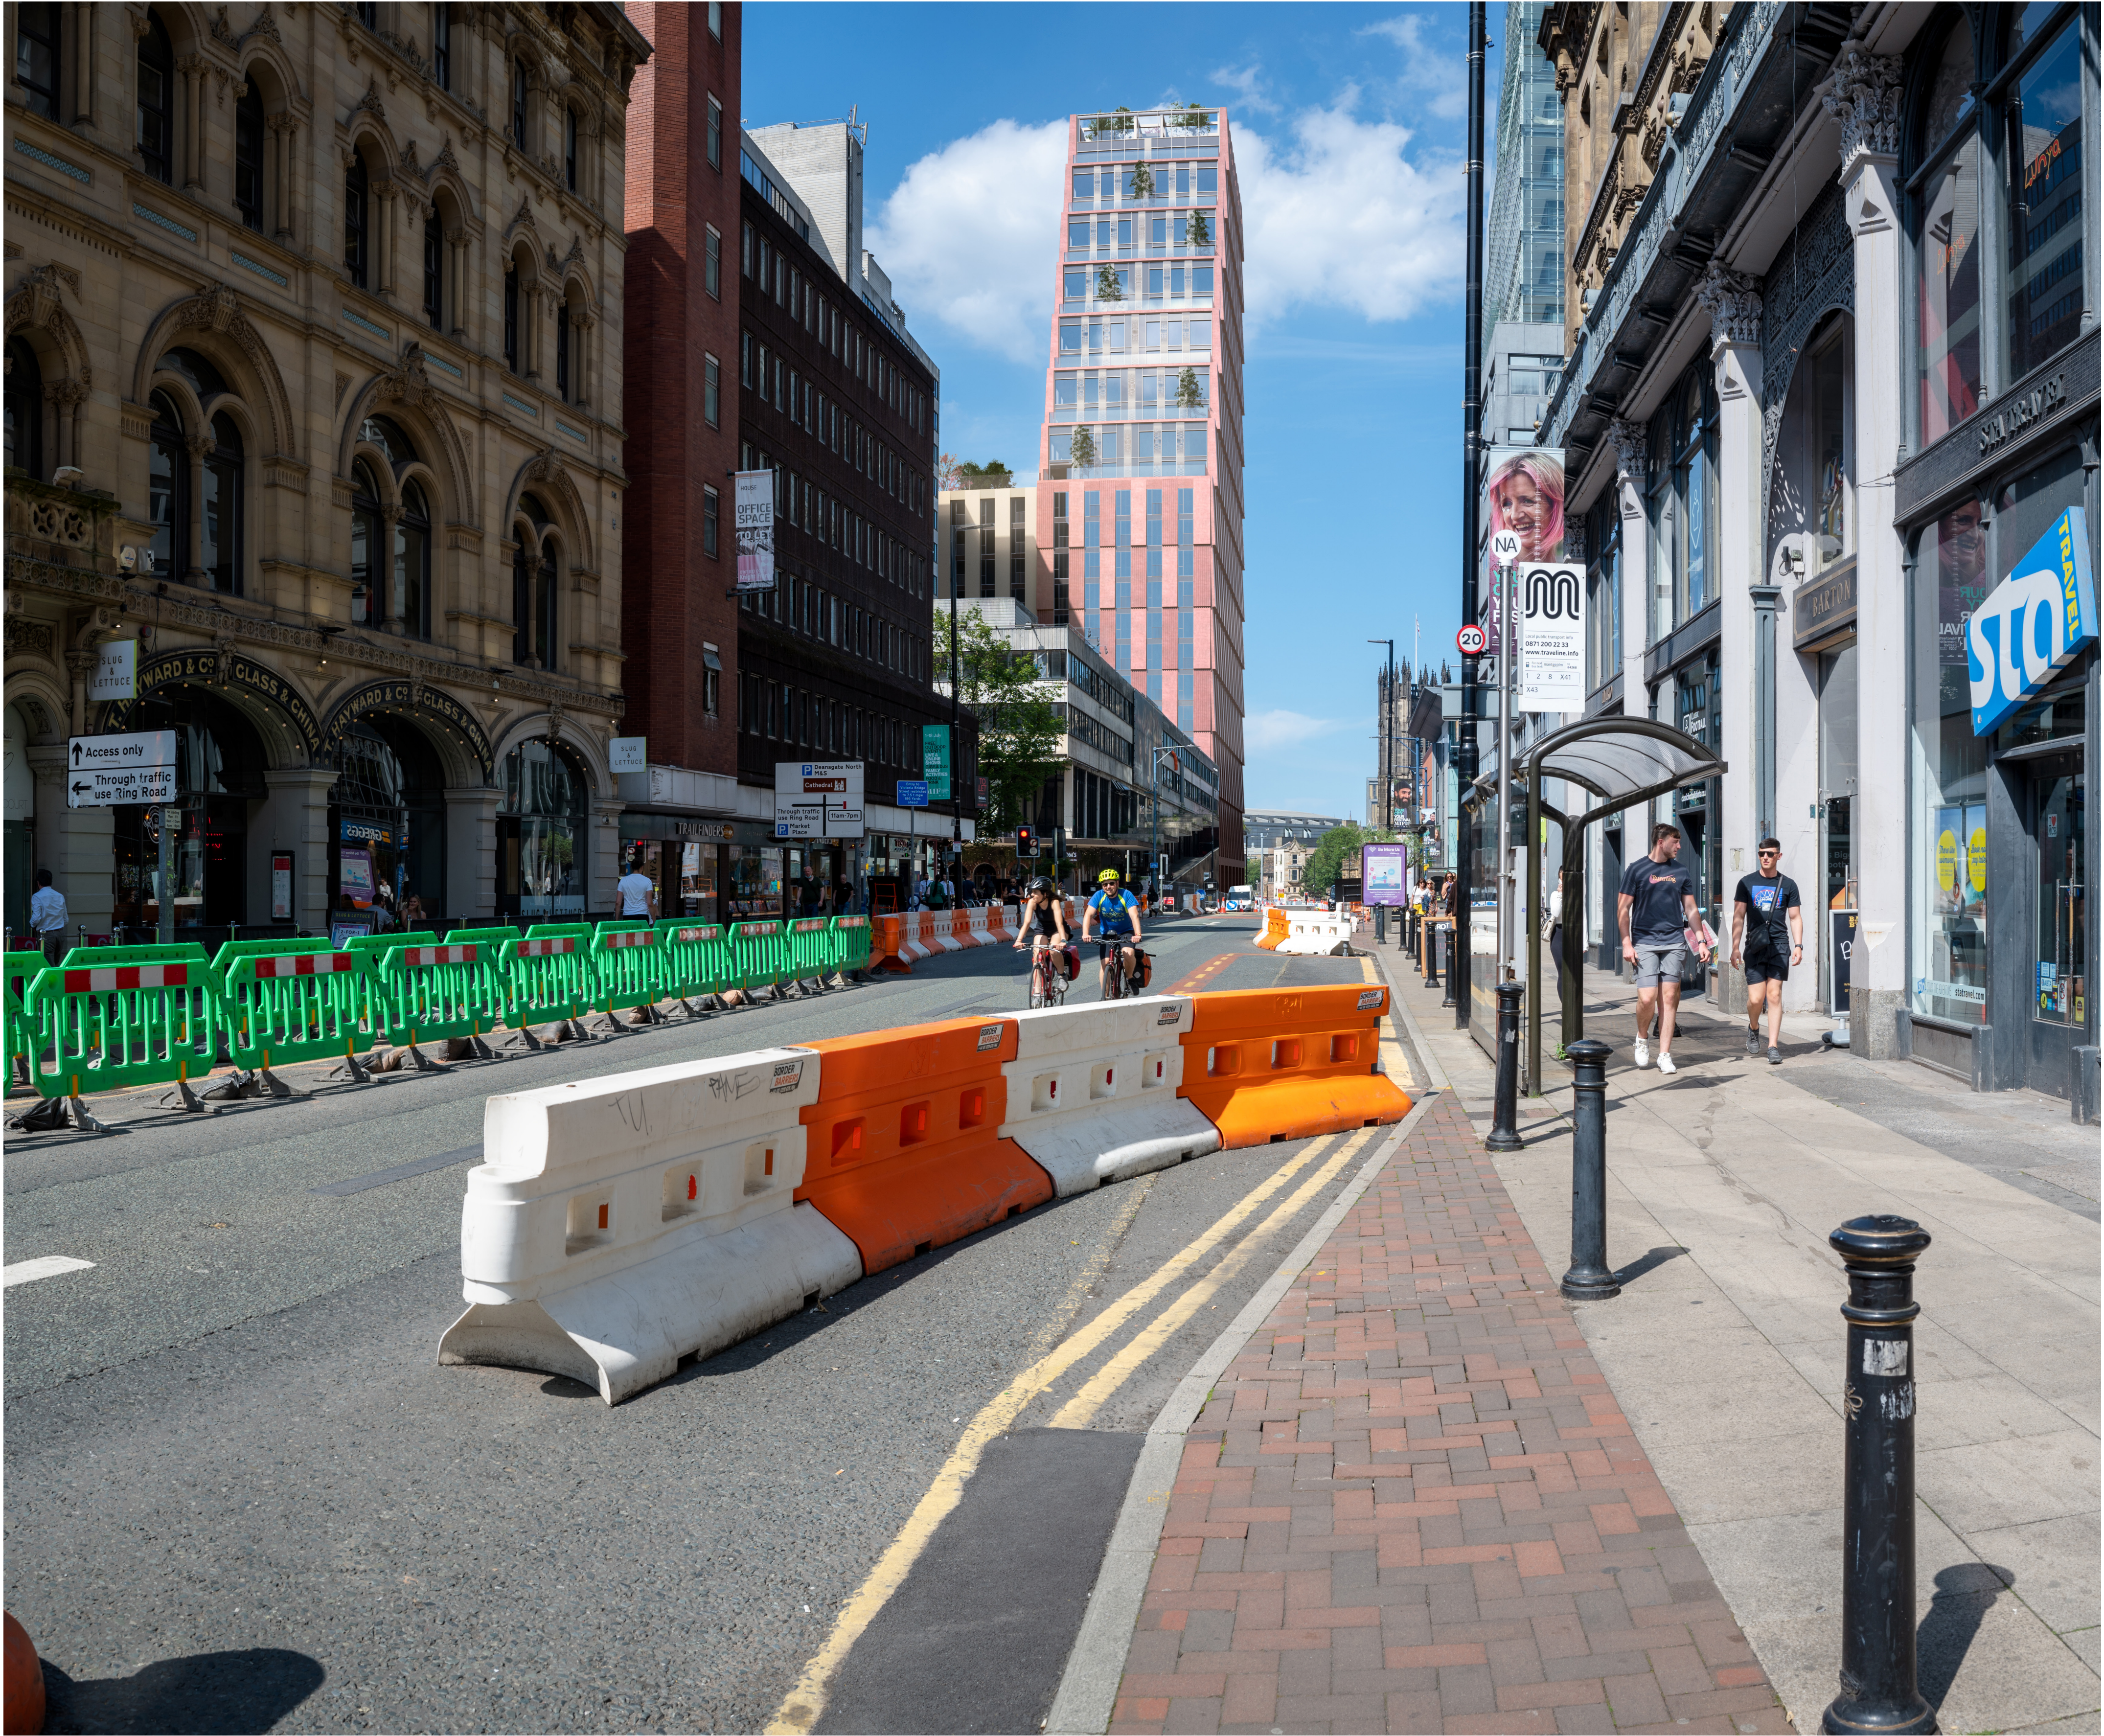
HFOV 65°

**Photo Captured** | 01/07/2021 @ 15:34  
**Camera Location** | E 383728.399, N 398470.169 @ 37.826m AOD  
**Camera's Nodal Point Height From Ground** | 1.601m  
**Direction of View** | 16° from N  
**Distance to Nearest Site Boundary** | 167m  
**Camera Model** | Nikon Z6ii, Full Frame Sensor  
**Camera Lens** | Nikon Nikkor Z S-Line 35mm

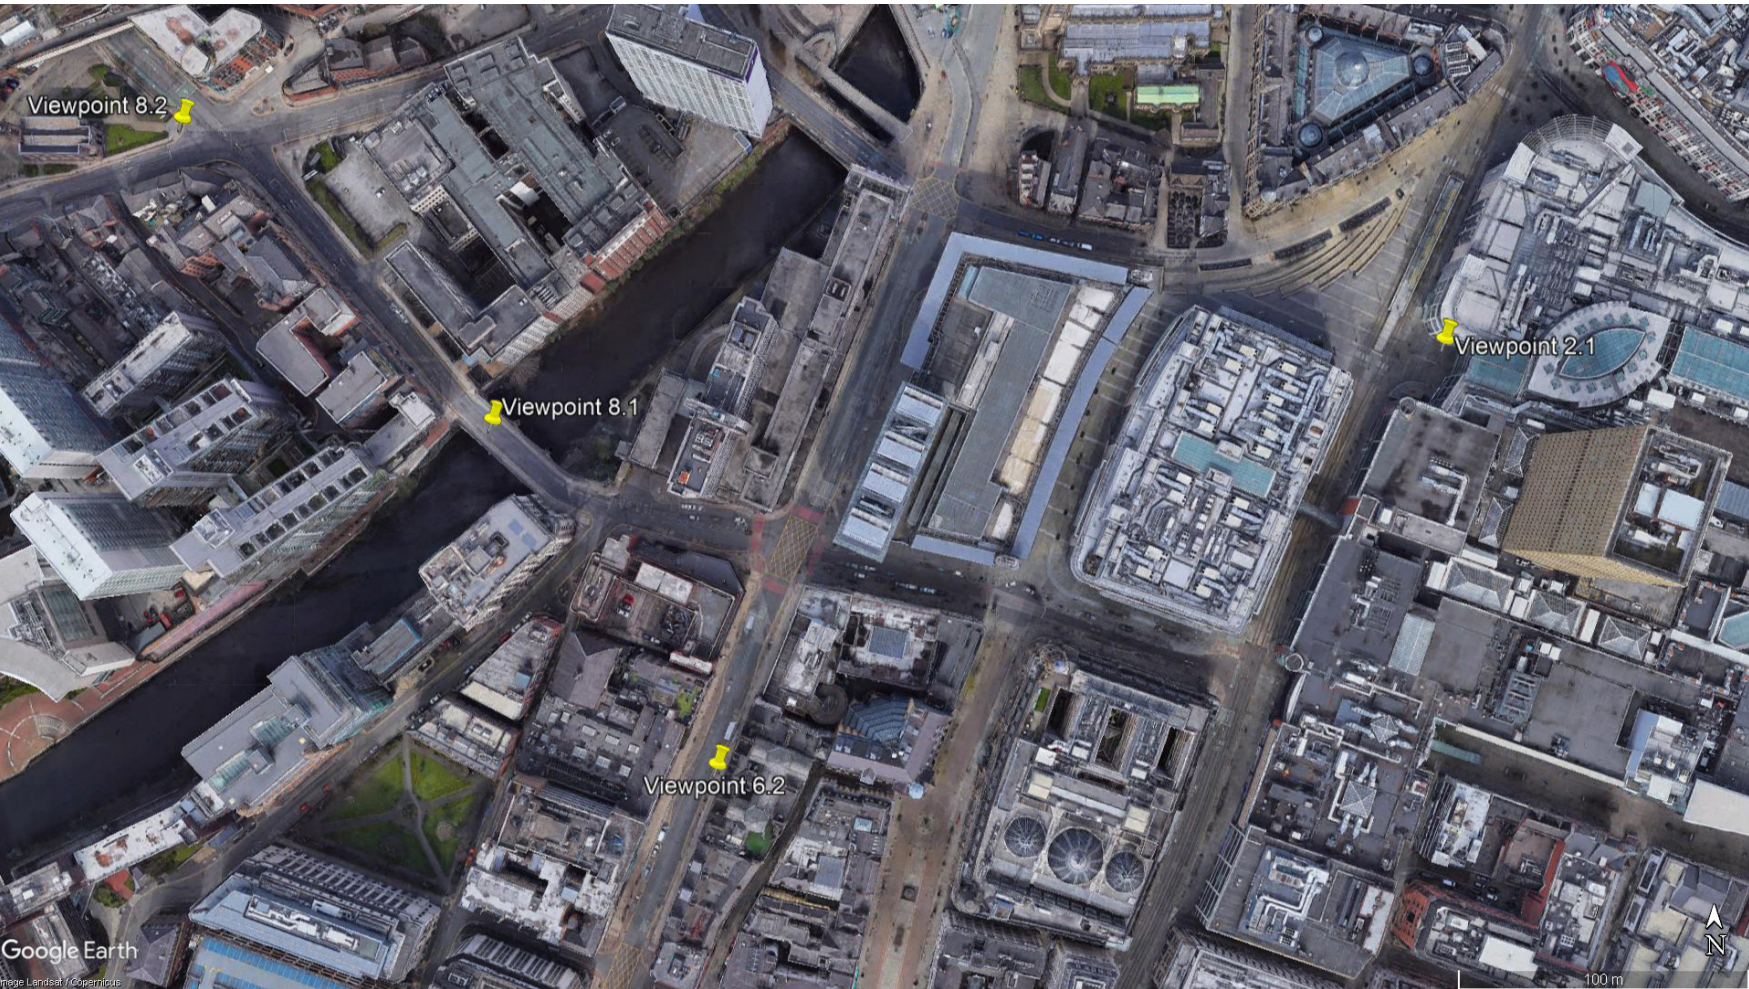
Photo Captured | 01/07/2021 @ 15:34  
Camera Location | E 383728.399, N 398470.169 @ 37.826m AOD  
Camera's Nodal Point Height From Ground | 1.601m  
Direction of View | 16° from N  
Distance to Nearest Site Boundary | 167m  
Camera Model | Nikon Z6ii, Full Frame Sensor  
Camera Lens | Nikon Nikkor Z S-Line 35mm  
Additional Location Info | Camera nodal point centred on the survey nail adjacent to drain cover.  
Located on the block pavers outside 'Lunya Catalan Deli' on Deansgate.

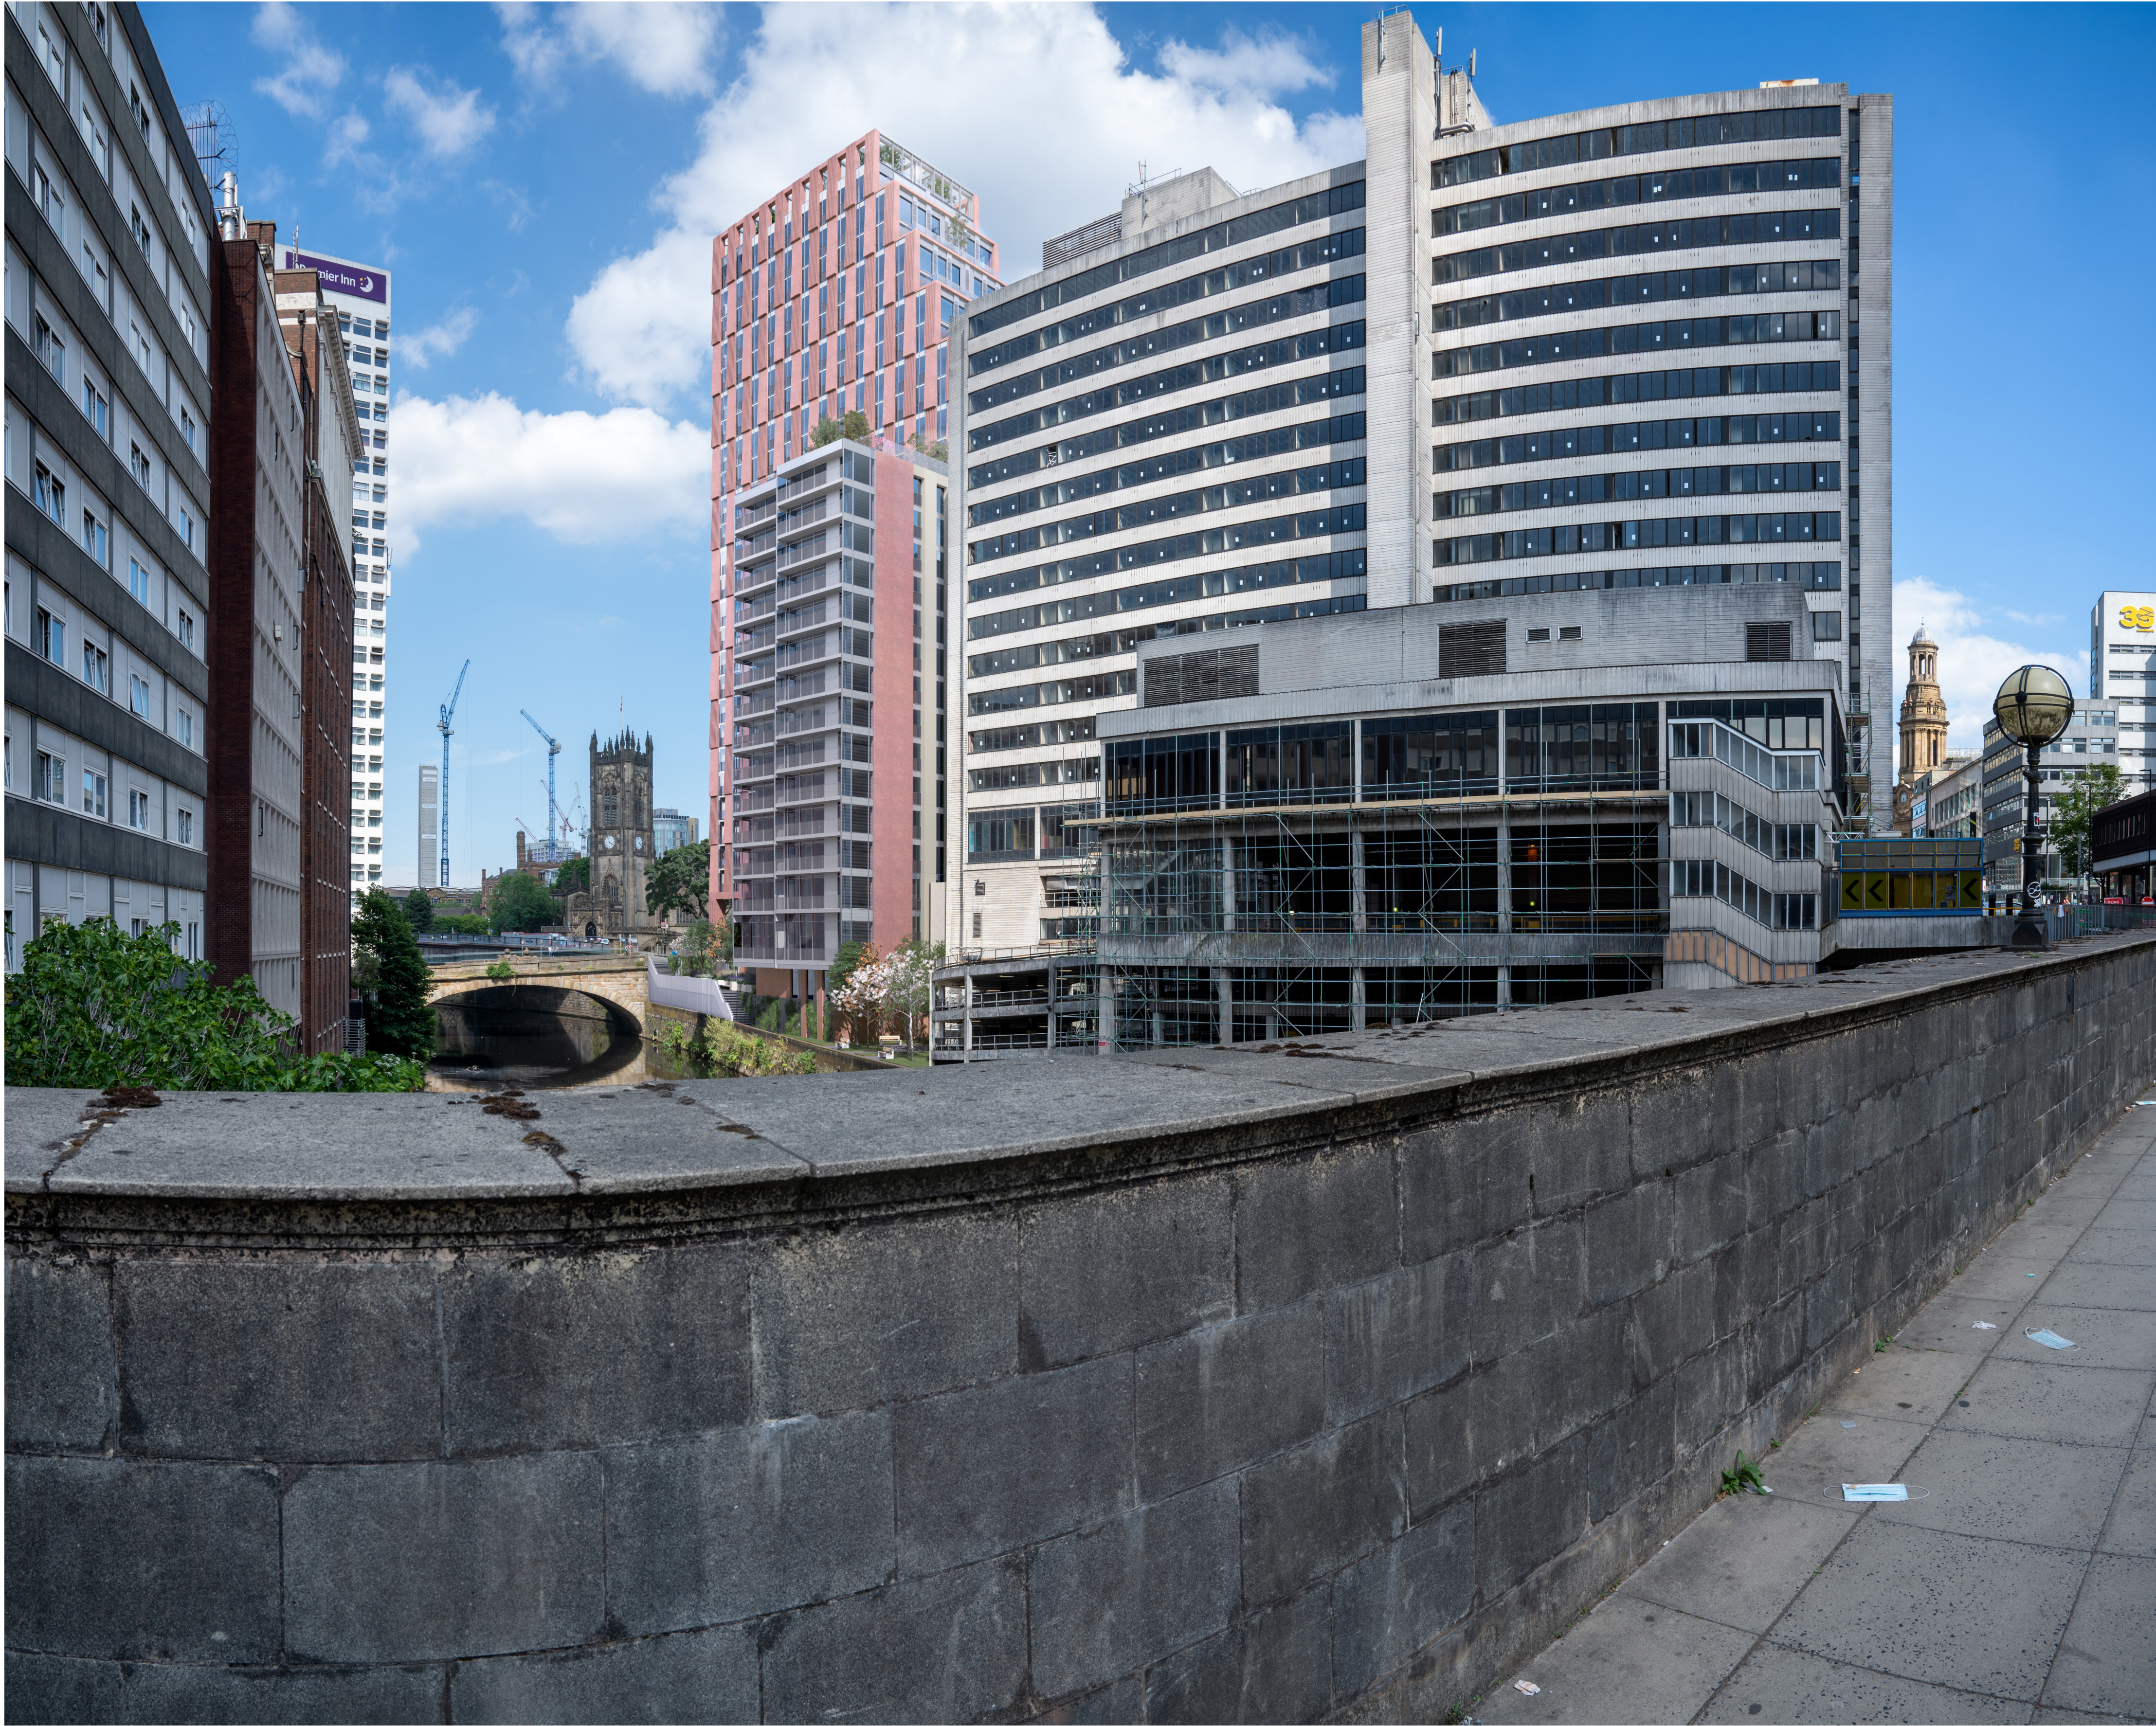
HFOV 98.5°

**Photo Captured** | 01/07/2021 @ 15:57  
**Camera Location** | E 383643.742, N 398603.583 @ 33.917m AOD  
**Camera's Nodal Point Height From Ground** | 1.599m  
**Direction of View** | 62° from N  
**Distance to Nearest Site Boundary** | 96m  
**Camera Model** | Nikon Z6ii, Full Frame Sensor  
**Camera Lens** | Nikon Nikkor Z S-Line 24mm
