# Verified View Methodology

Type 4 | AVR Level 0, 1 & 3

This document has been prepared to explain the process of generating verified views (also referred to as accurate visual representations (AVR)) for the proposed development at Renaissance Hotel, Manchester.

Renaissance Hotel, Manchester  
Verified Views  
October 2021 v1.0 DRAFT

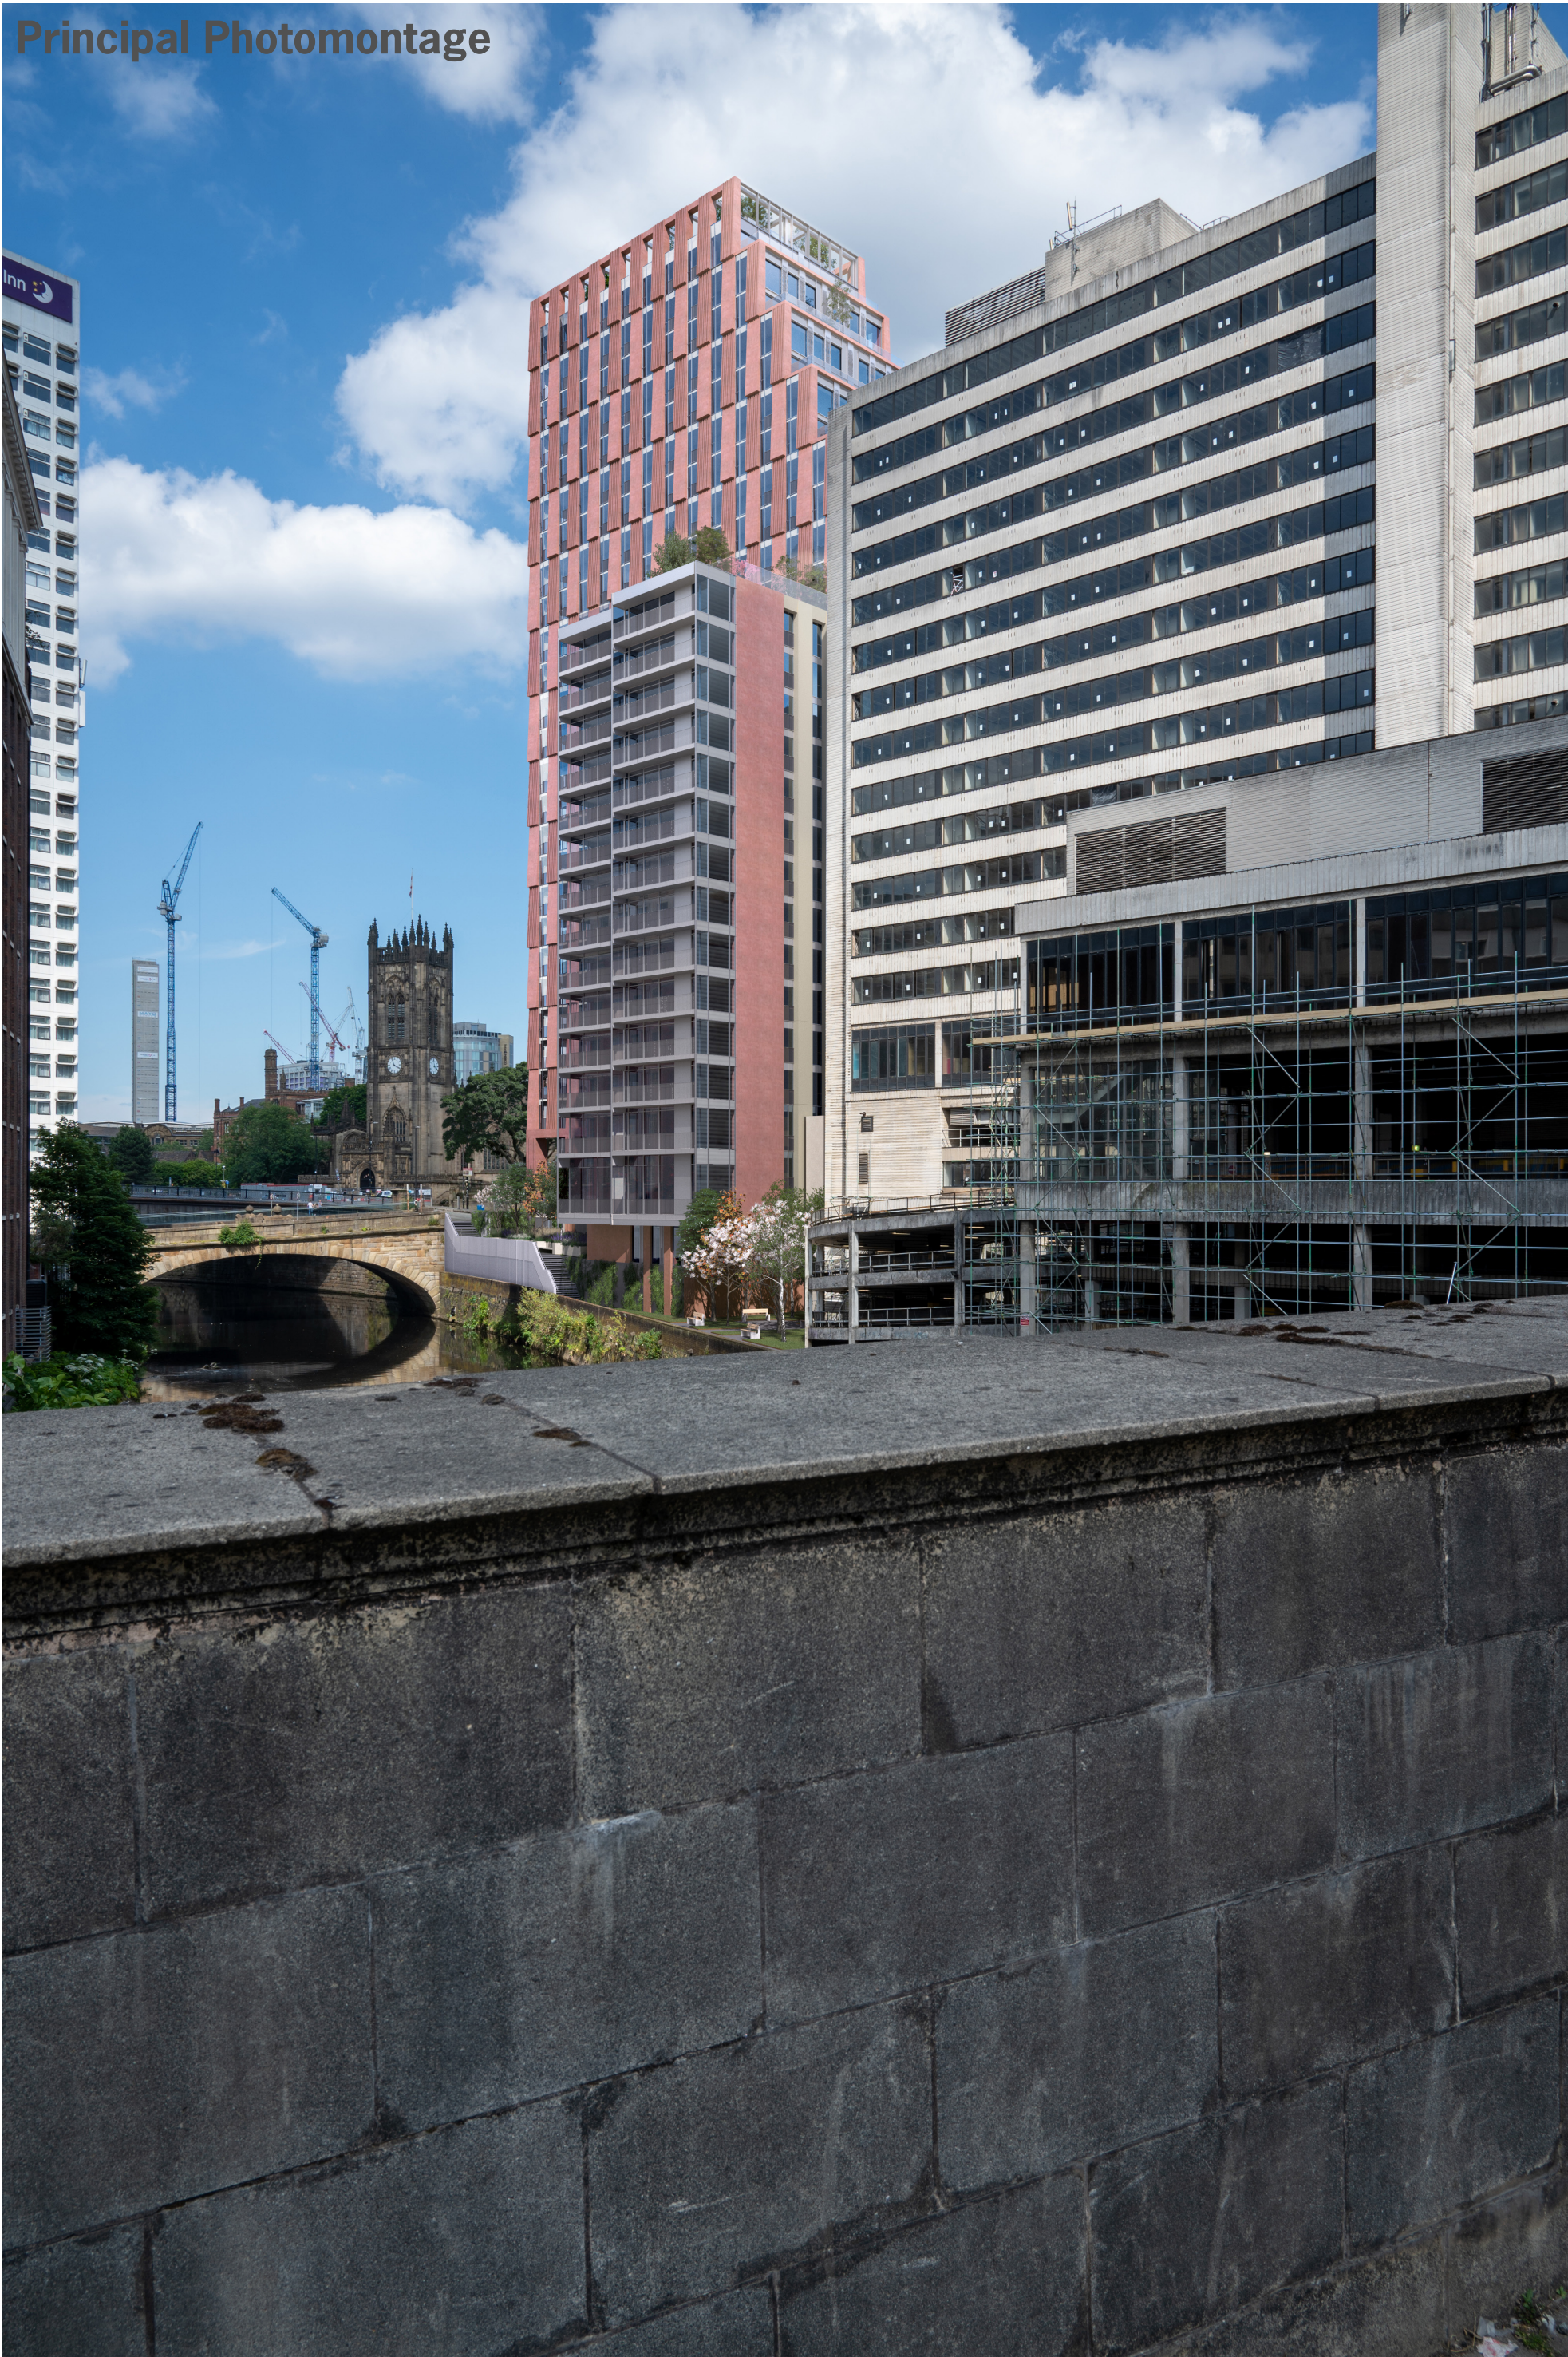
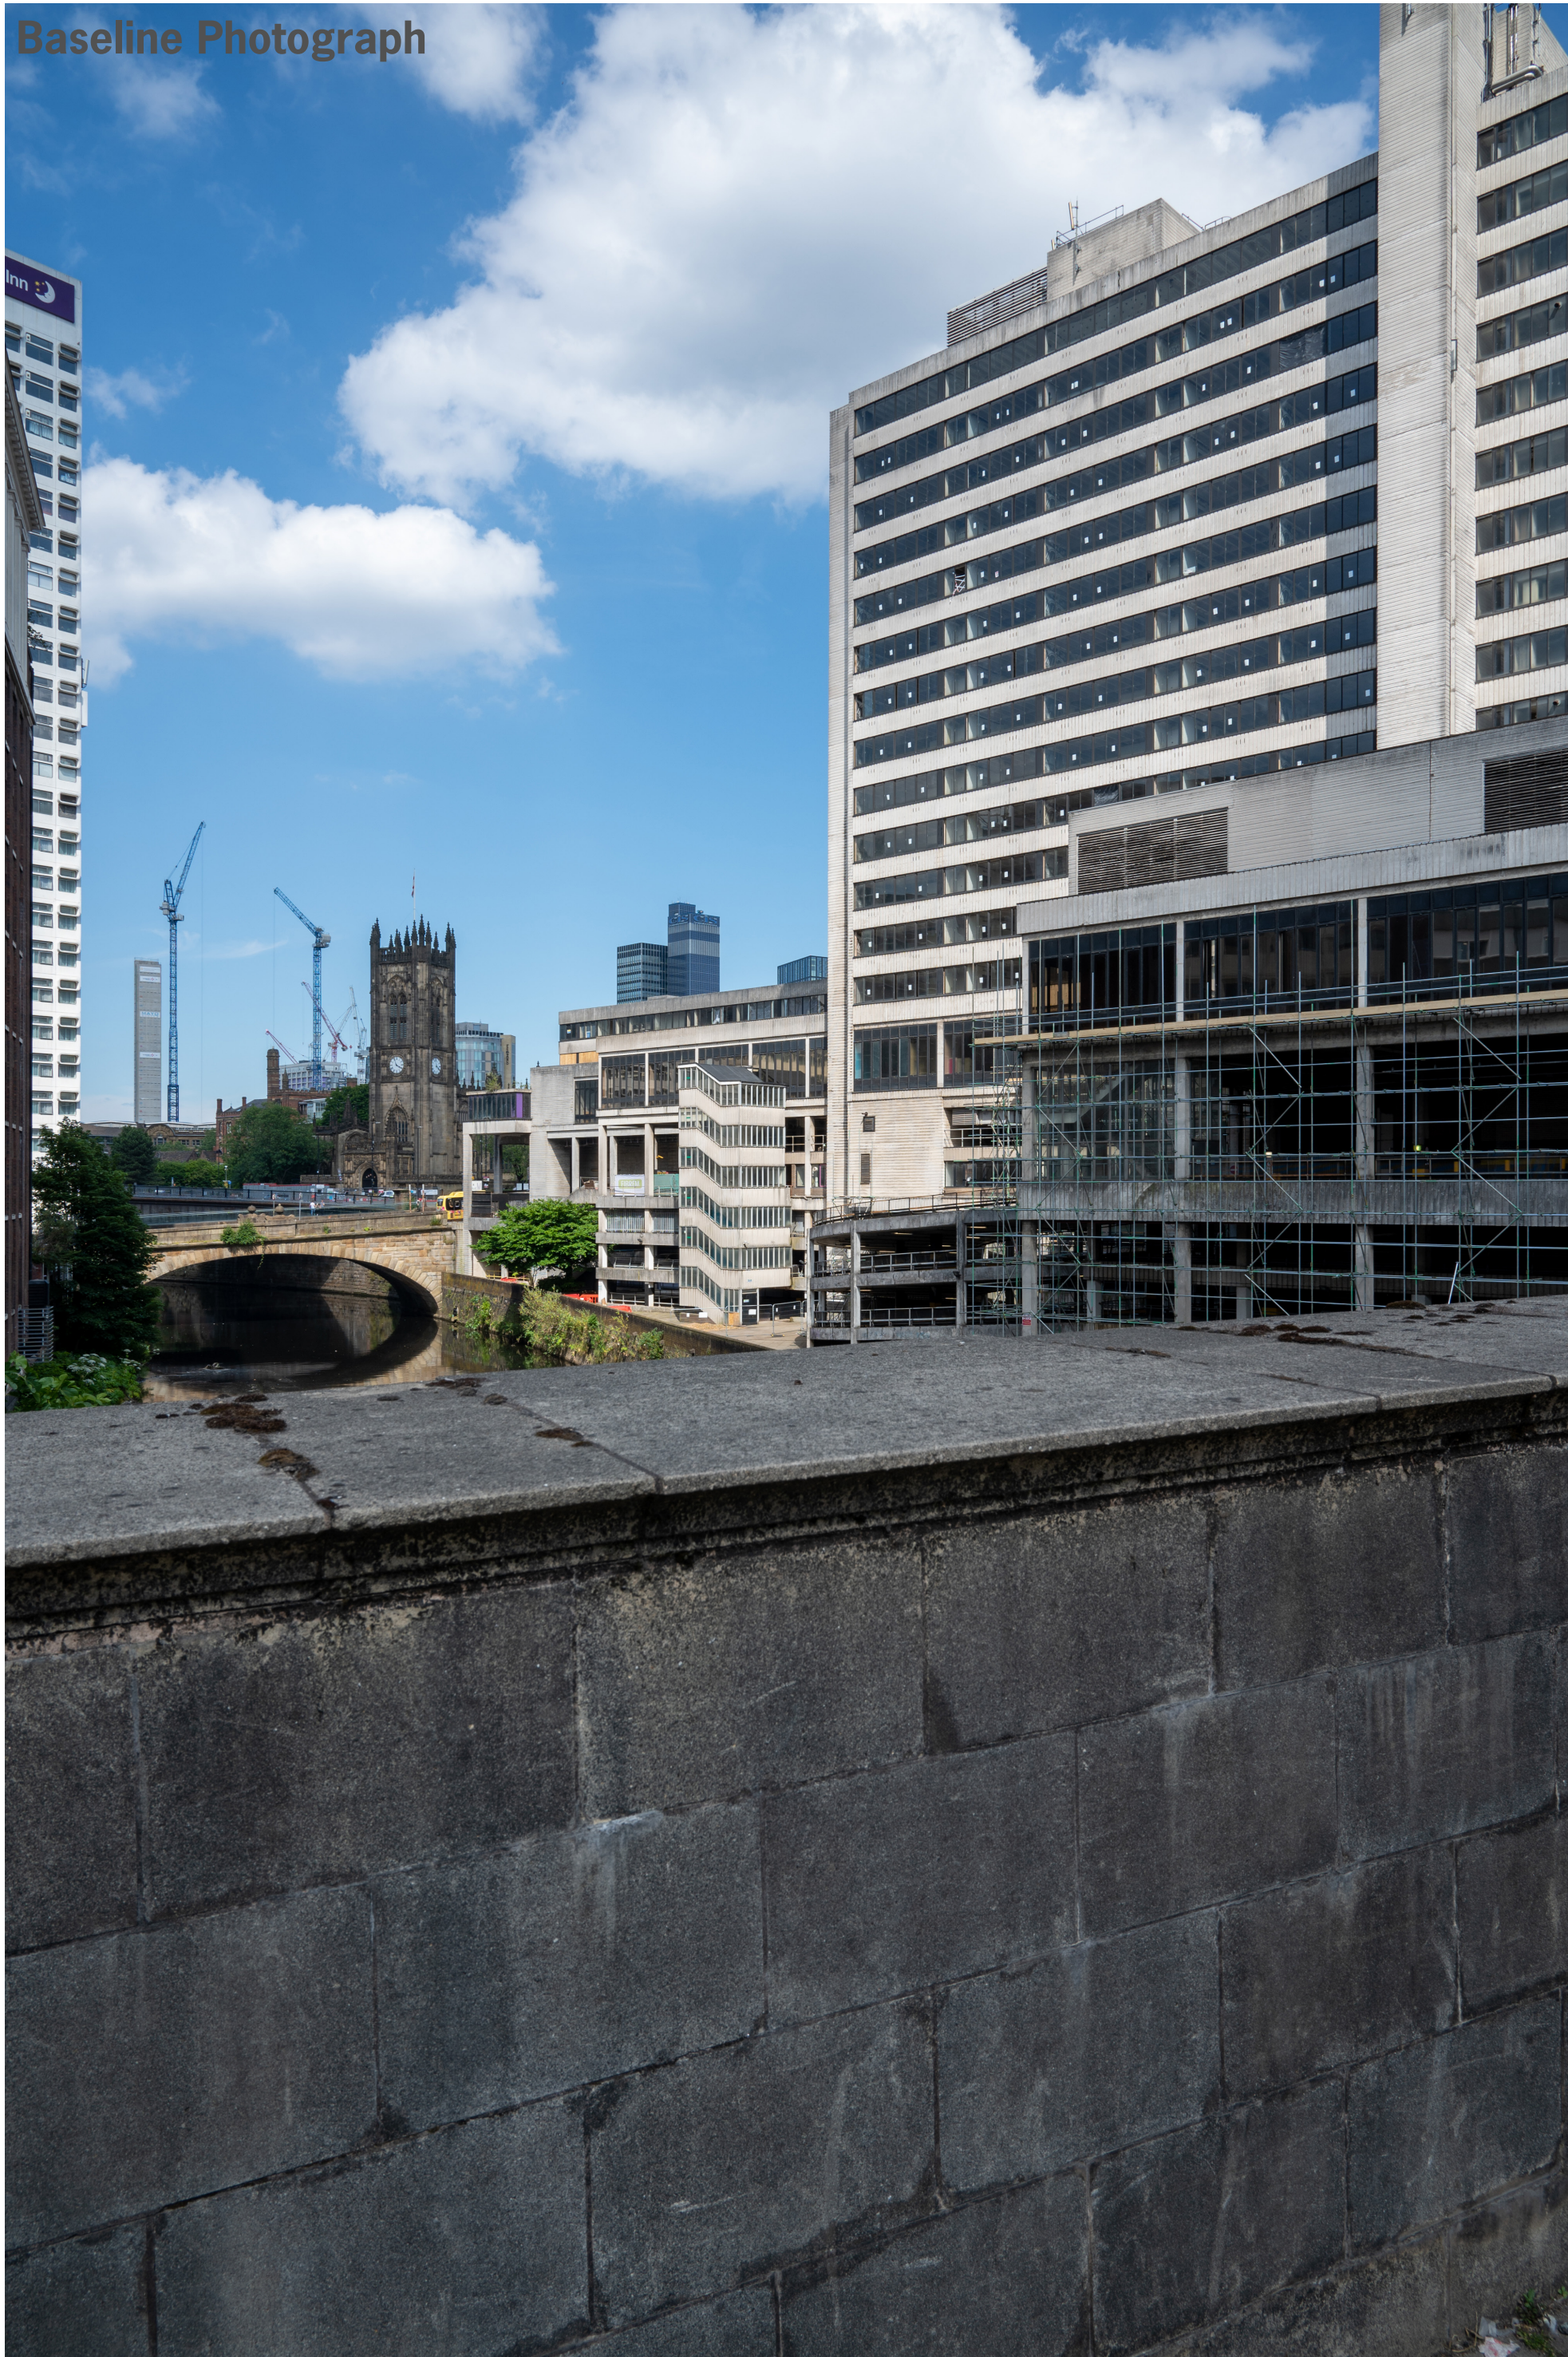
Enlargement 100% at A1 sheet size

**Photo Captured** | 01/07/2021 @ 15:57  
**Camera Location** | E 383643.742, N 398603.583 @ 33.917m AOD  
**Camera's Nodal Point Height From Ground** | 1.599m  
**Direction of View** | 62° from N  
**Distance to Nearest Site Boundary** | 96m  
**Camera Model** | Nikon Z6ii, Full Frame Sensor  
**Camera Lens** | Nikon Nikkor Z S-Line 24mm

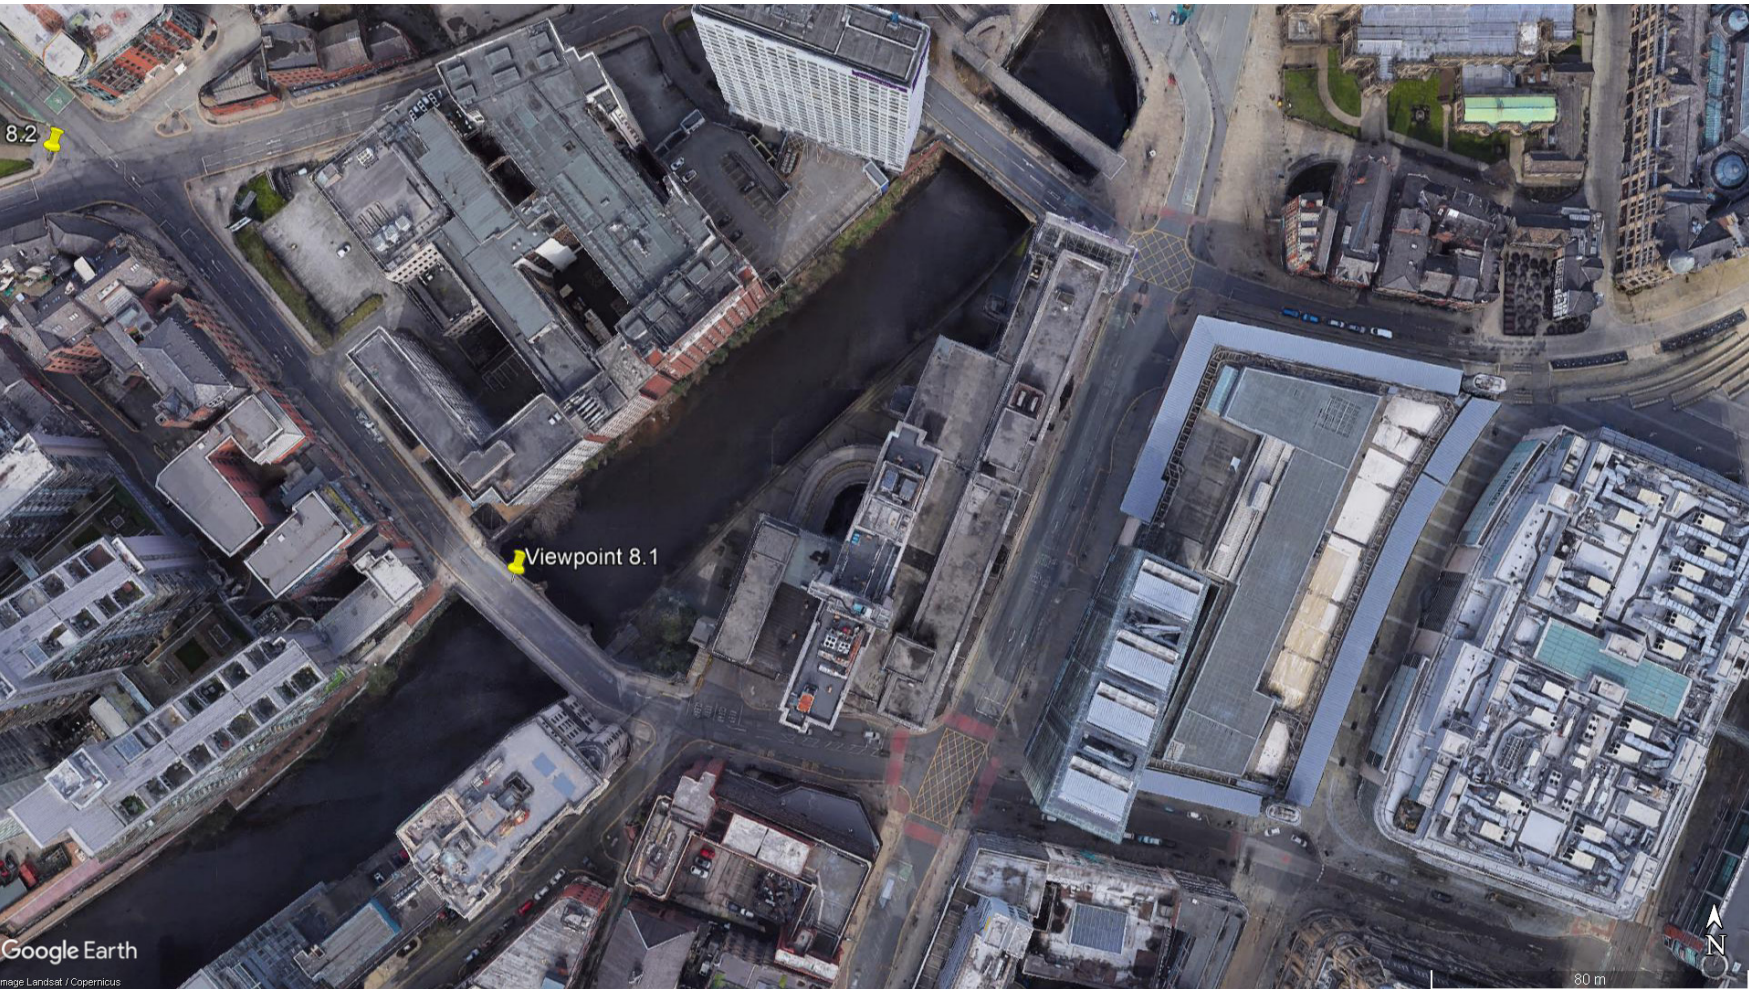
Photo Captured | 01/07/2021 @ 15:57  
Camera Location | E 383643.742, N 398603.583 @ 33.917m AOD  
Camera's Nodal Point Height From Ground | 1.599m  
Direction of View | 62° from N  
Distance to Nearest Site Boundary | 96m  
Camera Model | Nikon Z6ii, Full Frame Sensor  
Camera Lens | Nikon Nikkor Z S-Line 24mm  
Additional Location Info | Camera nodal point centred on the survey nail between paver and kerb as shown in photo.  
Located on Blackfriars St on the bridge overlooking the site.

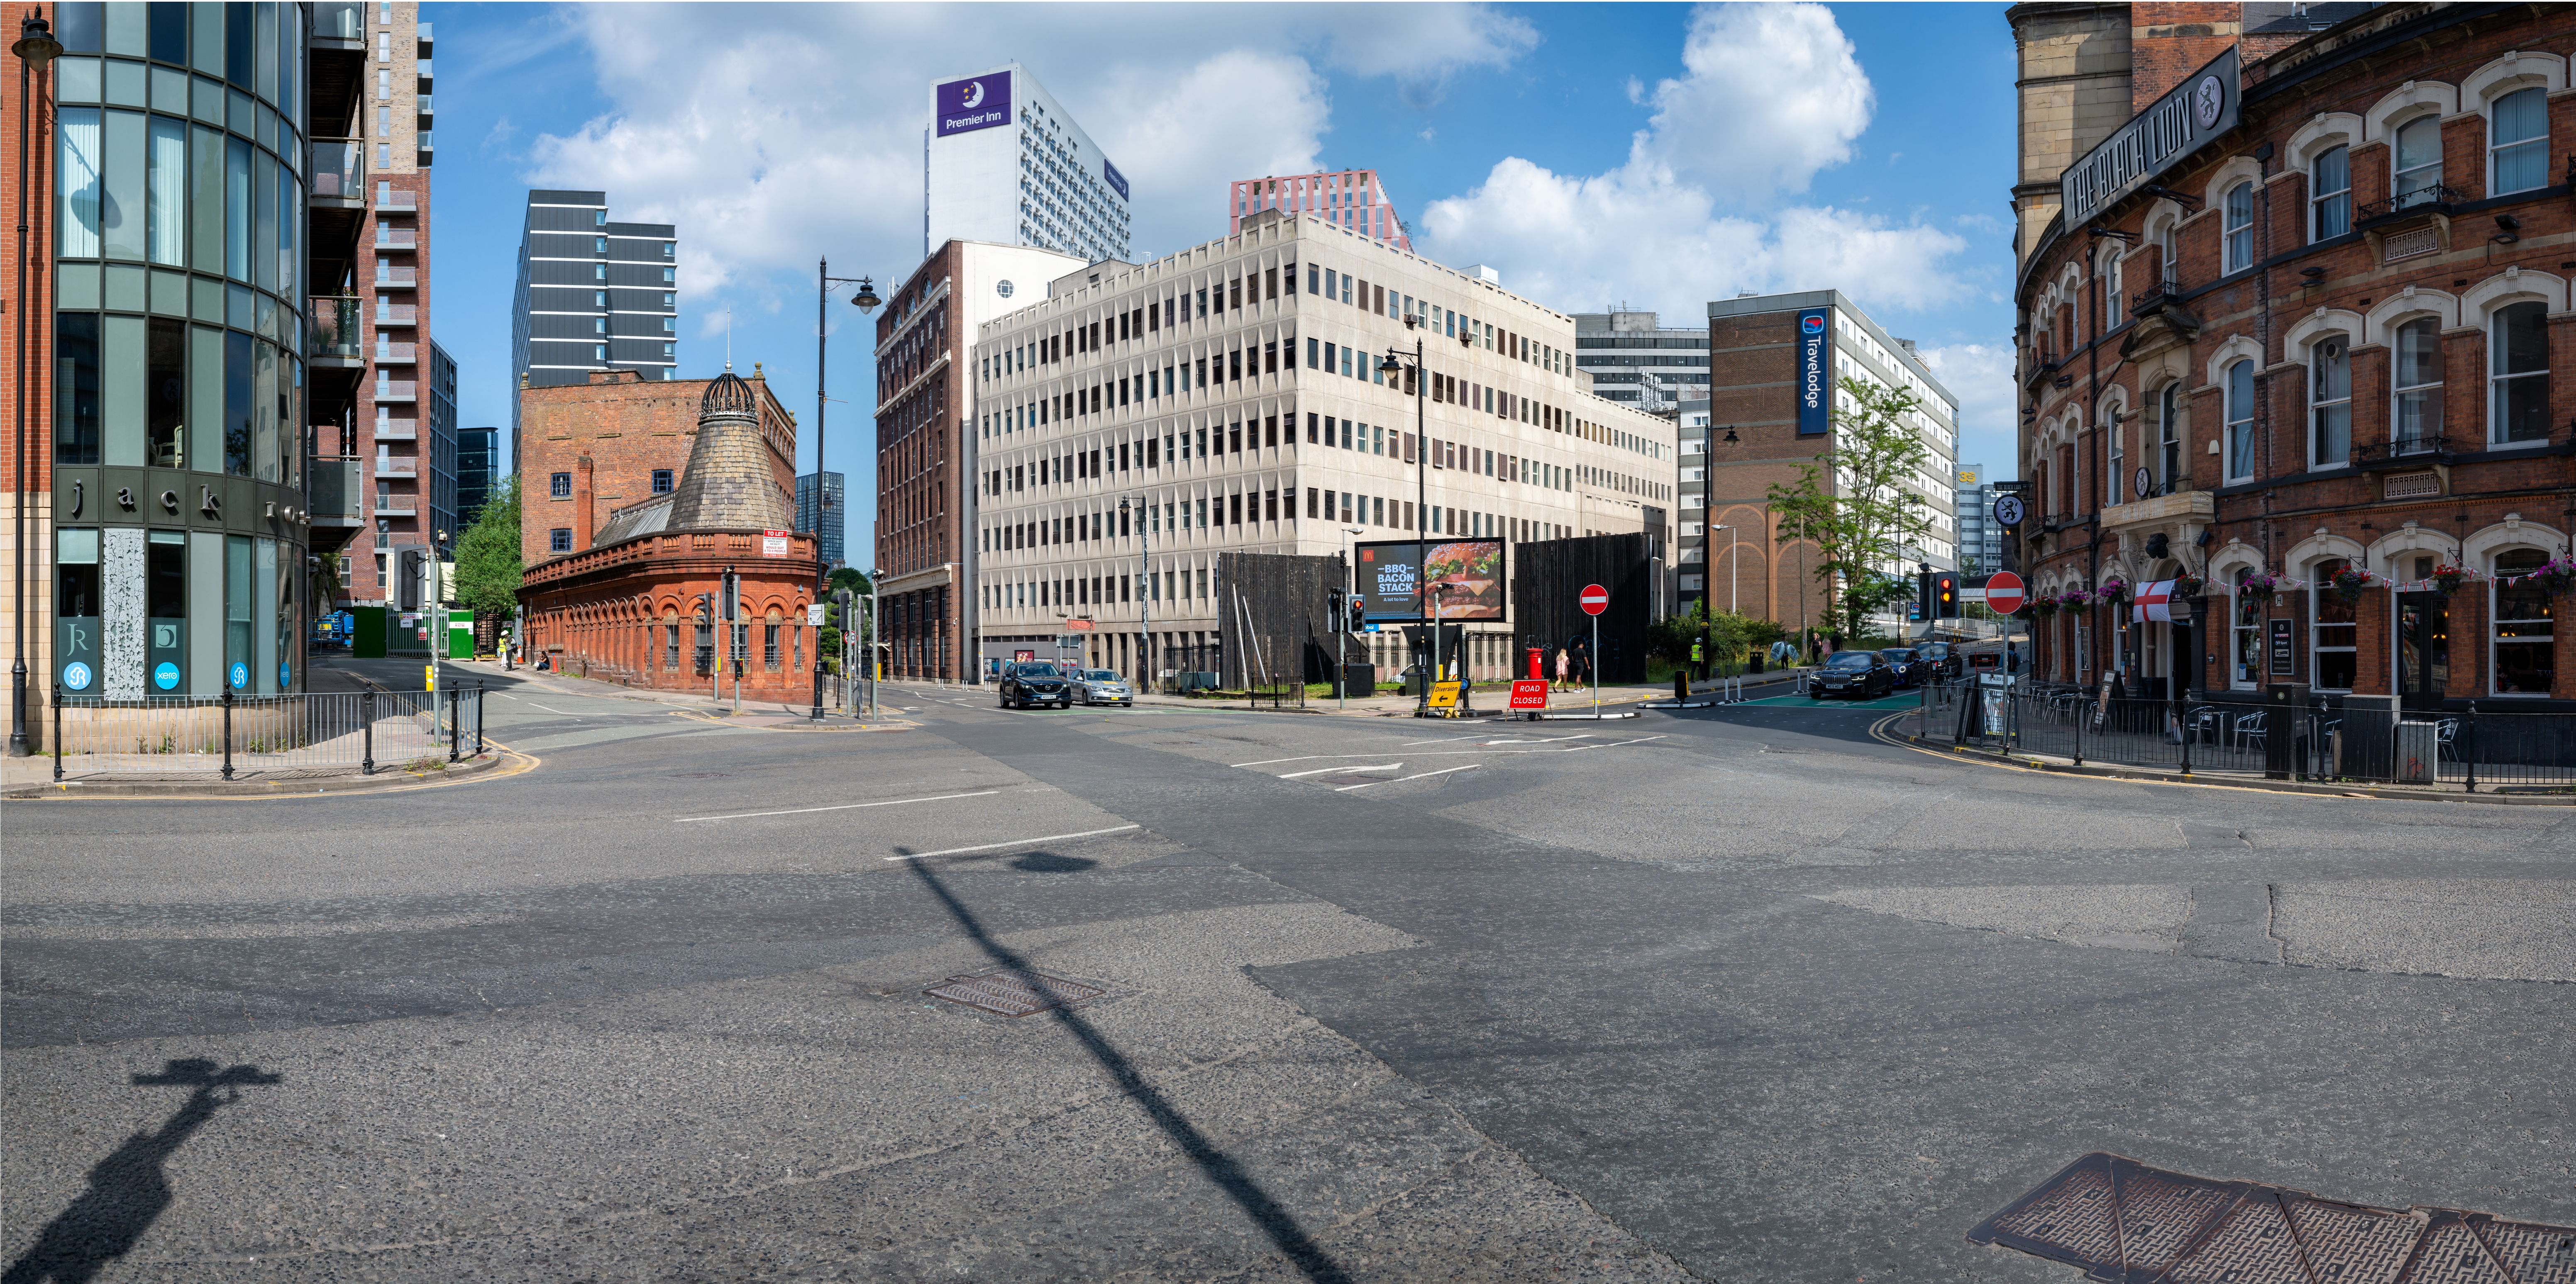
Viewpoint 8.2 - Cylindrical Projection Panorama | Type 4 | AVR Level 3

HFOV 108.1°

Photo Captured | 01/07/2021 @ 16:37  
Camera Location | E 383525.452, N 398712.89 @ 29.468m AOD  
Camera's Nodal Point Height From Ground | 1.603m  
Direction of View | 100° from N  
Distance to Nearest Site Boundary | 221m  
Camera Model | Nikon Z6ii, Full Frame Sensor  
Camera Lens | Nikon Nikkor Z S-Line 35mm

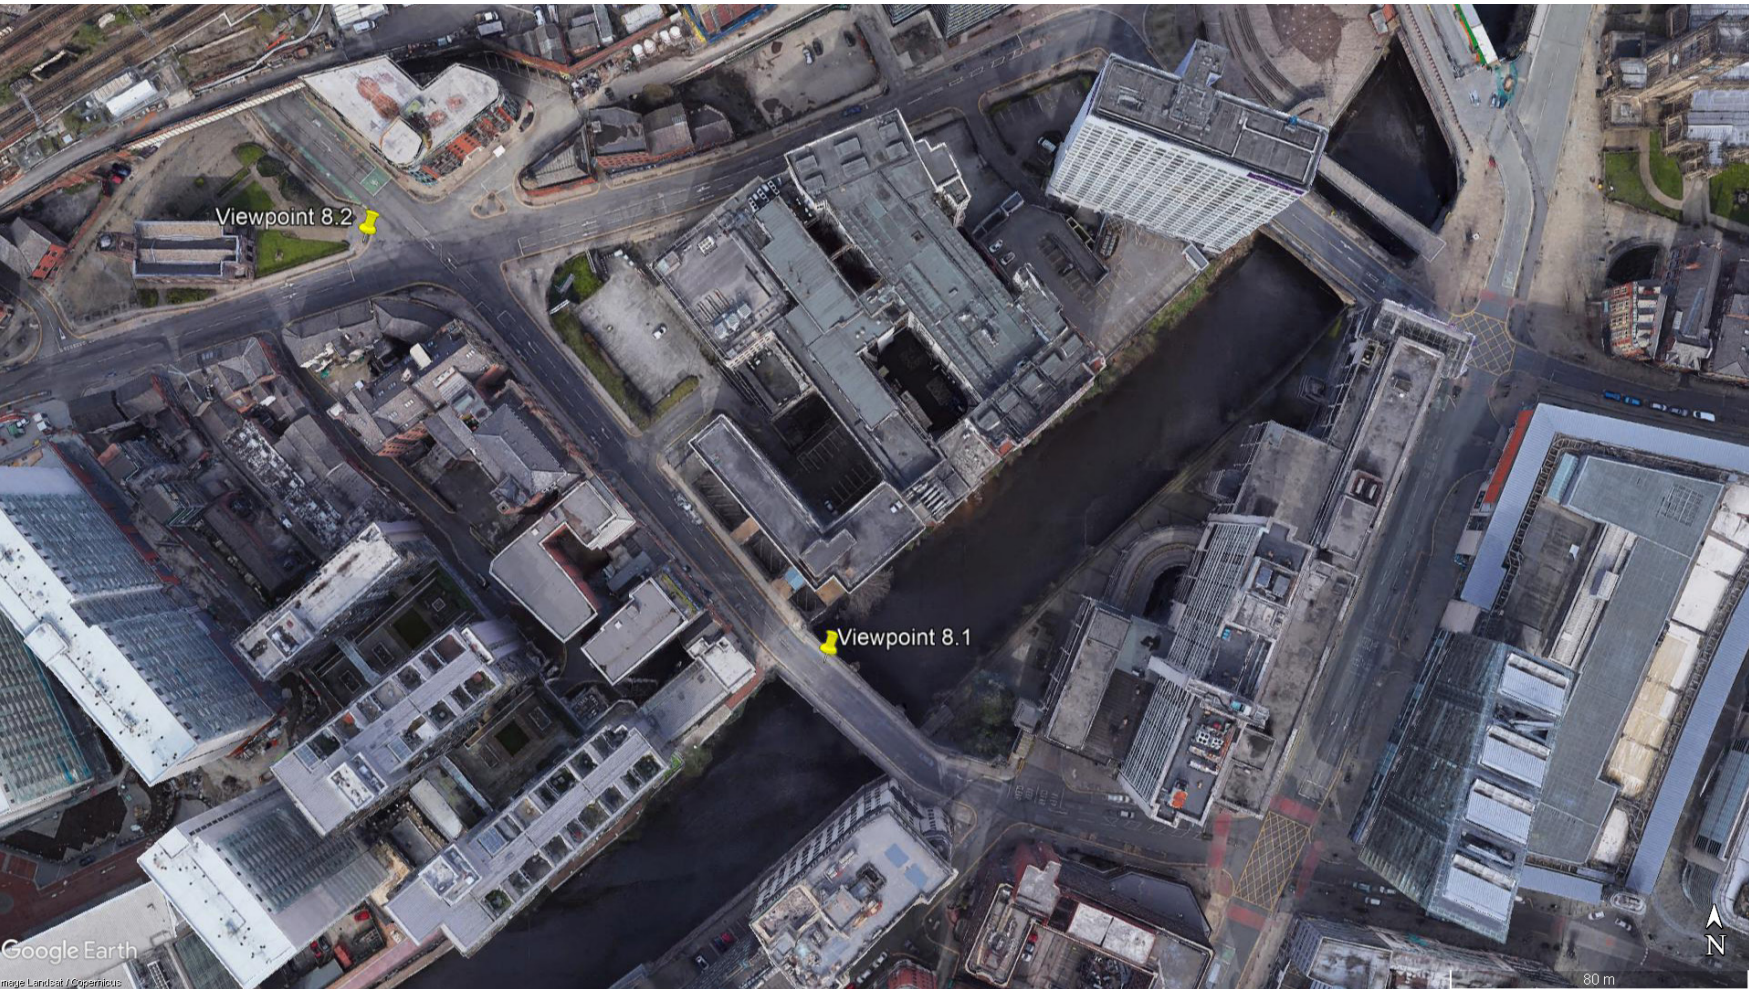
Photo Captured | 01/07/2021 @ 16:37  
Camera Location | E 383525.452, N 398712.89 @ 29.468m AOD  
Camera's Nodal Point Height From Ground | 1.603m  
Direction of View | 100° from N  
Distance to Nearest Site Boundary | 221m  
Camera Model | Nikon Z6ii, Full Frame Sensor  
Camera Lens | Nikon Nikkor Z S-Line 35mm  
Additional Location Info | Camera nodal point centred on the survey nail in block pavers next to the railings.  
Located by the road crossings outside the entrance to Sacred Trinity Church.

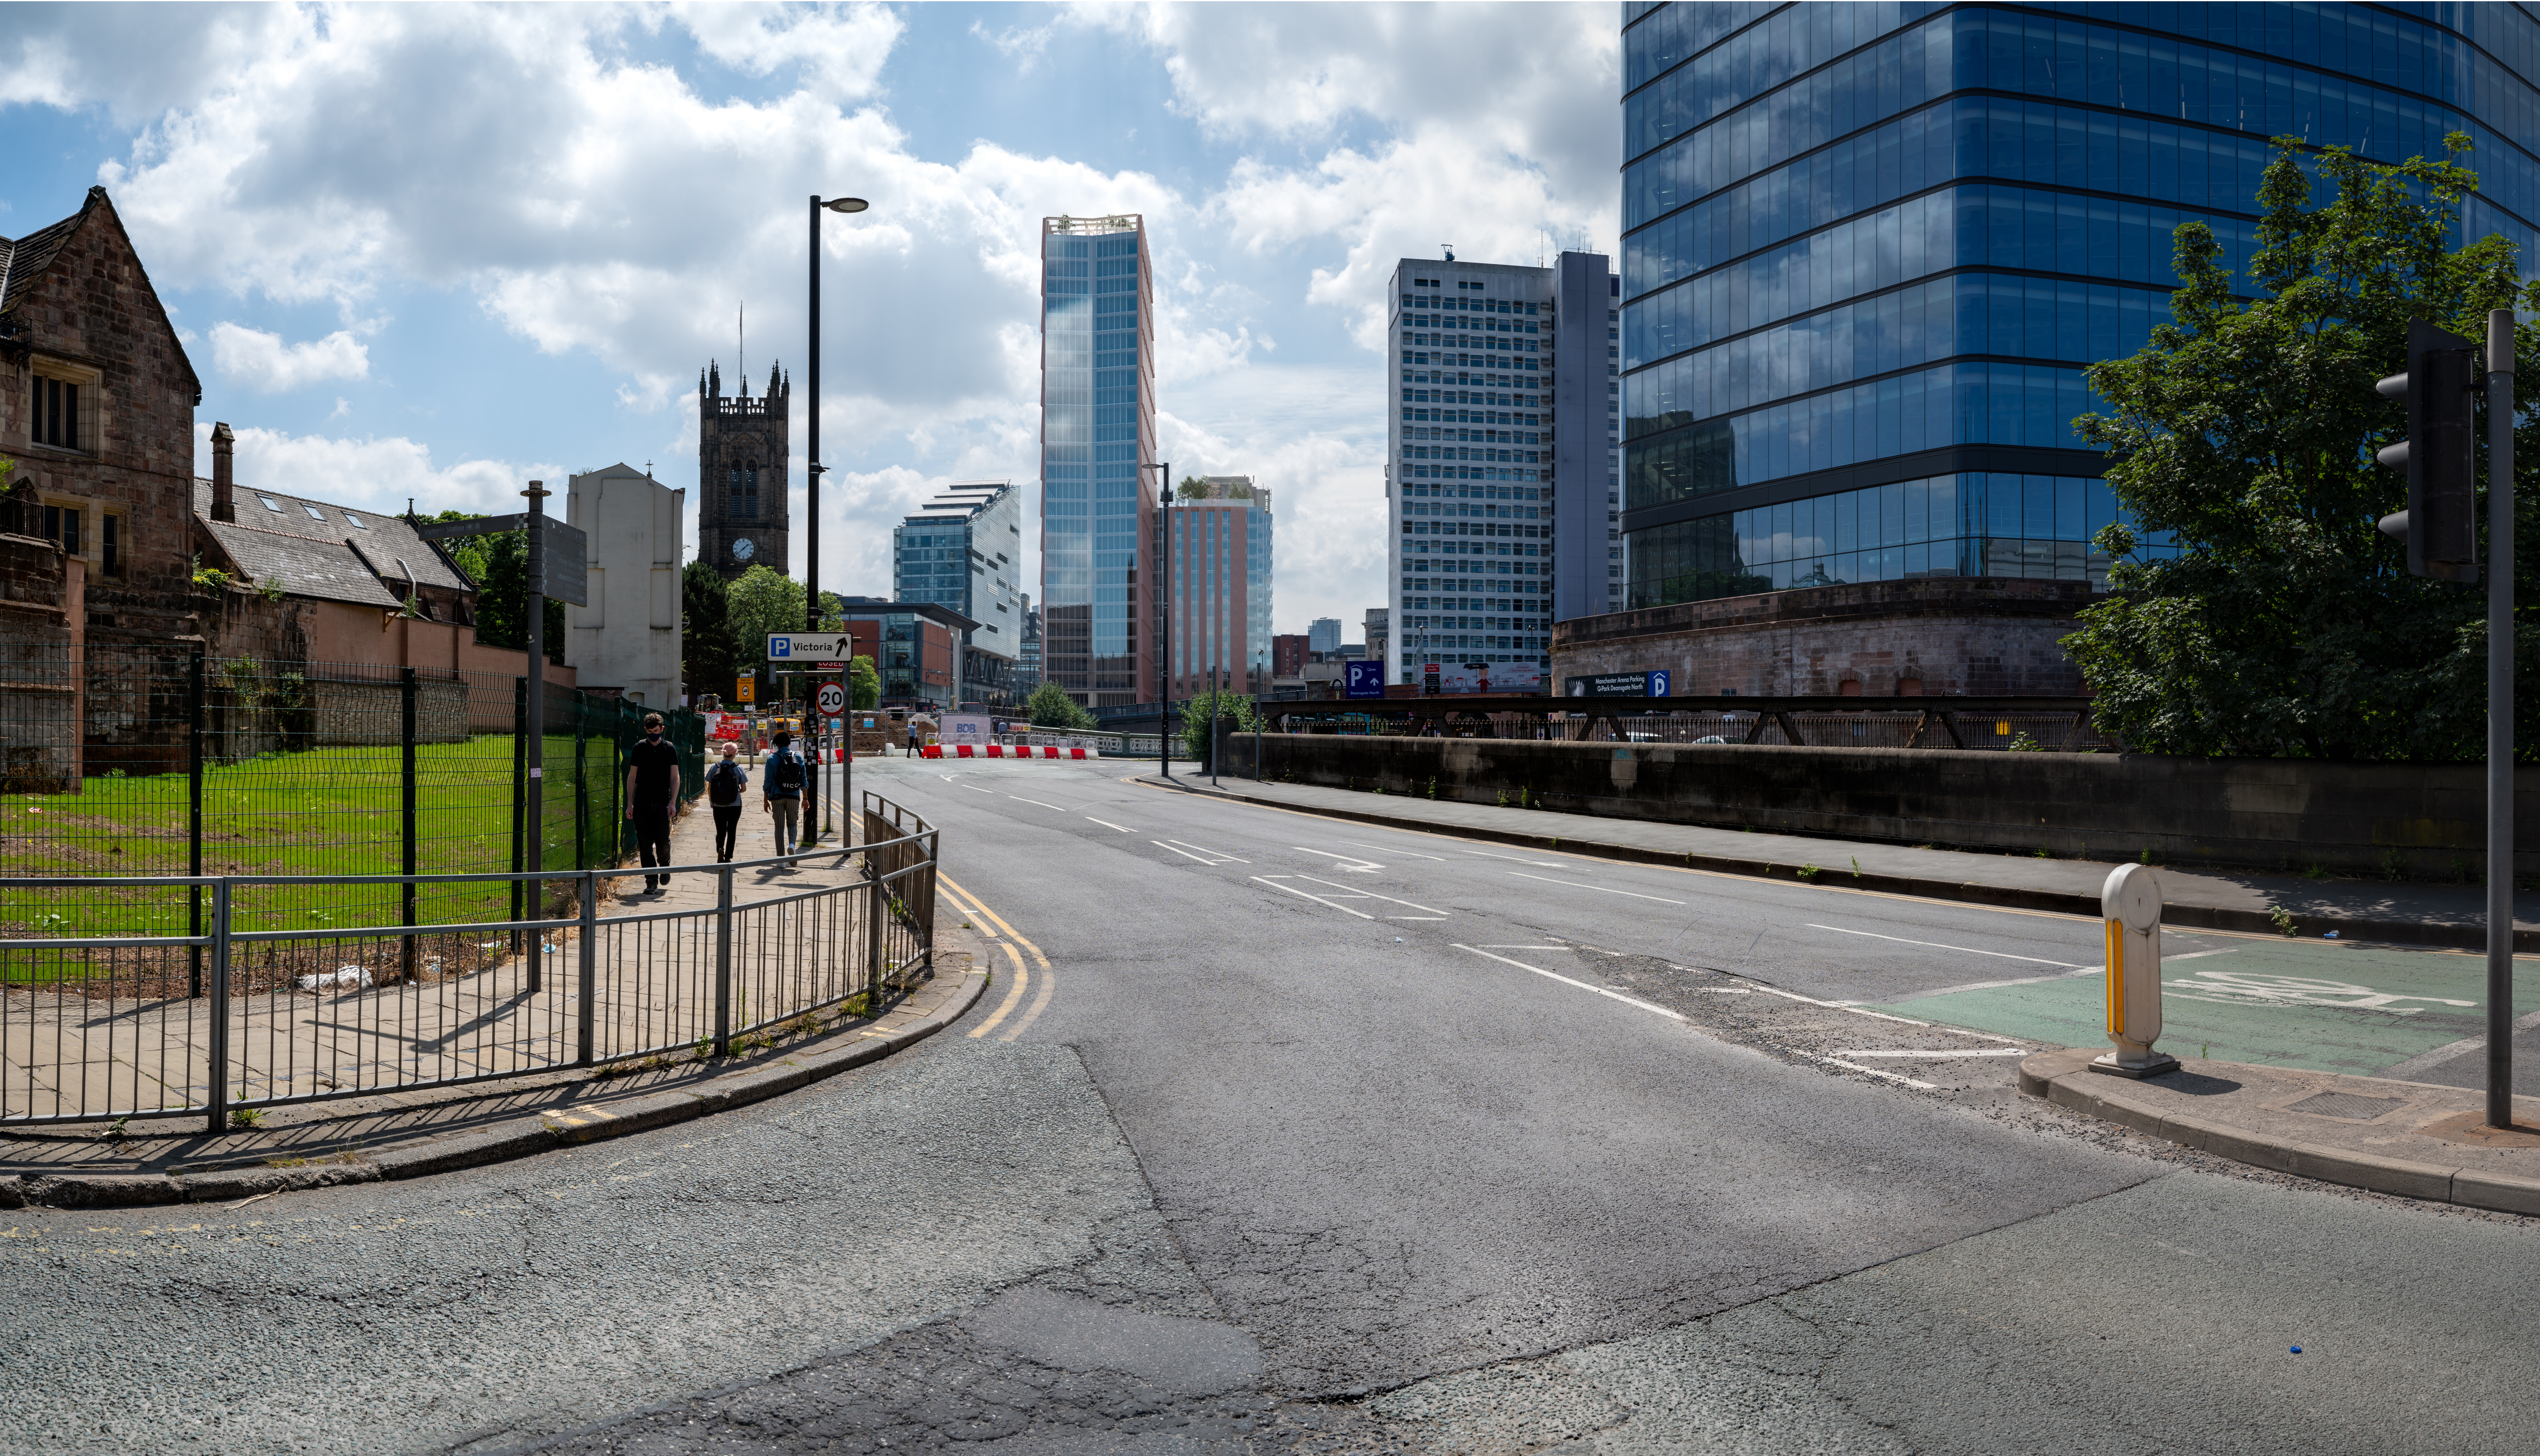
HFOV 94.2°

**Photo Captured** | 01/07/2021 @ 13:38  
**Camera Location** | E 383862.721, N 398930.913 @ 30.321m AOD  
**Camera's Nodal Point Height From Ground** | 1.603m  
**Direction of View** | 196° from N  
**Distance to Nearest Site Boundary** | 250m  
**Camera Model** | Nikon Z6ii, Full Frame Sensor  
**Camera Lens** | Nikon Nikkor Z S-Line 35mm
