# Verified View Methodology

Type 4 | AVR Level 0, 1 & 3

This document has been prepared to explain the process of generating verified views (also referred to as accurate visual representations (AVR)) for the proposed development at Renaissance Hotel, Manchester.

Renaissance Hotel, Manchester  
Verified Views  
October 2021 v1.0 DRAFT

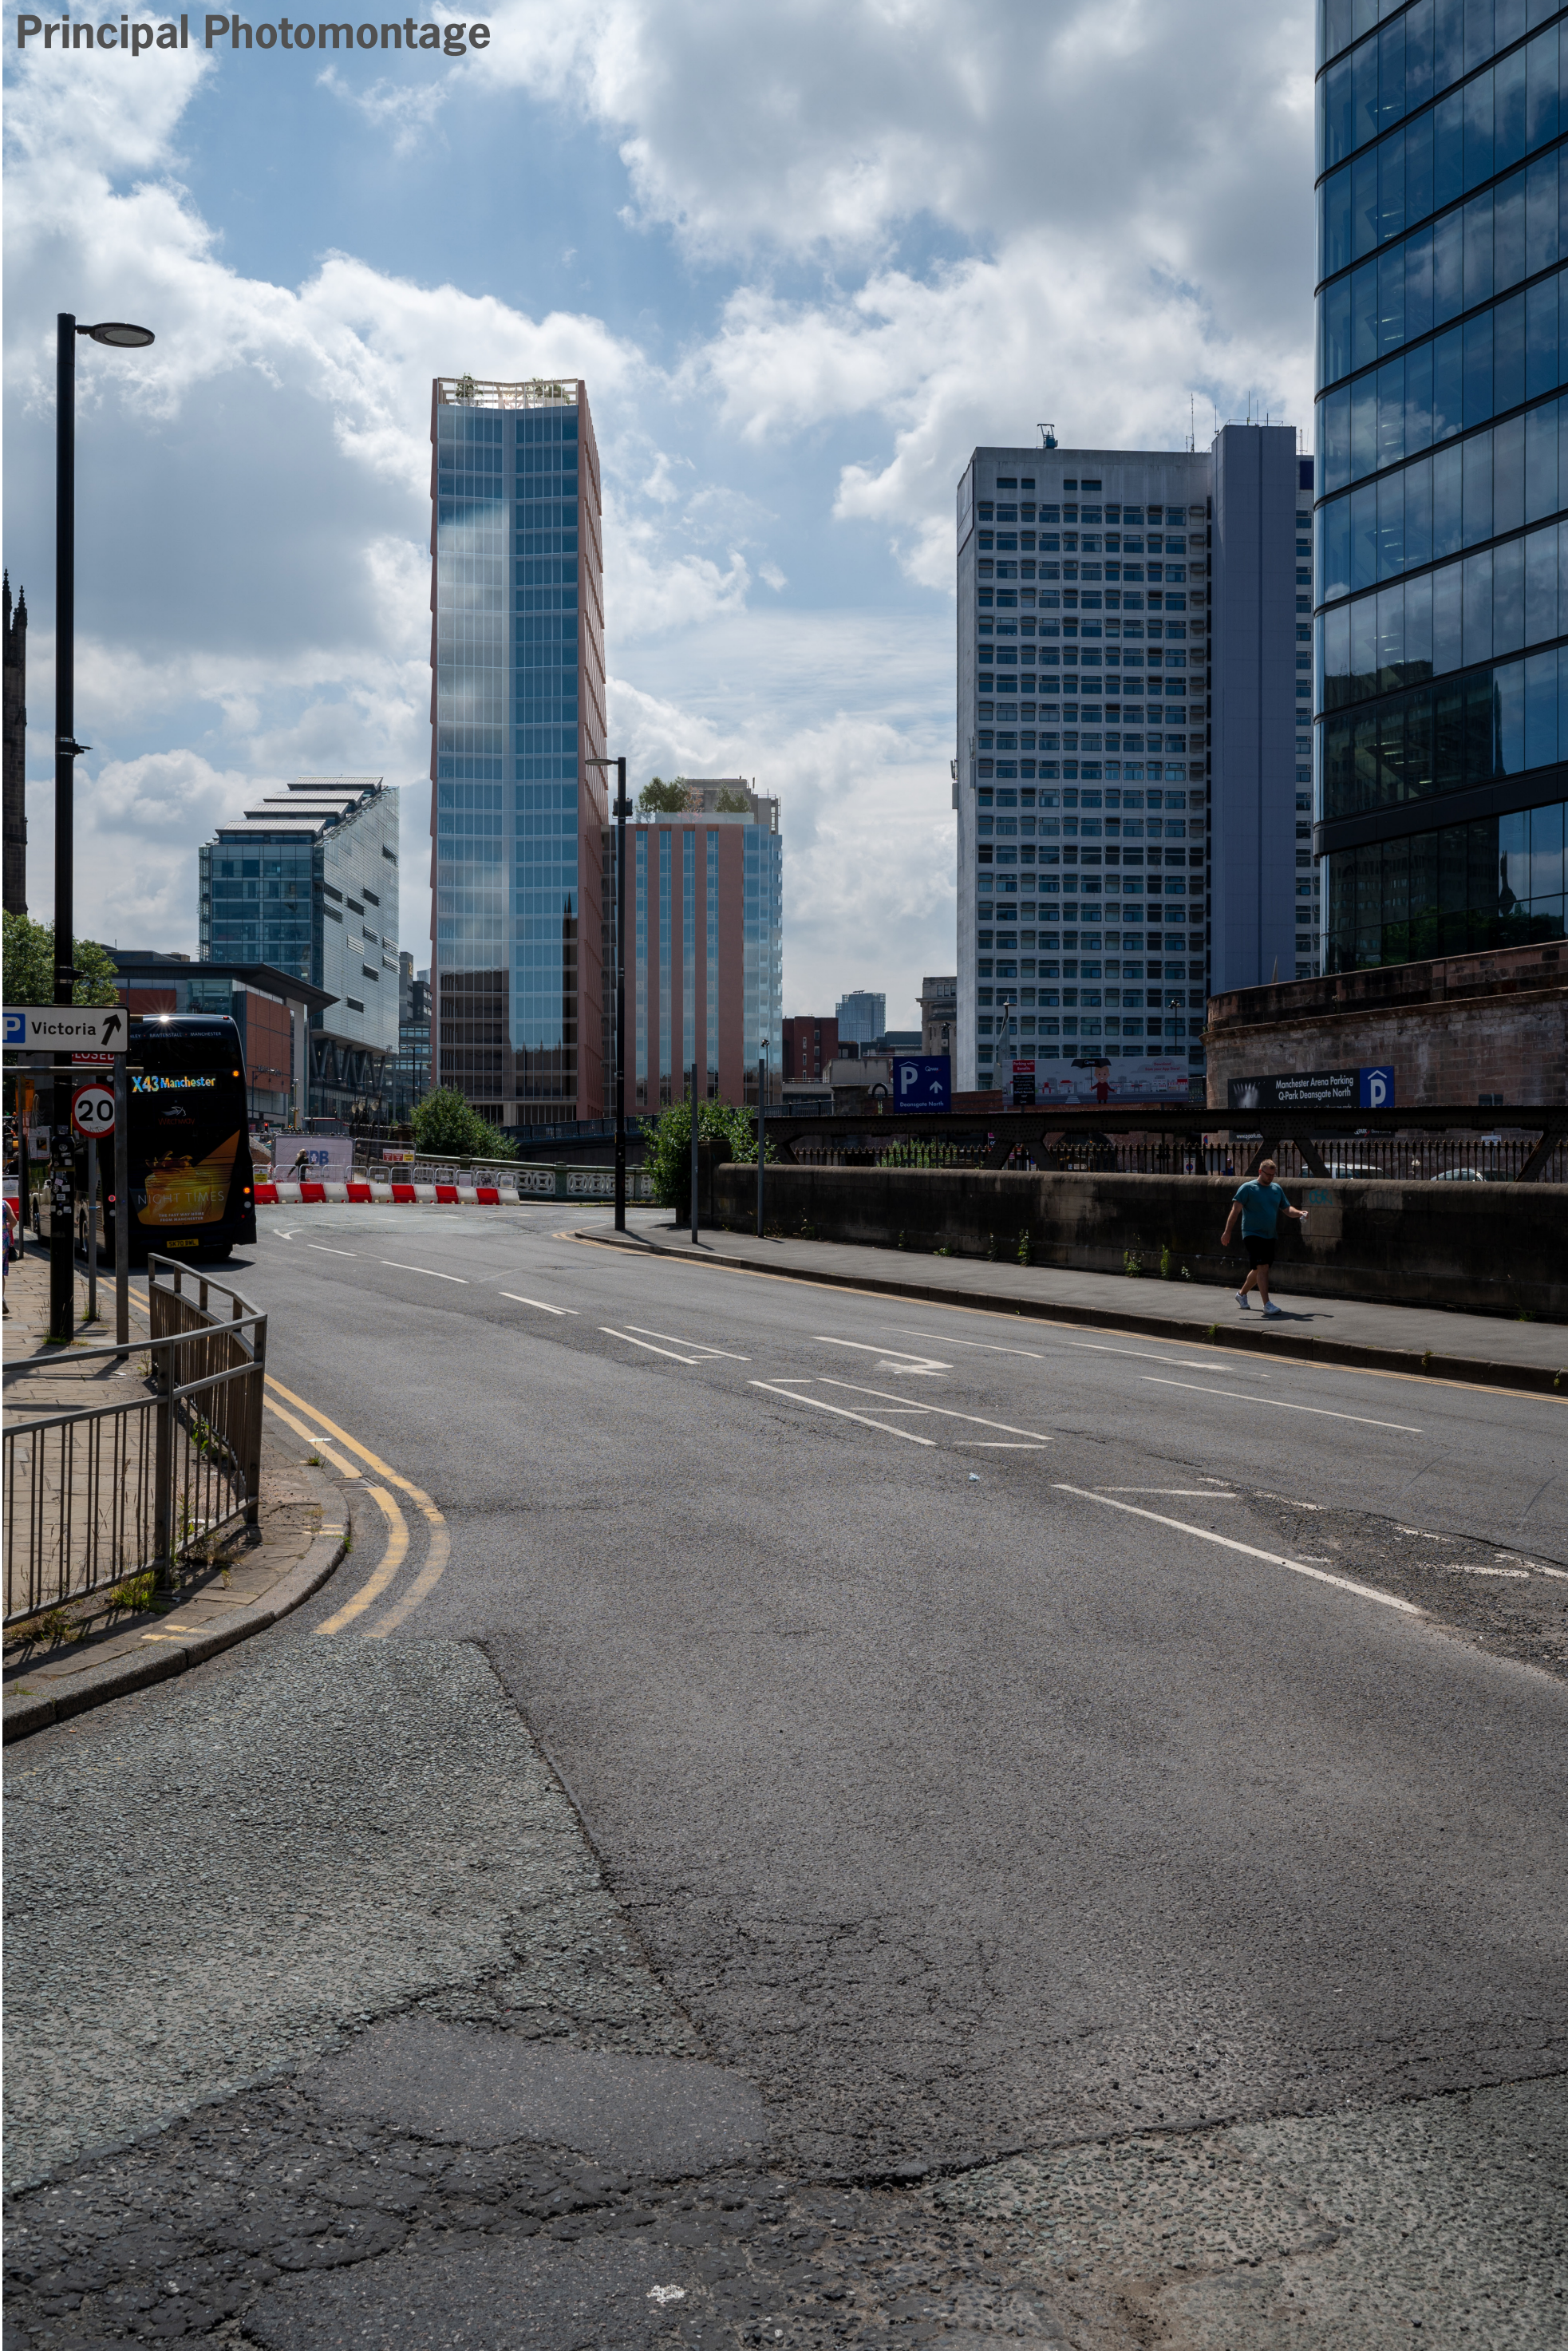
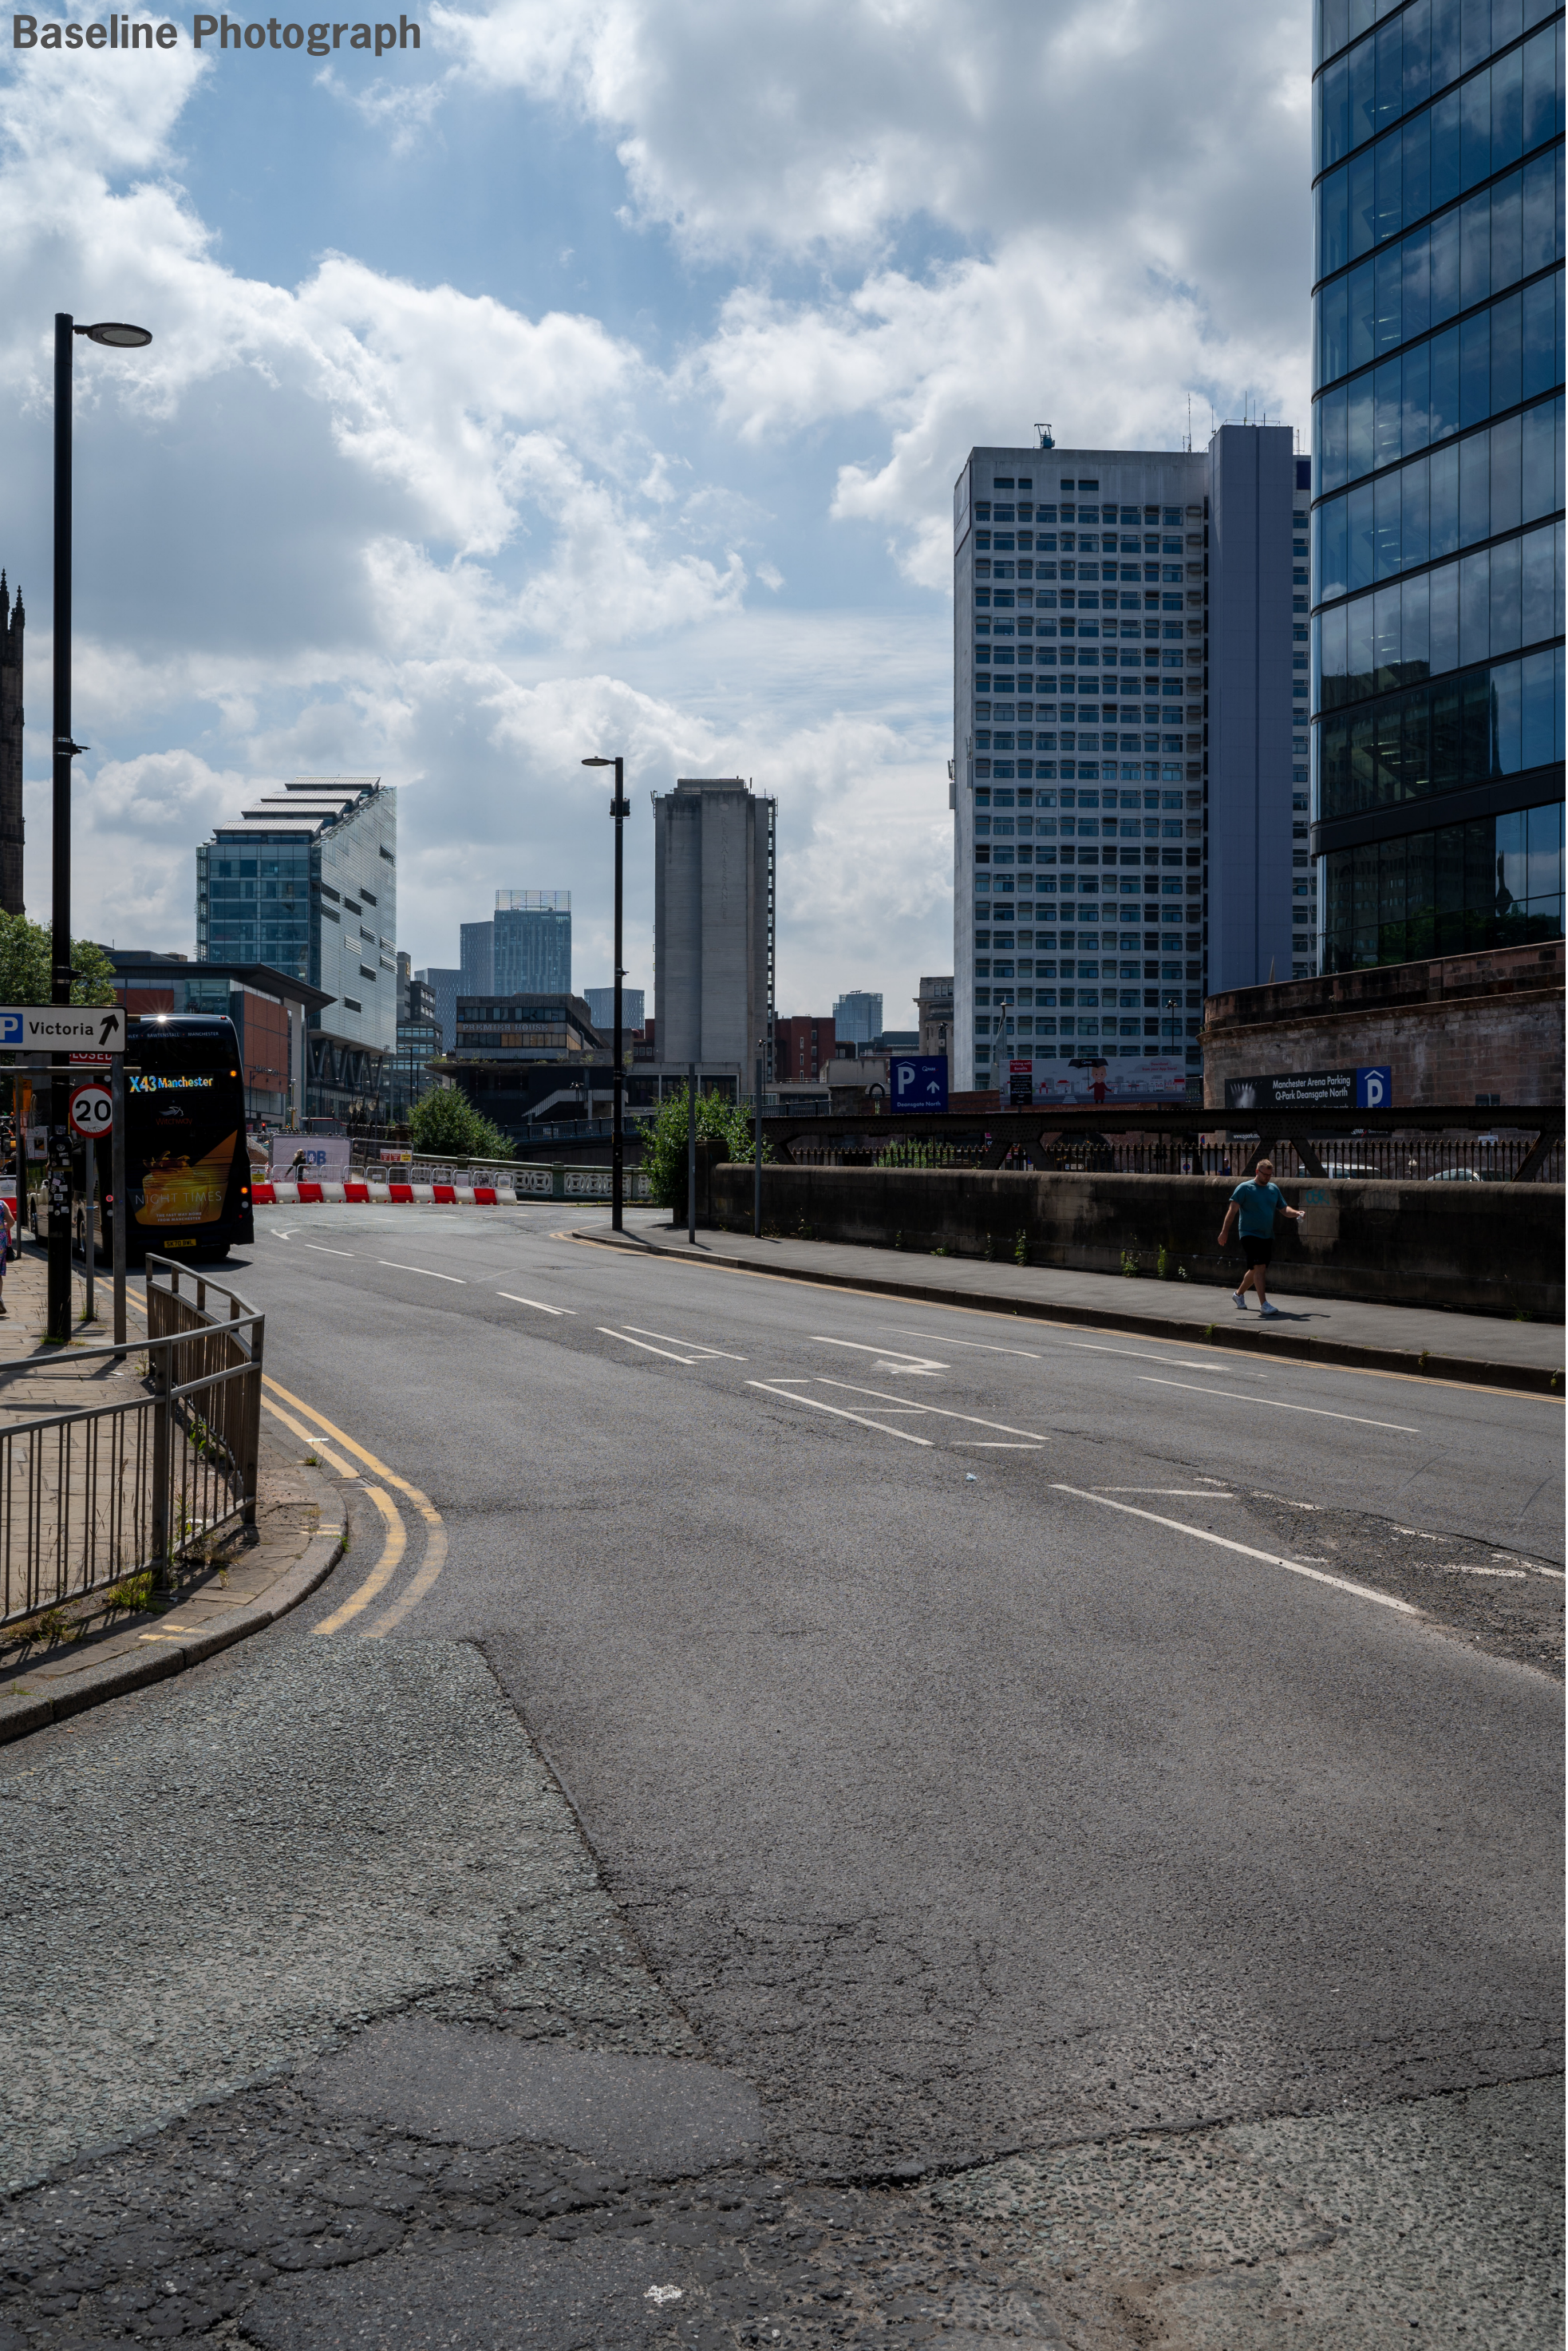
Enlargement 100% at A1 sheet size

**Photo Captured** | 01/07/2021 @ 13:38  
**Camera Location** | E 383862.721, N 398930.913 @ 30.321m AOD  
**Camera's Nodal Point Height From Ground** | 1.603m  
**Direction of View** | 196° from N  
**Distance to Nearest Site Boundary** | 250m  
**Camera Model** | Nikon Z6ii, Full Frame Sensor  
**Camera Lens** | Nikon Nikkor Z S-Line 35mm

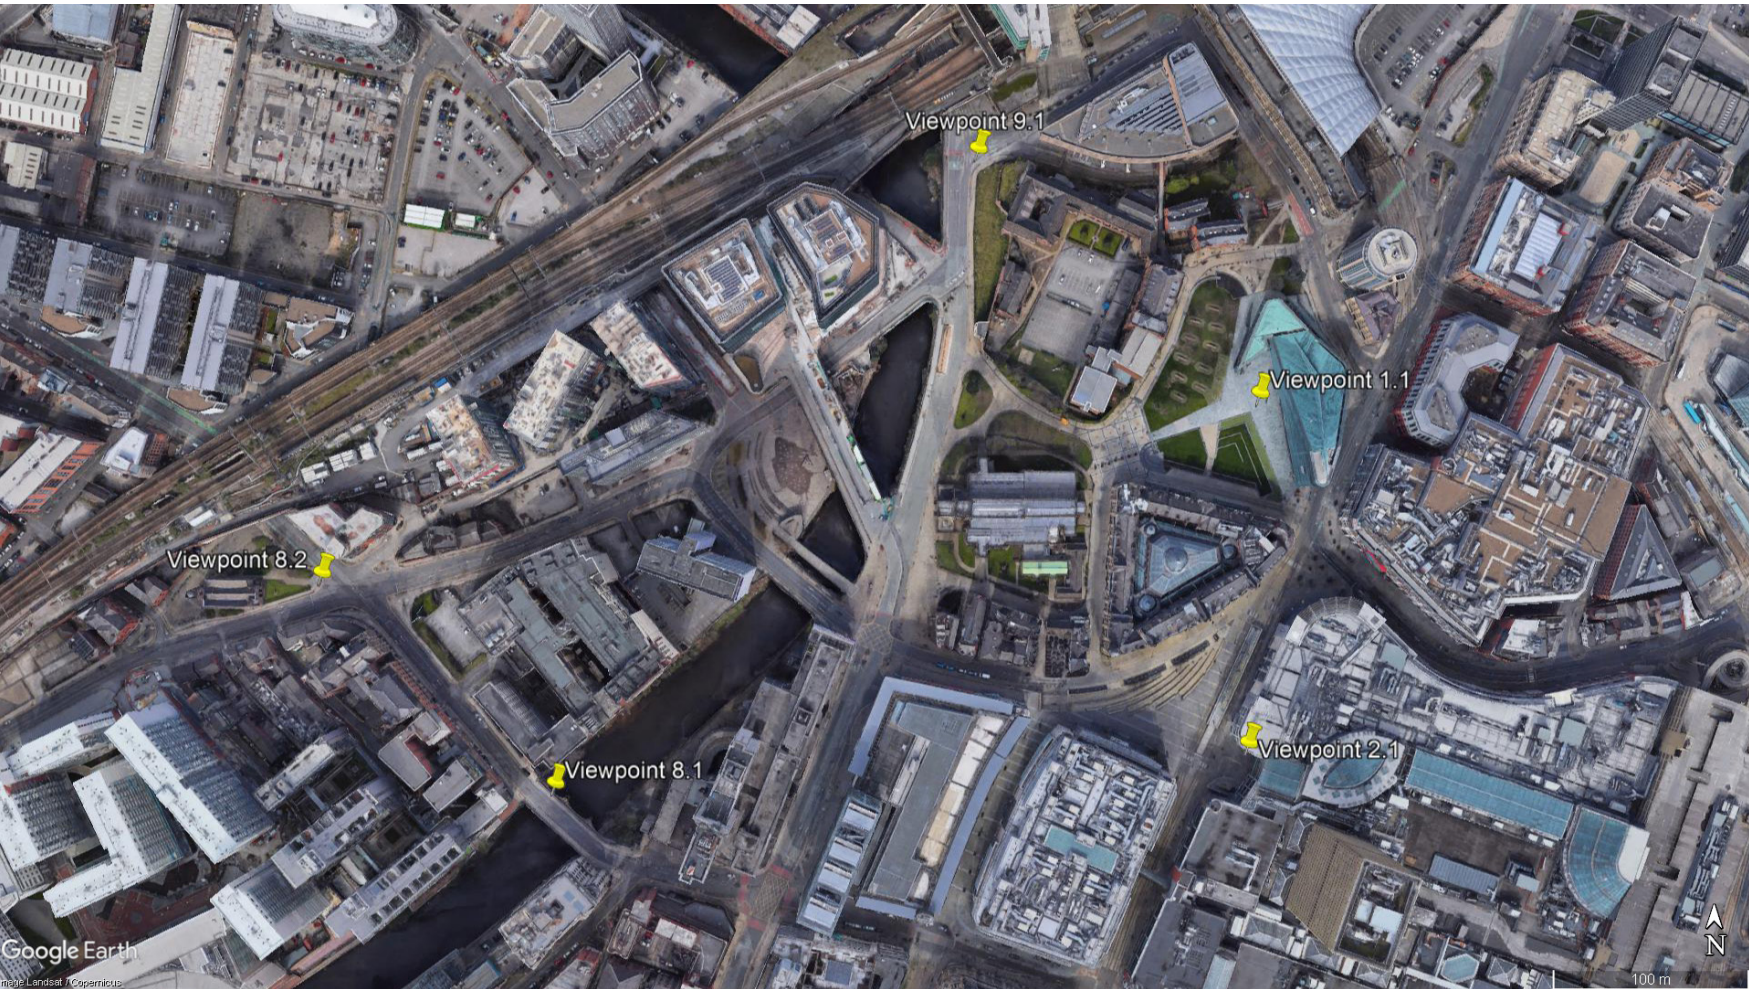
Camera Location

**Photo Captured** | 01/07/2021 @ 13:38  
**Camera Location** | E 383862.721, N 398930.913 @ 30.321m AOD  
**Camera's Nodal Point Height From Ground** | 1.603m  
**Direction of View** | 196° from N  
**Distance to Nearest Site Boundary** | 250m  
**Camera Model** | Nikon Z6ii, Full Frame Sensor  
**Camera Lens** | Nikon Nikkor Z S-Line 35mm  
**Additional Location Info** | Camera nodal point centred on the corner of the of the drain cover identified by yellow paint as shown in photo.  
Located on the traffic island on the junction of Hunts Bnk and Victoria St, adjacent to the tactile paving.

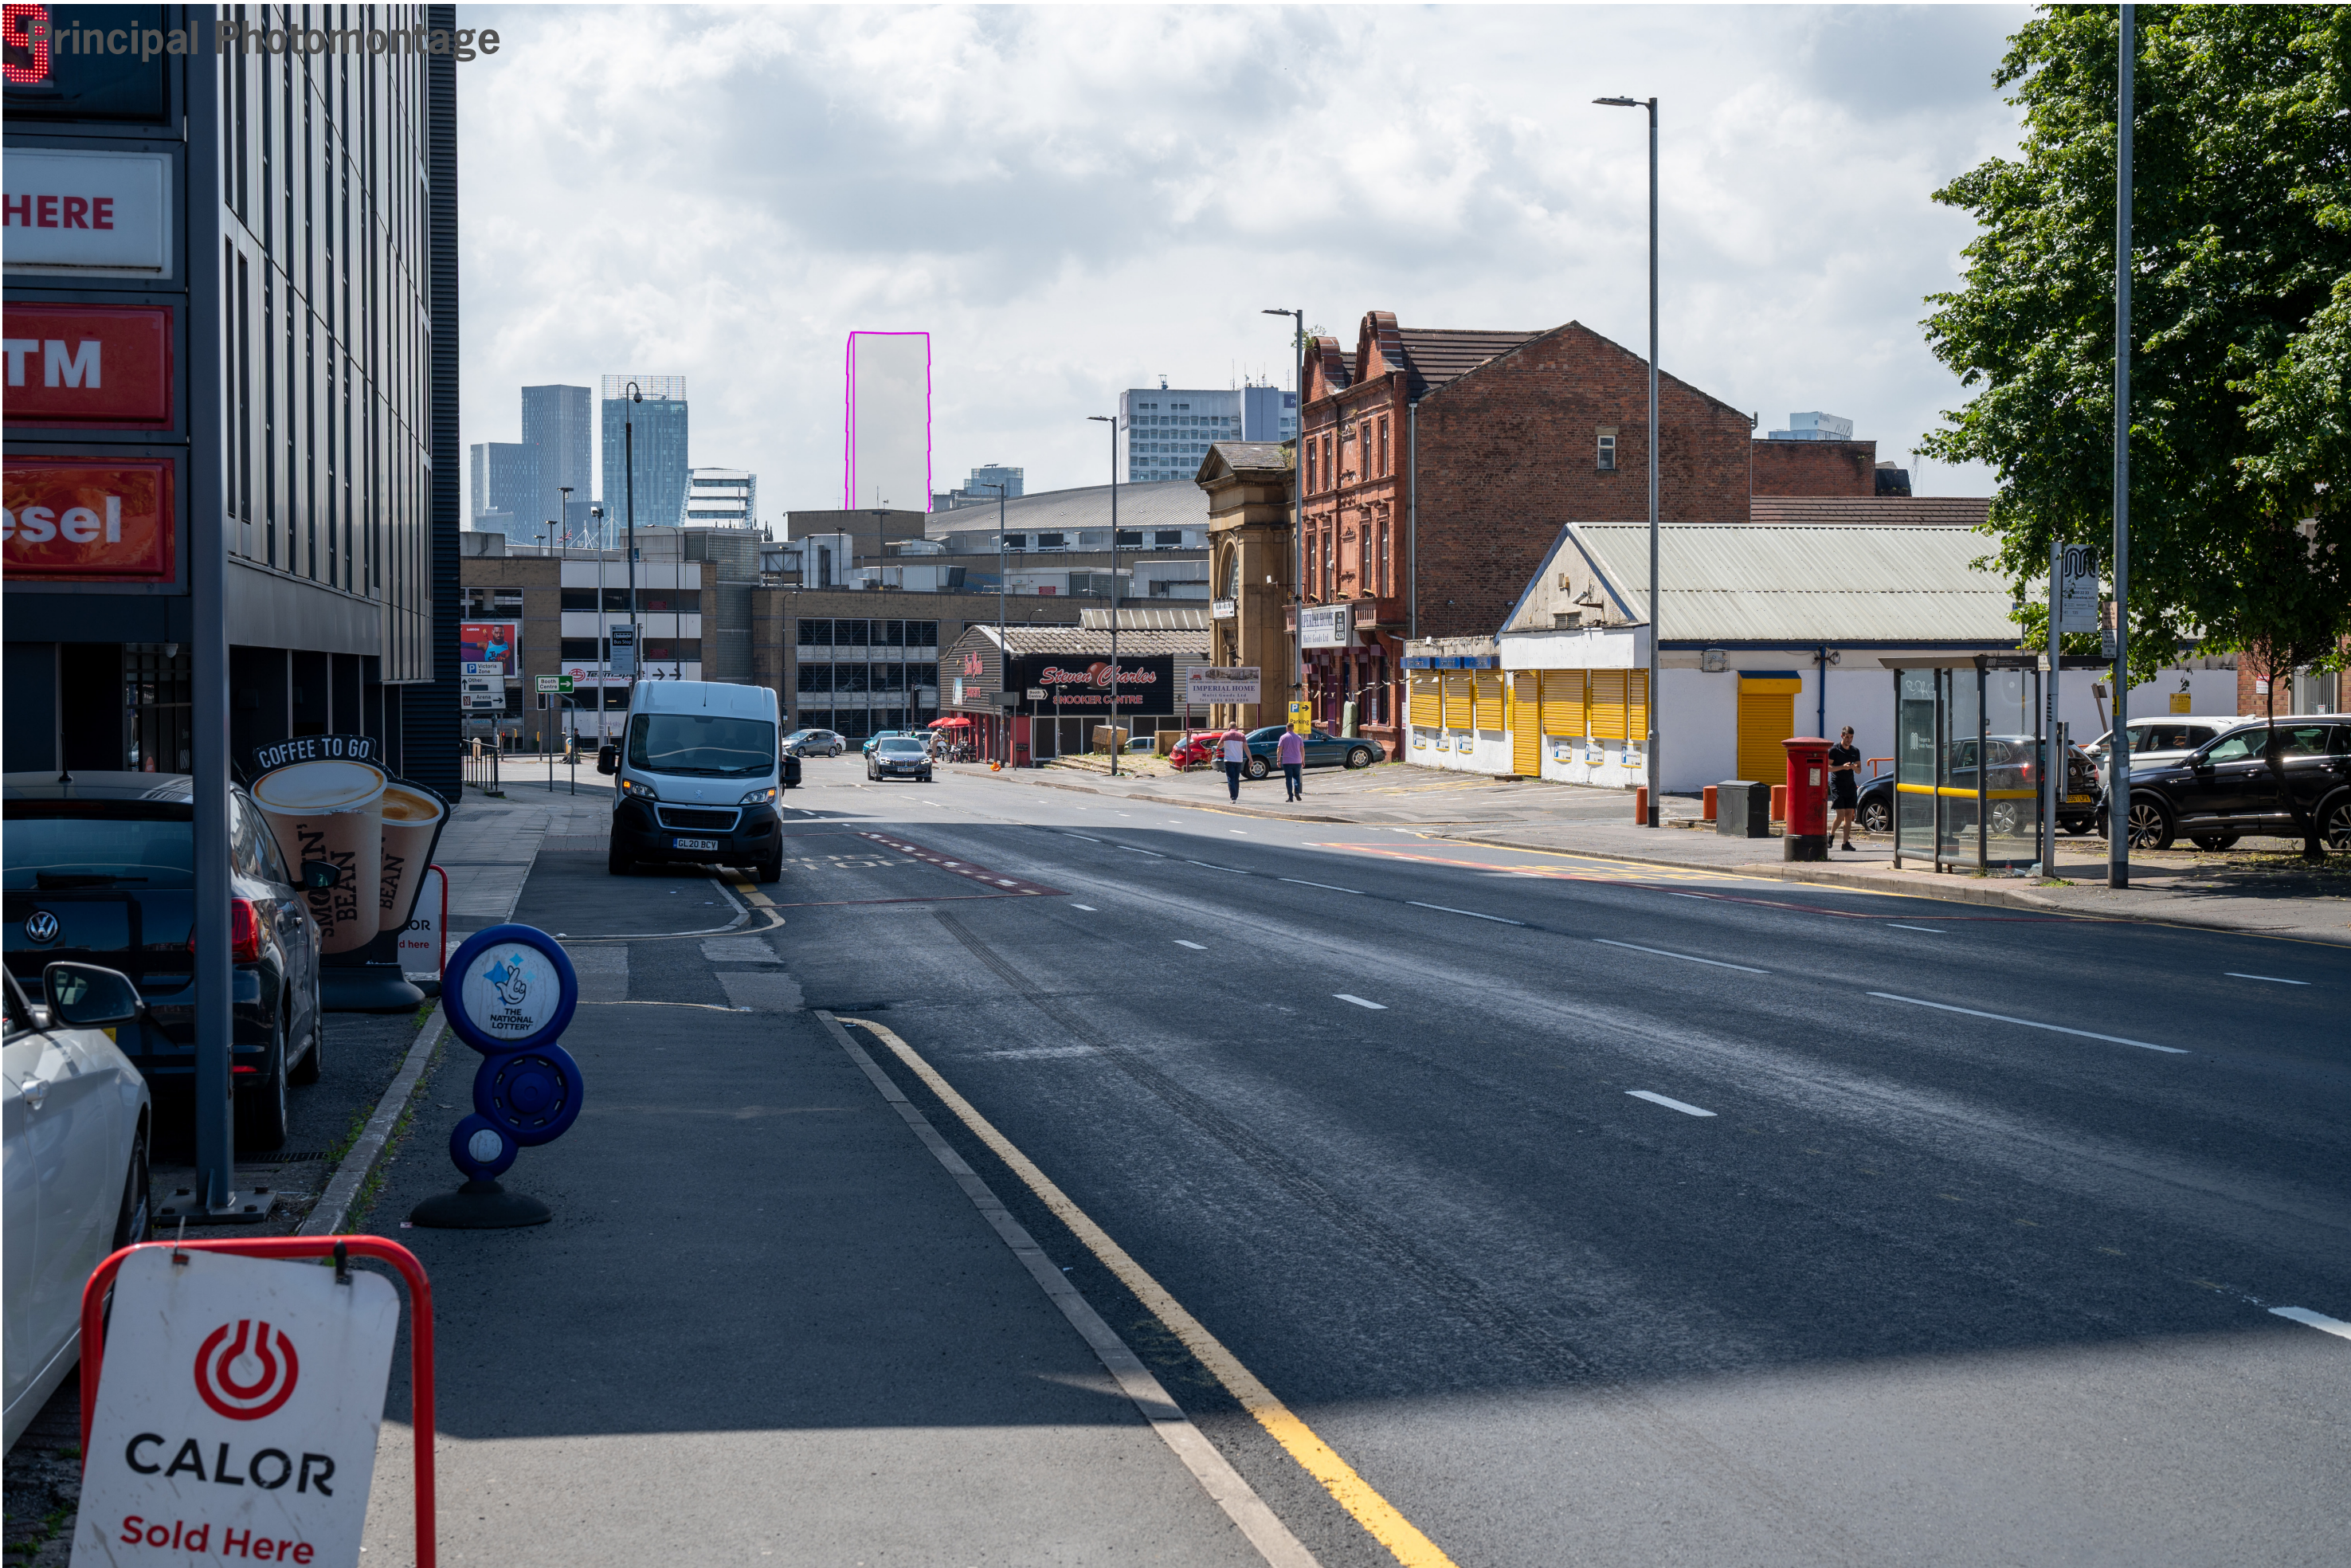
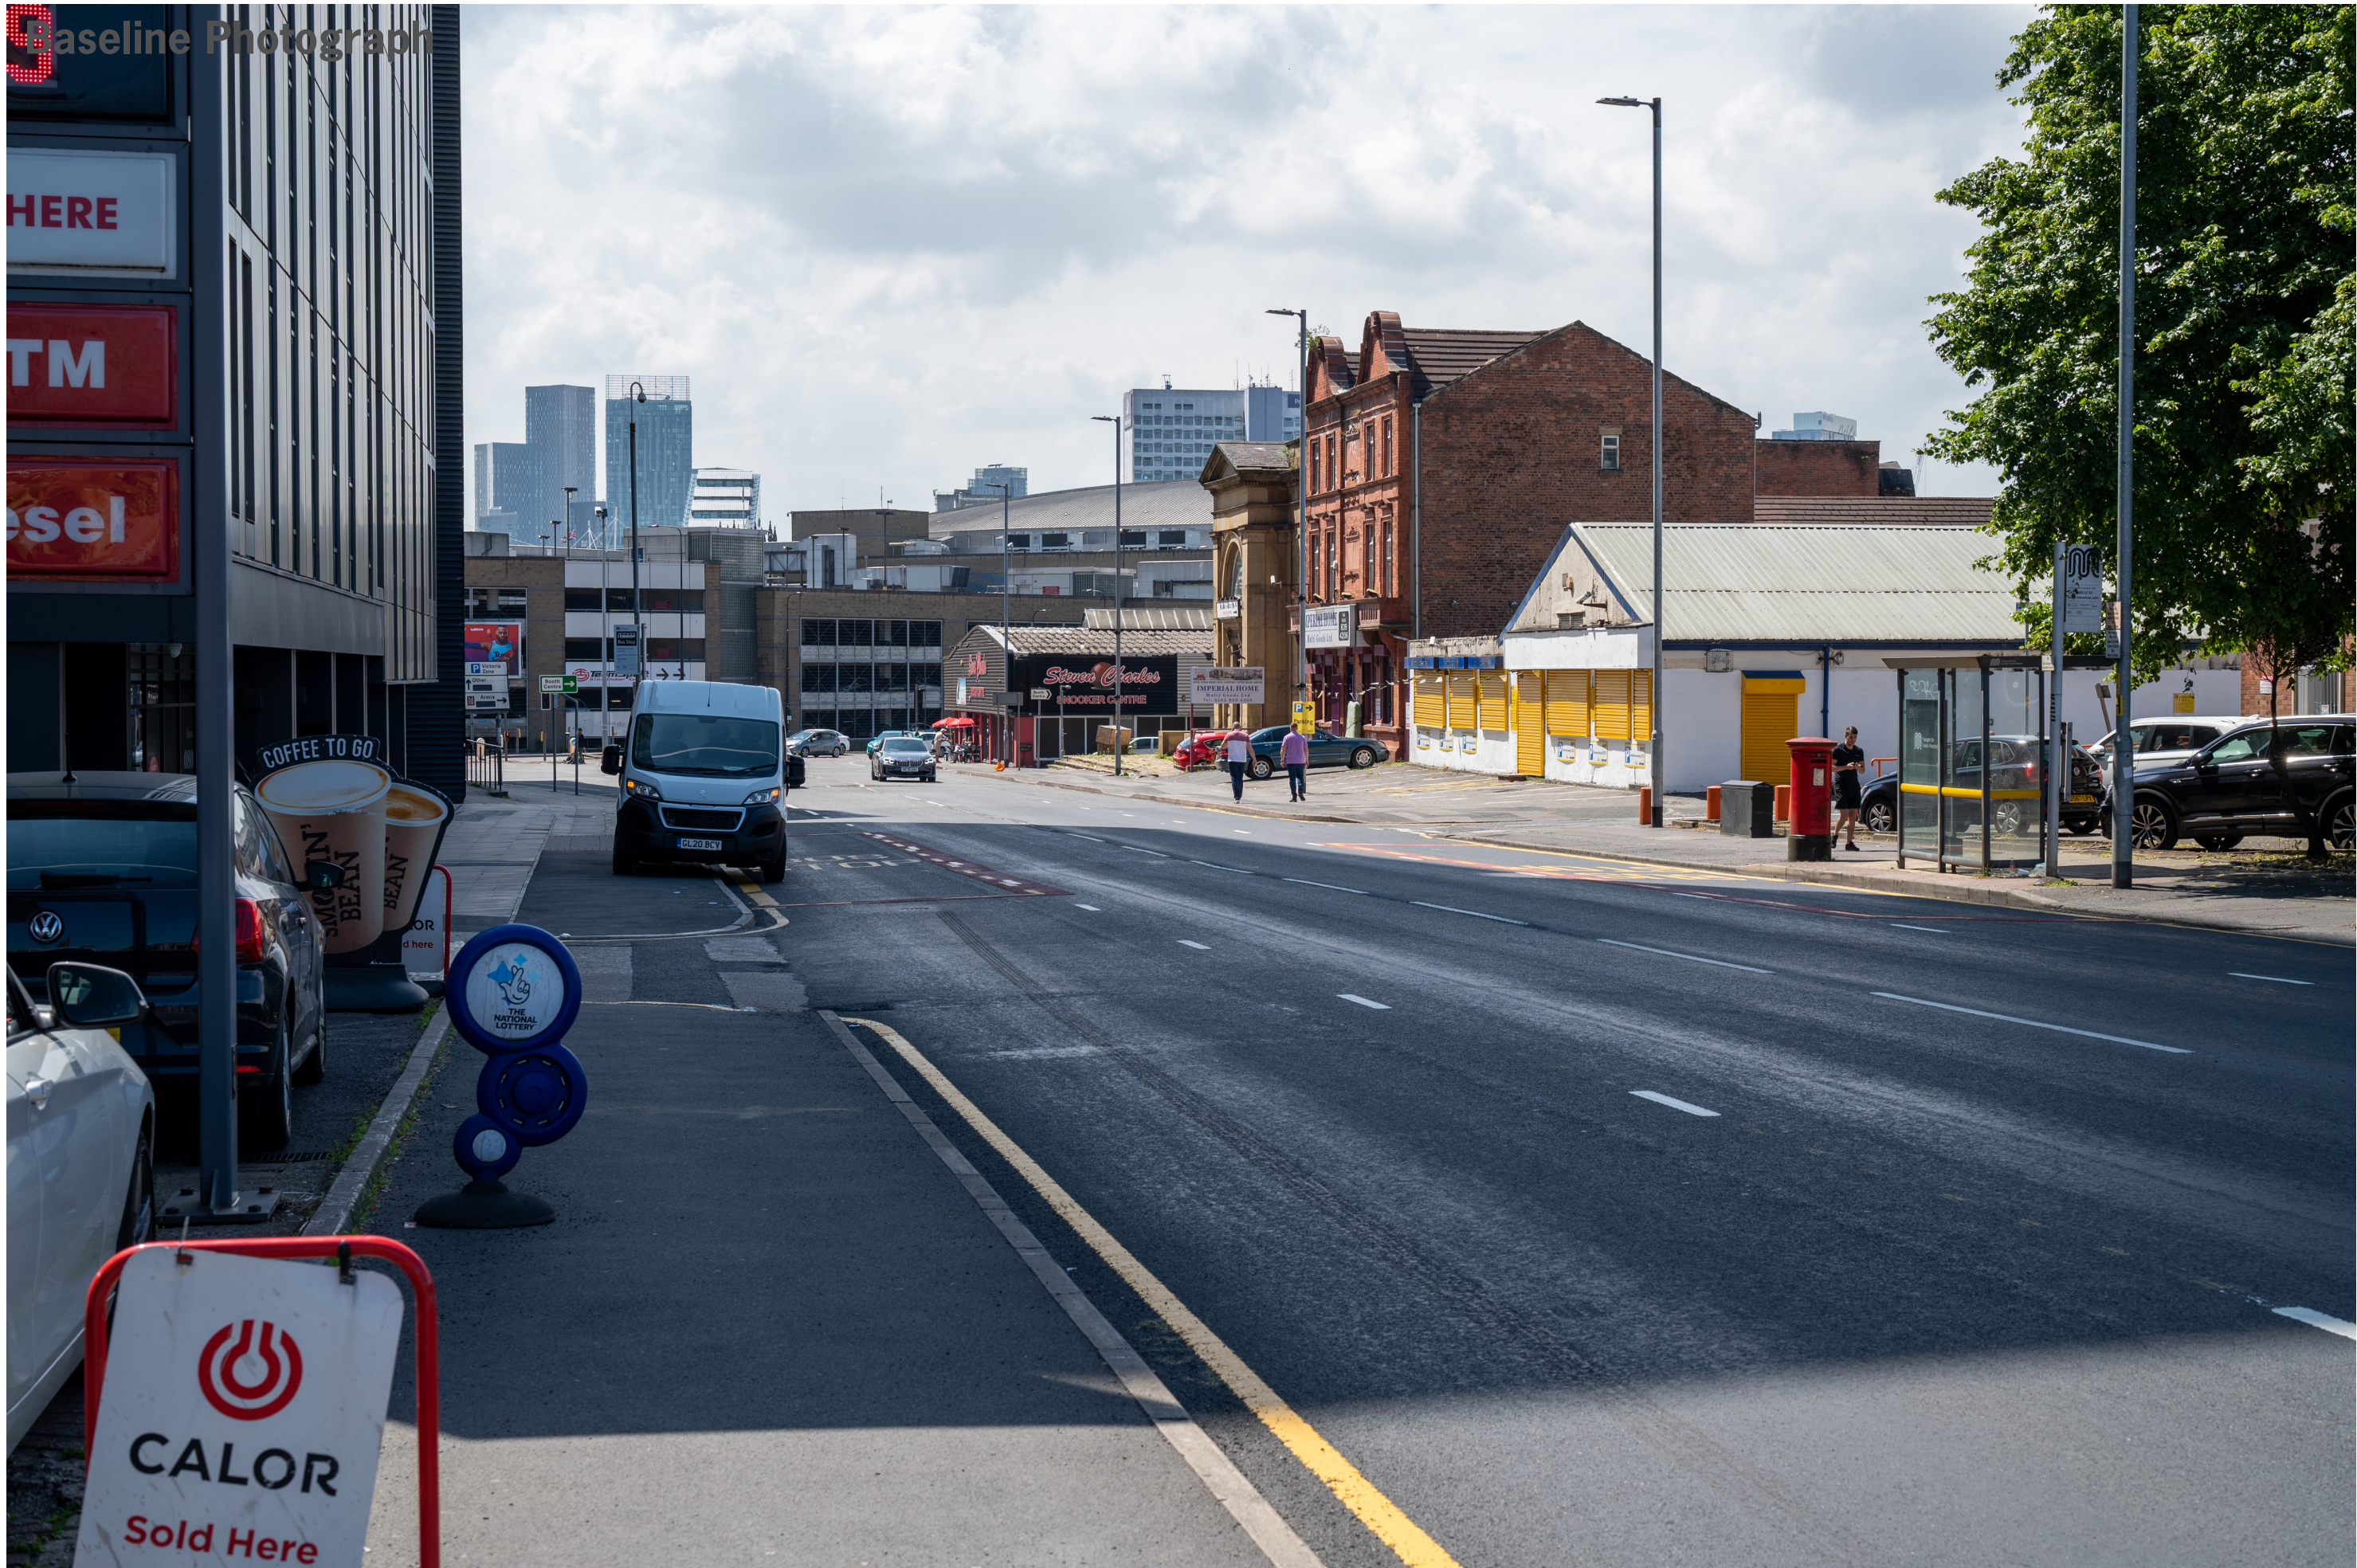
Viewpoint 11.1 - Photomontage | Type 4 | AVR Level 1

Enlargement 100% at A1 sheet size

— Solid Outline - Represents the extent of the proposed built form

HFOV 39.6°

VFOV 27.0°

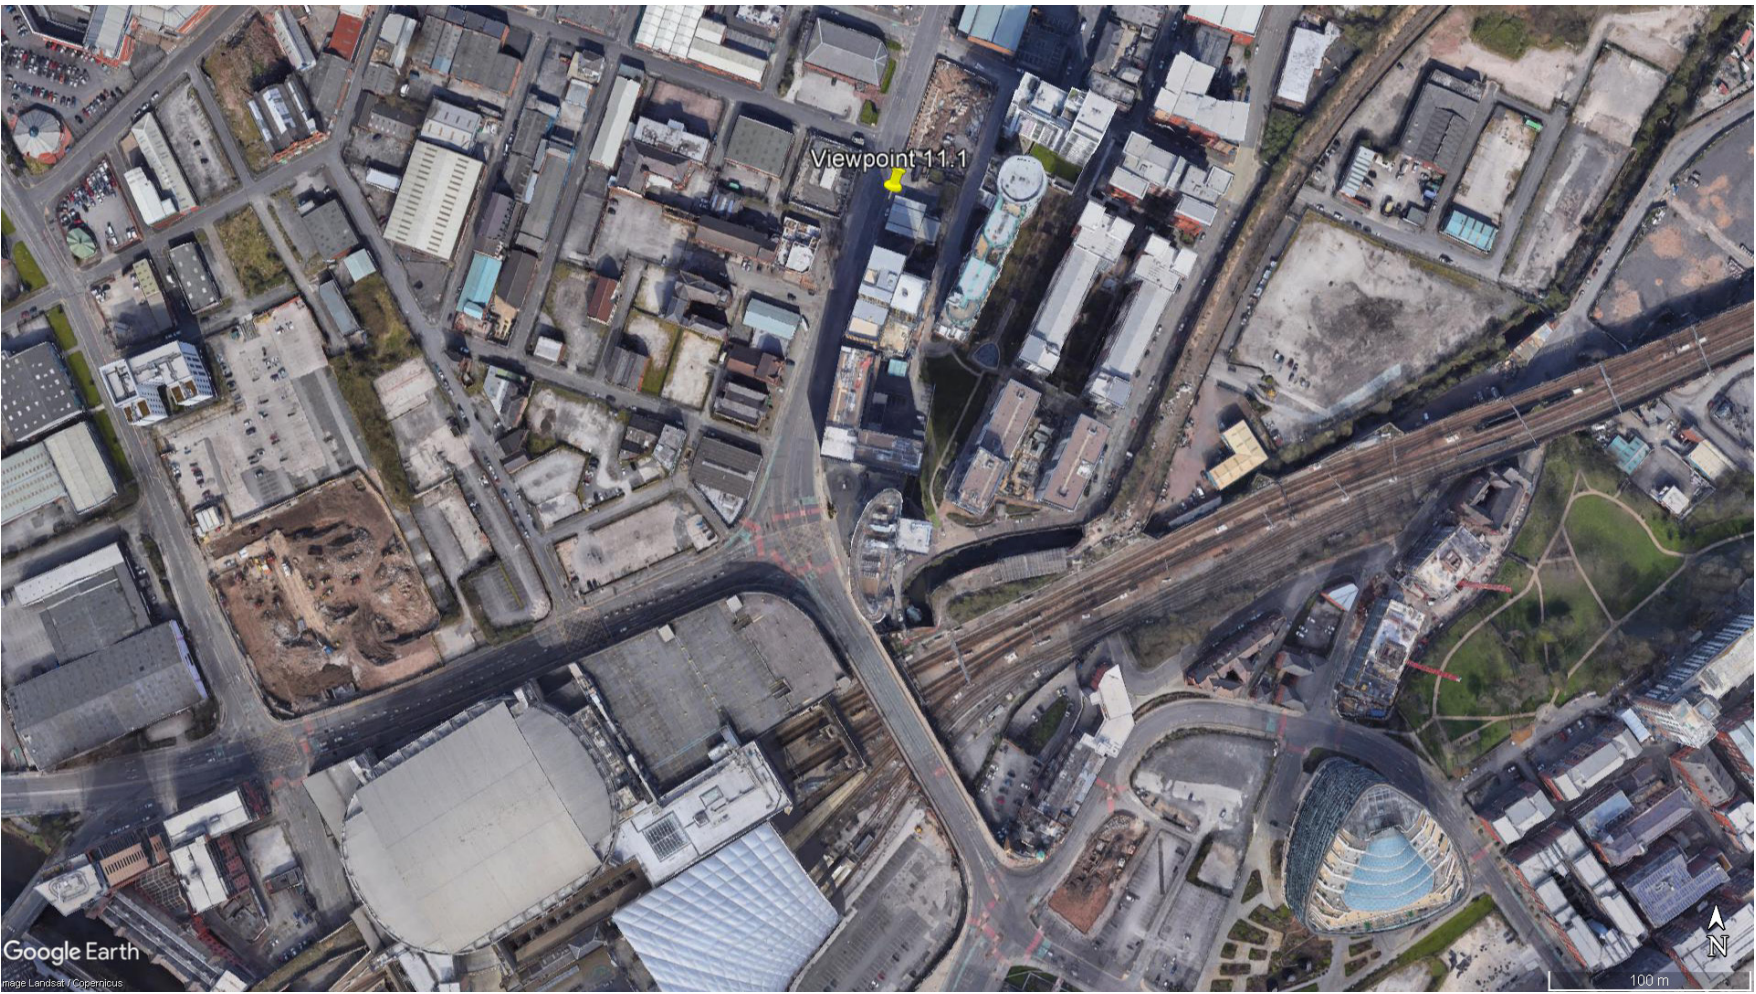
Camera Location

**Photo Captured** | 01/07/2021 @ 12:31  
**Camera Location** | E 384107.727, N 399391.53 @ 46.024m AOD  
**Camera's Nodal Point Height From Ground** | 1.602m  
**Direction of View** | 204° from N  
**Distance to Nearest Site Boundary** | 769m  
**Camera Model** | Nikon Z6ii, Full Frame Sensor  
**Camera Lens** | Nikon Nikkor Z S-Line 50mm  
**Additional Location Info** | Camera nodal point centred on the survey nail in the pavement on the corner where there is a change of tarmac. Located adjacent to the Texaco fuel station on Cheetham Hill Rd.

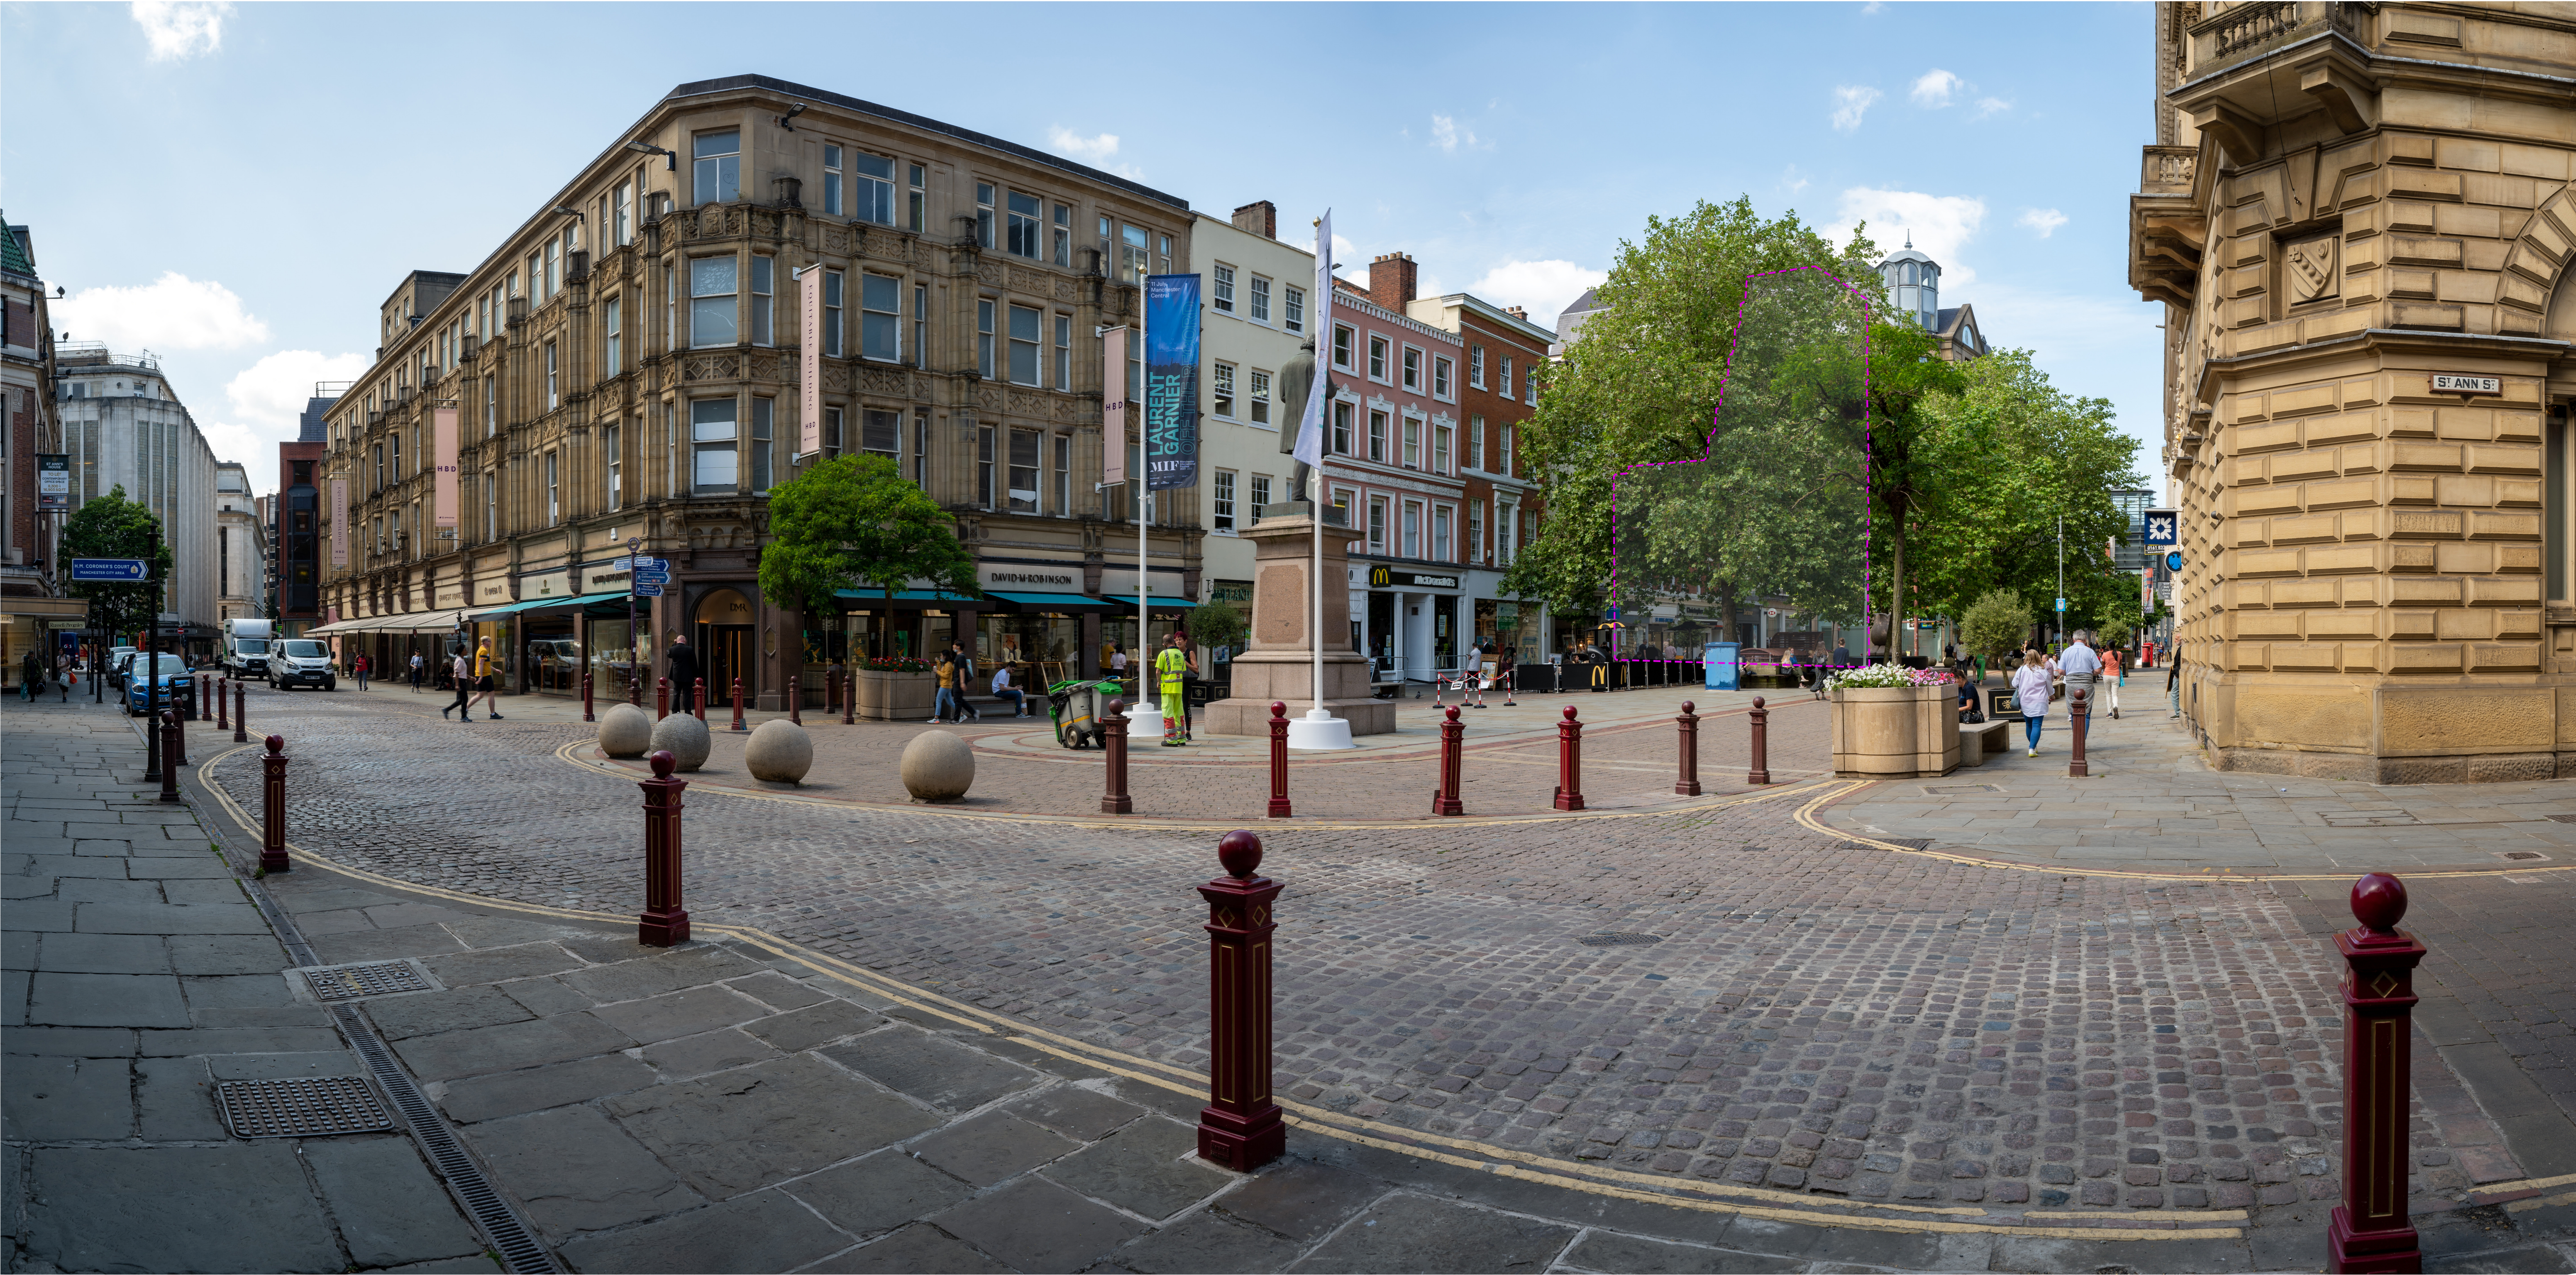
HFOV 109°

--- Dashed Outline - Represents the extent of the occluded proposed built form

**Photo Captured** | 01/07/2021 @ 15:11  
**Camera Location** | E 383799.999, N 398363.416 @ 38.491m AOD  
**Camera's Nodal Point Height From Ground** | 1.604m  
**Direction of View** | 356° from N  
**Distance to Nearest Site Boundary** | 267m  
**Camera Model** | Nikon Z6ii, Full Frame Sensor  
**Camera Lens** | Nikon Nikkor Z S-Line 35mm
