# Verified View Methodology

Type 4 | AVR Level 0, 1 & 3

This document has been prepared to explain the process of generating verified views (also referred to as accurate visual representations (AVR)) for the proposed development at Renaissance Hotel, Manchester.

Renaissance Hotel, Manchester  
Verified Views  
October 2021 v1.0 DRAFT

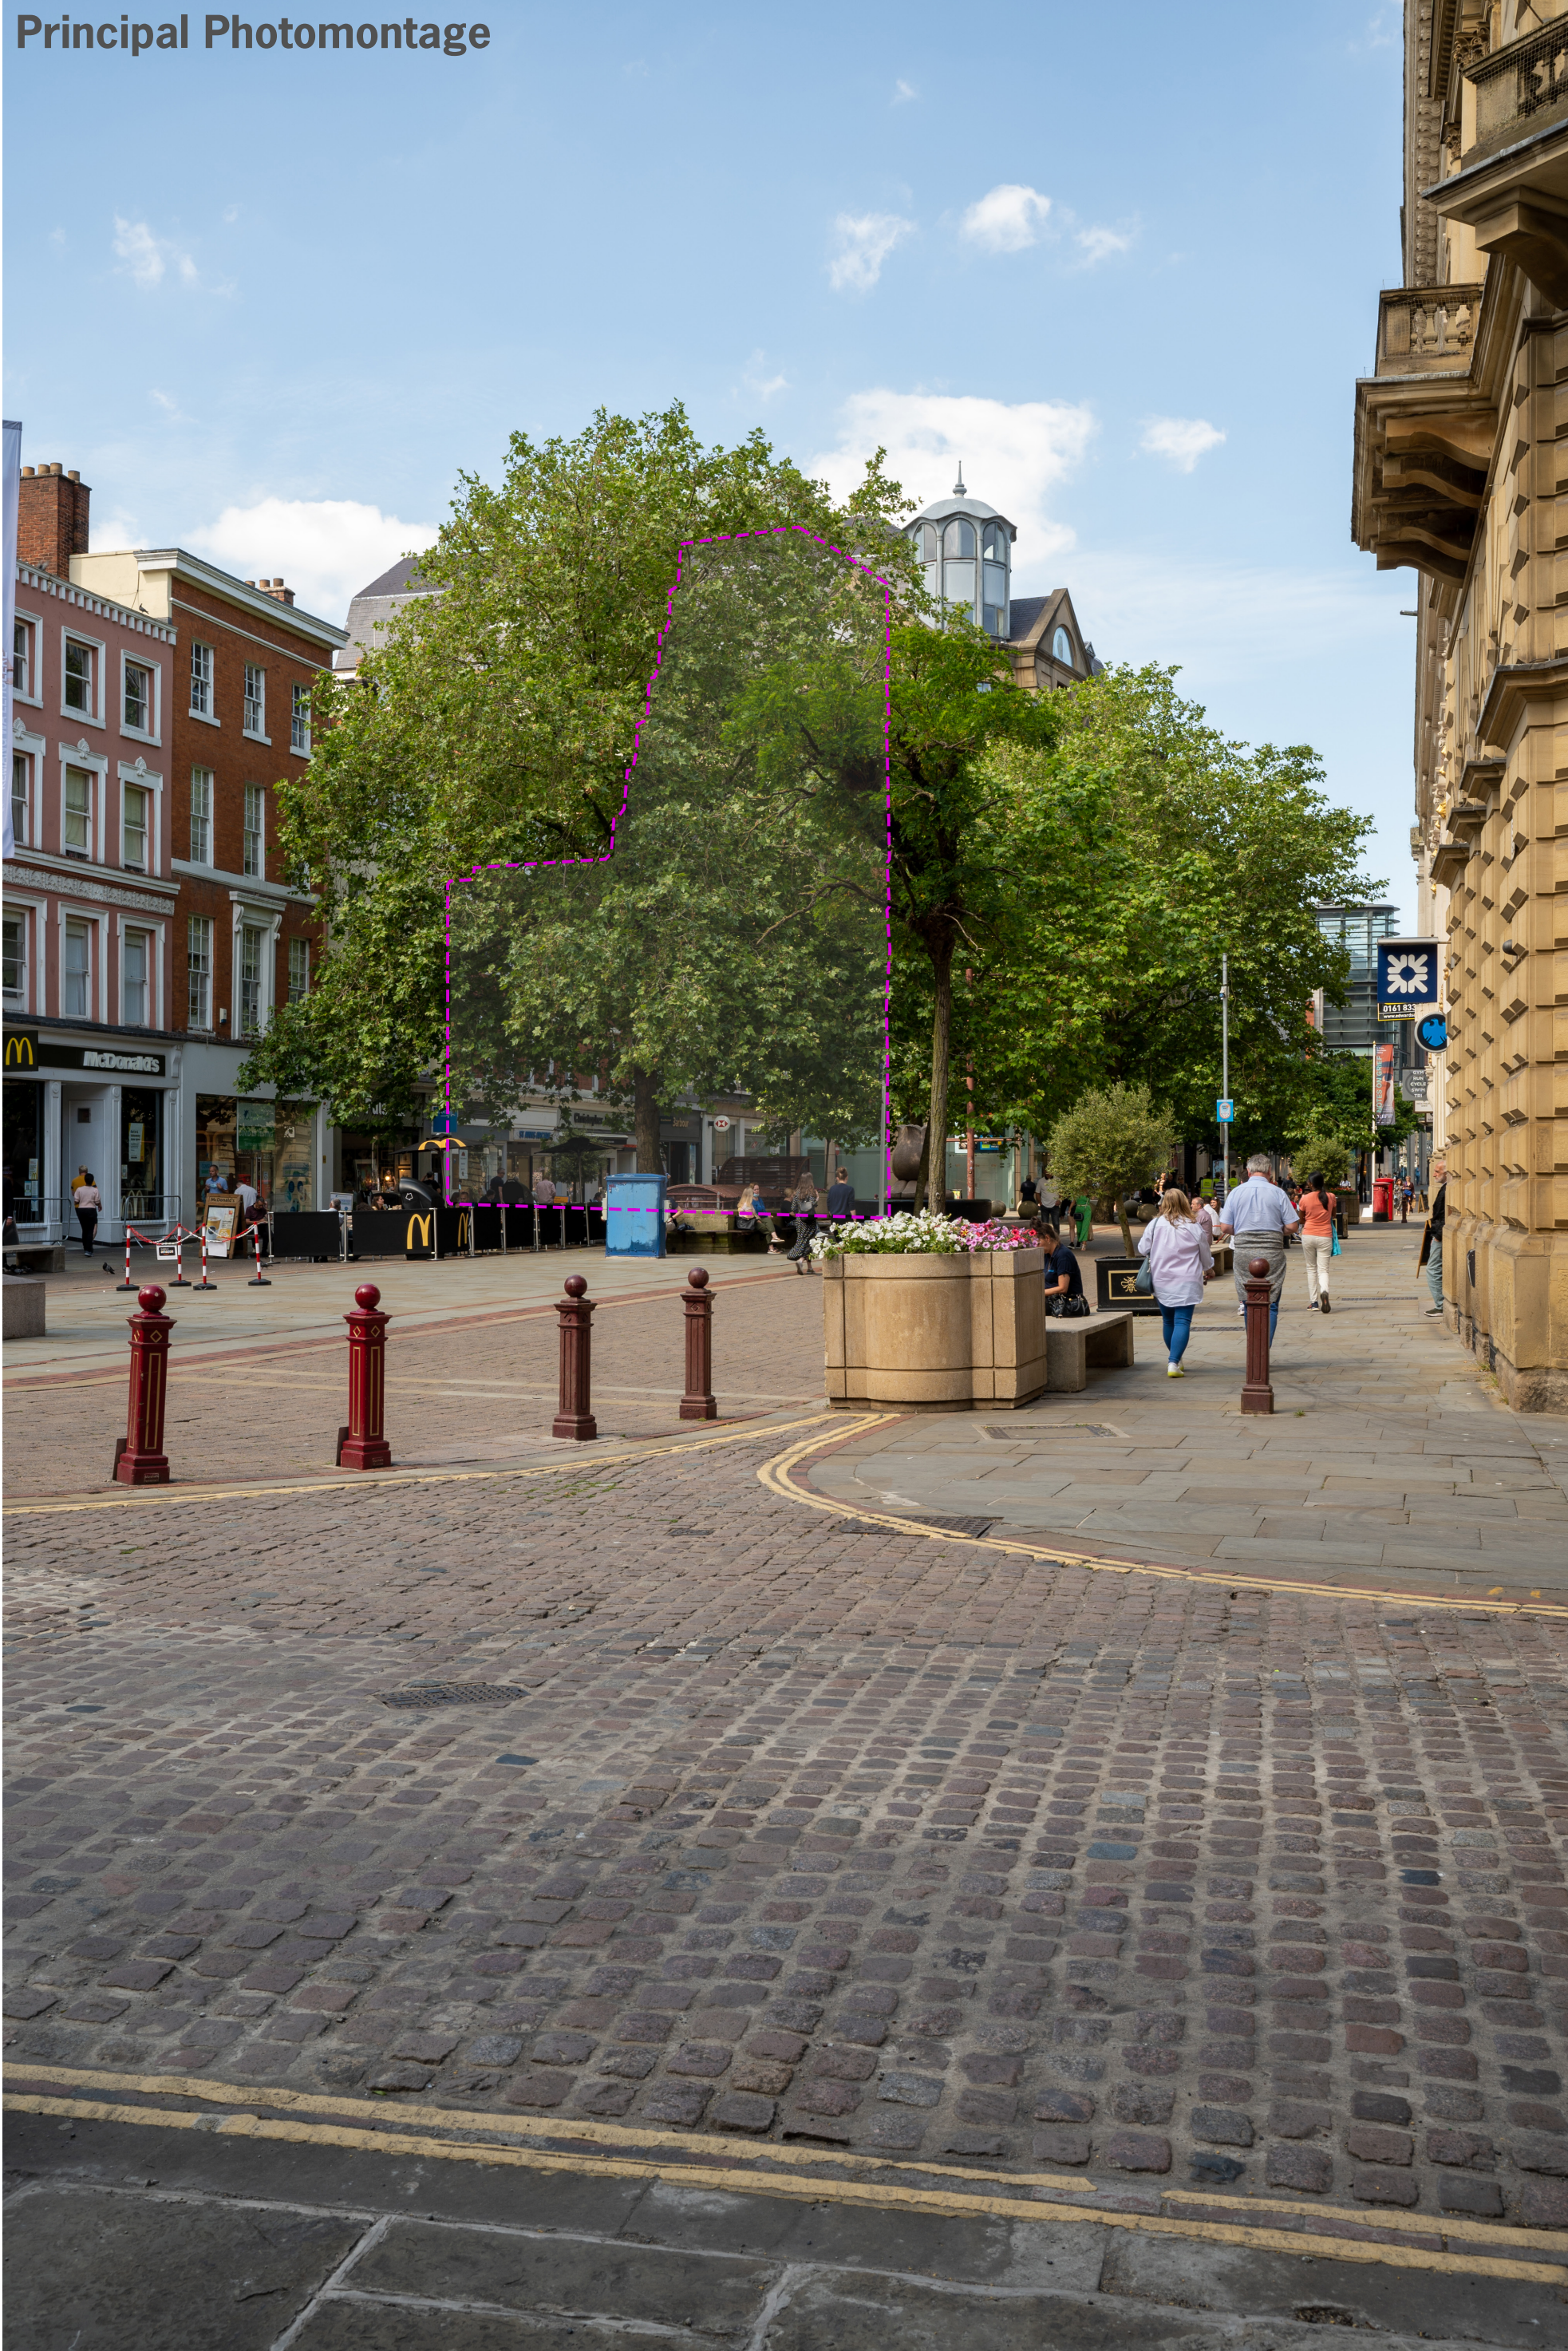
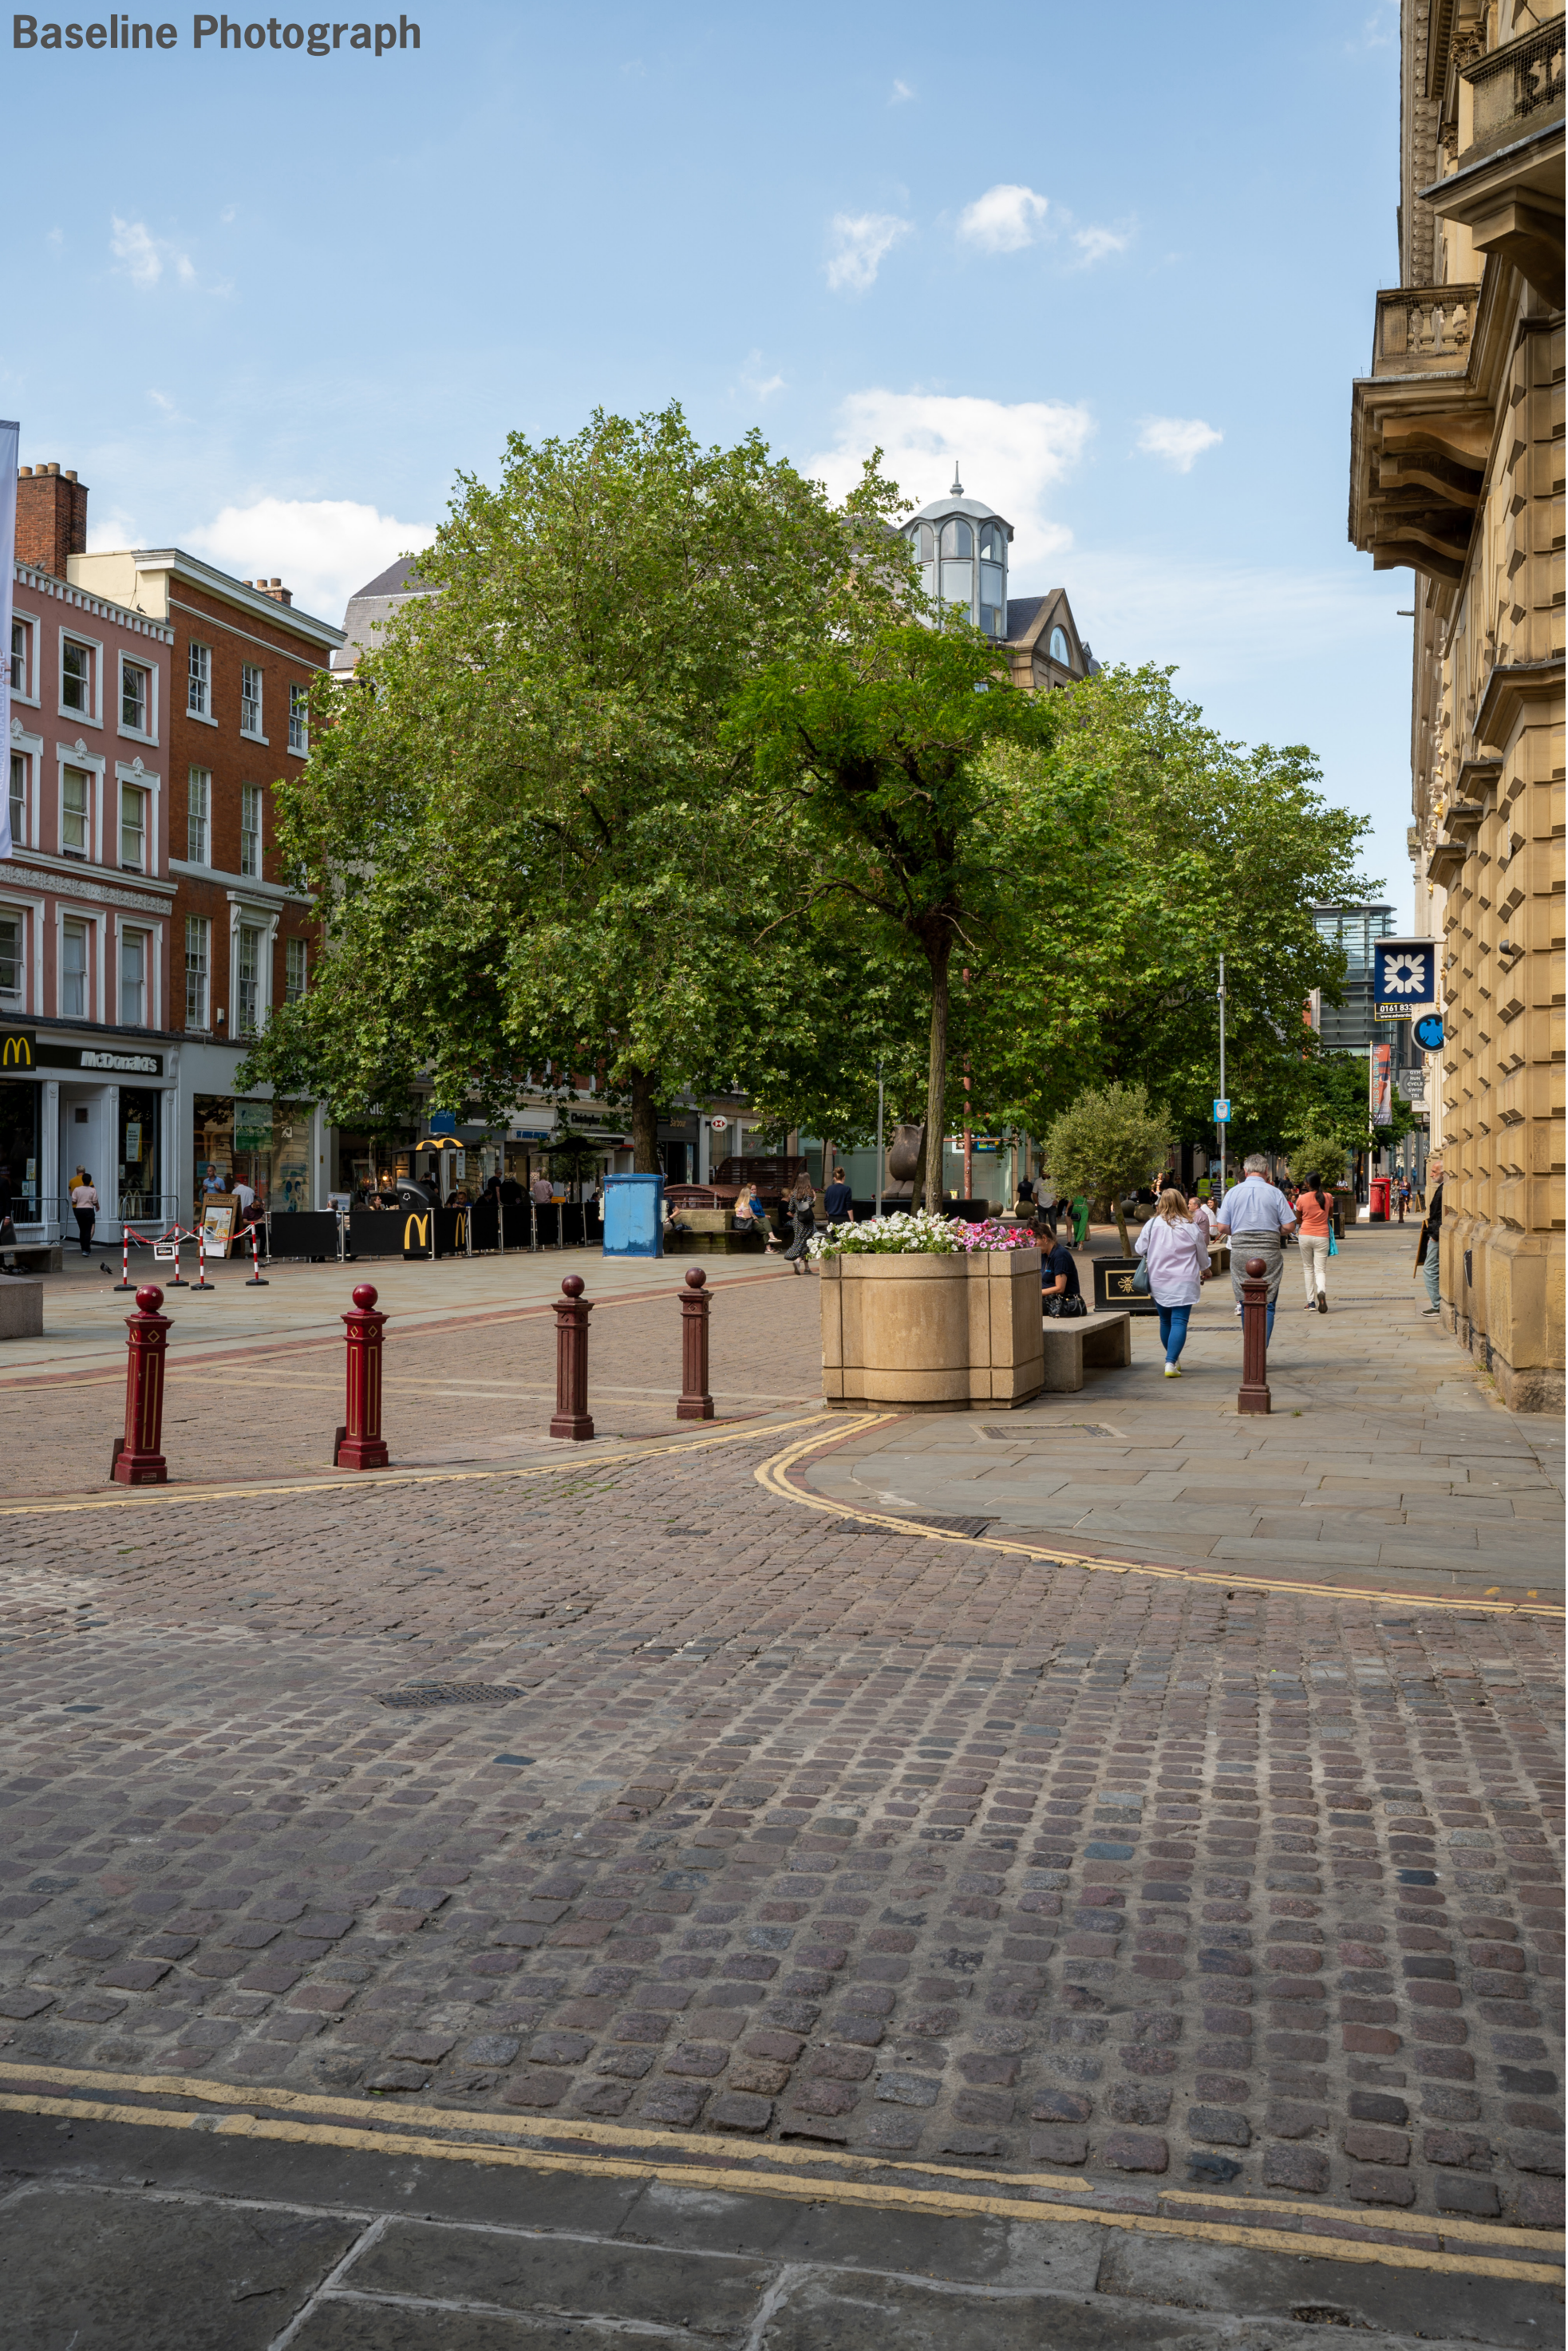
Enlargement 100% at A1 sheet size

--- Dashed Outline - Represents the extent of the occluded proposed built form

Baseline Photograph

HFOV 37.8°

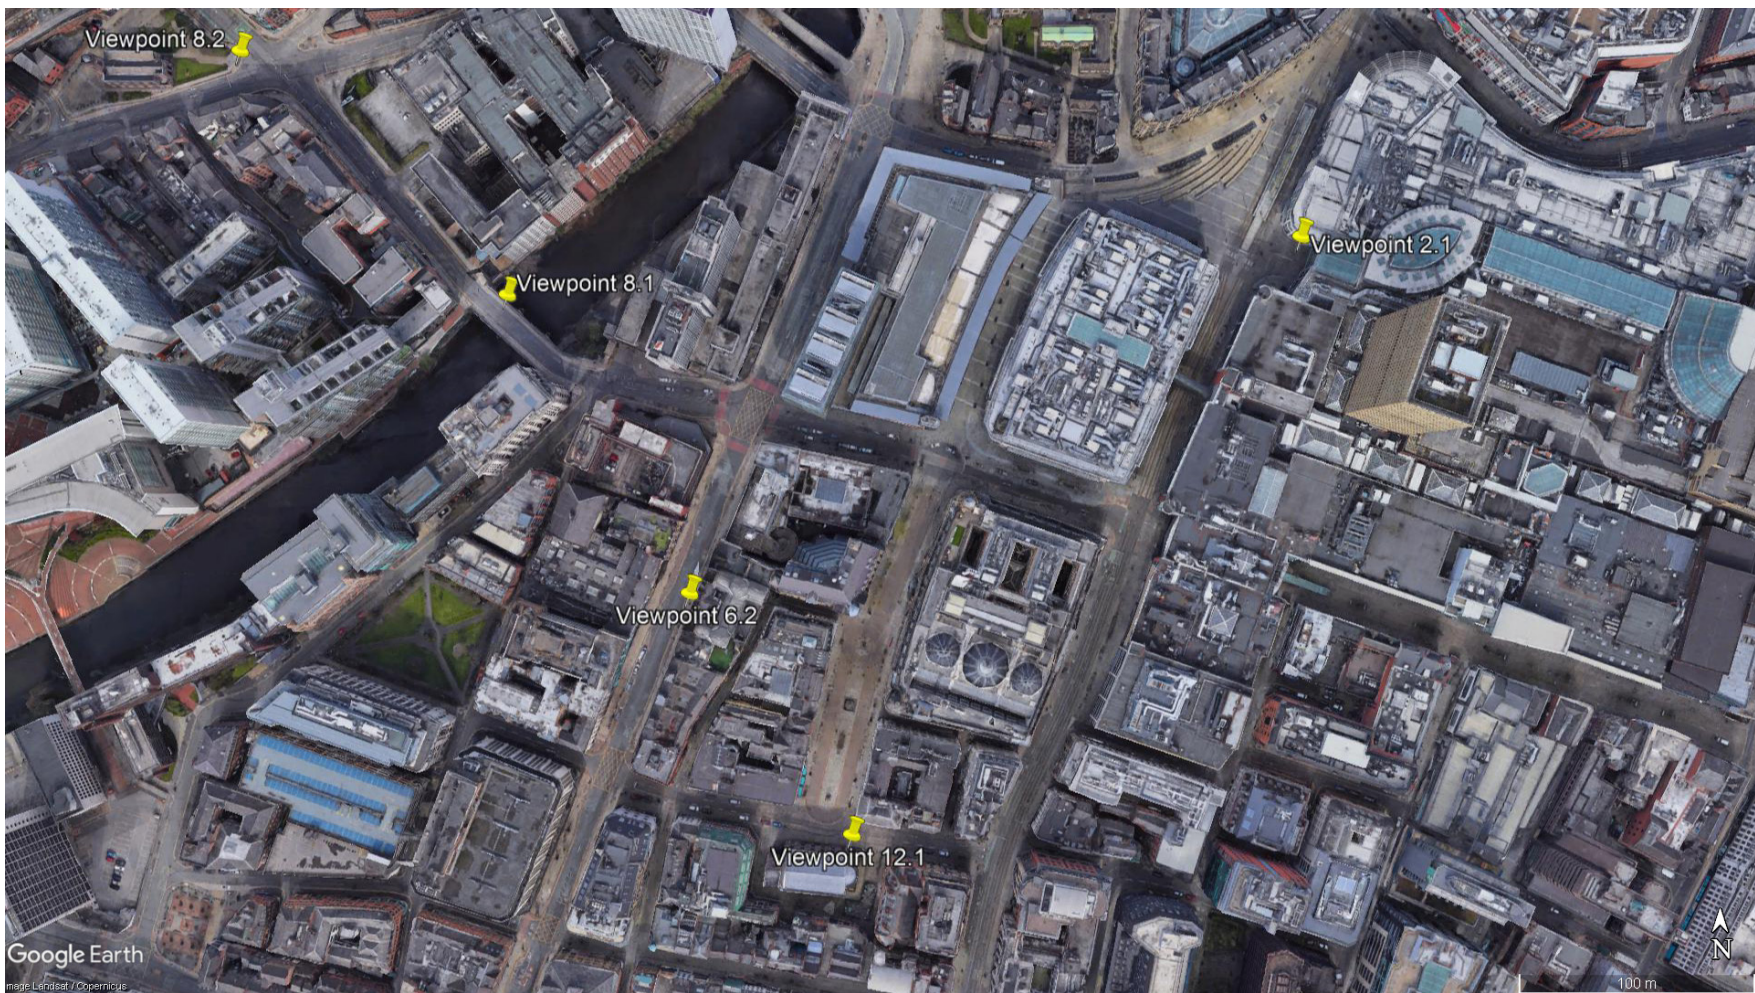
Camera Location

**Photo Captured** | 01/07/2021 @ 15:11  
**Camera Location** | E 383799.999, N 398363.416 @ 38.491m AOD  
**Camera's Nodal Point Height From Ground** | 1.604m  
**Direction of View** | 356° from N  
**Distance to Nearest Site Boundary** | 267m  
**Camera Model** | Nikon Z6ii, Full Frame Sensor  
**Camera Lens** | Nikon Nikkor Z S-Line 35mm  
**Additional Location Info** | Camera nodal point centred on the bottom right corner of the drain cover as shown in photo.  
Located on the large pavers adjacent to the strip drain outside the NE corner of St Ann's Church looking back into St Anne's Square.
