# Television Desk-Based Report and Baseline Reception Survey

Trinity Islands

Renaker Build Limited

October 2021

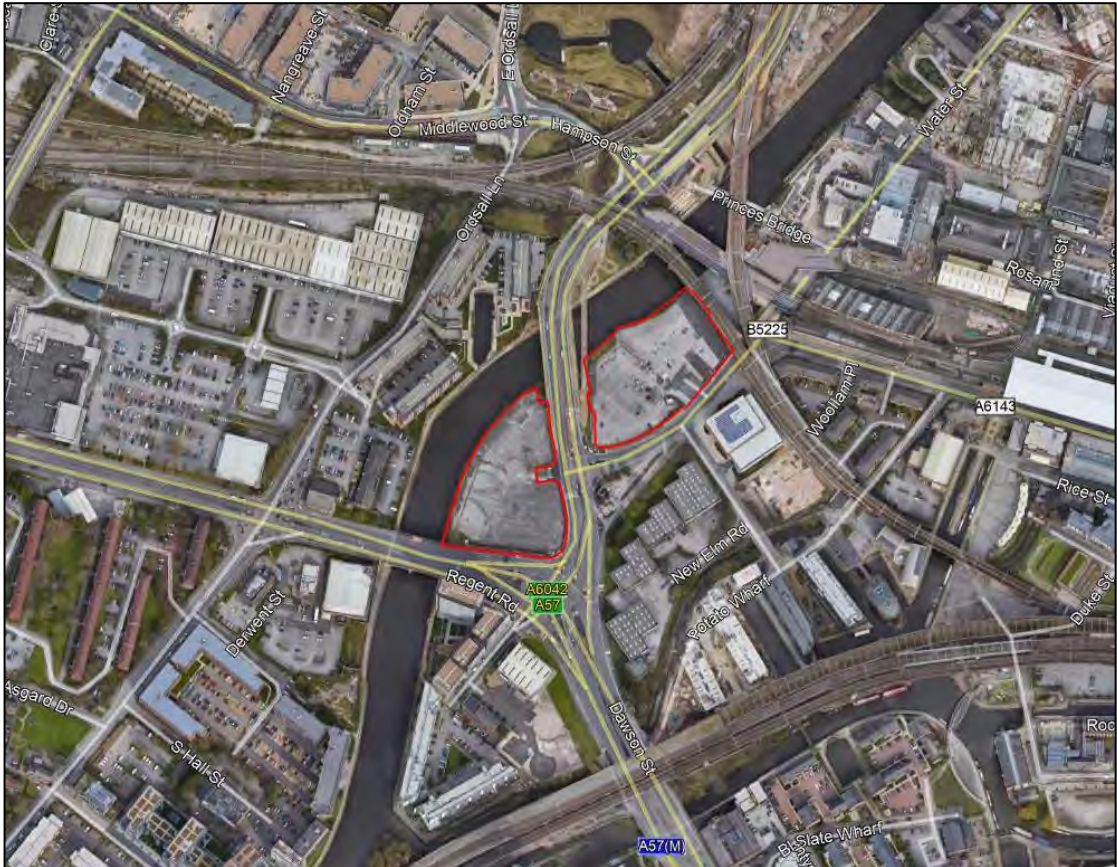
Figure 2 Proposed development red line boundary overlaid on aerial imagery

The red line boundary for the proposed development overlaid on aerial imagery is shown in Figure 2<sup>4</sup> below.

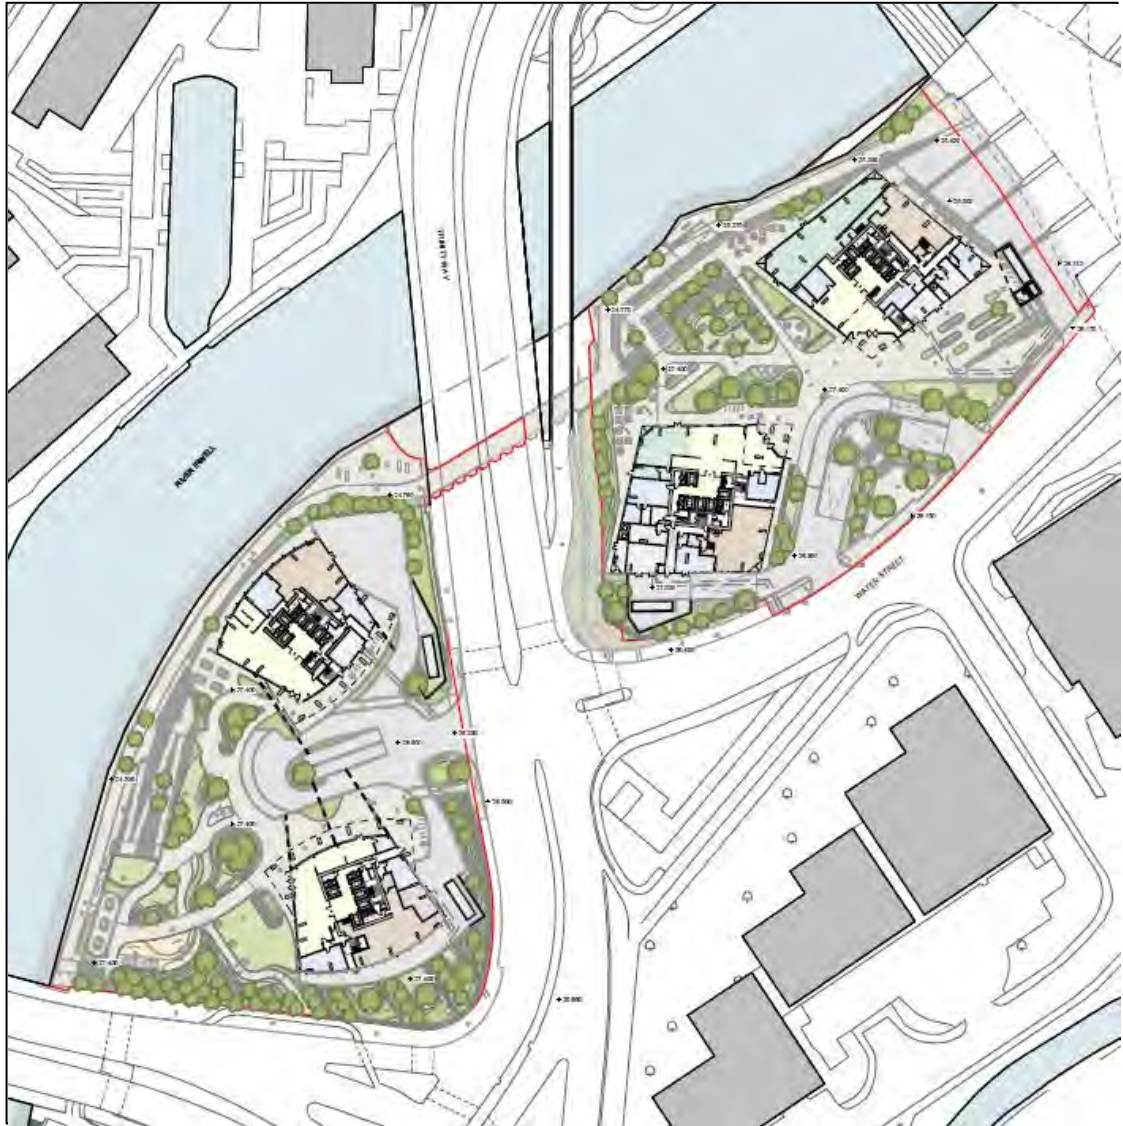
Figure 3 Proposed development ground floor plan

The ground floor plan for the proposed development is shown in Figure 3<sup>5</sup> below.

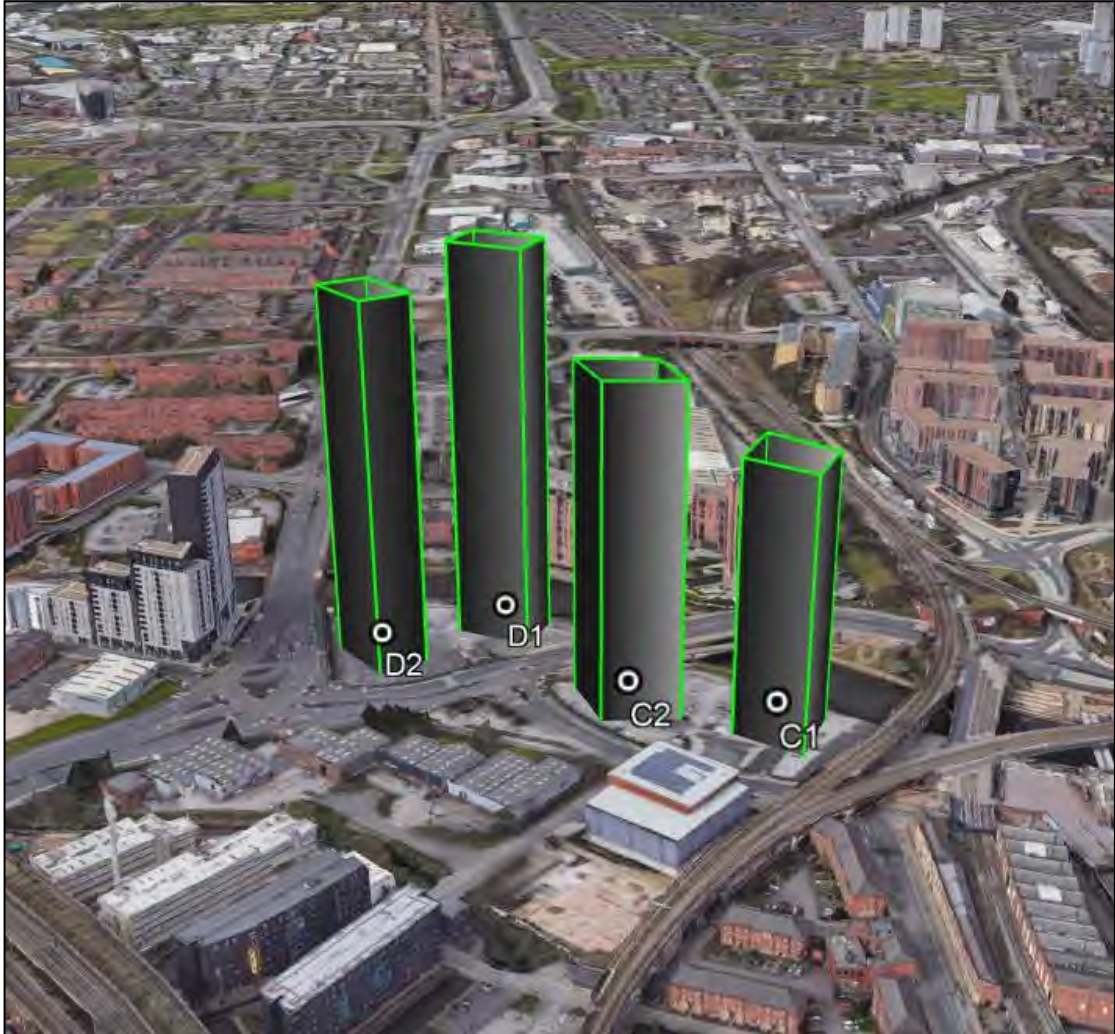
Figure 6 Proposed development 3D representation

Figure 6<sup>7</sup> below shows the 3D representation of the proposed developments. The image is aligned approximately west.

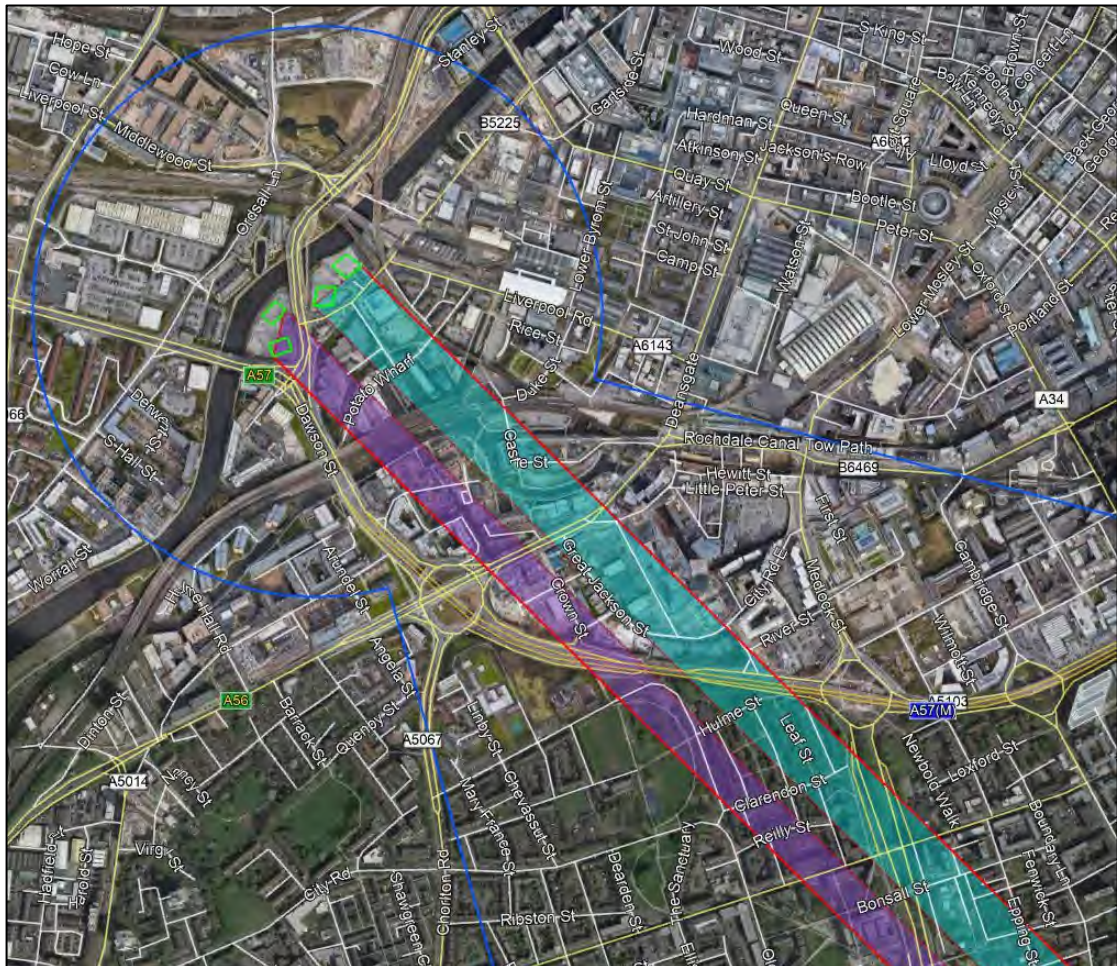
Figure 13 Interference zones – aerial image (zoomed) – approx. first 1.5km

Figure 13<sup>16</sup> below shows the interference zones overlaid onto an aerial image of the area zoomed in on approximately the first 1.5km of the shadow zone for all towers. The footprints of the towers are shown, defined by the green lines.

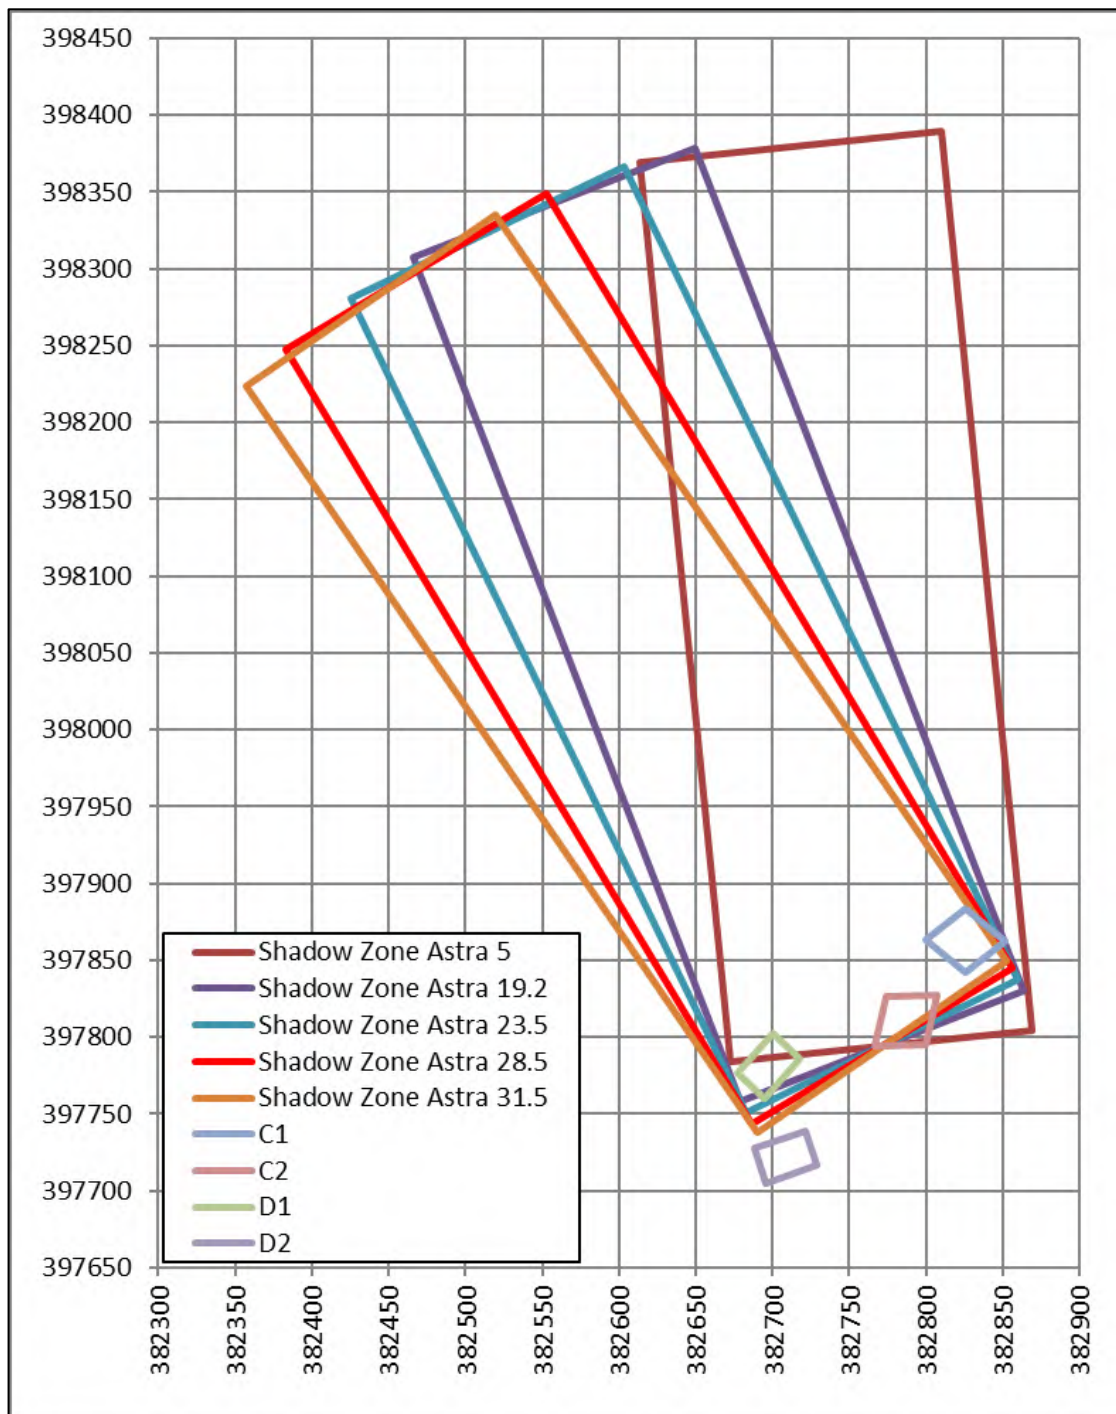
Figure 15 Satellite television interference zones

<sup>19</sup> The new maximum tower height is 183.00m agl which will result in a minor increase to the shadow zone length. This increase does not significantly affect the overall results and recommendations of this report with respect to satellite television interference.

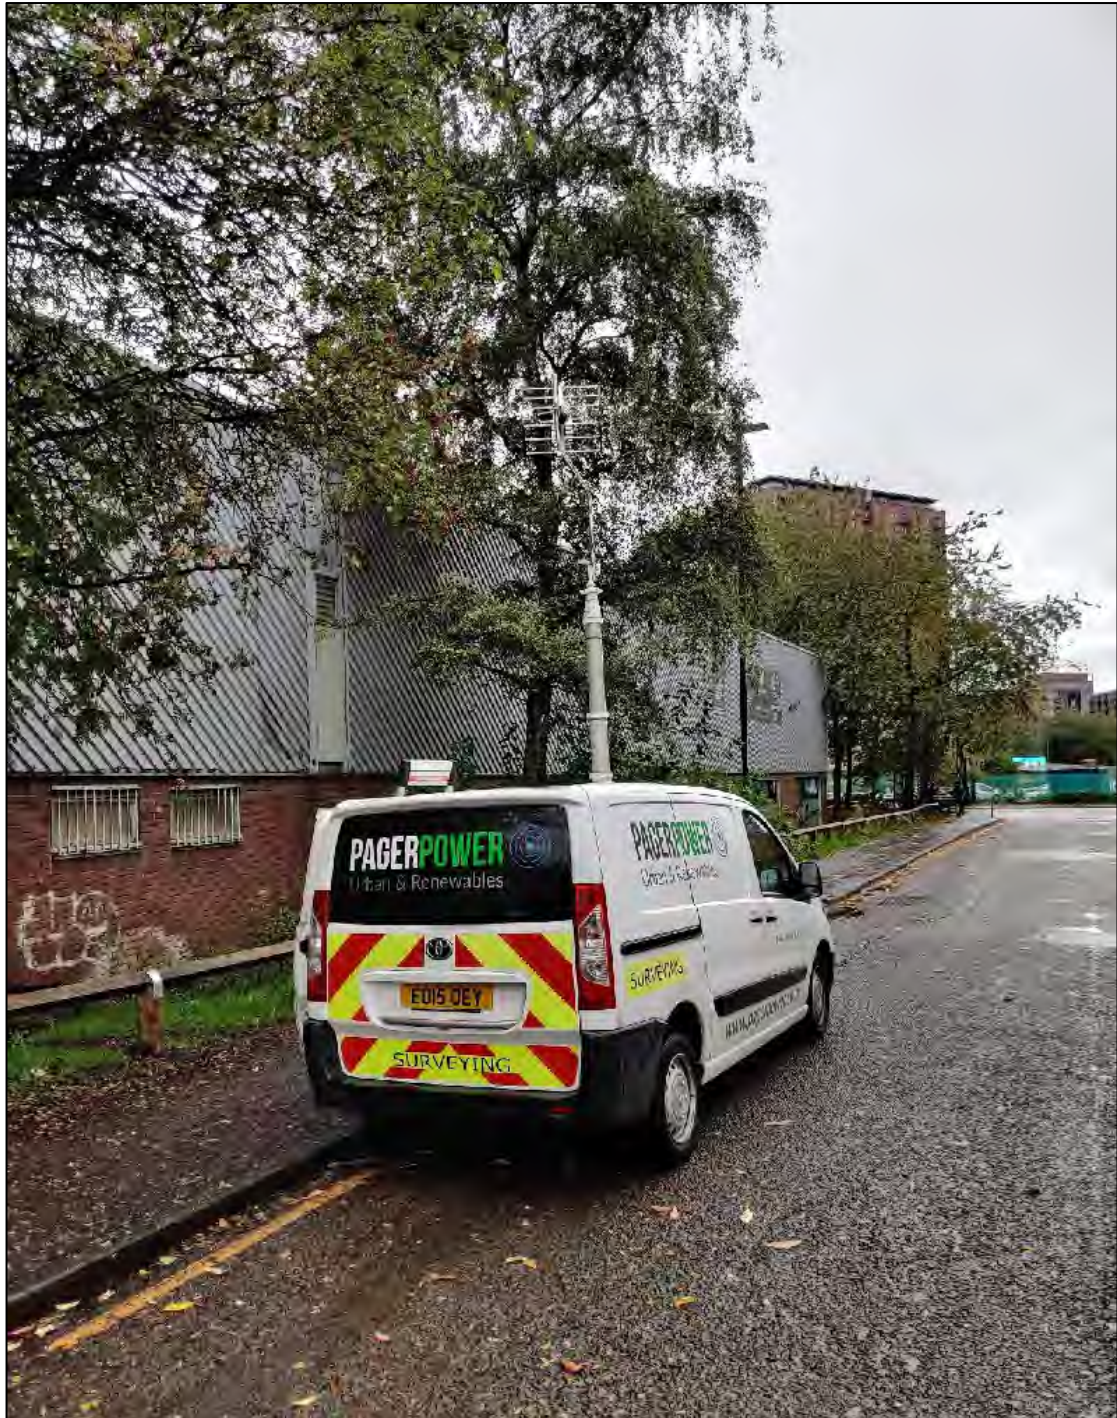
### Location 1

Notes: No UHF aerials or satellite dishes were observed at this location.

| Location | Average Measured Signal Strength (dB) | Remarks | High Level Conclusion |
|---|---|---|---|
| 1 | Main TV MUX: 47 (Good)<br>Local TV MUX: 33 (Low) | Aerials and satellite dishes were not observed at this survey location.<br><br>All main multiplexes displayed fine picture and audio quality, with signal fluctuations of less than 1dB and no signs of interference.<br><br>Two local multiplex was not decoded at this location. | The survey location is within 90m of the closest of the Proposed Development.<br><br>Effects are possible based on the proximity to the Proposed Development. This could depend on the relative height receiving aerials and quality of the receiving equipment. |

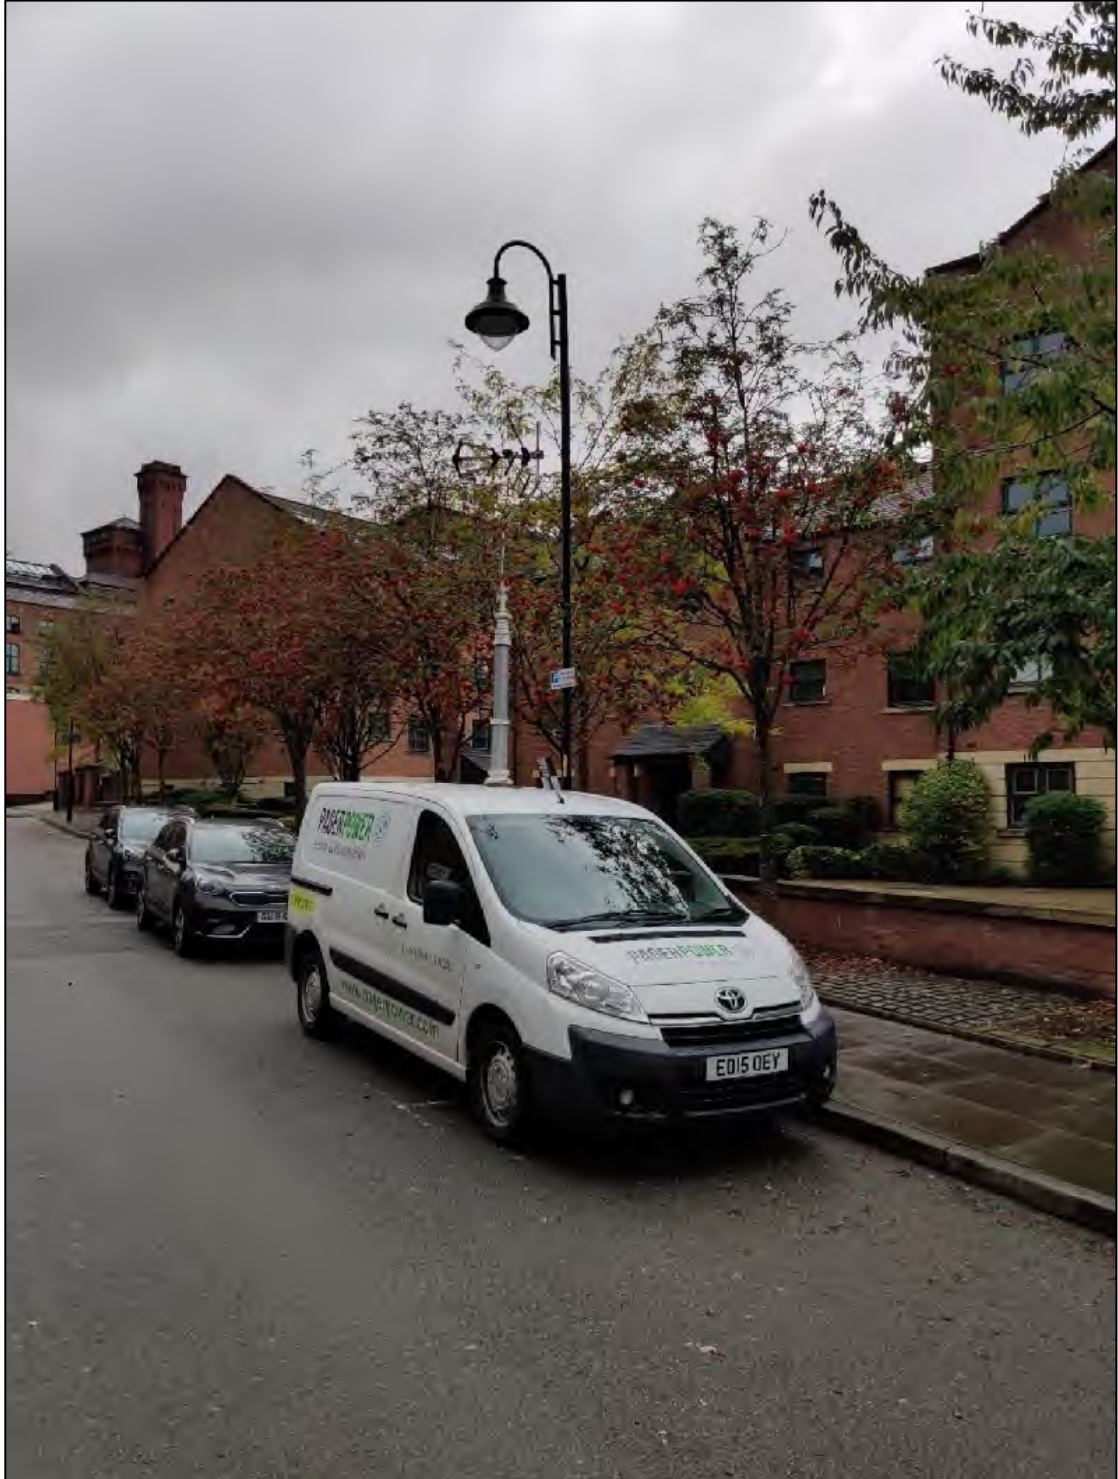
Location 2

Notes: One UHF aerial directed towards the Winter Hill transmitter was observed. Multiple satellite dishes observed.

| Location | Average Measured Signal Strength (dB) | Remarks | High Level Conclusion |
|---|---|---|---|
| 2 | Main TV MUX: 44 (Moderate)<br>Local TV MUX: 31 (Low) | One horizontally polarised aerial directed towards the Winter Hill transmitter and multiple satellite dishes were observed.<br><br>All main multiplexes displayed fine picture and audio quality, with signal fluctuations of less than 1dB and no signs of interference.<br><br>Two local multiplexes were not decoded at this location. | The survey location is within 350m of the closest of the Proposed Development.<br><br>Effects are possible based on the proximity to the Proposed Development. This could depend on the relative height receiving aerials and quality of the receiving equipment |

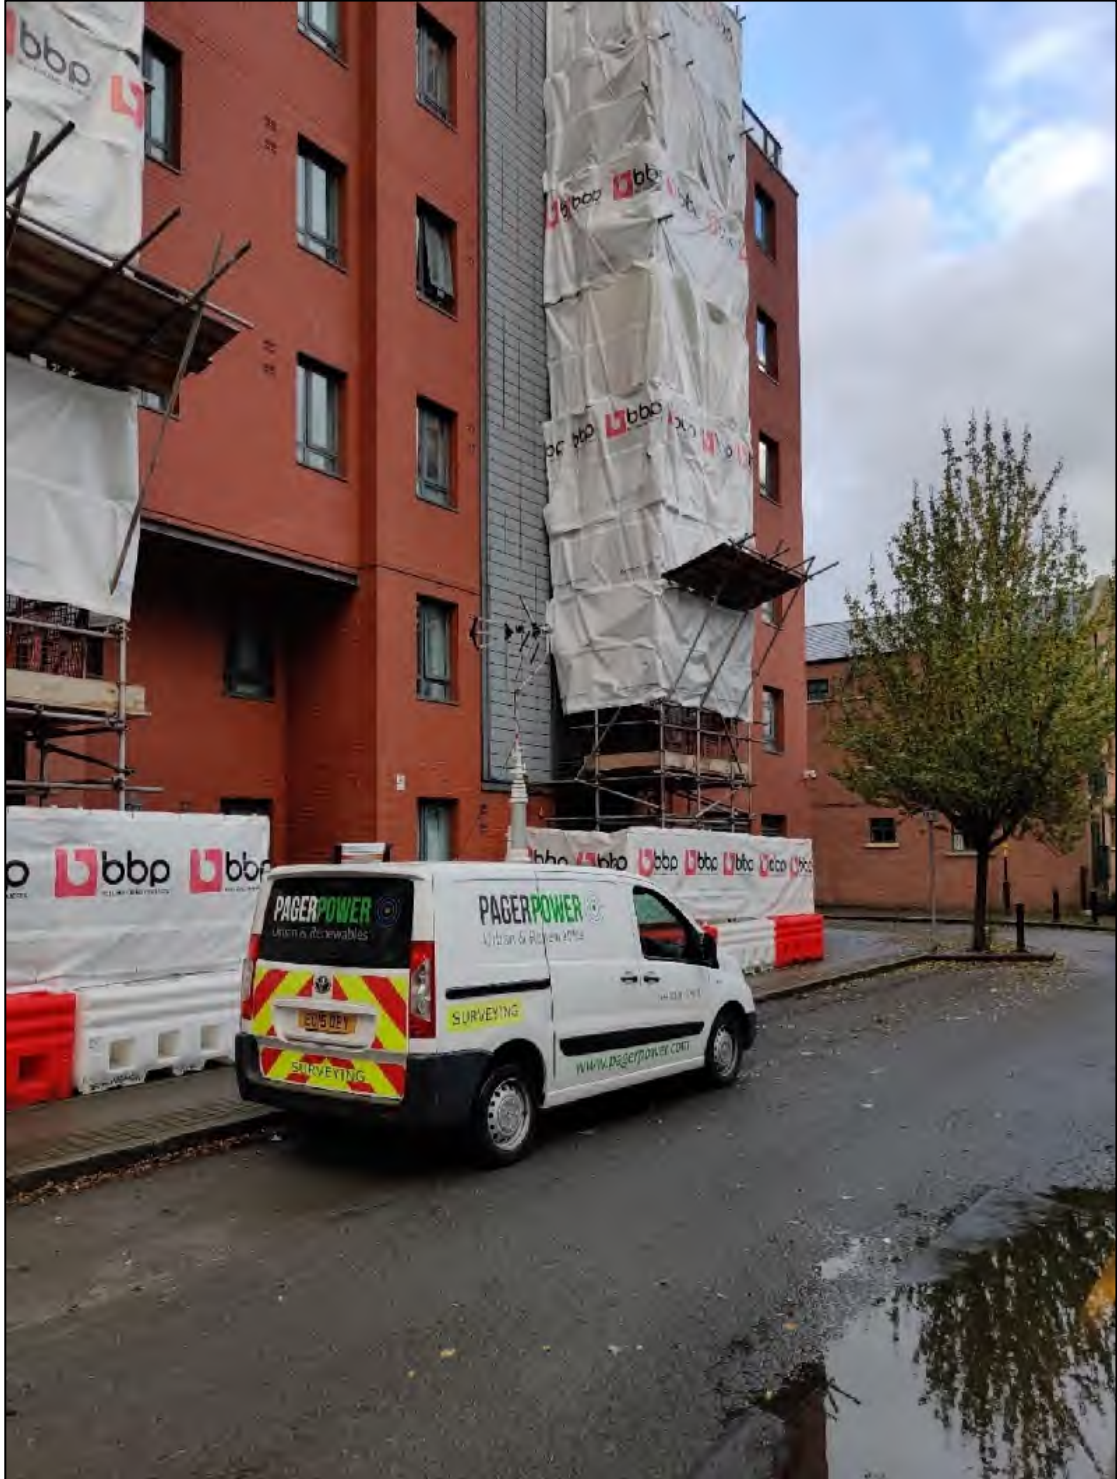
Location 3

Notes: No UHF aerials were observed at this location. One satellite dish was observed. Survey aerial looked east at this location because stronger signal in that direction were received.

| Location | Average Measured Signal Strength (dB) | Remarks | High Level Conclusion |
|---|---|---|---|
| 3 | <p>Main TV MUX: 47 (Good)</p> <p>Local TV MUX: 31 (Low)</p> | <p>Aerials dishes were not observed at this survey location. One satellite dish was observed.</p> <p>All main multiplexes displayed fine picture and audio quality, with signal fluctuations of less than 1dB and no signs of interference.</p> <p>Two local multiplexes were not decoded at this location.</p> | <p>The survey location is approximately 450m of the closest of the Proposed Development.</p> <p>It is possible that the signals are affected at this range, however significant effects are unlikely to be noticeable.</p> |

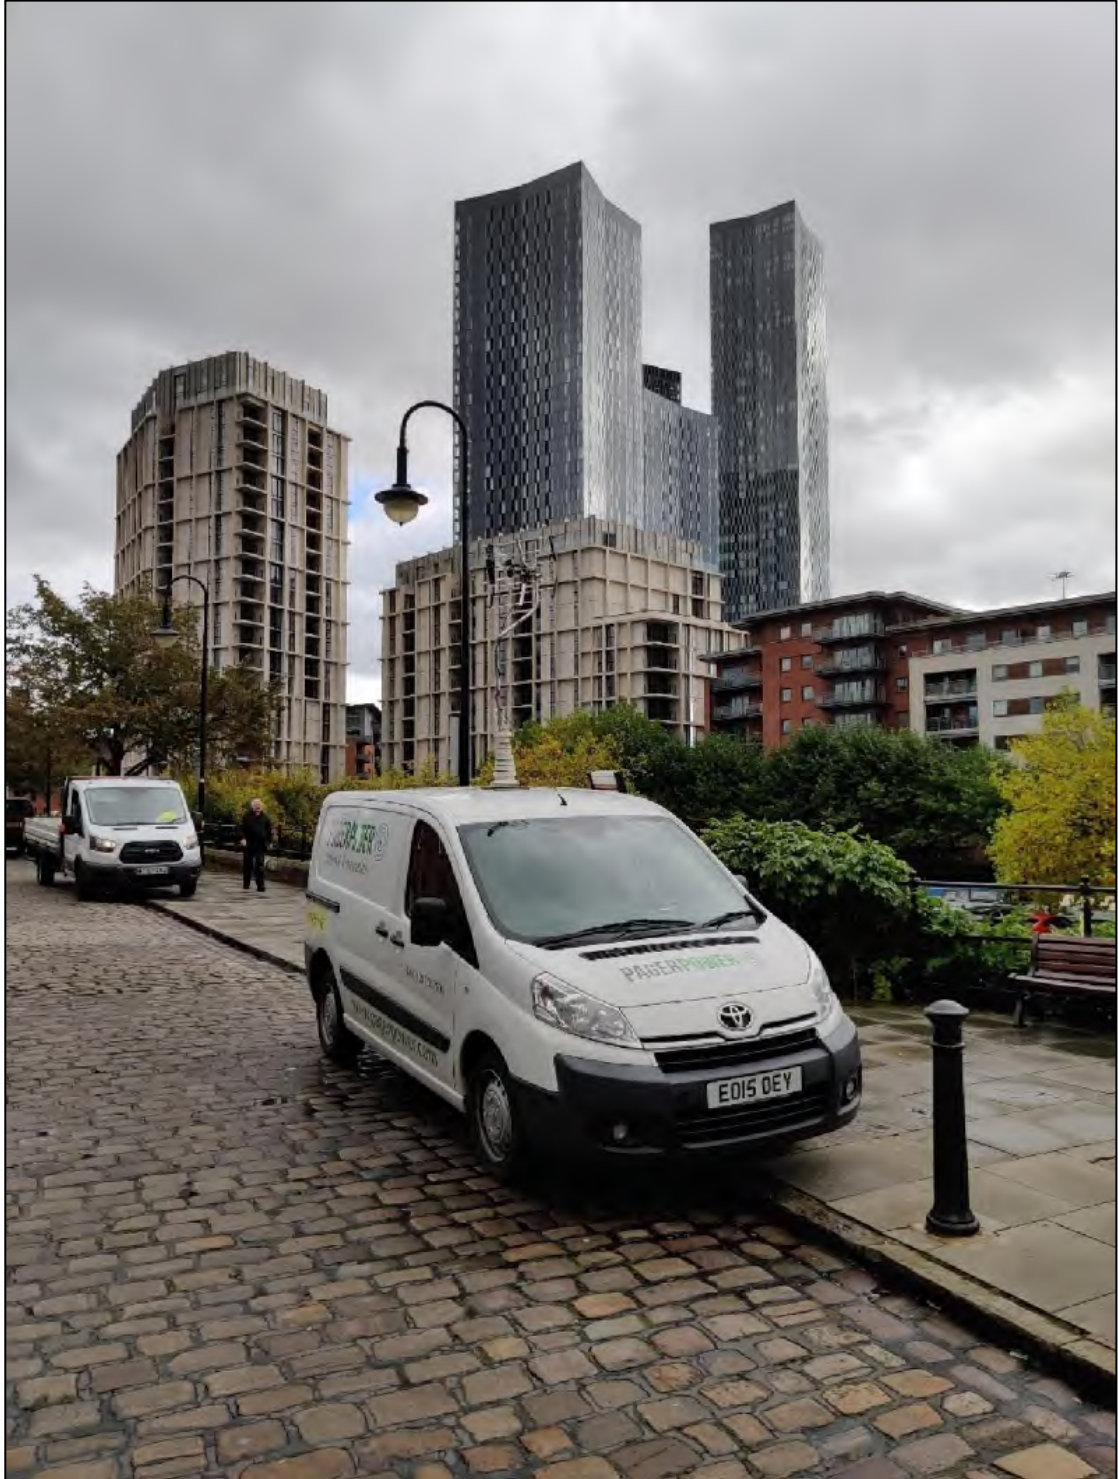
Location 4

Notes: No UHF aerials or satellite dishes were observed at this location.

| Location | Average Measured Signal Strength (dB) | Remarks | High Level Conclusion |
|---|---|---|---|
| 4 | <p>Main TV MUX: 51 (Good)</p> <p>Local TV MUX: 37 (Low)</p> | <p>Aerials and satellite dishes were not observed at this survey location.</p> <p>All main and local multiplexes displayed fine picture and audio quality, with signal fluctuations of less than 1dB and no signs of interference.</p> | <p>The survey location is more than 430m from the Proposed Development.</p> <p>It is possible that the signals are affected at this range, however existing good signal strength makes this less likely.</p> |

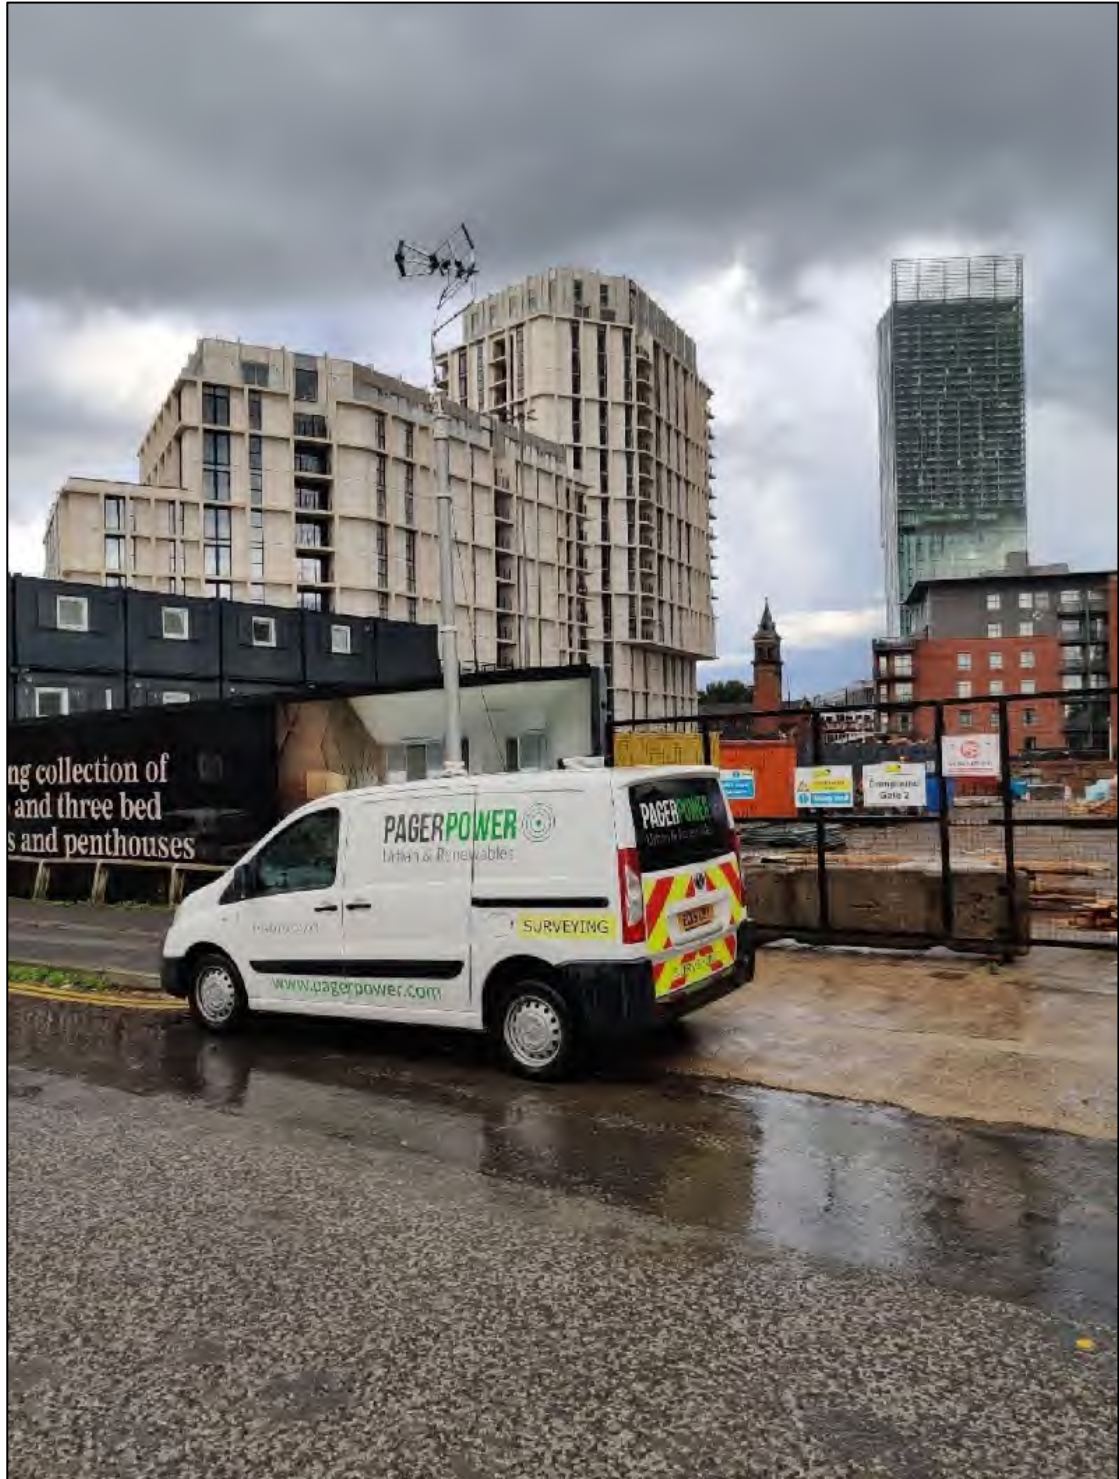
Location 5

Notes: Two UHF aerials directed towards the Winter Hill transmitter were observed. No satellite dishes were observed.

| Location | Average Measured Signal Strength (dB) | Remarks | High Level Conclusion |
|---|---|---|---|
| 5 | <p>Main TV MUX: 49 (Good)</p> <p>Local TV MUX: 35 (Moderate)</p> | <p>Two horizontally polarised aerials directed towards the Winter Hill transmitter.</p> <p>No satellite dishes were observed.</p> <p>All main multiplexes displayed fine picture and audio quality, with signal fluctuations of less than 1dB and no signs of interference.</p> <p>One local multiplex was not decoded at this location.</p> | <p>The survey location is more than 630m from the Proposed Development</p> <p>It is possible that the signals are affected at this range, however existing good signal strength makes this less likely.</p> |

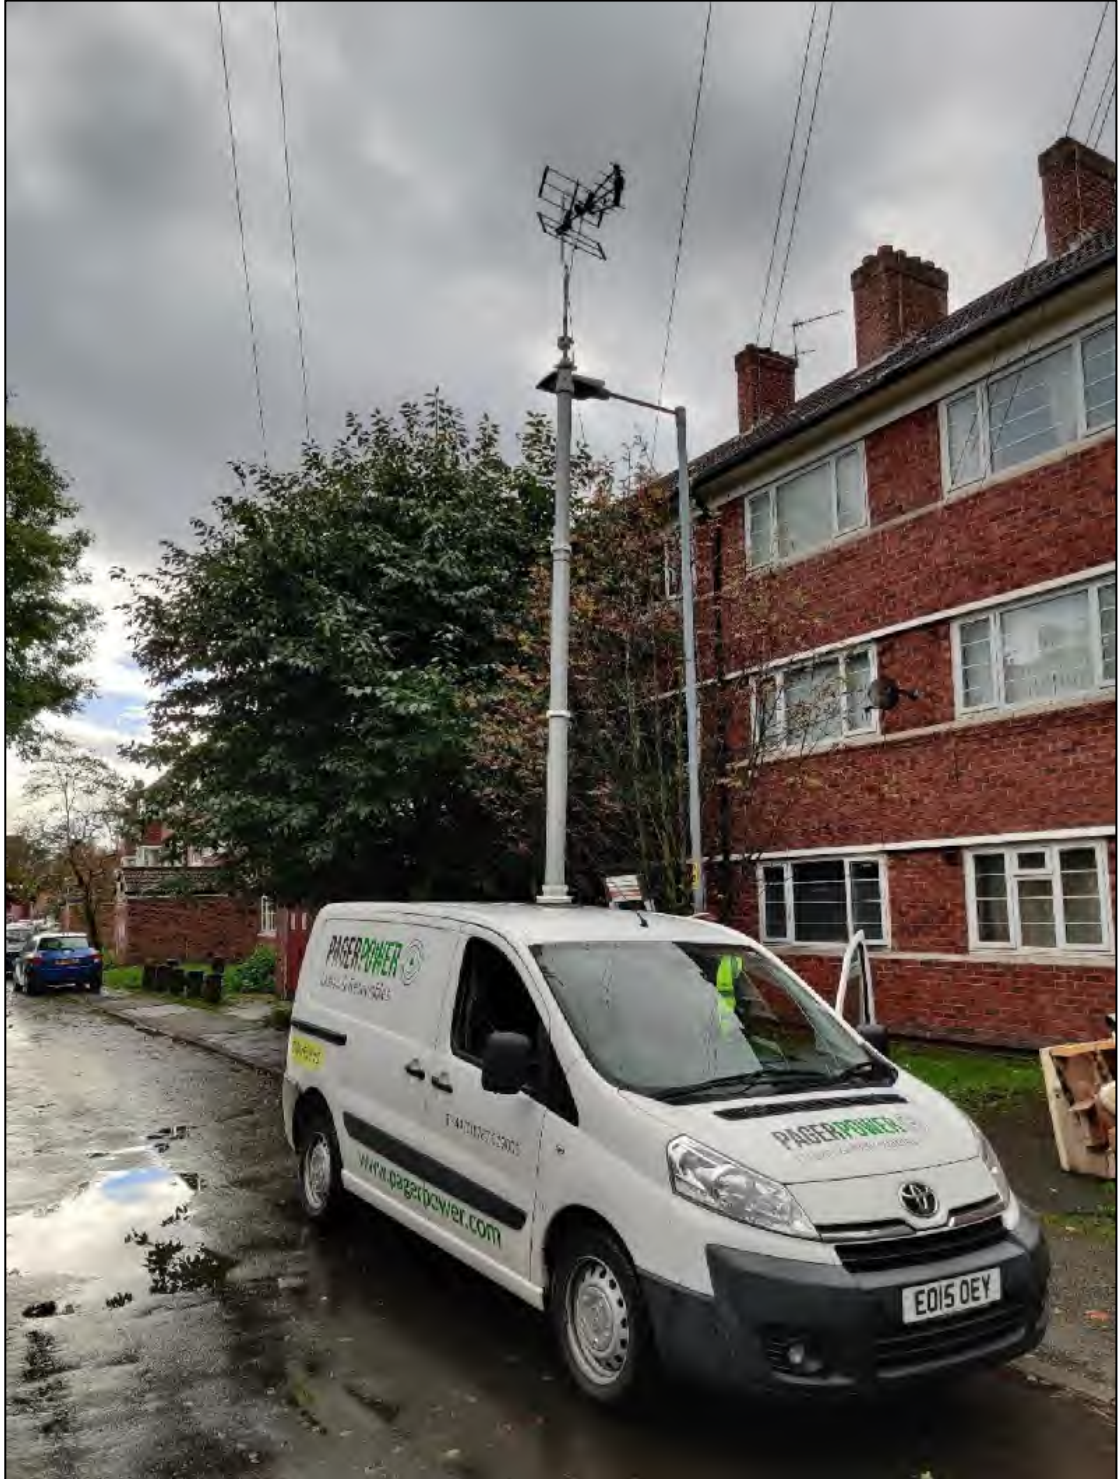
Location 6

Notes: Multiple UHF aerials directed towards the Winter Hill transmitter and satellite dishes were observed.

| Location | Average Measured Signal Strength (dB) | Remarks | High Level Conclusion |
|---|---|---|---|
| 6 | <p>Main TV MUX: 44 (Moderate)</p> <p>Local TV MUX: 32 (Low)</p> | <p>Multiple horizontally polarised aerials directed towards the Winter Hill transmitter and multiple satellite dishes were observed.</p> <p>All main multiplexes displayed fine picture and audio quality, with signal fluctuations of less than 1dB and no signs of interference.</p> <p>One local multiplex was not decoded at this location.</p> | <p>The survey location is more than 1.05km from the Proposed Development</p> <p>It is unusual for significant signal degradation to manifest itself at ranges of more than 1 km. There are however existing tall buildings (Crown Street, Deansgate Square etc.) between the survey location and the Proposed Development. This means that cumulative effects are possible.</p> <p>Significant interference is unlikely, however the possibility cannot be ruled out, particularly for the weakest multiplexes.</p> |

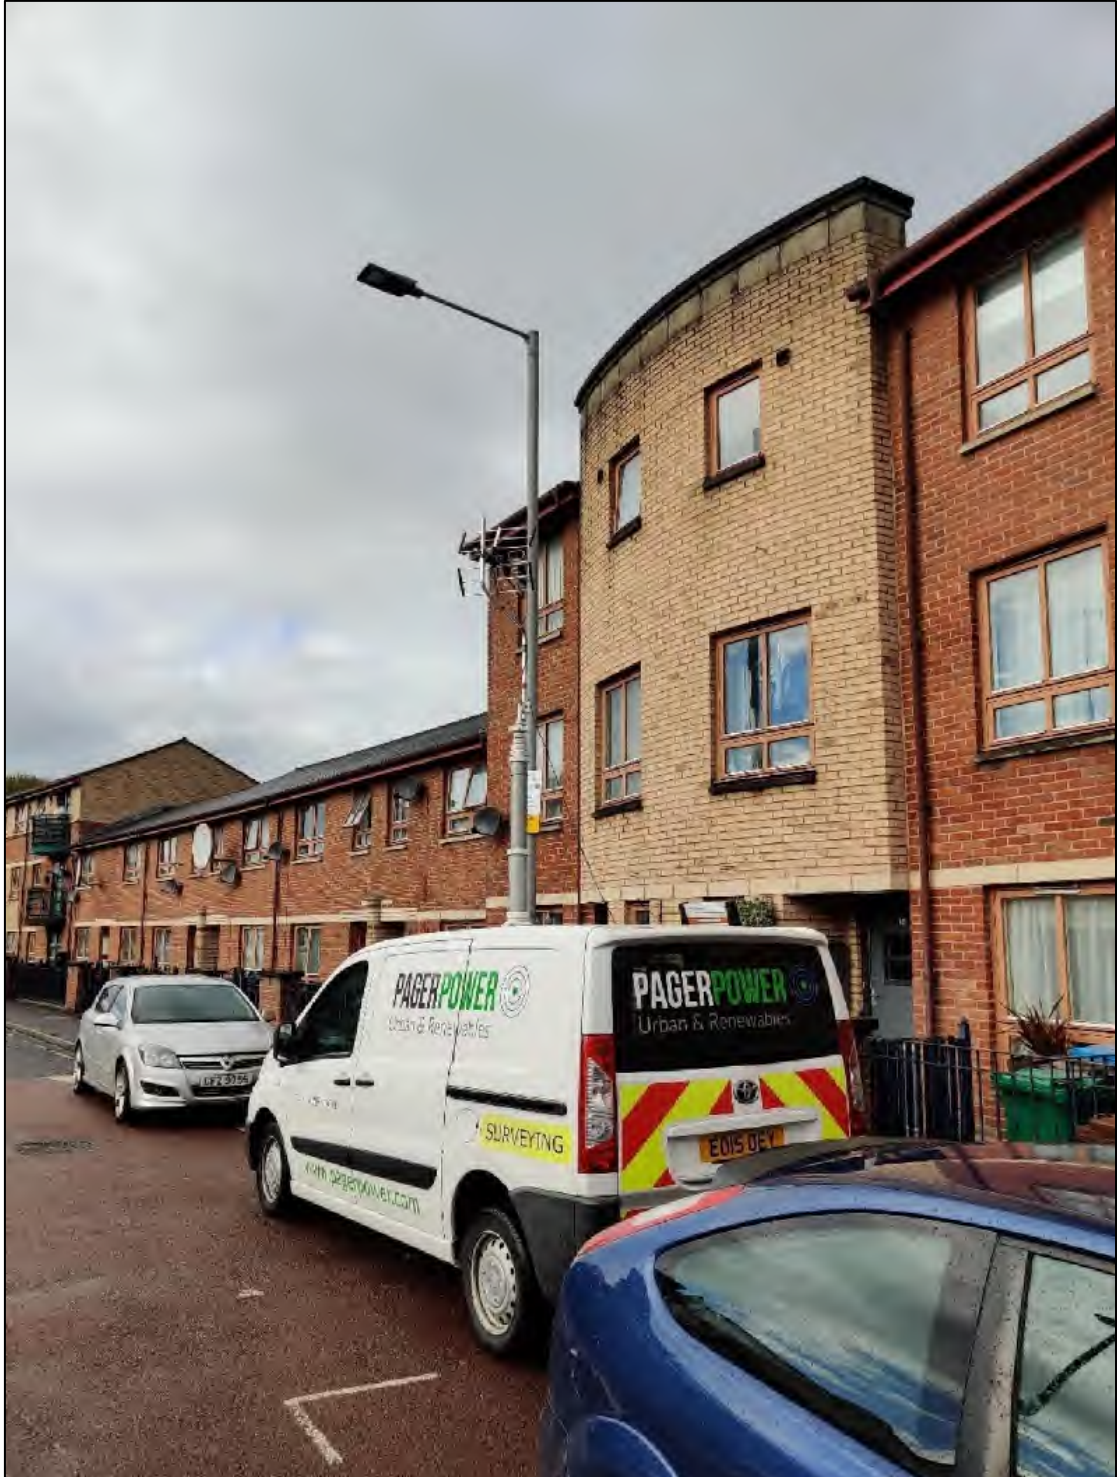
Location 7

Notes: Multiple UHF aerials directed towards the Winter Hill transmitter and satellite dishes were observed.

| Location | Average Measured Signal Strength (dB) | Remarks | High Level Conclusion |
|---|---|---|---|
| 7 | Main TV MUX: 49 (Good)<br>Local TV MUX: 34 (Low) | <p>Horizontally polarised aerials directed towards the Winter Hill transmitter and satellite dishes were observed.</p> <p>All main multiplexes displayed fine picture and audio quality, with signal fluctuations of less than 1dB and no signs of interference.</p> <p>One local multiplex was not decoded at this location.</p> | <p>The survey location is more than 1.20km from the Proposed Development</p> <p>It is unusual for significant signal degradation to manifest itself at ranges of more than 1 km. There are however existing tall buildings (Crown Street, Deansgate Square etc.) between the survey location and the Proposed Development. This means that cumulative effects are possible.</p> <p>Significant interference is unlikely, however the possibility cannot be ruled out, particularly for the weakest multiplexes.</p> |

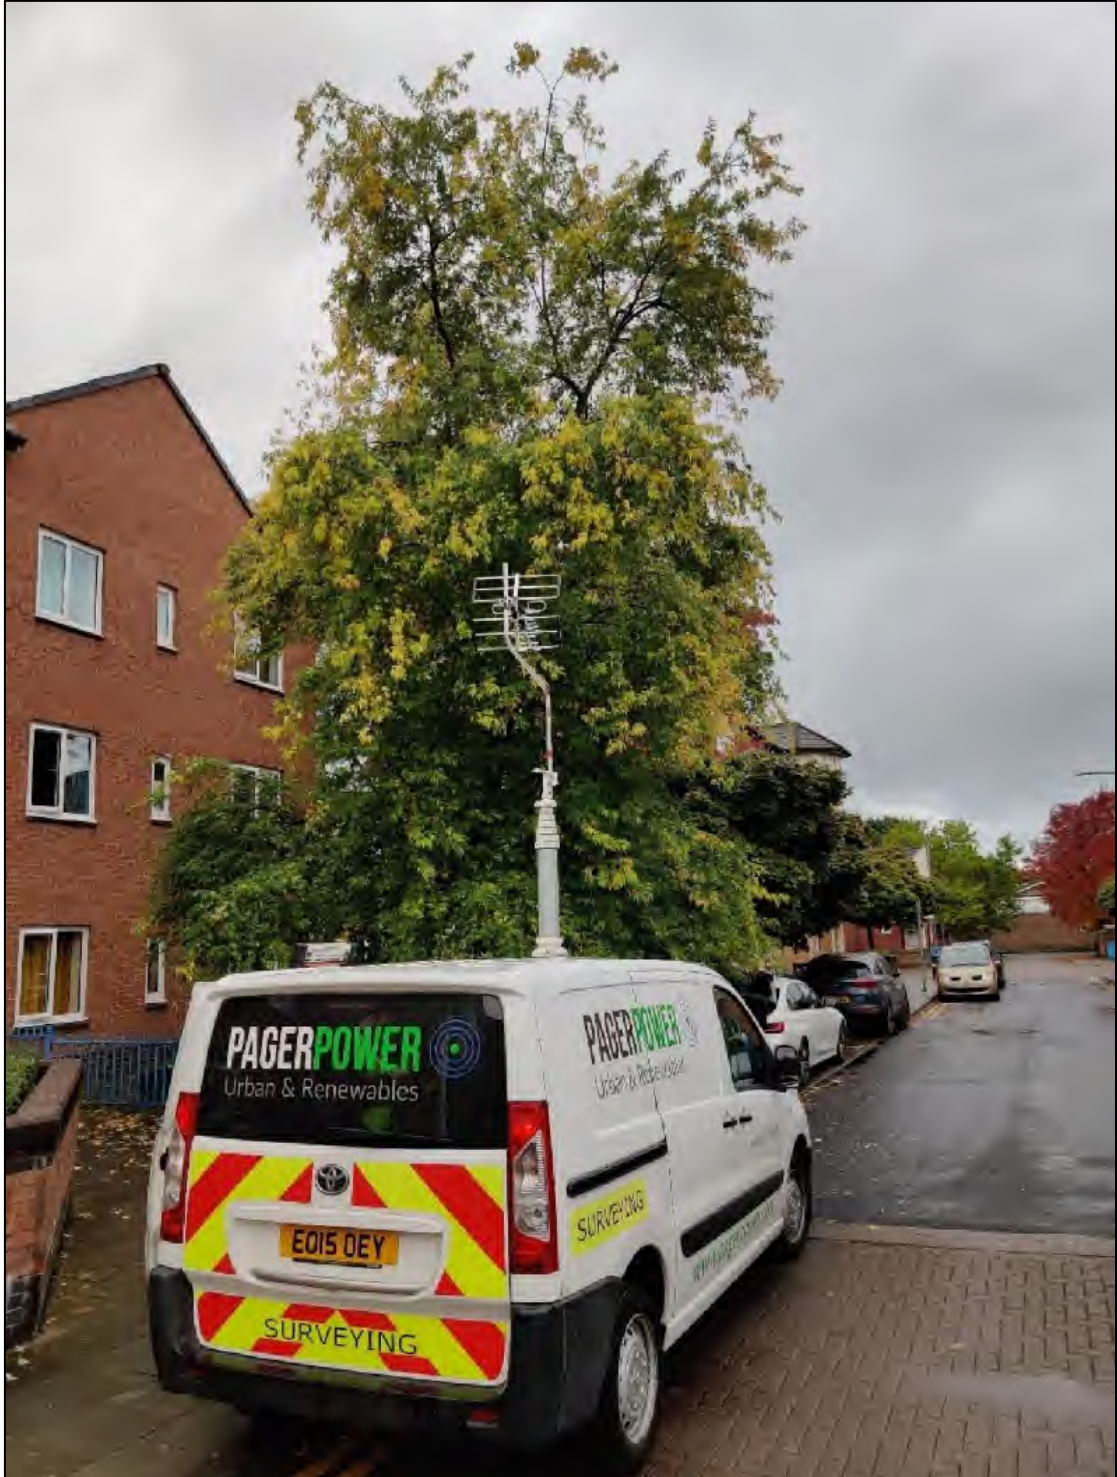
Location 8

Notes: Multiple UHF aerials directed towards the Winter Hill transmitter and satellite dishes were observed.

| Location | Average Measured Signal Strength (dB) | Remarks | High Level Conclusion |
|---|---|---|---|
| 8 | Main T V MUX: 47 (Good)<br>Local TV MUX: 31 (Low) | <p>Horizontally polarised aerials directed towards the Winter Hill transmitter and satellite dishes were observed.</p> <p>All main multiplexes displayed fine picture and audio quality, with signal fluctuations of less than 1dB and no signs of interference.</p> <p>Two local multiplex was not decoded at this location.</p> | <p>It is unlikely that noticeable losses would occur at 2.01km from the Proposed Development based on previous assessment experience even considering potential cumulative effects.</p> <p>Significant interference is unlikely.</p> |
